# TOTE ROAD BG-27

# TOTE ROAD BG-30

BAFFINLAND IRON MINES  
MARY RIVER PROJECT

**North/South Consultants Inc.**  
Aquatic Environment Specialists

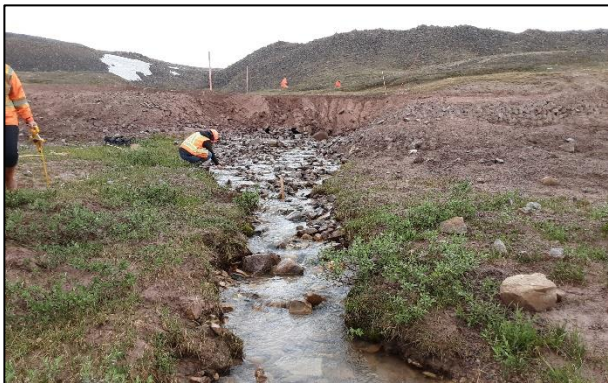
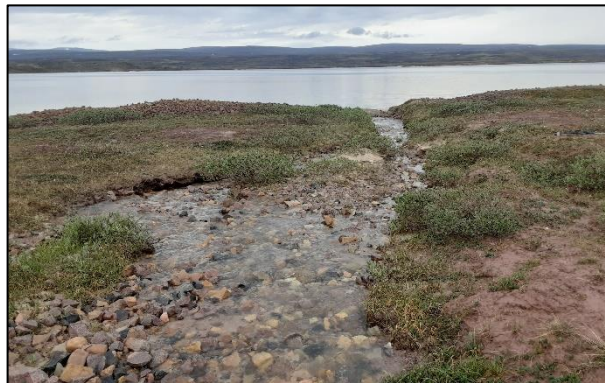
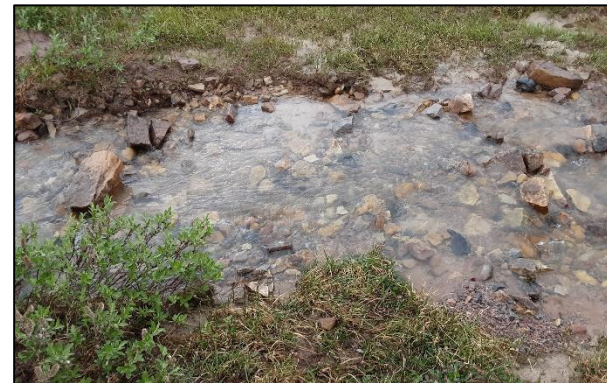
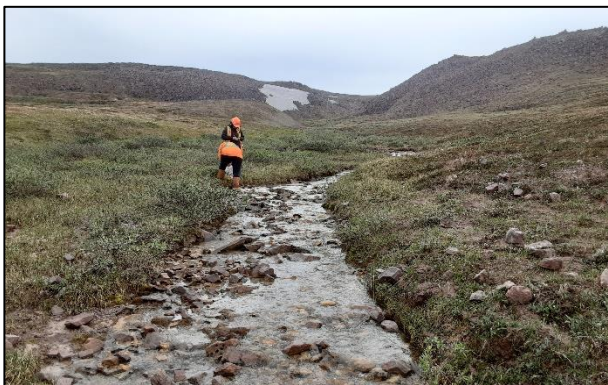
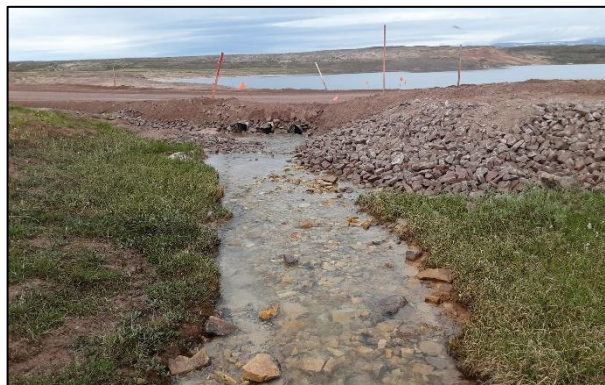
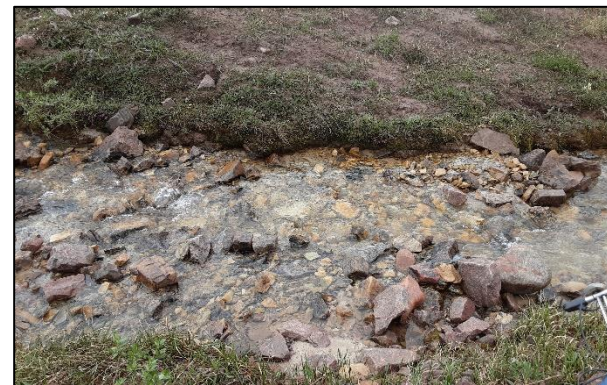
**Photos 1-1.** Photos taken 20 m downstream (top) and 20 m upstream (bottom) in spring 2024: (A,D) facing upstream; (B,E) facing downstream; and (C,F) across (left bank looking at right bank).

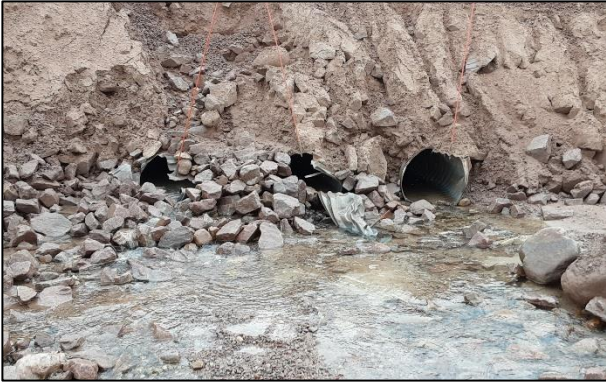
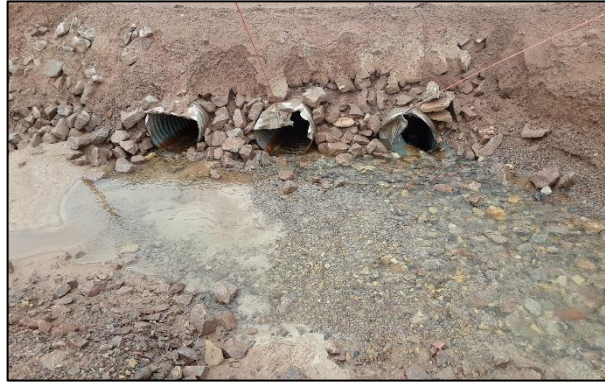
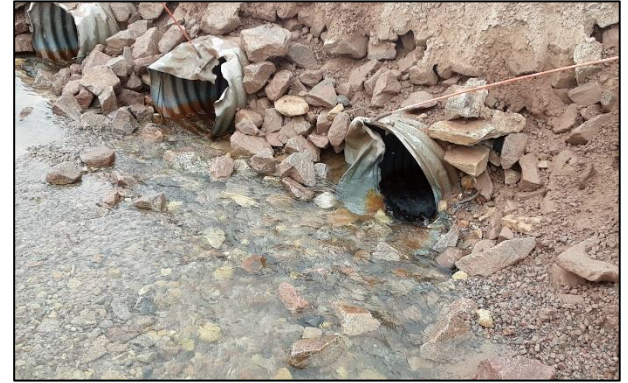
**Photos 1-2.** Photos taken of the culverts in spring 2024: (A) downstream end; and (B,C) upstream end.

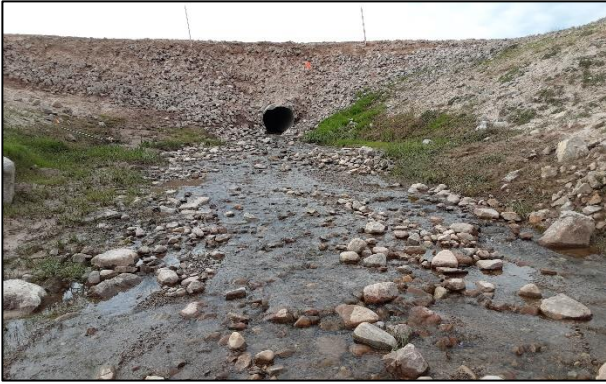
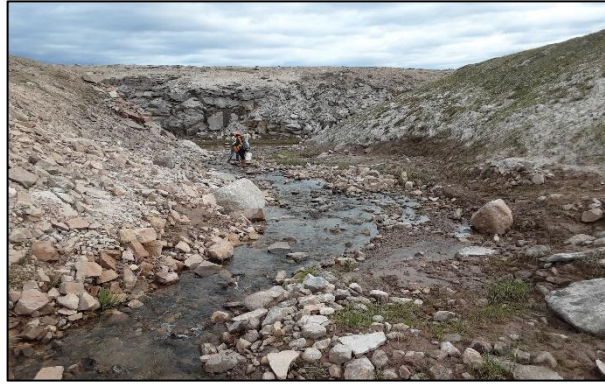
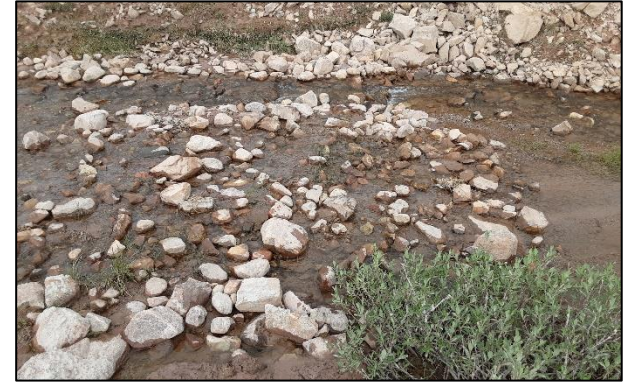
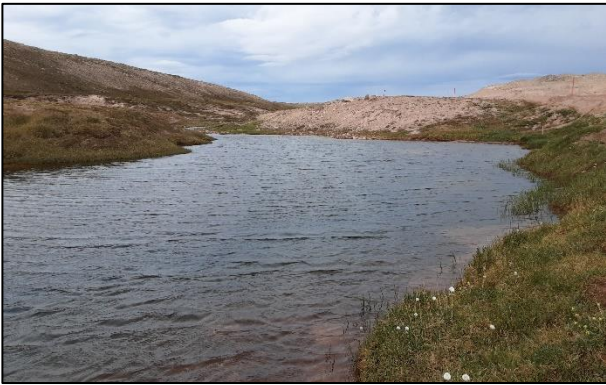
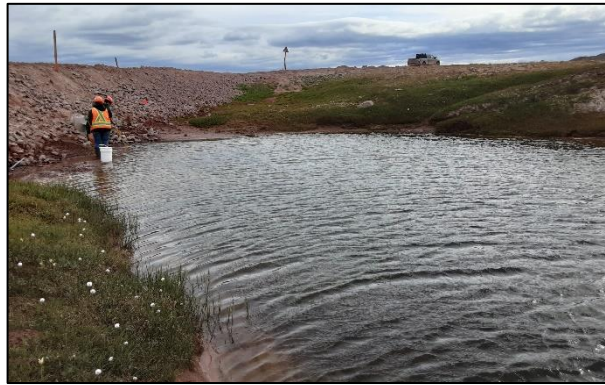
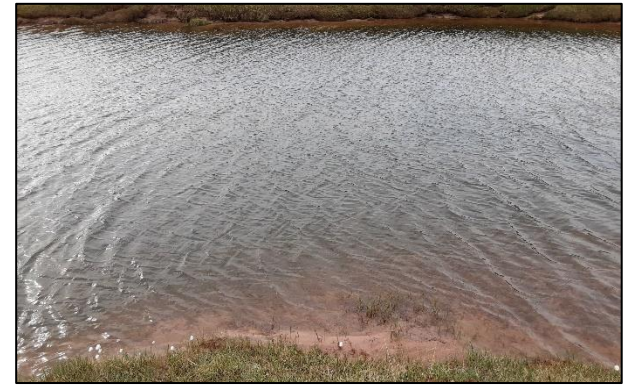
In late spring 2024, measured wetted stream width 20 m downstream from the culvert was 4.6 m. and depths ranged from 0.03-0.14 m. A large pool is present immediately upstream of the road that persists throughout the open-water period. In spring 2024, the pool had a wetted width of 17.1 m and estimated maximum depth of >1.5 m. Measured velocities ranged from 0.16-0.77 m/s downstream; velocity was negligible in the upstream pond. Habitat was mainly riffle/run/pool downstream and deep pool upstream of the crossing. Substrates were predominantly cobble/gravel downstream and fines upstream.

**Photos 1-1.** Photos taken 20 m downstream (top) and 20 m upstream (bottom) in spring 2024: (A,D) facing upstream; (B,E) facing downstream; and (C,F) across (left bank looking at right on top, right bank looking at left bank on bottom).

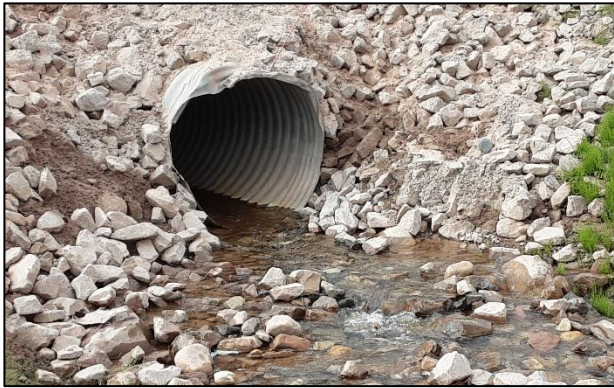
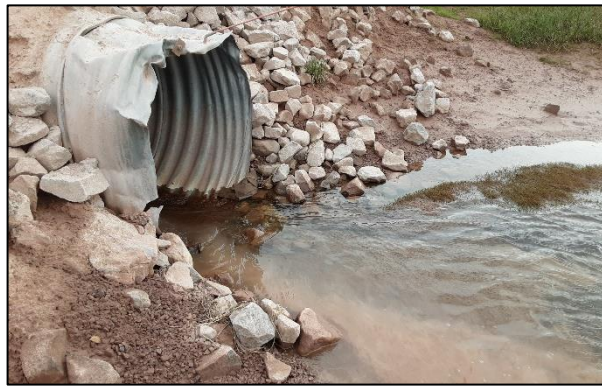
The Tote Road crosses a small, unnamed stream at site BG-30 that flows 70 m north to the BG-29 stream system, sharing the same nearby potential overwintering lakes. This stream was part of the compensation plan for the original HADD authorization. A natural rockslide near the confluence with the BG-29 stream that had blocked fish access from overwintering areas and prevented fish use of available habitat upstream from the rockslide was removed in 2010. The channel was remediated into a natural step-pool approach to the culvert, successfully restoring fish passage to the entire watershed. This crossing is scheduled for additional future remediation.

**Photos 1-2.** Photos taken of the culvert in spring 2024: (A) downstream end; and (B) upstream end.

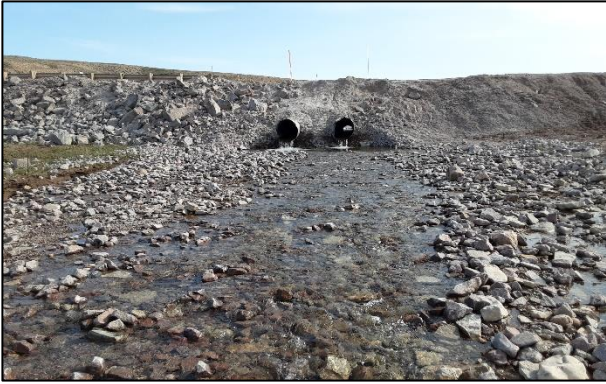
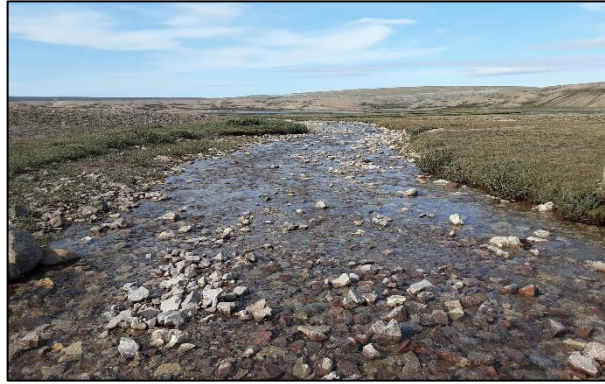
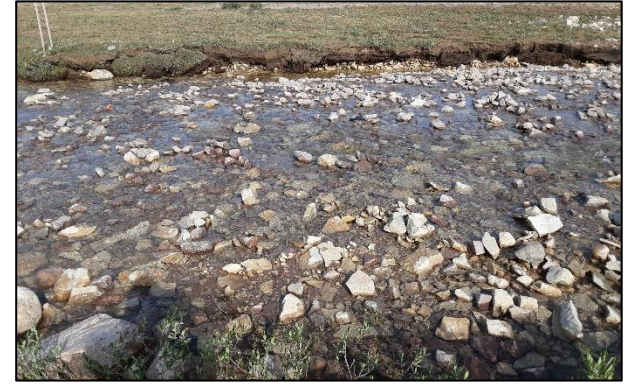
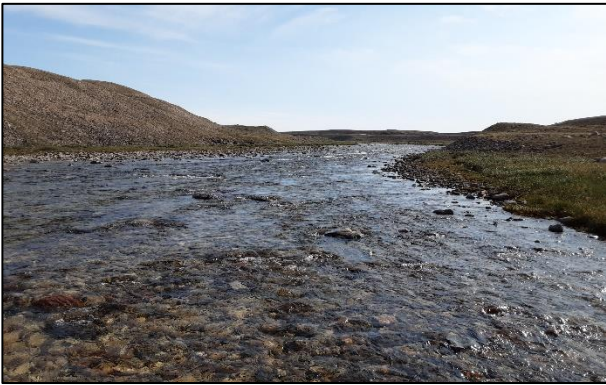
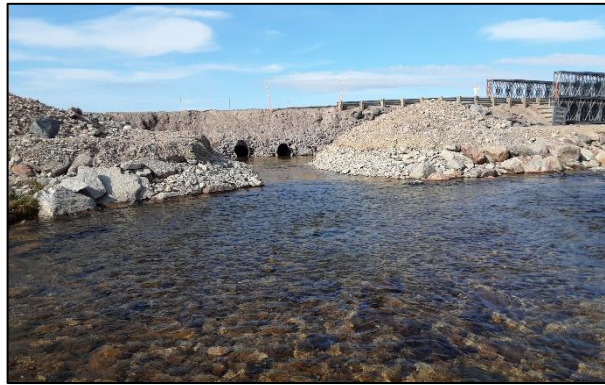
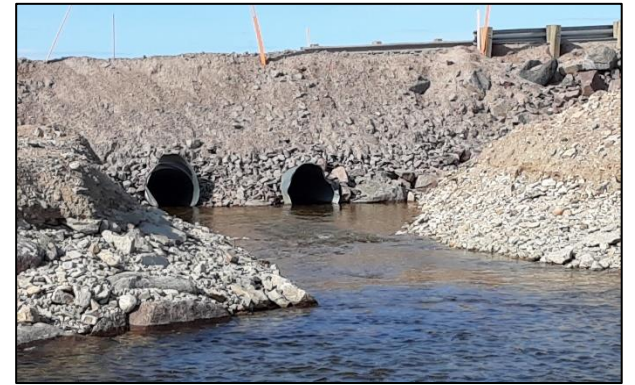
**Photos 1-1.** Photos taken 20 m downstream (top) and 20 m upstream (bottom) in spring 2024: (A,D) facing upstream; (B,E) facing downstream; and (C,F) across (right bank looking at left bank).

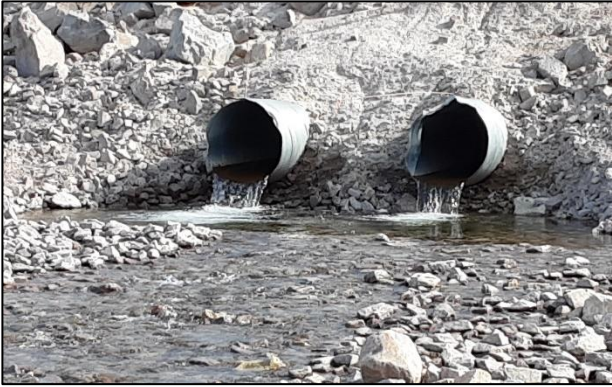
**Photos 1-2.** Photos taken of the culvert at the downstream end in spring 2024. The upstream end of the culverts could not be accessed due to water depth and steep banks near the road.

The Tote Road crosses a large, unnamed river at site BG-50 that flows 1.0 km west to a small lake. Although a bathymetric survey has not been conducted, the lake is suspected of being of sufficient depth to support overwintering based on shoreline surveys and review of available imagery. The road crossing is located at the upstream end of a mid-channel island and is separated into a bridge crossing on the larger north channel and a culvert crossing at the smaller south channel. The culverts are perched and impassable to fish but the bridge crossing does not affect fish passage. This road crossing is scheduled for future remediation.

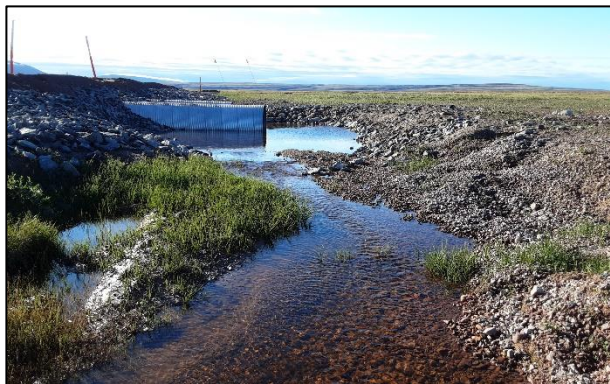
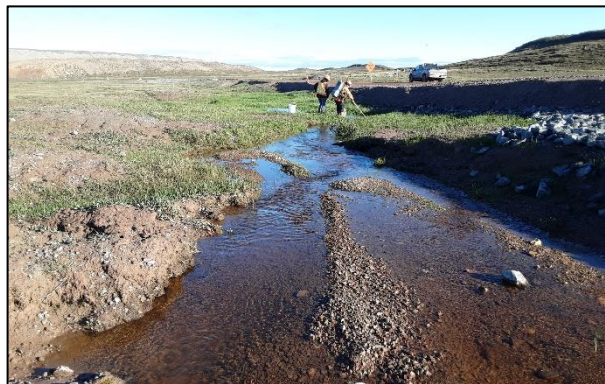
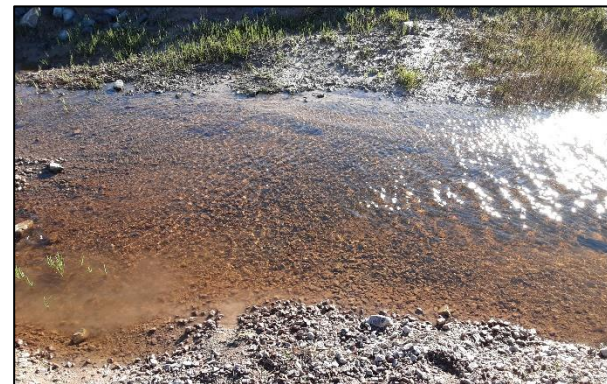
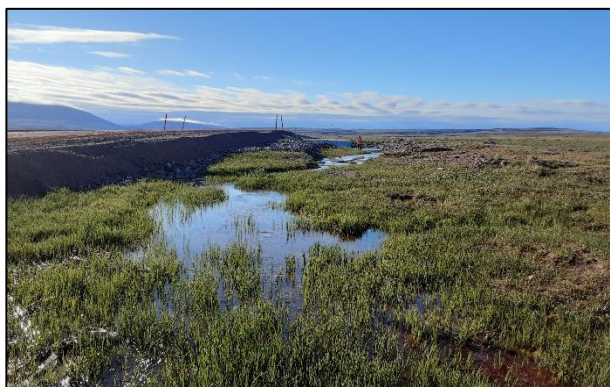
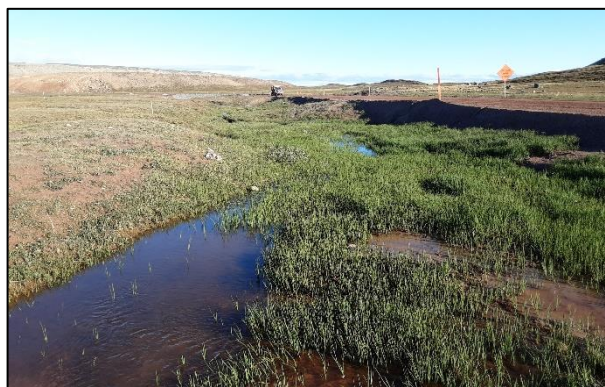
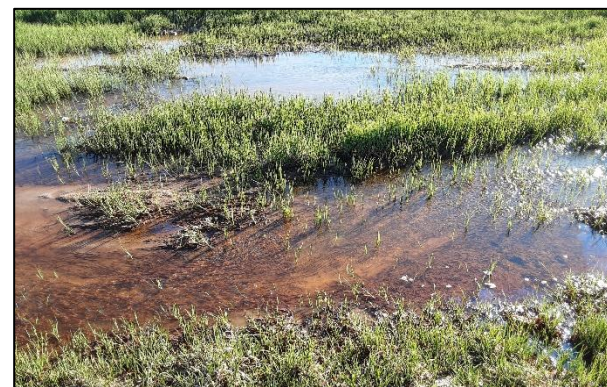
**Photos 1-1.** Photos taken 20 m downstream (top) and 60 m downstream (bottom) in spring 2024: (A,D) facing upstream; (B,E) facing downstream; and (C,F) across (left bank looking at right bank).

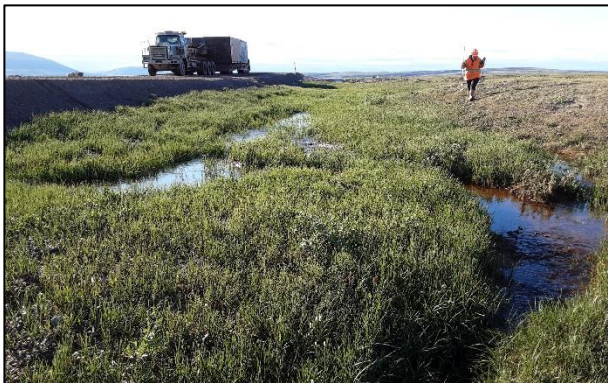
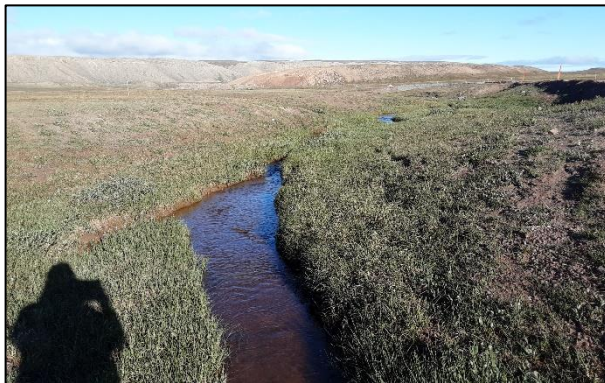
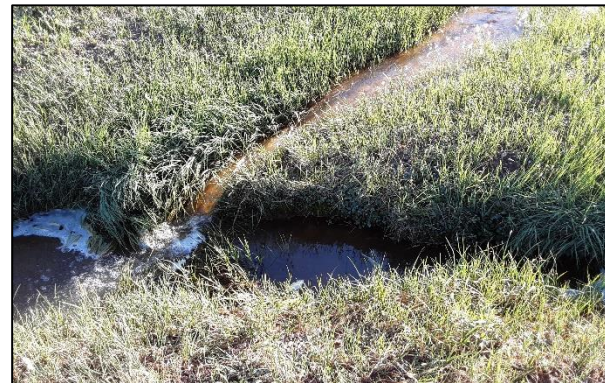
**Photos 1-2.** Photos taken 100 m downstream in spring 2024: (A) facing upstream; (B) facing downstream; and (C) across (left bank looking at right bank).

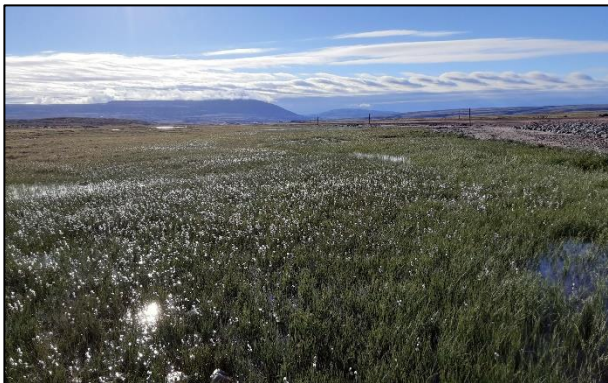
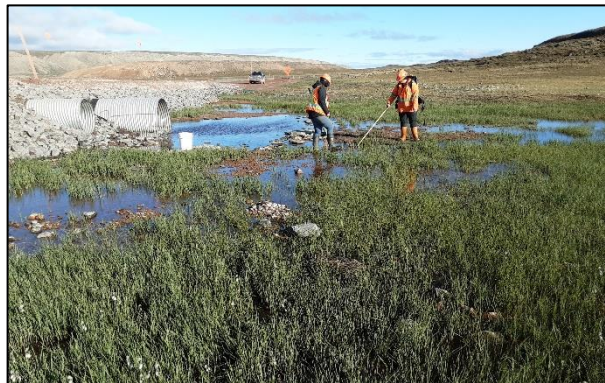
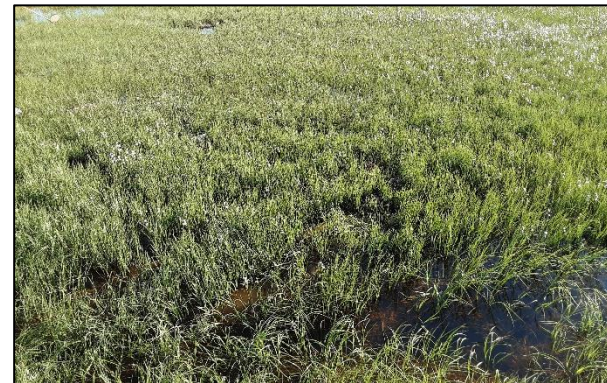
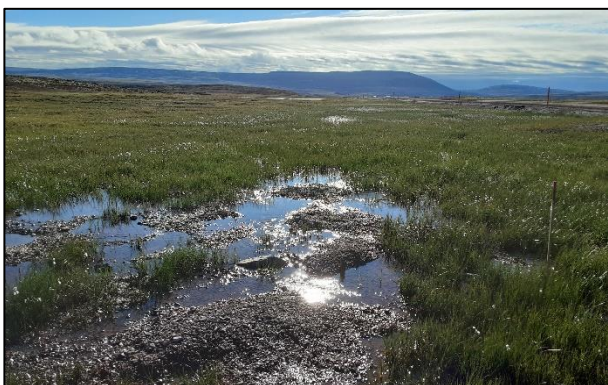
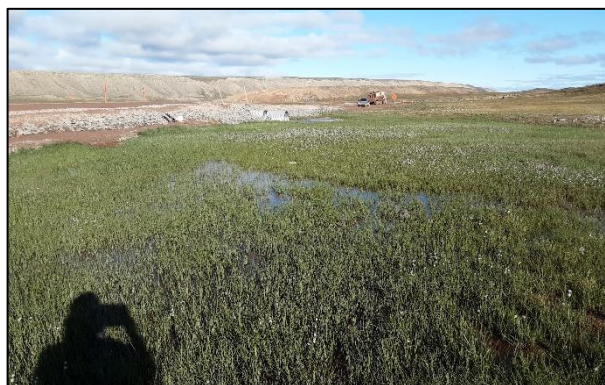
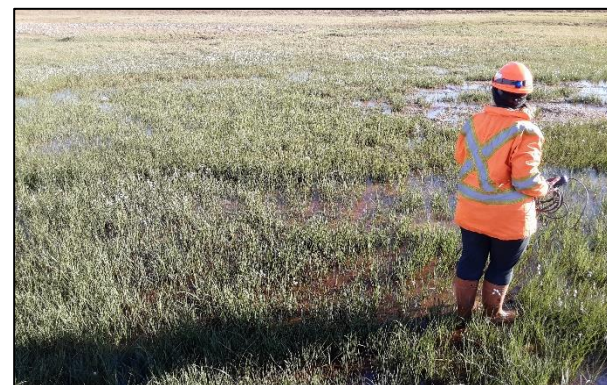
**Photos 1-3.** Photos taken 20 m upstream (top) and 60 m upstream (bottom) in spring 2024: (A,D) facing upstream; (B,E) facing downstream; and (C,F) across (left bank looking at right bank).

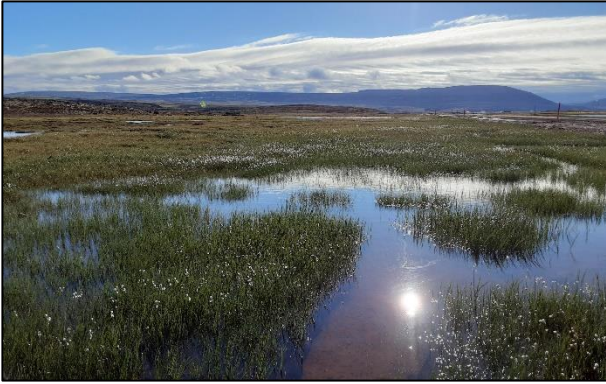
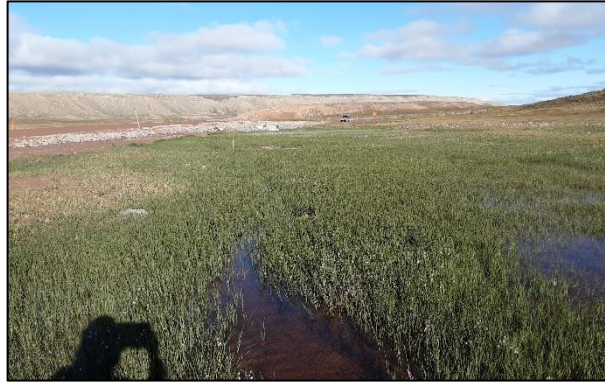
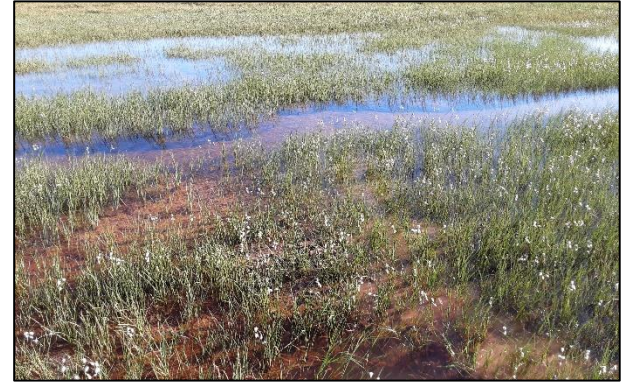
**Photos 1-4.** Photos taken 100 m upstream in spring 2024: (A) facing upstream; (B) facing downstream; and (C) across (left bank looking at right bank).

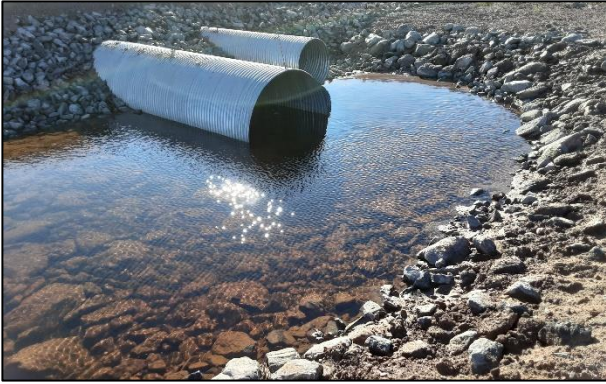
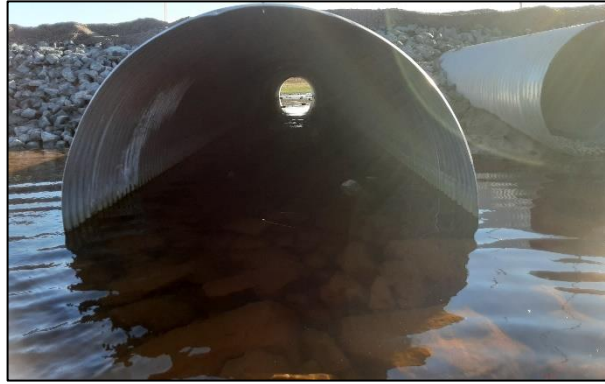
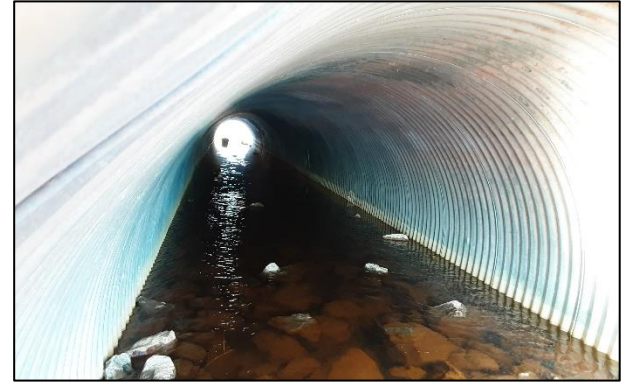
This crossing was remediated in winter 2023/2024. The crossing now consists of two large, embedded culverts with cobble substrate that allow unimpeded fish passage. No issues with the crossing were identified.

**Photos 1-5.** Photos taken of the culvert in spring 2024: (A, B) downstream end; and (C) upstream end.

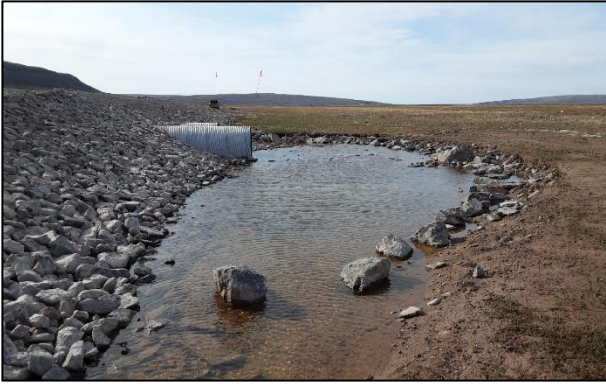
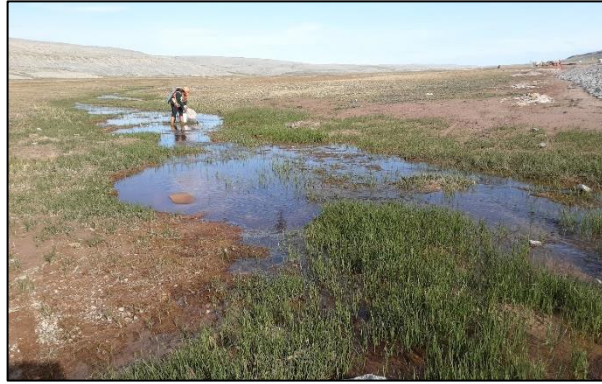
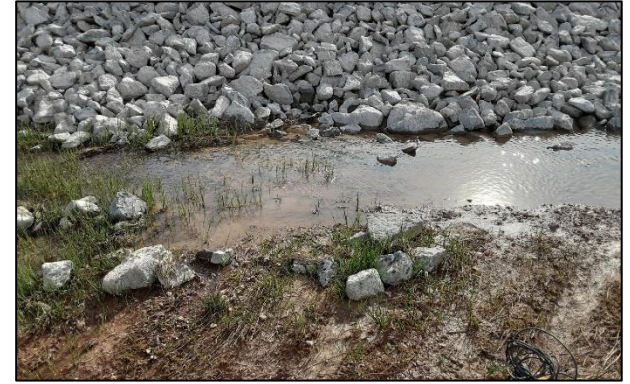
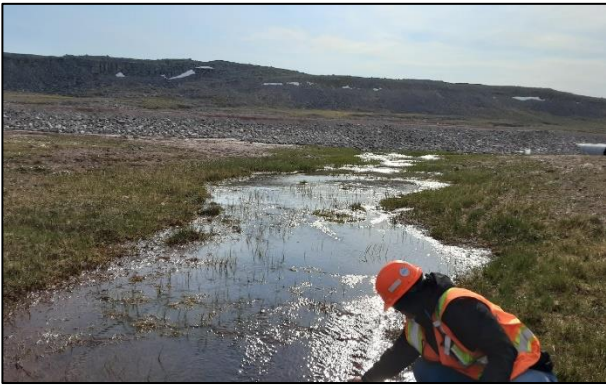
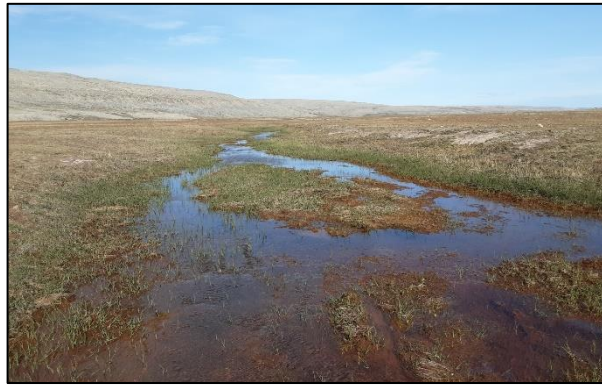
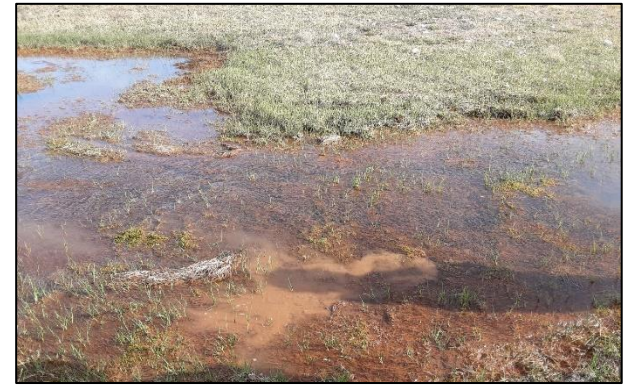
**Photos 1-1.** Photos taken 20 m downstream (top) and 60 m downstream (bottom) in spring 2024: (A,D) facing upstream; (B,E) facing downstream; and (C,F) across (left bank looking at right bank).

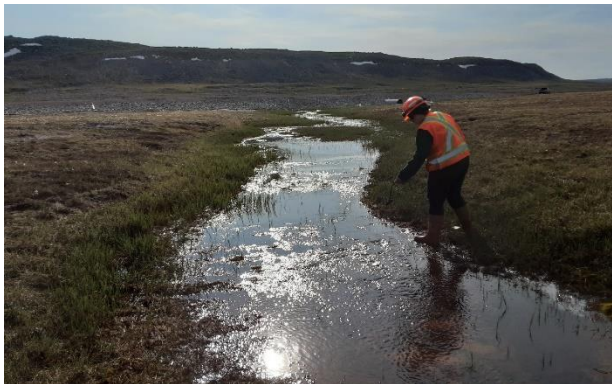
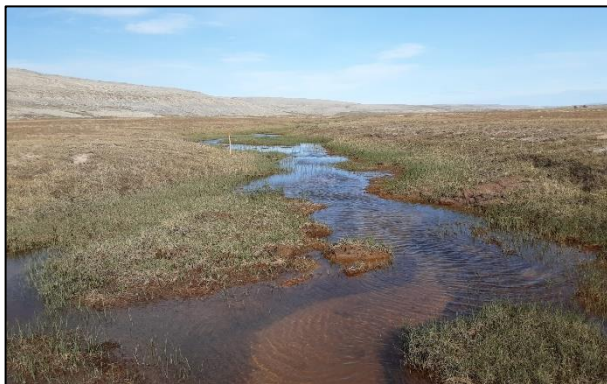
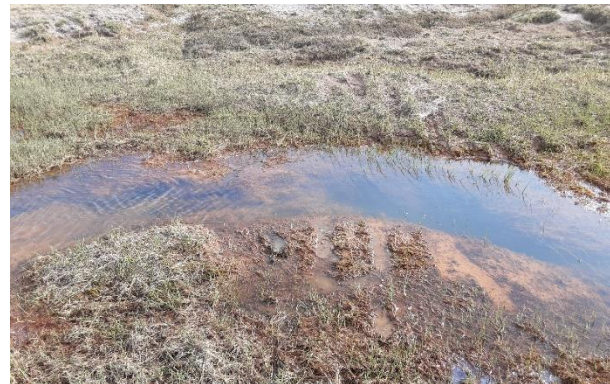
**Photos 1-2.** Photos taken 100 m downstream in spring 2024: (A) facing upstream; (B) facing downstream; and (C) across (left bank looking at right bank).

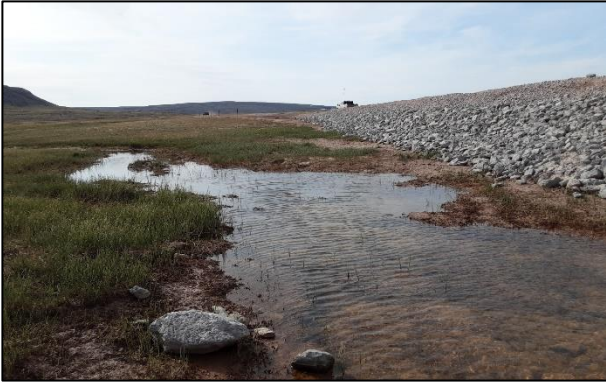
A

**Photos 1-3.** Photos taken 20 m upstream (top) and 60 m upstream (bottom) in spring 2024: (A,D) facing upstream; (B,E) facing downstream; and (C,F) across (left bank looking at right bank).

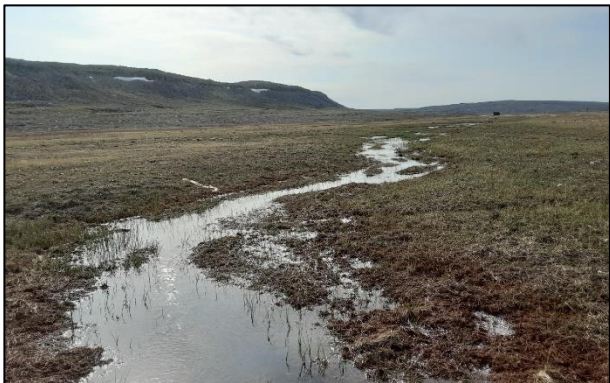
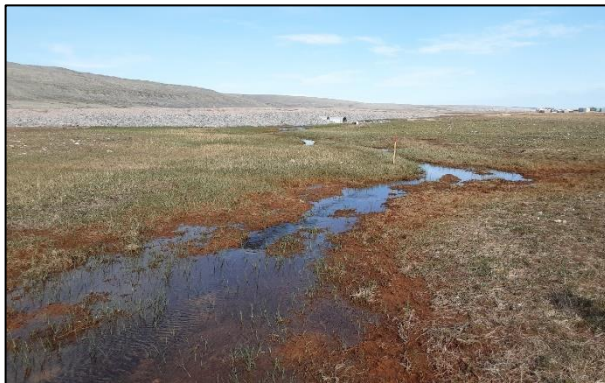
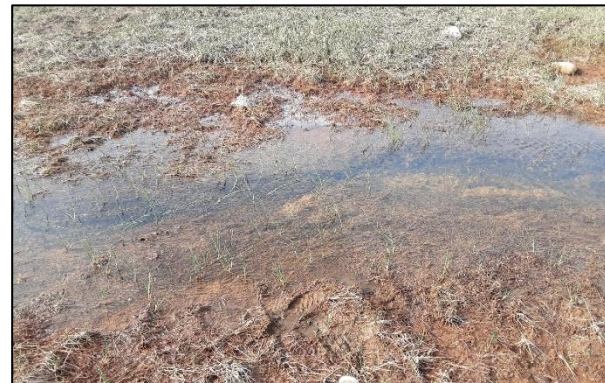
**Photos 1-4.** Photos taken 100 m upstream in spring 2024: (A) facing upstream; (B) facing downstream; and (C) across (left bank looking at right bank).

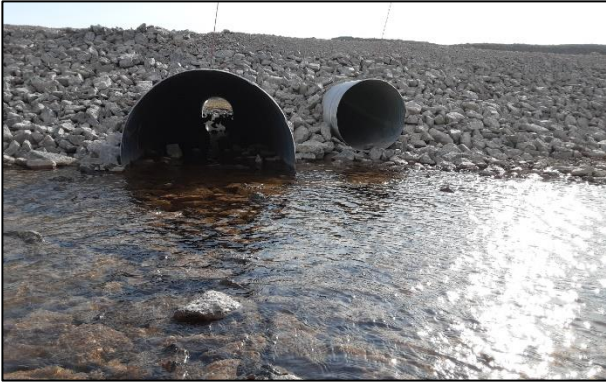
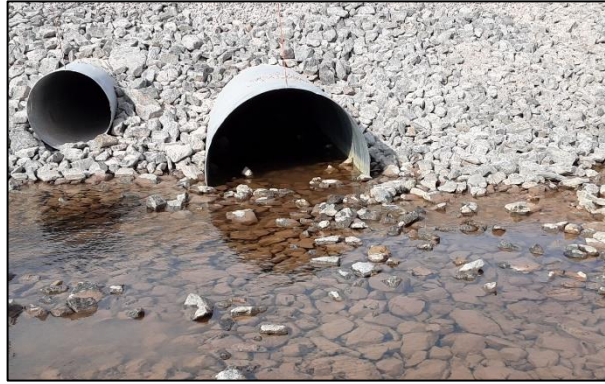
This crossing was remediated in winter 2023/2024. There is now a large, embedded culvert with a cobble apron and in-culvert cobble that allows unimpeded fish passage. No issues with the crossing were identified.

Stream morphology was a combination of shallow and deep pools in wider areas and riffle-run at constrictions throughout. The stream is nearly uniformly composed of fine substrate with small patches of gravel and occasional piece of cobble. There are greater proportions of cobble within 20 m of the culvert since remediation due to the new cobble aprons.

**Photos 1-5.** Photos taken of the culverts in spring 2024: (A) downstream end; and (B) upstream end.
