Re: Baffinland Response to the 2025 Site Visit Report (NIRB FILE No. 08MN053)

Thank you for providing Baffinland Iron Mines Corporation (Baffinland) with your 2025 Site Visit Report for the Mary River Project.

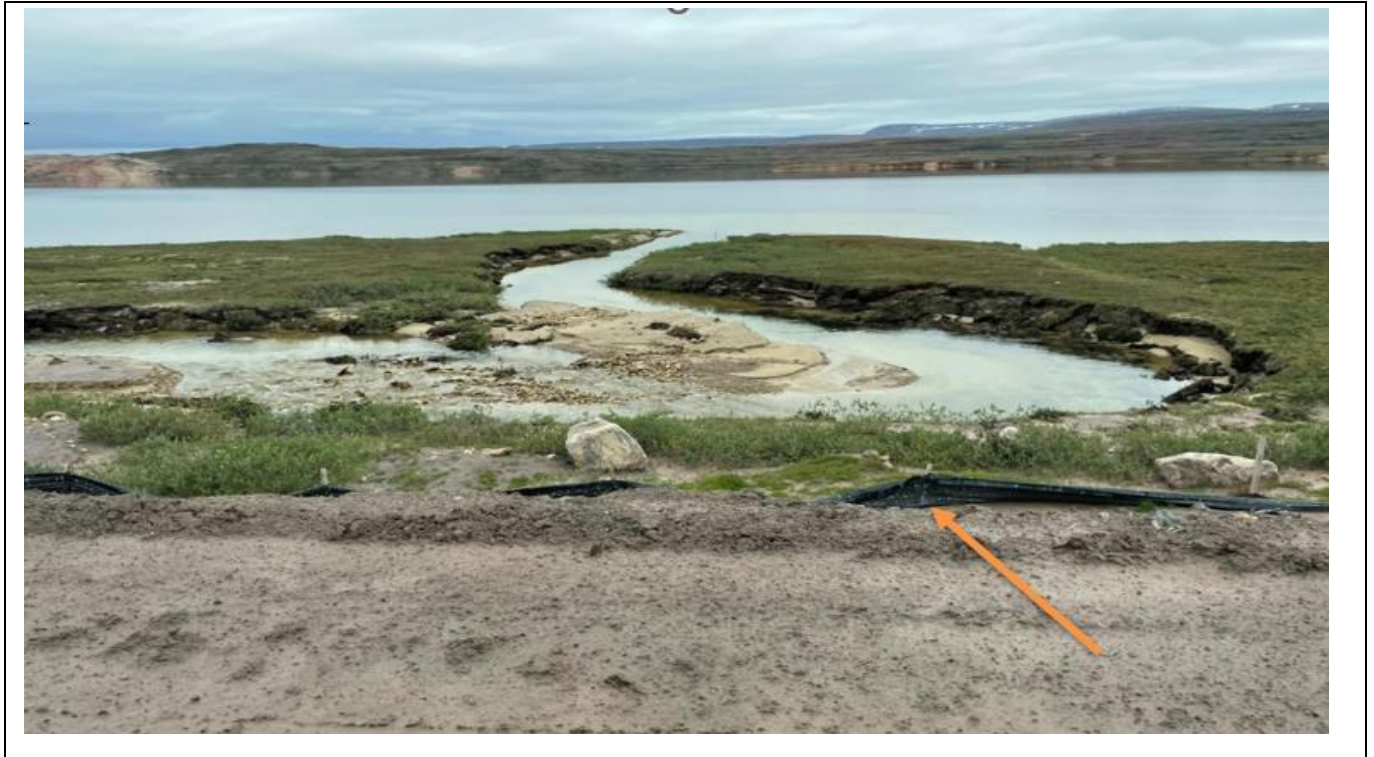
Photo 1. BG 24 (KM 87.5)– Photo 46 from the NIRB inspection.

Baffinland routinely performs erosion and sediment control inspections on the tote road and prioritises repairs at locations that are adjacent to fish bearing crossings. After receiving the Site Visit Report, damaged silt fences identified on the tote road were evaluated and many have been restored and documented in the bi-weekly DFO reports (see attached photos). Silt fences that were unable to be repaired due to freeze-up and frozen ground will be remediated upon thawed conditions in 2026. Baffinland will continue to review silt fences and erosion and sediment control measures in 2026 to ensure they are operating effectively. In addition, Baffinland is working with DFO to permit road embankment retrofits that will reduce erosion at select fish bearing crossings.

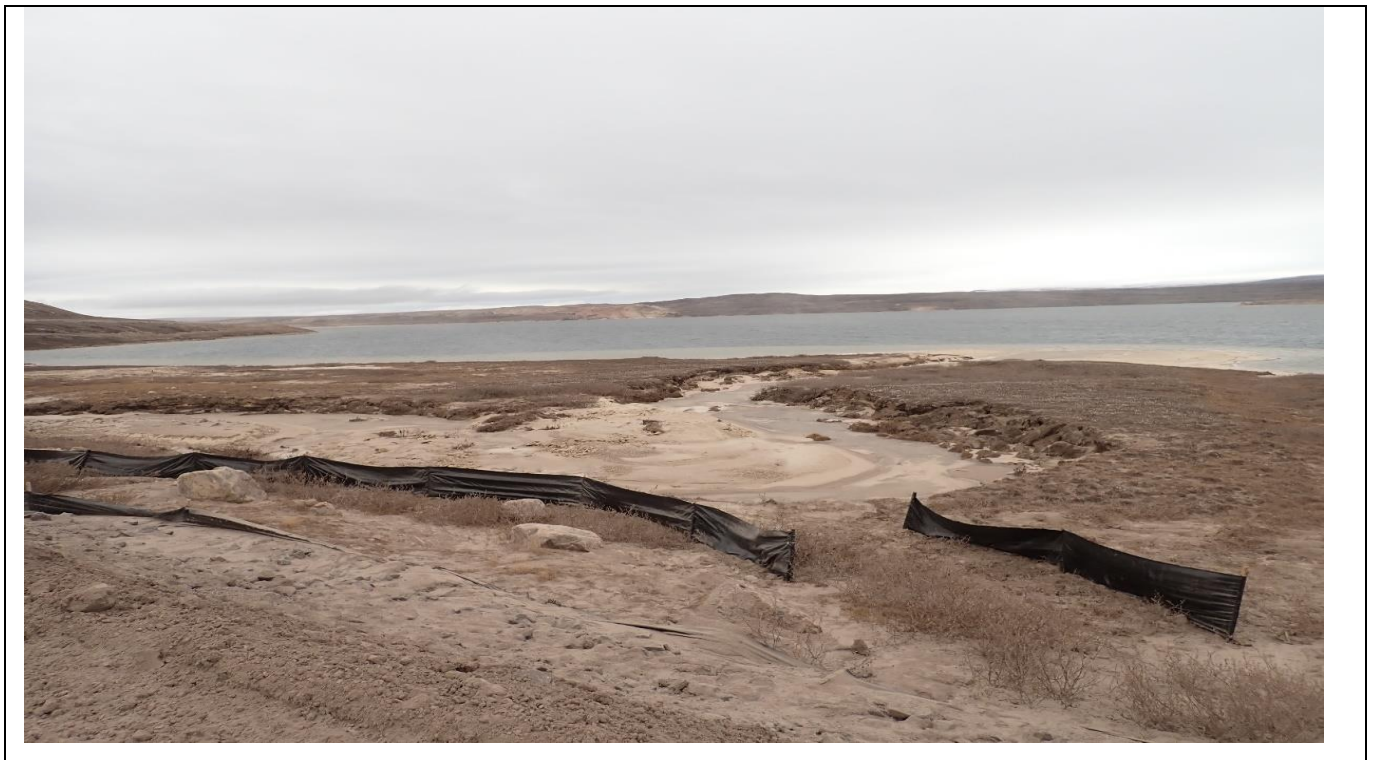
Photo 2. BG-24 (KM 87.5)- Follow up photo of new silt fences installed to mitigate erosion and sedimentation adjacent to the crossing.

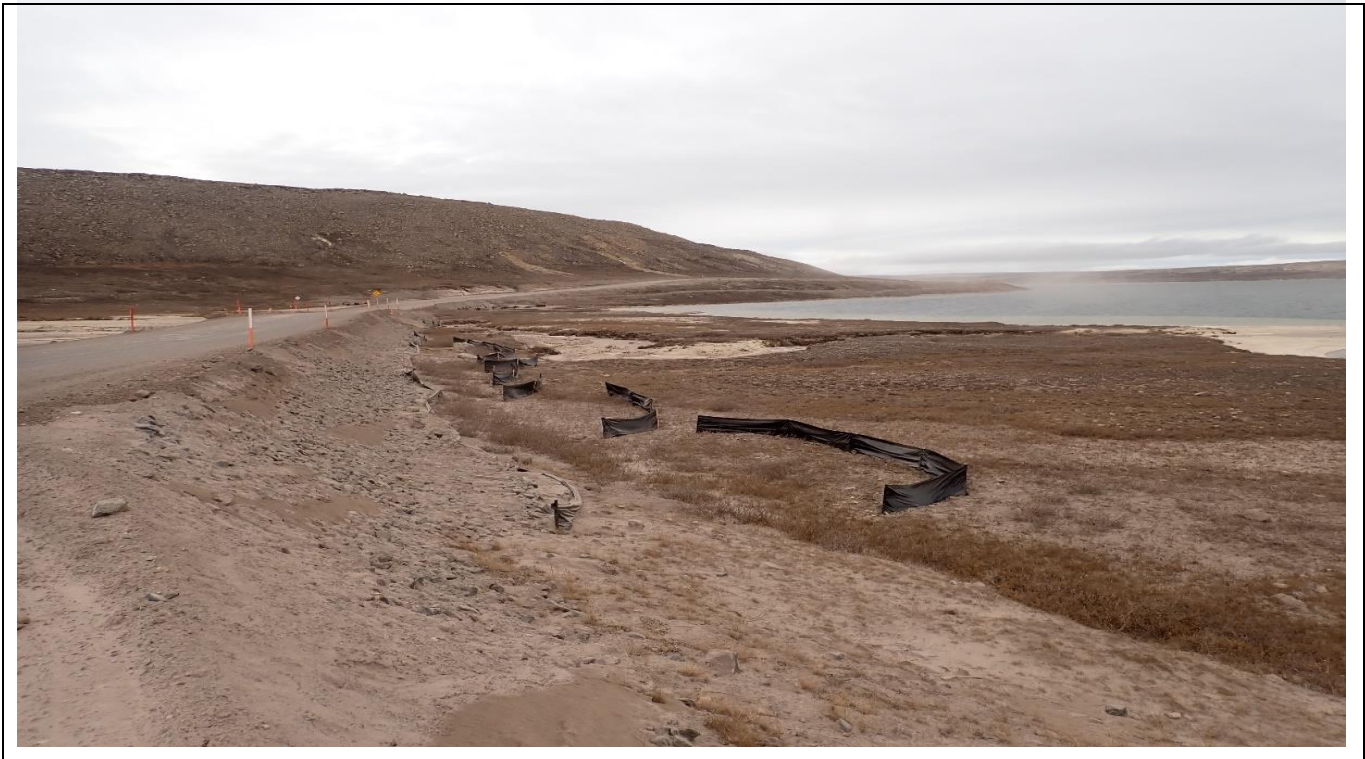
Photo 3. BG-24 (KM 87.5)- Follow up photo of new silt fences installed to mitigate erosion and sedimentation adjacent to the crossing.

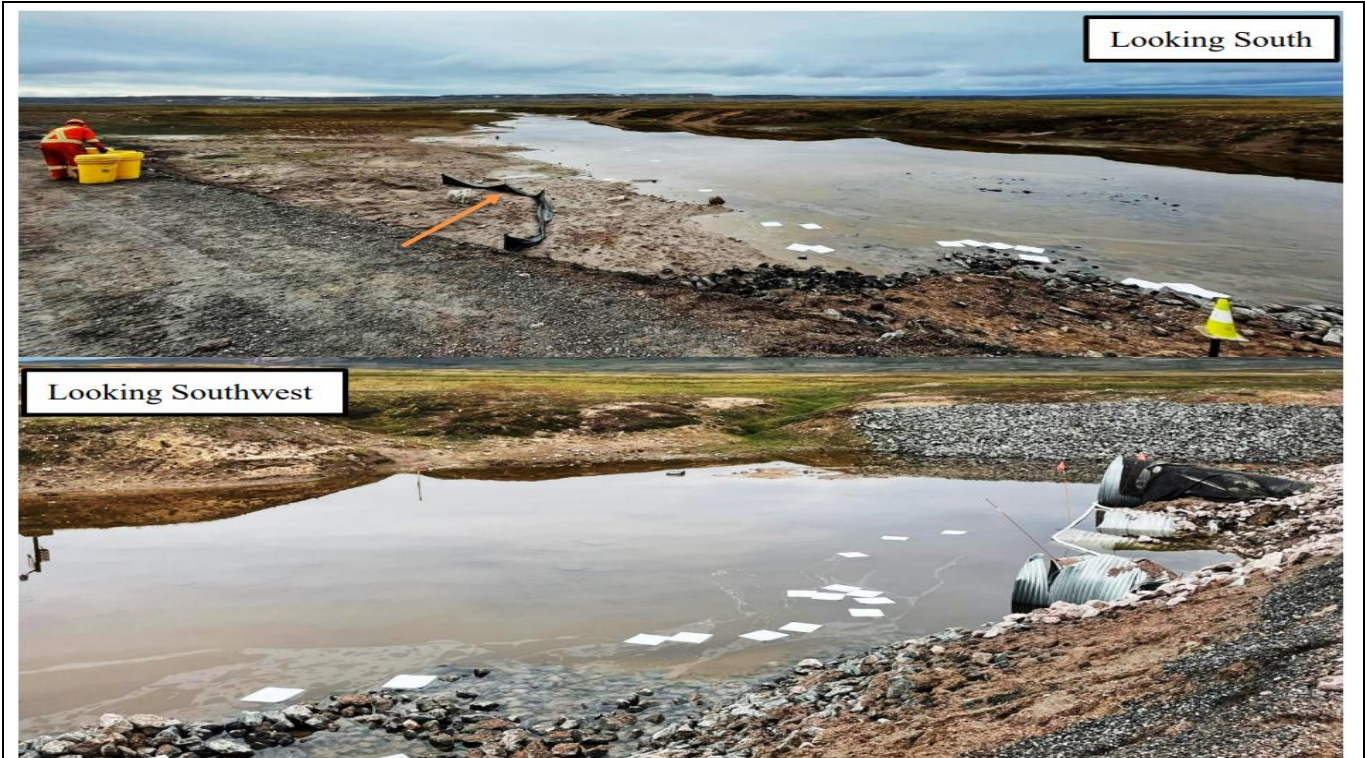
Photo 4. CV-216 (km 82) -Photo 48 from the NIRB inspection

Baffinland finalised the permitting process with DFO, QIA, and the NWB for the CV 216 culvert replacement at Km 82 in Q3. Erosion and sediment control measures and fish salvage was completed prior to freeze-up and the culvert replacement is scheduled for Q4, 2025. Photos of the repair work will be forthcoming. With respect to the exposed liners within sedimentation ponds, Baffinland confirms that this is consistent with the design and industry standard and mitigates interaction of sediments within the sedimentation ponds.

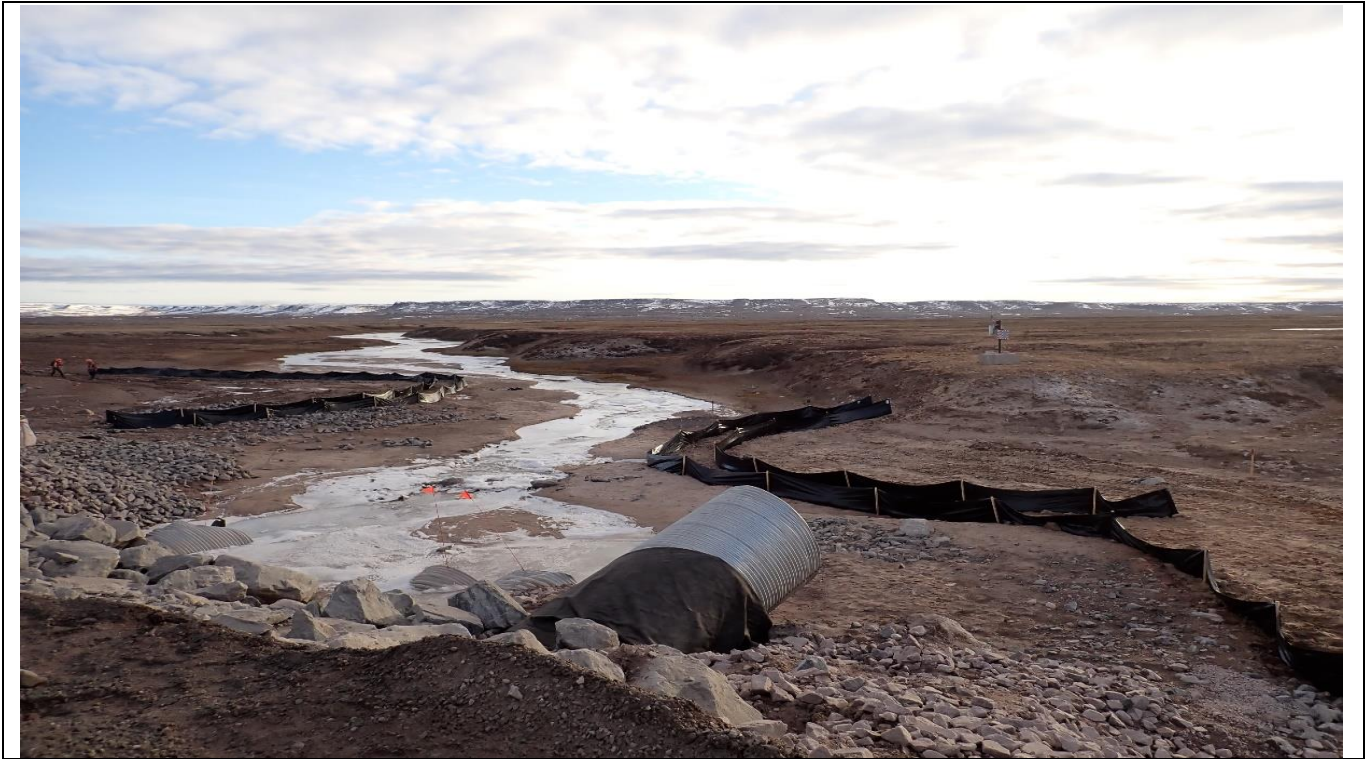
Photo 5. CV-216 (KM 82) – Follow up photos of new silt fences installed to mitigate erosion and sedimentation adjacent to the crossing.

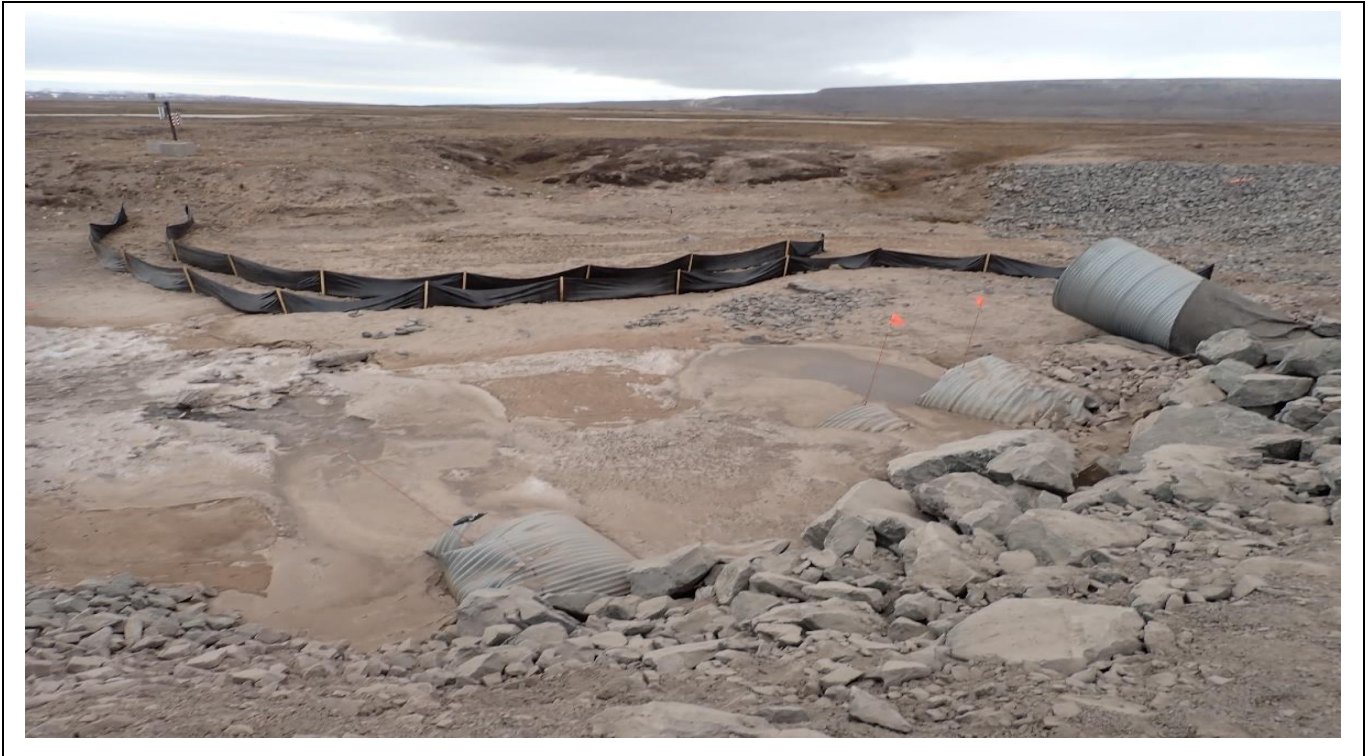
Photo 6. CV-216 (KM 82), Follow up photos of new silt fences installed to mitigate erosion and sedimentation adjacent to the crossing.

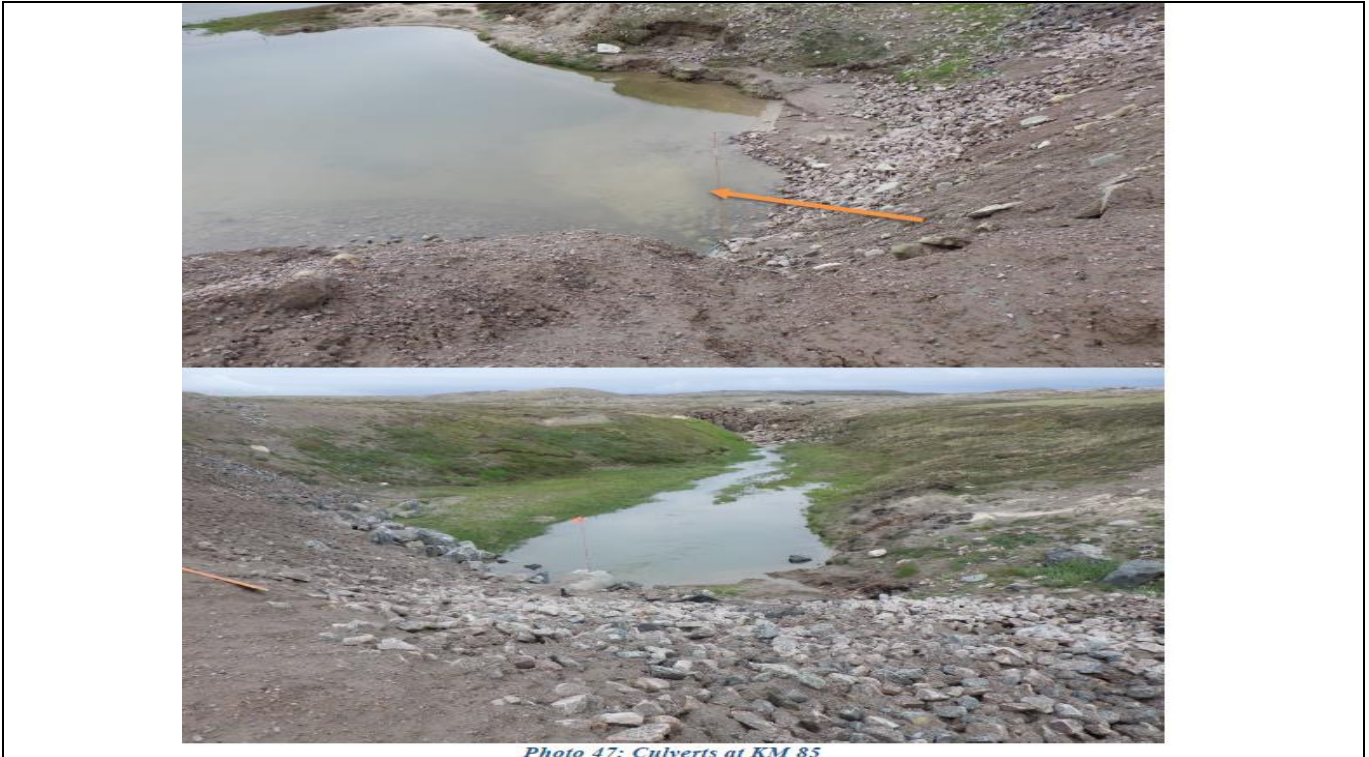
Photo 47: Culverts at KM 85

Photo 7. BG 29/30 (KM 85)- Photo 47 of the NIRB inspection Report KM 85),

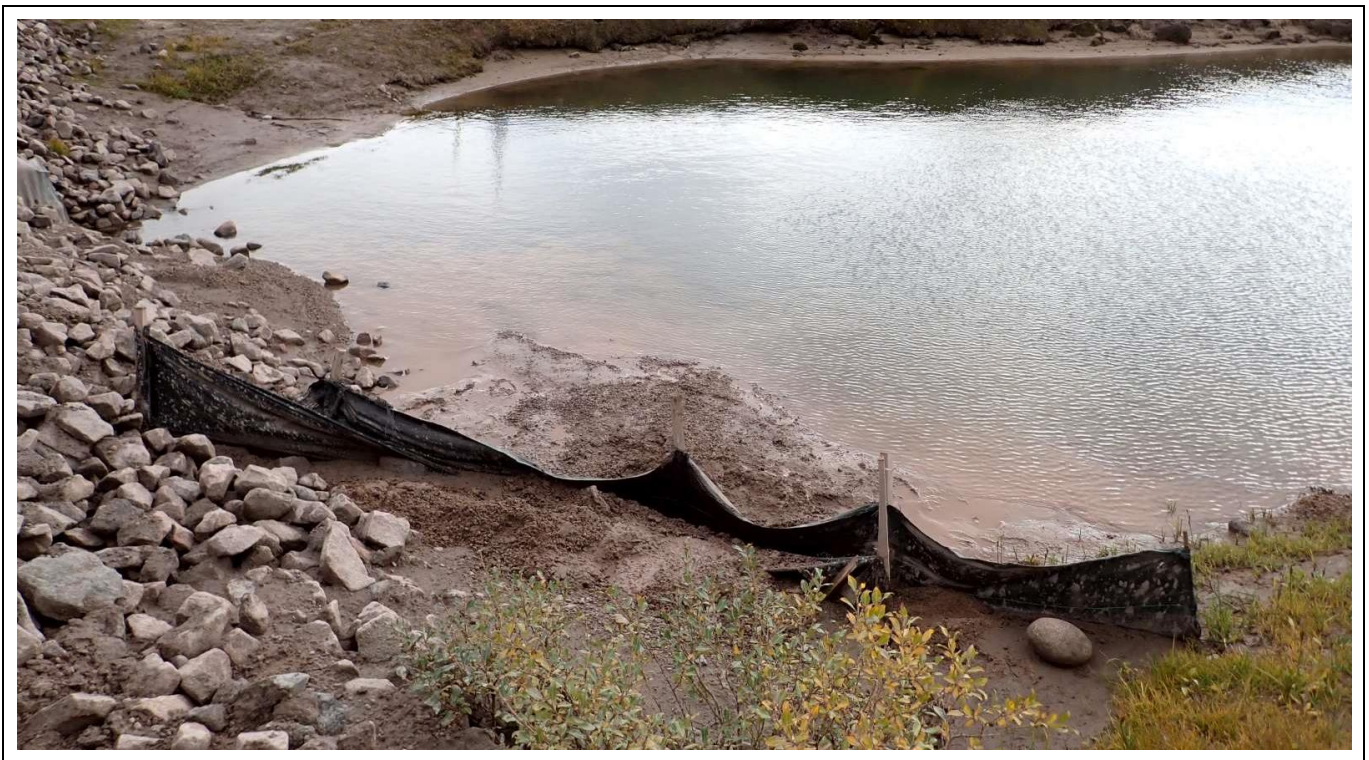
Photo 8. BG-30 (KM 85)- Re-secured and performed maintenance on silt fence

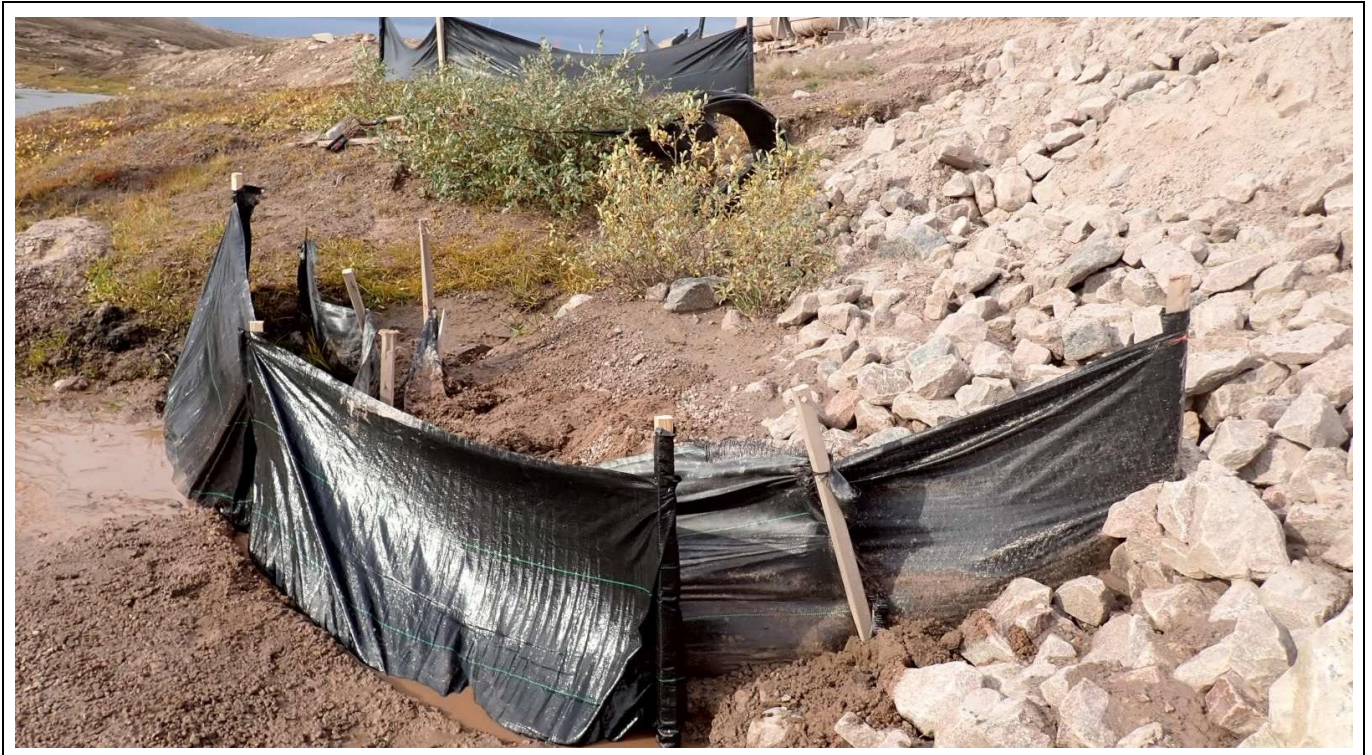
Photo 9. BG-30 (KM 85), Roadway bank erosion, additional silt fence installed upstream of culvert

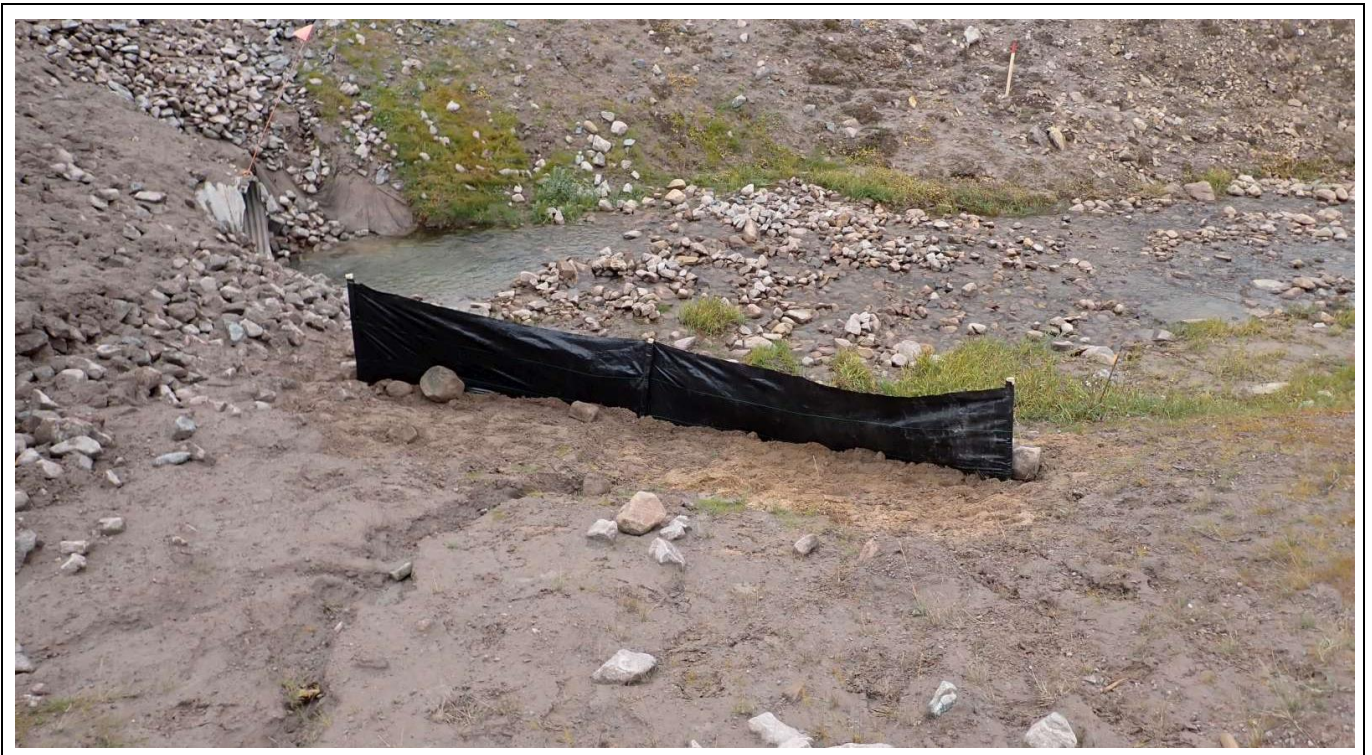
Photo 10. BG-30 (KM 85), Roadway bank erosion, silt fence installed downstream of crossing

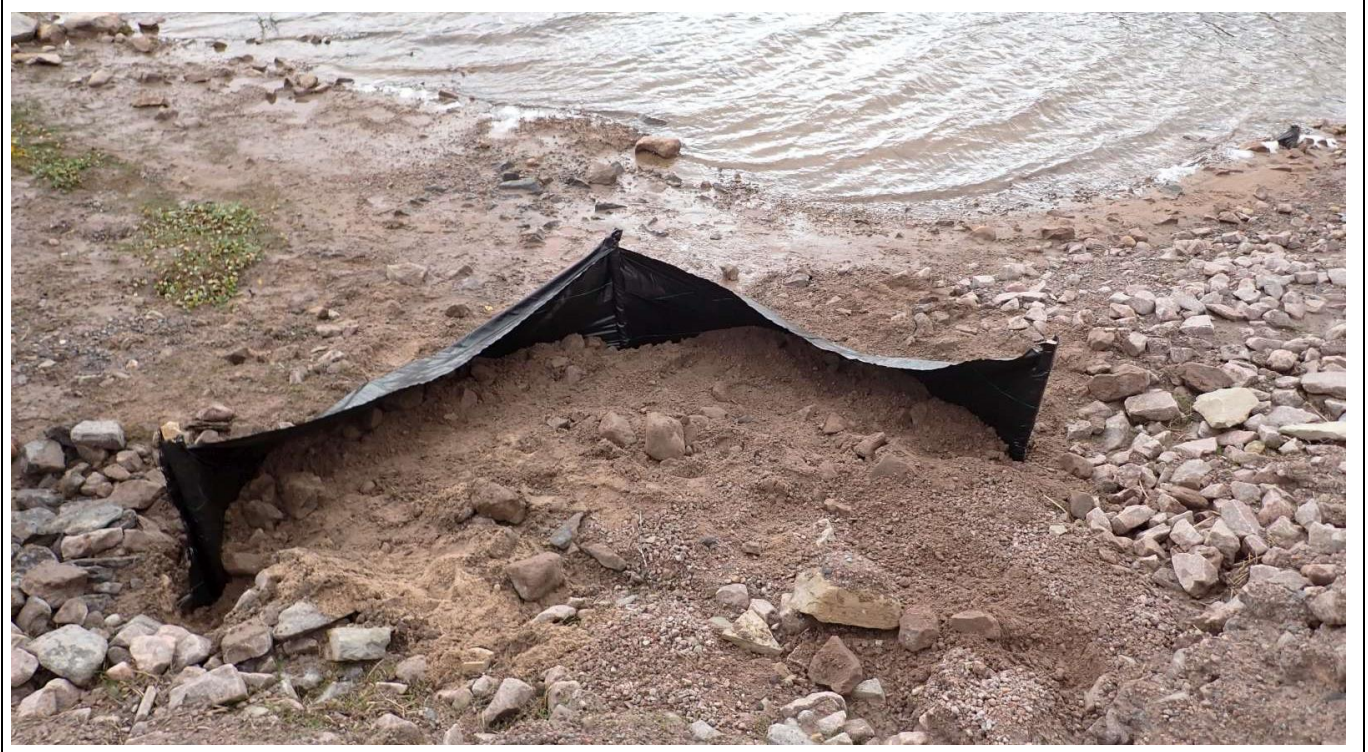
Photo 11. BG-29 (KM 85.5), Roadway bank erosion, silt fence installed upstream of crossing
