# MARY RIVER PROJECT RECLAMATION PILOT STUDY

## Revegetation Survey & Preliminary Reclamation Trial 2025 Project Update

25C0127  
REV.0  
October 2025

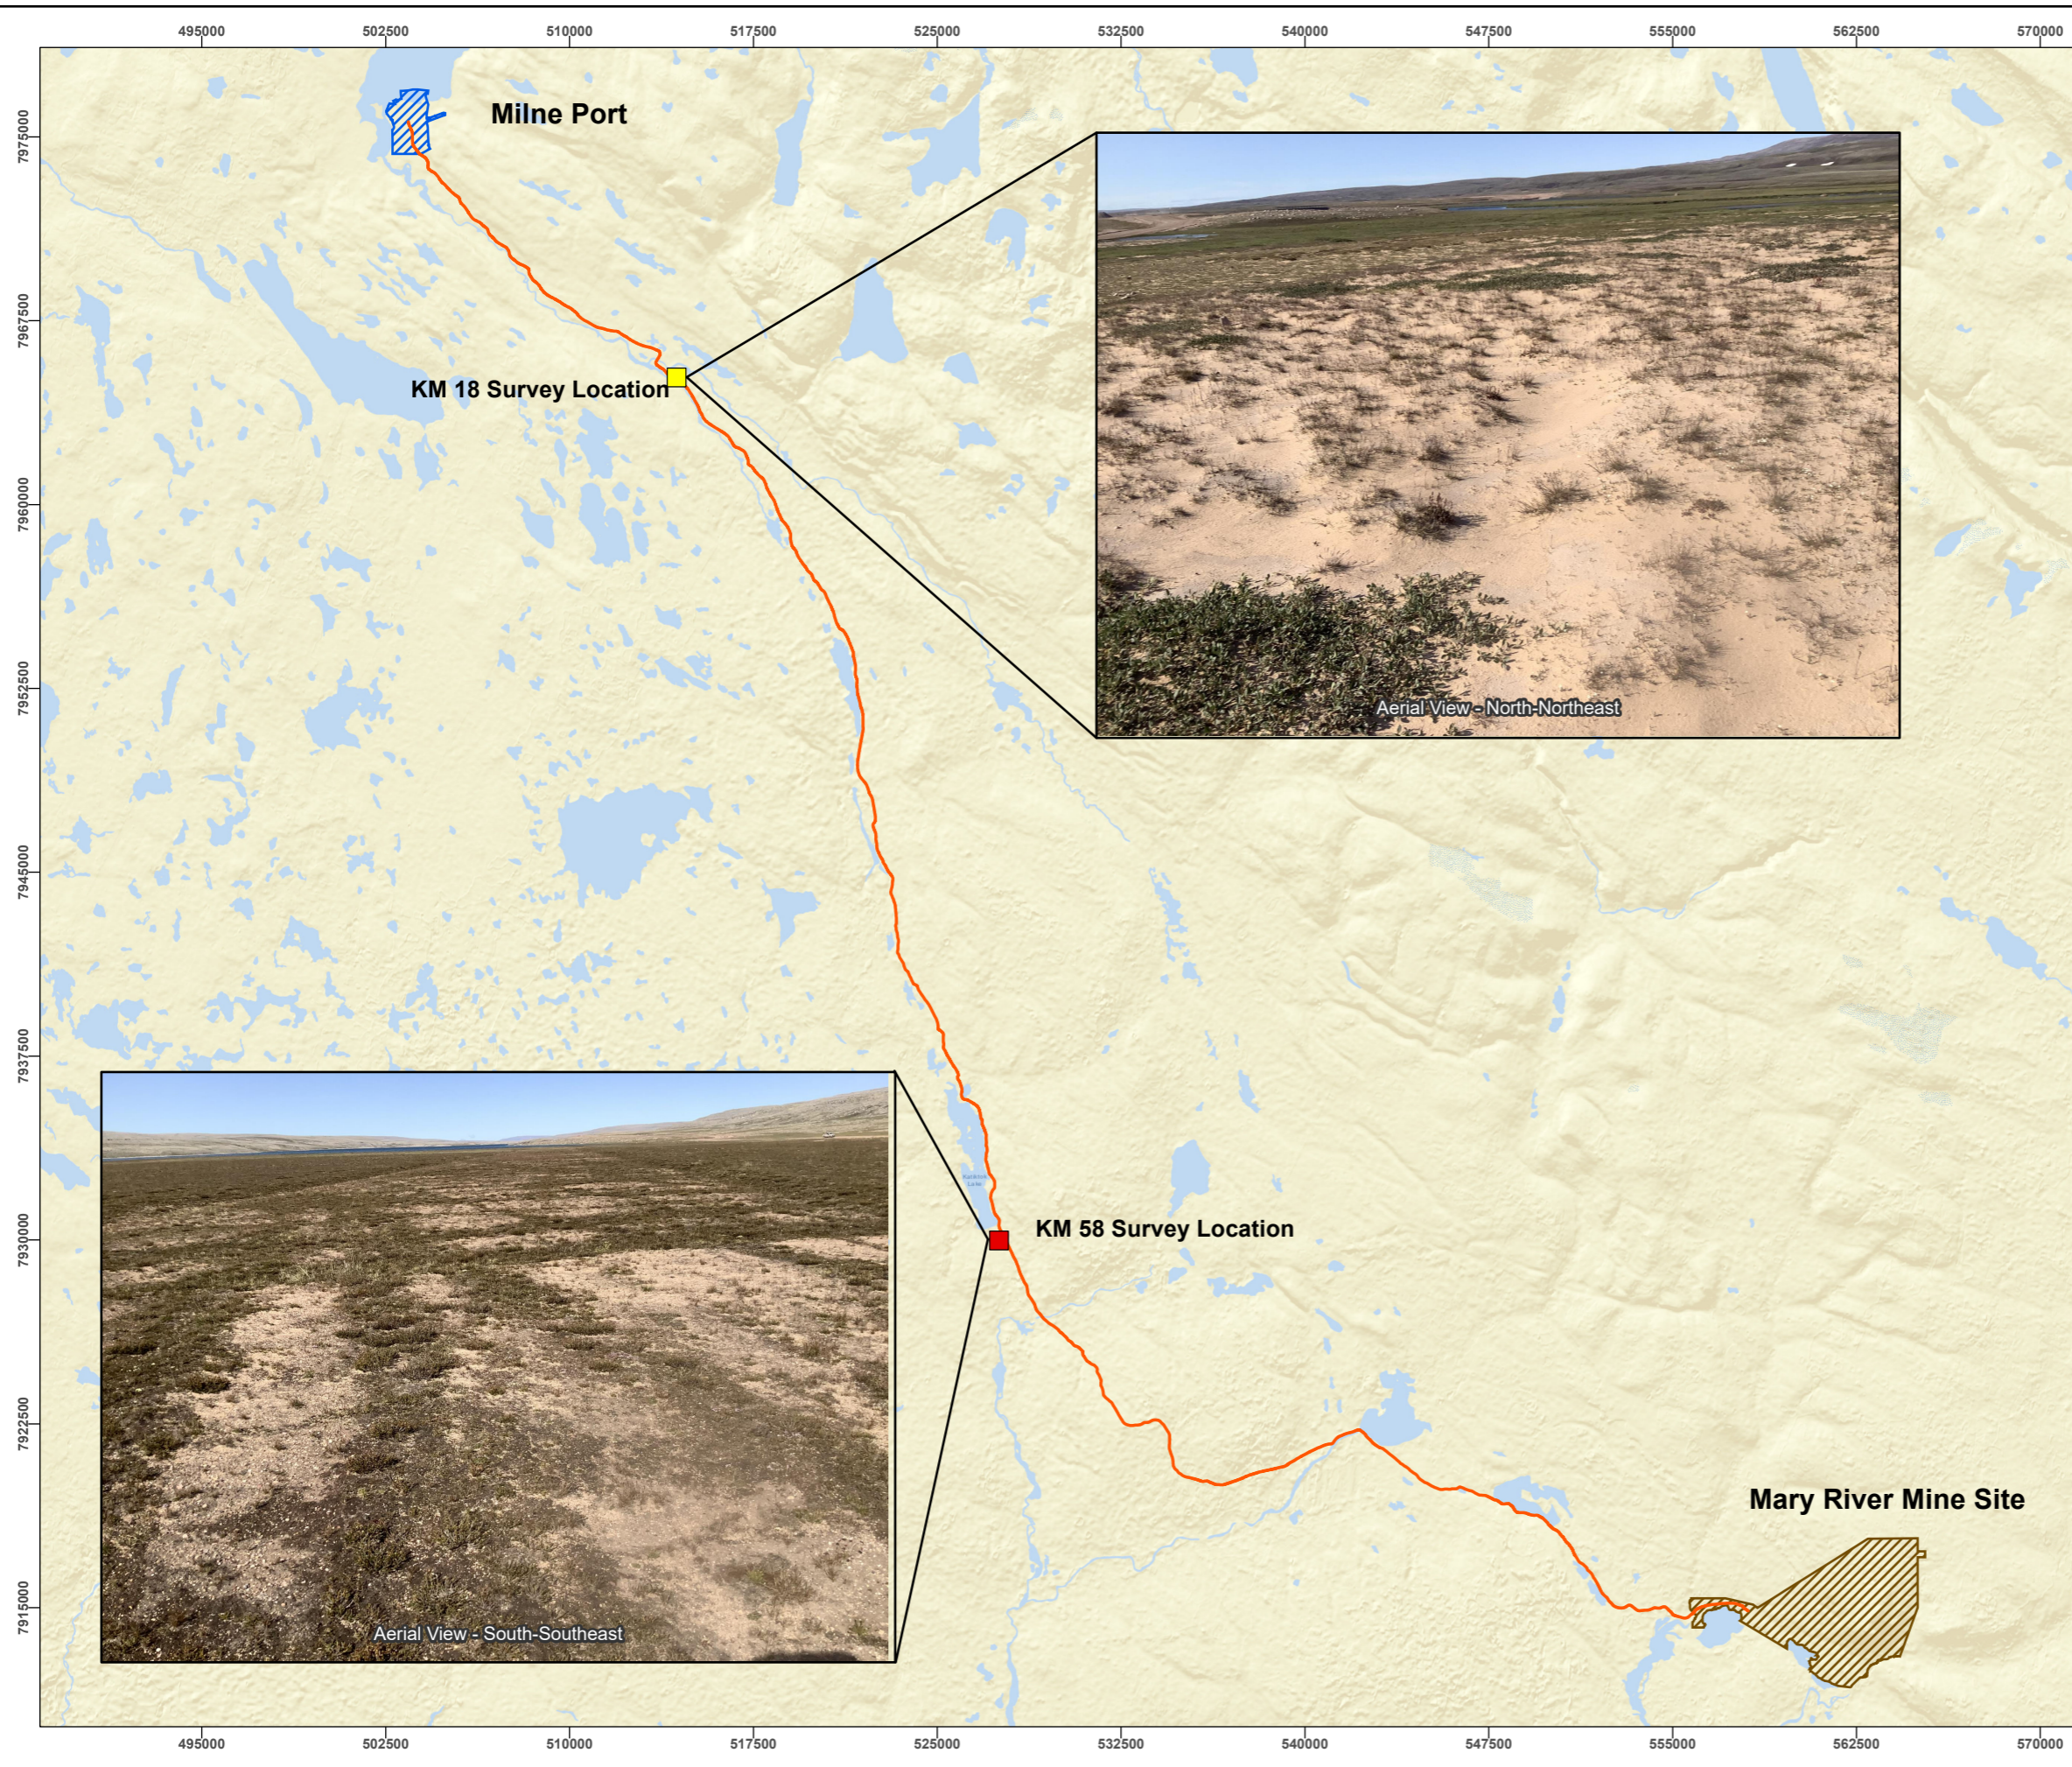
Drawn: Y. Navarro	Checked: P. Audet	<b>Map 2</b>	Date: 2021-10-08
----------------------	----------------------	--------------	------------------

During the 2021 field/survey period, EDI established one site along the Tote Road at KM18 (adjacent to a construction borrow pit). Another site was established within an abandoned airstrip near KM58, approximately 500 m outside the Project footprint (Map 2). Survey site KM18 was selected because it was disturbed during the construction of the nearby borrow pit and during ongoing road maintenance activities representing 1-3 years post disturbance (depending on location), and because it reflected a different ecotype than previous field surveys. Survey sites at the KM58 Abandoned Airstrip (i.e., comprising three survey areas, due to the size of the disturbance footprint; Figure 1b) were selected as they represented >40 years post-disturbance<sup>1</sup> and a unique location to investigate natural revegetation after disturbance (i.e., no seeding or planting and no reclamation earthworks and/or surficial preparations).

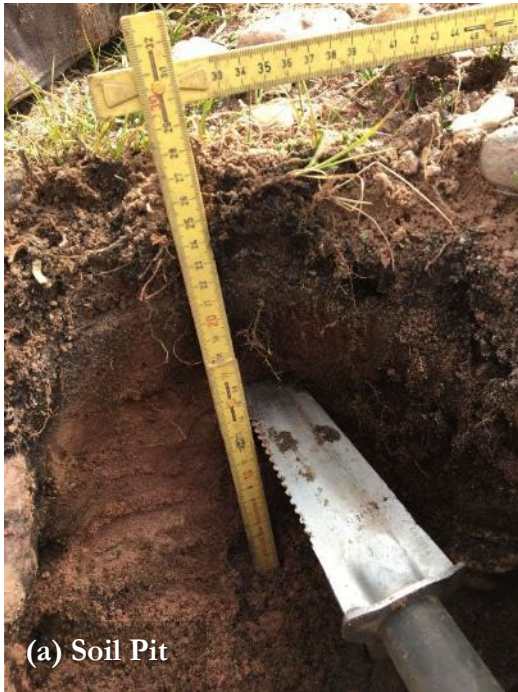
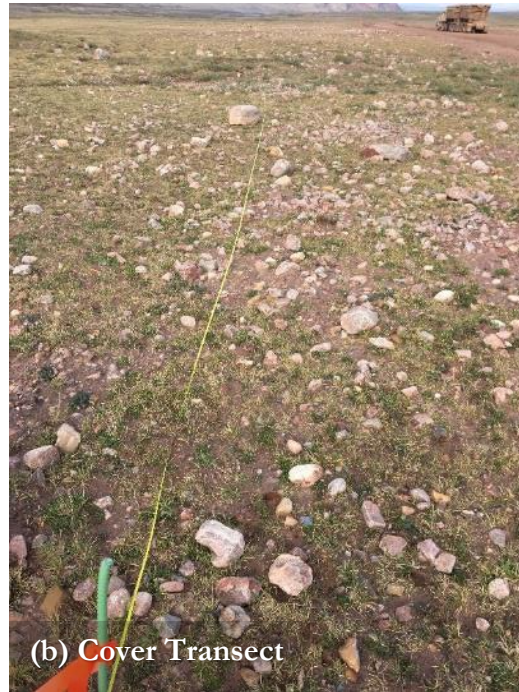
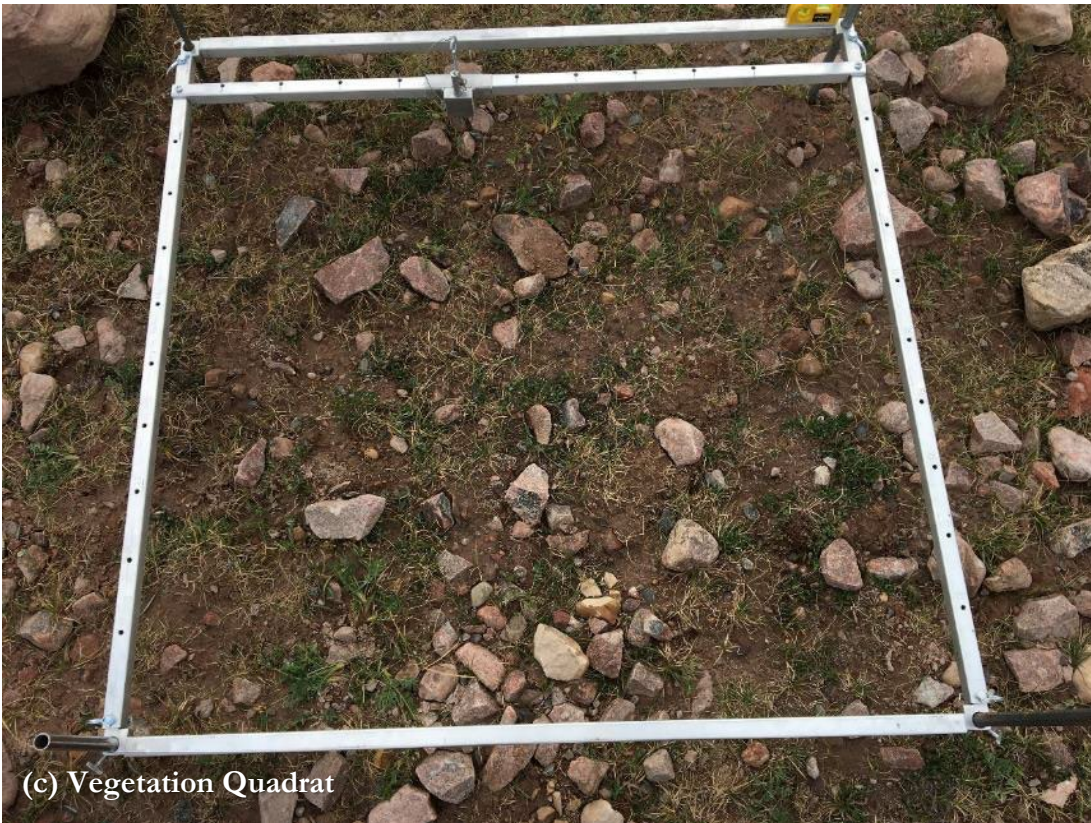
(a) Soil Pit

(b) Cover Transect

(c) Vegetation Quadrat

Photo 1. SURVEY METHODS — Soil survey pit (a), cover transect (b), and vegetation quadrat (c).

**Landscape, Terrain and Soil**— Survey procedures for characterizing landscape, terrain and soil were based on methods described in the Field Manual for Describing Terrestrial Ecosystems — Land Management Handbook No. 25 (B.C. Ministry of Forests and Range and B.C. Ministry of Environment 2010) and The Canadian System of Soil Classification, 3<sup>rd</sup> Edition (Soil Classification Working Group 1998). Landscape features and terrain (e.g., slope grade, aspect, geomorphological process) were assessed at the transect scale. Soils were assessed at the plot scale. At each soil survey plot (Photo 1a), a shovel and hand trowel were used to expose a 30x30 cm area and dig up to a depth of 30 cm (being mindful not to disturb permafrost occurring below this depth) to access the subsoil layers (B or C horizons). Documented soil profile information included parent material, horizon depths, texture, colour, and structure. Soil samples were collected from the top 10–30 cm from each soil pit to analyze textural and nutritional attributes by ALS Environmental Laboratories.

**Vegetation Surface Cover and Composition**— Survey procedures for characterizing vegetation surface cover and composition were based on methods used in Baffinland’s existing vegetation monitoring program, and described in the Canadian Tundra and Taiga Experiment (CANTTEX) — Field Manual (Bean and Henry 2003, Bean et al. 2003). Vegetation species lists within and directly adjacent to the survey plots were recorded using various taxonomic reference guides (Bean and Henry 2003, Aiken et al. 2011, Mallory and Aiken 2012); bryophytes and lichen taxons were not characterized at the species level and only recorded in terms of presence or absence. Vegetation cover and structural composition were assessed at the transect and plot scale. The surface projective cover<sup>2</sup> was calculated based on measurements at 1 m intervals along the 100 m or 150 m transect (Photo 1b). Surface projective cover within the 1x1 m vegetation quadrats was recorded at two basal strata (i.e., due to overlapping structural cover components) and calculated based on 100–200 measurements within the point-frame grid (Photo 1c).

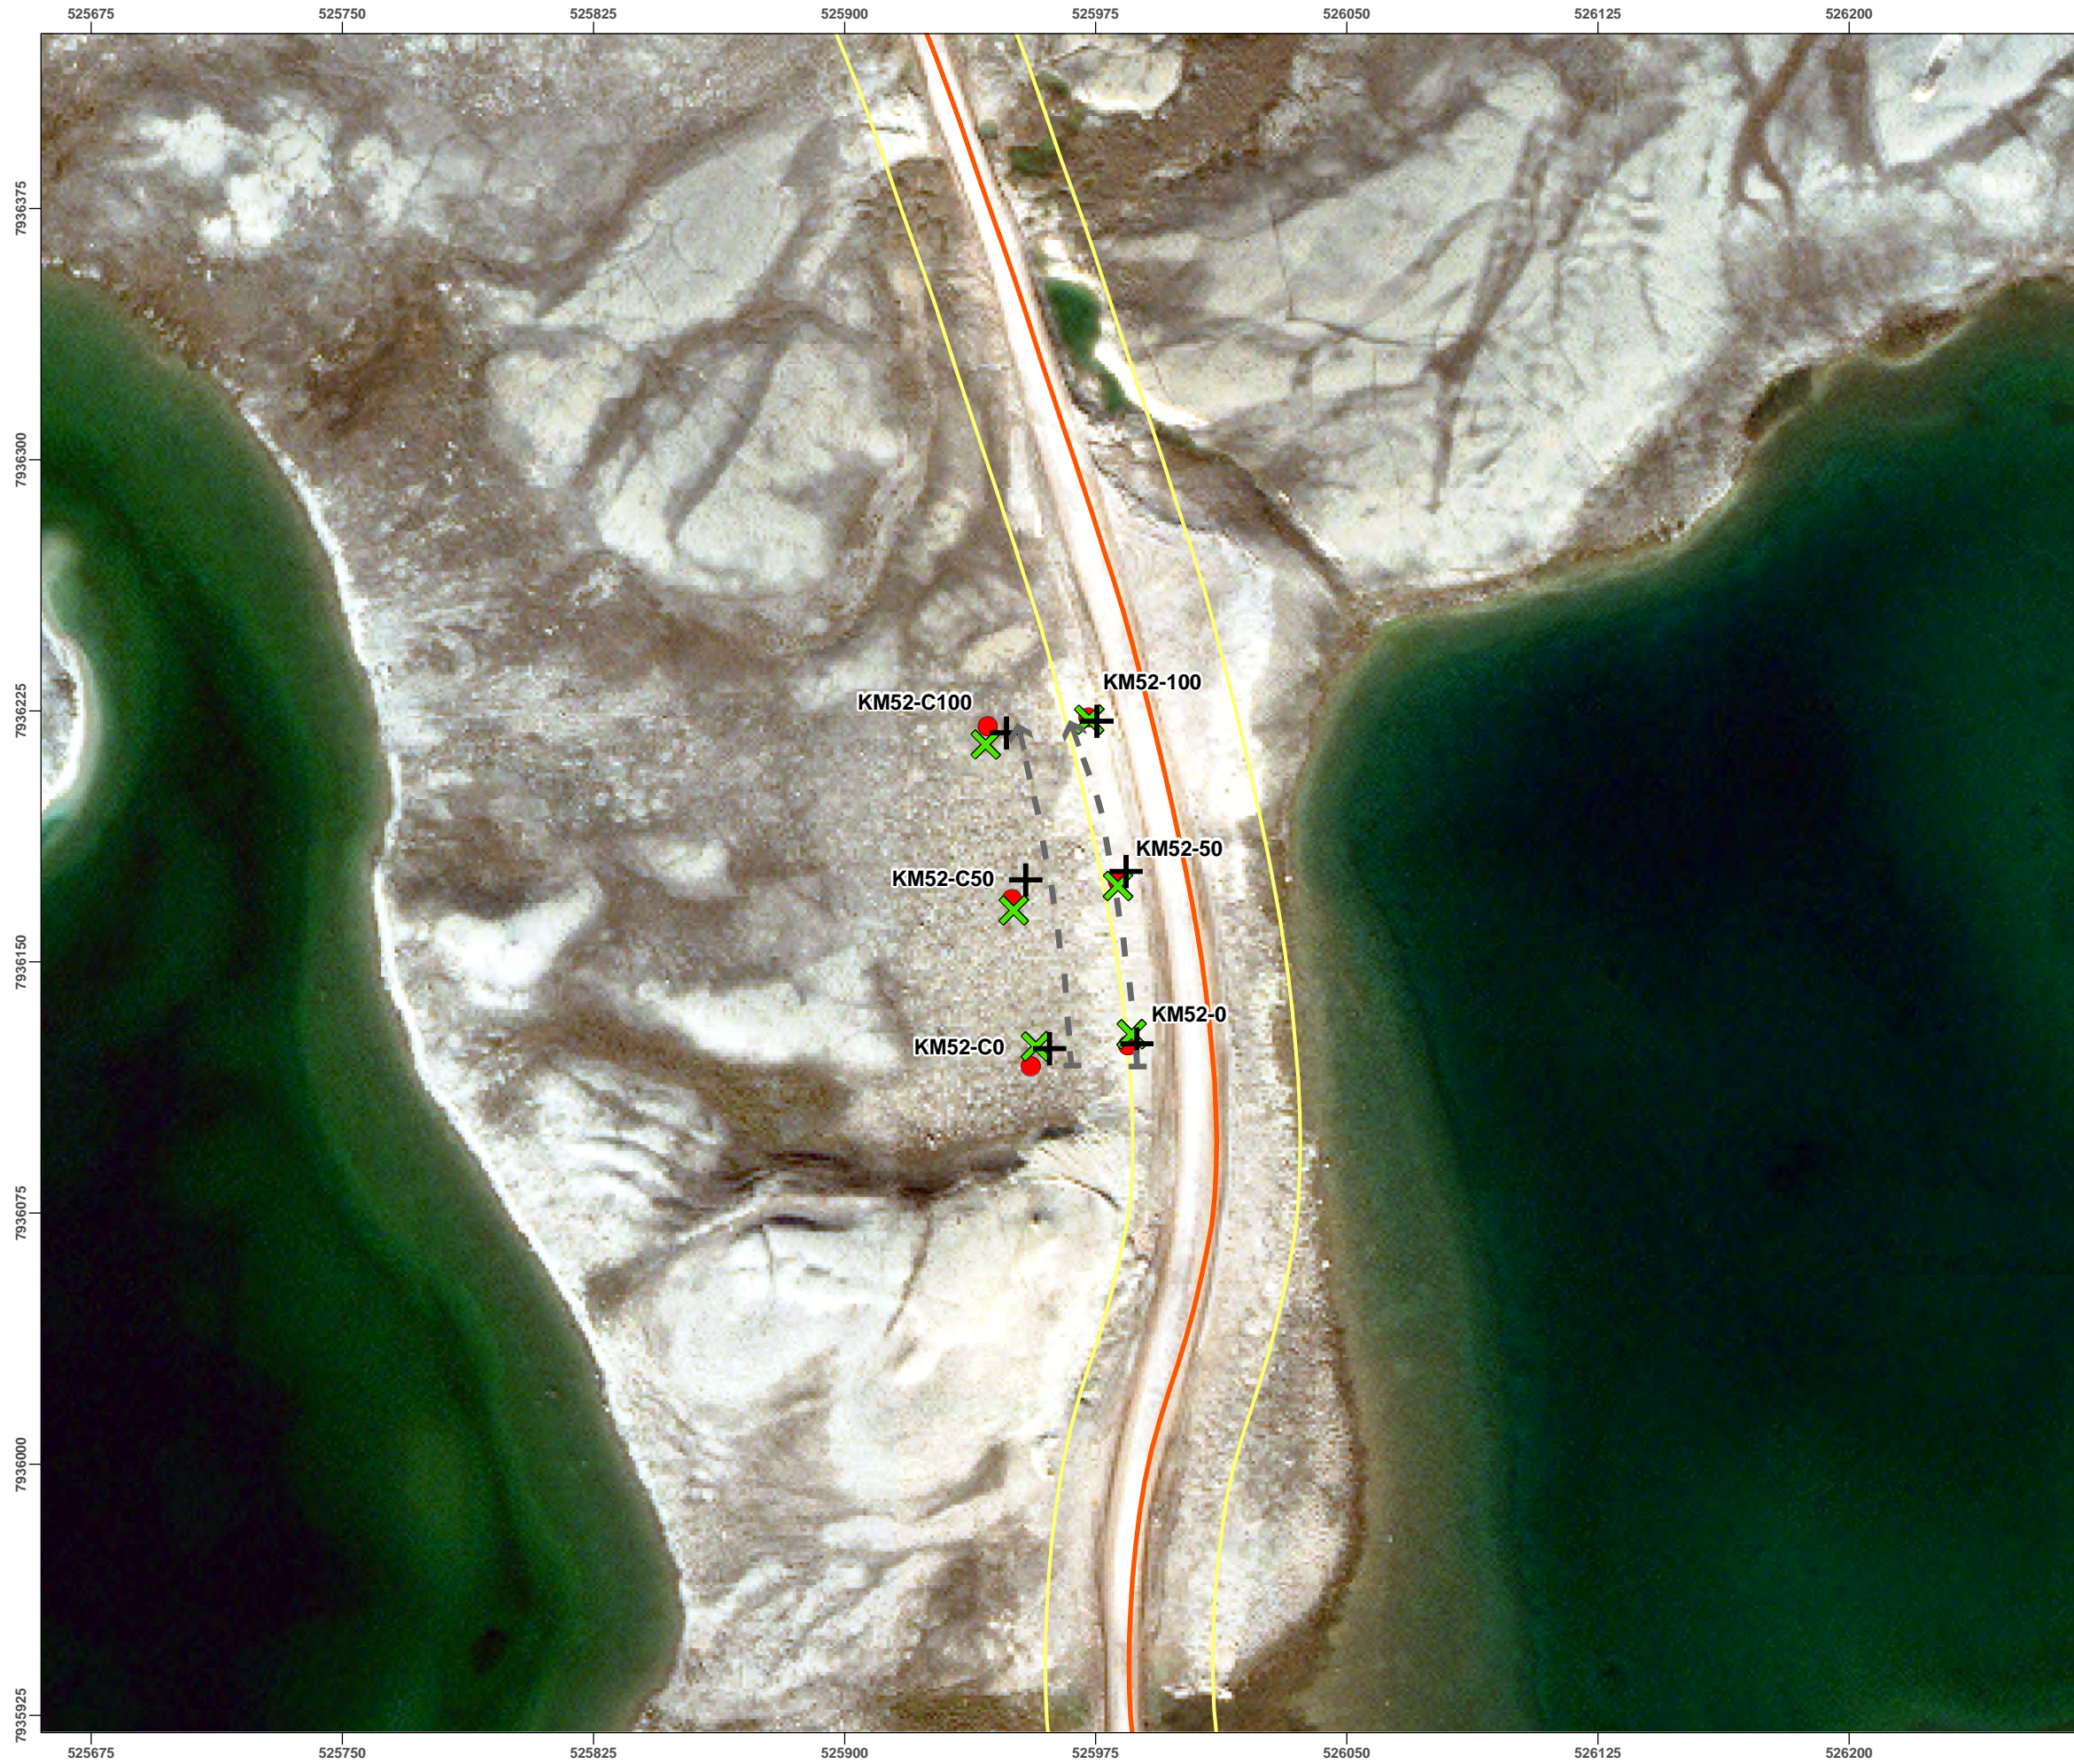
Drawn: Y. Navarro	Checked: P. Audet	Map 3	Date: 2019-08-28
----------------------	----------------------	-------	------------------

**KM52  
Vegetation and Soil Sampling Sites**

Map 3 shows the sampling layout at KM52. Table 1 summarizes landscape, terrain and soil attributes. Table 2 lists observed vegetation species within and directly adjacent to the survey plots. Table 3 summarizes the mean surface projective cover within vegetation quadrats. Figure 2 shows the total projective cover along the survey transect. Supporting information (e.g., geo-referencing and lab analysis) is provided in Appendix B1.

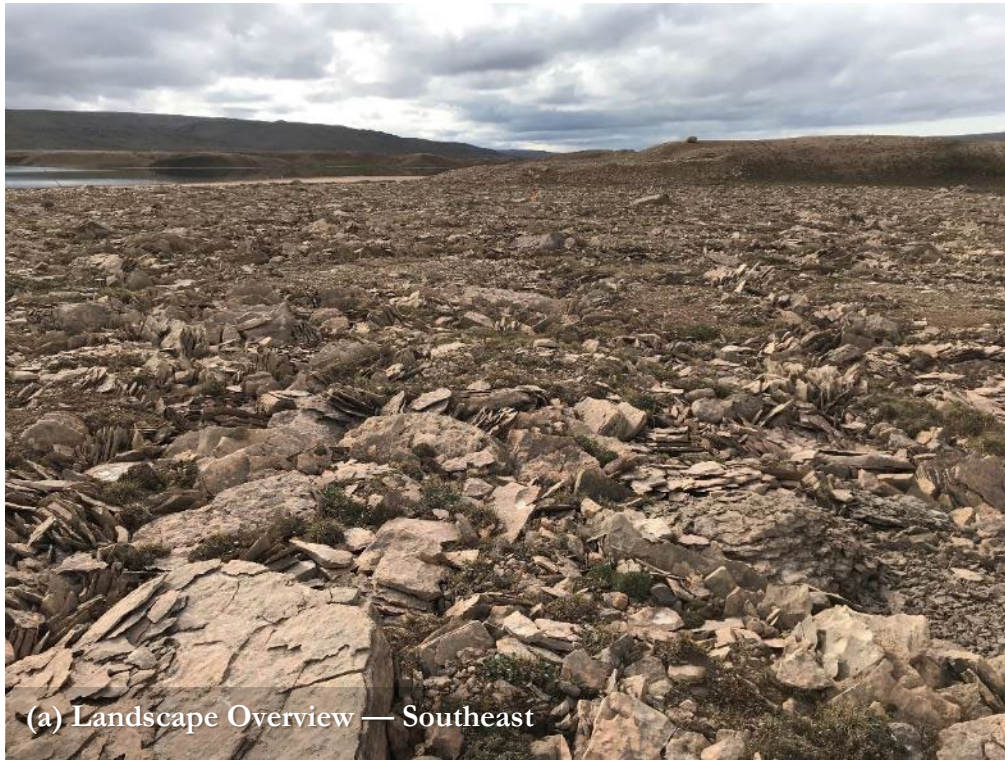
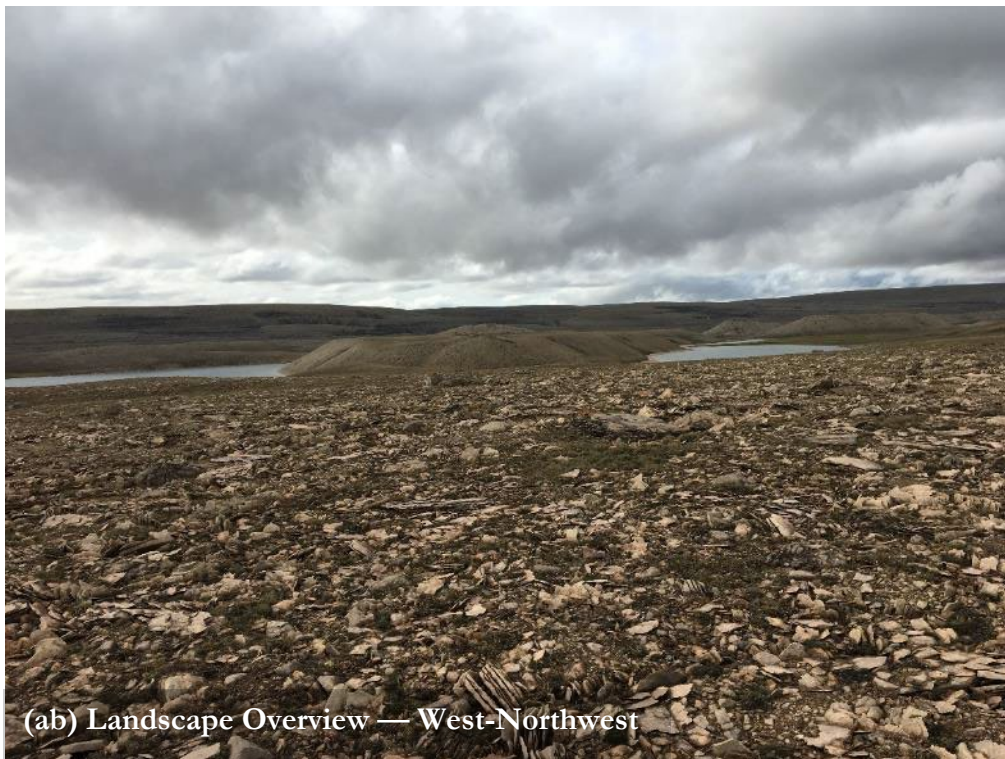
Photo 2. KM52 — Landscape overview southeast (a) and northwest (b).

**Landscape, Terrain and Soil**— Located near Katitkok Lake, the survey transects occur within a glaciofluvial and periglacial landform characterized by an undulating surface expression with nearly level to very gentle slopes with intermittent soils and frost-weathered bedrock (Photo 2a–b). Native (control) soils appeared to be Regosolic Turbic Cryosols as defined by an Om and Cy/Cgy/Cz sequence<sup>3</sup>. Control soil profiles (KM52-C0, -C50, -C100) were characterized by a discontinuous surface organic layer (Om, 0–2 cm in depth) and a sandy loam textured C horizon. If/where soils were present, the high incorporation of coarse parent materials (i.e., till and frost-weathered bedrock at the surface) resulted in a restrictive layer at 25–30 cm in depth. The soil moisture regime was xeric (dry); no mottling or gleying<sup>4</sup> was observed within any soil profile. Disturbed soil profiles (KM52-0, -50, -100) had no surface organic layer, a similarly textured sandy loam C horizon with high incorporation of coarse parent materials, but no discernible subsoil structure due to the site's disturbance history.

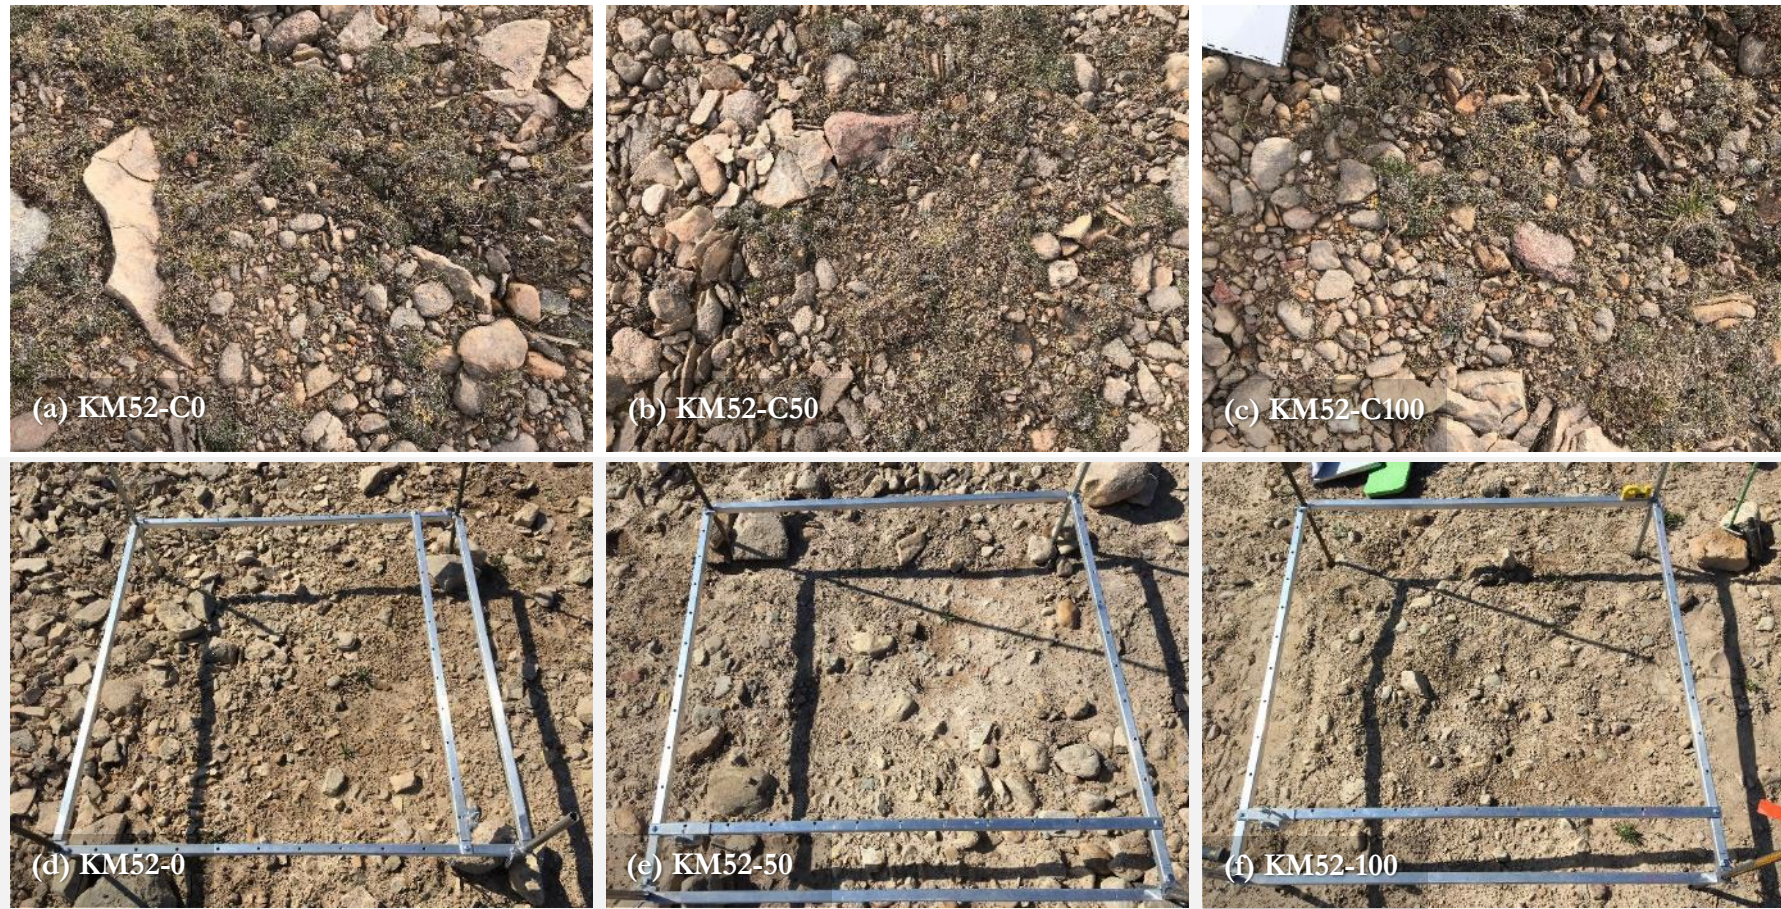
Photo 3. KM52 — Cover vegetation at KM52-C0, -C50 and -C100 (a-c) and KM52-0, -50 and -100 (d-f).

**Vegetation Surface Cover and Composition**— Given the landform attributes and soil conditions described above, vegetation cover in control areas was sparse (29% along the transect; 66% within quadrats) and composed of graminoids, forbs/perennial herbs, shrubs, bryophytes and lichen (Photo 3a–c). Whereas disturbed areas exhibited scarce cover vegetation (4% along the transect; <2% within quadrats), primarily composed of small/juvenile graminoids and forbs (Photo 3d–f) if/where present.

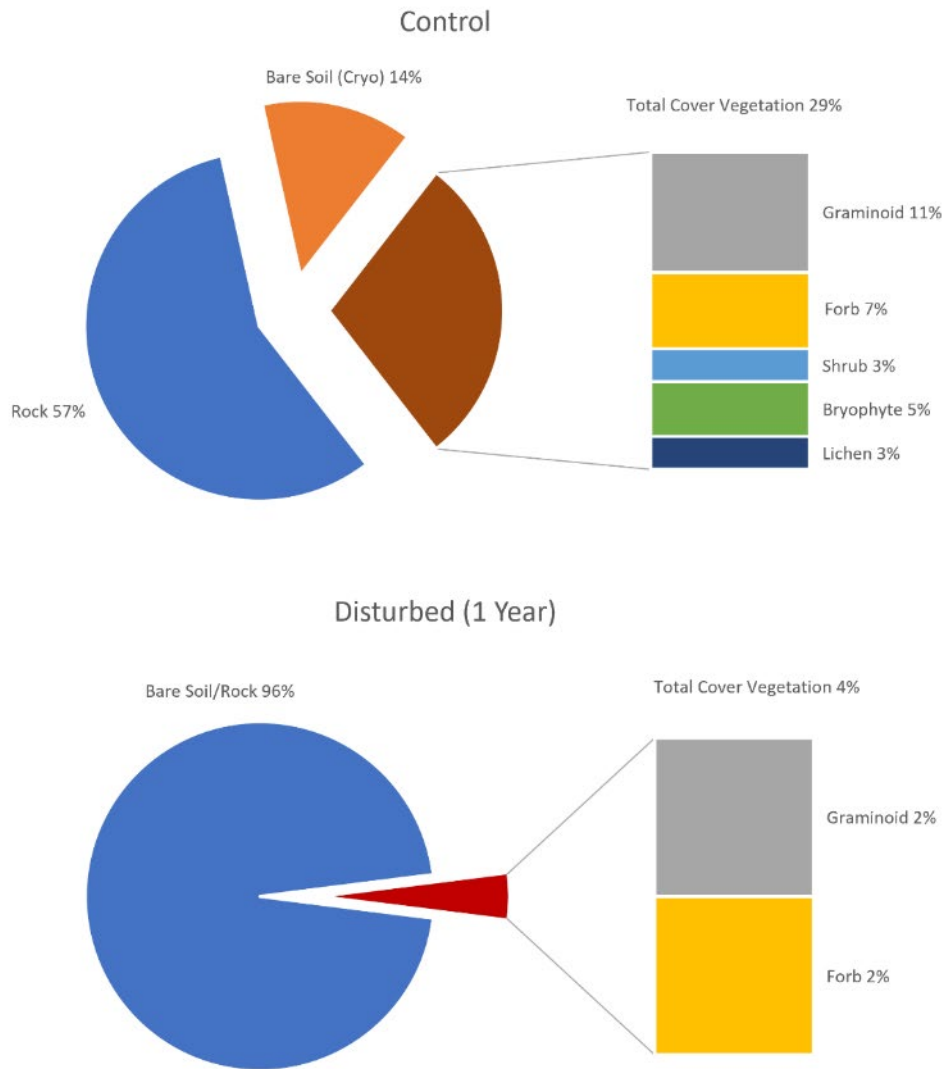
Figure 2. KM52 — Surface projective cover (%) along vegetation transect.

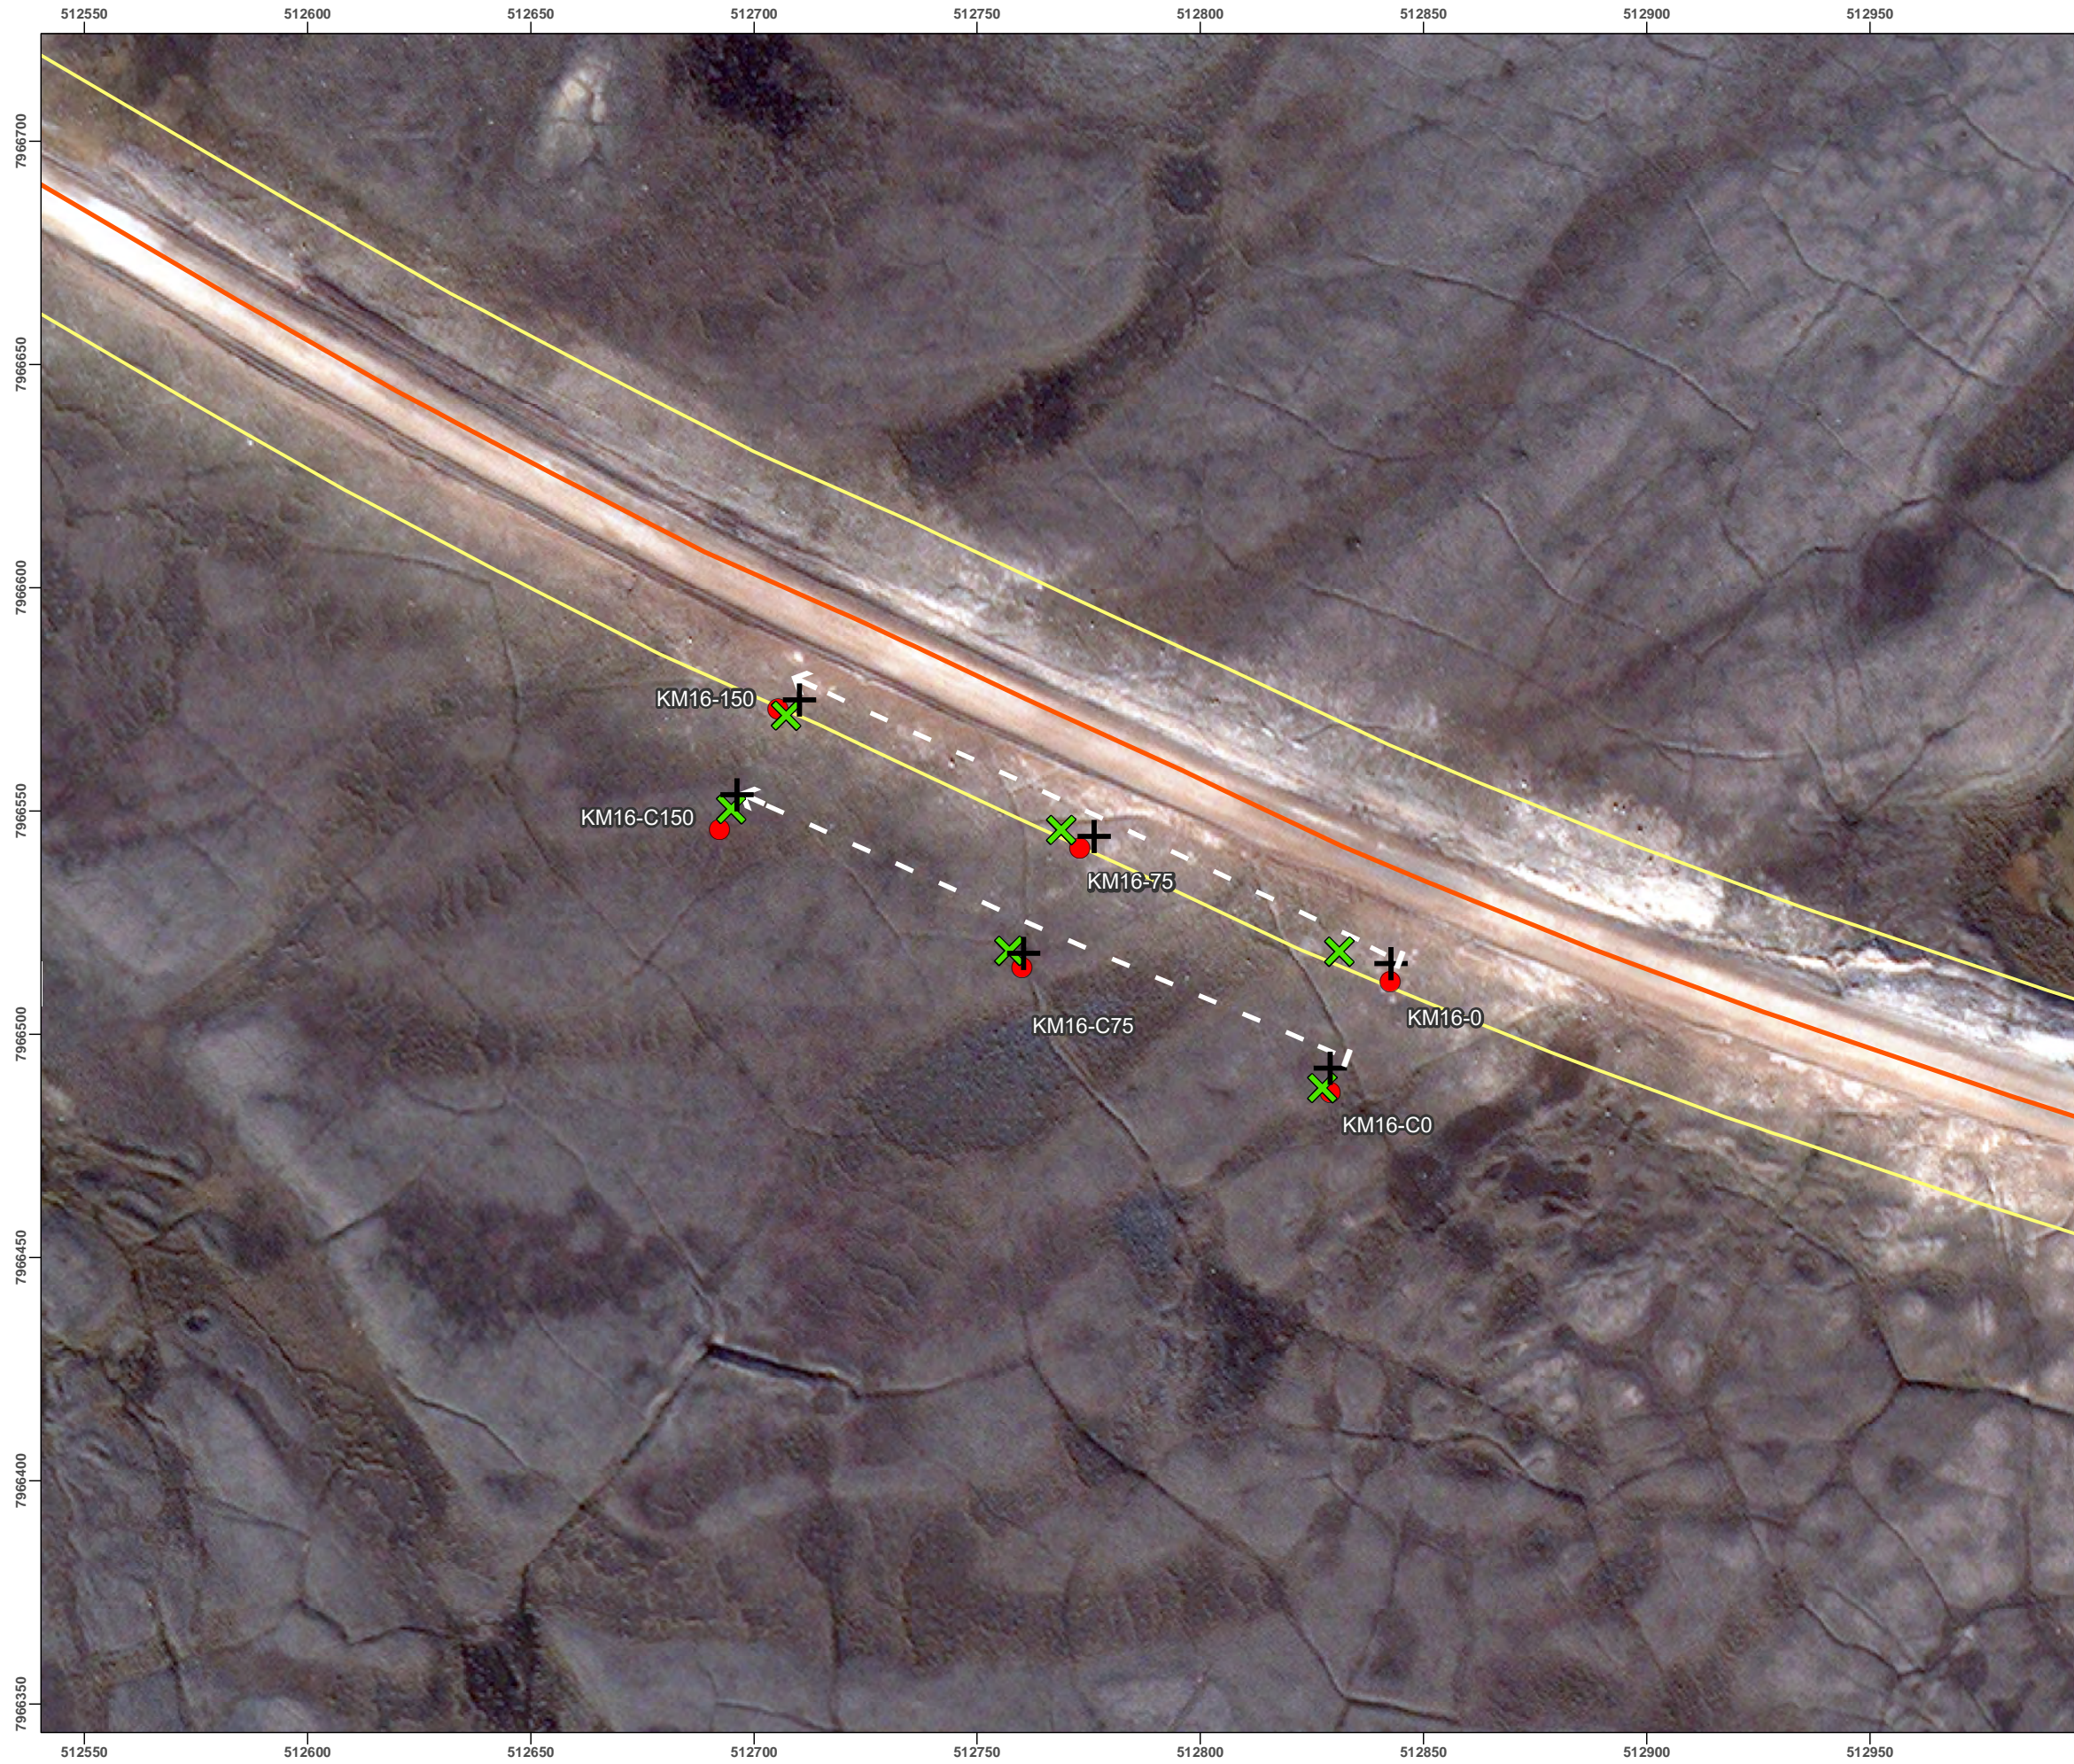
Drawn: Y. Navarro	Checked: P. Audet	Map 4	Date: 2019-08-28
----------------------	----------------------	-------	------------------

**KM16**  
Vegetation and Soil Sampling Sites

Map 4 shows the sampling layout at KM16. Table 4 summarizes landscape, terrain and soil attributes. Table 5 lists observed vegetation species within and adjacent to the study area. Table 6 summarizes mean surface projective cover within the vegetation quadrats. Figure 3 shows total projective cover along the survey transect. Supporting information (e.g., geo-referencing and lab analysis) is provided in Appendix B2.

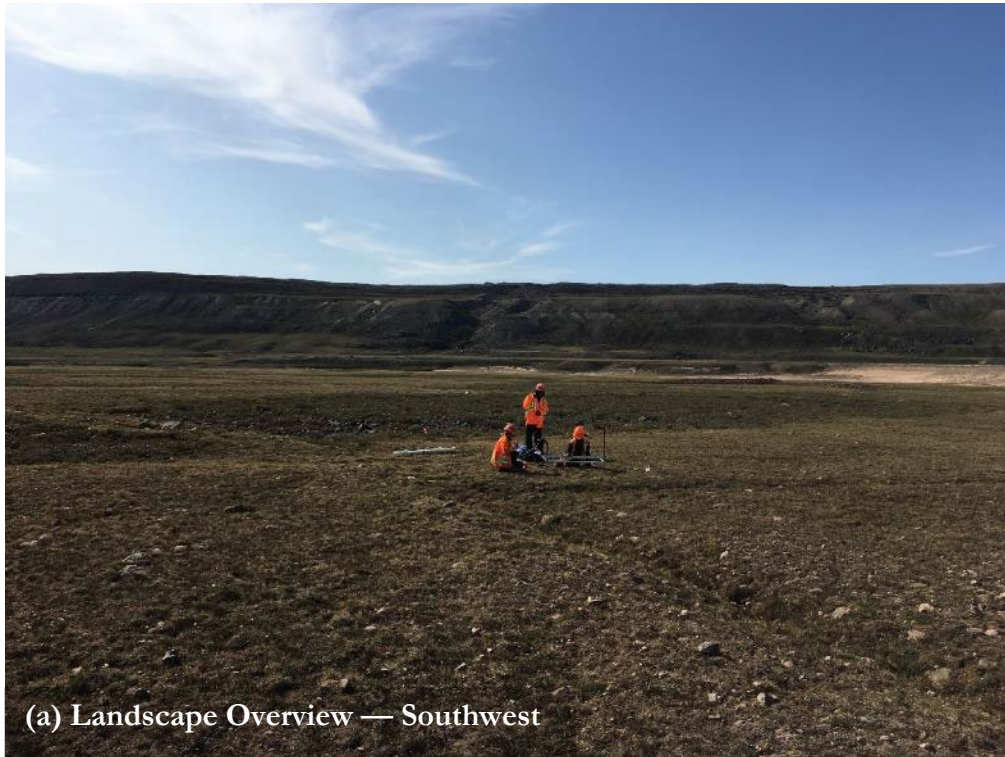
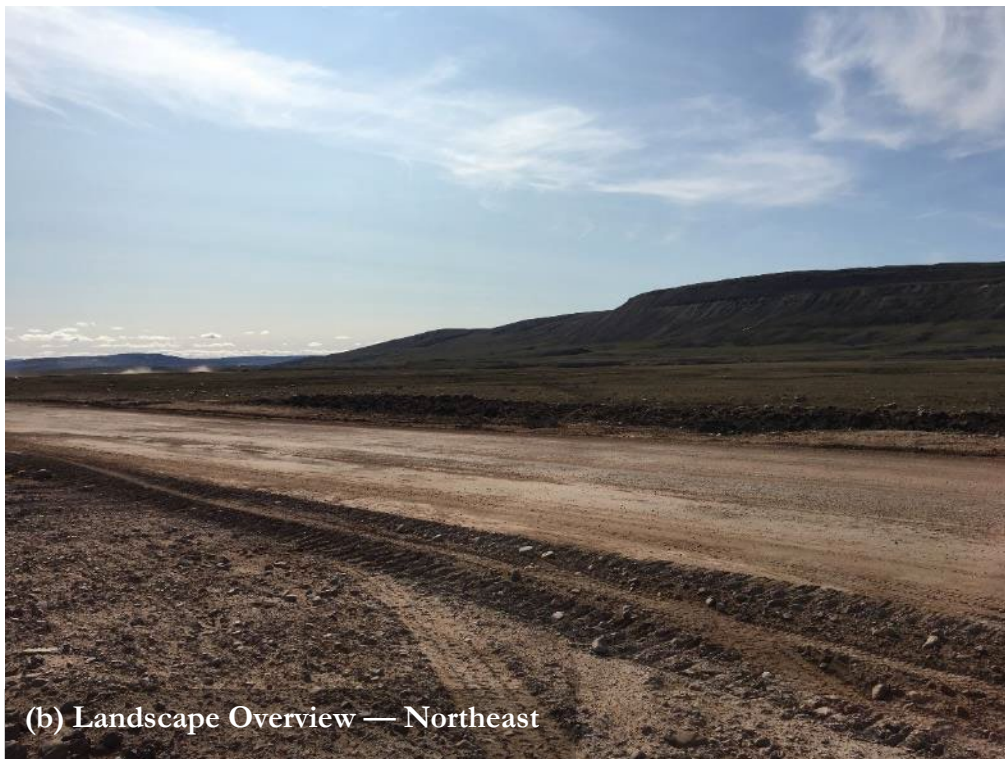
Photo 4. KM16 — Landscape overview southwest (a) and northeast (b).

**Landscape, Terrain and Soil**— Located near Phillips Creek, the survey transects occur on an upland plateau with near-level slopes (Photo 4 a–b). The landscape is characterized by low-centred polygons (i.e., patterned ground caused by permafrost), resulting in an abundance of small hummocks and shallow depressions. Native (control) soils appeared to be Brunisolic Turbic Cryosols as defined by an Om and Bm/Bmy sequence<sup>5</sup>. Control soil profiles (KM16-C0, -C75, -C150) were characterized by a thin surface organic layer (Om, 4–6 cm in depth) followed by a sandy loam textured B horizon. The moderate incorporation of coarse parent materials (i.e., till) resulted in a restrictive layer at ~25 cm deep. The soil moisture regime was subxeric (dry); faint mottling<sup>6</sup> was observed in the soil profile. Disturbed soil profiles (KM16-0, -75, -150) were characterized by a discontinuous surface organic layer (Om, up to 2 cm deep, where present), a similar sandy loam B horizon with the incorporation of coarse parent materials and some discernible horizons or structure, but no mottling or gleying. Subsoils were intact, suggesting that the area had only been superficially disturbed.
