## 2.4 2021 SURVEY | RESULTS

### KM18 — 1–3 YEARS POST DISTURBANCE

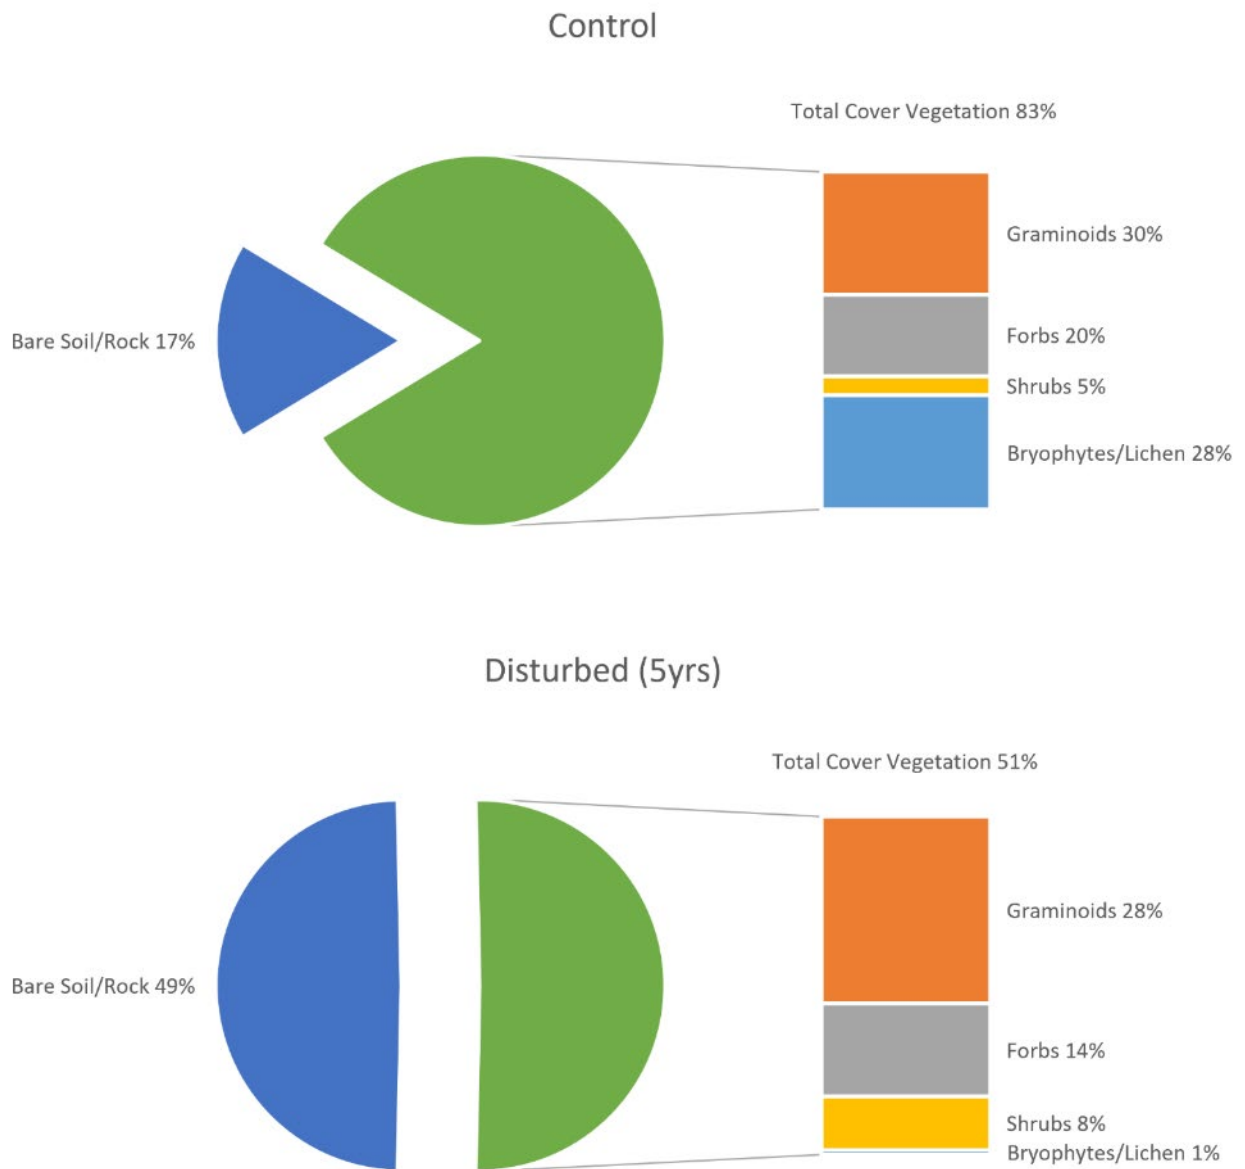
Figure 3. KM16 — Surface projective cover (%) along vegetation transect.

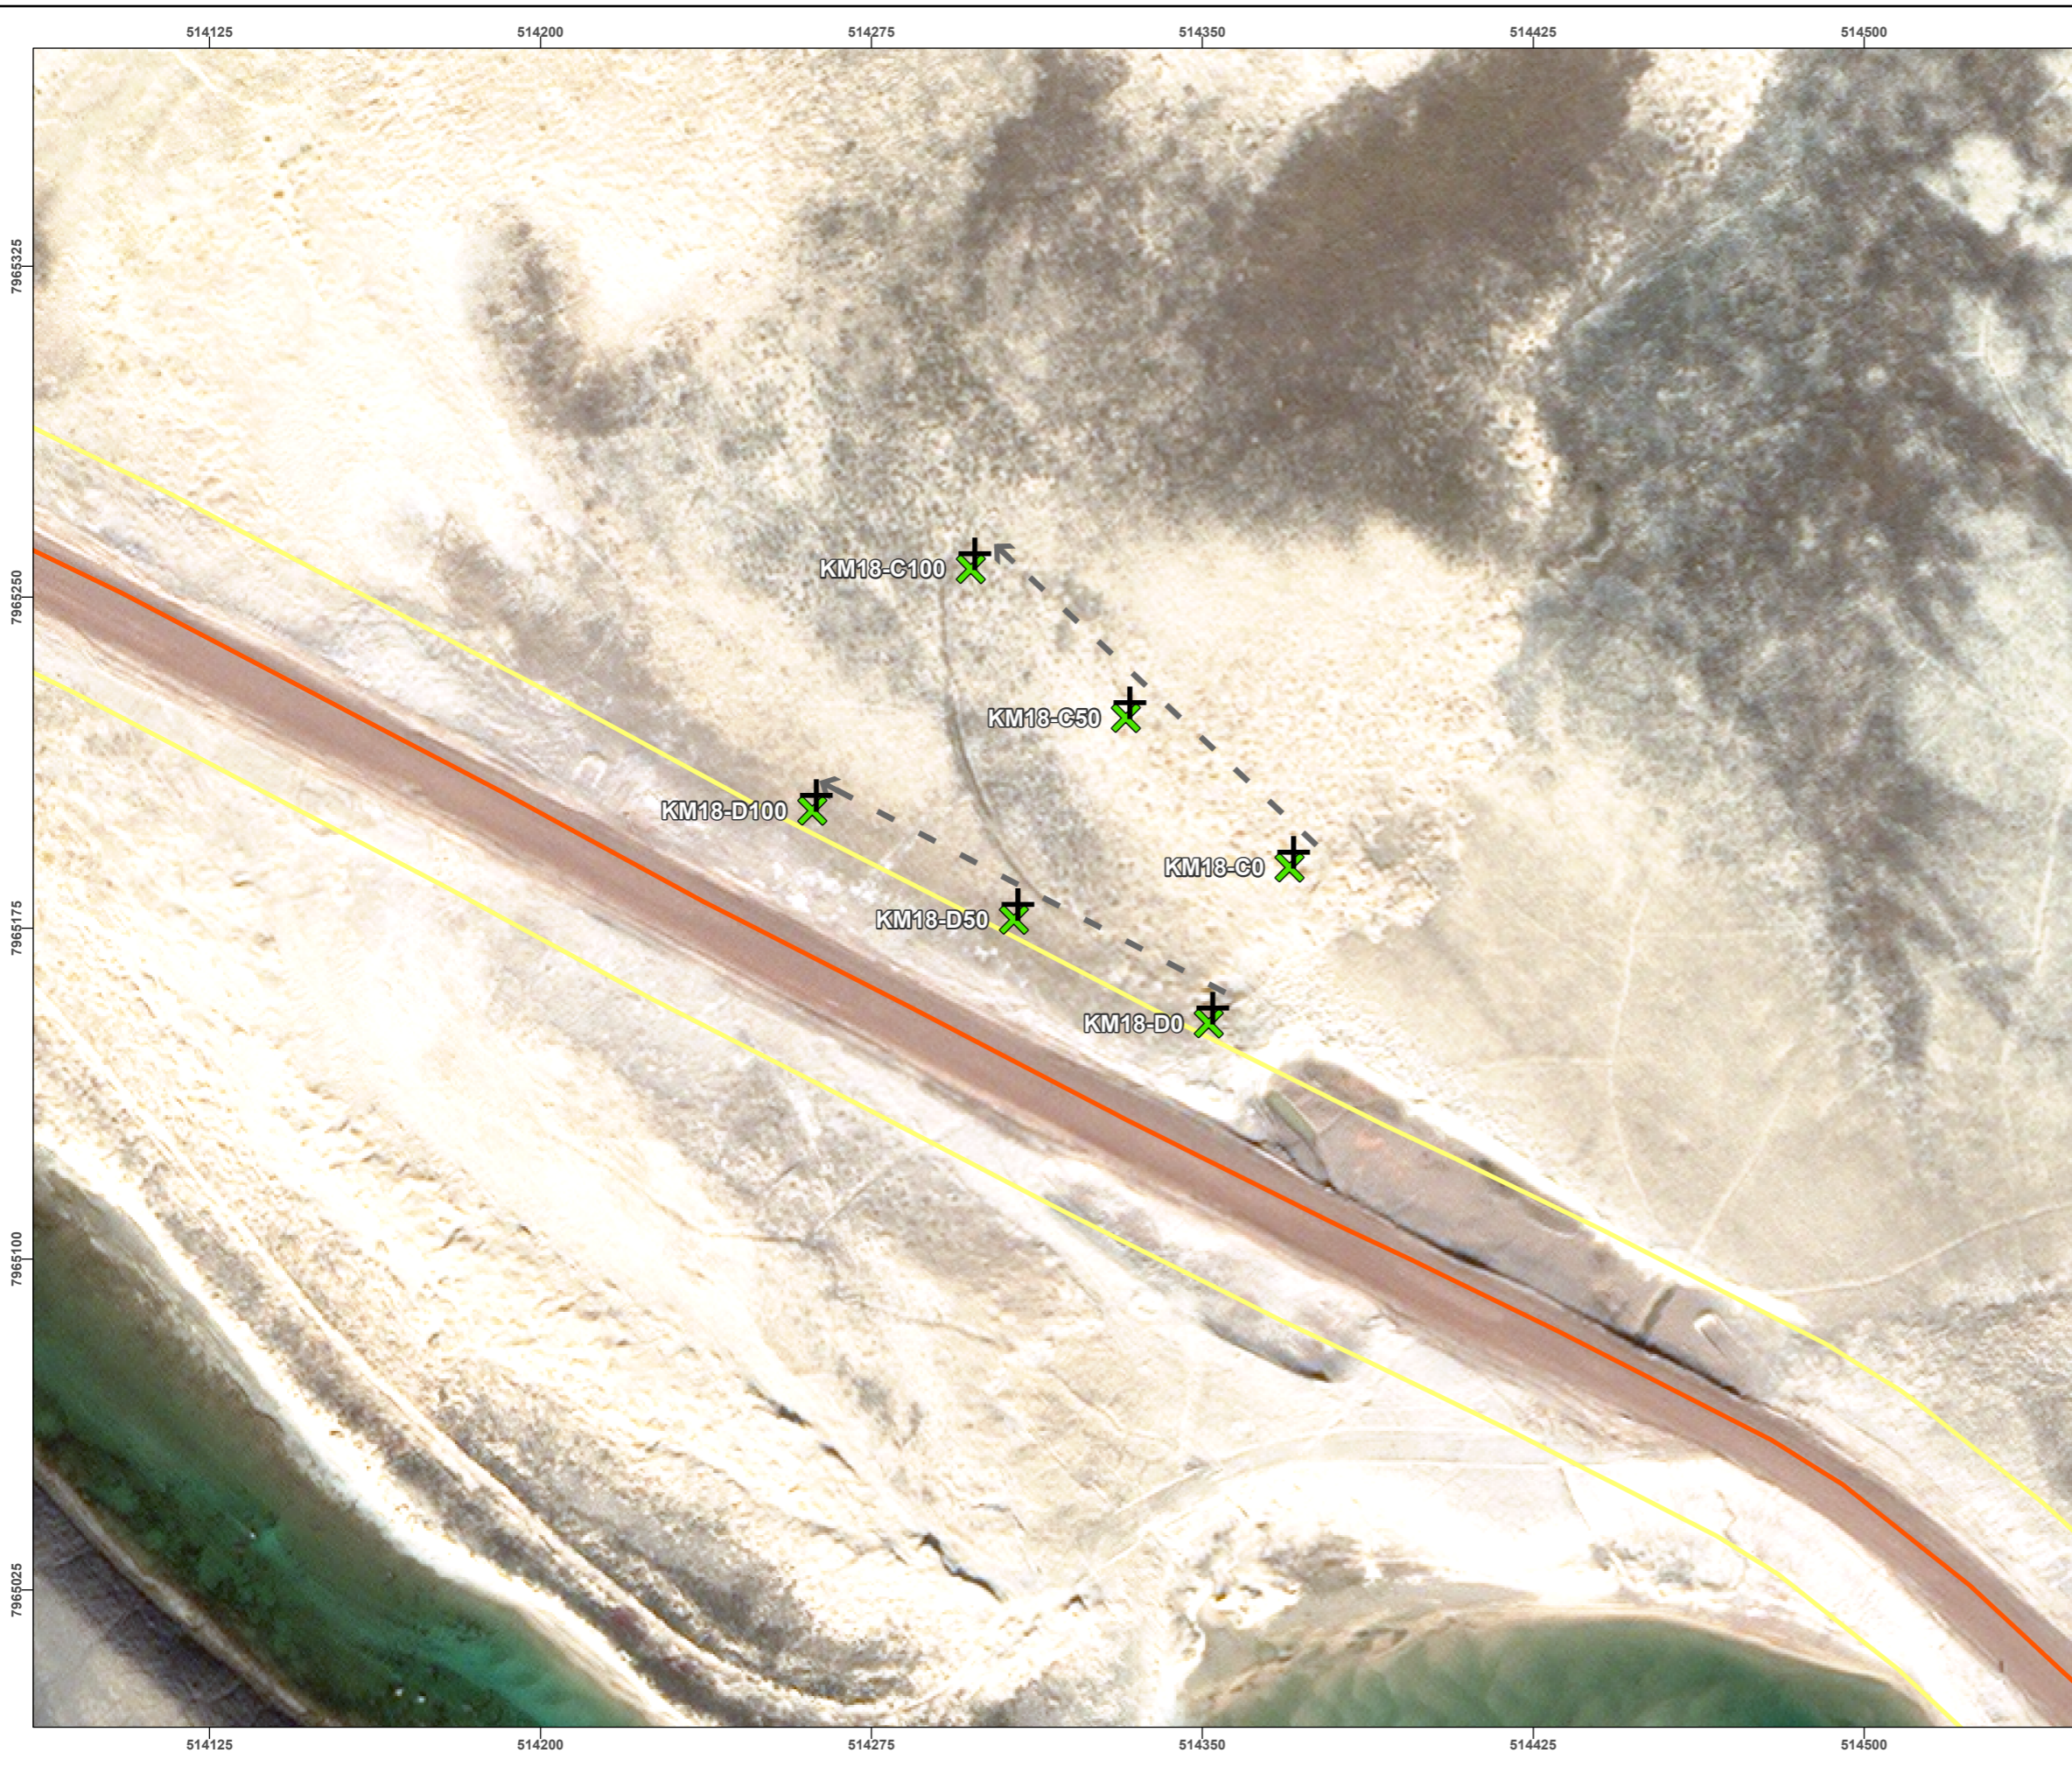
Drawn: Y. Navarro	Checked: P. Audet	<b>Map 5</b>	Date: 2021-10-08
----------------------	----------------------	--------------	------------------

Map 5 shows the sampling layout at KM18. Table 7 summarizes landscape, terrain and soil attributes. Table 8 lists observed vegetation species within and adjacent to the study area. Table 9 summarizes mean surface projective cover within the vegetation quadrats. Figure 4 shows total projective cover along the survey transect. Supporting information (e.g., geo-referencing and lab analysis) is provided in Appendix B3.

**KM18**  
Vegetation and Soil Sampling Sites

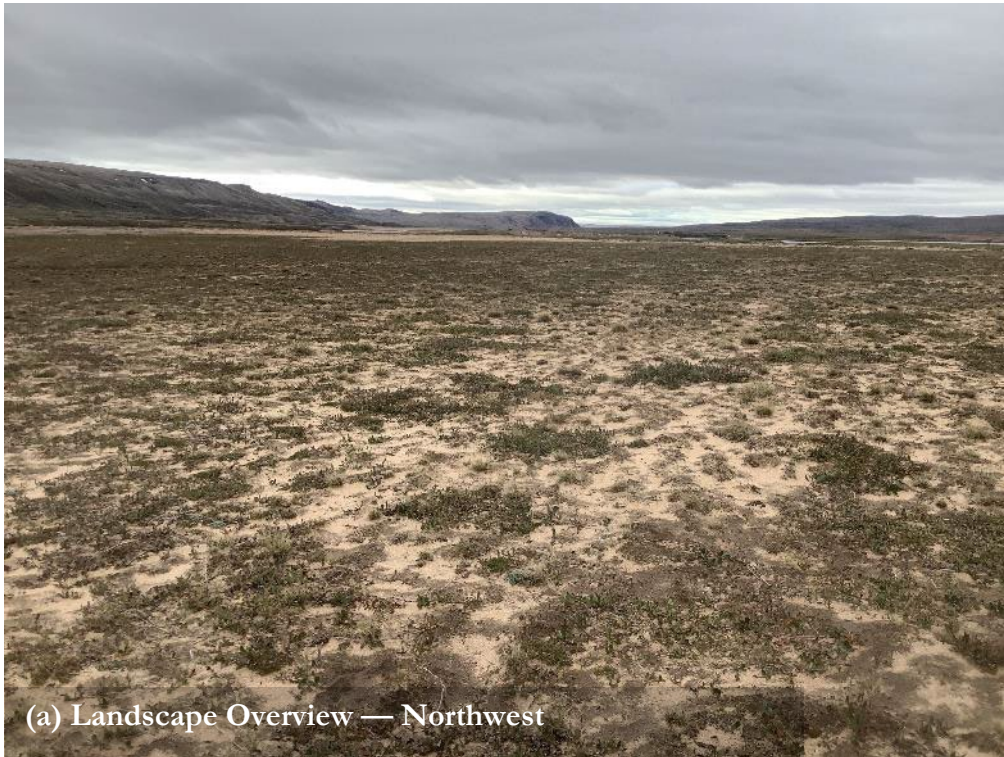
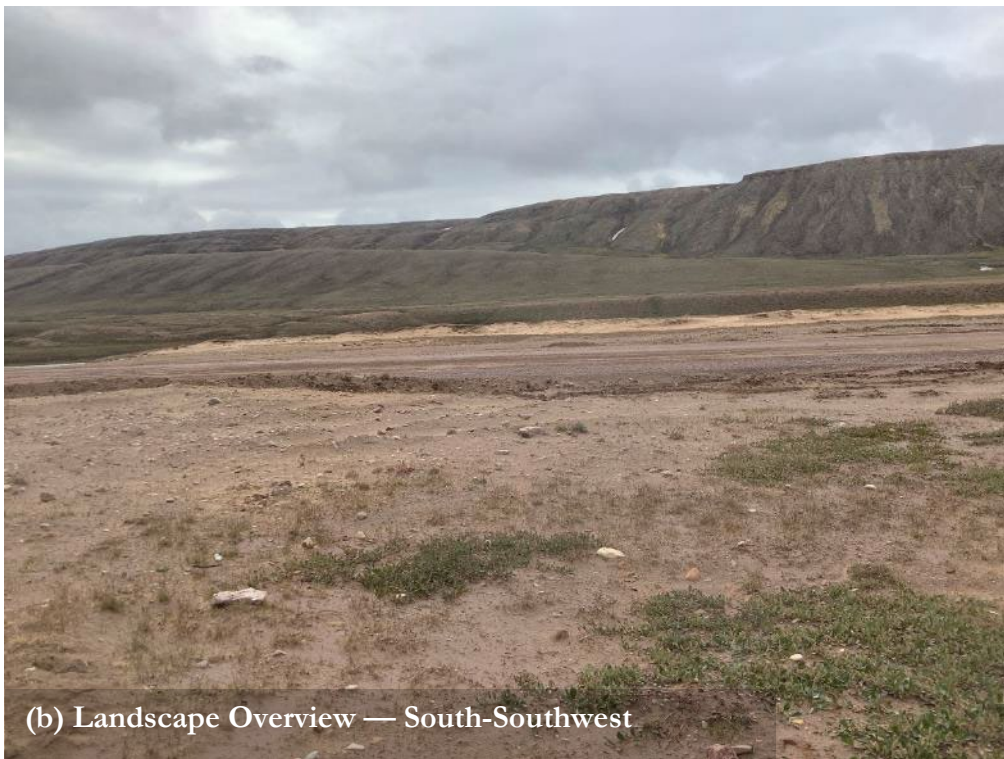
**Landscape, Terrain and Soil**— Located along Phillips Creek, the survey transects occur on a sandy terrace with level slopes that are characterized by generally loose, well-drained and unconsolidated surficial geology, and no apparent bedrock (Photo 6a–b). Although terrain within the study area was homogenous and had little micro-topographical variations, the broader landscape indicated ground patterning associated with permafrost. Therefore, native (control) soils likely refer to Brunisolic Turbic Cryosols. Soil profiles at the control (KM18-C0, -C75, -C150) and disturbed locations (KM18-D0, -D75, -D150) were similarly characterized by a discontinuous surface organic layer followed by a sand textured B horizon. Little-to-no coarse parent materials (i.e., till) were observed. The restrictive layer (assumed to be permafrost) was not encountered. The soil moisture regime was xeric (dry); no mottling was observed in the soil profile.

(a) Landscape Overview — Northwest

(b) Landscape Overview — South-Southwest

Photo 6. KM18 — Landscape overview at -C50 (a) and -D0 (b).

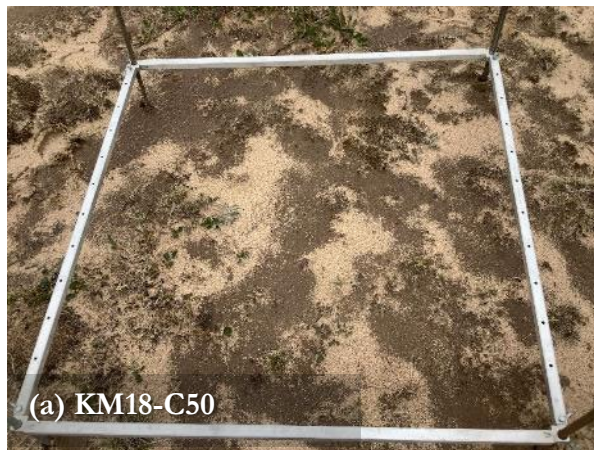
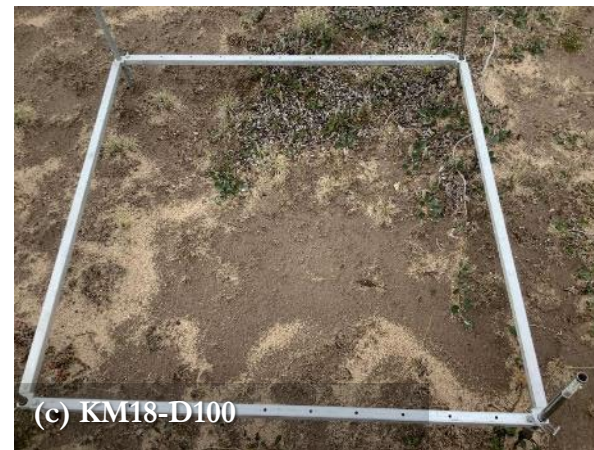
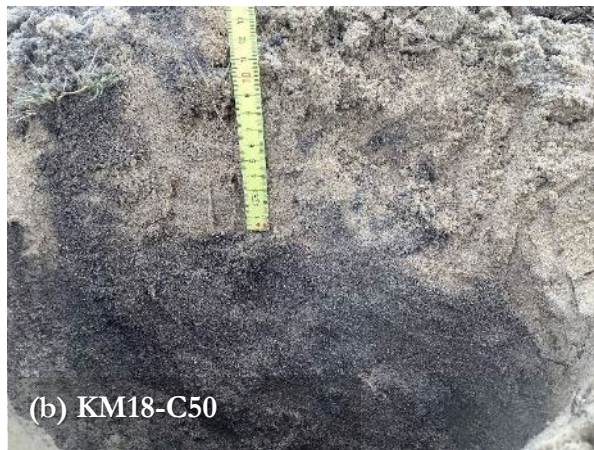
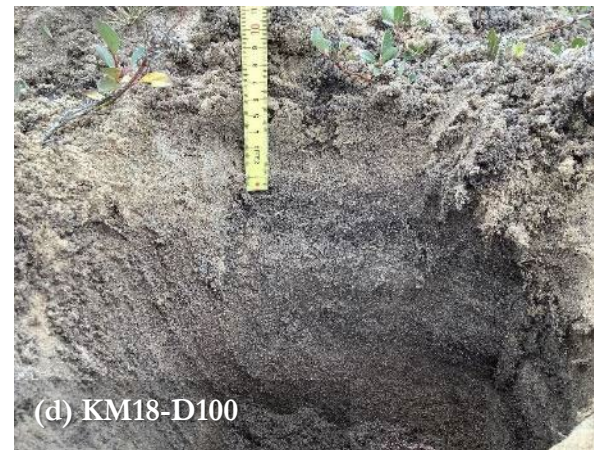
**Vegetation Surface Cover and Composition**— Vegetation cover in control areas was characterized by a discontinuous vegetative mat (40% along the transect; 90% within quadrats) with representation by graminoids, forbs/perennial herbs, shrubs, and bryophytes (Photo 7a–b), but no lichen. Disturbed areas were also characterized by a discontinuous and uneven (i.e., patchy) vegetative cover (43% along the transect; 2% within quadrats) that was primarily composed of graminoids and forbs/perennial herbs (Photo 7c–d), but no shrubs, bryophytes or lichen.

Photo 7. KM18 — Cover vegetation and soil profile at -C50 (a-b) and -D100 (c-d)

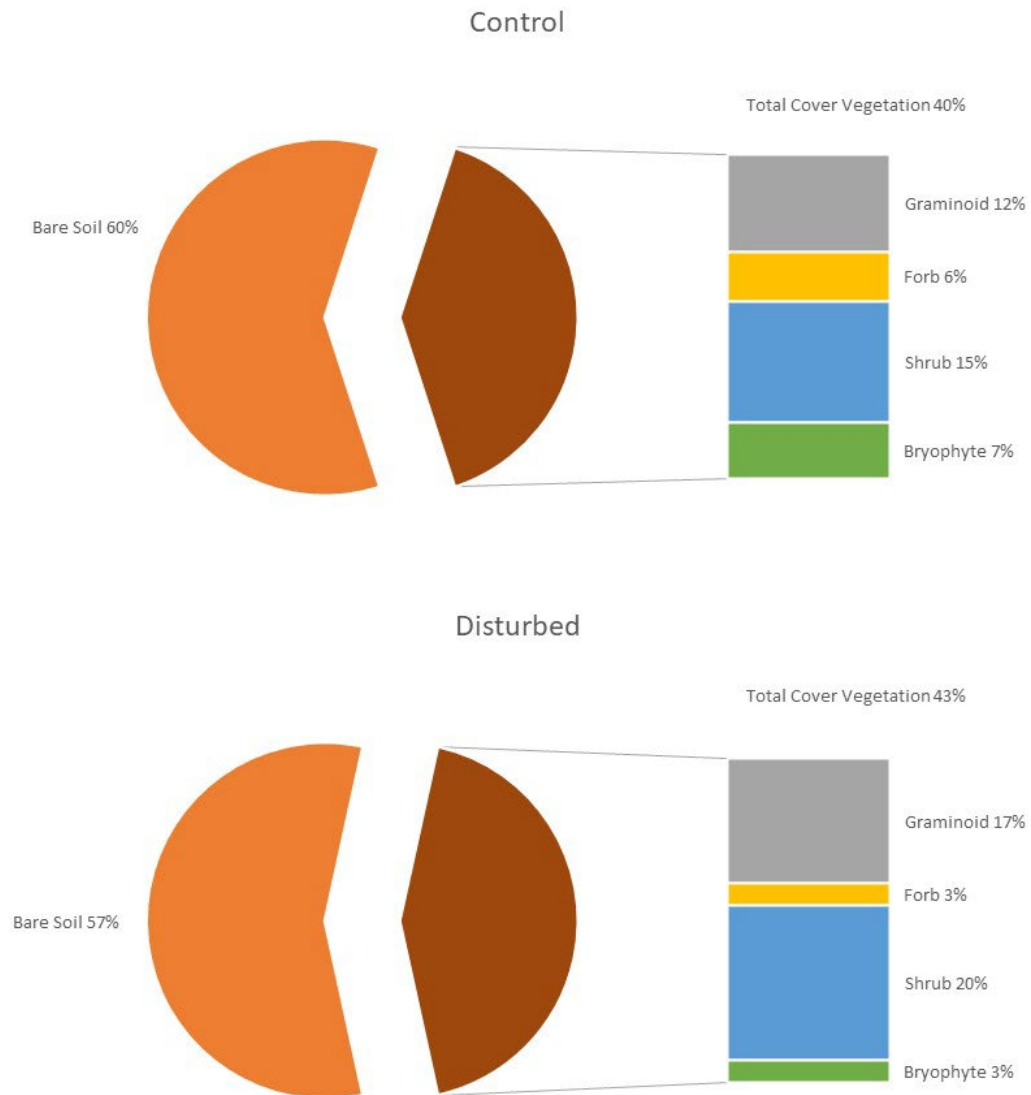
Figure 4. KM18 — Surface projective cover (%) along vegetation transect.
