KM58 Vegetation and Soil Sampling Sites

Table 10. KM58 (Abandoned Airstrip) — Summary of landscape, terrain and soil attributes.

3 RECLAMATION TRIAL

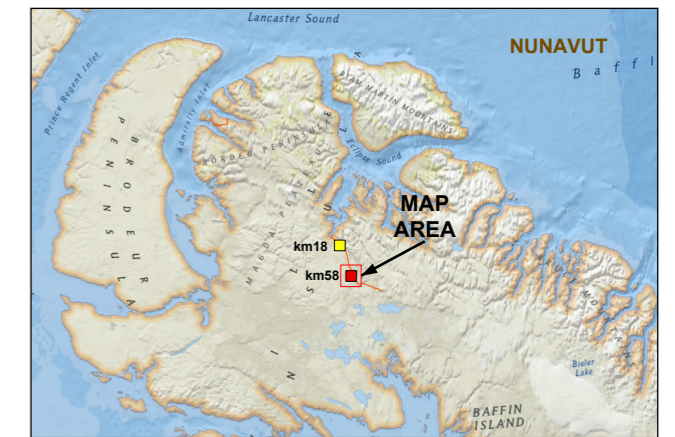
Drawn: Y. Navarro	Checked: P. Audet	Map 6	Date: 2021-10-12
----------------------	----------------------	--------------	------------------

- Tote Road
- Tote Road (25m Buffer)
- Study Area
- Soil
- Vegetation
- Cover Transect

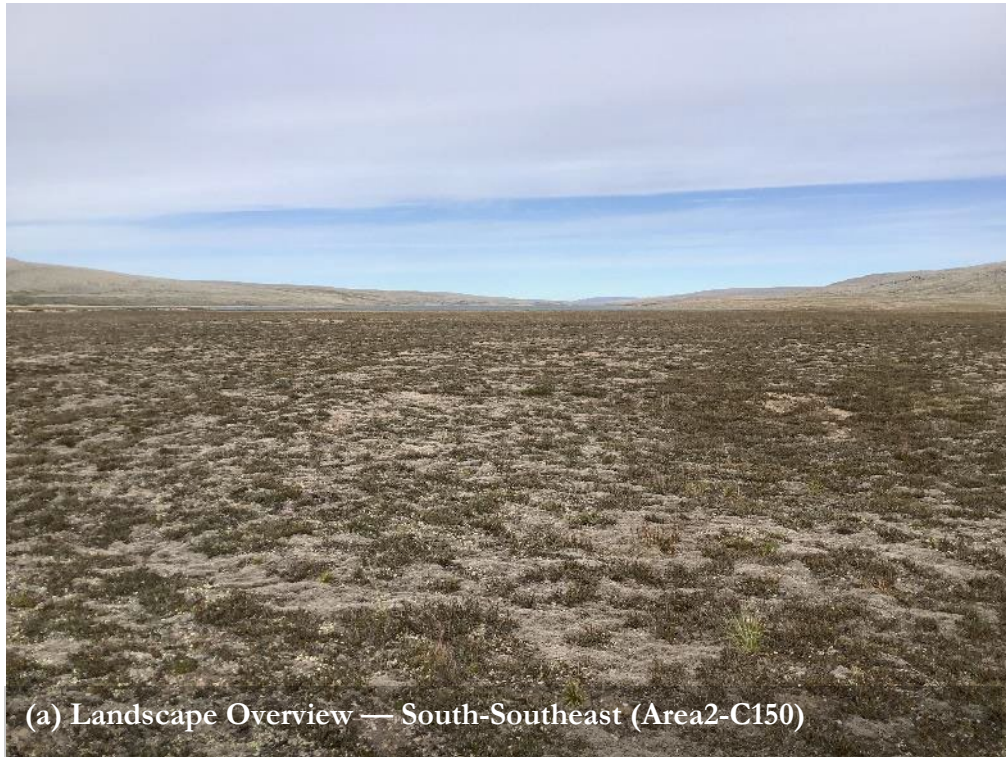
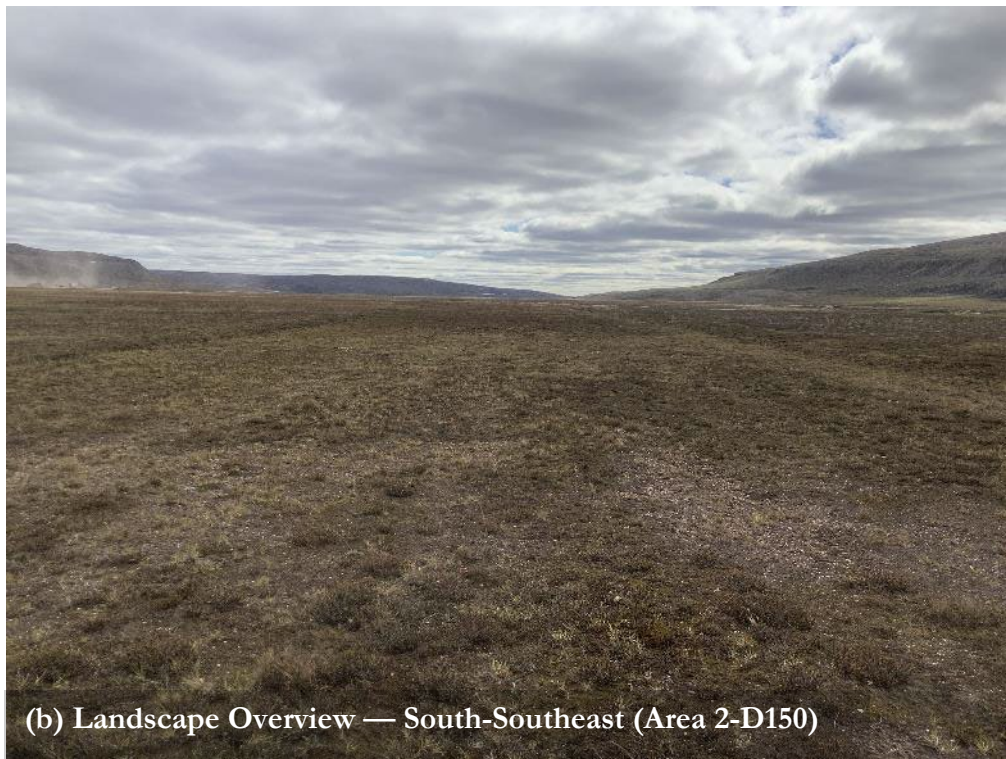
(a) Landscape Overview — South-Southeast (Area2-C150)

Photo 8. KM58 — Landscape overview at Area2-C150 (a) and Area2-D150 (b).

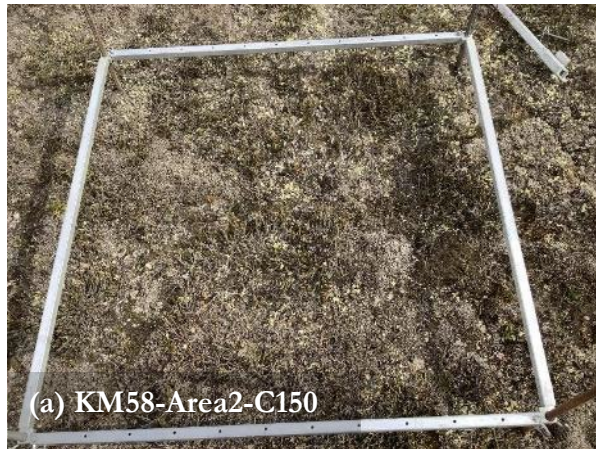
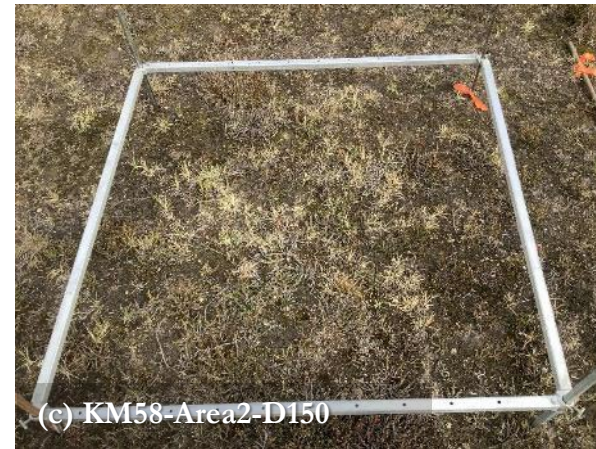
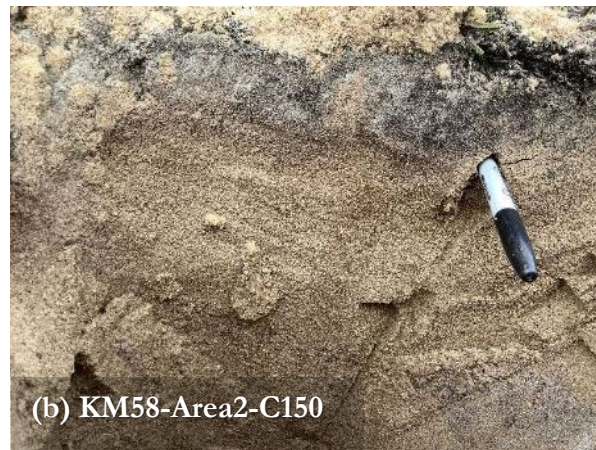
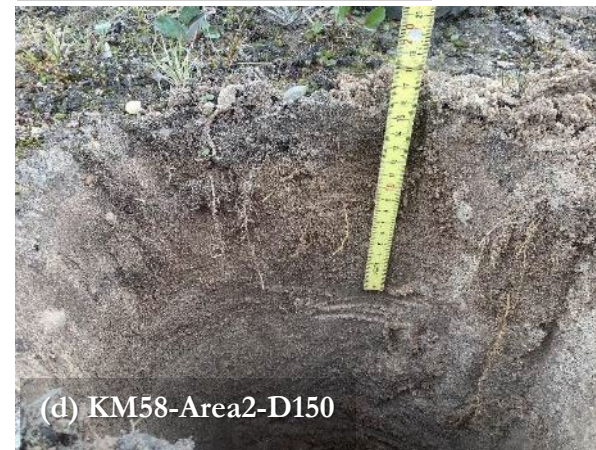
Photo 9. KM58 — Cover vegetation and soil profile at Area 2-C150 (a-b) and Area2-D150 (c-d)

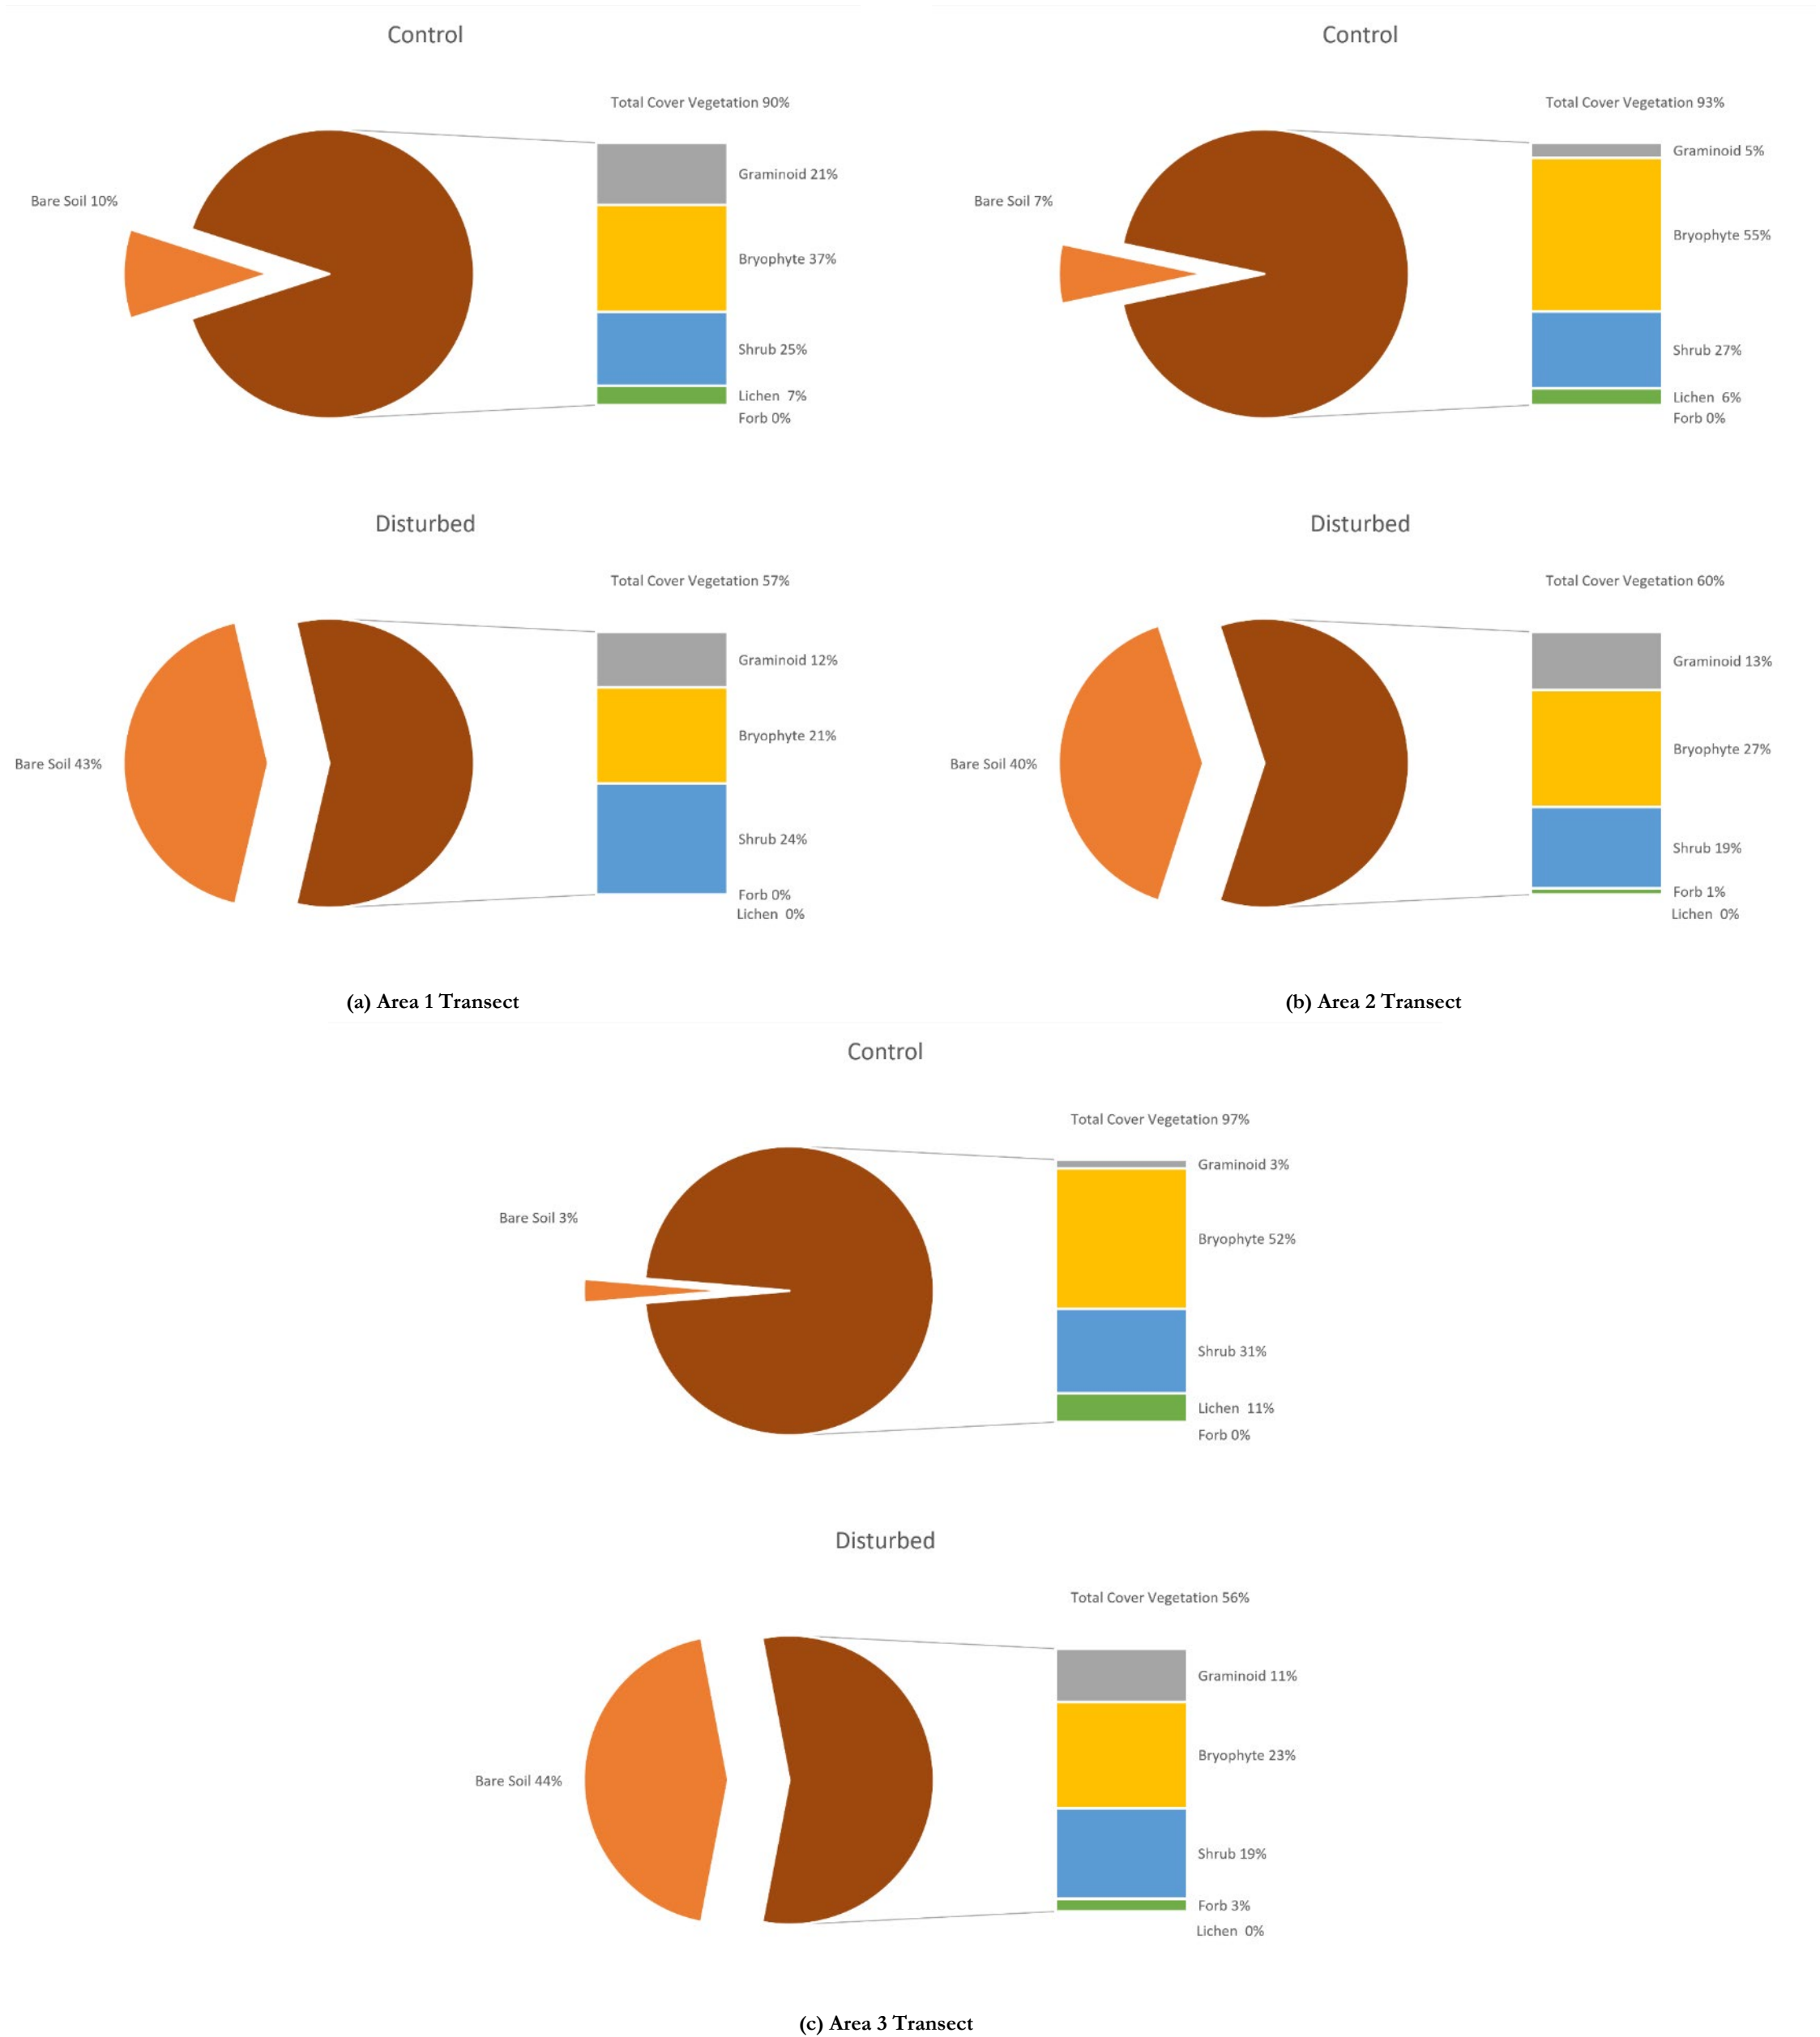
Figure 5. KM58 (Abandoned Airstrip) — Surface projective cover (%) along vegetation transects.

Survey Area (Survey Marker ID)	KM58 — Disturbed (-0, -75, -150)			KM58 — Control (-C0, -C75, -C150)		
	Area 1	Area 2	Area 3	Area 1	Area 2	Area 3
*Bare Soil/Rock	39.0% (±16.4 SD)	34.3% (±28.5 SD)	27.3% (±8.4 SD)	7.6% (±12.4 SD)	0.3% (±0.6 SD)	4.7% (±6.4 SD)
*Bryophytes	33.3% (±13.3 SD)	36.0% (±9.6 SD)	40.3% (±5.7 SD)	33.0% (±12.5 SD)	42.3% (±7.6 SD)	41.3% (±5.5 SD)
*Lichen	2.7% (±3.1 SD)	0.7% (±1.1 SD)	0.3% (±0.6 SD)	25.0% (±12.1 SD)	25.7% (±3.5 SD)	22.3% (±5.1 SD)
*Litter	0.3% (±0.6 SD)	2.7% (±2.5 SD)	0.0% (±0.0 SD)	2.6% (±4.6 SD)	0.0% (±0.0 SD)	0.0% (±0.0 SD)
*Graminoids	11.3% (±4.6 SD)	11.0% (±6.6 SD)	5.7% (±1.5 SD)	7.6% (±12.4 SD)	1.0% (±0.0 SD)	0.3% (±0.6 SD)
*Forbs	2.0% (±2.0 SD)	1.0% (±0.0 SD)	1.3% (±1.5 SD)	0.3% (±0.6 SD)	0.0% (±1.5 SD)	0.0% (±0.0 SD)
*Shrubs/Ericaceae	11.3% (±4.6 SD)	14.3% (±10.2 SD)	25.0% (±1.0 SD)	23.7% (±8.5 SD)	29.3% (±5.9 SD)	31.3% (±4.2 SD)

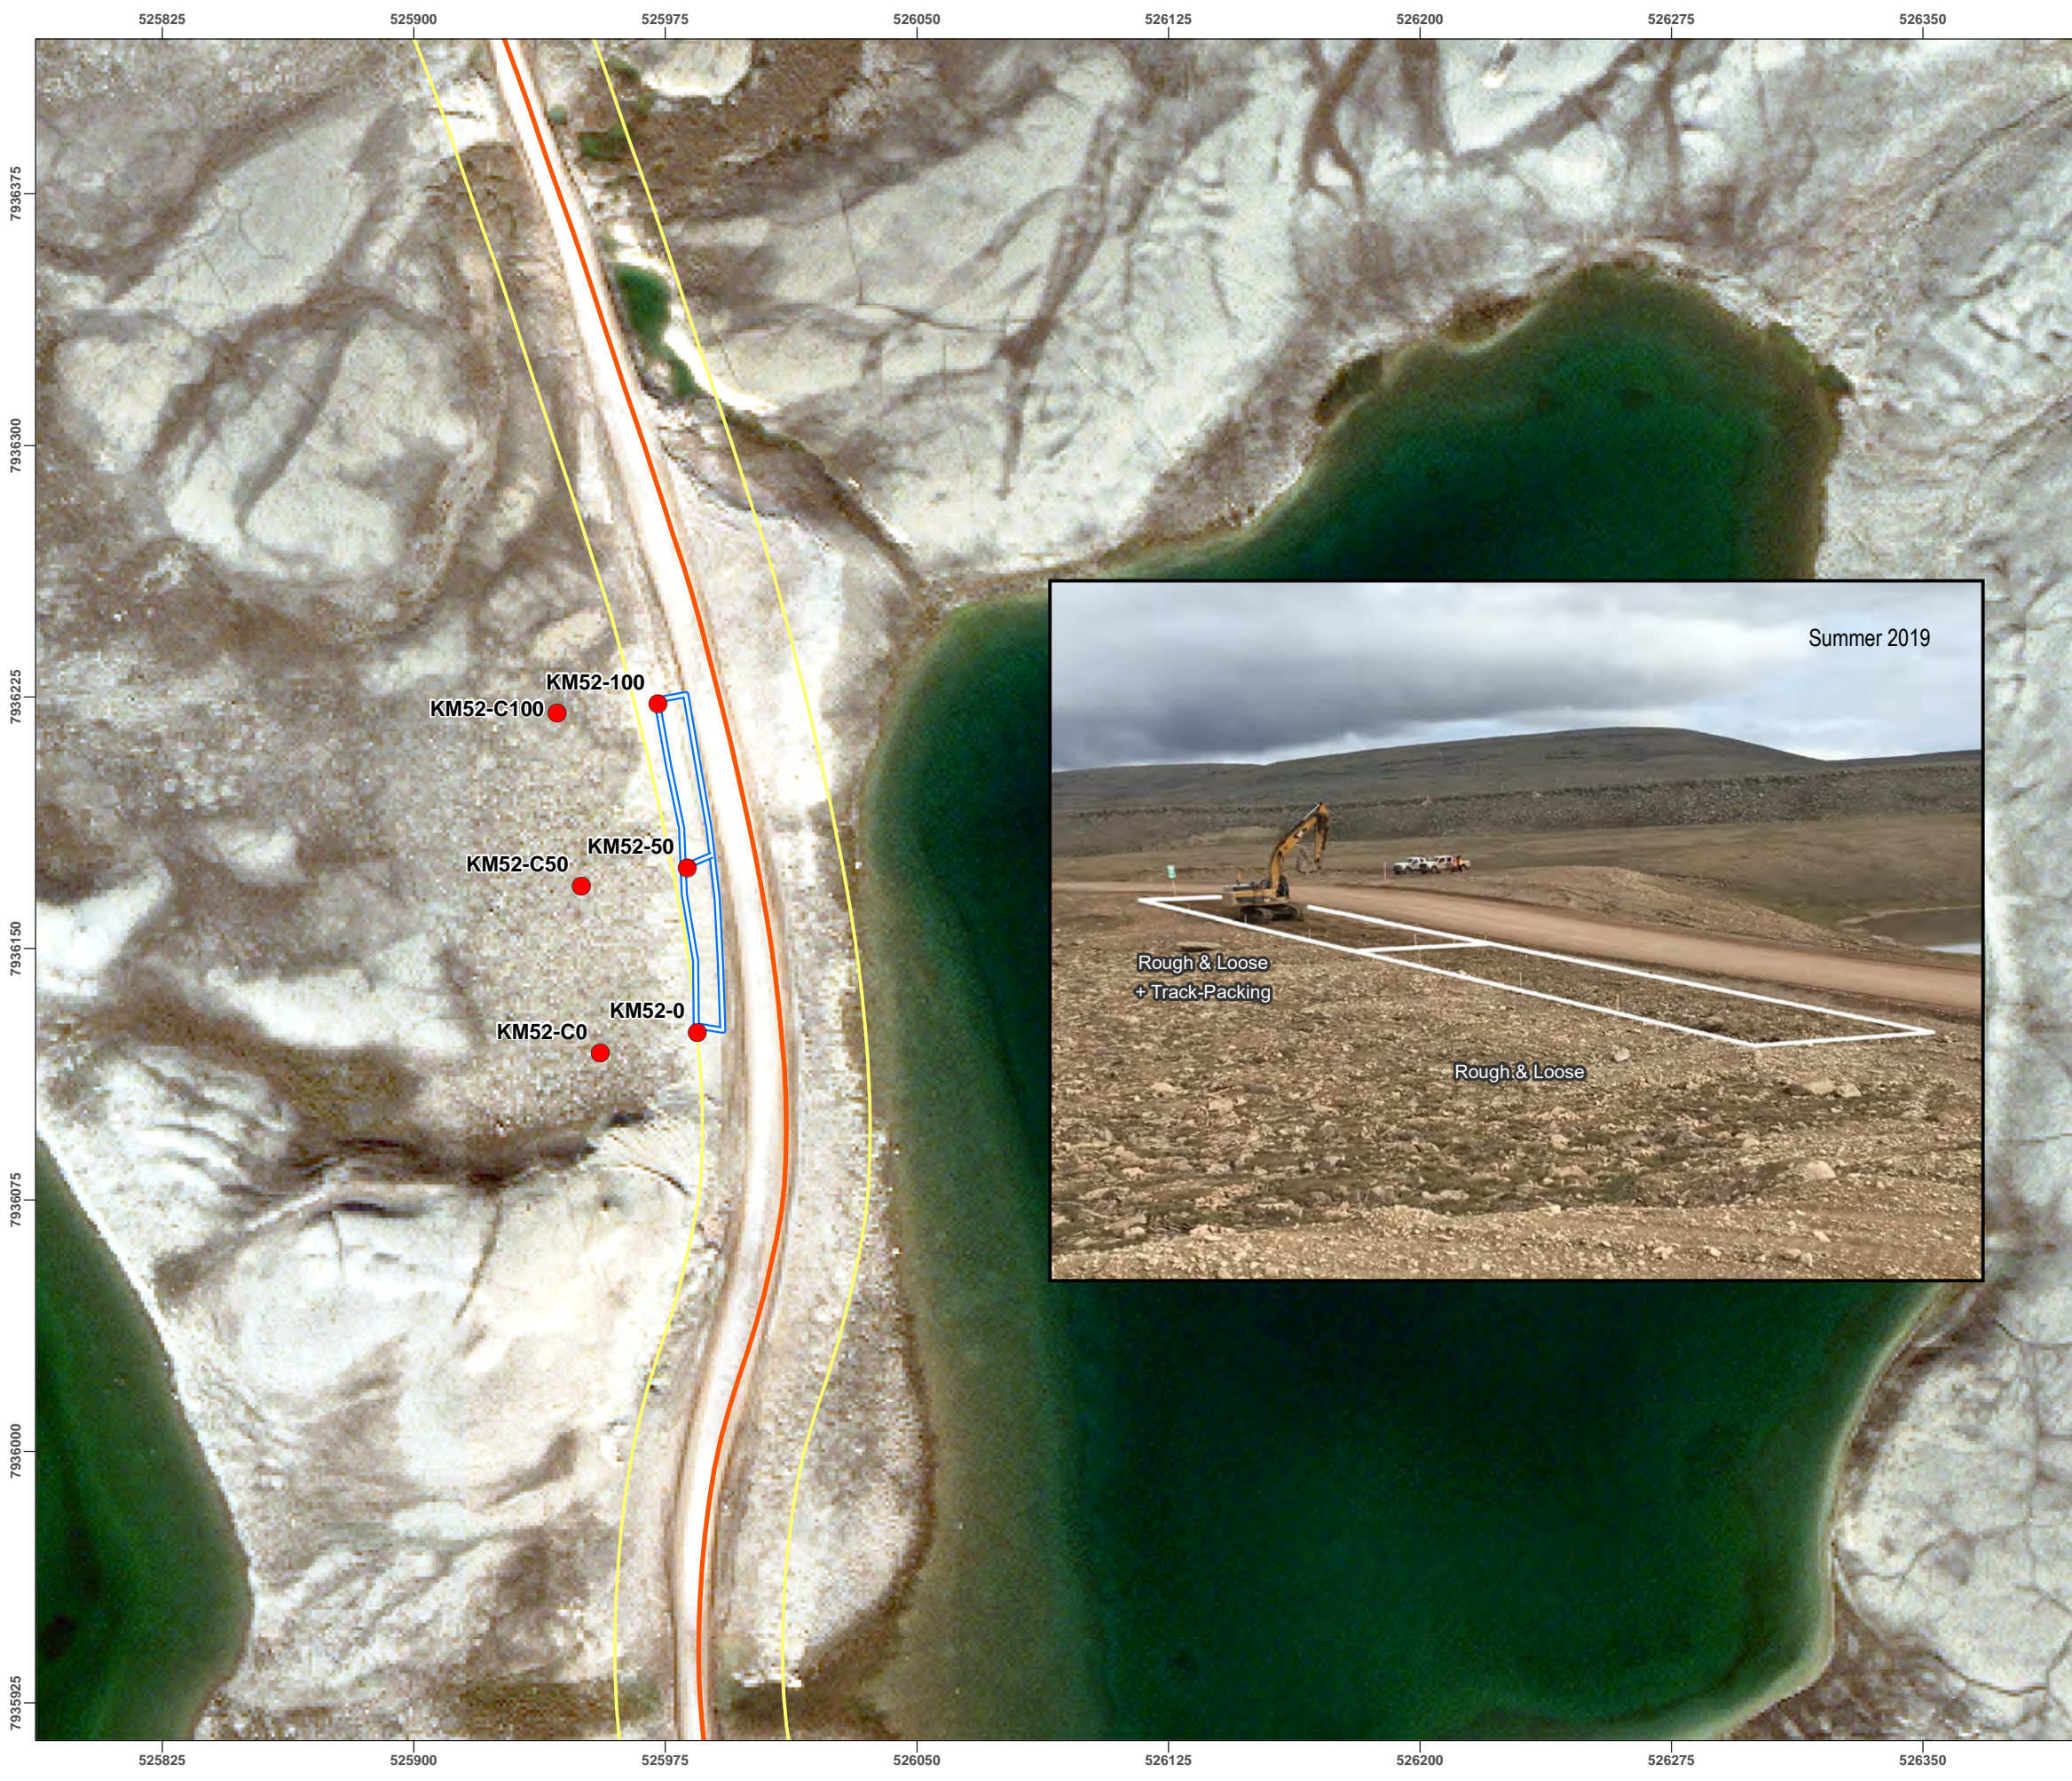
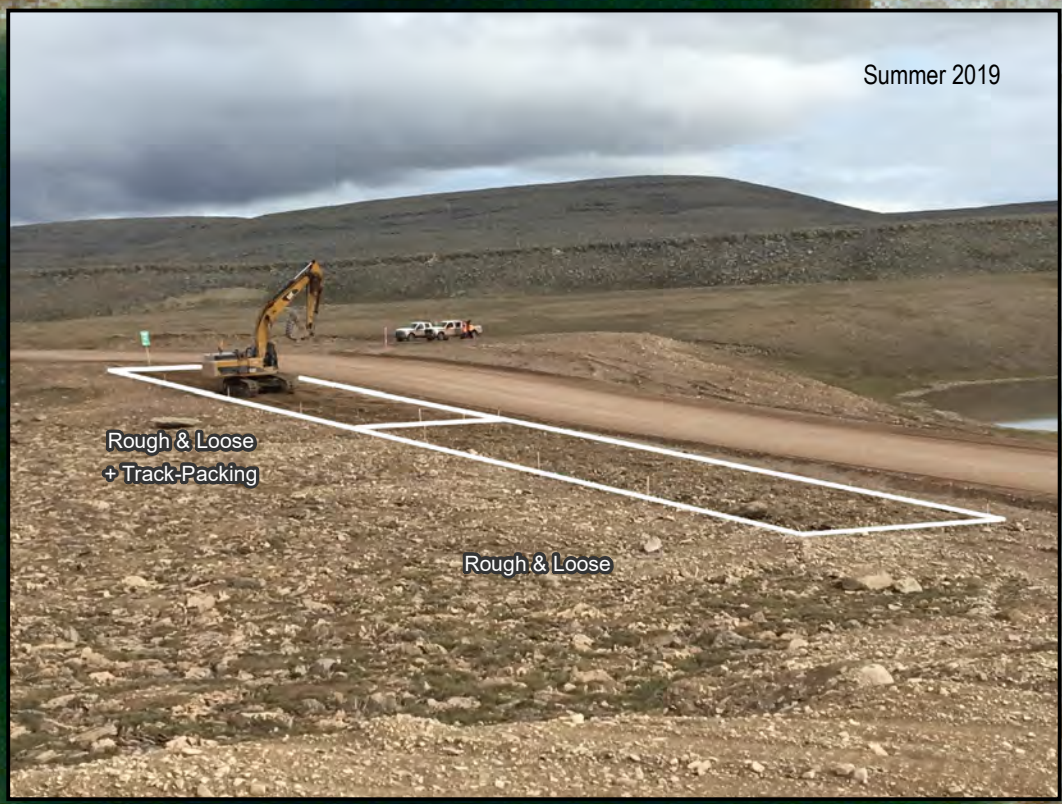
Drawn: Y. Navarro	Checked: P. Audet	Map 7	Date: 2019-08-28
----------------------	----------------------	-------	------------------

KM52
Layout of Preliminary Reclamation Trial

Site Layout— The second portion of the reclamation pilot study focused on initiating preliminary reclamation trials at the Project. The locations of the reclamation trials correspond with the KM52, KM16, and KM18 post-disturbance revegetation survey areas (described in Section 2.1); reclamation trial design and layout are shown on Map 7, Map 8, and Map 9. At each trial location, a 100x10 m (at KM52) or 150x10 m trial strip (at KM16 and KM18) was delineated, all within the 25 m buffer from the centreline of the right of way and corresponding with the permissible Project area for earthworks and maintenance along the Tote Road.
