Memo

To: Grant, Environmental Committee
From: Darren Lindsay
cc: Enviro Technician, Camp Operations
Date: September 23, 2025
Re: Contaminated soils update

This memorandum updates the 2019 contaminated soils investigation (SRK, 2020) with activities undertaken in 2021, 2022, 2024, 2025 continuing the investigation of areas where petroleum hydrocarbon (PHC) products were historically handled on the Ulu Gold project site, the definition of the extent of impacts, and the re-use of soils that met the applicable criteria. The initial objective of the proposed Soil Treatment Facility (STF) was to treat soils until they met Canadian Council of Ministers of the Environment (CCME) parkland land use (PL) guidelines for surface soils, surface soil re-use (Table A).

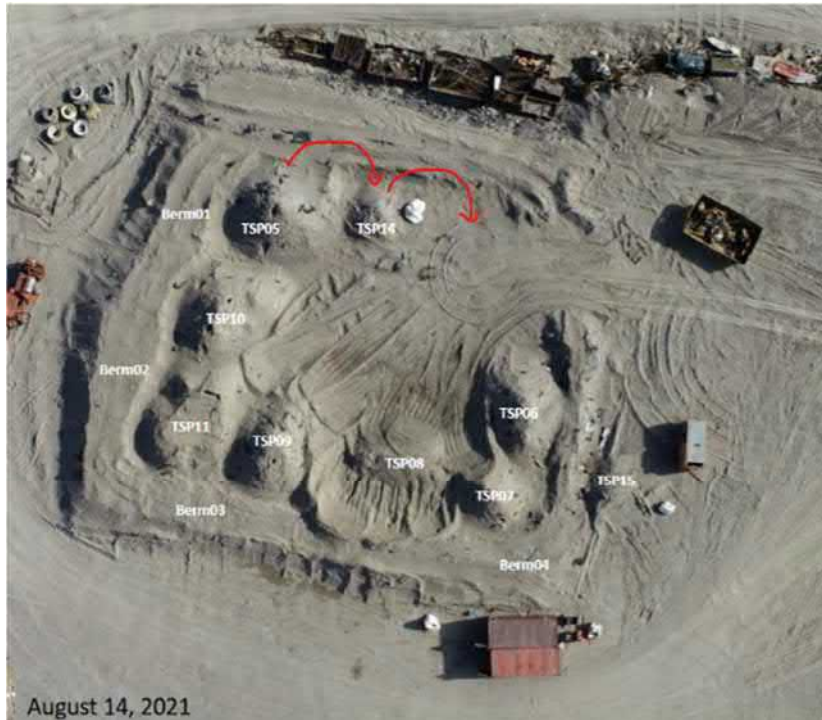
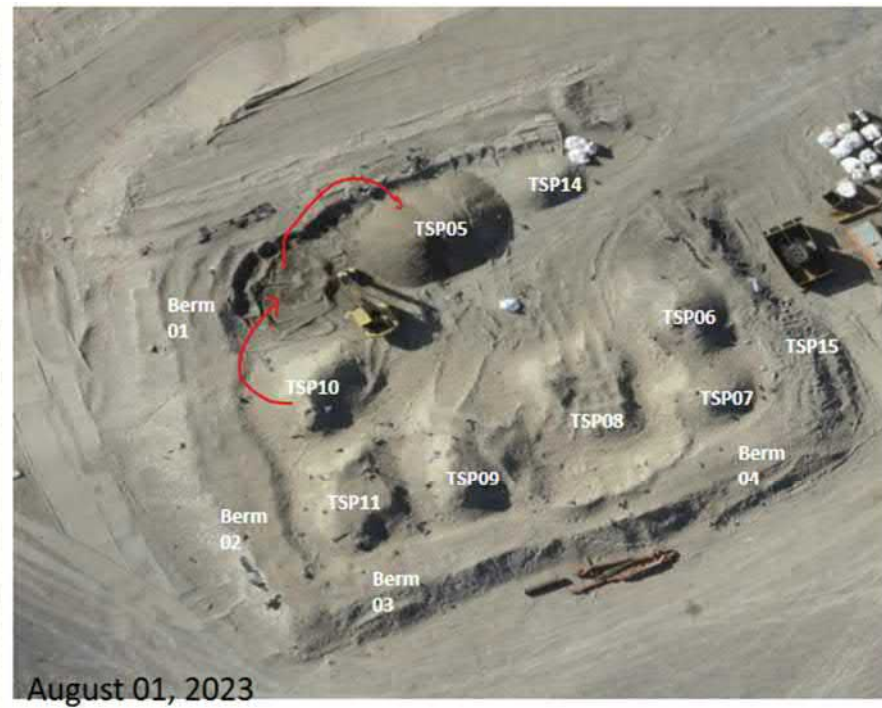
Figure 1: Aerating of stockpiles in the soil holding area August 2023.

No sampling program undertaken during the season however stockpiles were fully aerated using an excavator (Figure 1).

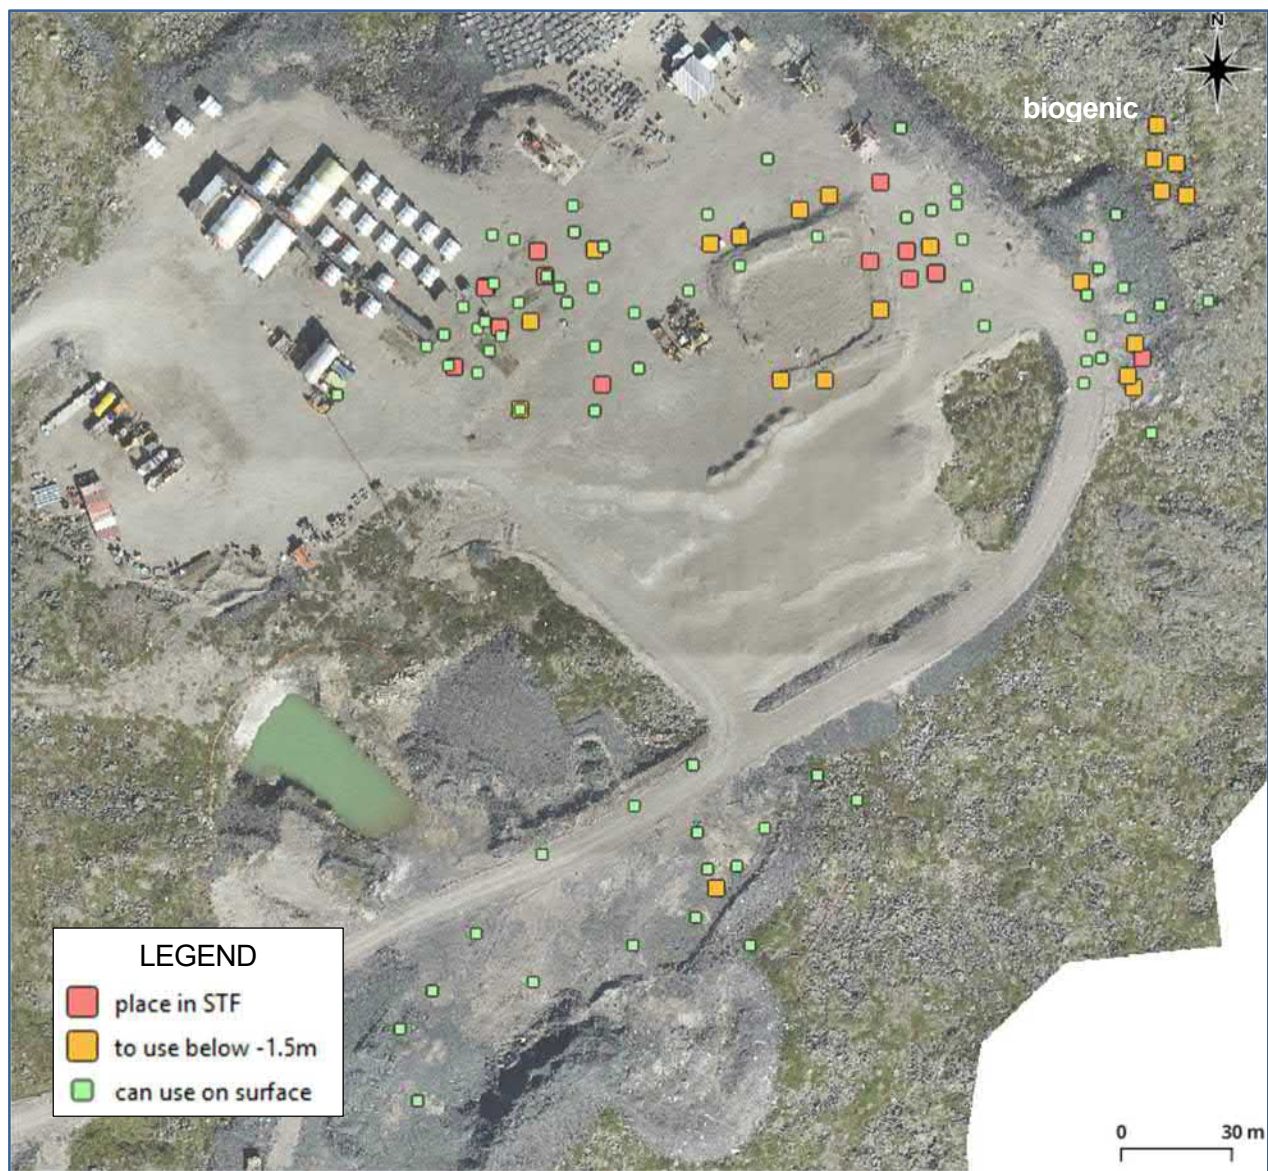
Figure 2: Distribution of PHC contaminated soils as sampled 2019 – 2023; material in holding area used subsurface in 2024.

Approximately 20 m³ of material may need to be shipped off-site for disposal; approximately 1,200 m³ of material requires treatment and all other material can be used as surface cover (Figure 2).
