FIGURE 1.2-1
 2015 DRILLING KIGGAVIK AREAS
 2015 KIGGAVIK ANNUAL REPORT

2015 KIGGAVIK ANNUAL REPORT

**KIGGAVIK
 PROJECT**

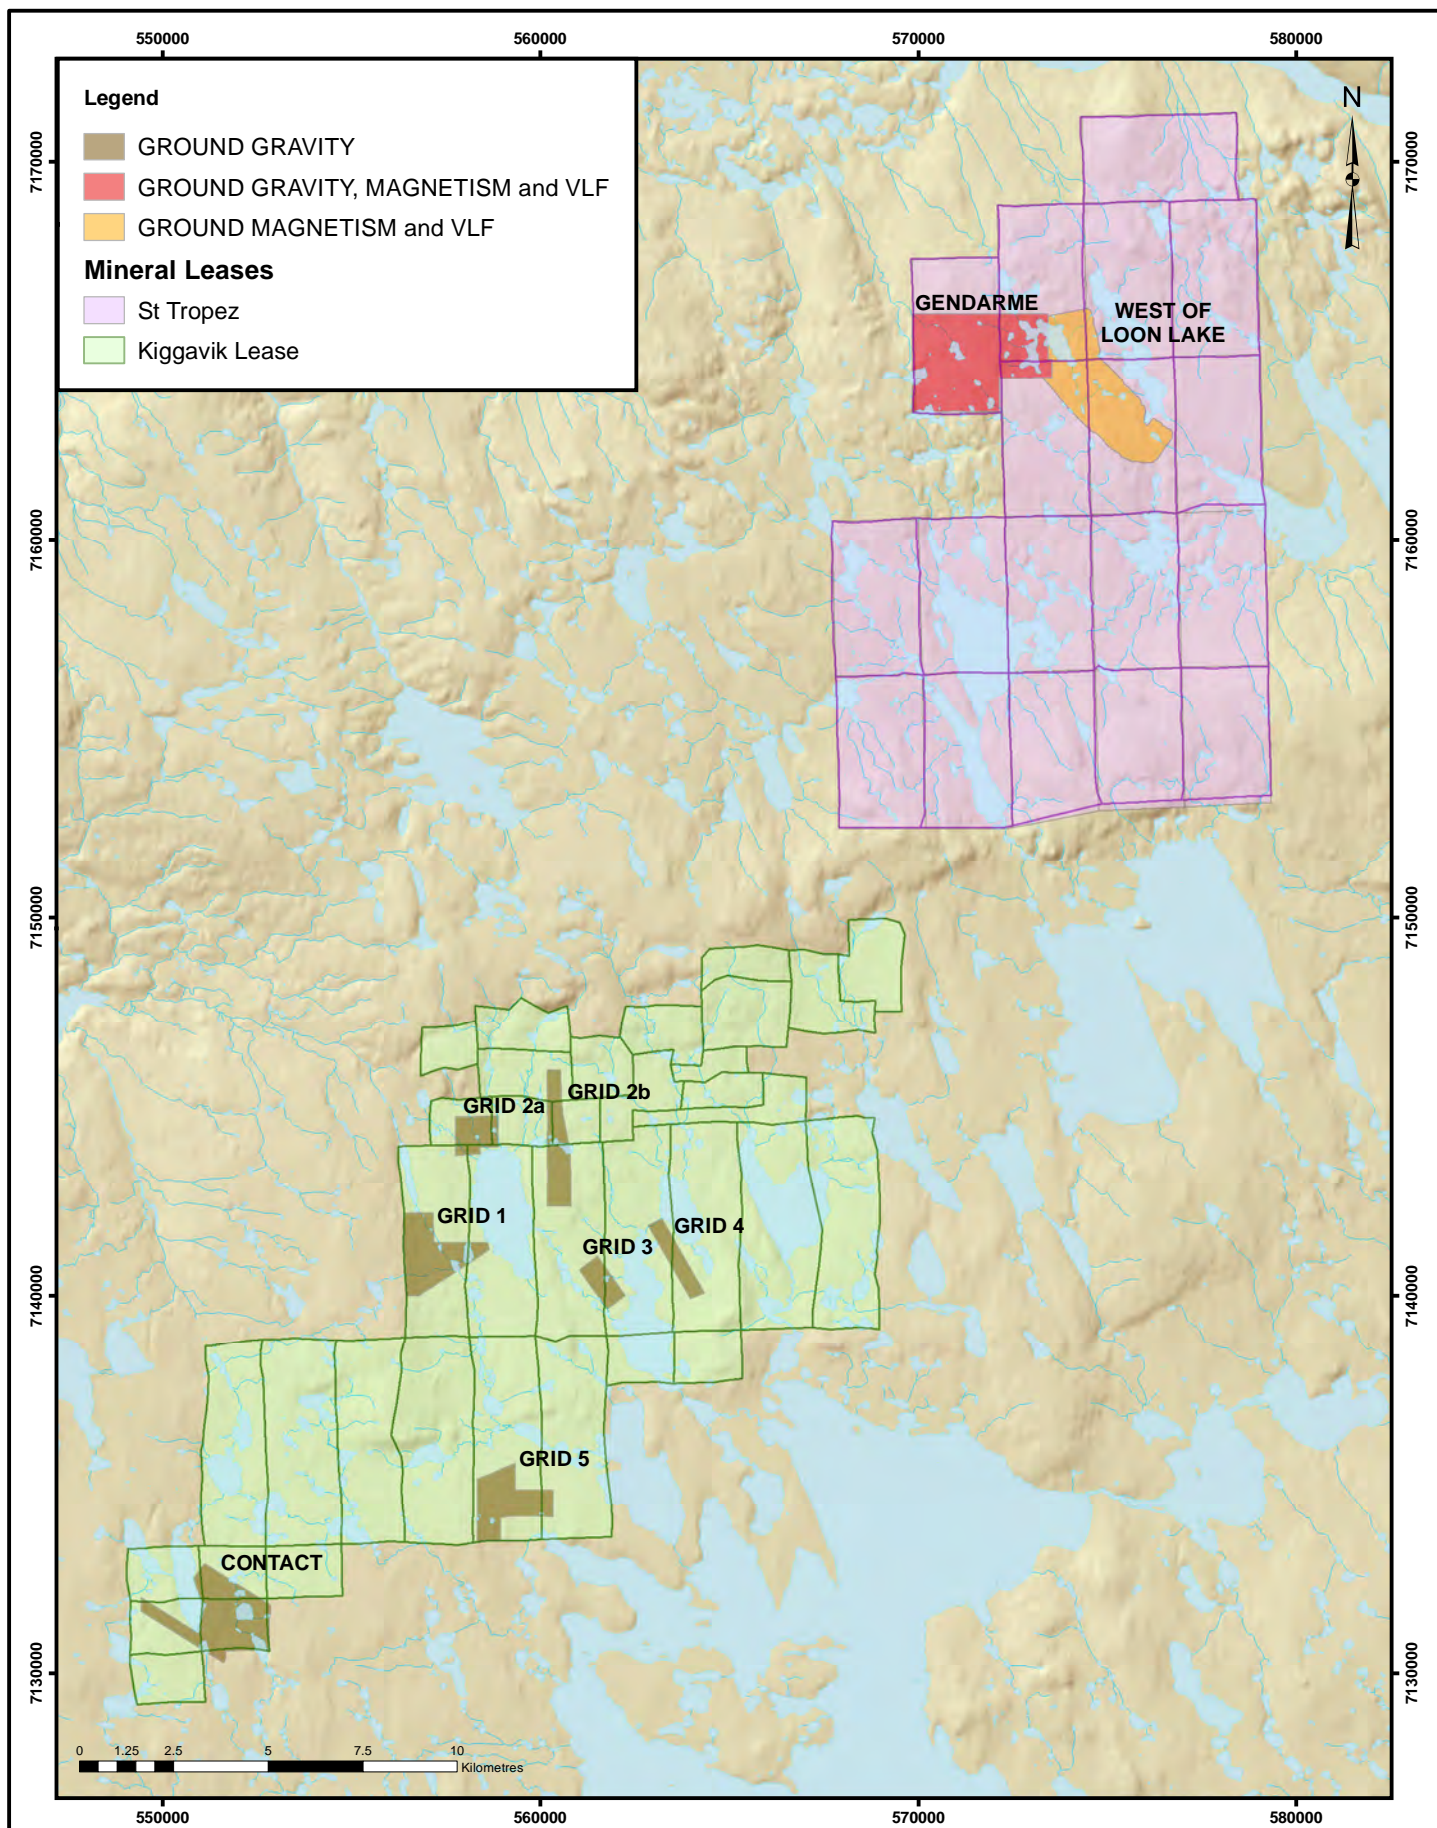
FIGURE 1.3-1
 2015 GEOPHYSICAL SURVEYS
 2015 KIGGAVIK Annual Report

A ground geophysical program was completed in June/July 2015. Seven grids were surveyed on the Kiggavik lease and two grids were covered in the St Tropez lease as shown by Figure 1.3-1: *2015 Geophysical Surveys* and listed in Table 1.3-1: *2015 Ground Geophysics Program*.

In the Kiggavik area, the ground survey consisted of acquiring gravity data to assist in the levelling of historical surveys and to link "floating" grids. In the St Tropez area two types of ground surveys were conducted:

- a ground gravity survey on the Gendarme grid, and
- Magnetic and VLF surveys on both the Gendarme and the West of Loon Lake grids.

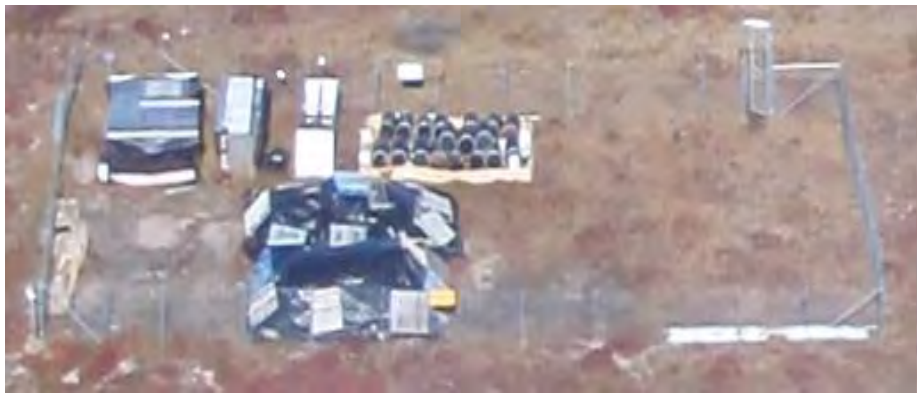
Photograph 3.2-1: Kiggavik Radioactive Storage Compound

All drill cuttings with a uranium concentration greater than 0.05 percent are collected and stored in the radioactive storage compound for future management (Photograph 3.2-1). Food, paper and non-treated wood waste are incinerated onsite (Photograph 3.2-2).
