Committee Bay Project

Annual Report

2017

North Country Gold Corp.
November 2017

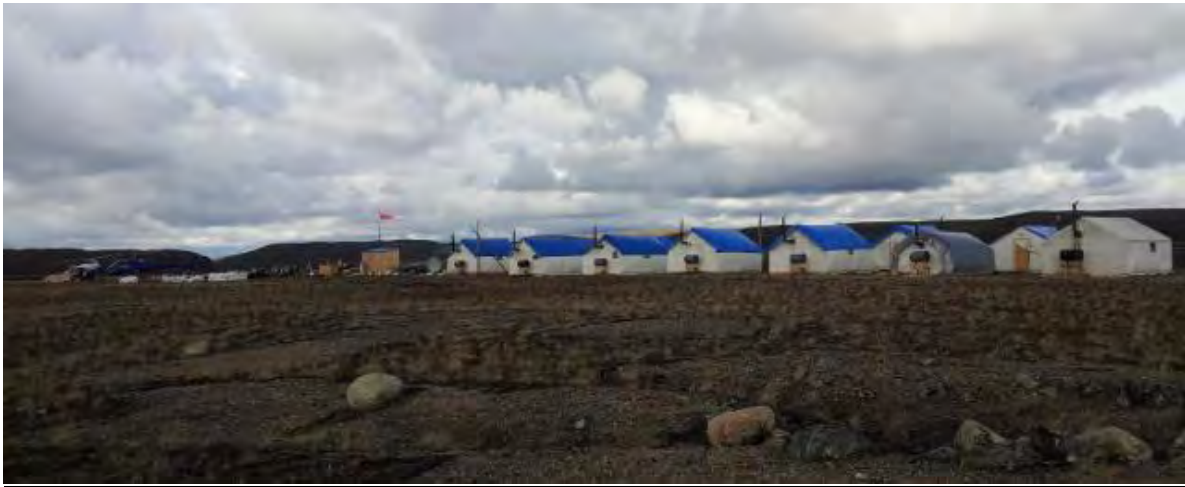
Figure 9: Crater Camp – August 2017

- Mobilization / Camp construction
- Inspection of camp and infrastructure was completed.
- Water samples taken and tested.
- Fuel containment berm was inspected.
- Demobilization and winterization.

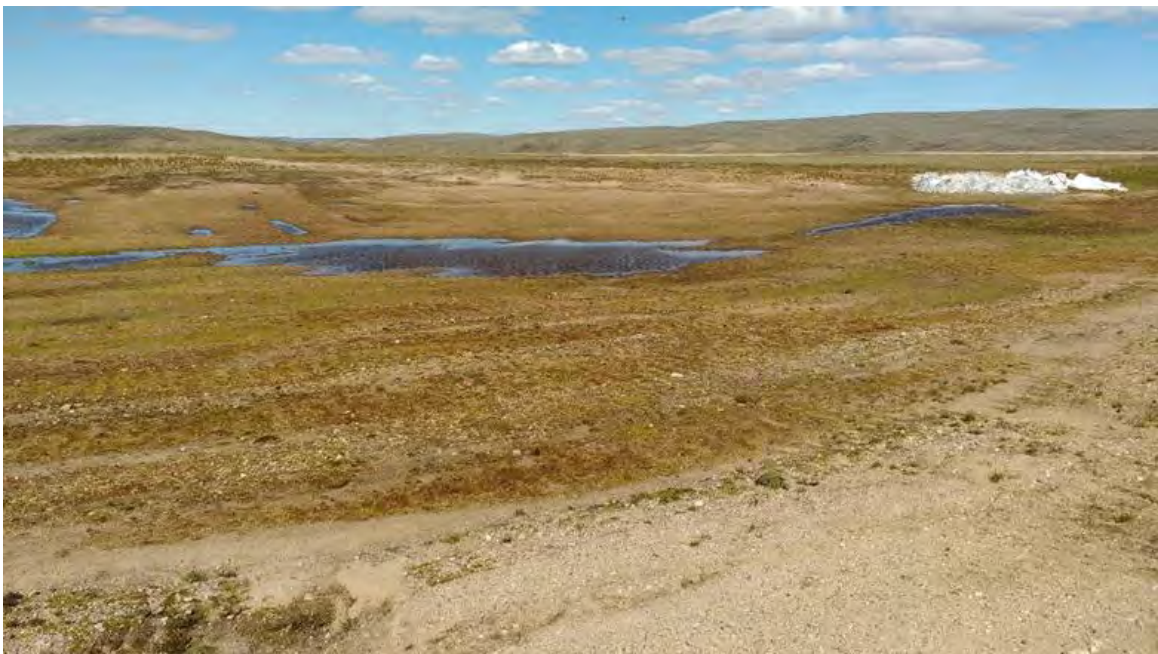
Figure 11: Burrow Area 1: July 8, 2017 (facing NE)

Observation: 5. Water is accumulating in Borrow Area 1, which could result in impacts to the permafrost beneath. Historic drainage channels are visible, but the water level within

the quarry is lower than the old drainage channels. The Quarry Development Plan was not found on-site, and is not currently being implemented; particularly the water management procedures and closure/ remediation.

Action required: E. A plan for restoring drainage from Borrow Area 1 is to be submitted to the Inspector and implemented upon approval. Complete closure and remediation of the quarry should be implemented if no further use is forecasted, to reduce the need for active water management.

Remedial action: An electronic copy of the Quarry Development plan is available. The Mitigative Measures outlined on section 4.0 of the Quarry Development plan include the use of sand bags and silt fences to prevent erosion and sedimentation. The naturally accumulated rain water typically either evaporates or infiltrates the esker surface by mid-summer. During high flow periods, particularly Spring Freshet, accumulated water is pumped out of the Burrow Area and directed along natural drainages with erosion controls erected. The pumping of water is believed to be a lower impact solution than the creation of a drainage ditch. Both pumping and ditching are covered in the Quarry Development Plan. Figures 11, 12 and 13 detail the current state of Burrow Area 1. The quarry areas were selected based on material needs, proximity to infrastructure to be constructed and environmental considerations, including surface drainage. The Hayes camp and airstrip are situated on an esker along a lake. Natural drainage flows along this esker toward the lake from a number of points. NCGC is currently putting together a remediation plan to enact for Burrow Areas 1, 2 and 3 as no material has been removed from any of these sites since 2011.

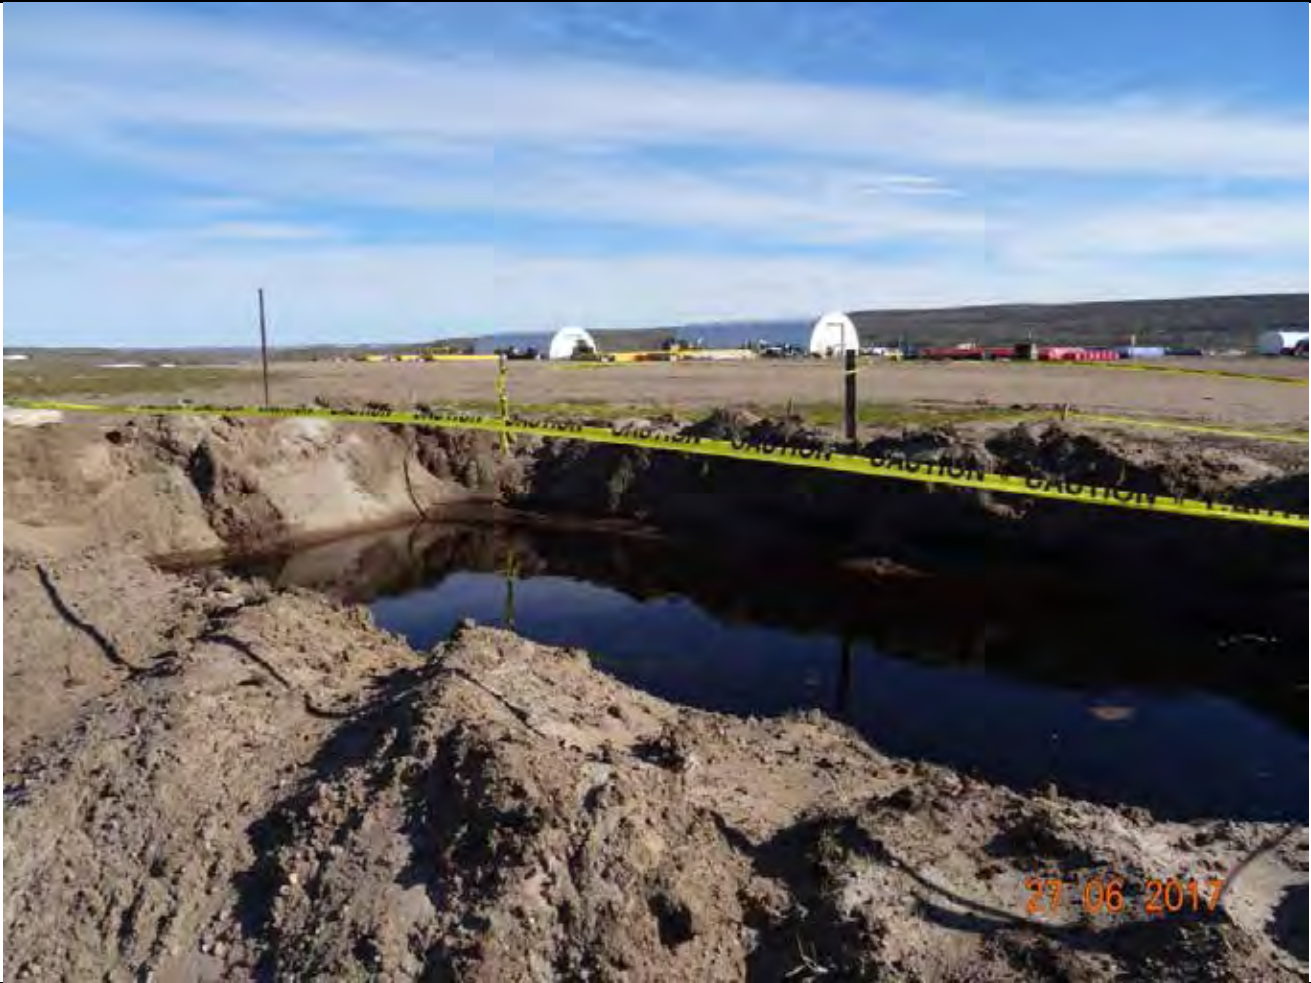
Date	Camera	Inspector	Authorization
27 June 2017	SONY DSC-HX50V	EVA PAUL	2BE-CRA1520
Photo Log # 1		Location (NAD 83 DD MM SS.SS)	
Photo DSC06591		N66 39 34.8 W91 33 07.4

Description: Temporary sump in use for storing WWTP effluent.

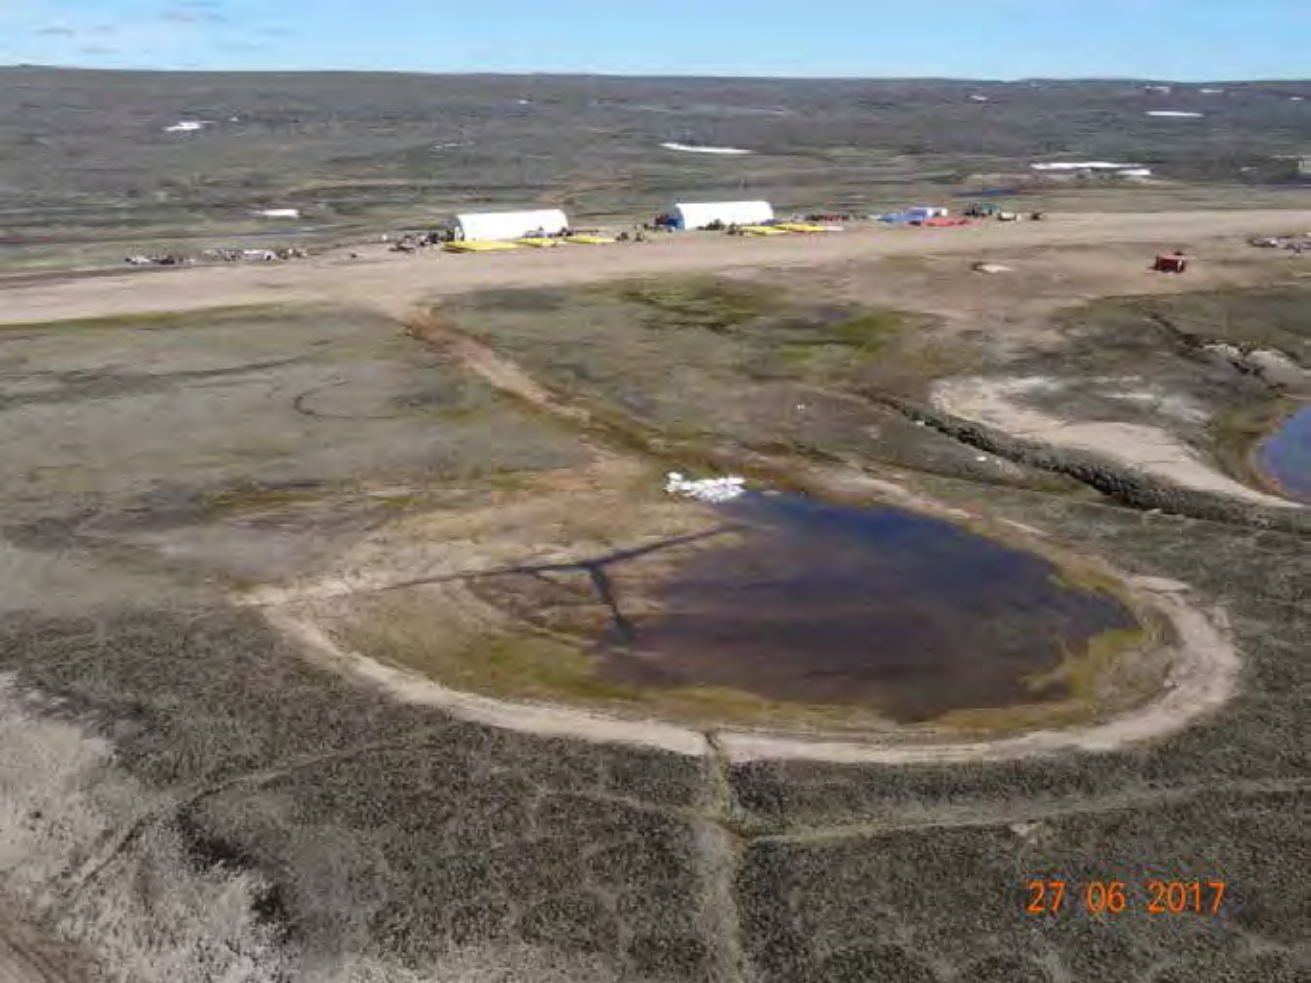
Photo Log # 2	Location (NAD 83 DD MM SS.SS)	
Photo DSC06685	N	W

Description: Borrow Area 1 is accumulating water. Historic drainage paths can be seen.

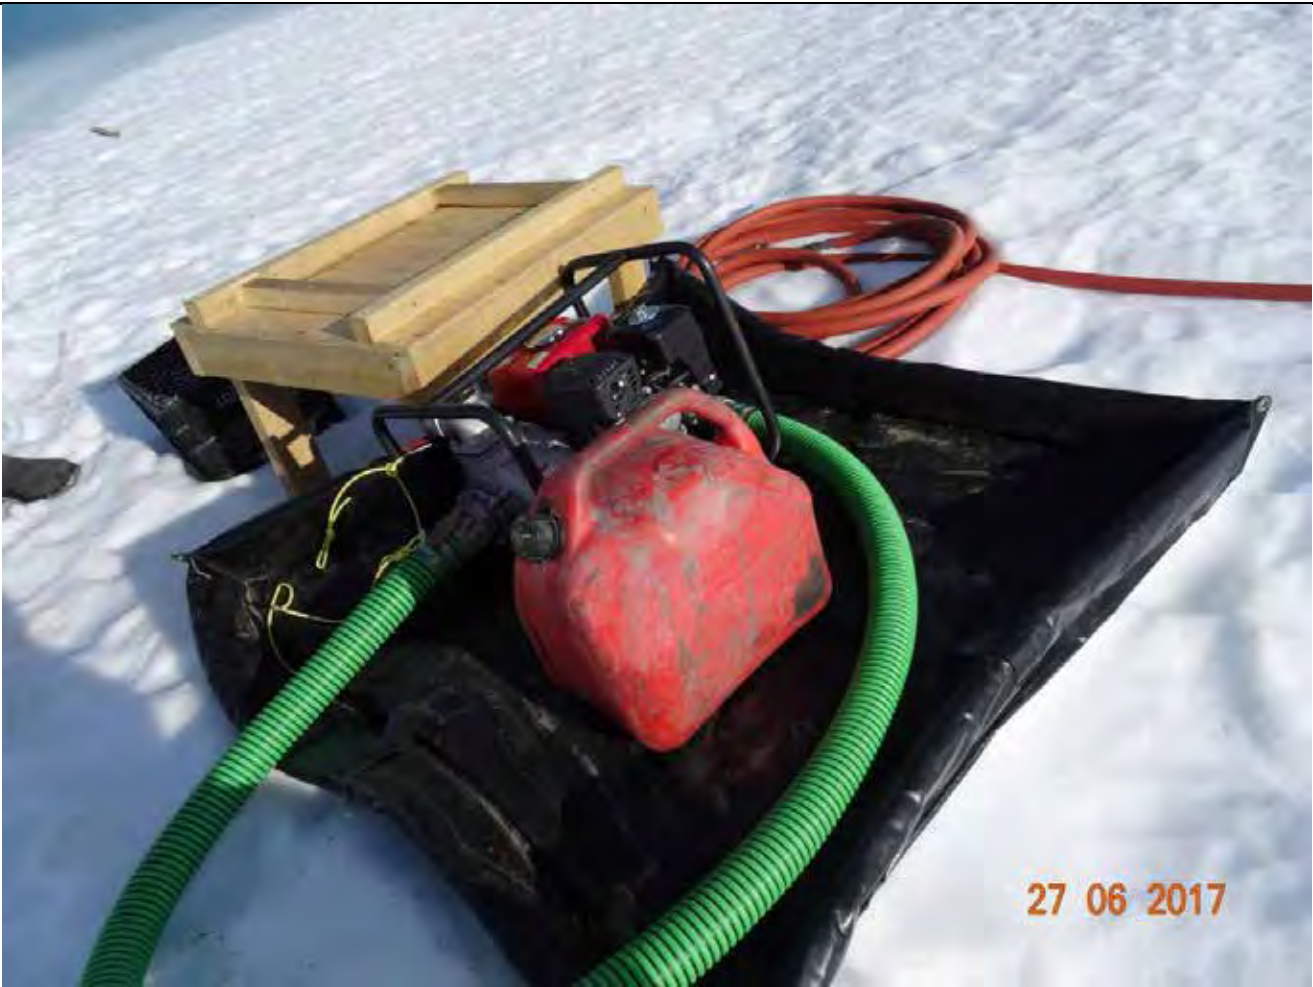
Description: Small spill tray with jerry can by Crater Lake. The fuel is to be stored on solid ground more than 30 m from the lake.

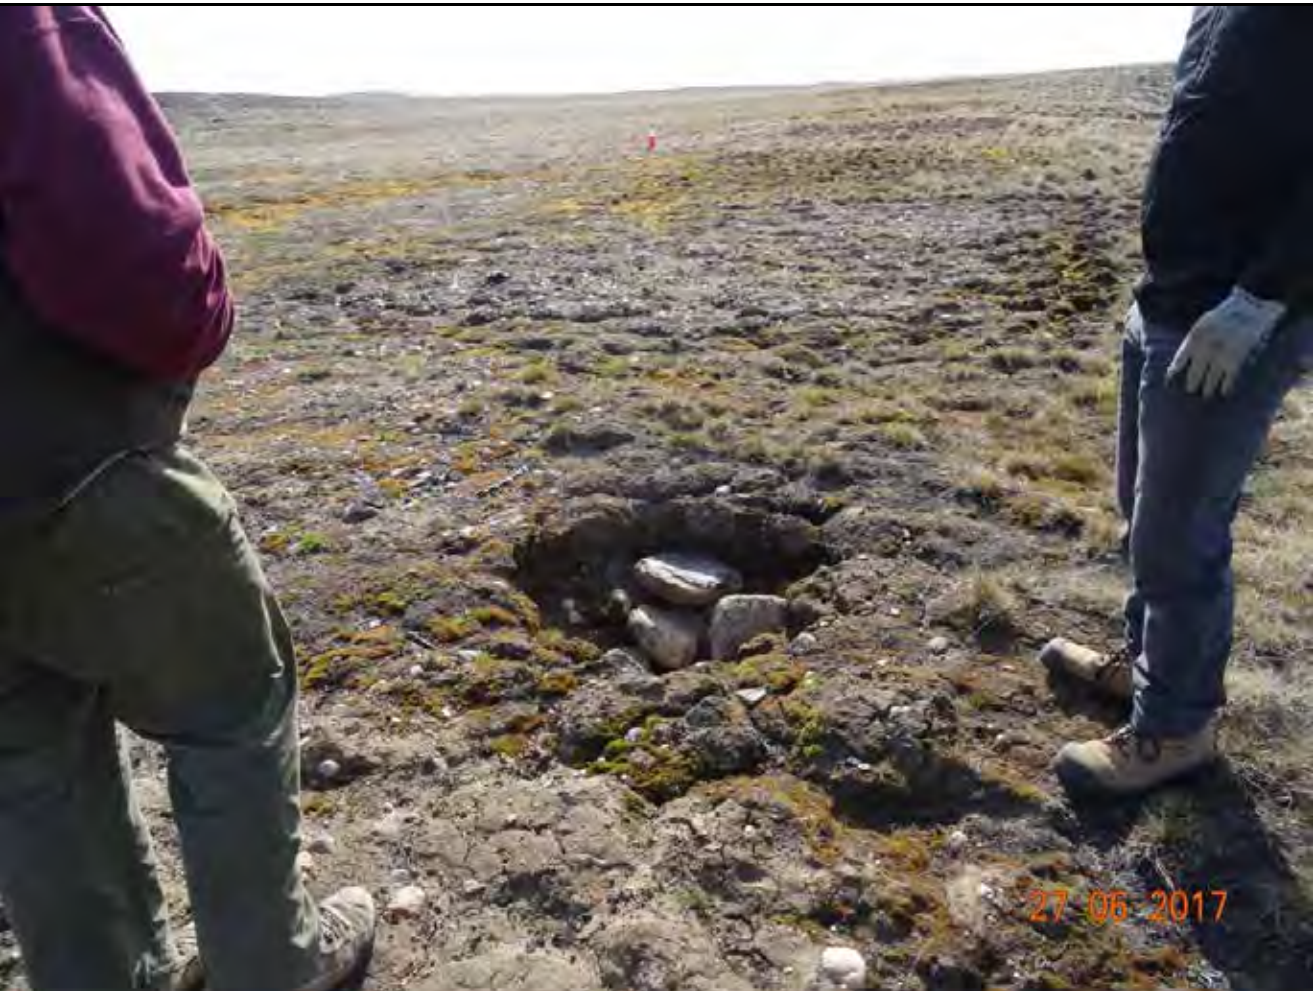
Photo Log # 4

Observation: 8. The old Crater Camp site was also inspected, and it was found that burned debris is left, and the sumps have not been backfilled.

Description: One of 3 sumps remaining at old Crater Camp that are to be backfilled. Debris also to be cleaned up.

Action required: H. The cleanup of the old Crater Camp should be completed, including removal of burned debris and backfilling of sumps.

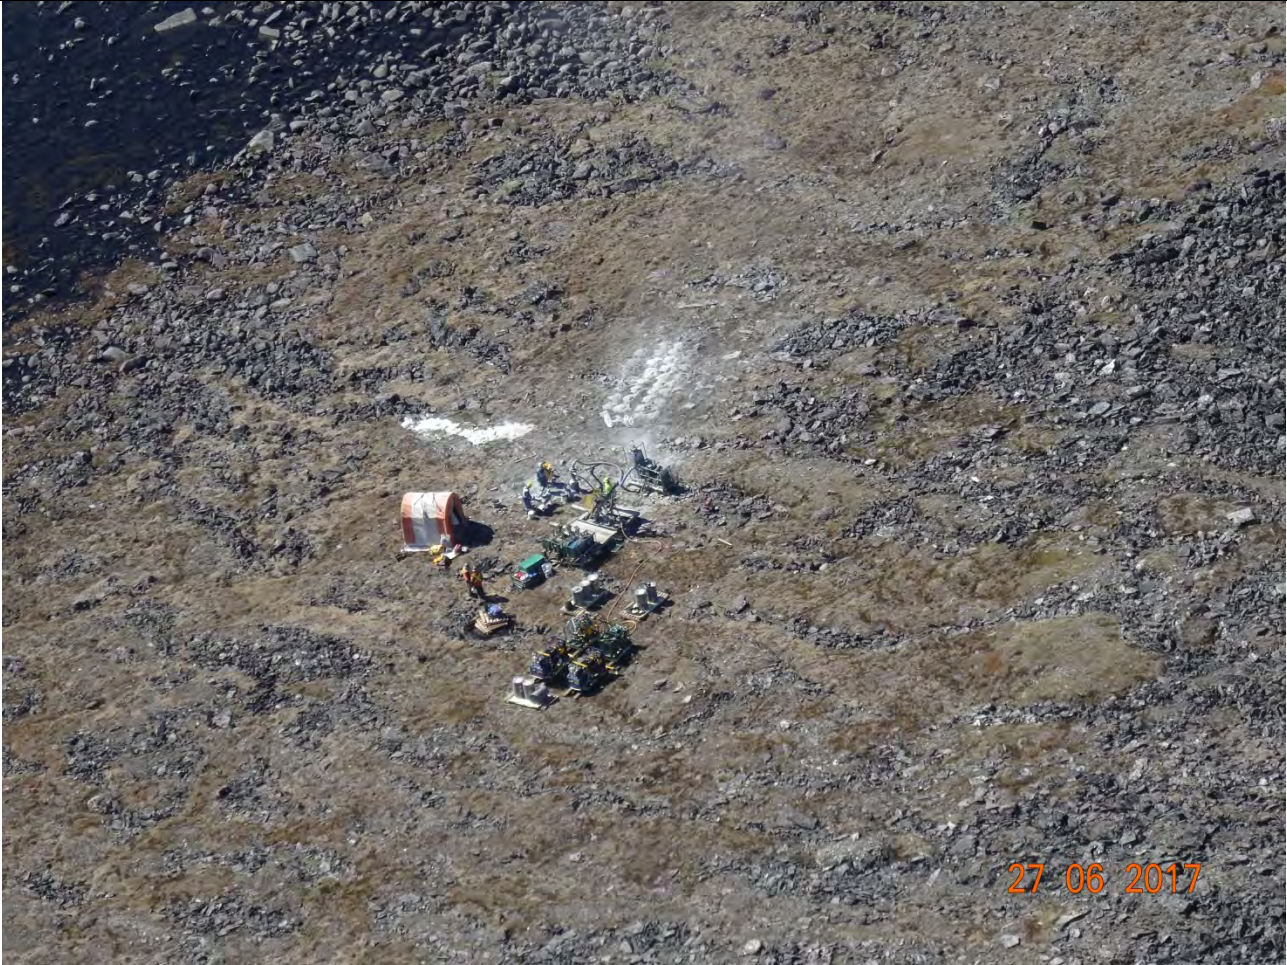
Date	Camera	Inspector	Authorization
27 June 2017	SONY DSC-HX50V	EVA PAUL	N2014C0002
Photo Log # 1		Location (NAD 83 DD MM SS.SS)	
Photo DSC06639		N66 34 37.2	W92 25 18.1

Description: RAB drills at Ziggy. Dust created from the process can be seen around the drill setup.

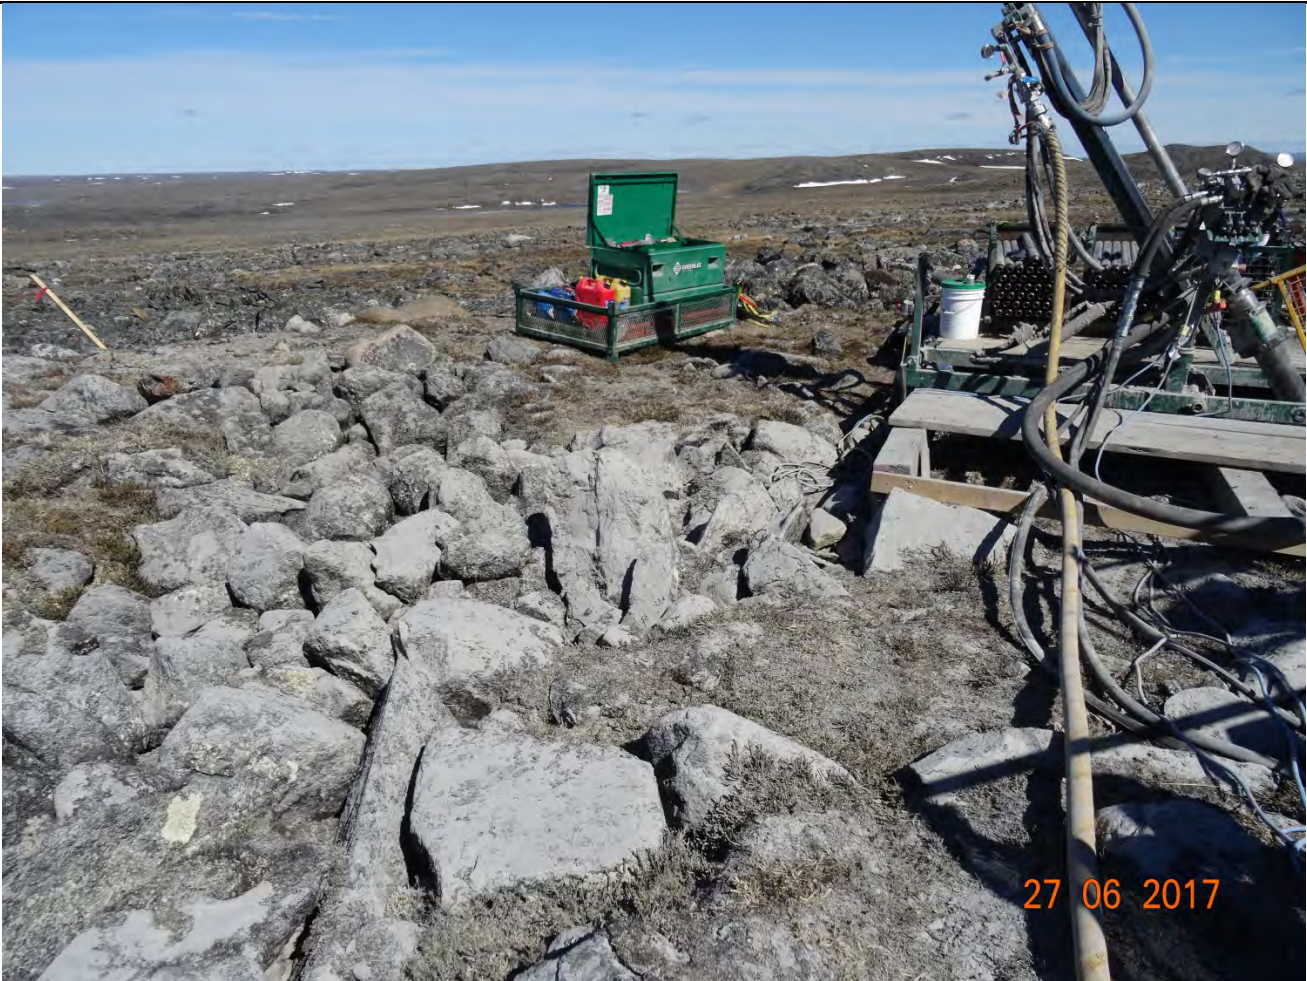
Photo Log # 2	Location (NAD 83 DD MM SS.SS)	
Photo DSC06649	N66 33 53.6	W92 24 38.3

Description: Dust created by RAB as seen from the ground.

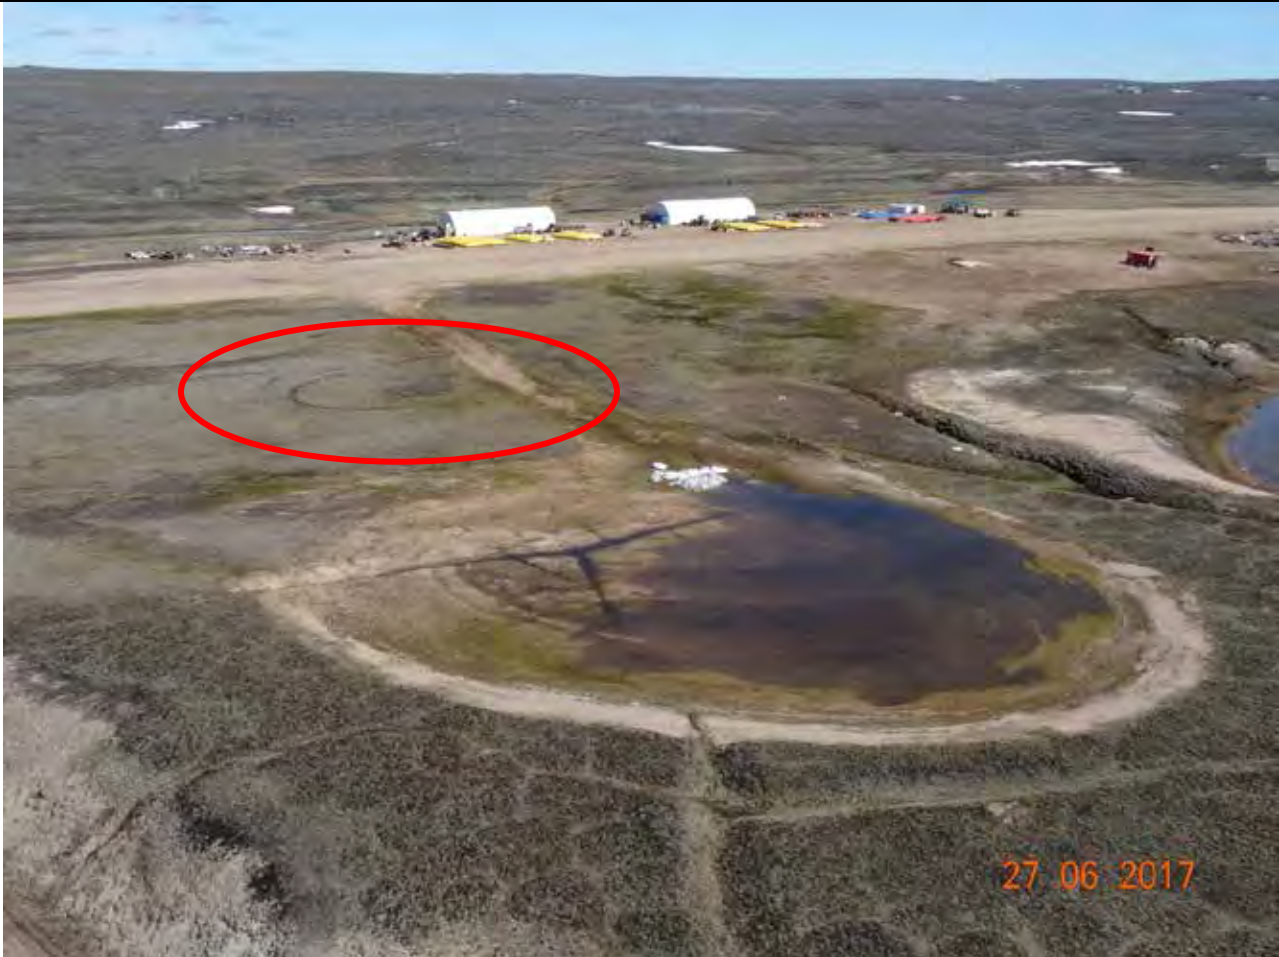
Date	Camera	Inspector	Authorization
27 June 2017	SONY DSC-HX50V	EVA PAUL	056J/12-1 /
Photo Log # 1		Location (NAD 83 DD MM SS.SS)	
Photo DSC06685		N	W

Description: Borrow Area 1 identified in expired quarry permits has not been reclaimed and is accumulating water. Historic drainage channels are evident. Sampling was done to determine whether the cuttings placed in the quarry are affecting the water chemistry. Red circle above the quarry denotes the recent ruts caused by turning the plane. This tundra is easily rutted, and further impacts are to be mitigated.

Remedial action: The Mitigative Measures outlined on section 4.0 of the Quarry Development plan include the use of sand bags and silt fences to prevent erosion and sedimentation. The naturally accumulated rain water typically either evaporates or infiltrates the esker surface by mid-summer. During high flow periods, particularly Spring Freshet, accumulated water is pumped out of the Burrow Area and directed along natural drainages with erosion controls erected. The pumping of water is believed to be a lower impact solution than the creation of a drainage ditch. Both pumping and ditching are covered in the Quarry Development Plan. Figures 11, 12 and 13 detail the current state of Burrow Area 1. The quarry areas were selected based on material needs, proximity to infrastructure to be constructed and environmental considerations, including surface drainage. The Hayes camp and airstrip are situated on an esker along a lake. Natural drainage flows along this esker toward the lake from a number of points. NCGC is currently putting together a remediation plan to enact for Burrow Areas 1, 2 and 3 as no material has been removed from any of these sites since 2011.

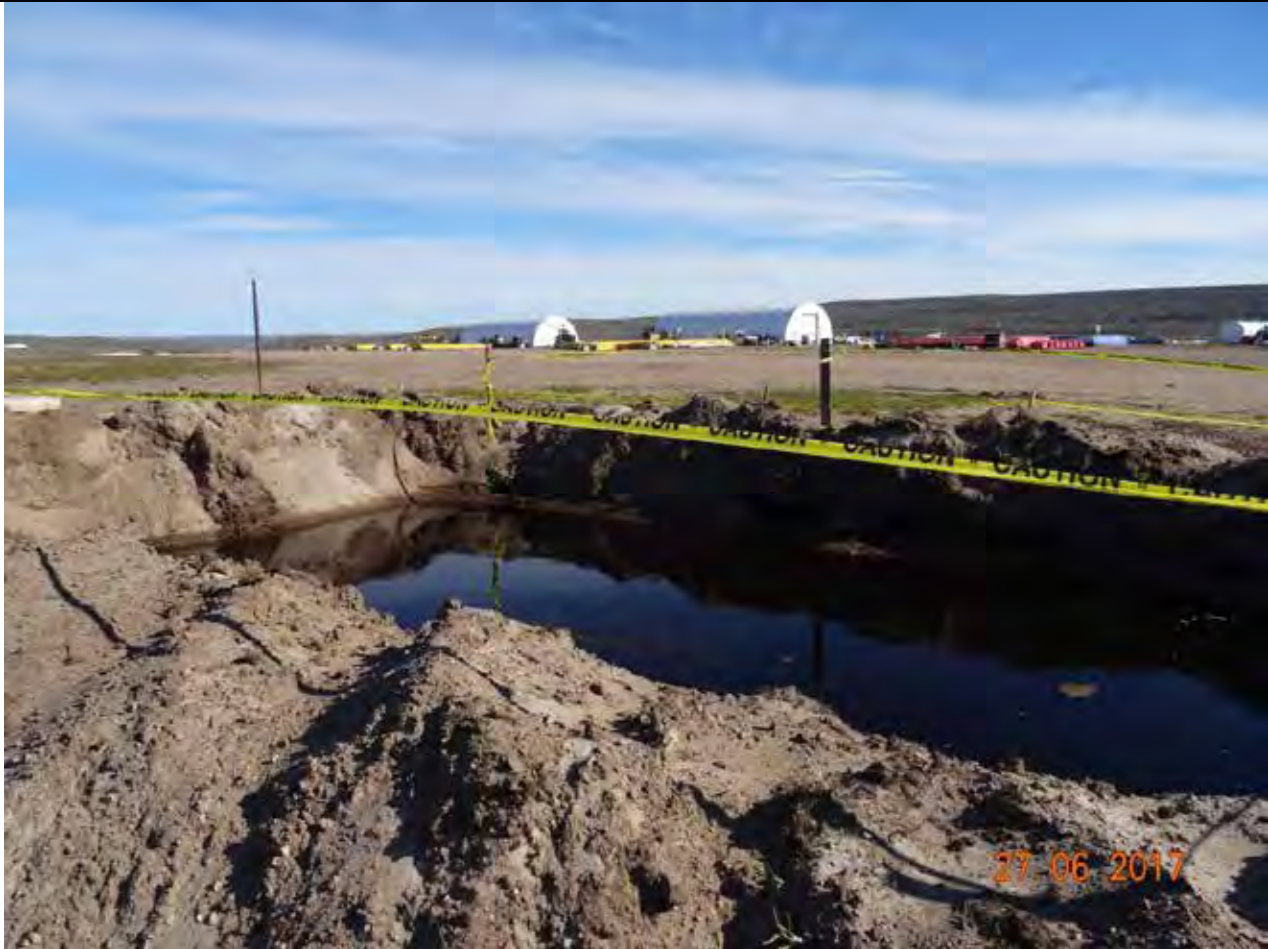
Photo Log # 2	Location (NAD 83 DD MM SS.SS)	
Photo DSC06591	N66 39 34.8	W91 33 07.4

Observation: 3. A temporary sump has been created to hold the discharge from the WWTP until it achieves compliance with the water licence. This sump should be backfilled as soon as possible to limit impacts to the permafrost underneath. The kitchen sump has doubled in size from last year, presumably to accommodate the increased camp size and activity, and grease was visible on the surface. Discussions with the WWTP operator indicate that grease is incompatible with the WWTP, so this greywater stream cannot be included in the treatment.

Description: Temporary holding pond for WWTP discharge. This is to be reclaimed as soon as possible to prevent impacts to the permafrost below.

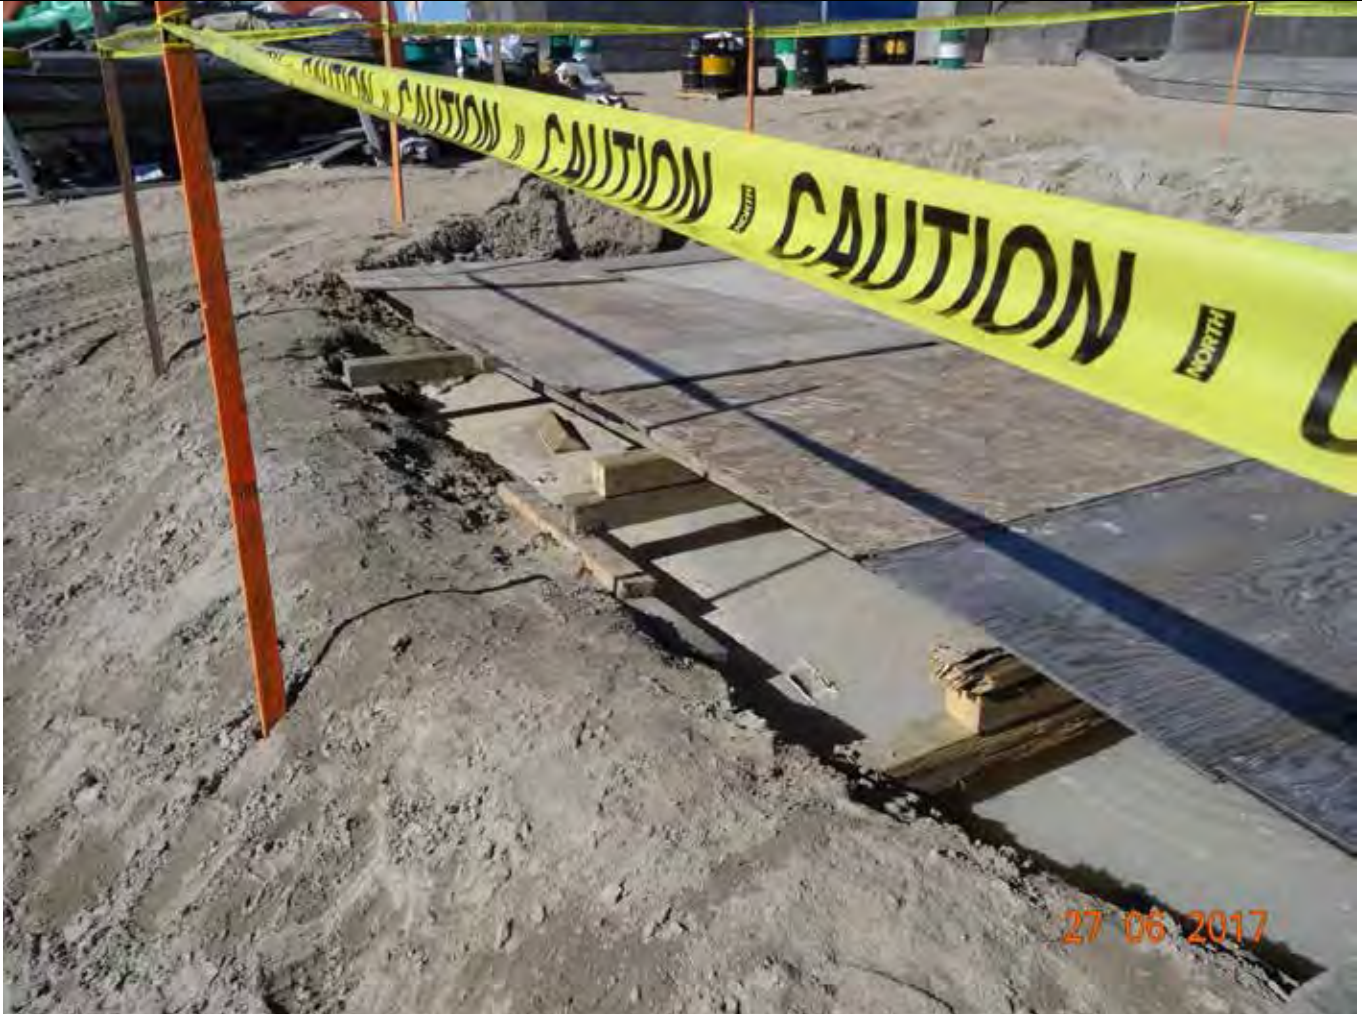
Description: Kitchen sump has doubled in size since last year. A thick grease layer indicates grease trap is not working properly and the system needs to be examined.

Remedial action: A commercial style grease trap was installed in line between the kitchen at Hayes camp and the grey water sump. The commercial grease trap allowed greywater from the kitchen to be processed through the WWTP. The accumulated grease observed by the inspector was skimmed off of the greywater sump using absorbent matting and disposed of appropriately.

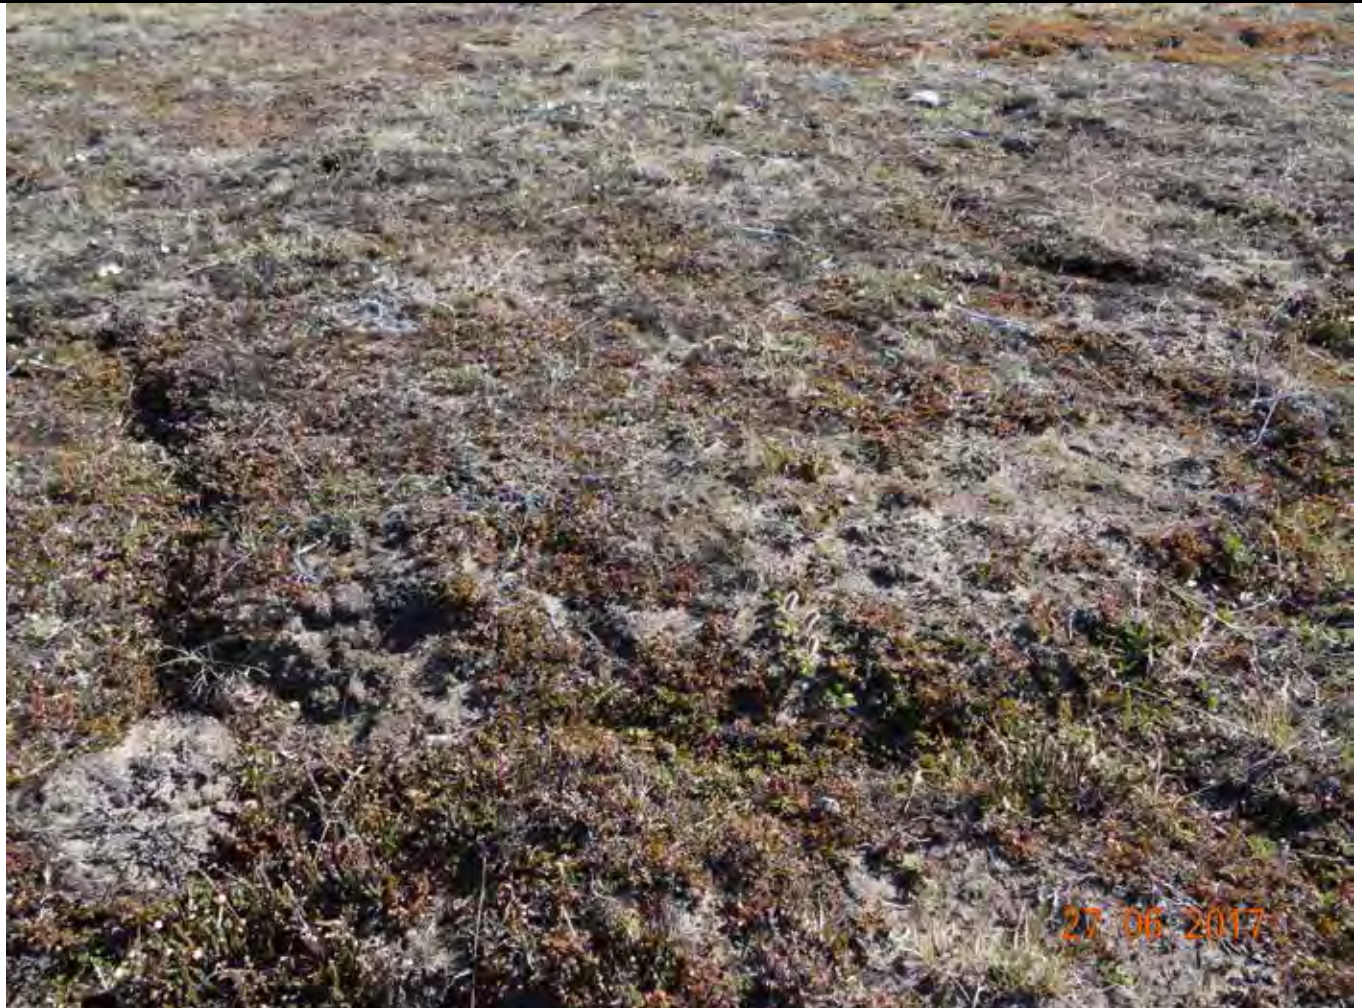
Photo Log # 4

Observation: 4. Garbage is visible around camp, on the tundra, and along the shoreline. Particularly of concern: old tarp fragments are blown on the tundra and are a potential hazard if ingested by wildlife.

Description: Filaments from the old tarp that surrounded the weather station are spread across the tundra and pose a risk to wildlife. This and other small debris and garbage need to be addressed daily.

In 2016 and 2017 NCGC replaced all of the disintegrating blue fibre tarps with UV resistant tarps rated for 10 years. The switch over to these UV resistant tarps is an ongoing process and NCGC aims to complete the transition within the next few field seasons.

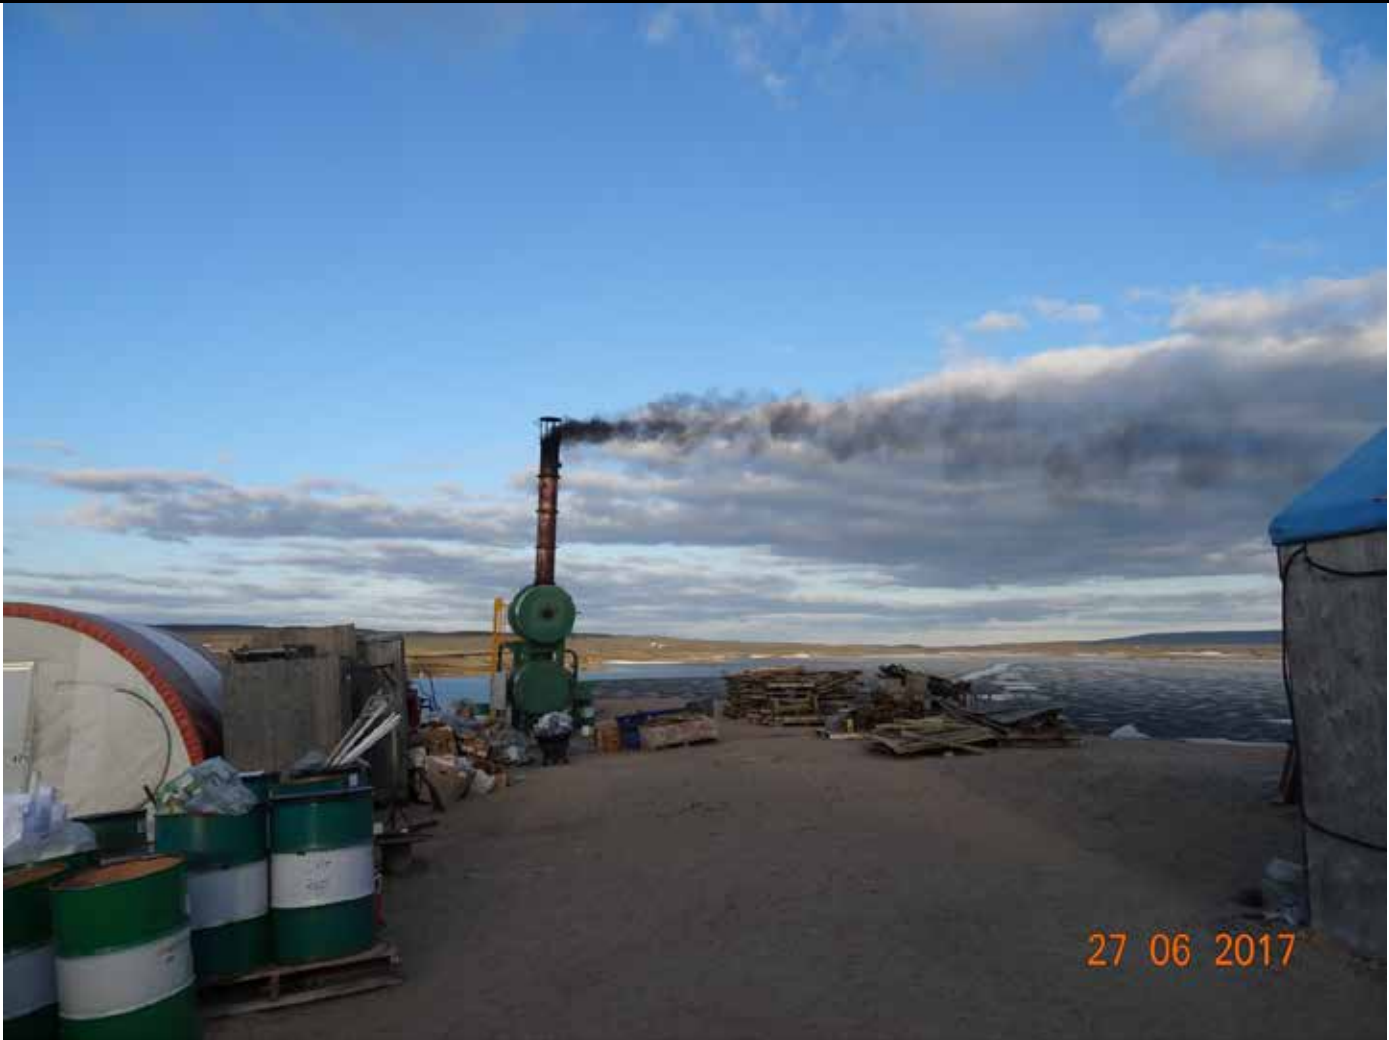
Photo Log # 5	Location (NAD 83 DD MM SS.SS)	
Photo DSC06721	N	W

Description: Incinerator at Hayes blowing uncharacteristically dark smoke. Signals improper combustion.

inspectors visit a representative from Ketek Group, manufacturer of the incinerator, was on site and performed the required repairs on the incinerator.

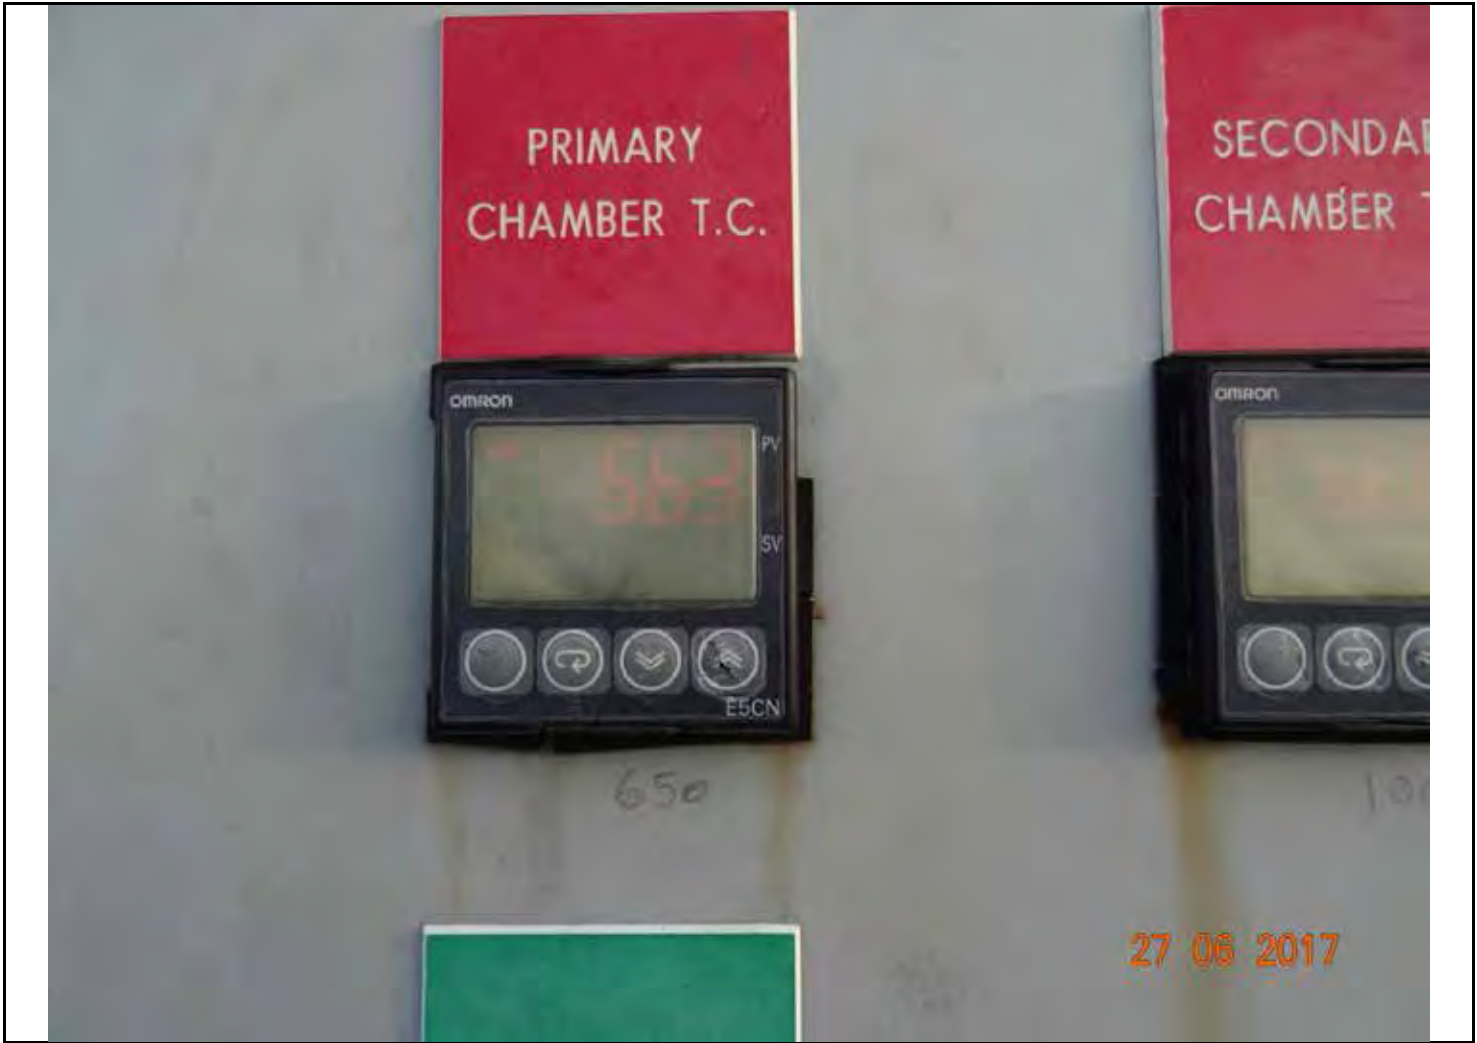
Photo Log # 6	Location (NAD 83 DD MM SS.SS)	
Photo DSC06723	N	W

Description: Low temperature and sensor errors showing on incinerator.
