**RE: FOX-D, Kivitoo Remediation Project: 2017 Annual Report for Water Licence
1BR-KIV1621**

FOX-D Water Licence 1BR-KIV1621

Monitoring Program Annual Reporting 2017 – Additional Information

RE: FOX-D Soil Treatment Area Monitoring Well Samples - Water License No. 1BR-KIV1621

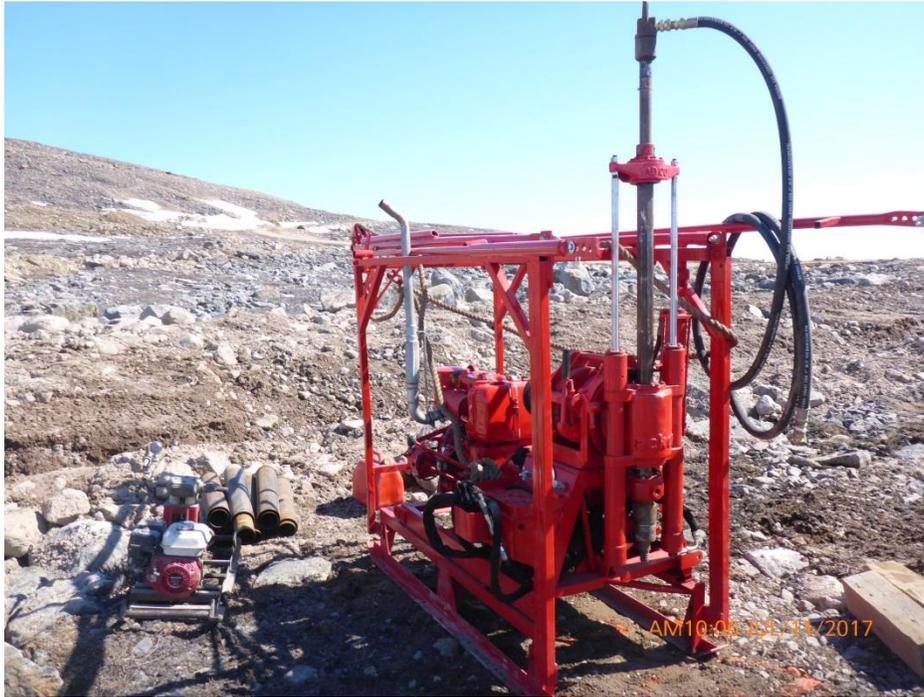
Photograph 1. Coring Machine – July 11, 2017 é

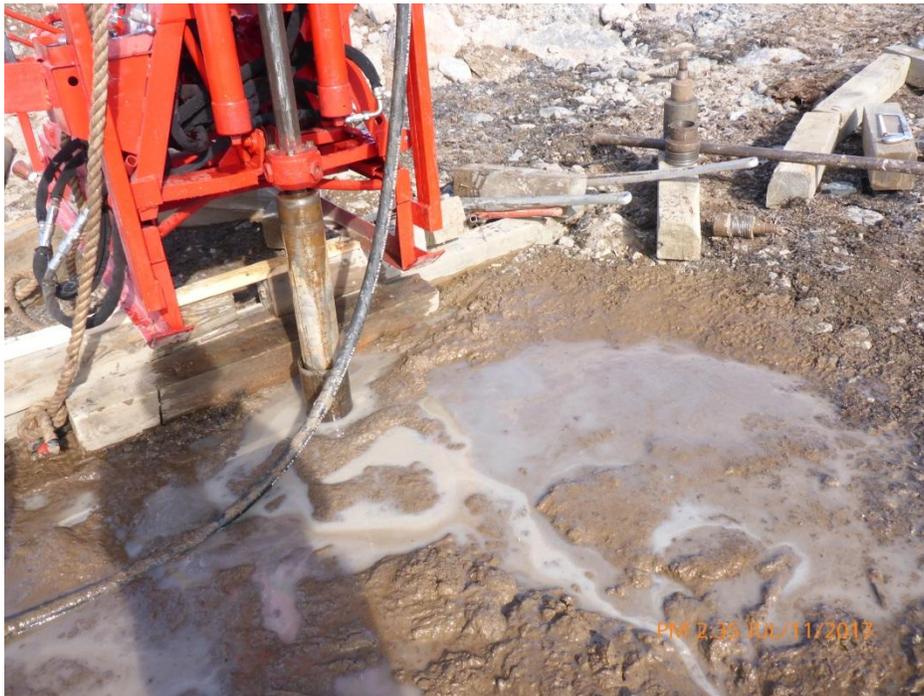
Four (4) monitoring wells were installed surrounding the soil treatment area at FOX-D between July 11 and July 15, 2017 to monitor any potential impact resulting from the treatment area;

Photograph 2. Drilling monitoring wells – July 11, 2017 é

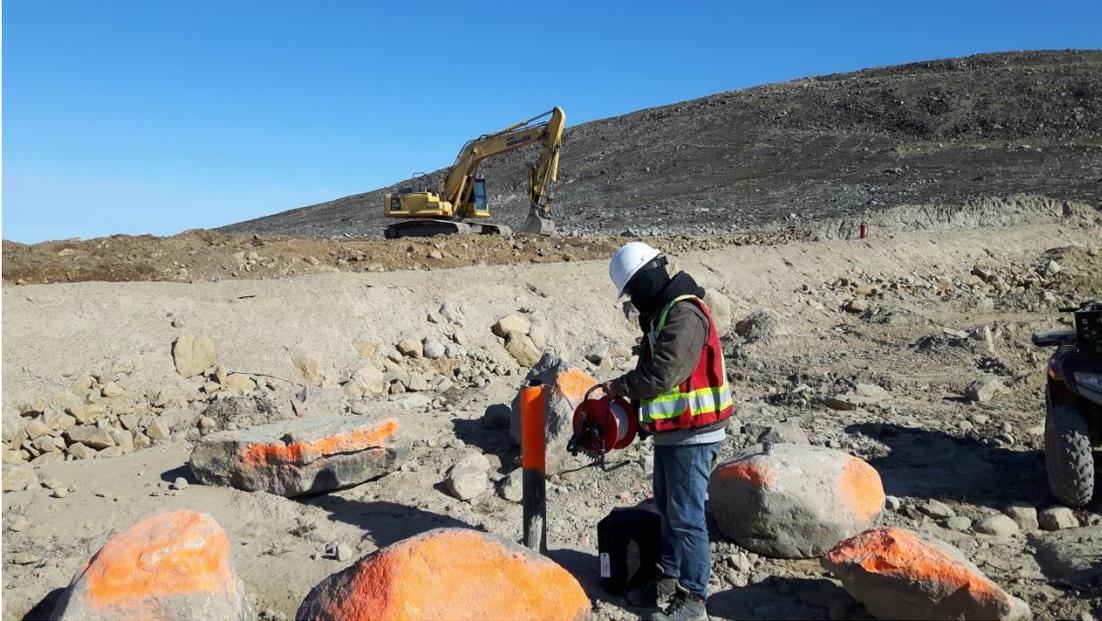
AECOM measured groundwater levels in the monitoring wells using an interface meter on July 22, August 9, August 17 and August 31, 2017. After the monitoring wells were installed, AECOM developed the wells by purging them dry with bailers to ensure that fresh groundwater would be present in the wells for future water samples. Due to the permafrost and the conductivity of the steel casings, AECOM suspects that the water in the monitoring wells froze at a level above the active layer base. Ice was encountered approximately 1 m below ground surface in the wells and minimal free water was present. On August 31, 2017, the final attempt in obtaining a groundwater sample, approximately 3 – 5 cm of water was present in the bottom of the wells KIV 5b, KIV 5c and KIV 5d and 40 cm was present in KIV 5b. Only approximately the top 2-3 cm of the water in KIV 5b was suitable for sampling as the remainder contained a large amount of drilling fluid. For the analysis listed under Part K of The License, the laboratory requires approximately 3 litres of water, of which 580 ml is required for the analysis of BTEX, F1-F4. Groundwater samples were therefore unable to be obtained due to the insufficient volume of water and drilling fluid suspended within the water column in the bailer.

Photograph 3. AECOM measuring water levels at KIV 5d - August 09, 2017 €

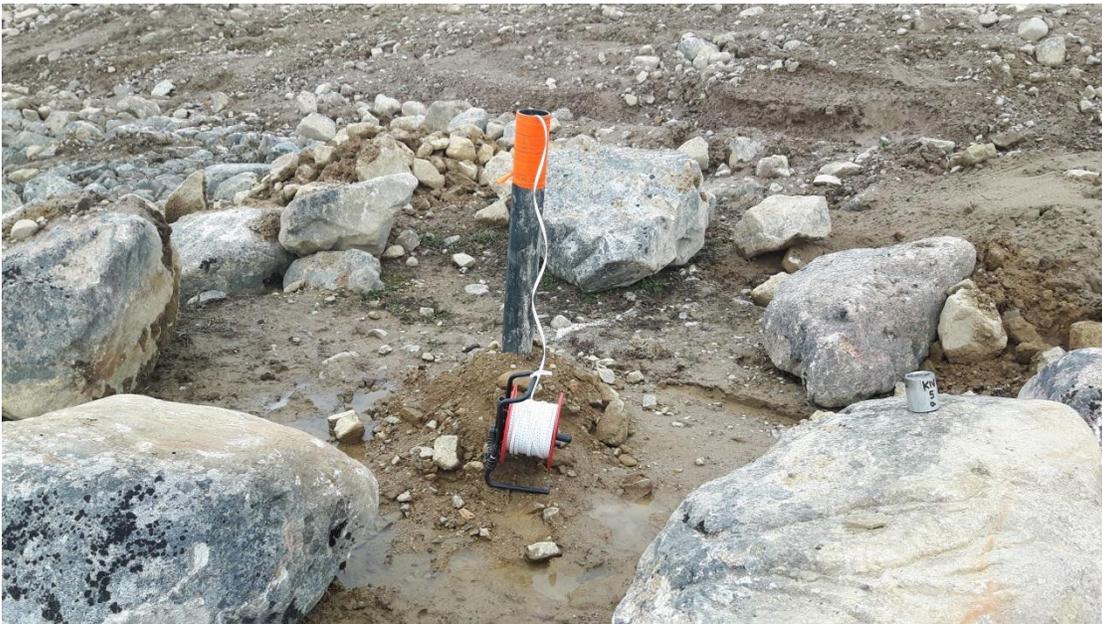
Photograph 4. AECOM measuring water levels at monitoring well KIV 5a – August 17, 2017 €

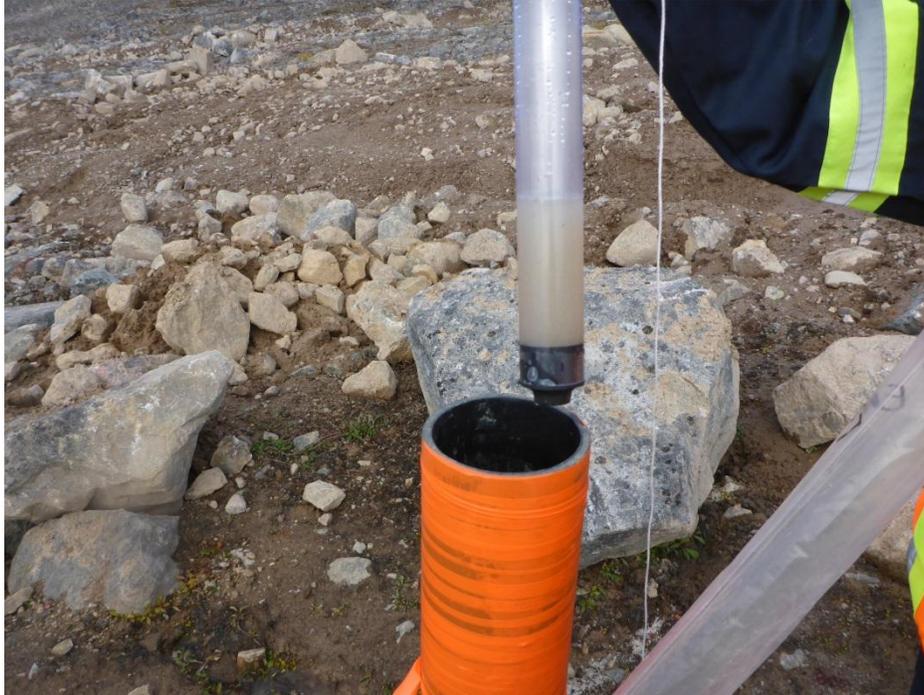
Photograph 5. Water in bailer from monitoring well KIV 5a – August 31, 2017 é

Additional attempts will be made in 2018 to obtain groundwater samples from the wells.

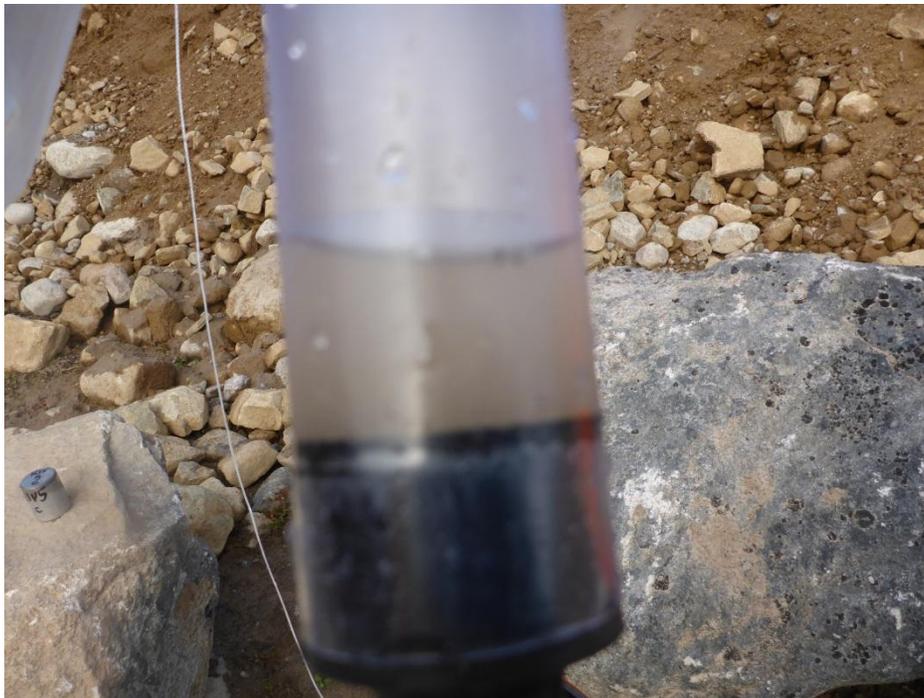
Photograph 6. Water in bailer from monitoring well KIV 5c – August 31, 2017 é
