WATER LICENCE INSPECTION FORM

SECTION 1	<input checked="" type="checkbox"/> Comments	<input type="checkbox"/> Non-Compliance with Act or Licence	<input type="checkbox"/> Action Required
<b>Background</b>			
Water Licence 3BC-FOH0919 issued to the Government of Canada, Department of National Defence for the use of water from a man-made reservoir owned and operated by the Hamlet of Hall Beach and the deposit of waste during the operation and maintenance of the FOX-M Long Range Radar Station and Logistics Support Site located on Melville Peninsula within the Qikiqtani Region, Nunavut.			
<b>Inspection:</b>			
<b>1. Water Use:</b>

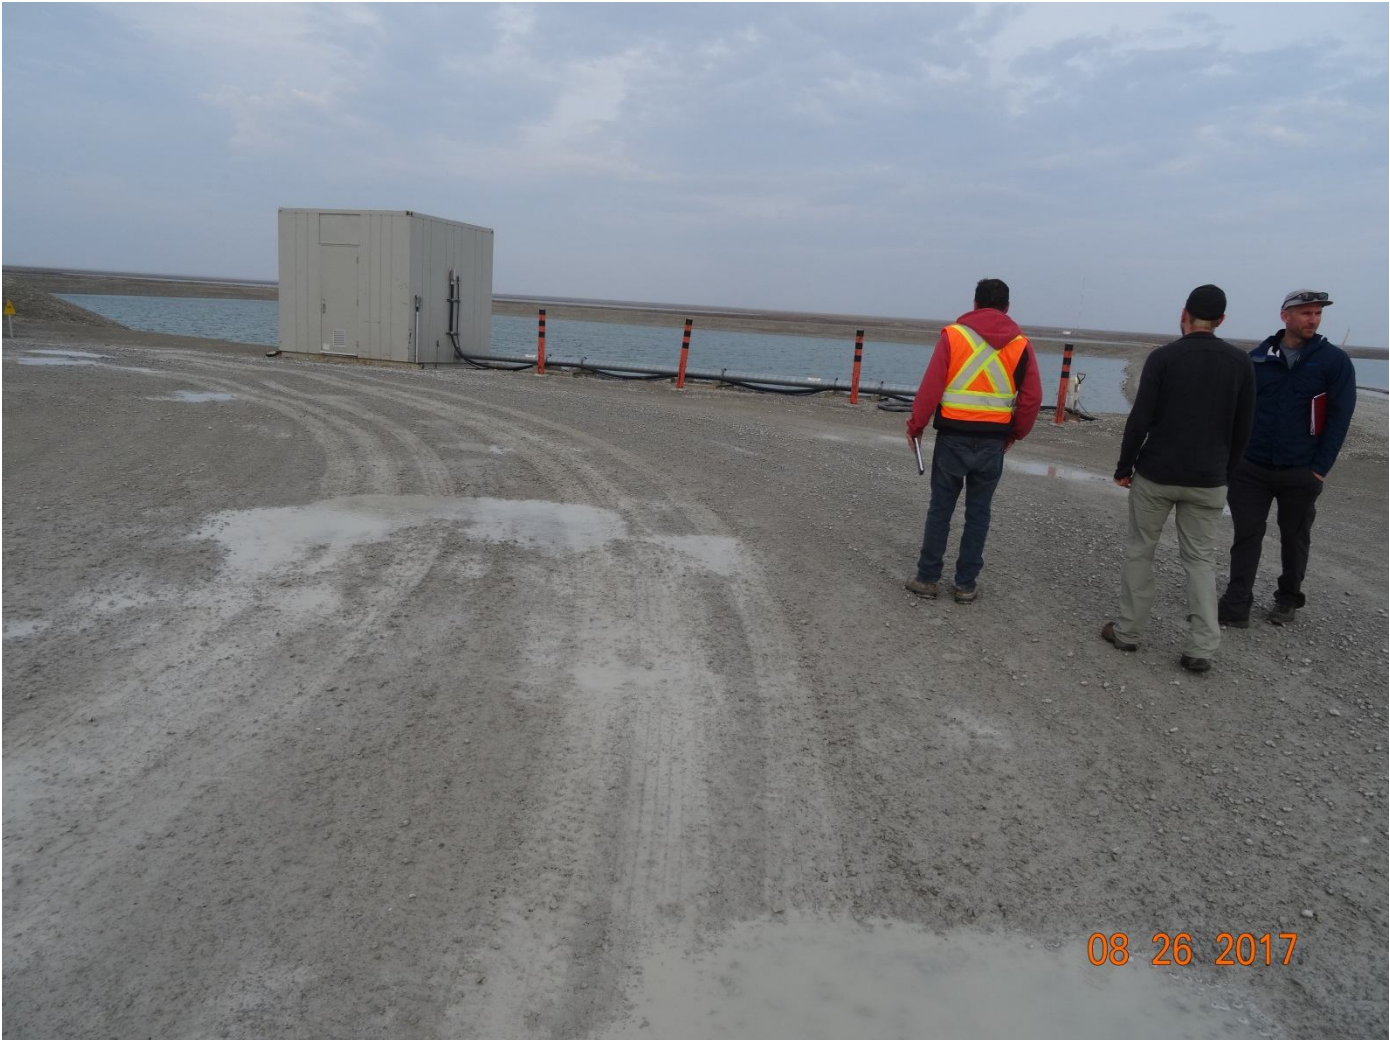
a) The Licensee obtains its raw water from the same reservoir as the municipality of Hall Beach. See figure 1 for a photo of the reservoir.			
b) The licensee has a pump house located near the municipality's truck fill station which is currently not in use. The licensee is currently using water trucks to transfer water from the reservoir to holding tanks.

Figure 1: water reservoir.

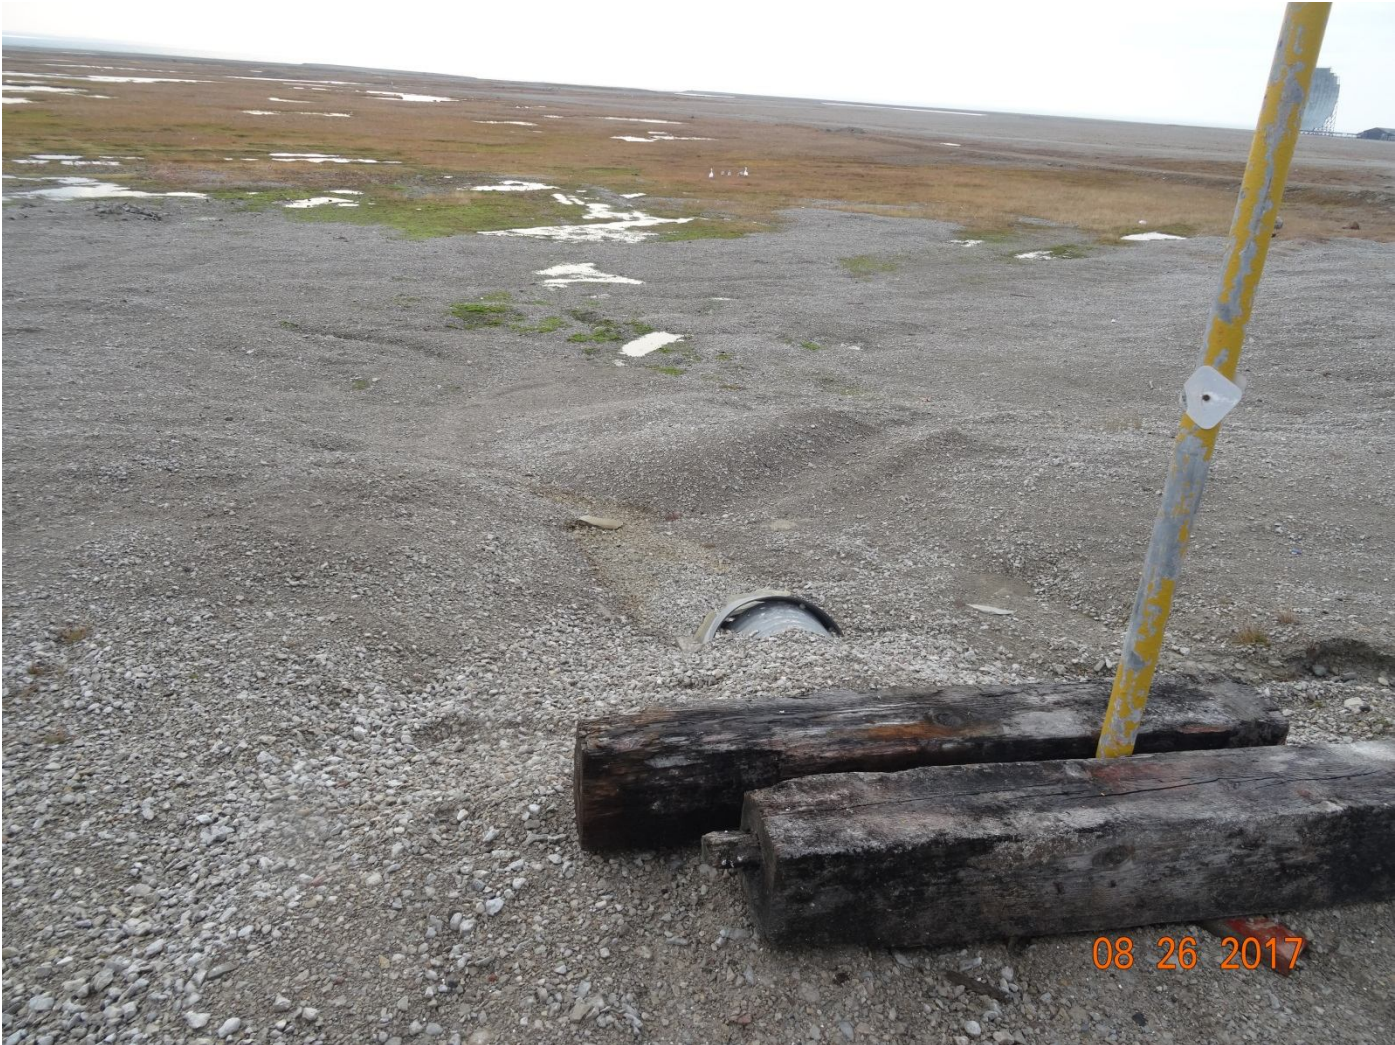
c) No issues were noted about this use of water.			
<b>2. Sewage Disposal Facility</b>			
a) Sewage is treated and tested before it is released approximately 100m from the main complex. See figure 2 for location of the end of the pipe and the receiving environment.

Figure 2: Waste water end of pipe and receiving environment.

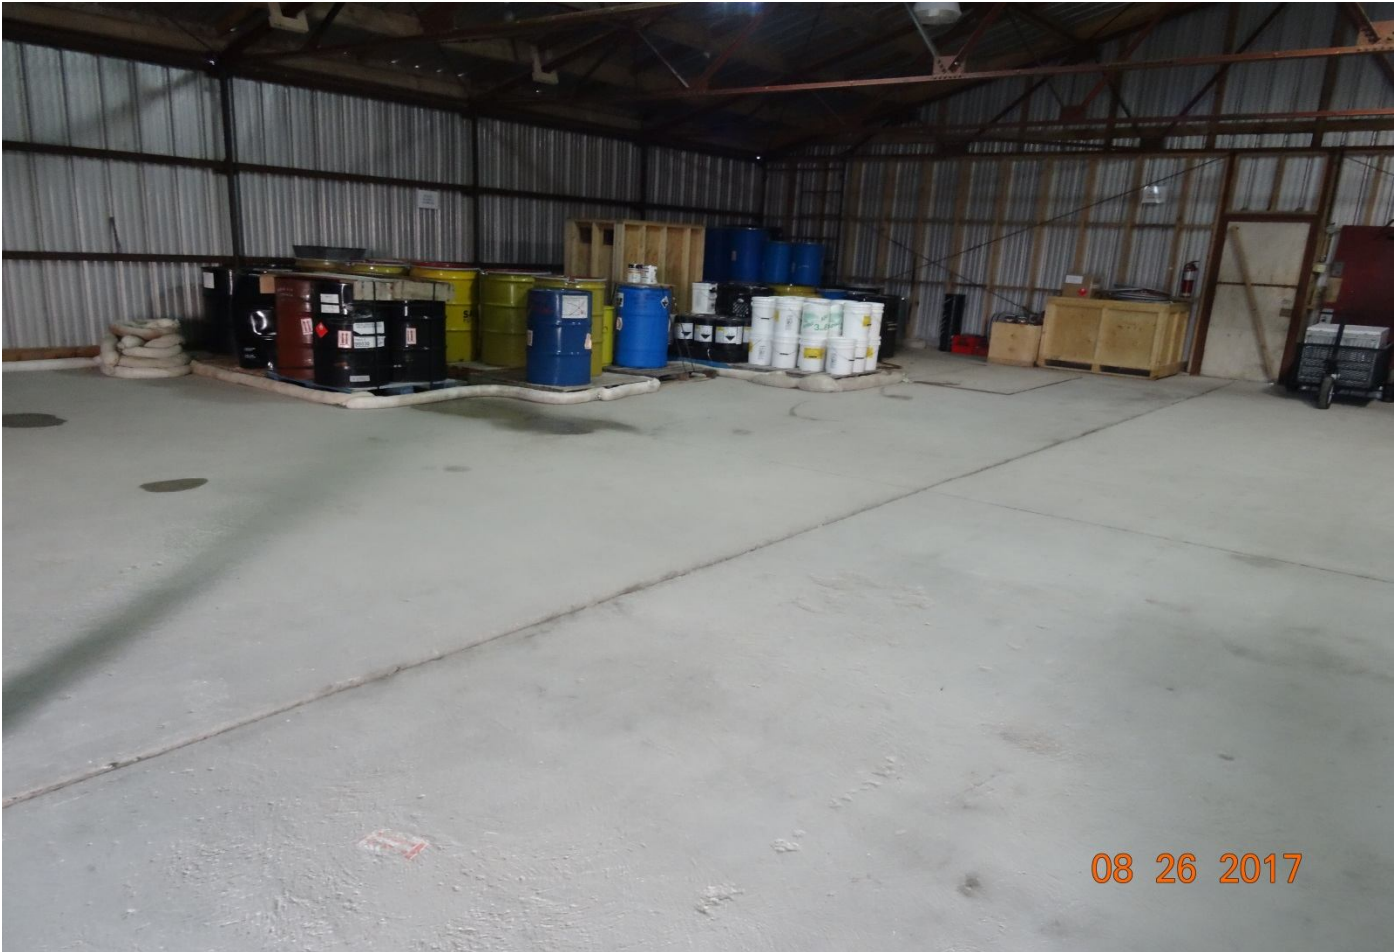
b) Signs were in place and records appeared to be in good order.			
c) No issues were noted about this deposit of waste.			
<b>3. Hazardous waste</b>			
a) The licensee contains the hazardous Waste and other hazardous material inside a building on site.

b) The hazardous material is surrounded by absorbent material.			
c) No issues were noted about this storage of hazardous waste.

Figure 3: Hazardous material storage.

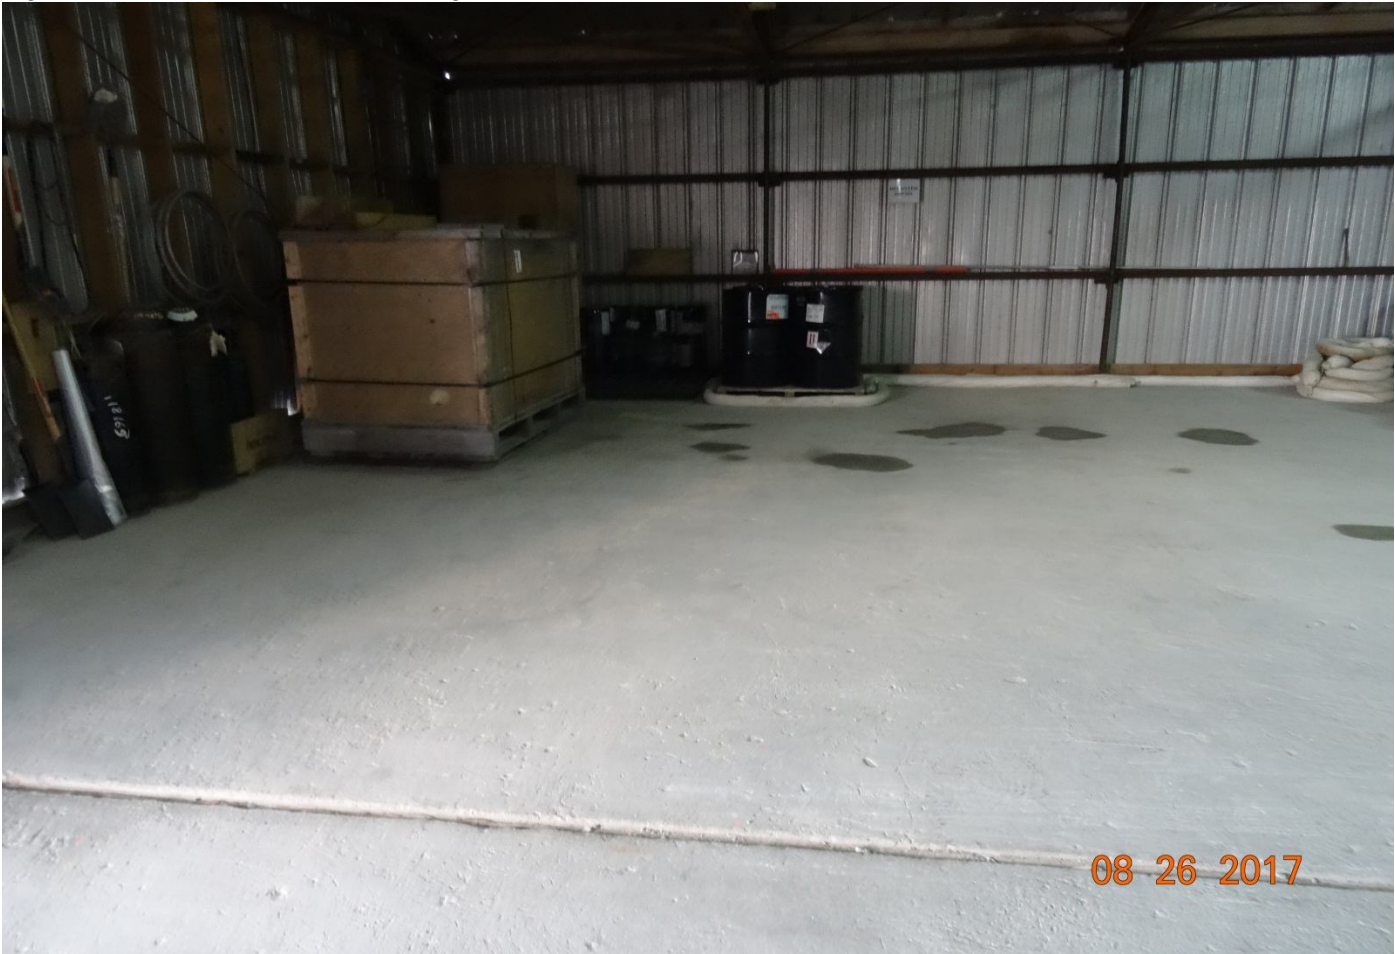
Figure 4: Hazardous material storage
