# **JERICO DIAMOND MINE SITE STABILIZATION PROJECT**

## **NUNAVUT IMPACT REVIEW BOARD FILE #16UN058 2018 ANNUAL REPORT**

**June 11, 2019**

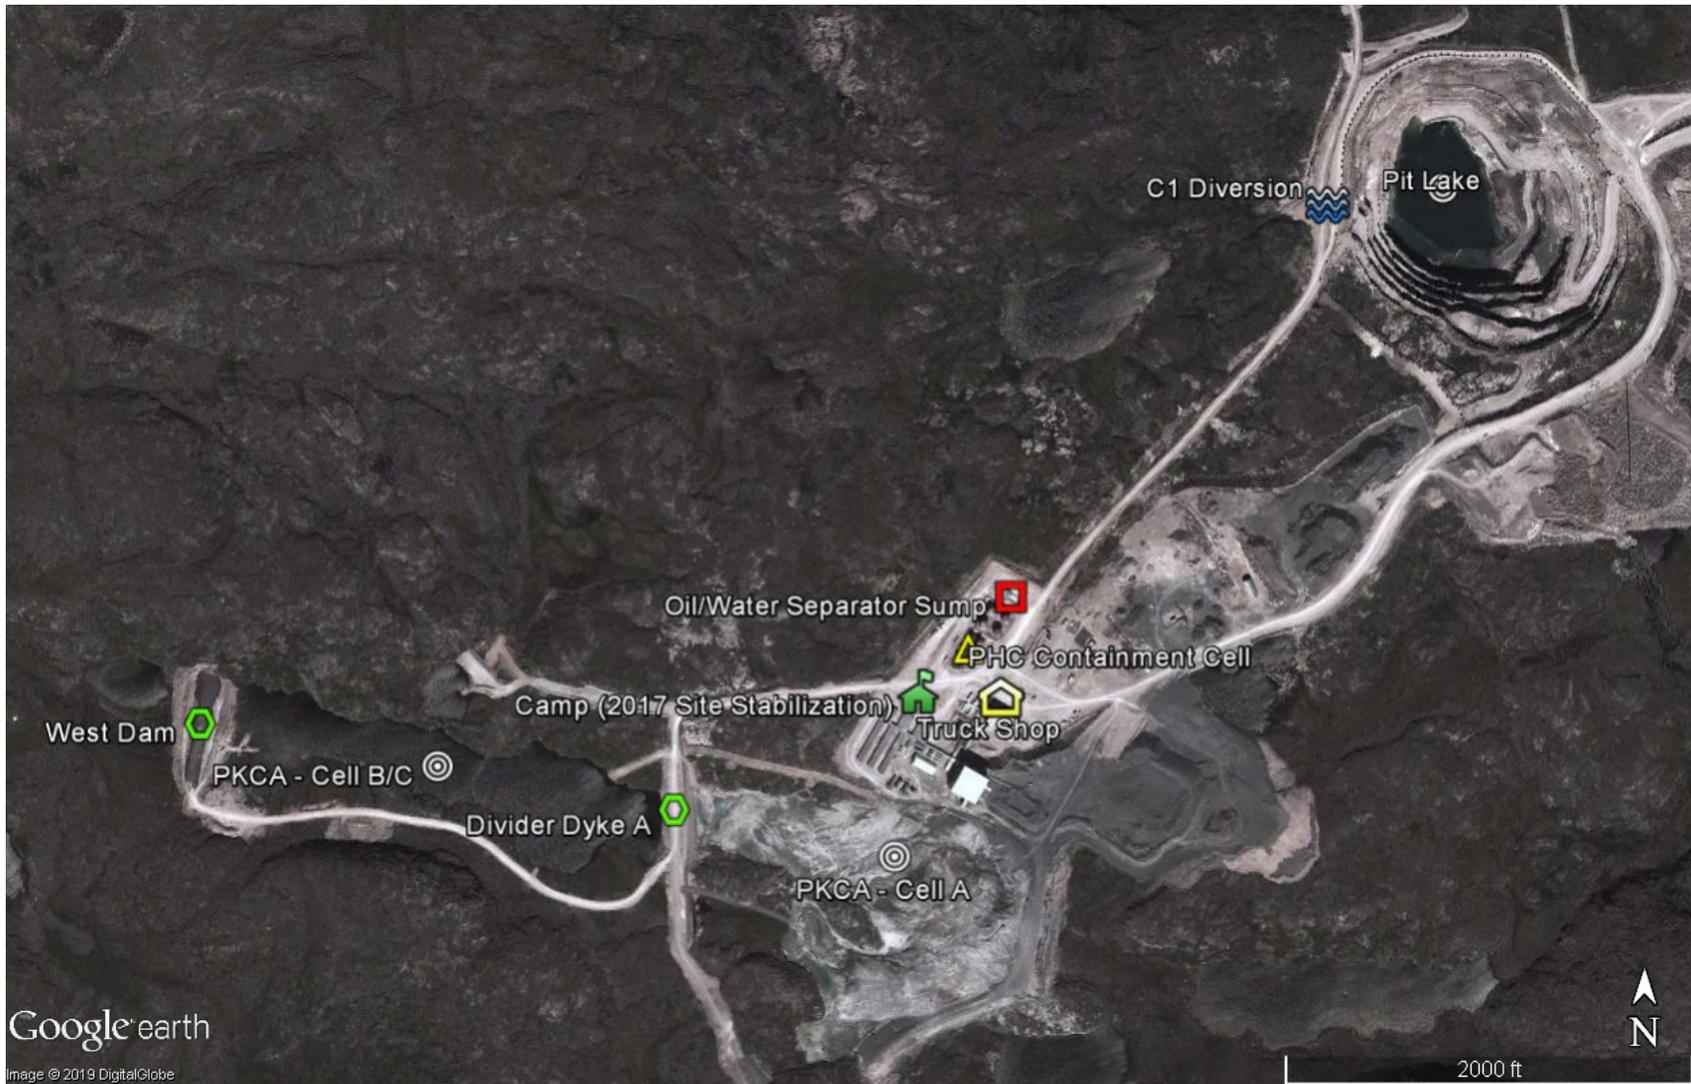
Figure 2: South End of Site – Showing 2018 Work Areas

See Appendix A for maps of the site showing all work areas.

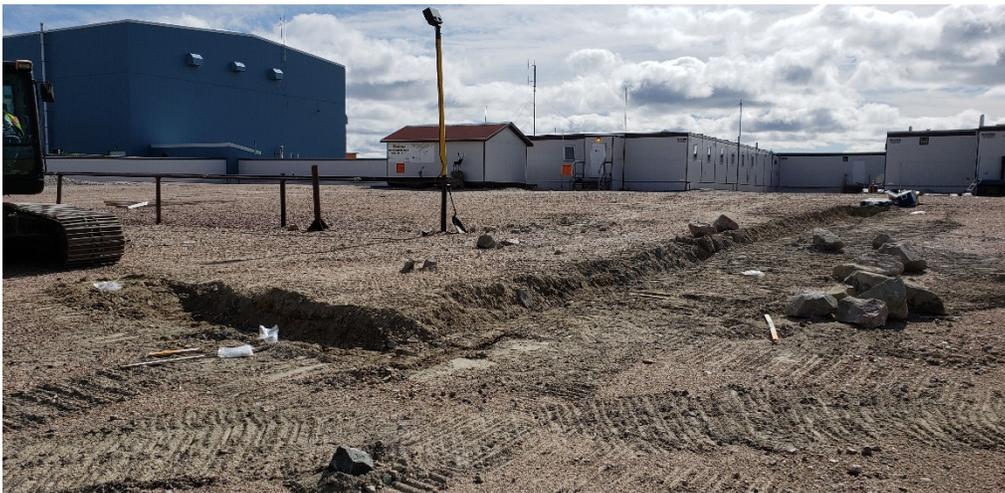
**Description**  
Surface staining  
observed in Spring 2018  
near Main Camp.

- 1- **11 Stained Spots** – On August 1, 2018 and using the crown owned CAT 320 ROJV excavated a single trench will be excavated to a depth of 50-cm and a width of 1-m, the entire length of the 11 stained spots, approximated at 18 metres in length, with a 5-m northern section. This trench excavated all 11-spots and the potentially impacted soils beneath them.

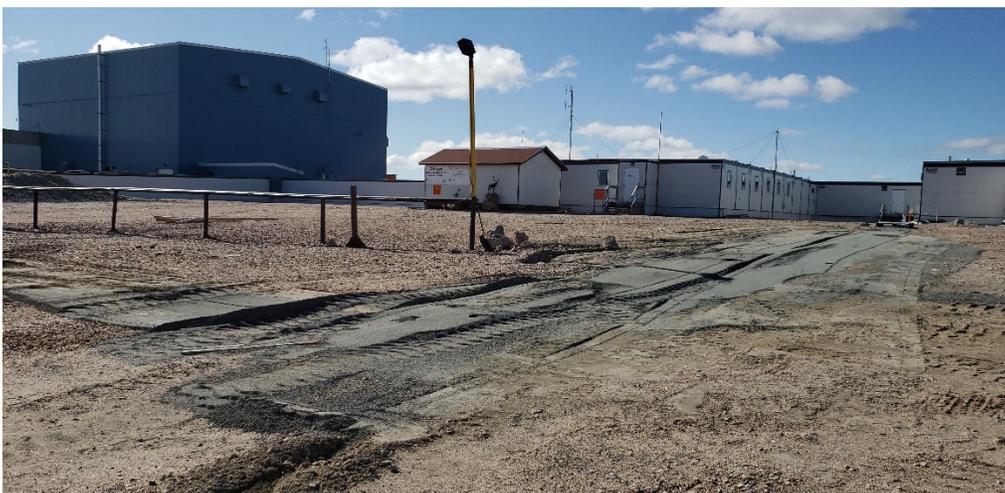
**Photo 2**

**Description**  
Excavation of the stained  
area near the Main  
Camp.

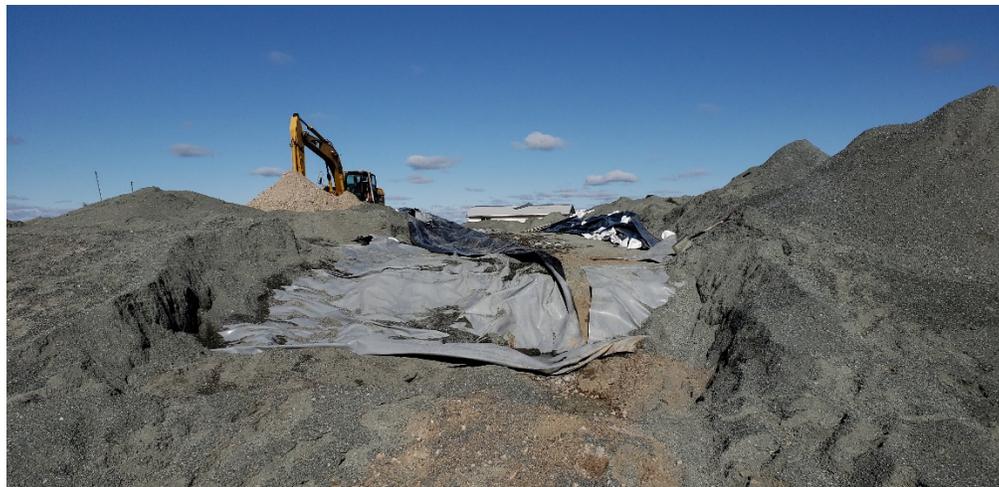
**Photo 3**

**Description**  
Final backfilled  
Excavation of the stained  
area near the Main  
Camp.

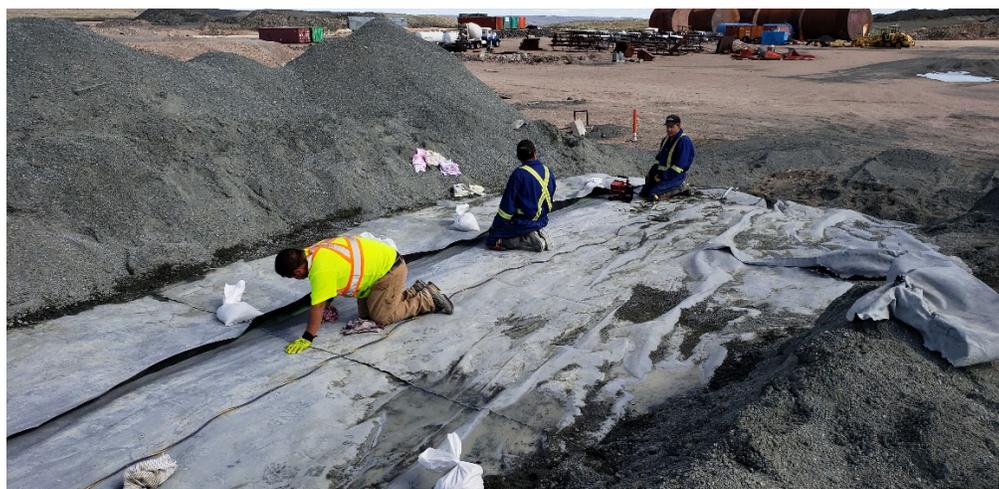
**Description**  
Liner pulled back to place the stained soils.

The small volume (0.5 x 1.0 x 18 metres = 9 cubic metres) of hydrocarbon contaminated soils excavated in 2018 was added to the PHC Containment Cell when the liner was removed to repair the S-bend. Further details can be found

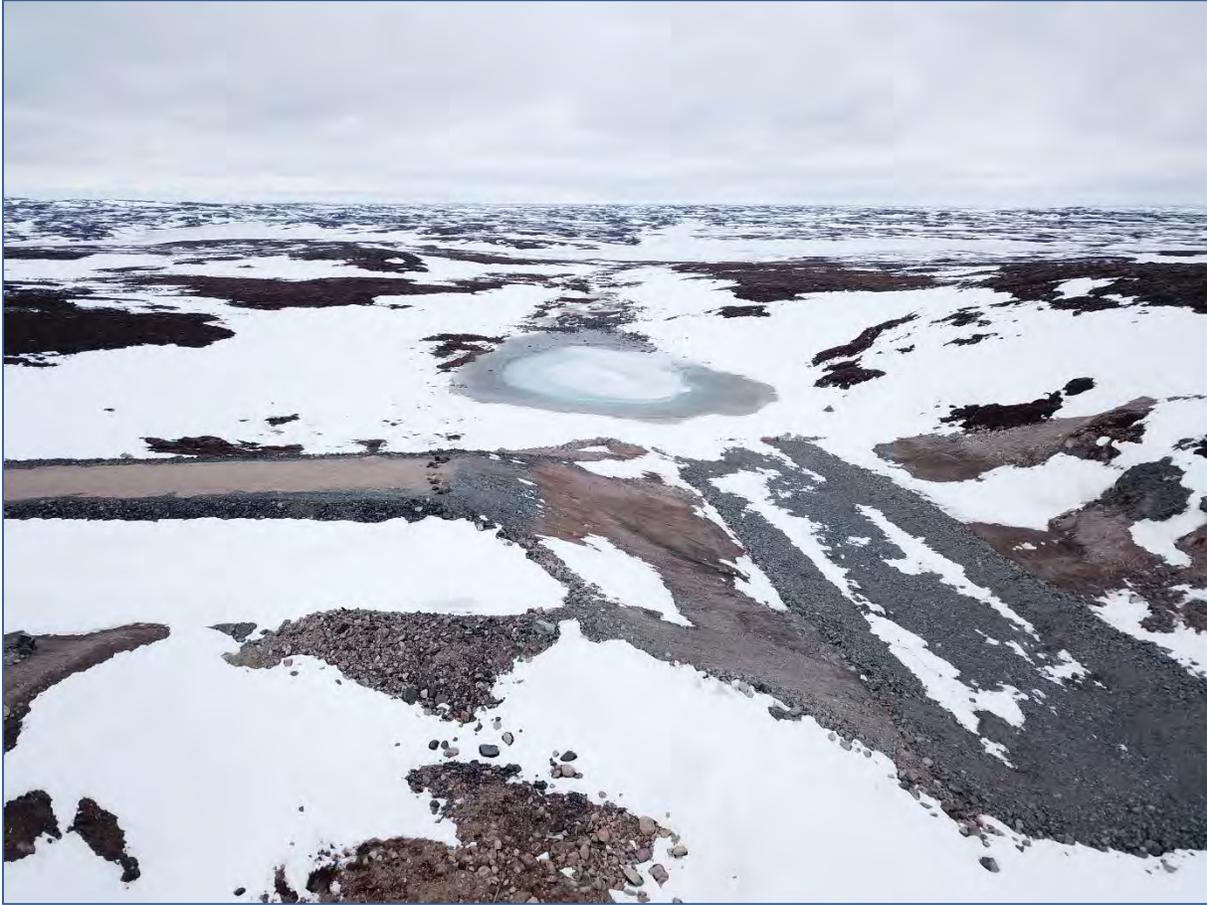
**Photo 1: June 6, 2018 West Dam Breach – Looking West (downstream).**

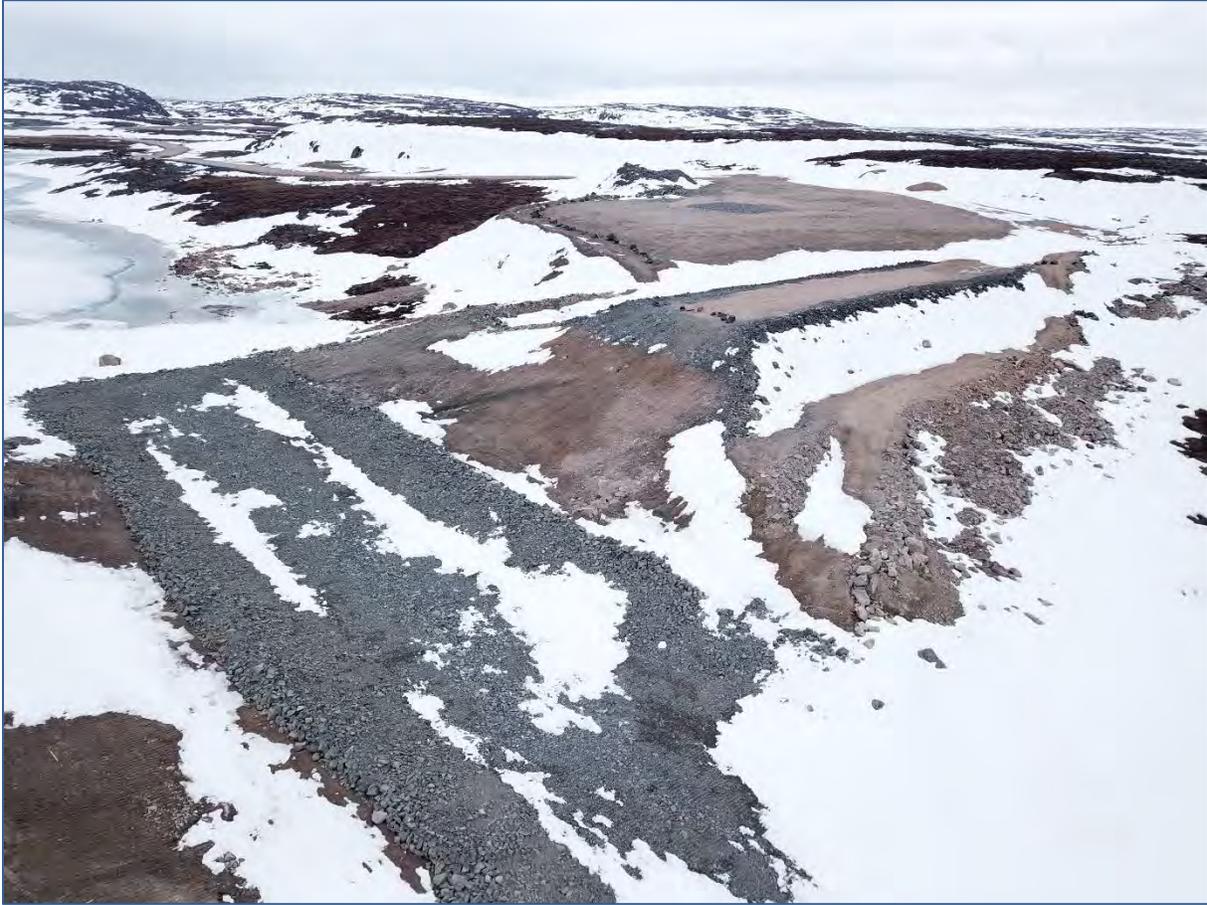
**Photo 2: June 6, 2018 West Dam Breach – Looking East (upstream).**

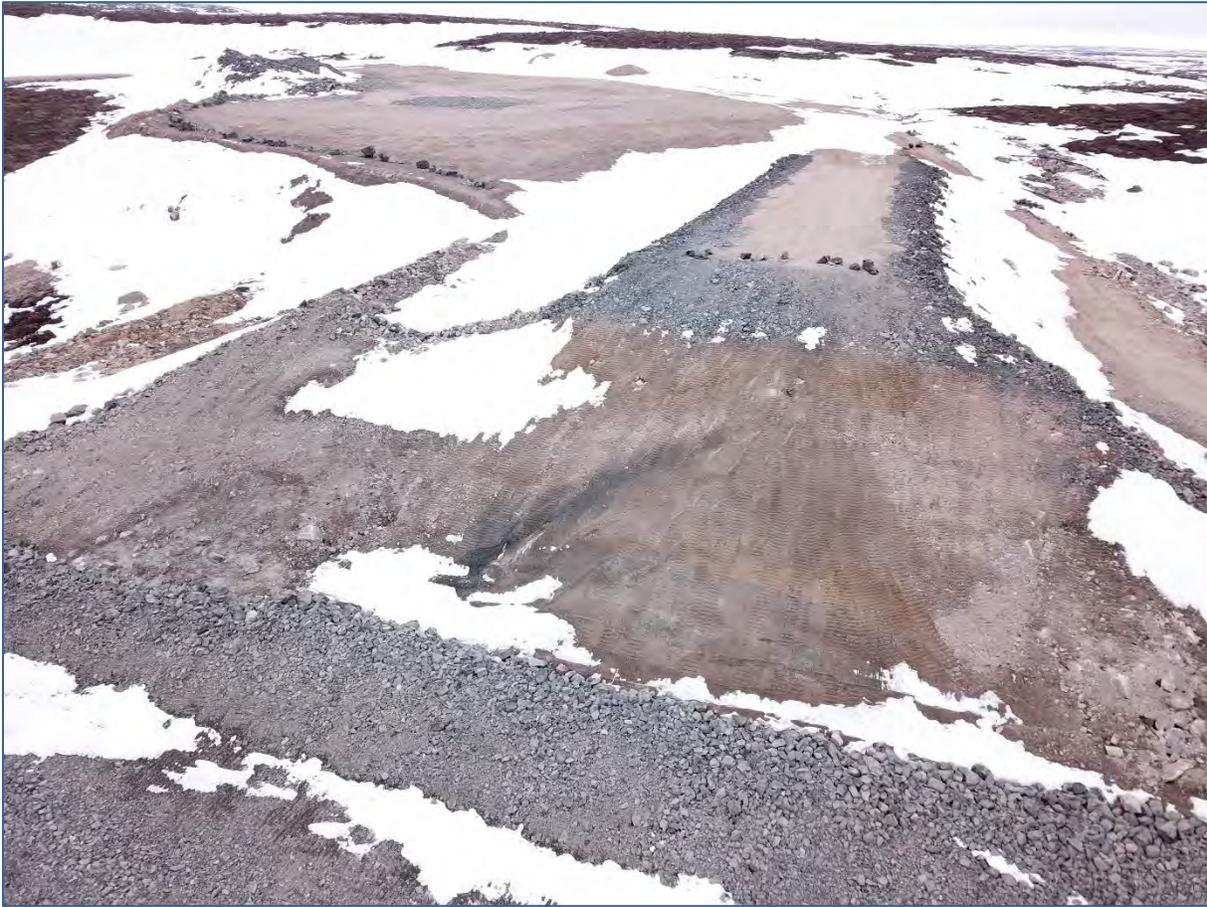
**Photo 3: June 6, 2018 West Dam Breach – South Bank.**

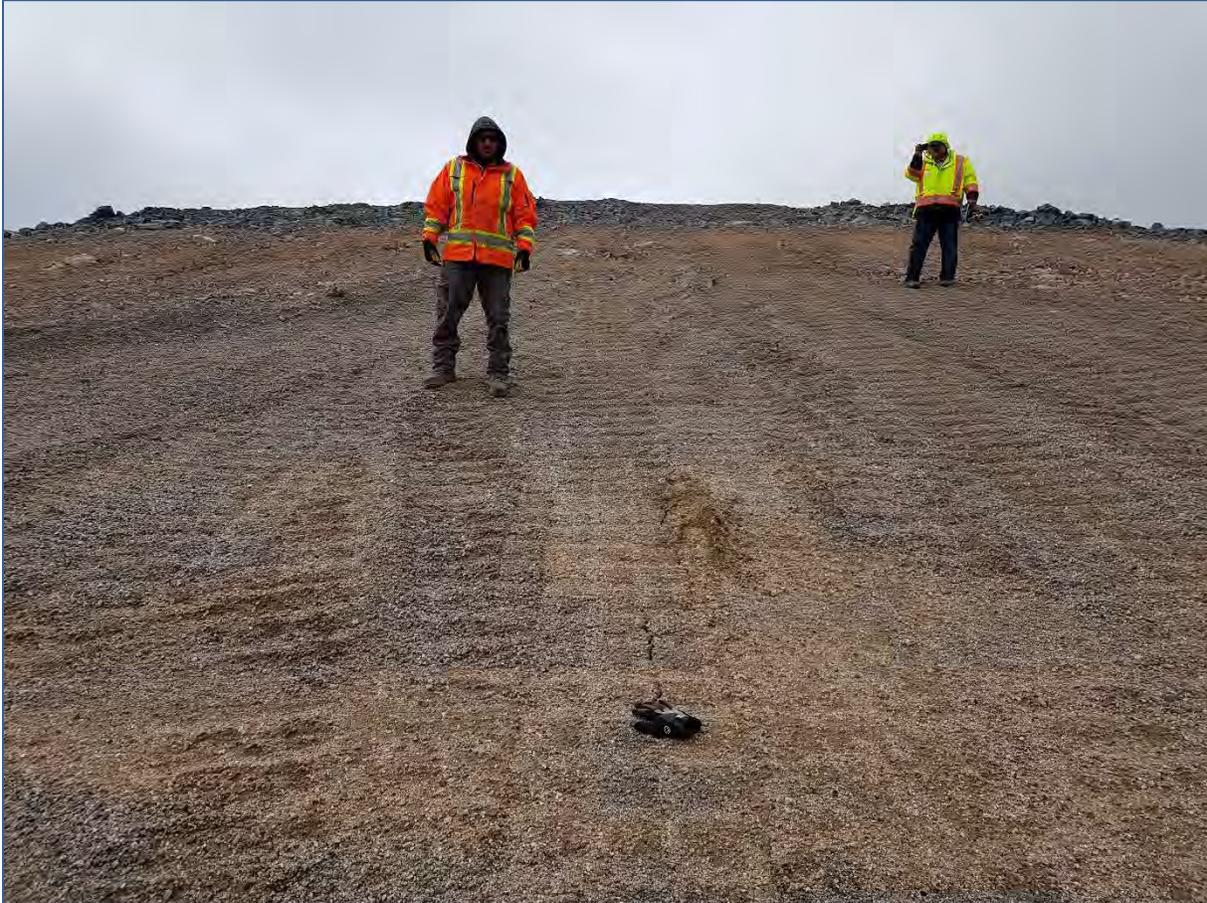
**Photo 4: August 3, 2018 West Dam Breach – Minor Erosion in South Bank.**

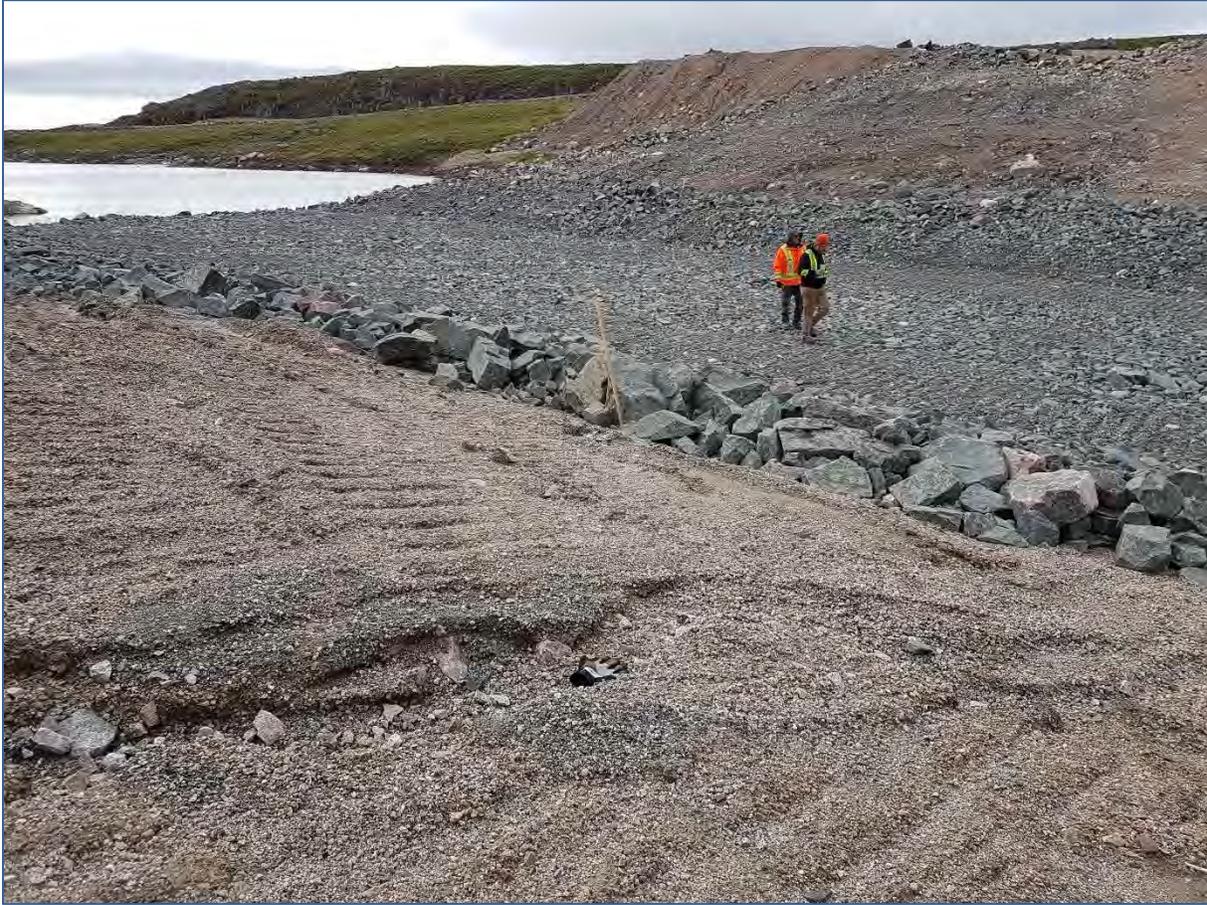
**Photo 5: August 3, 2018 West Dam Breach – North Bank Erosion Gully.**

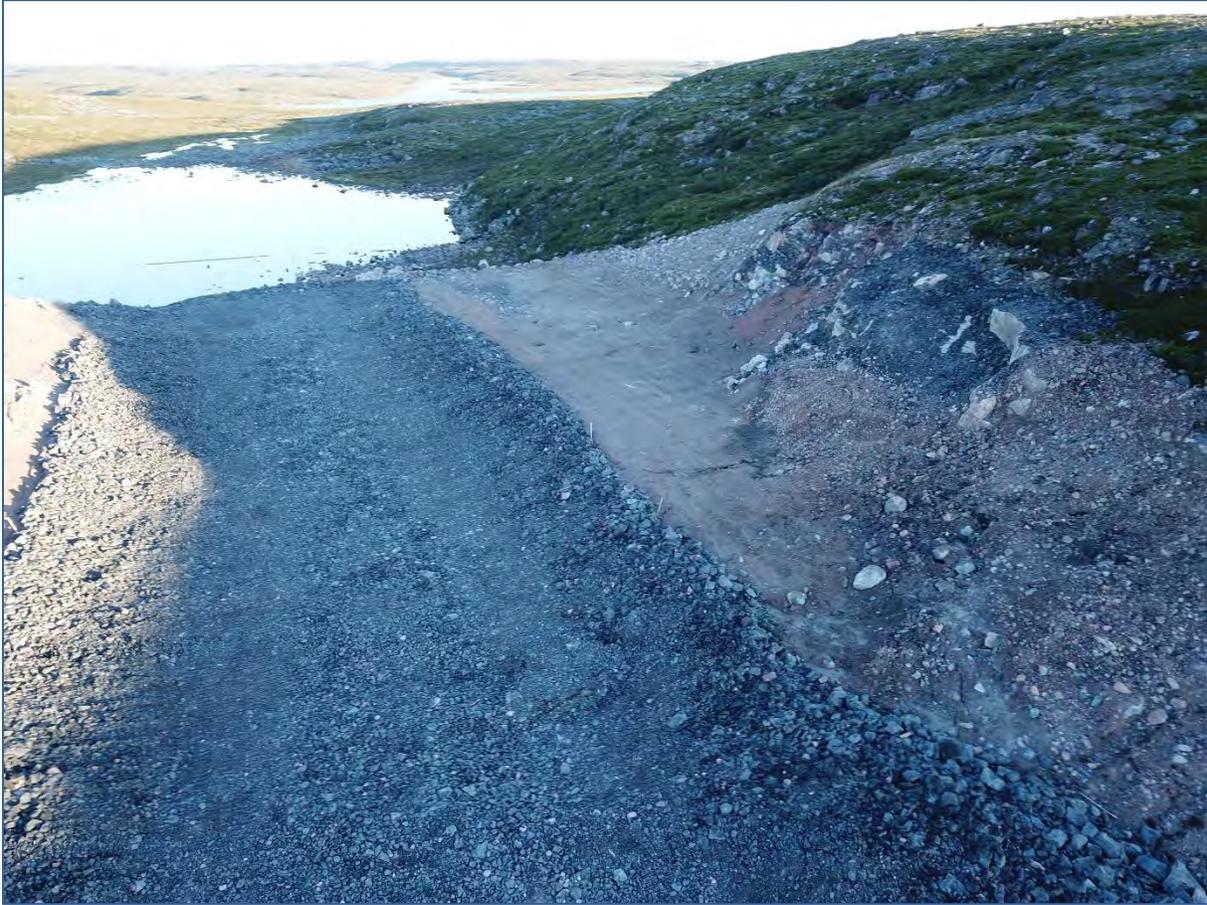
**Photo 6: August 4, 2018 West Dam Breach – North Bank.**

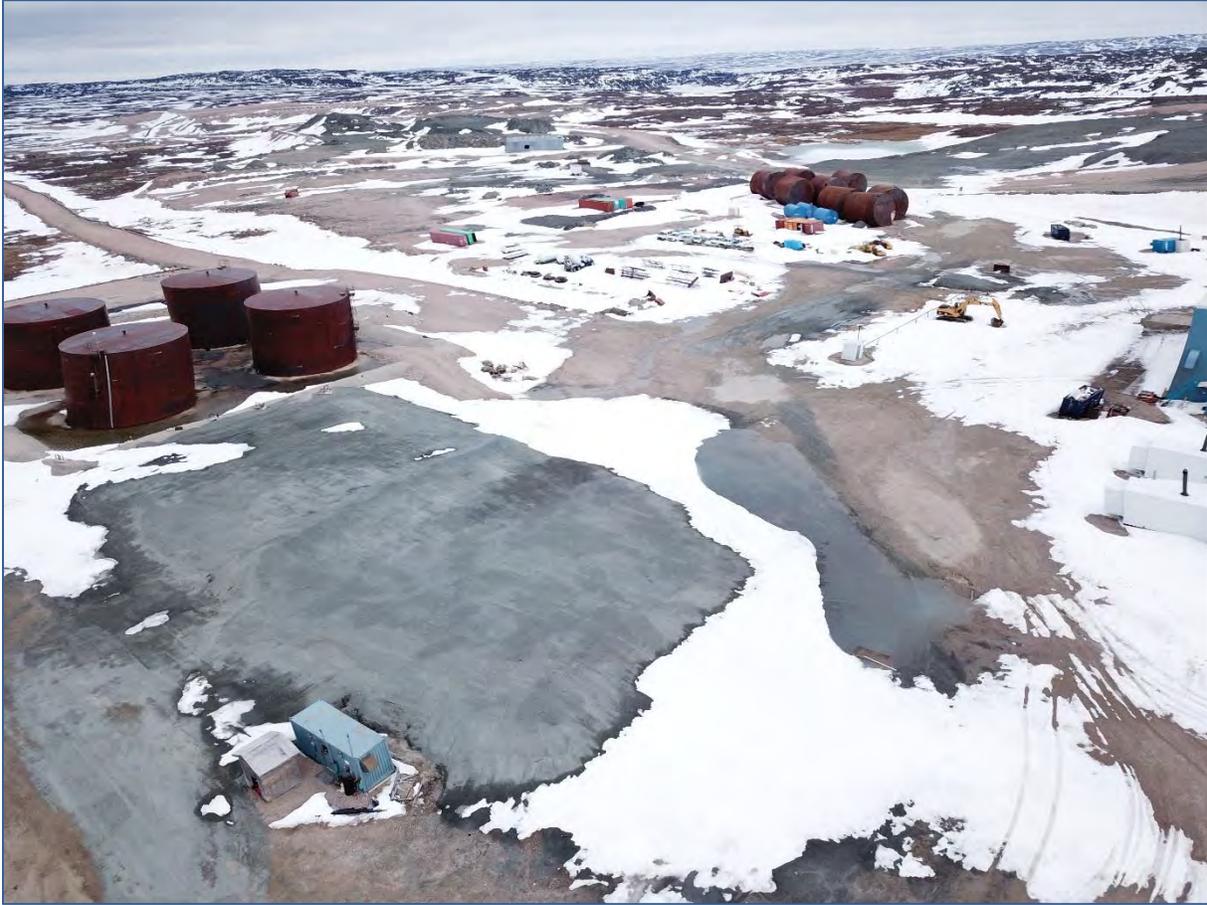
**Photo 7: June 6, 2018 PHC Containment Cell Cover – Pre-Deficiency Repair (mound in middle).**

- 3- Uncover the LLDPE liner used to cover the PHC Containment Cell located in the Phase 1 Tank Farm such that the S-fold can be cut out and that the liner can be repaired providing a flat top surface. The liner to be recovered with the removed aggregates.

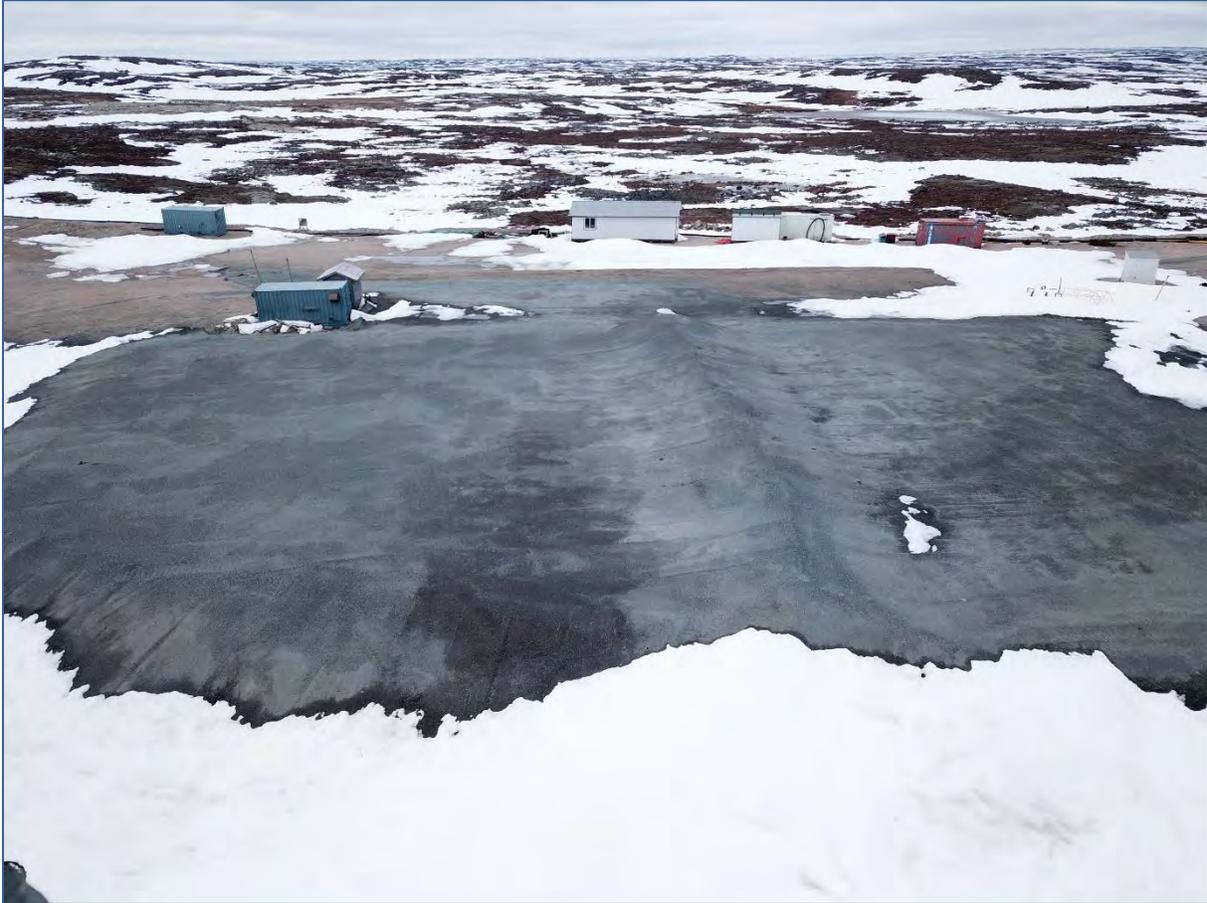
**Photo 8: June 6, 2018 PHC Containment Cell Cover – Pre-Deficiency Repair.**

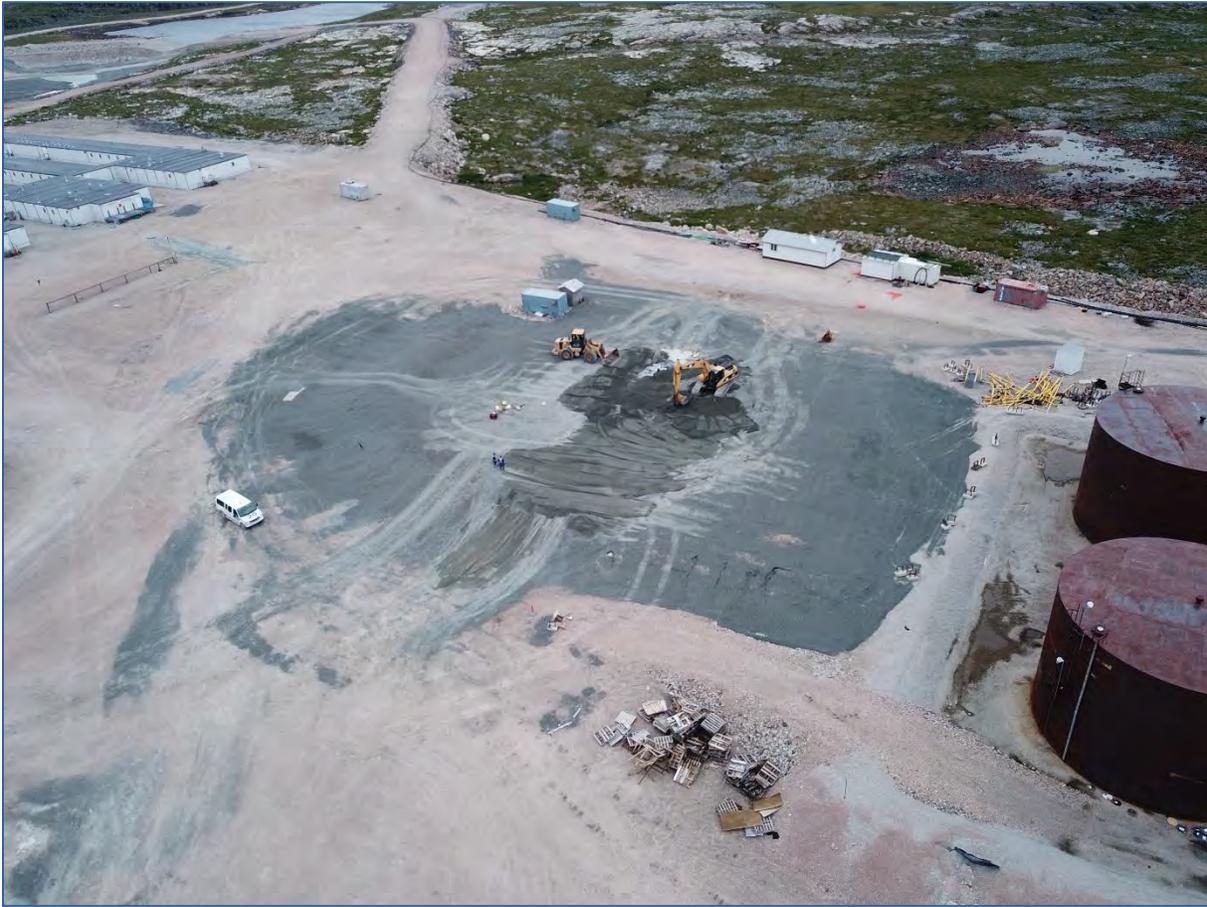
**Photo 9: August 5, 2018 PHC Containment Cell Cover – Post-Deficiency Repair.**

After field approval of the liner repairs, ROJV then covered the LLDPE liner with 0.5m of coarse PK aggregate and graded the top surface to uniformly match the remainder of the containment cell. Any excess coarse PK aggregates were placed and graded along the western side of the containment cell.

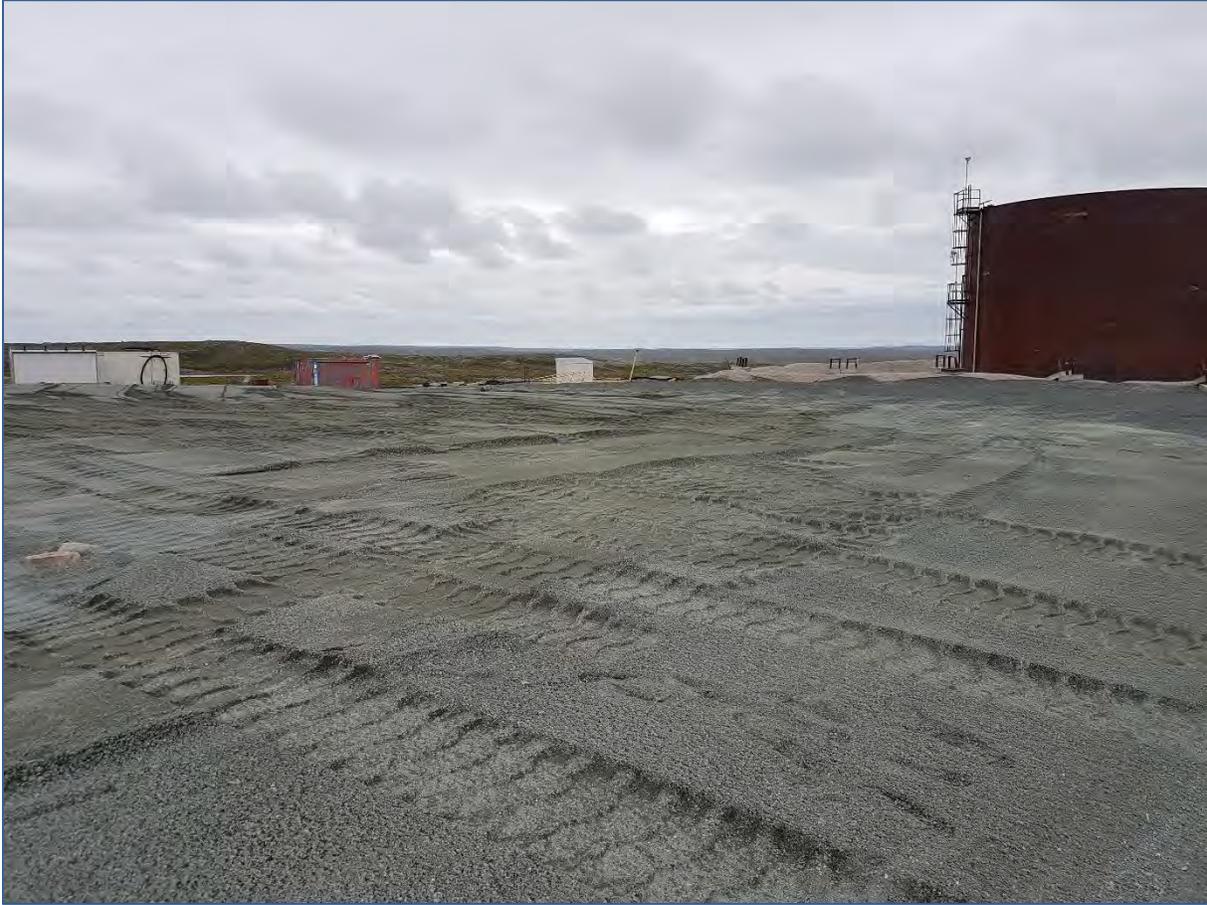
**Photo 10: August 5, 2018 PHC Containment Cell Cover – Looking North, Re-Instated Cover.**

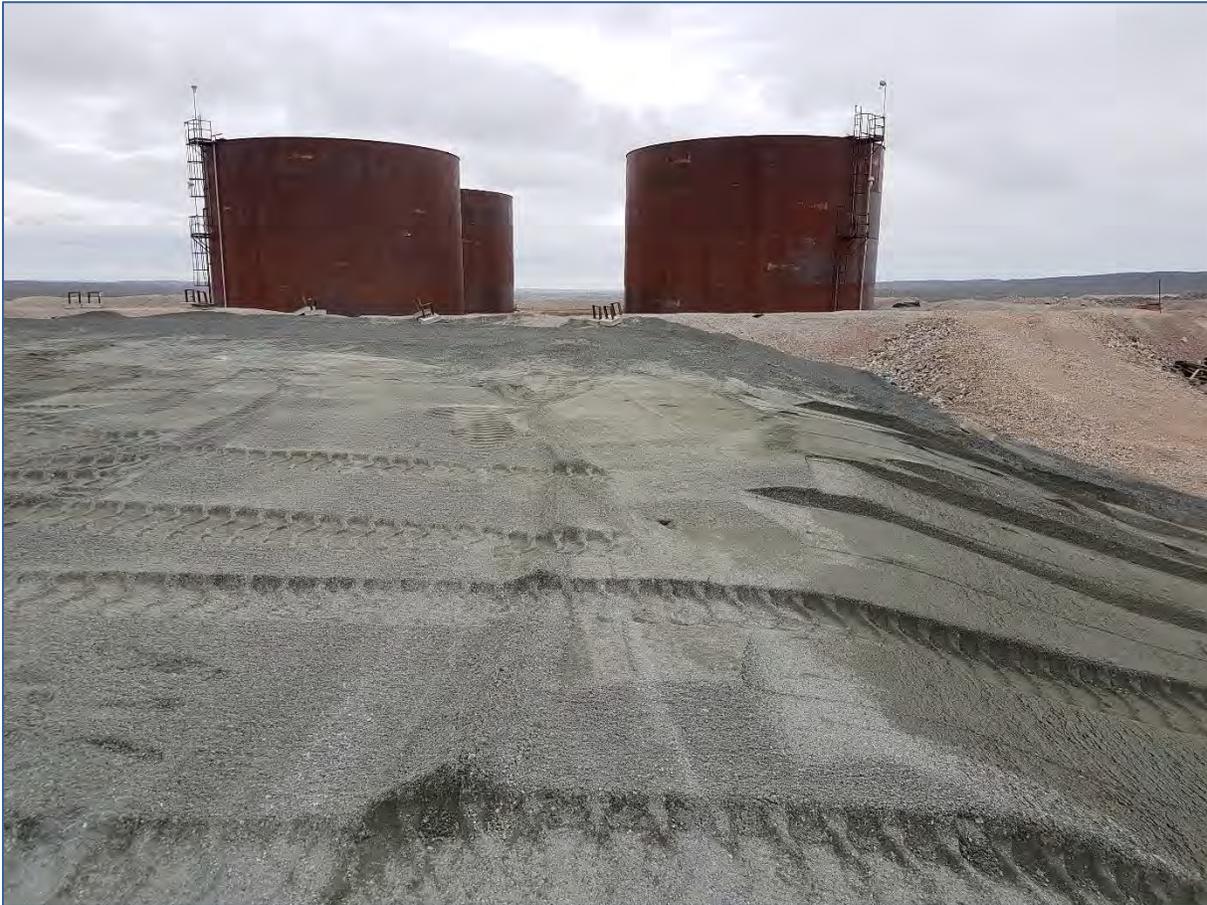
**Photo 11: August 5, 2018 PHC Containment Cell Cover – Looking North, Re-Instated Cover.**

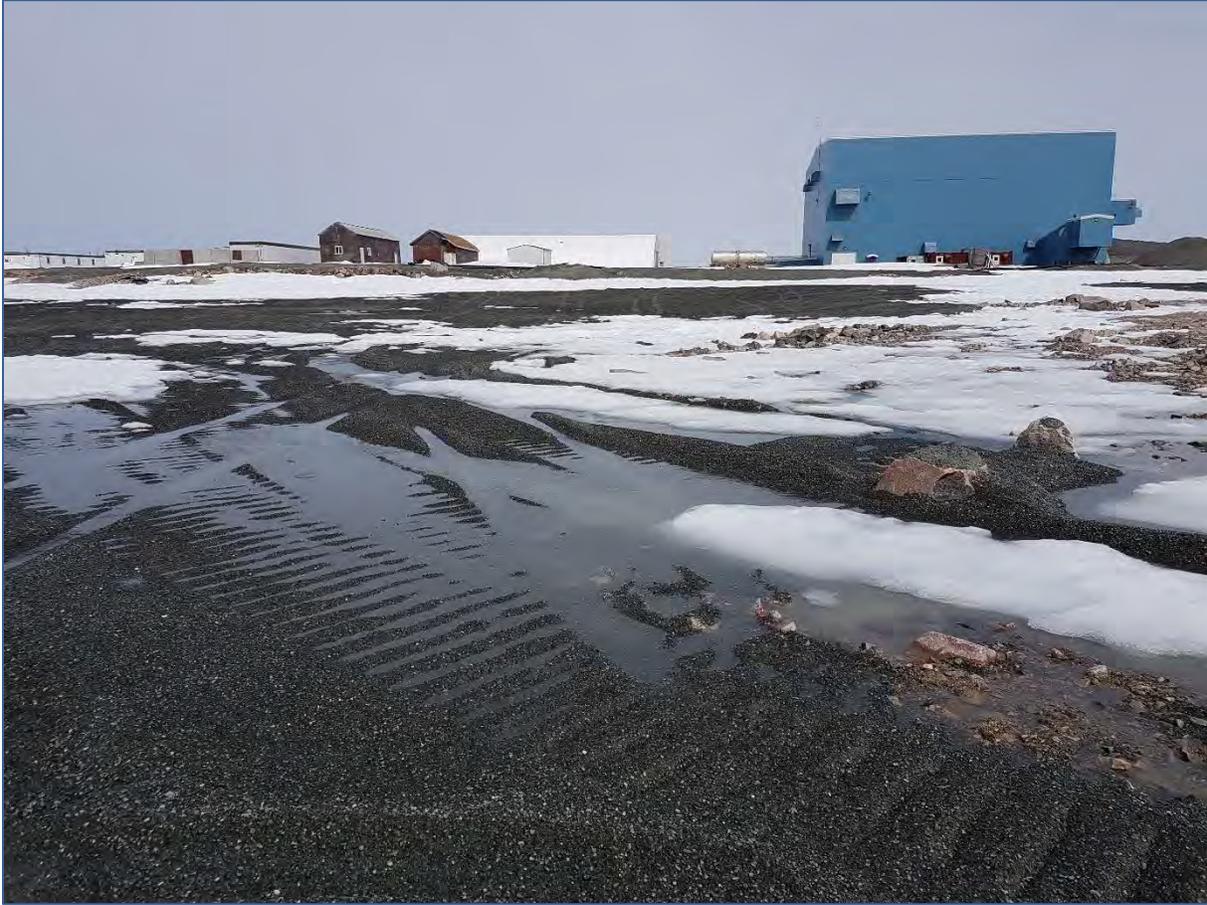
**Photo 12: June 5, 2018 PKCA Cover, North PKCA – Looking North.**

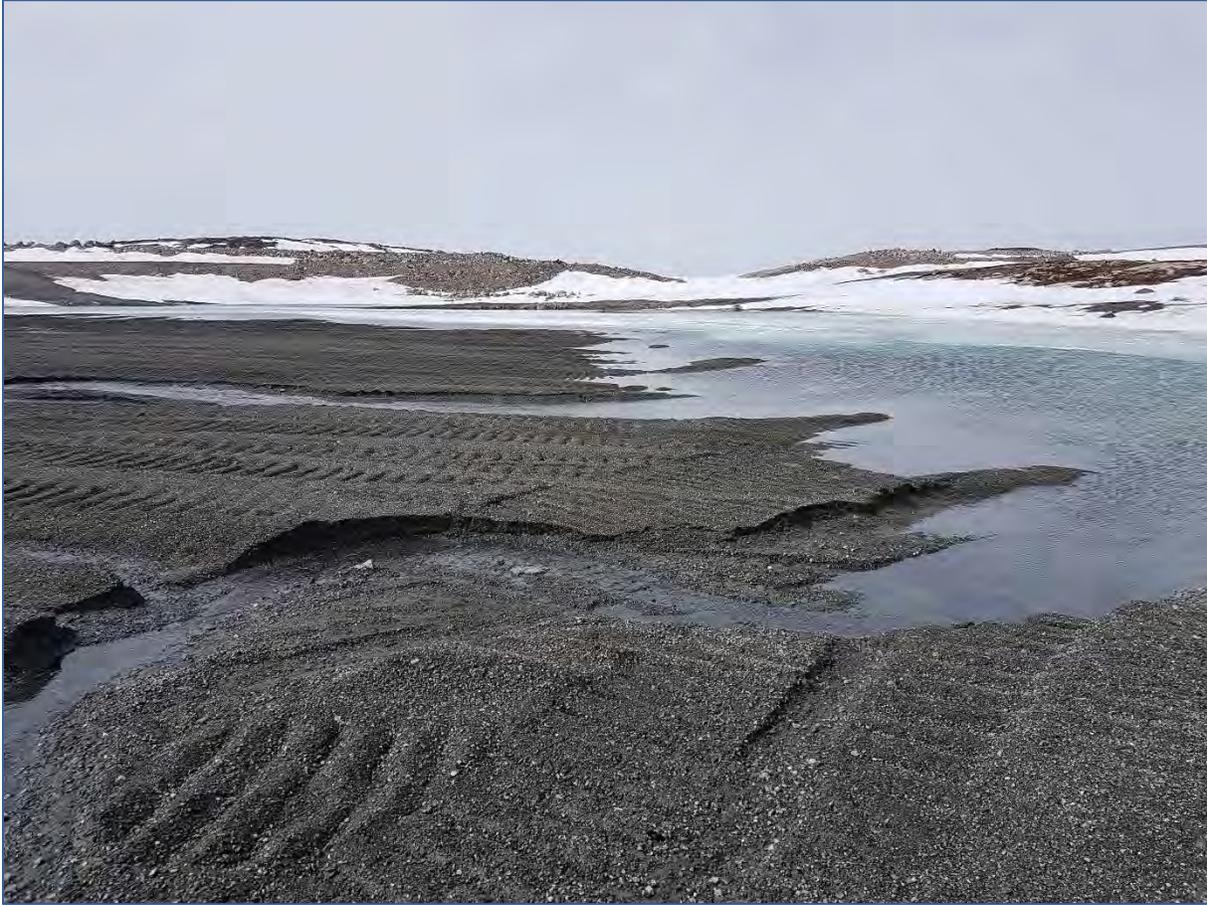
**Photo 13: June 5, 2018 PKCA Cover, North PKCA – Looking South, Surface Melt Channels.**

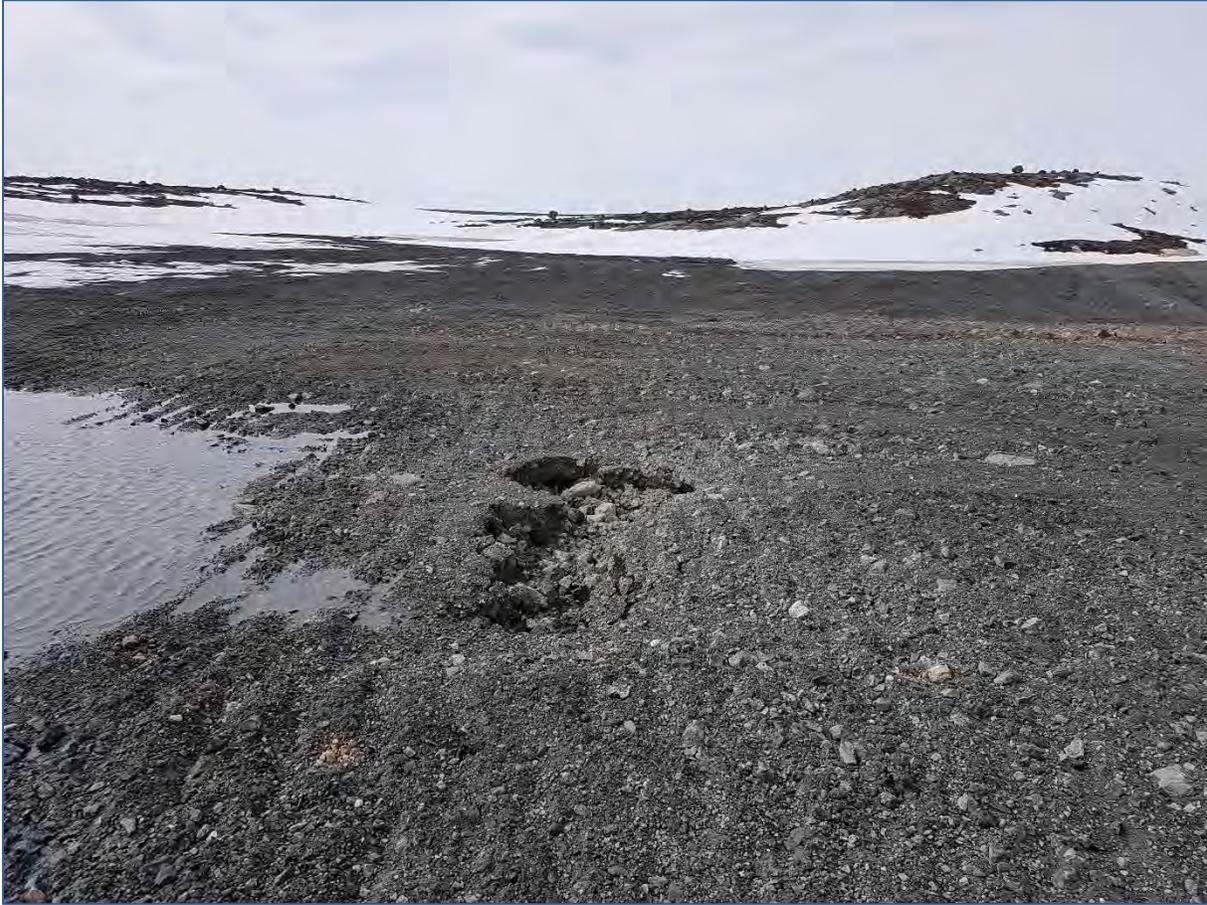
**Photo 14: June 5, 2018 PKCA Cover, North PKCA – New Pot Hole.**

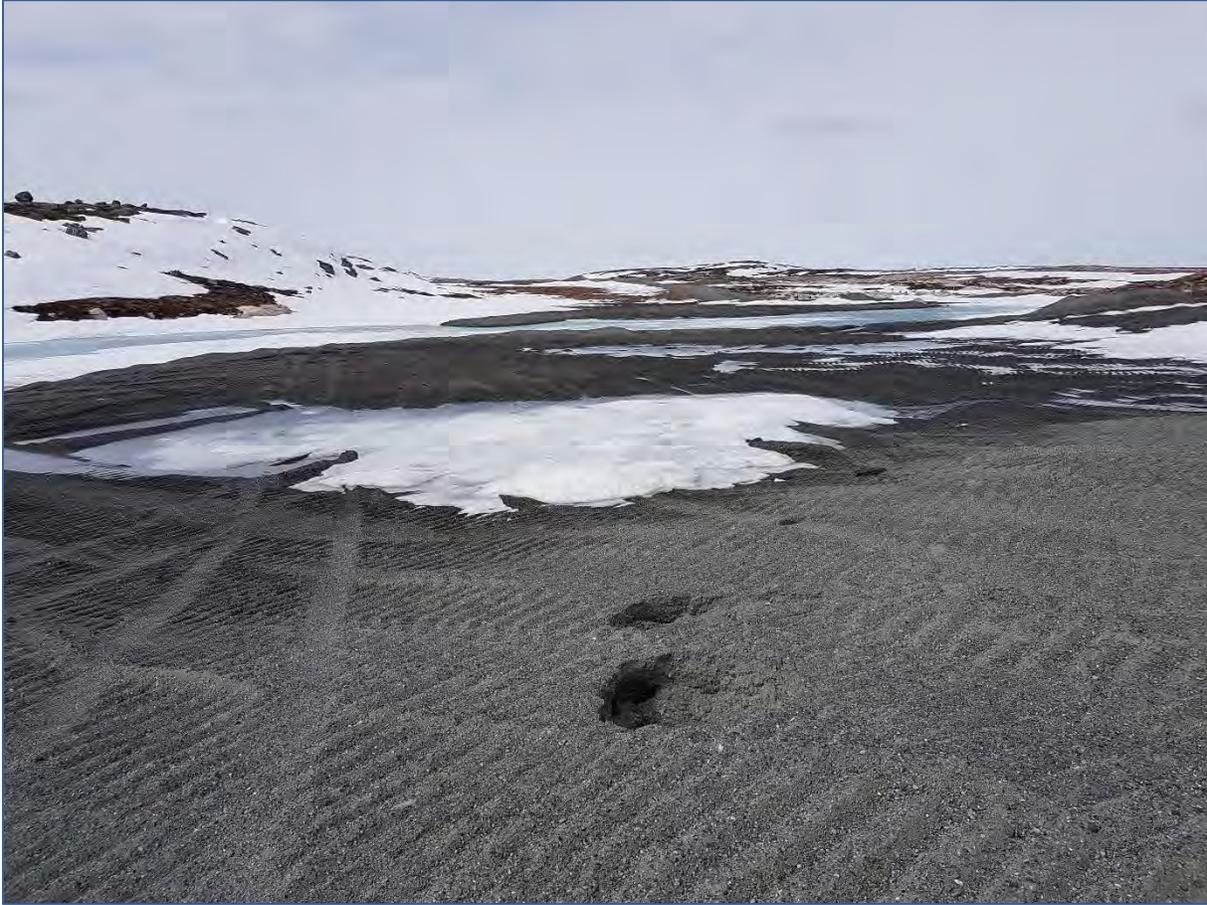
**Photo 15: June 5, 2018 PKCA Cover, Southeast PKCA – Previously Identified Pot Hole.**

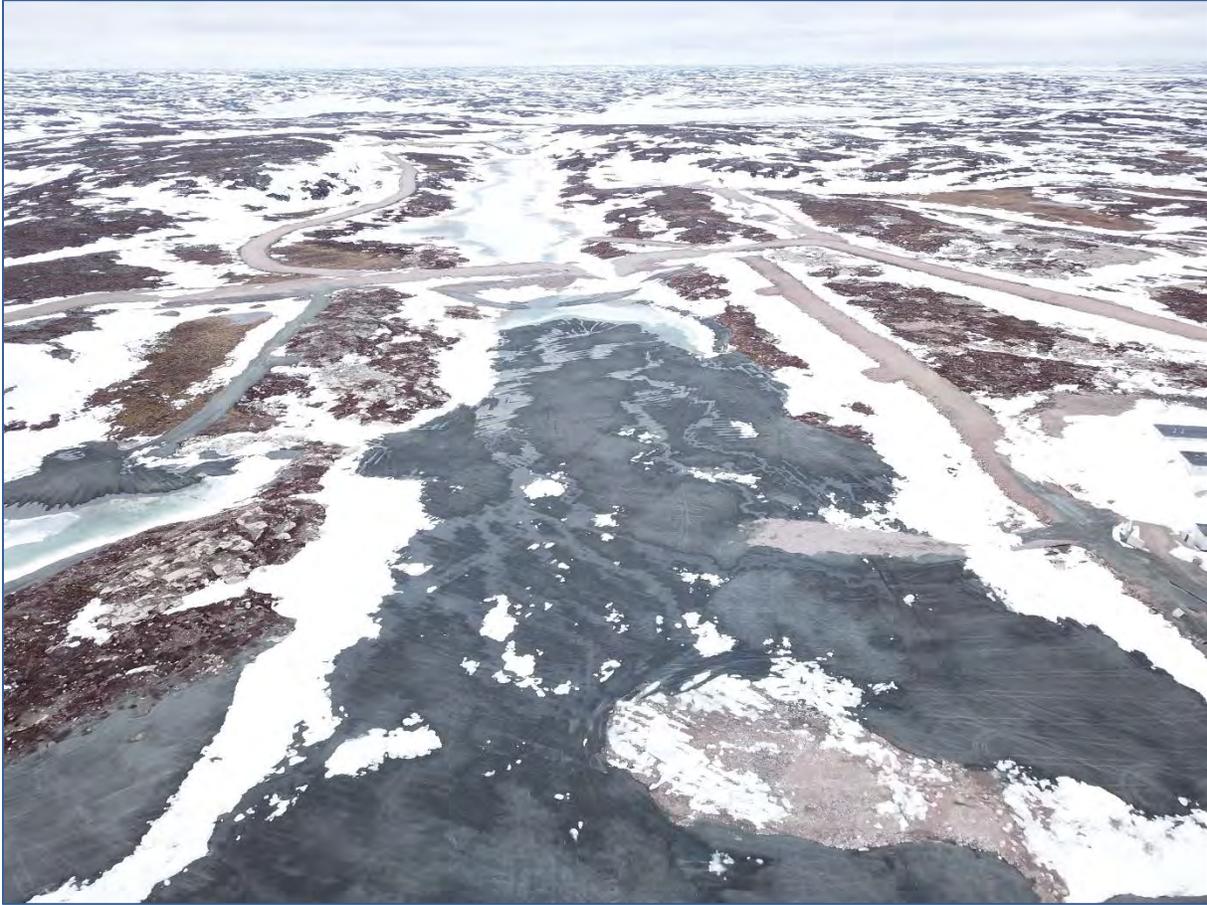
**Photo 16: June 6, 2018 PKCA Cover, North PKCA – Looking West (downstream).**

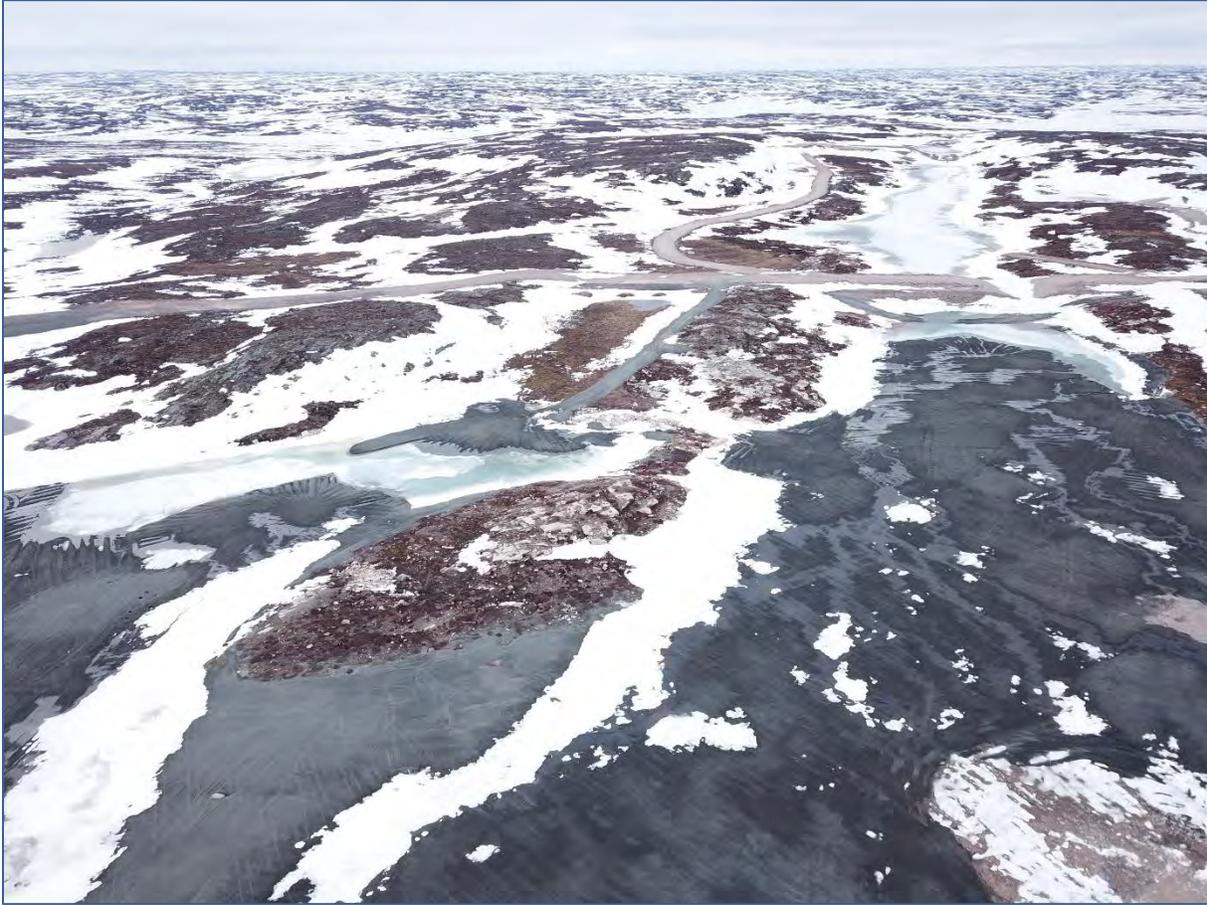
**Photo 17: June 6, 2018 PKCA Cover, North+ South PKCA – Looking West (downstream).**
