# **JERICO DIAMOND MINE SITE STABILIZATION PROJECT**

## **NUNAVUT IMPACT REVIEW BOARD FILE #16UN058 2018 ANNUAL REPORT**

**June 11, 2019**

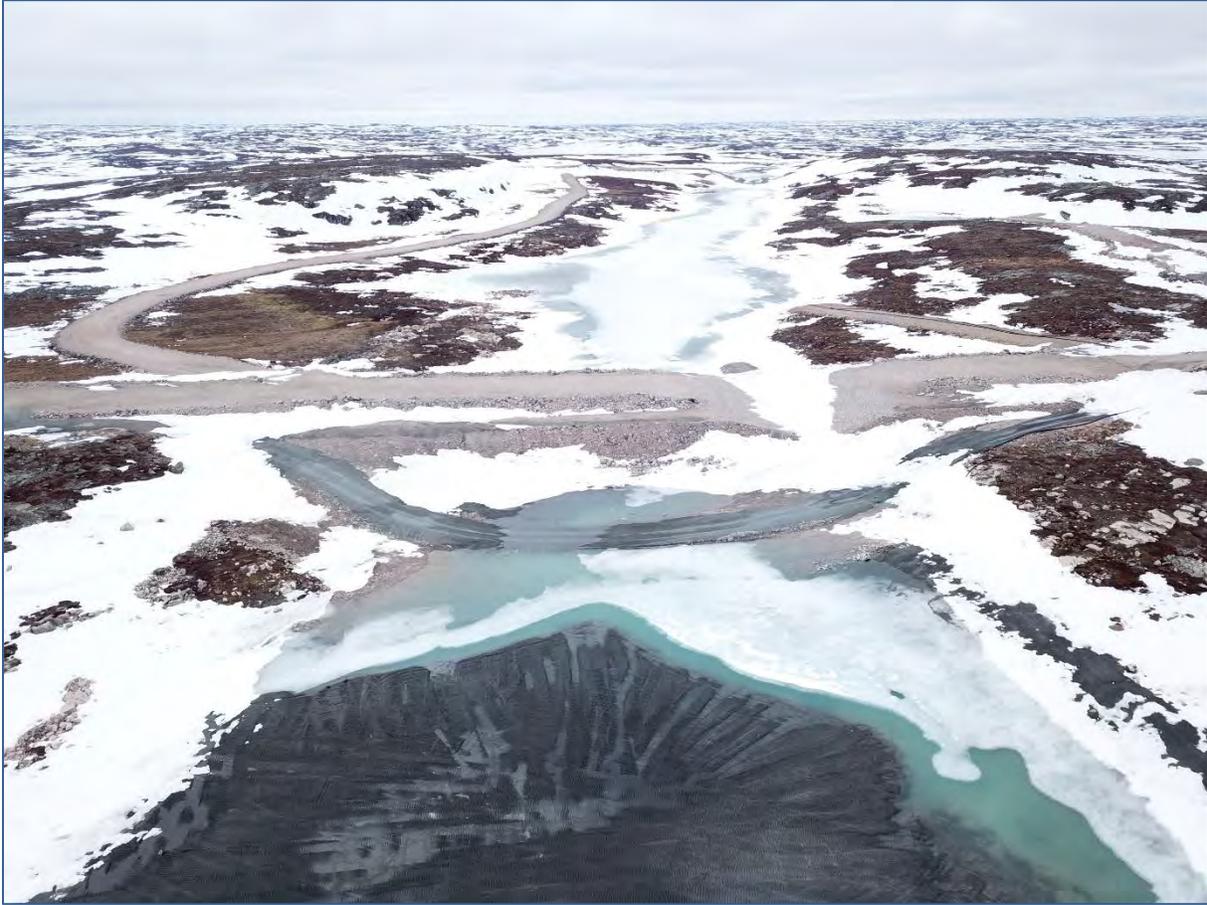
**Photo 18: June 6, 2018 PKCA Cover/ Divider Dike A – Looking West (downstream).**

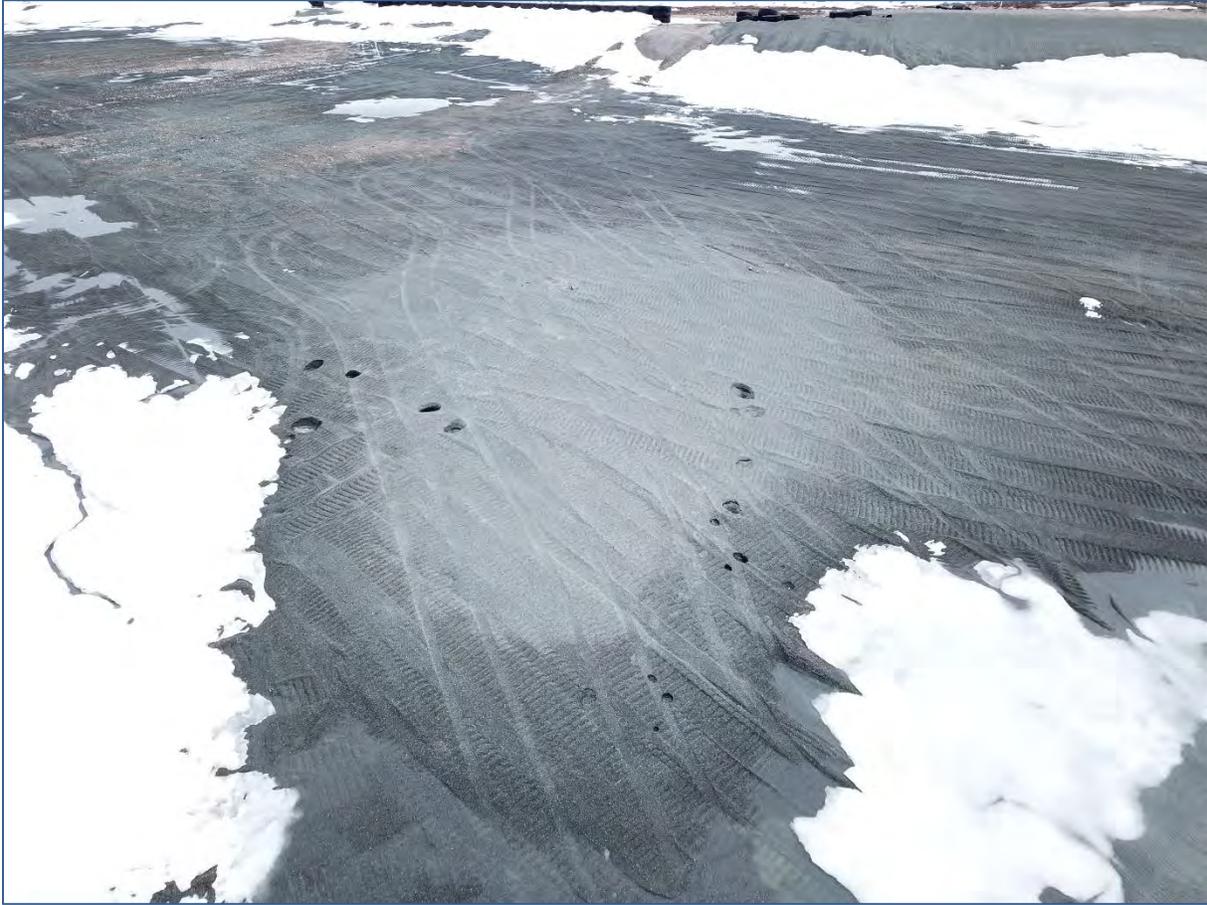
**Photo 19: June 6, 2018 PKCA Cover, Southeast PKCA – Previously Identified Pot Holes.**

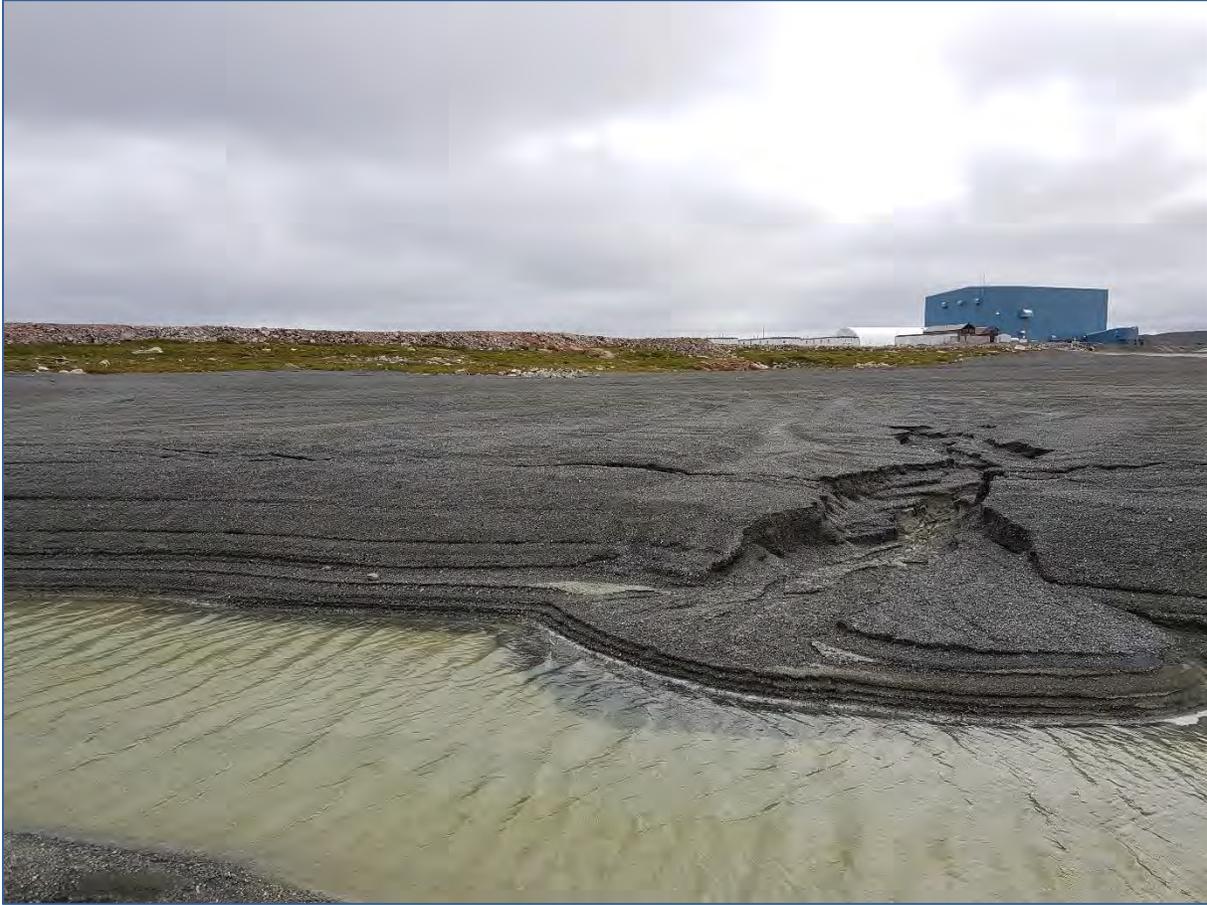
**Photo 20: August 3, 2018 PKCA Cover, North PKCA – Outlet of Erosion Channel near ponded water adjacent Divider Dike A.**

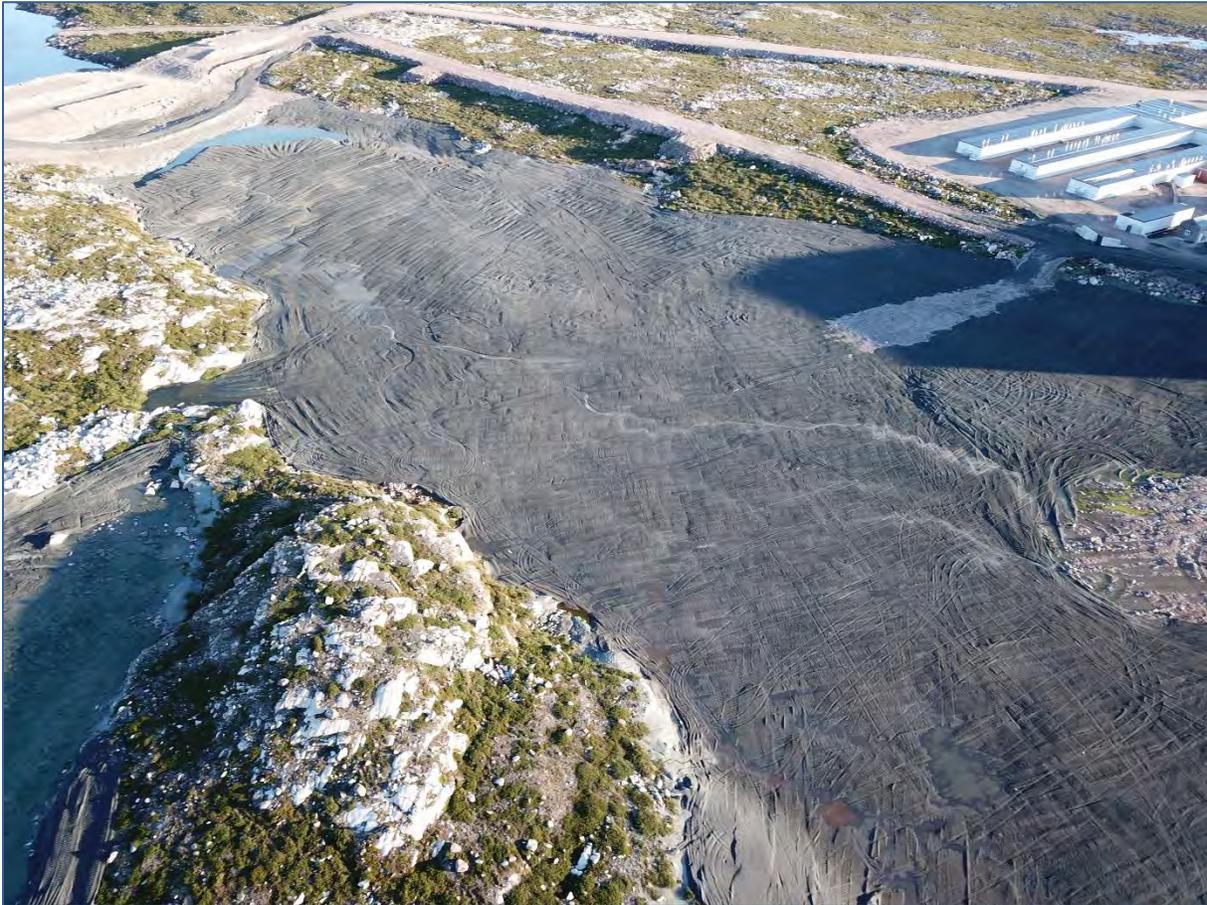
**Photo 21: August 4, 2018 PKCA Cover, North PKCA – Summer Surface Water Channels.**

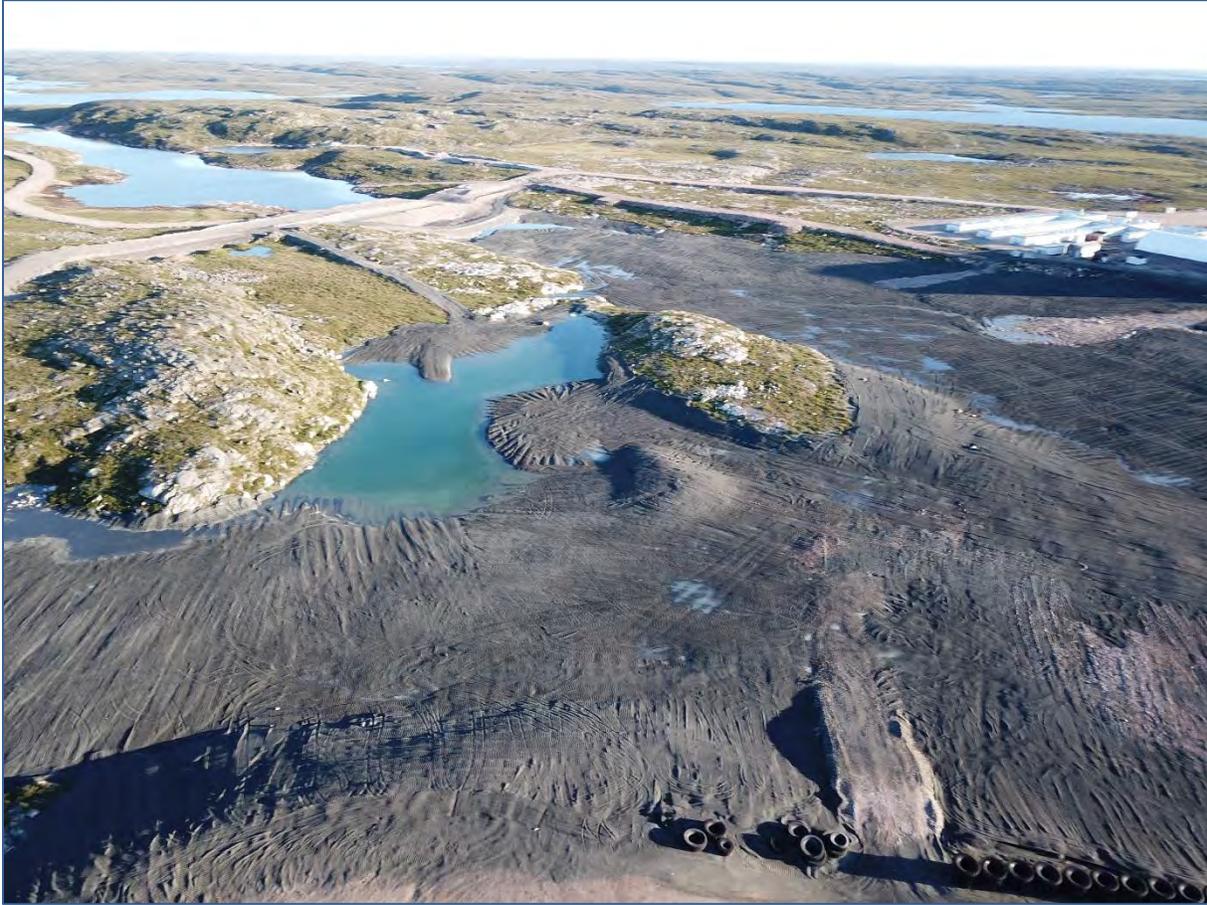
**Photo 22: August 4, 2018 PKCA Cover, North+ South PKCA – Looking Northwest.**

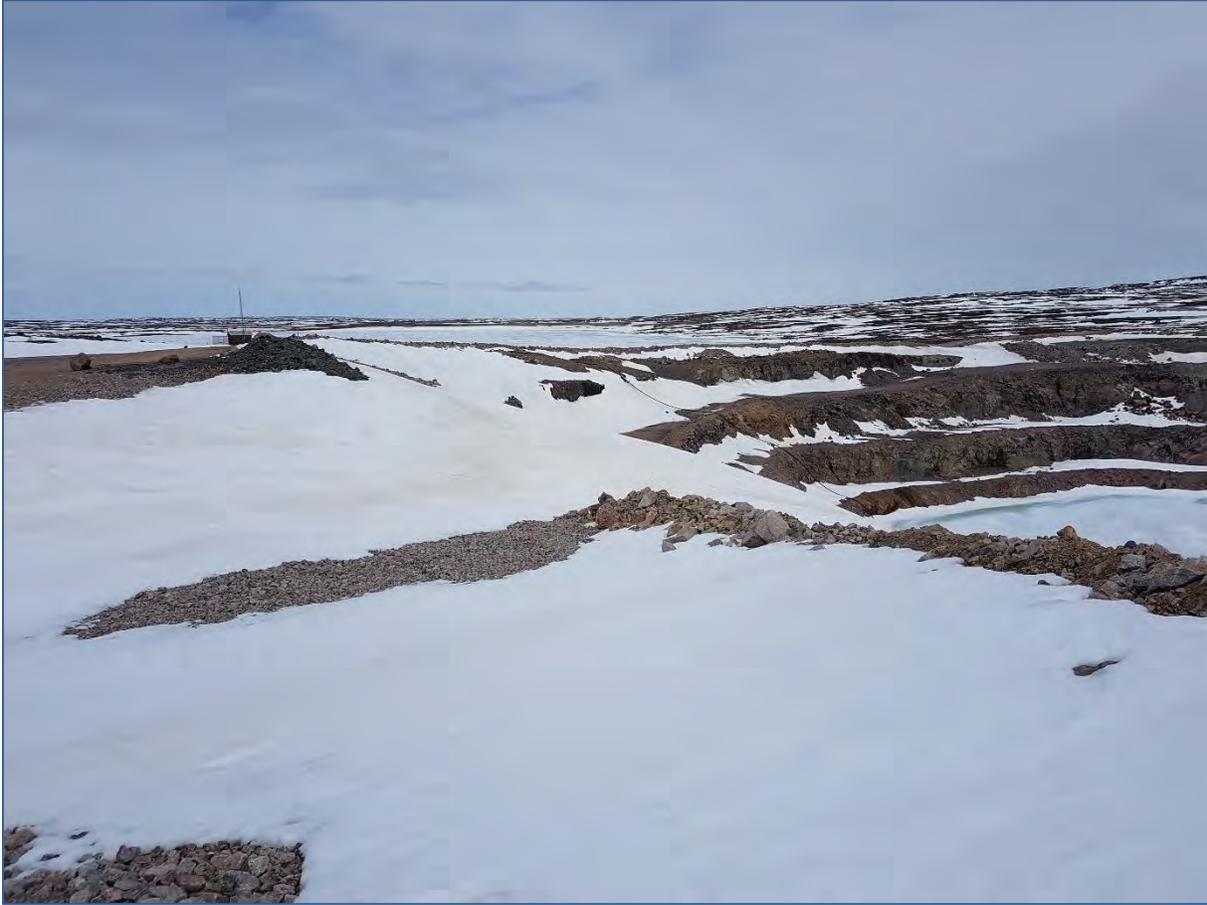
**Photo 23: June 5, 2018 C1 Channel – Looking North, Channel snow covered.**

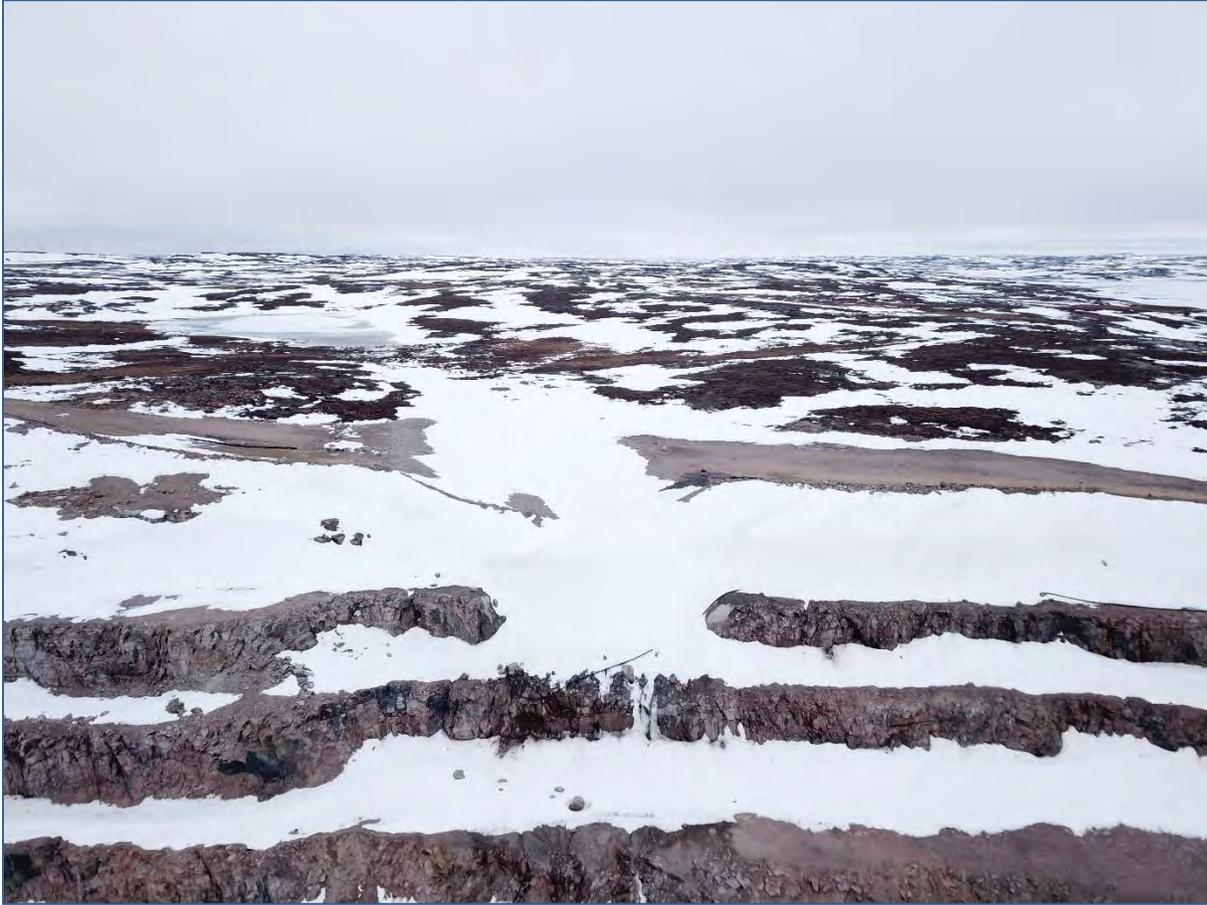
**Photo 24: June 6, 2018 C1 Channel – Looking West, Channel snow covered.**

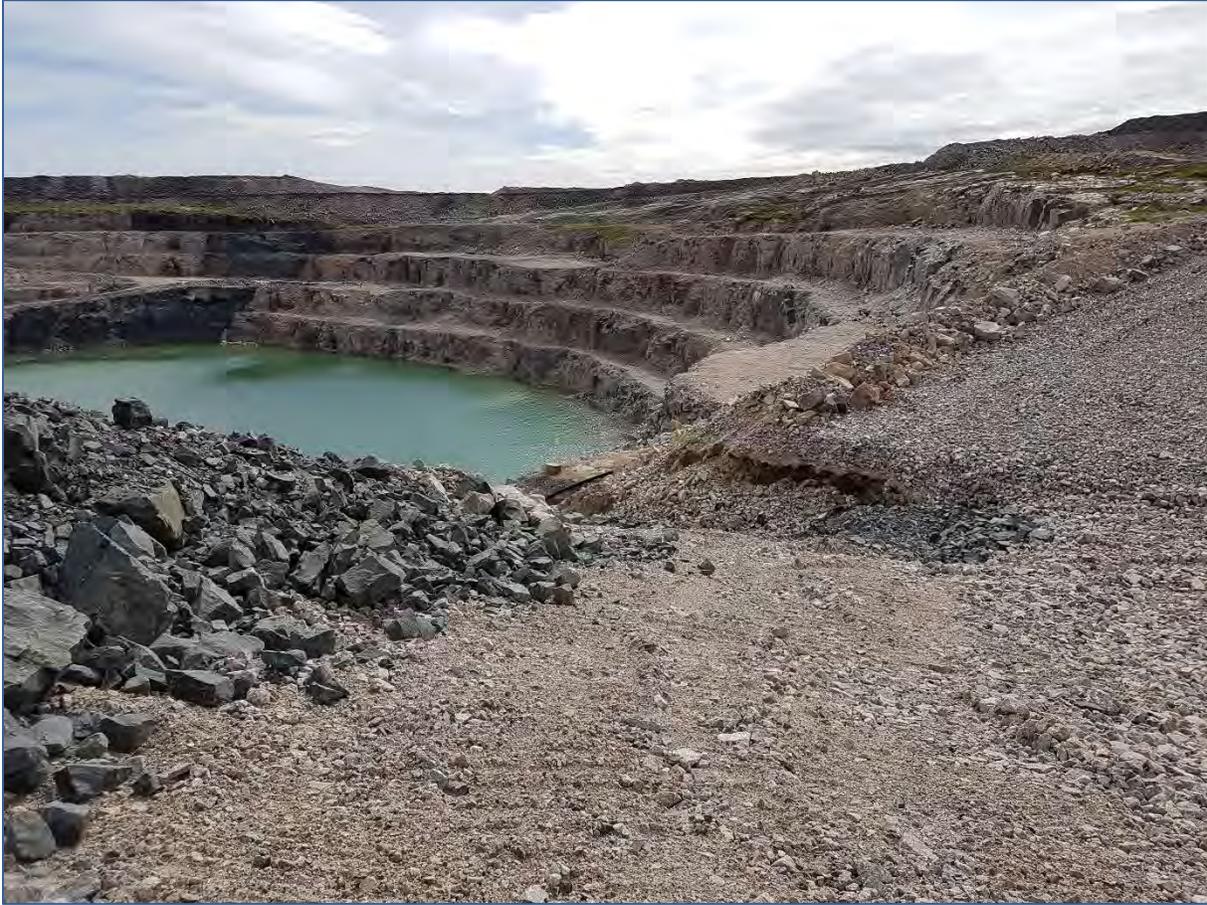
**Photo 25: August 2, 2018 C1 Channel – Looking South, Erosion at Outlet into Open Pit.**

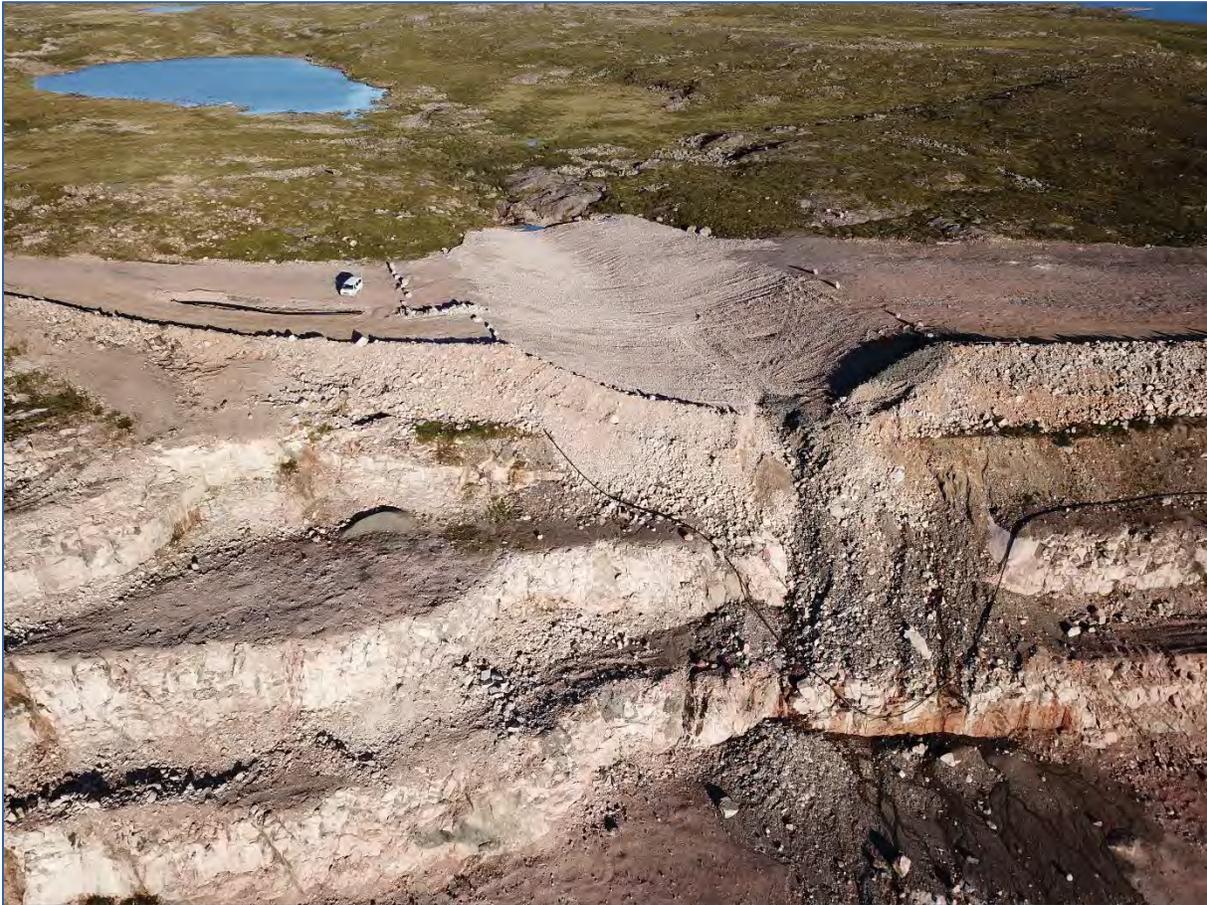
**Photo 26: August 4, 2018 C1 Channel – Looking West, Erosion at Outlet into Open Pit.**

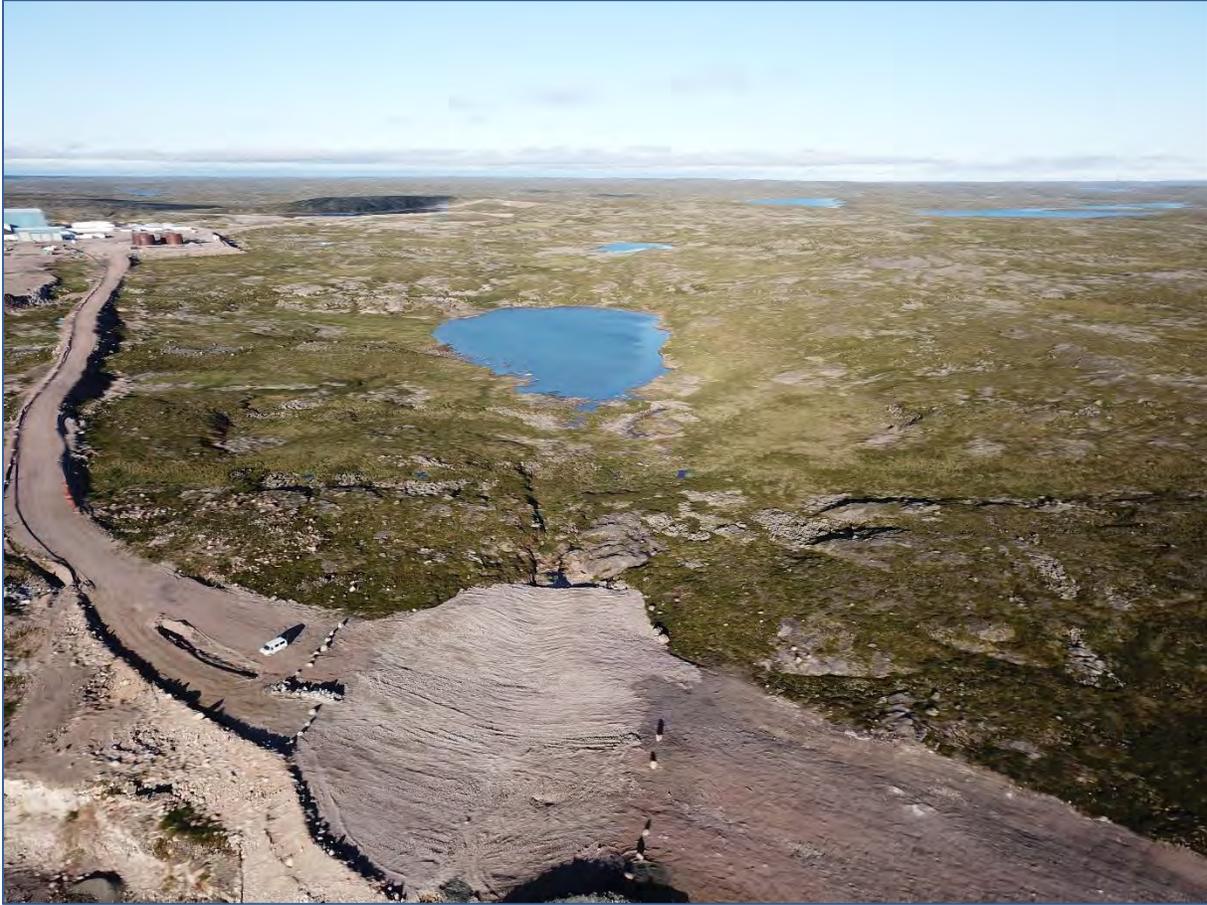
**Photo 27: August 4, 2018 C1 Channel – Looking West, Upstream Catchment.**

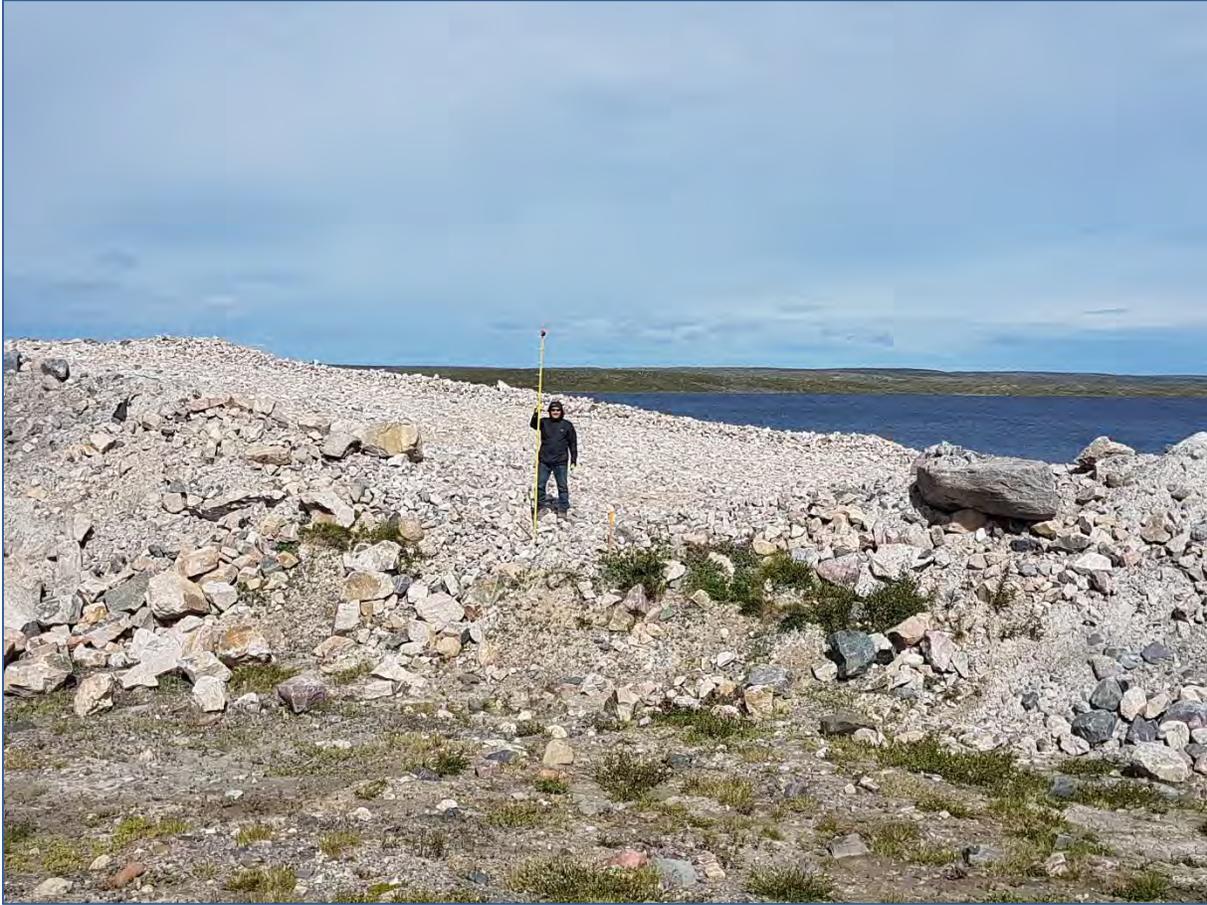
**Photo 28: August 2, 2018 Pit Perimeter Road – Survey of Out Flow.**

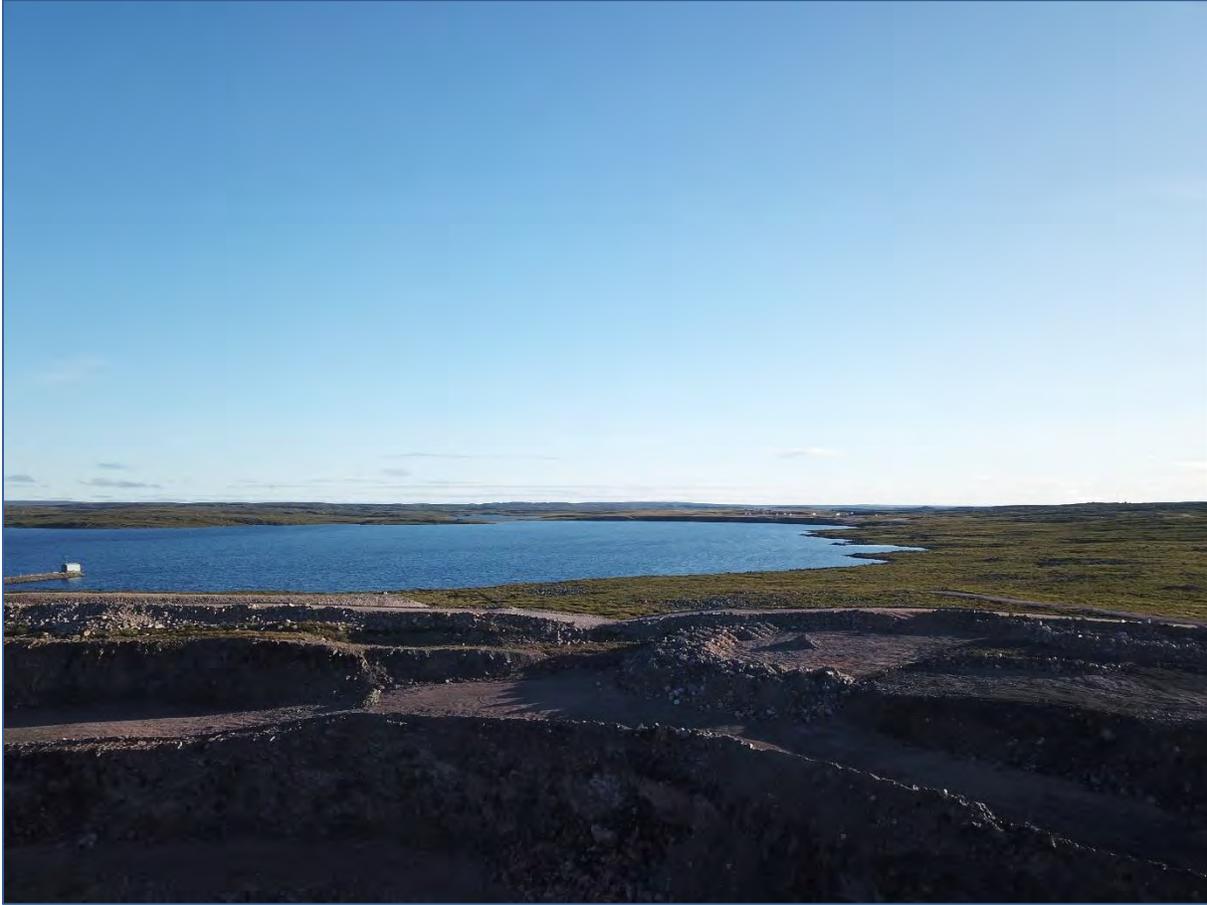
**Photo 29: August 4, 2018 Pit Perimeter Road – Looking North, Outflow at Low Grade Point.**

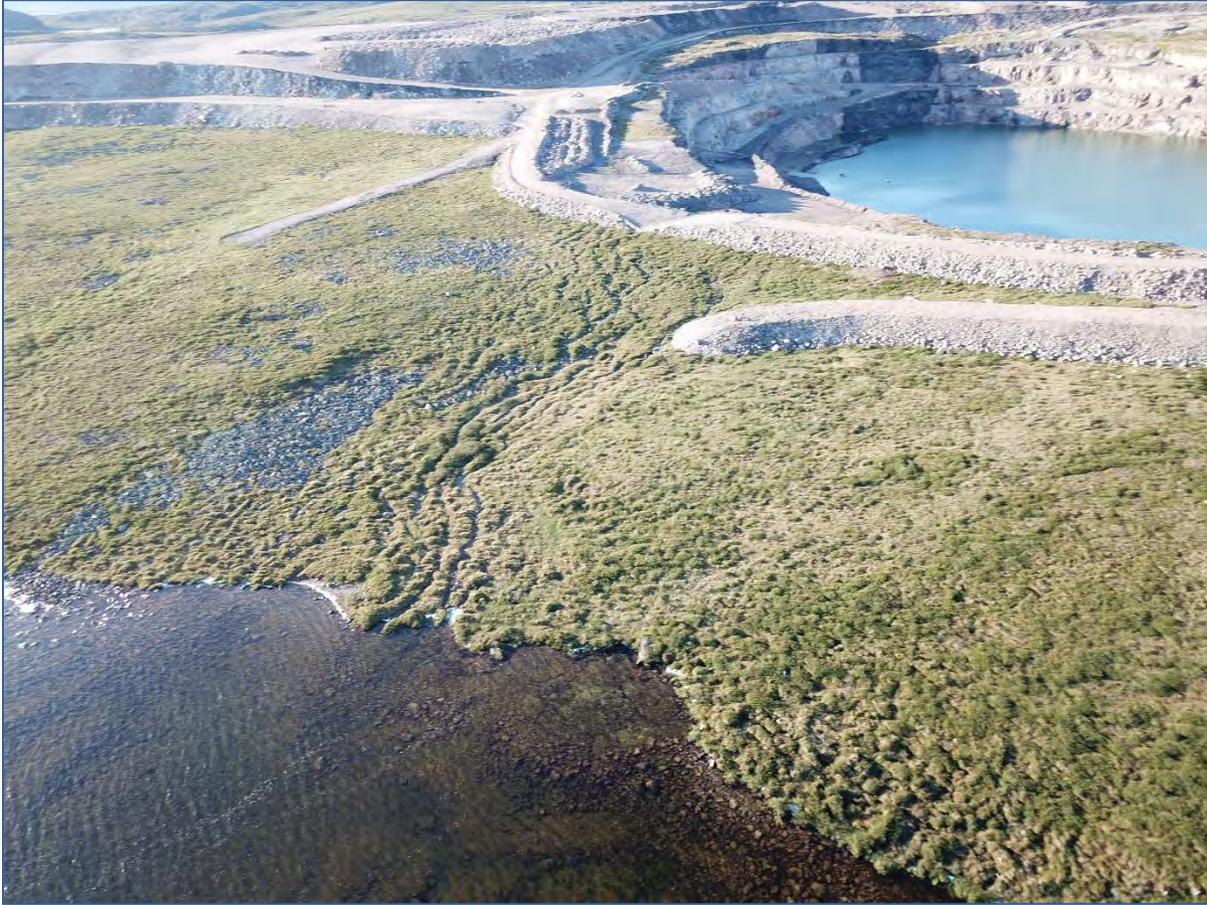
**Photo 30: August 4, 2018 Pit Perimeter Road – Looking South.**

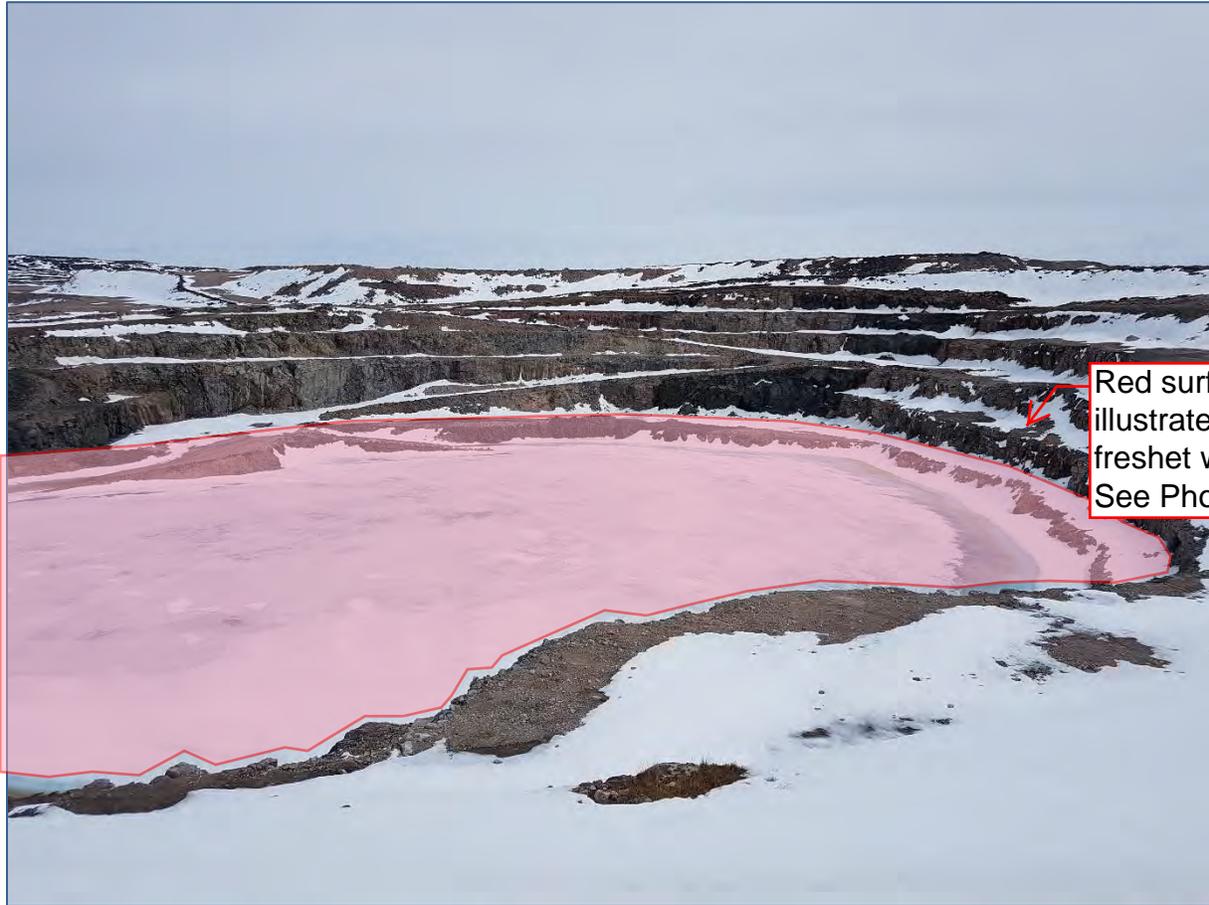
Red surface illustrates post-freshet water level; See Photo 33.

**Photo 31: June 5, 2018 Open Pit – Looking Southeast, Open Pit Water Level.**

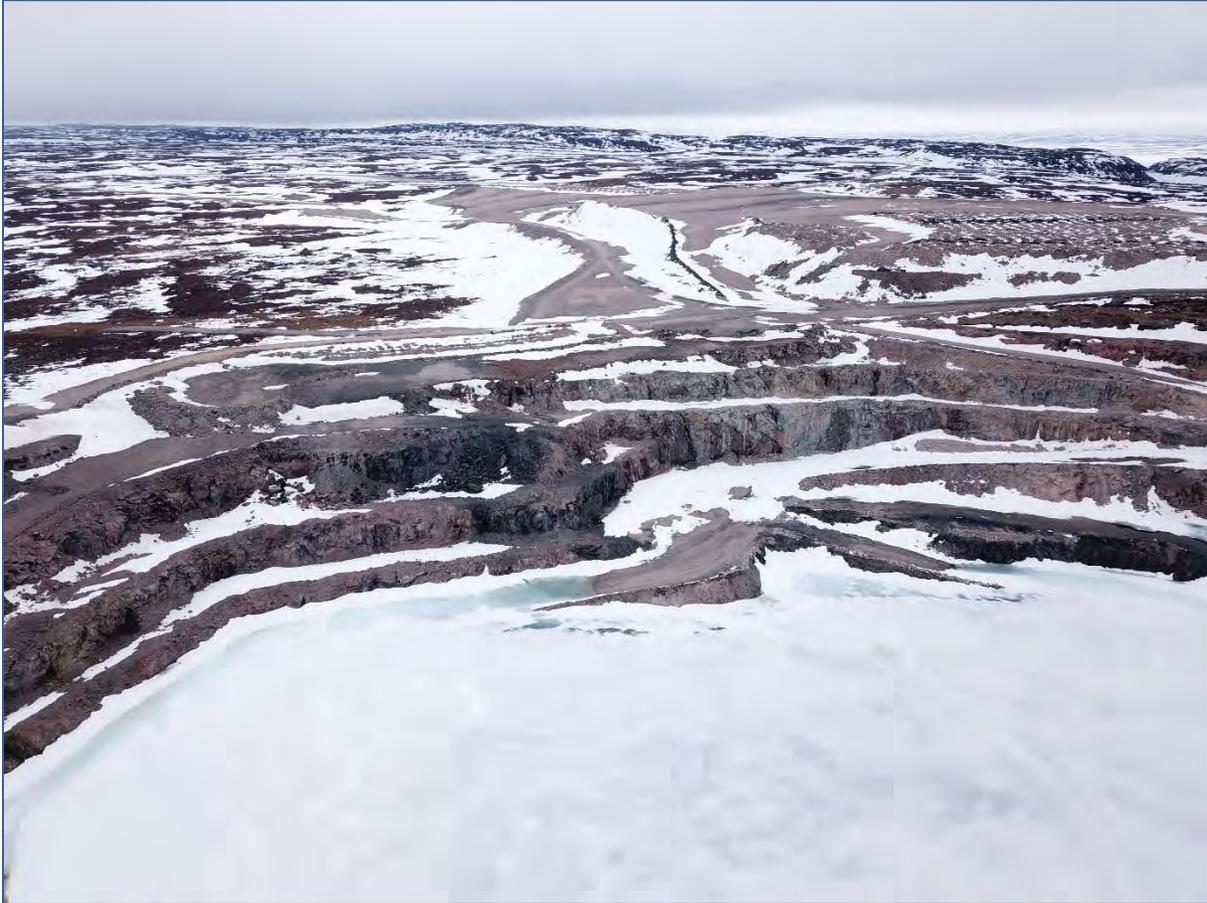
**Photo 32: June 6, 2018 Open Pit – Looking East.**

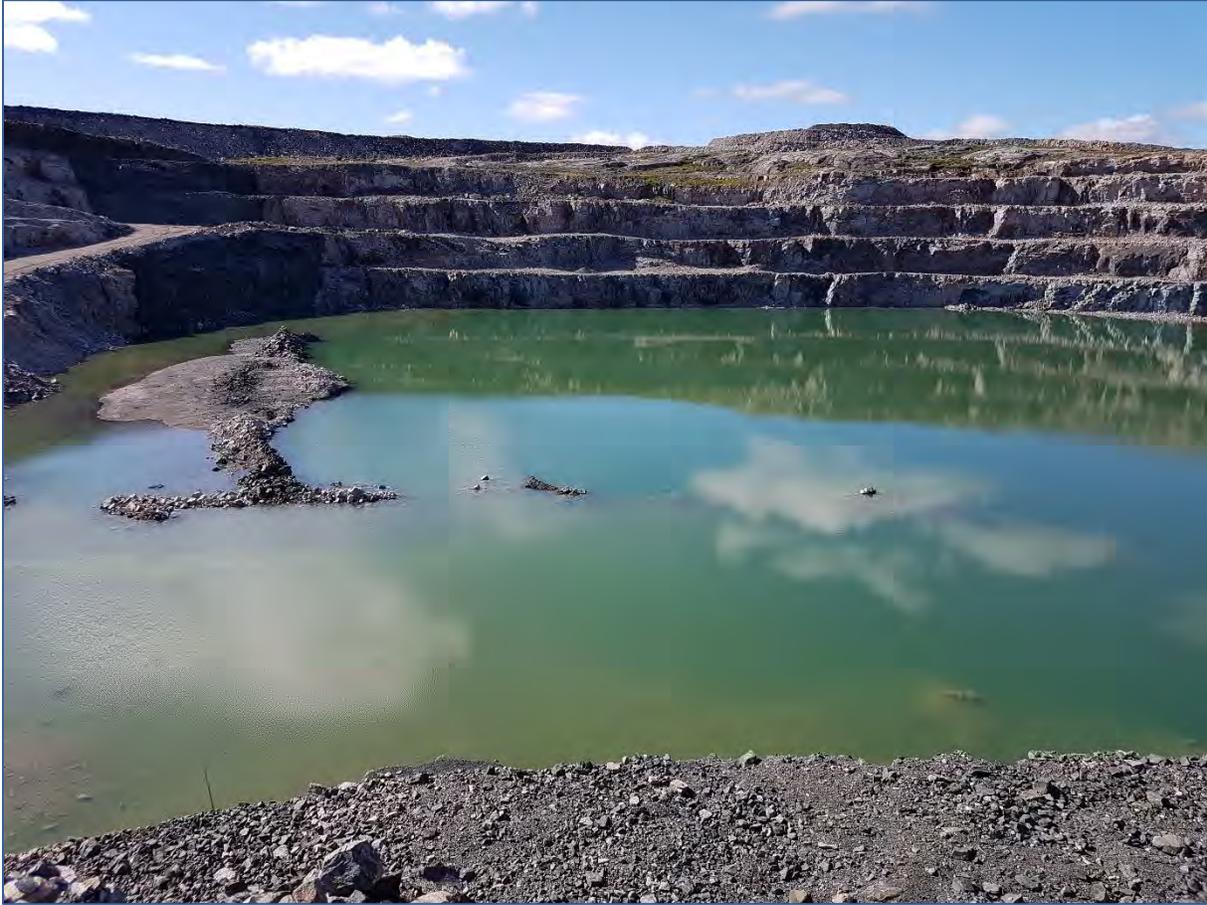
**Photo 33: August 4, 2018 Open Pit – Looking South, Open Pit Water Level.**

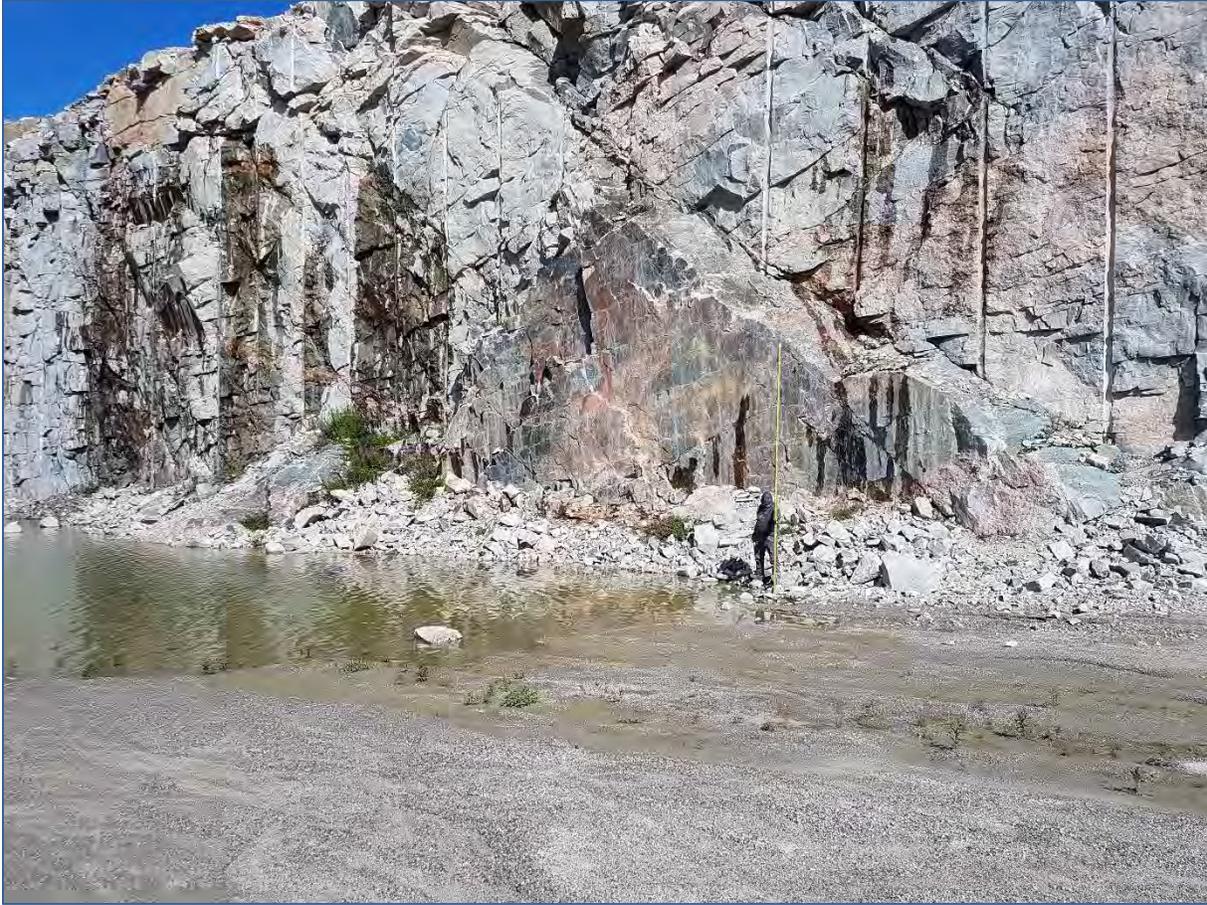
**Photo 34: August 4, 2018 Open Pit – Water Level Survey.**

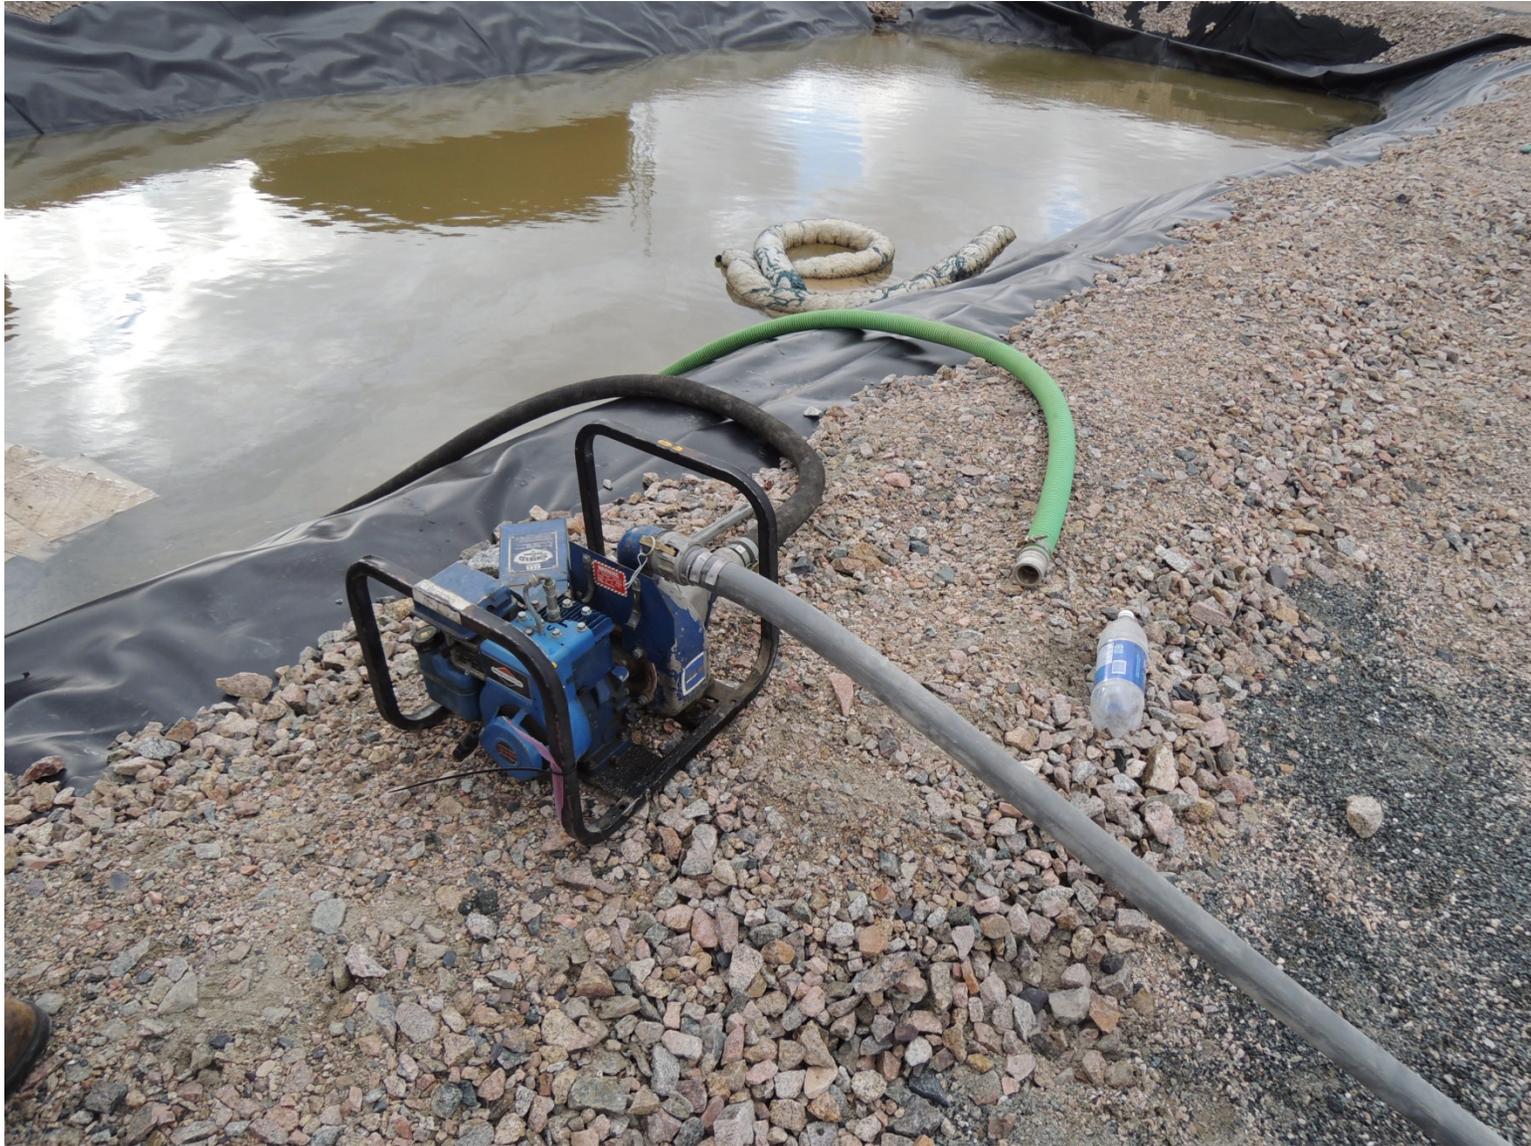
Picture #1 – Pump Setup

- Pumping of water to the pit
    - Removal and storage of residual gravel/sludge and absorbent materials
    - Removal and storage of geomembrane and geotextile

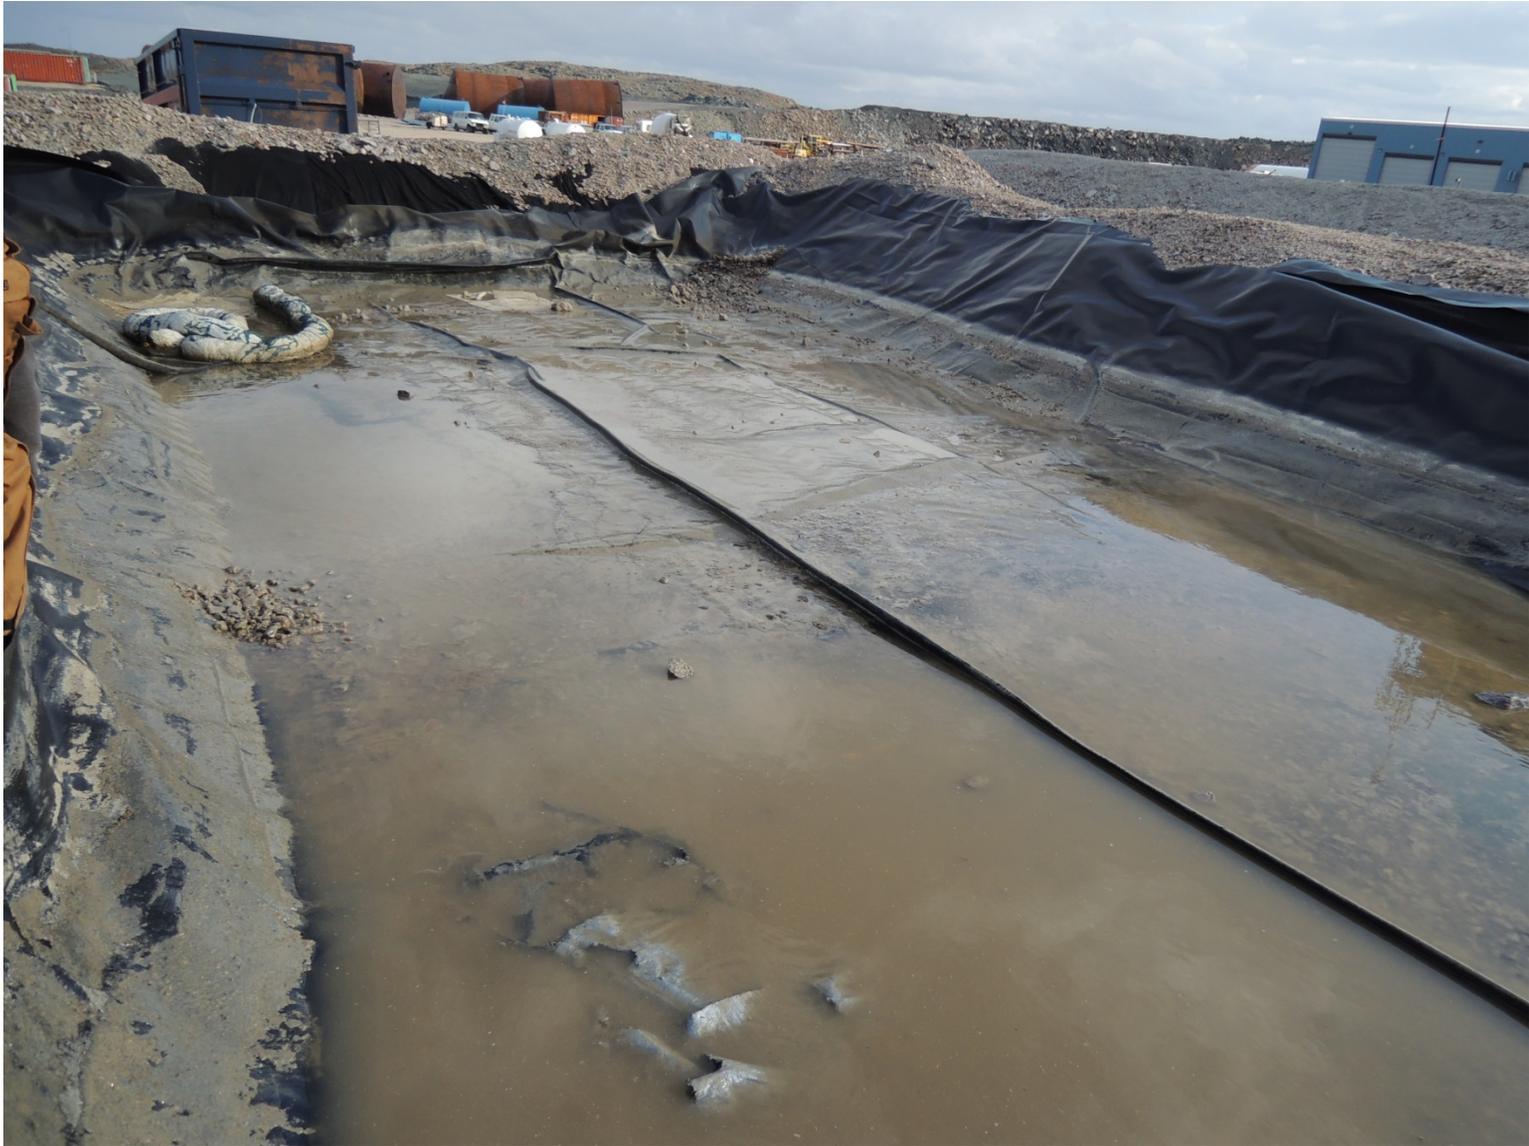
Picture #2 – Majority of Water Pumped
