# **JERICO DIAMOND MINE SITE STABILIZATION PROJECT**

## **NUNAVUT IMPACT REVIEW BOARD FILE #16UN058 2018 ANNUAL REPORT**

**June 11, 2019**

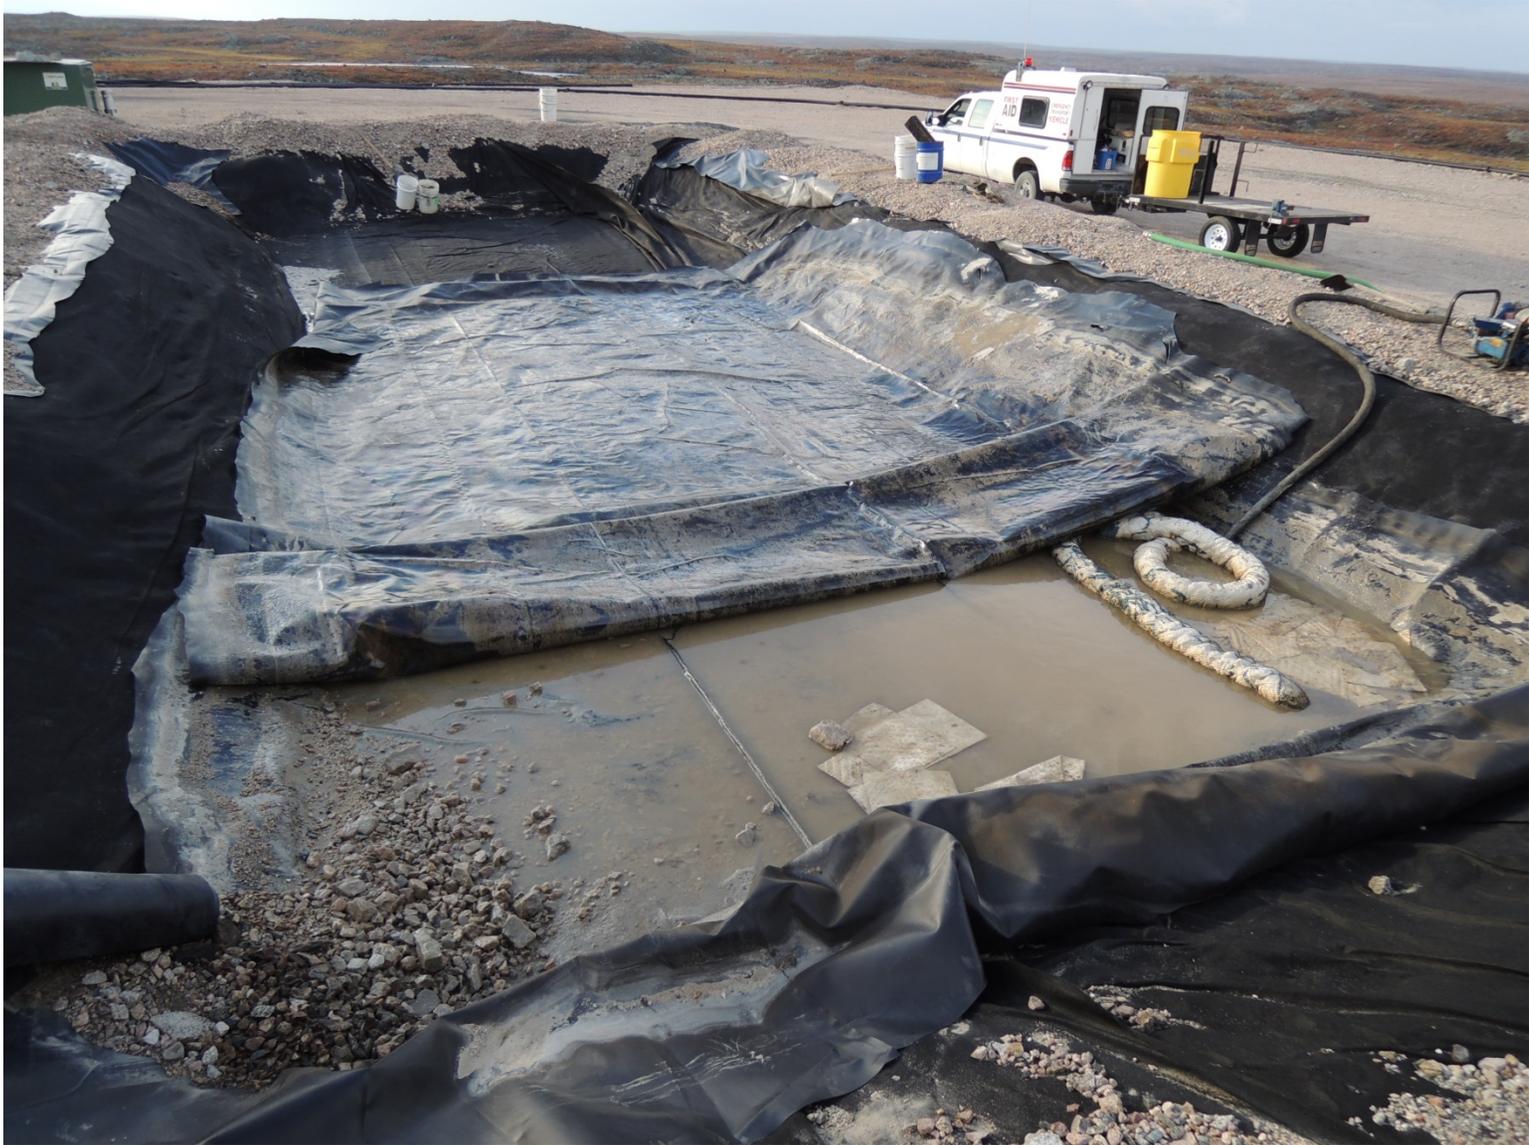
Picture #3 – Peeling Back Geomembrane to Consolidate Water/Gravel/Sludge

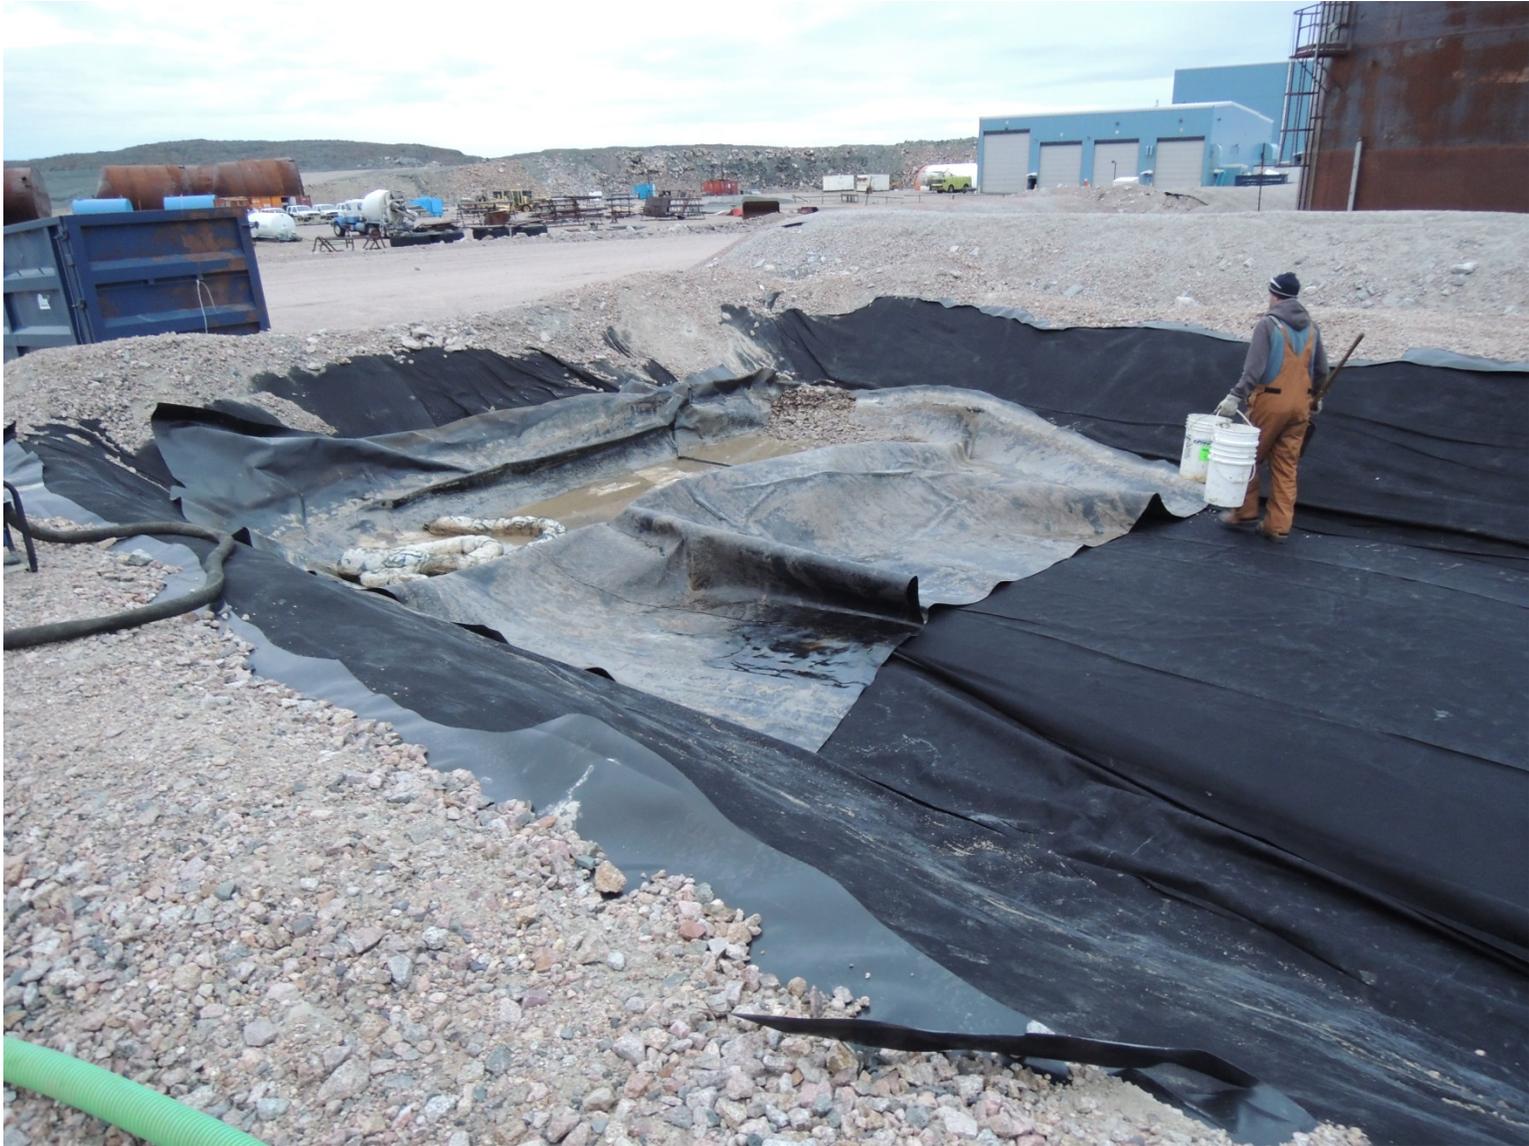
Picture #4 – Removal of Soil & Sludge by Shovel

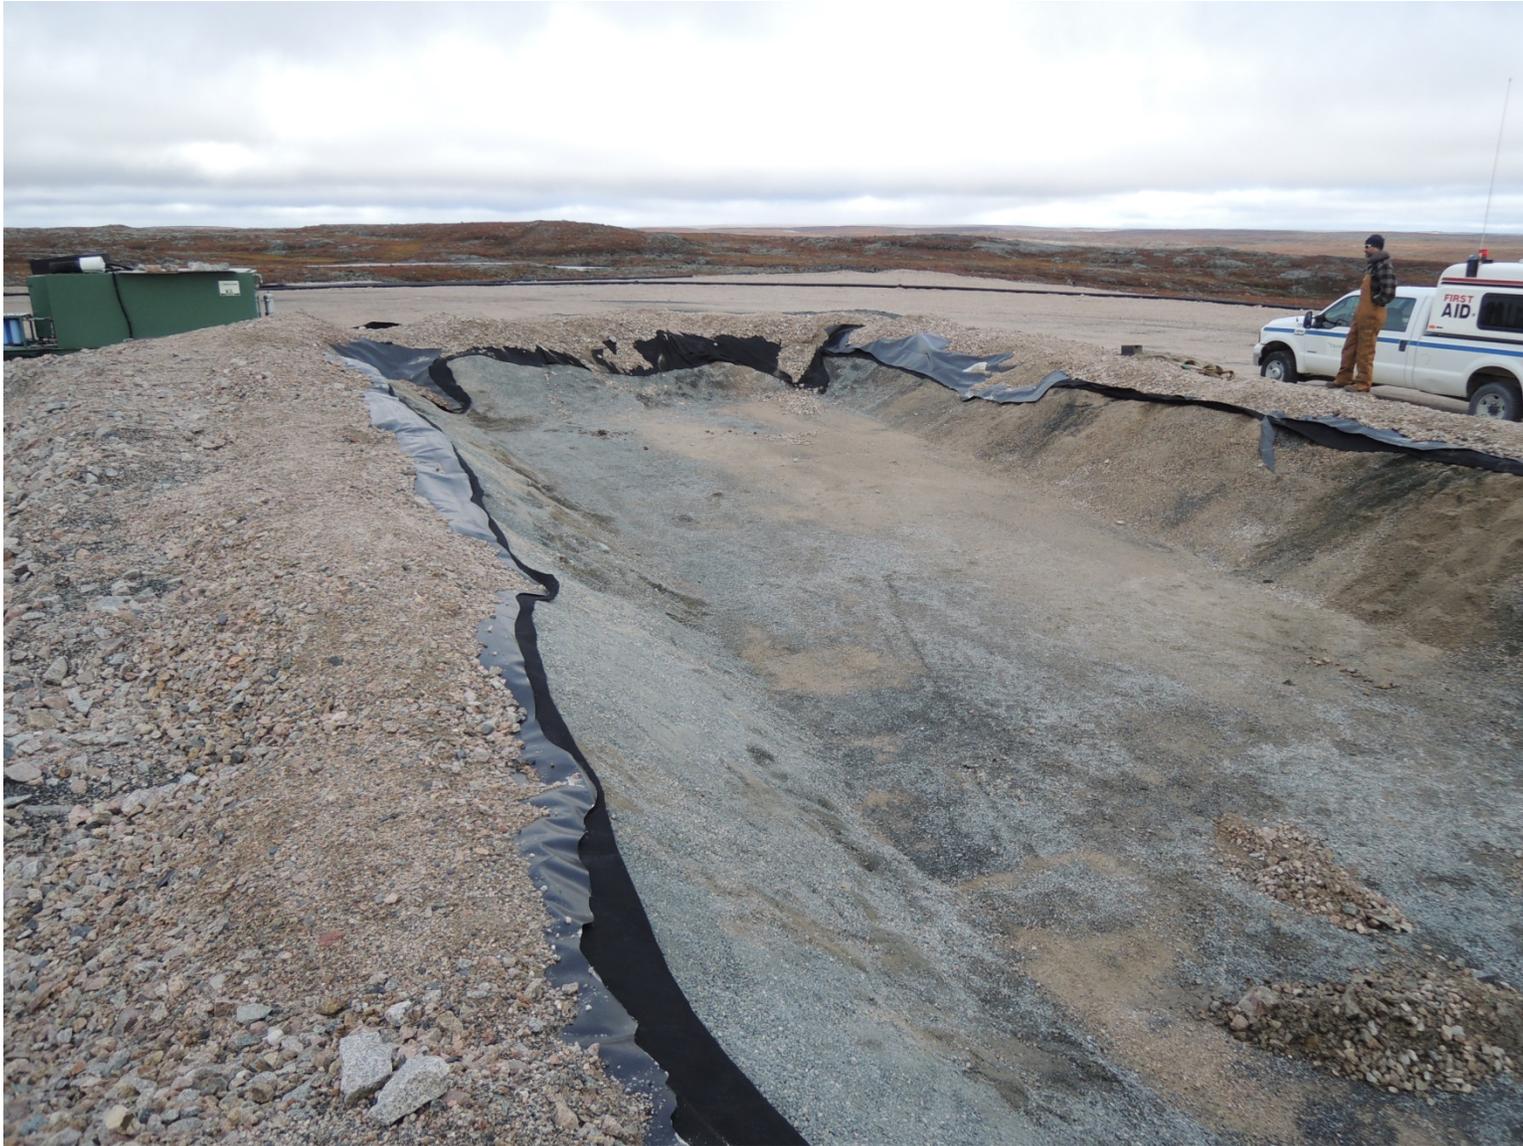
Picture #5 – Both Geomembrane and Geotextile Removed

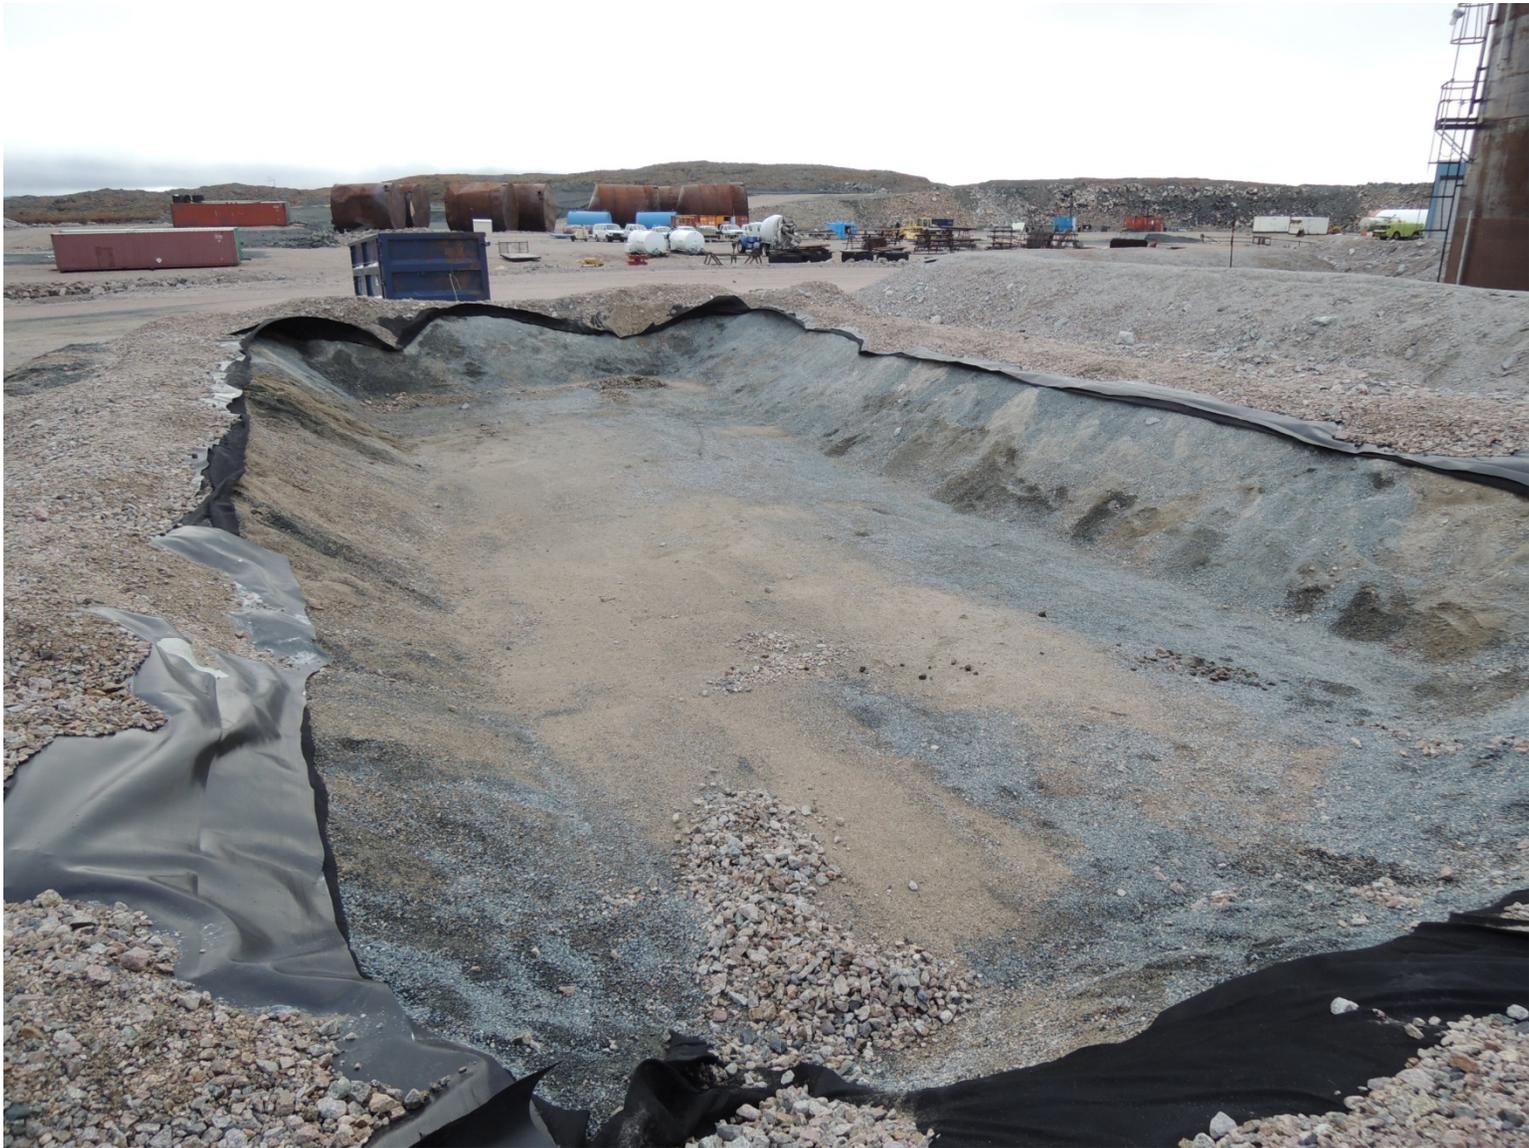
Picture #6 – Final Condition of Bermed Area
