Nunavut Impact Review Board
2019 June Site Visit Report
Jericho Diamond Mine Project
Shear Diamonds (Nunavut) Corporation
NIRB File No. 00MN059

Report Title: The 2019 Site Visit Report for the Nunavut Impact Review Board's Monitoring of the Jericho Diamond Mine Project

Site visit date: June 19, 2019
Previous site visit: June 6, 2018

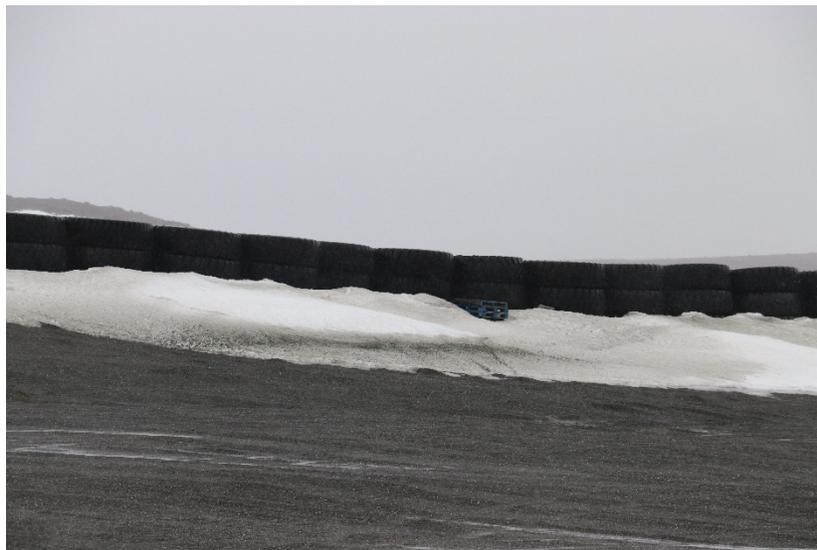
During the 2019 site visit the NIRB staff observed no dustfall monitoring stations. It was evident from visible dust traces in the snow that fine dust particles from the PKCA do not remain entirely within the containment facility. The tire berm (Photo 1) is used to mitigate dust deposition from the PKCA. CIRNAC does not have any formal dustfall monitoring as part of their OMS Plan; however, CIRNAC will be installing a camera facing the PKCA (Photo 1) with a satellite uplink that will monitor the location in real time to ensure that the PKCA course cover has stabilized the area as it was designed to.

Photo 1: Camera-1 View of Tire Berm at PKCA

As previously noted in section 4.2.1, CIRNAC does not have any formal dustfall monitoring as part of their OMS Plan; however, CIRNAC will be installing a camera facing the PKCA (*Photo 1*) with a satellite uplink that will monitor the location in real time to ensure that the PKCA course cover has stabilized the area as it was designed to.

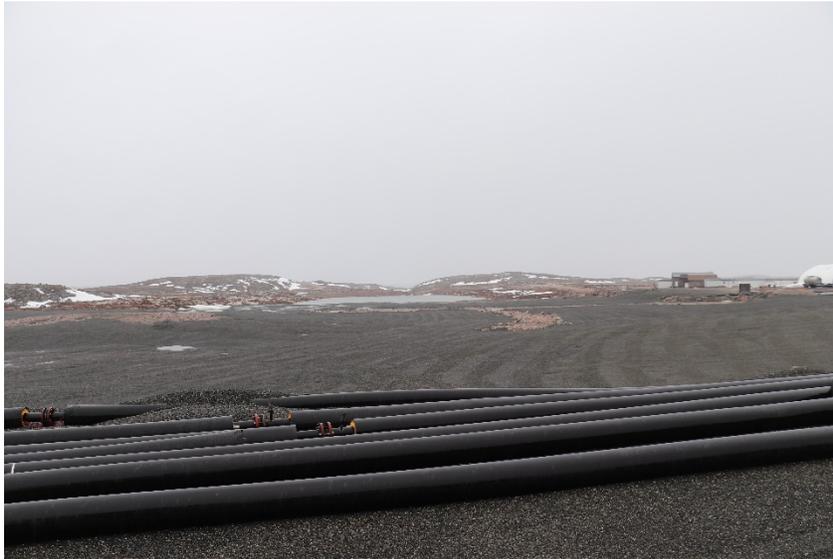
The Monitoring Officer continues to have concerns about future dust dispersion as “*Processed kimberlite tailings weather when exposed to air and break down into finer particle sizes over time. This has implications for revegetation – first moisture retention capacity on tailings is increased, and second reduced resistance of establishing plants to wind and water erosion. Tailings are also highly susceptible to erosion by water, and where the water from side drainages flows across the*

surface erosion is “rapid and progressive”.³ Further observations will be required to ensure short and long-term effectiveness of the coarse kimberlite cover (Photo 2).

Photo 2: Coarse kimberlite cover on PKSA

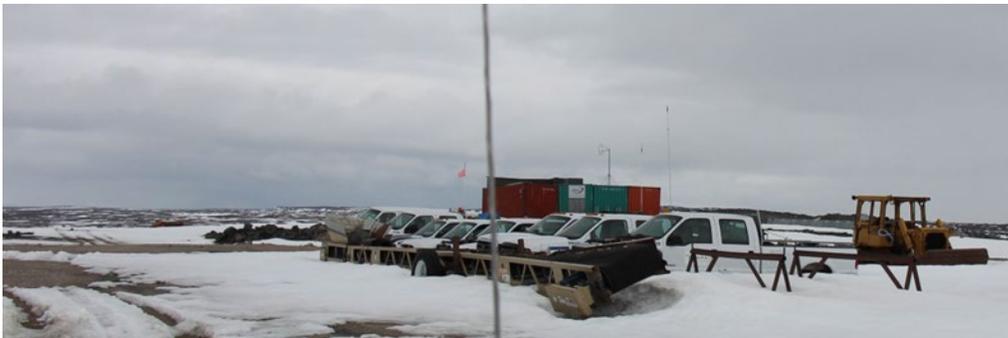
As the site is non-operational, there were no observed noise monitoring or mitigation activities being undertaken related to mining-specific activities. The potential impacts from noise disturbance at the site is low, and in the future will be mainly from aircraft travel to the site for monitoring. The majority of heavy equipment has been removed from the site and only a few working vehicles remain (Photo 3).

Photo 3: Abandoned light duty vehicles (2018)

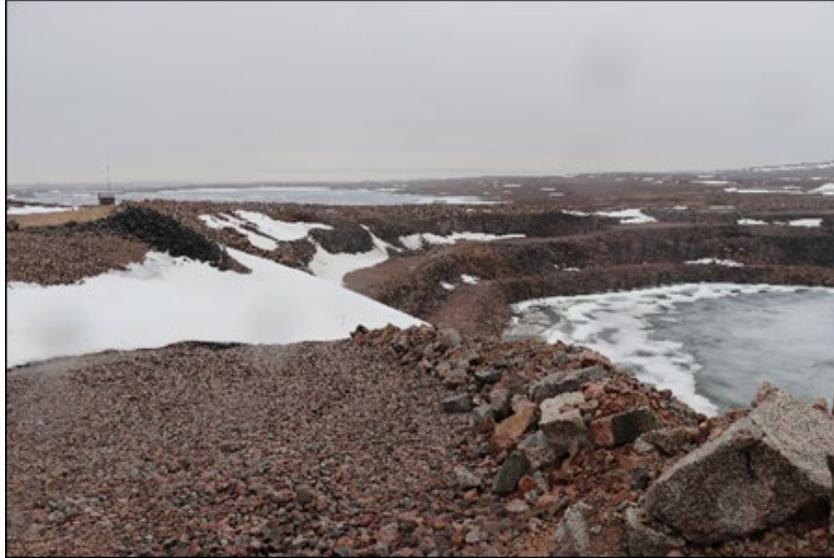
Although the alteration of site features could alter the navigable landscape through the area, NIRB staff did not identify any constraint to movement related to site infrastructure with the exception of the pit. The berm surrounding the pit was intact except for in areas where water management features were being rerouted during stabilization activities (*Photo 4*).

The berm area was not very high or wide and the Monitoring Officer had some concern that there are no caribou deterrent features such as Enokhuk to divert caribou away from the pit area or around the mine site in general.

Photo 4: Berms surrounding Open Pit

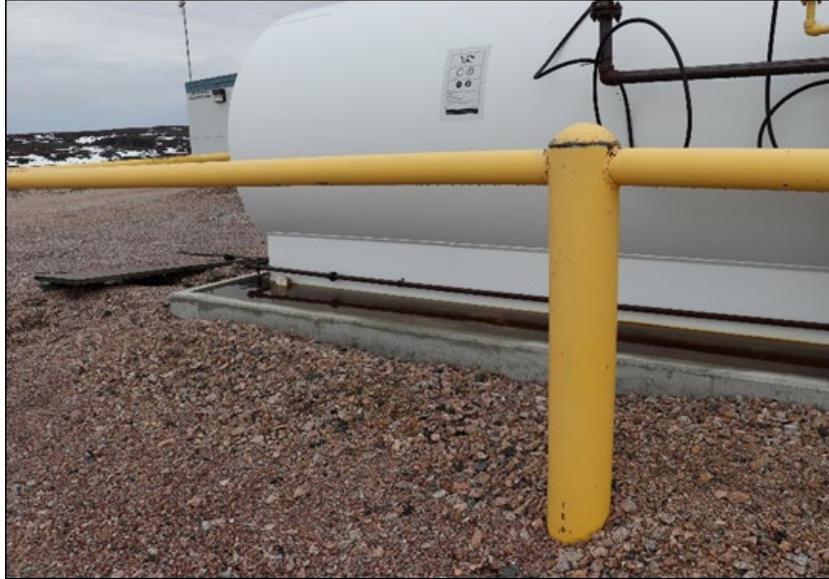
Mining-related blasting activities are not currently being undertaken on-site. During the 2019 site visit the NIRB staff was able to visit the, emulsion plant ([Photo 5](#)) and the magazine ([Photo 6](#)) which are located on Inuit Owned Lands, and that the site did not contain any blasting materials.

Photo 5: Fuel Tank at Emulsion Plant

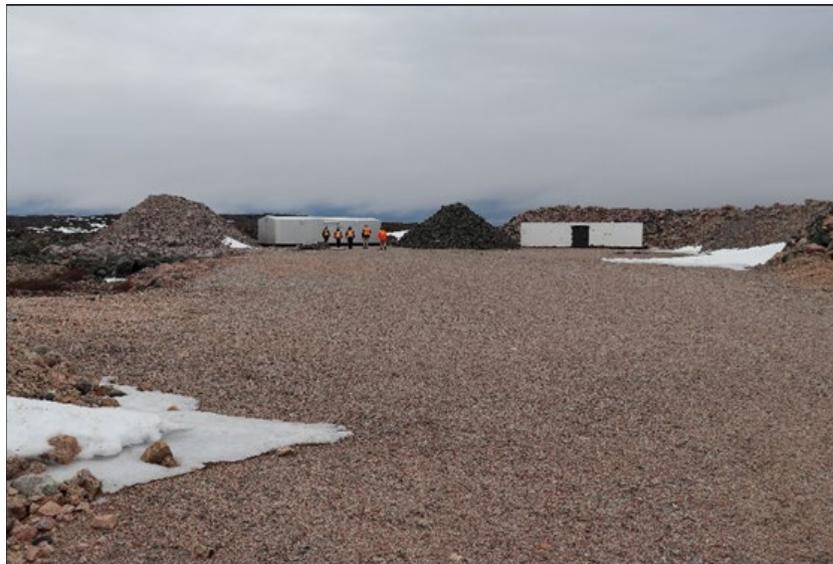
Photo 6: Magazine Storage

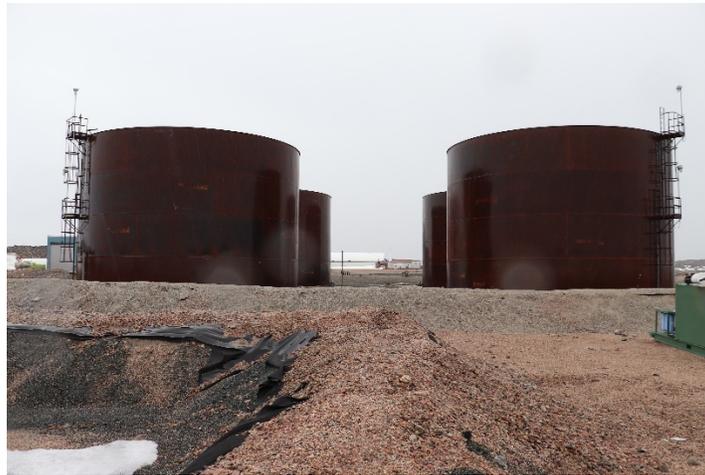
As part of the stabilization activities being undertaken by CIRNAC under NIRB File No. 16UN058, contractors on-site conducted substantial works related to fuel storage areas. Fuel tanks within the Phase I and Phase II fuel tank farm have been purged, cleaned, removed, and are being stored on-site (*Photo 7* and *Photo 8*).

Photo 7: Phase II Remediated Fuel Tanks and Sump

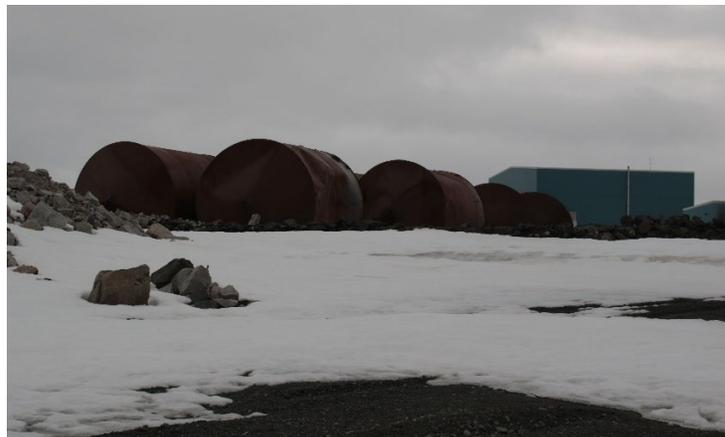
Photo 8: Phase I Remediated Fuel Tanks

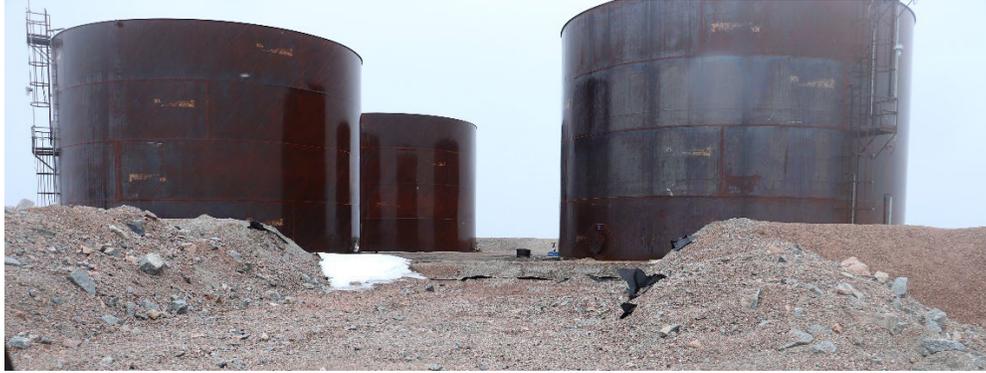
The majority of the berms have been breached to avoid seasonal water accumulation (*Photo 9*).

Photo 9: Phase II fuel tanks with breach in berm

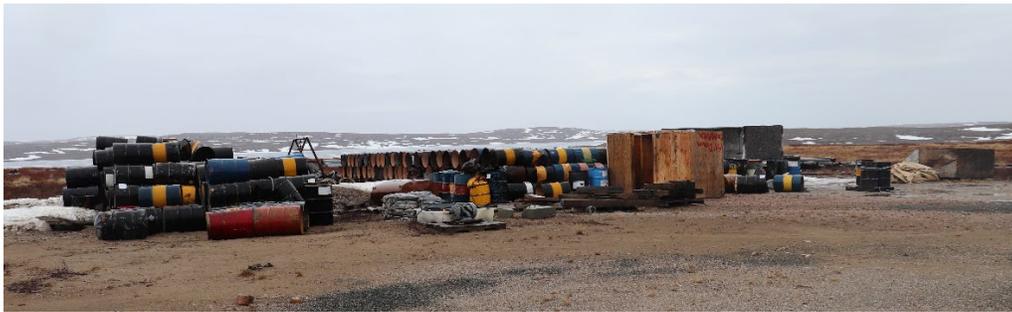
All remaining fuel on-site has been purged and burned off using an on-site incinerator, except for a few drums which are being stored in truck shop building for use when CIRNAC is on site. All drums have been emptied, cleaned, and stacked (*Photo 10*).

Photo 10: Cleaned fuel drums

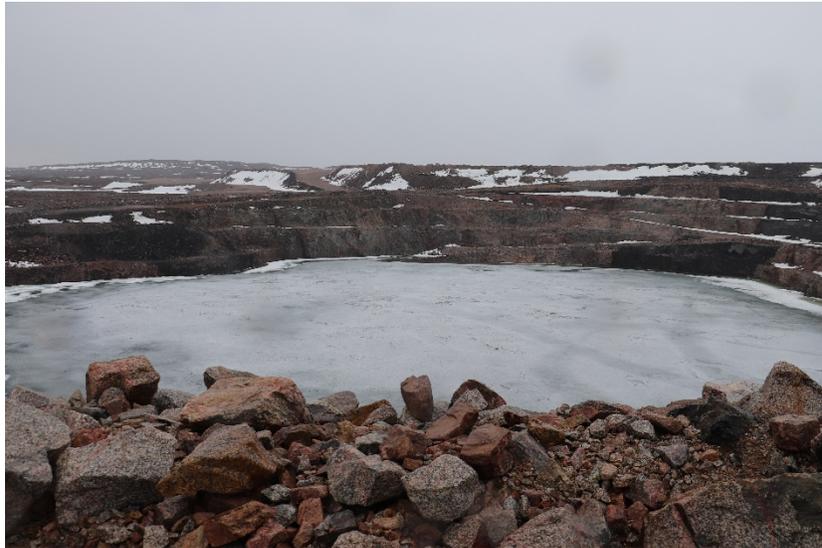
As observed during previous site visits, the water within the open pit continues to rise annually (*Photo 11*). The water level in the pit has risen half a bench level (1.5 to 2 metre (m) based on visual estimate)⁵ from the previous year 2018. As part of the stabilization activities the C1 stream diversion was removed and plugged, the pit side wall was breached and a channel was restored to allow the original natural water flow back to the pit area which would accelerate the pit infill (*Photo 12*). During the site visit there was noticeable erosion of the C1 channel and a waterfall was cascading into pit. Water quality samples are being from the pit but the only water quality parameter being monitored as part of the OMS plan is uranium.

Photo 11: Open Pit

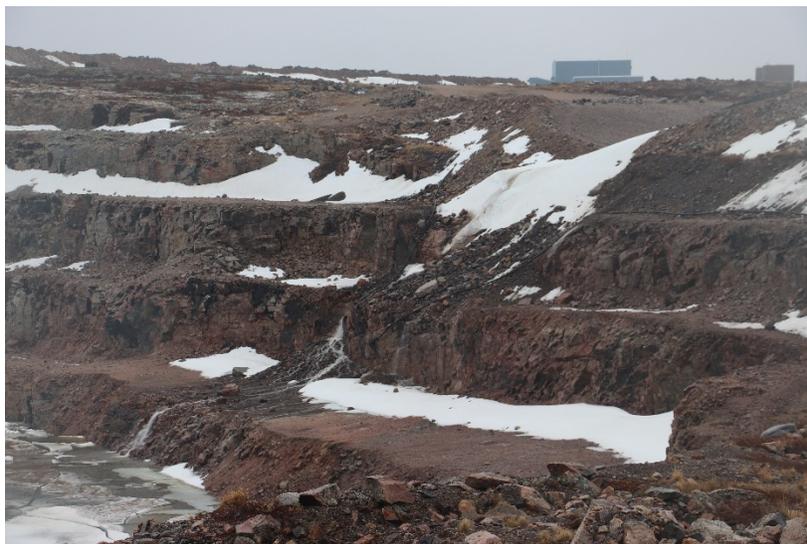
Photo 12: C1 Diversion and waterfall

As part of the stabilization activities approved under NIRB File No. 16UN058, the C1 stream diversion was plugged and removed and the channel was restored to allow the natural water flow back to the pit area ([Photo 4](#) and [Photo 12](#)). This was not a fish bearing stream.

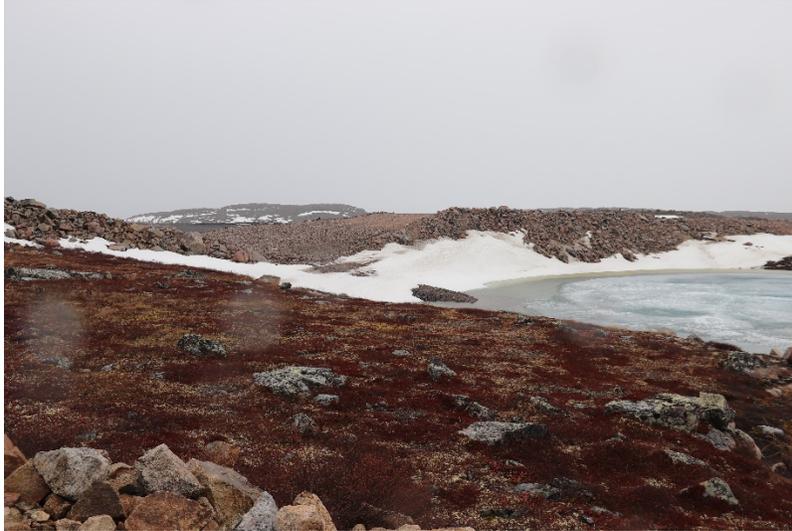
Photo 14: Breach in Divider Dyke A

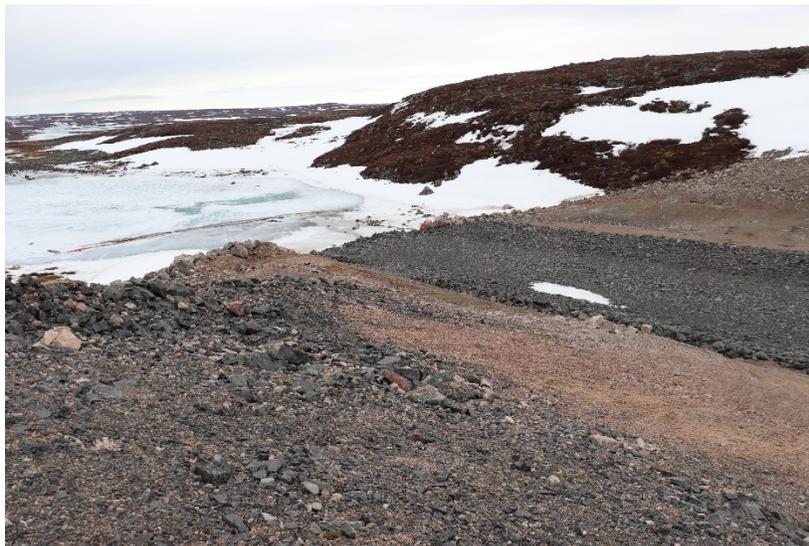
Photo 15: West Dam breach to receiving environment

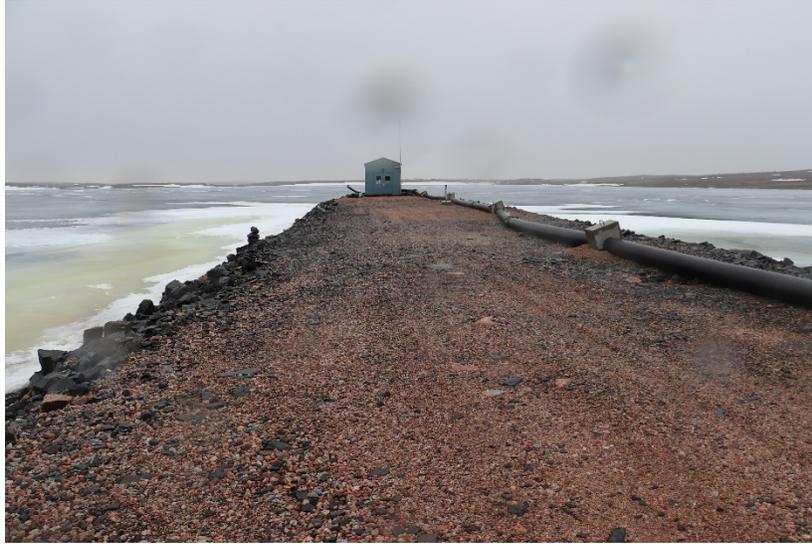
As reported in 2017 under the revised scope of activities approved under NIRB File No. 16UN058, CIRNAC intended to remove the water intake jetty in Carat Lake on behalf of Fisheries and Oceans Canada (DFO) to create additional fish habitat in the area. To date, the jetty has not been altered and the proposed activities will not be undertaken as per the direction from DFO ([Photo 16](#)).

Photo 16: Jetty and water intake in Carrat Lake

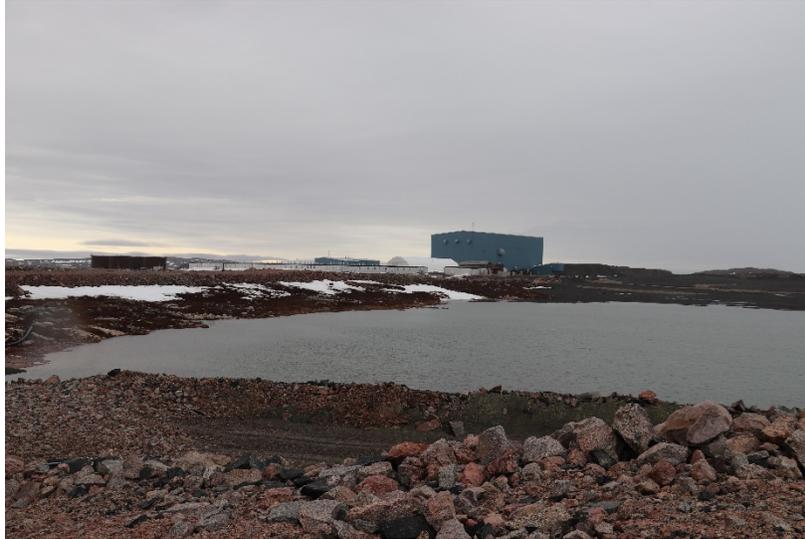
Due to the absence of mining operations and the production of wastewater, the PKCA remains mostly dry. A large pond was observed at the west side of Cell A ([Photo 17](#)) from snowmelt; however, Divider Dyke A is still functioning as a filtration dyke and very little water is expected to flow through the PKCA containment cells B/C into the receiving environment by the West Dam ([Photo 18](#)). Previous water quality testing indicated the water quality met discharge criteria and did not need to be treated. The OMS plan has no future water quality monitoring planned at the West Dam prior to water being allowed to discharge into the receiving environment.

Photo 17: Cell A standing on Dyke A

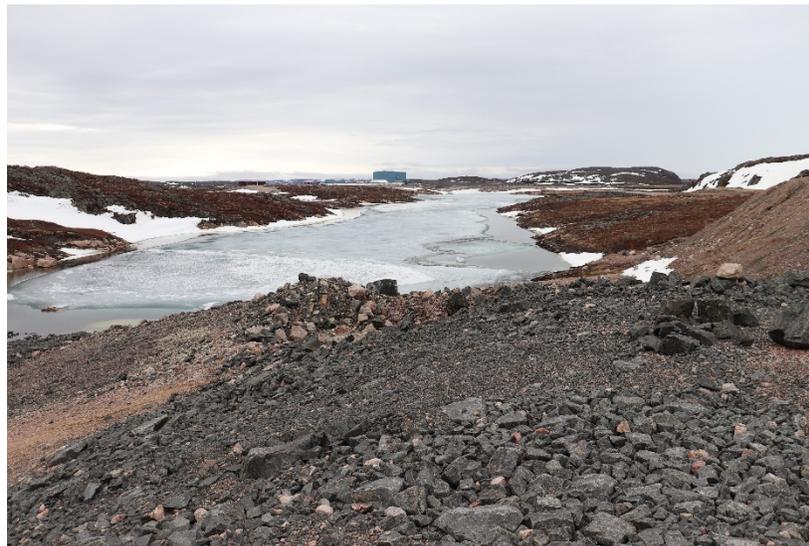
Photo 18: West Dam Cell B/C looking east toward process plant

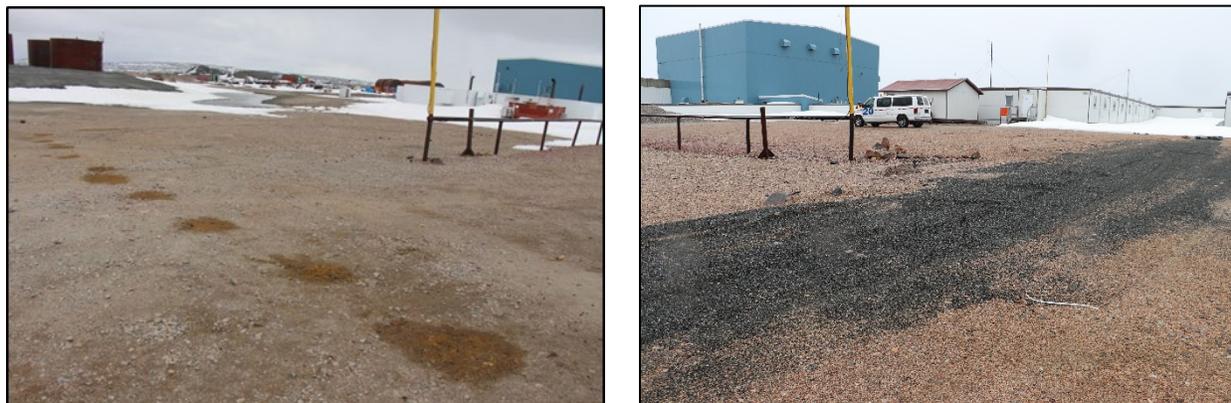
In 2018 at the contractor's temporary camp location, the Monitoring Officer observed a trail of 11 spills of unknown origin, electrical cords, and miscellaneous materials left behind. During the

summer of 2018 the spills cleaned up (*Photo 19*) and any remaining materials were removed and this was confirmed by NIRB staff in 2019.

Photo 19: before (2018) and after (2019) clean up of spill
