**RE: Follow up to NIRB 2019 Summer and Winter Site Visits, Findings and Recommendations**

### **Baffinland Responses to NIRB 2019 Site Visit Findings and Recommendations**

**Table 1 – Baffinland Responses to NIRB Finding and Recommendations - Winter and Summer 2019 Site Visit**

**Baffinland Follow-Up Photos**

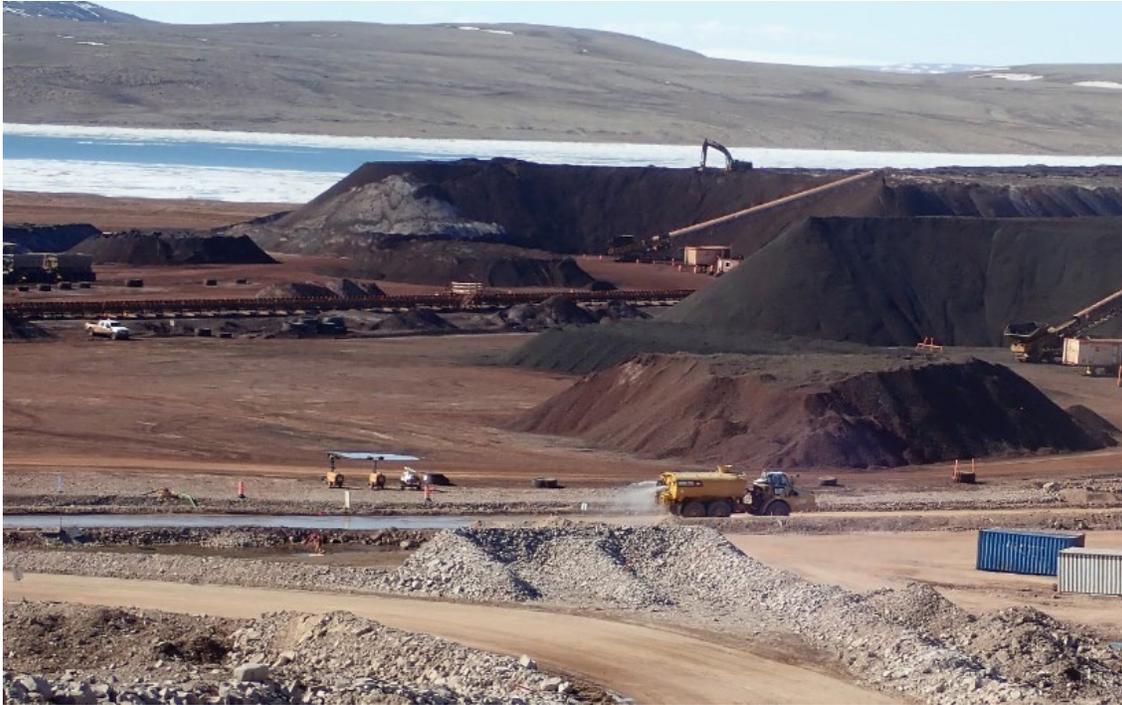
**PHOTO 1** – Dust Suppression Application along Project Roads

#	Site Inspection	Project Location	Description of Concern or Finding	Recommended Action	Response	Update from August 26, 2019 Submission to NIRB
1	Summer	Mine Site / Milne Port / Tote Road / Mine Haul Road	Dust deposition on Project Roads and dust generation at site.	Update on mitigations implemented to minimize dust deposition. Provide update on dust stop trial. Continued application of dust suppressant.	<p>Baffinland is committed to controlling dust sources on the Project. This has included continual development of new dust suppression alternatives at Milne Port, including ore pad redesign to position fines in the centre and lump ore around the margins, installation of downwind fencing and proper positioning of the conveyors to minimize distances when stock piling. Additional shrouds were also installed at the Mine Site crusher in 2019 and is actively considering and/or implementing new methods for reducing dust generation through reengineering of equipment designs to minimize dust generation.</p> <p>Calcium Chloride and water has also been applied on road surfaces throughout the history of the project to mitigate dust emissions. After discussions with Stakeholders and regulators in 2018, the Project actioned an implementation plan for testing new dust suppression products with increased durability and longevity for site infrastructure. Dust Stop, produced by Cypher Environmental and an approved product for dust suppression under Nunavut’s Environmental Guideline for Dust Suppression on unpaved Roads was elected for trial and road application. Dust Stop is environmentally friendly, and is expected to have a longer lasting durability for both traffic and rainfall impact, as it promotes a hard, competent water repellant surface when properly applied. A micro trial of Dust Stop was performed in August 2019 from km 103.5 - km 97 on the Mine Site and Tote Road to determine efficacy of the product on site. Improved dust suppression was observed throughout the application zones and the product also showed signs of water shedding during rain events supporting improved road sealant and application lifespan.</p> <p>Photos taken during the August 2019 micro-trial have been provided in Attachment 2.</p>	Results of the micro-trial indicate that Dust Stop is a successful and feasible alternative for dust management along Project roads. Subsequent to this, Baffinland has an available 720 totes (1000 L) of Dust Stop on site, which will be applied in spring of 2020 with fresh gravel. Results show that it will remain in place for most of the summer season, assuming routine maintenance after initial application. An additional order will be made for resupply on the 2020 sealift pending ongoing review of effectiveness.

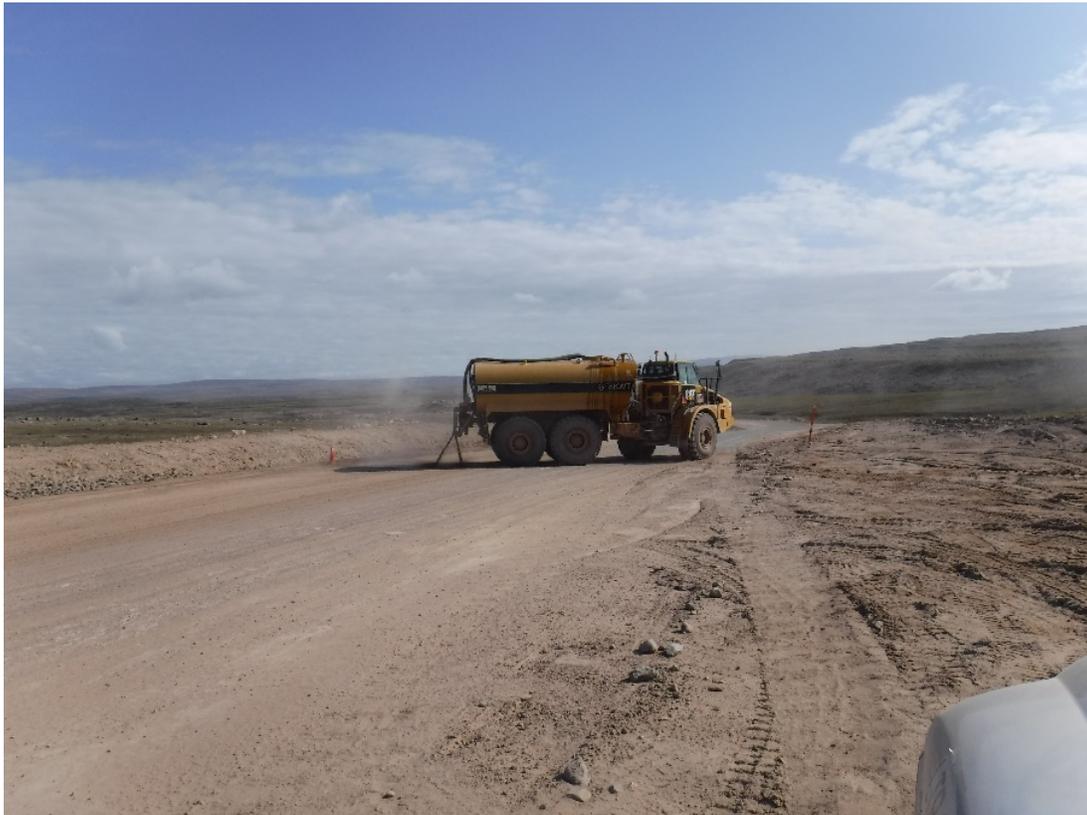
**PHOTO 2** – Dust Suppression Application along Project Roads

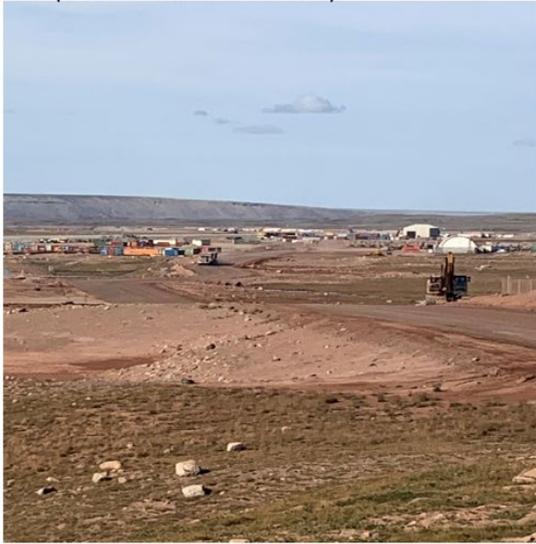
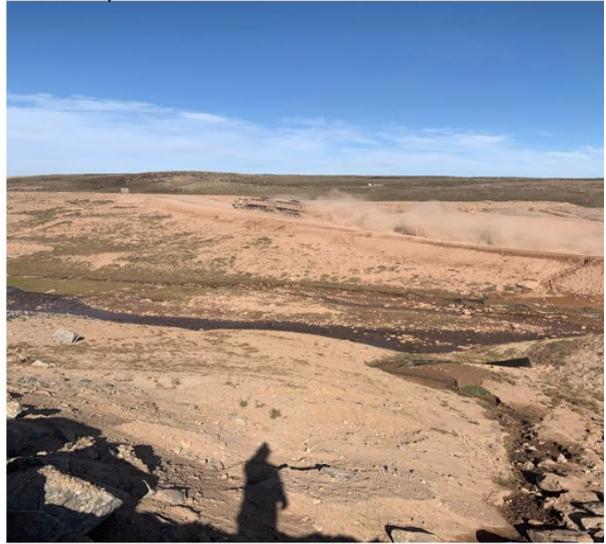
Long range visual-TREATED- Minimal dust off OHT (24 hours after treatment)

Long range Visual- UNTREATED- Visual dust off OHT at KM100 dip northbound

**PHOTO 3 and 4** – Long Range Visual of Treatment Area Post-Trial

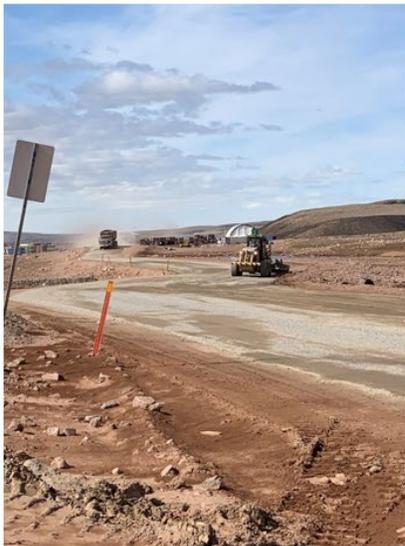
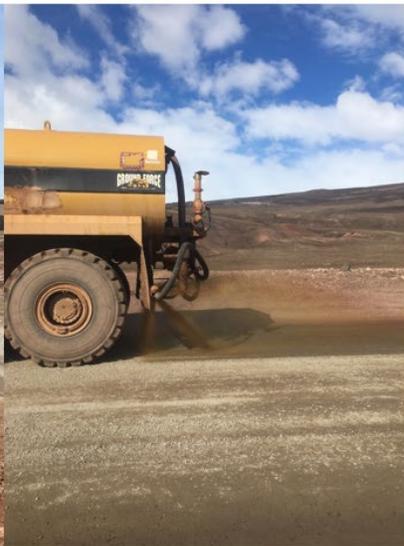
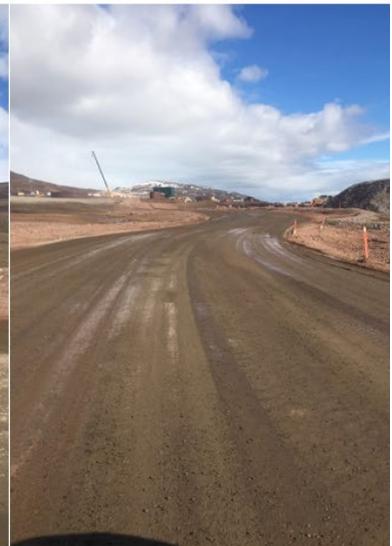
Fresh gravel laid out

Pressurized application of DSMB

Product applied – full coverage

**PHOTO 5, 6 and 7** – Photos Taken During August 2019 Dust Stop Trial

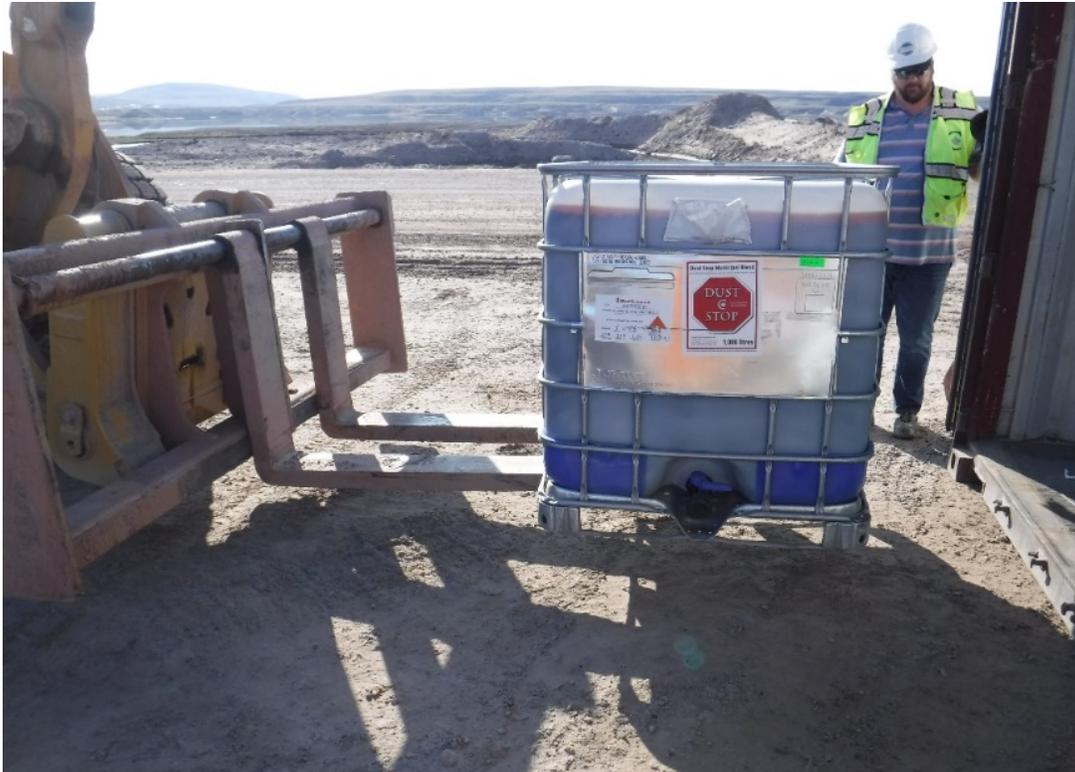
**PHOTO 8 – Dust Stop Tote**

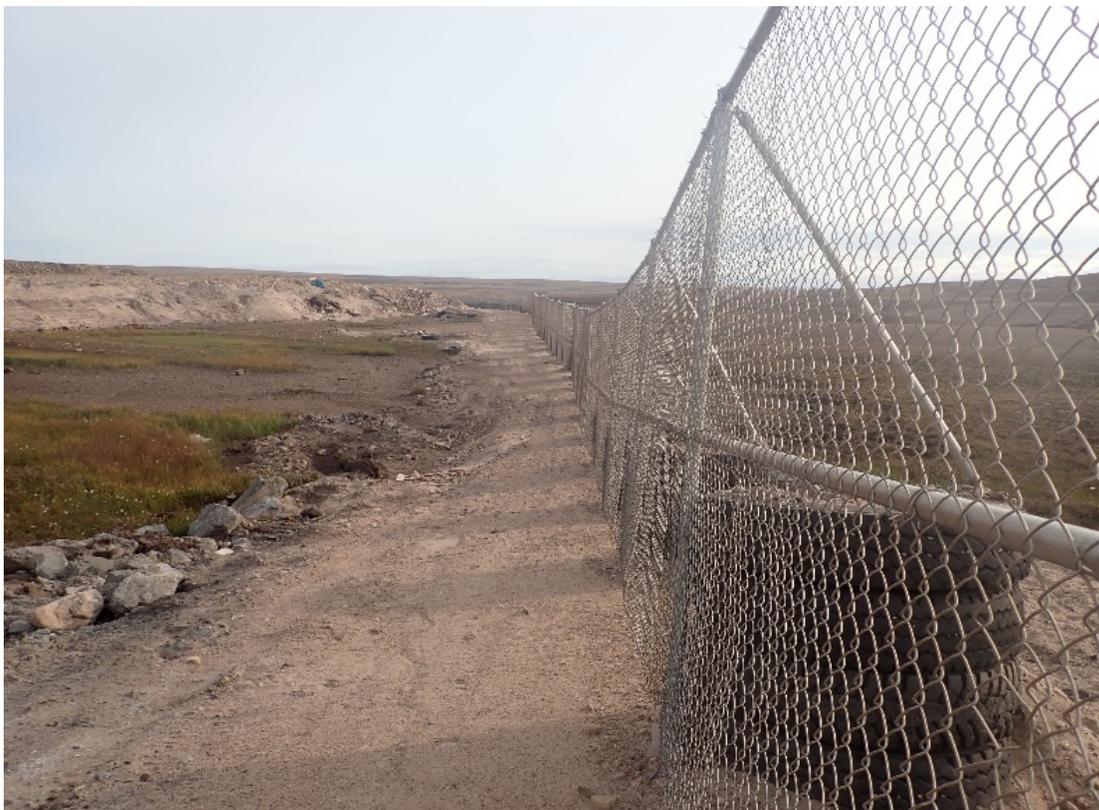
**PHOTO 9 – Existing Fencing at Landfill**

3	Winter and Summer	Mine Site / Landfill	Landfill fence does not completely surround active landfill areas. More cover material required on top of current layer and west side.	Develop detailed action plan for landfill fence construction that surrounds entire action landfill area.	<p>Baffinland is committed to managing the Mine Site Landfill as per the approved Waste Management Plan. After discussions with NIRB, a fence was installed on the west side of Cell 1 to address concerns of potential wind-blown debris sourcing from the landfill to the Tundra from prevailing winds. Baffinland erected a litter capture fence in the fall of 2018 installing approximately 275 metres of fence on the downwind side of the landfill. The fence also repurposed over 800 used tires as part of Baffinland's used tire disposal and recycling initiative. The fence currently captures windblown debris from the landfill effectively.</p> <p>An additional 405 metres of Landfill litter fence was ordered by Baffinland for delivery on the 2019 sealift. The fence will be erected to further mitigate the potential for wind-blown debris impacting the tundra that the prevailing winds fence was not already capturing.</p> <p>Figure 1 (Attachment 3) shows the plan to enclose the current working space of the landfill by the end of Q4 2019.</p>	<p>Contractors procured for work are scheduled to arrive on site in October to complete the enclosure of Cell 1 and 2.</p> <p>Images depicting preparatory work completed at landfill in advance of fence installation have been included in Attachment 2.</p>

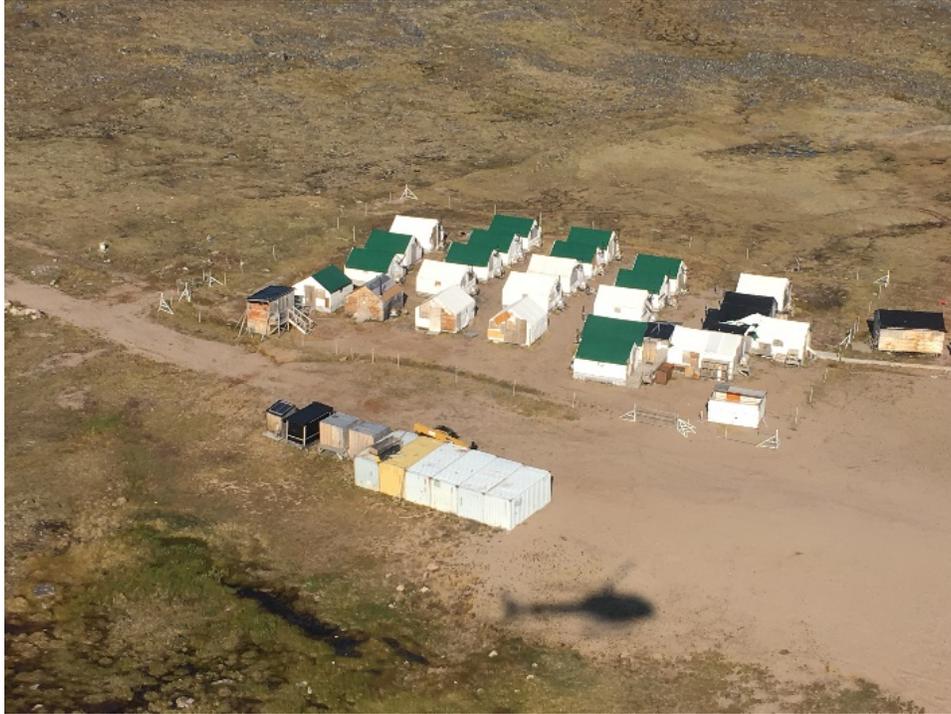
**PHOTO 10** – Steensby Camp Post- August Site Clean Up

#	Site Inspection	Project Location	Description of Concern or Finding	Recommended Action	Response	Update from August 26, 2019 Submission to NIRB
4	Summer	Steensby	General maintenance and clean-up of site.	General site clean-up required.	<p>In 2016 Baffinland performed a major sealift operation at Steensby that removed hazardous substances, heavy equipment and camp modules.</p> <p>Following NIRB's Site Visit in August, Baffinland performed a general cleanup of windblown debris and potential hazards to the Tundra and completed critical repairs to weatherhaven tents to minimize future dispersion of materials in the general area (see photo in Attachment 2).</p> <p>Baffinland will continue to run its annual end of year clean-up of the Site and may consider backhauling the weatherhaven tents, if feasible, in 2020.</p>	No further update required.
5	Winter and Summer	Mine Site / Waste Management Building	Waste Management building. Excess garbage present, fluids on the ground and oil dispensing system needs shelving or frame.	Overall clean up and organization of waste management building	<p>As part of Baffinland's approved Waste Management Plan, waste management buildings are used to store, segregate and sort all kinds of waste on the Project Site. The structures are concrete floor secondary containment buildings with built in sump systems which water is processed from. When waste is actively processed and sorted in these buildings it can appear visually unappealing however this is the intent and function of the buildings and is consistent with Baffinland's Waste Management Plan.</p> <p>Weekly waste retention structure inspections are performed to consistently identify improper waste sorting practices and resultant corrective actions. It was noted during the NIRB visit in August 2019 that fluids were present on the concrete floor sourcing from the lube and oil station. All fluids impacting the floor have been cleaned up and tertiary containment has been installed under all totes and sources of leaks.</p>	No further update required.

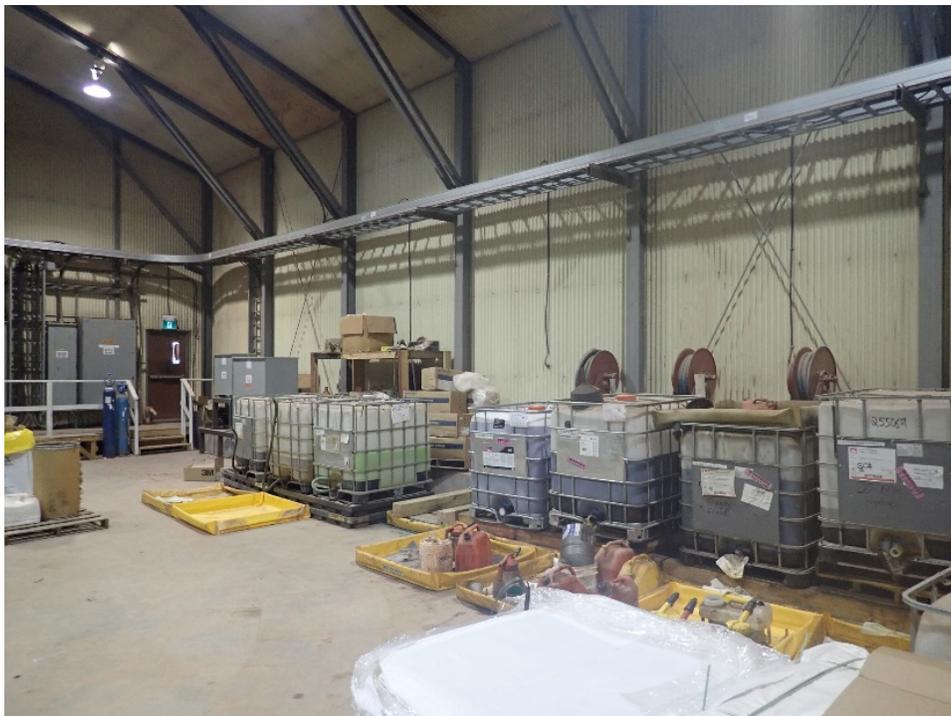
**PHOTO 11** – Waste Management Building Post-August Clean Up and Installation of Tertiary Containment Under Totes

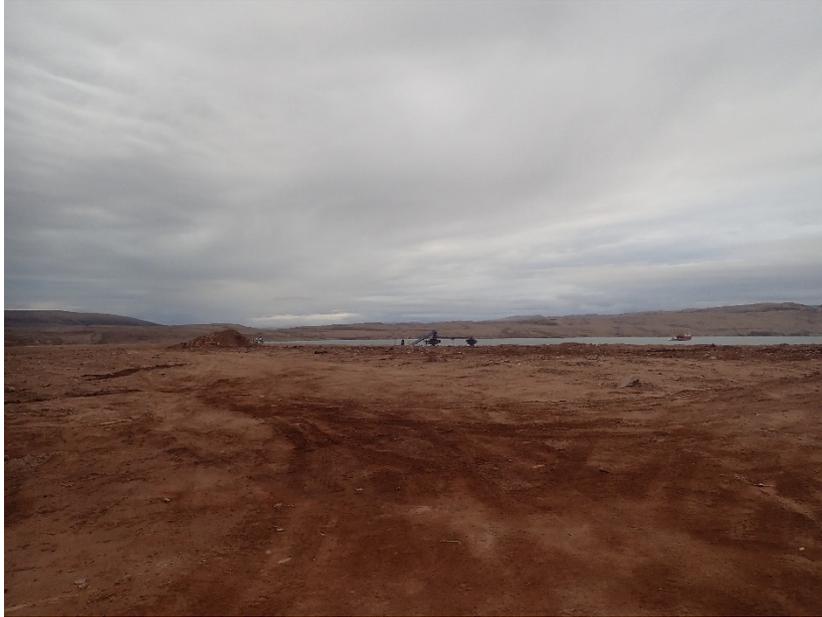
**PHOTO 12** – Ongoing Clean-Up of Plastics at Milne Port Land Farm

#	Site Inspection	Project Location	Description of Concern or Finding	Recommended Action	Response	Update from August 26, 2019 Submission to NIRB
9	Winter and Summer	Milne Port / Landfarm	Remaining buried plastic in Landfarm.	Need to remove plastics in landfarm as more is tilled to surface.	NIRB has noted that light plastics continue to present in the Milne Port Landfarm a lined engineered containment facility. The plastics in the Landfarm are actively cleaned up and removed on an annual ongoing basis. Active tilling to remediate contaminated soils in the Landfarm regularly unearths plastic to the surface which are then subsequently cleaned up and removed. Remediated soil from the containment facility will not be removed with any liner. Baffinland will continue to remove plastics from the Landfarm on an annual basis and maintains that the plastics do not impact functional efficacy of the containment facility.	<p>The Milne Port Landfarm facility was designed in accordance with Environment Canada's Federal Guidelines for Landfarming Petroleum Hydrocarbon Contaminated Soils to ensure both the protection of the environment and the health and safety of all personnel. The layout of the landfarm consists of a lined, containment area for stockpiling and remediating contaminated soils. During the recent inspection, NIRB had noted that light plastics continue to be present in the Milne Port Landfarm. The plastics in the Landfarm are actively cleaned up and removed on an ongoing basis to ensure overall effectiveness of landfarming is not impacted. Active tilling to remediate contaminated soils in the Landfarm unearths plastic to the surface which are then subsequently cleaned up and removed. Since August 2019, Baffinland has conducted additional plastics removal at the facility. Baffinland will continue to remove plastics from the Landfarm on an annual basis and maintains that the plastics do not impact functional efficacy of the containment facility.</p> <p>Additional pictures depicting further clean-up efforts in mid-September 2019 have been included in Attachment 2.</p>

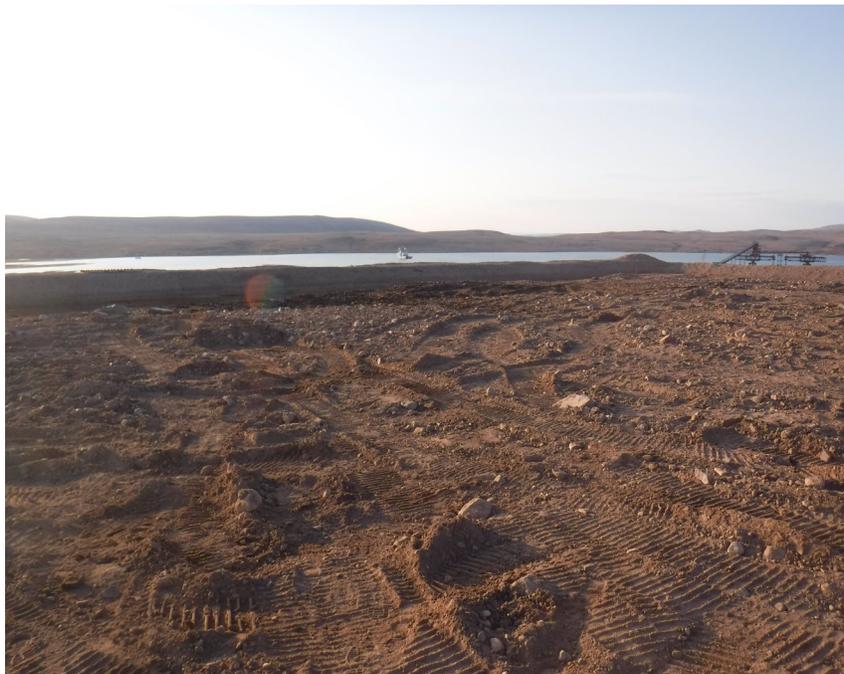
**PHOTO 13** – Mine Port Land Farm: Post 2nd Mid-September 2019 Clean-Up

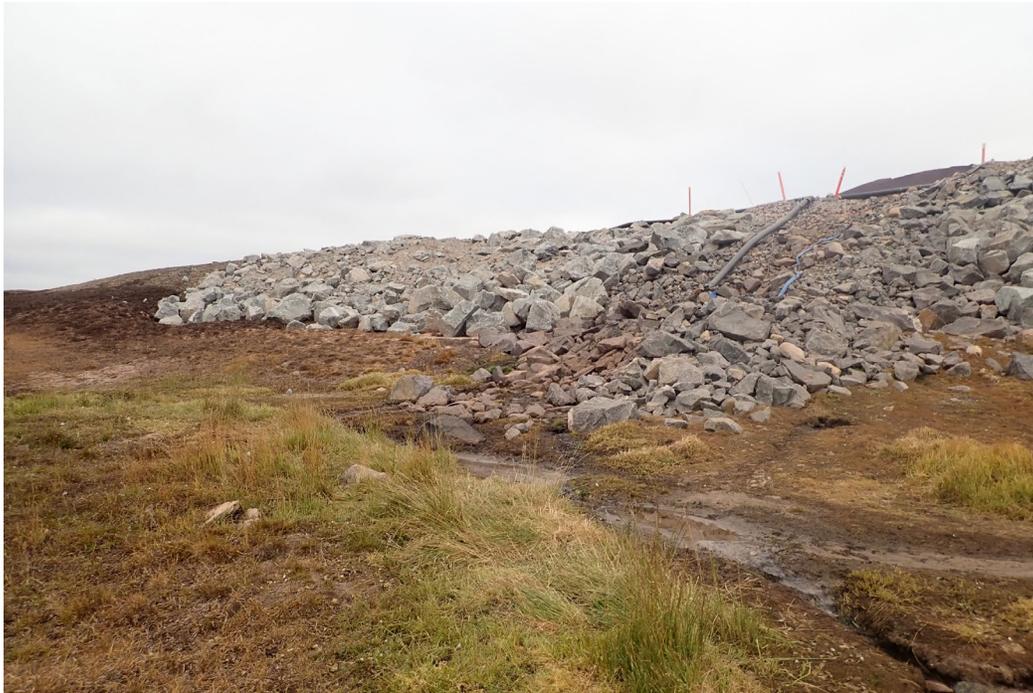
**PHOTO 14** – Remediation at Sewage Outfall Area

#	Site Inspection	Project Location	Description of Concern or Finding	Recommended Action	Response	Update from August 26, 2019 Submission to NIRB
8	Winter and Summer	Mine Site	Effluent line erosion present.	Need to add armour/rip rap to slope that has stability issues	<p>It was noted during the 2018 NIRB visits that erosion of a tundra bank nearby to the Mine Site Waste Water Treatment Plant effluent outfall location was occurring. This erosion has been evaluated by geotechnical inspectors on a bi-annual basis since its identification. Results of these inspections have determined that the erosion is not a concern for stability of the outfall laydown pad. It is also noted that this erosion is naturally occurring and has not been impacted or influenced by effluent as it segregated from the outfalls.</p> <p>Baffinland has however, committed to remediating the natural erosion occurring with armour and rip rap stone so that further slope erosion does not occur by the end of September.</p>	<p>Identified area has been remediated with armour rock and rip rap to ensure slope stability and will continue to be part of the bi-annual geotechnical inspections.</p> <p>Images showing the results of remediating the natural erosion with armour and rip rap stone have been included in Attachment 2.</p>

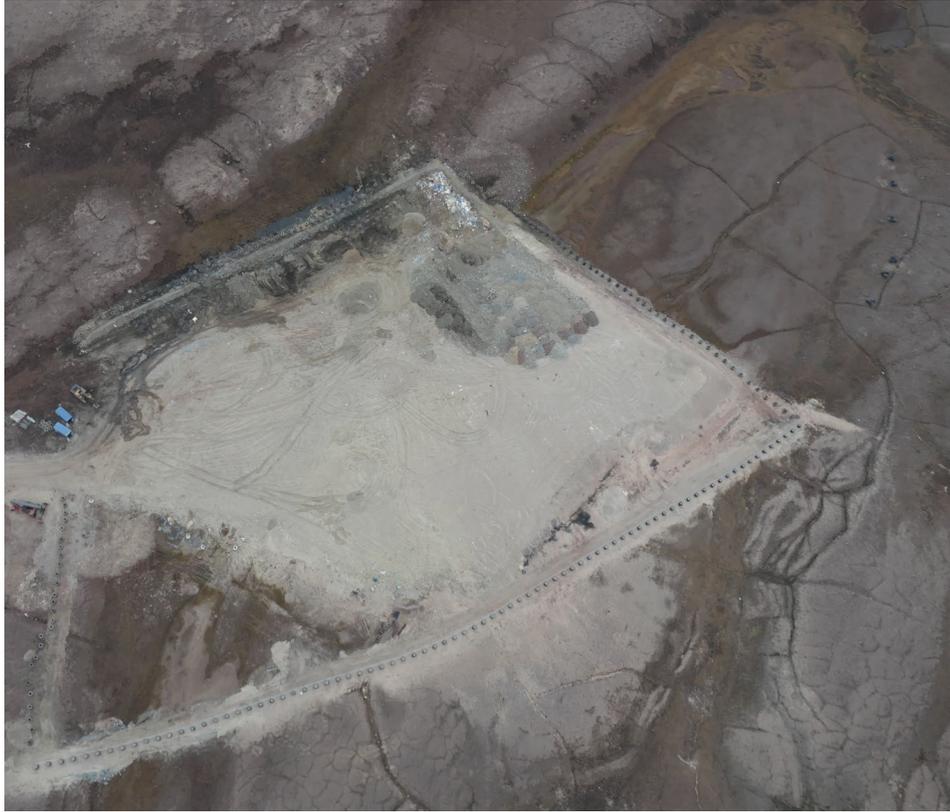
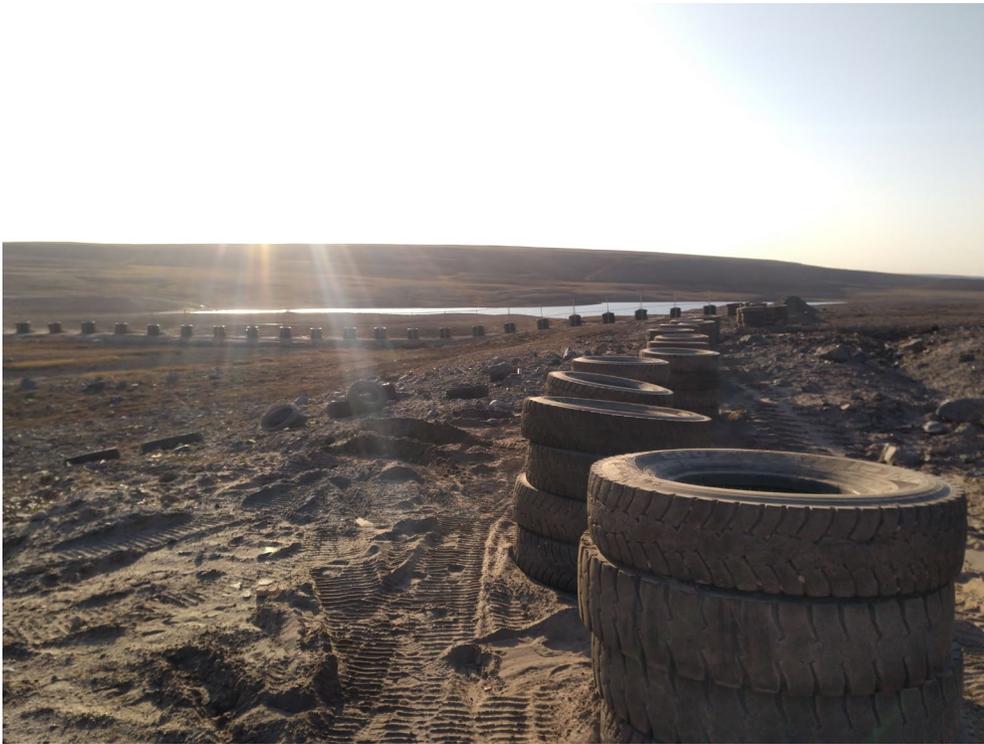
**PHOTO 15 and 16** – Preparatory Work for Cell 1 and 2 Enclosure at the Landfill

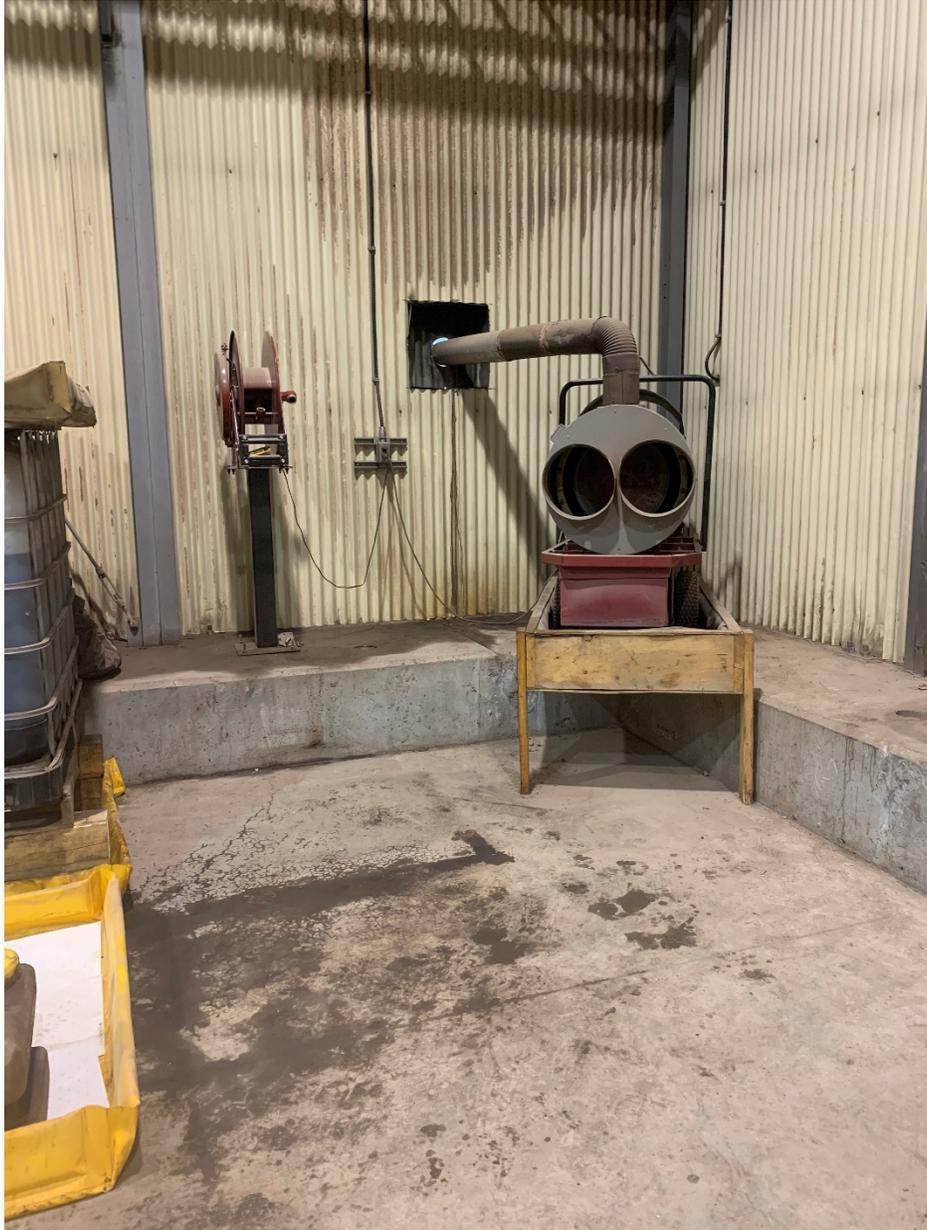
**PHOTO 17** – Frost Fighter in Waste Management Building

6	Winter	Waste Management Building	Storage of Frost Fighters near fluid totes.	Proximity of frost fighters in Waste Management Building near fluid totes.	Frost fighters are operated inside the waste management buildings to protect from the elements. The exhaust from each unit is directed outside via stove piping. The fluid tote has been relocated as shown in Attachment 2.	No further update required.
