Nunavut Impact Review Board 2018-2019 Monitoring Report

Jericho Diamond Mine Project

NIRB File No. 00MN059

Report Title: The Nunavut Impact Review Board's 2018 – 2019 Annual Monitoring Report for the Jericho Diamond Mine Project (NIRB File No. 00MN059)

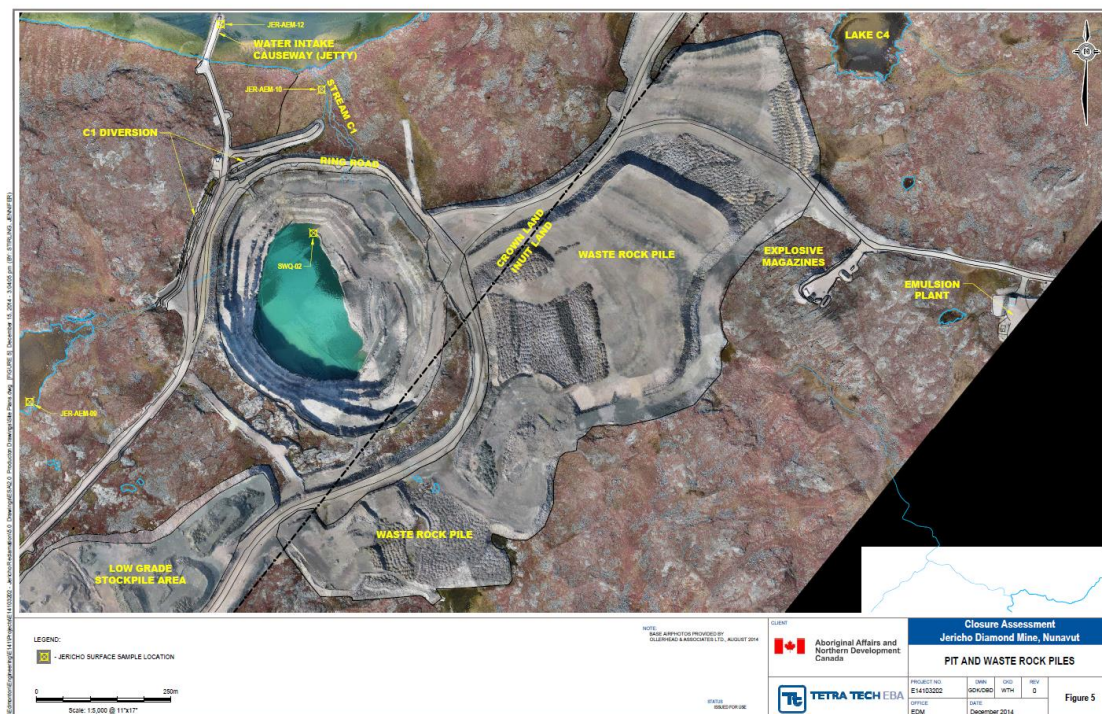
Figure 2: Water Diversion Channels and Pit¹⁰

CIRNAC's remediation goals included returning the water flow to its original state as much as practical at the Jericho site. Water flow works in 2017 included re-routing the C1 Diversion to redirect water into the Open Pit to allow the eventual formation of a Pit Lake and breaching the pit wall to allow the original natural flow of surface water into Carat Lake to be restored. Additional water works included grading the existing tailings in Cell A to allow water to flow in its original direction, lowering the top and creating a breach in Dyke A, and breaching the West Dam to restore the original surface water flow.

The Monitoring Officer has concerns that with the re-establishment of the water flow noted above as the pit fills it will eventually overflow into Carat Lake and while the OMS plan includes long-term monitoring and analysis for total uranium in the pit lake water no other water quality parameters are being tested. Additionally, as uranium levels are expected to decrease as the pit fills and if/when uranium levels fall below CCME guidelines, no further testing will be undertaken of the water in Pit Lake. Throughout the site visits, it has been observed that not only water from re-established water courses is filling the pit, Pit Lake is also the receiving environment of runoff from the waste rock piles which may have seeps with unknown contaminants. As currently the waste rock piles are not being monitored this

The Monitoring Officer also has concerns regarding future water quality in that the kimberlite in the PKCA upstream of Cell B/C. Kimberlite will break down over time, as has been observed in other mine sites in the Northwest Territories, and this may leach unknown contaminants into Cell B/C and eventually the receiving aquatic environment. Currently, the OMS Plan has no further designs to test the water quality in Cell B/C.
