Baffinland-ወር ካልናኑክሙ ስራዎች ስራ

NIRB File No. 08MN053

**RE: Follow up to NIRB August 2019 Site Visit, Findings and Recommendations**

**Table 1 – Baffinland Responses to NIRB Finding and Recommendations - August 2019 Site Visit**

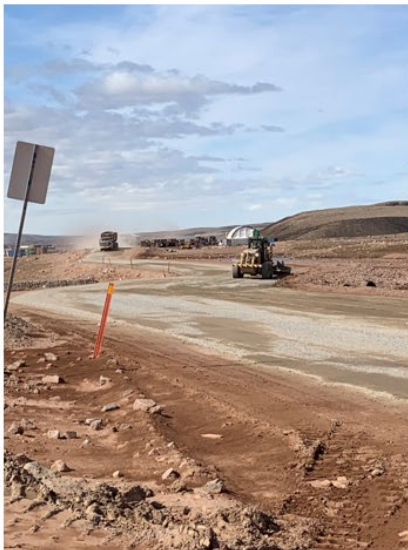
Fresh gravel laid out

#	Project Location	Description of Concern or Finding	Recommended Action	Response
2	Mine Site / Milne Port / Tote Road / Mine Haul Road	Dust deposition on Project Roads and dust generation at site.	Update on mitigations implemented to minimize dust deposition. Provide update on dust stop trial. Continued application of dust suppressant.	<p>Baffinland is committed to controlling dust sources at the Project. This has included continual development of new dust suppression alternatives at Milne Port, including ore pad redesign to position fines in the centre and lump ore around the margins, installation of downwind fencing and proper positioning of the conveyors to minimize distances when stock piling. Additional shrouds were also installed at the Mine Site crusher in 2019 and Baffinland is actively considering and/or implementing new methods through reengineering of equipment designs to minimize dust generation.</p> <p>Calcium chloride and water has also been applied on road surfaces throughout operations to mitigate dust emissions. Based on feedback received from communities, the QIA and other regulators, Baffinland actioned an implementation plan for testing new dust suppression products with increased durability and longevity for site infrastructure.</p> <p>Dust Stop, produced by Cypher Environmental is an approved product for dust suppression under Nunavut's Environmental Guideline for Dust Suppression on unpaved Roads. Dust Stop is environmentally friendly, and is expected to have a longer lasting durability for both traffic and rainfall impact, as it promotes a hard, competent water repellant surface when properly applied.</p> <p>Dust Stop product was shipped on the 2019 sealift and a full application along the Tote Road is expected to commence in September 2019. A micro trial of Dust Stop was performed in August 2019 from km 103.5 - km 97 on the Mine Site and Tote Road to determine efficacy of the product on site. Improved dust suppression was observed throughout the application zones and the product also showed signs of water shedding during rain events supporting improved road sealant and application lifespan. (Refer to photos provided in Attachment 2).</p> <p>Following arrival of the sealift, Baffinland will implement an expanded trial and use the results to determine the efficacy and feasibility of this alternative. If it is determined that Dust Stop is both economically feasible and a more effective alternative, Baffinland will procure a larger volume to be delivered on summer 2020 sealift for ongoing application.</p>

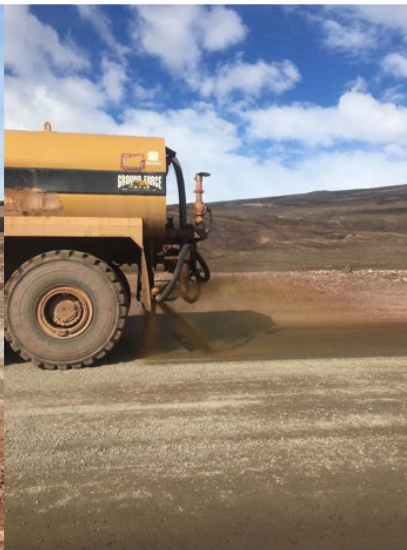
Pressurized application of DSMB

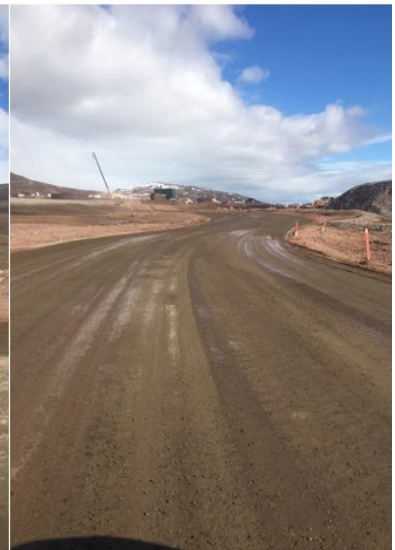
**PHOTO 5, 6 and 7** – Photos Taken During August 2019 Dust Stop Trial

Product applied – full coverage
