Appendix F-3

Reportable Spills and Follow-up Reports

Follow Up Report: #19-020

January 18, 2019 Emulsion Tote Spill

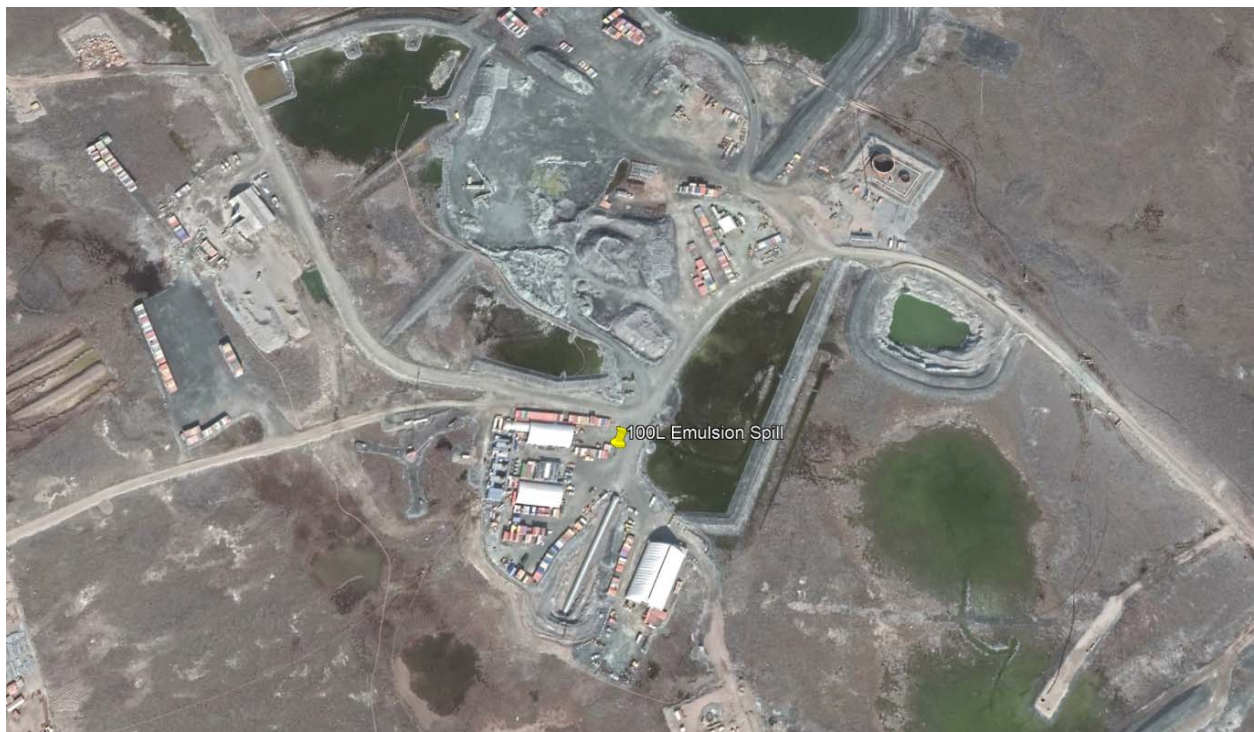
While loading a storage tote containing 1m³ of emulsion onto a boom truck, using a forklift, the tote shifted out of the forks. Due to extreme cold, the forklift hydraulics were unresponsive, and could not prevent the tote from falling. Approximately 100L of emulsion spilled to the ground and froze. No water bodies were impacted by the spill. The nearest water body is A11 which is >390m away. The coordinates of the spill were, 63° 1'36.87"N, 92°12'39.39"W.

Figure 1: Spill at Portal 1 entrance, opposite P3.

Site personnel shut down equipment and prevented further spillage. The majority of the material was cleaned up immediately with a shovel and placed back into the original tote. The material will be stored until it is reprocessed by the emulsion plant. Snow contaminated with emulsion residue was disposed of as hazmat.

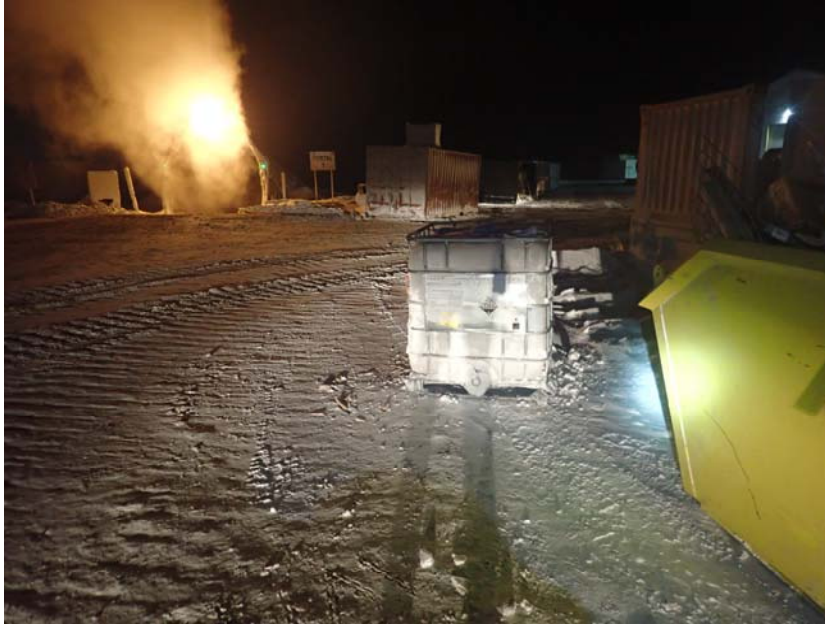
The release occurred due to the failure of forklift hydraulics which were too cold to operate optimally. Operators will ensure equipment has sufficient time to heat hydraulic oil and function correctly, prior to commencing transfers of emulsion, as per standard operating procedures.

Figure 2: Emulsion tote following spill and clean up.

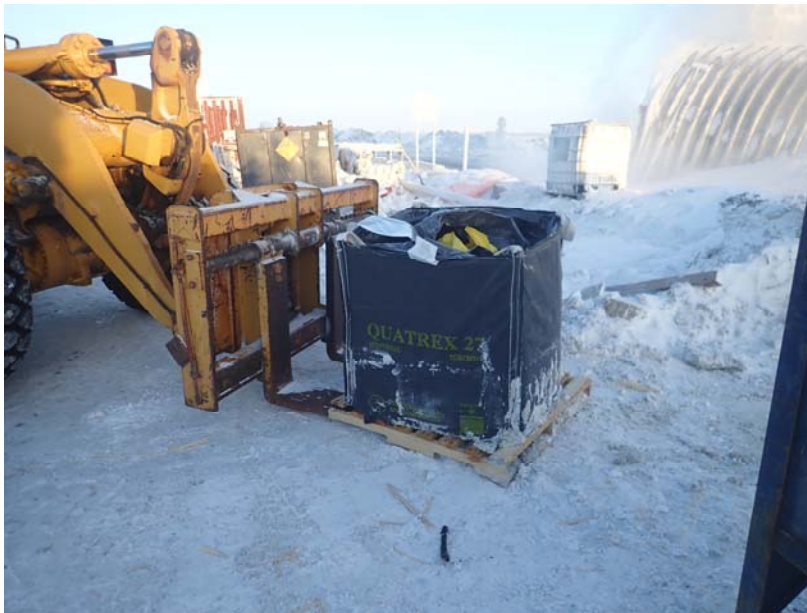
Figure 3: Snow contaminated with emulsion residue disposed of as hazmat.

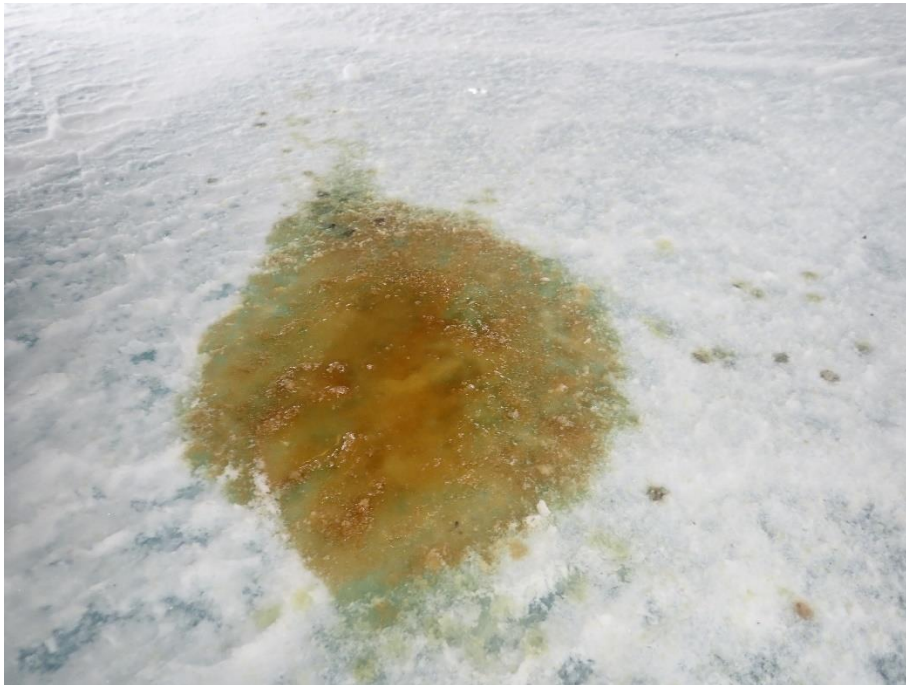
On April 12th 2019, a slow leak of hydraulic oil was identified on a loader operating at an active drill site on Lake B7. Approximately 1 litre of hydraulic oil spilled to the frozen lake surface. GPS coordinates of the location are 538226.97m E, 6989369.38m N.

Figure 1: Hydraulic oil over approximately 0.5m² of Lake B7.

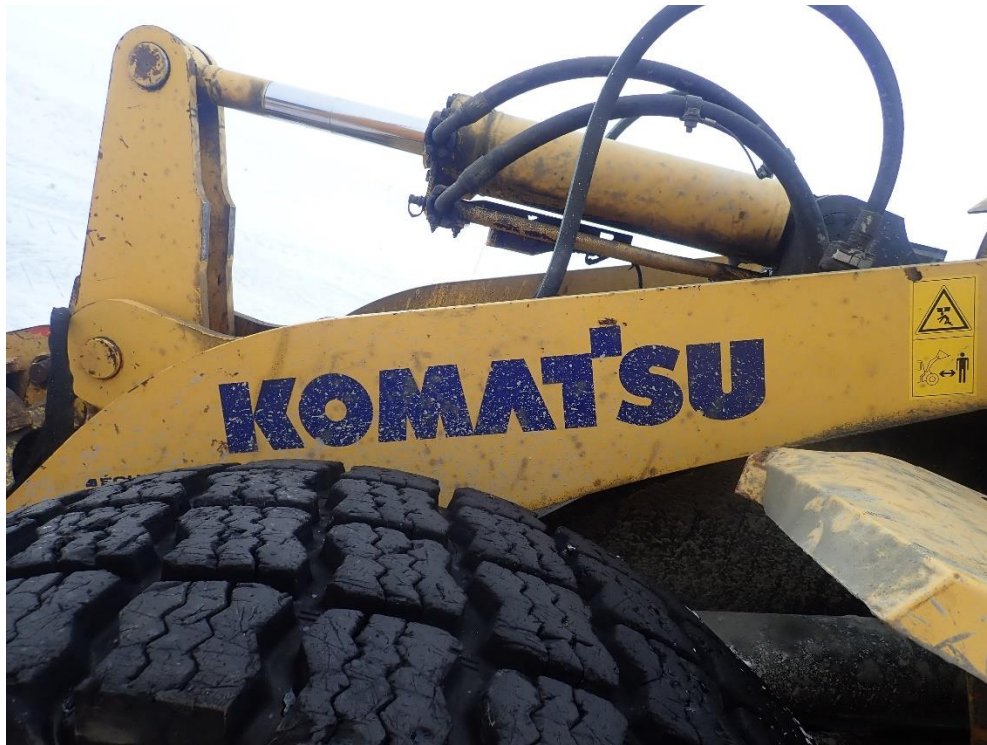
An investigation was completed and the cause of the spill was determined to be a failed seal on the hydraulic shaft. The contractor followed the spill reporting procedure and cleaned up the spill as required. The equipment was sent for servicing and the hydraulic seal was replaced.

Figure 2: Failed hydraulic seal on Orbit Loader

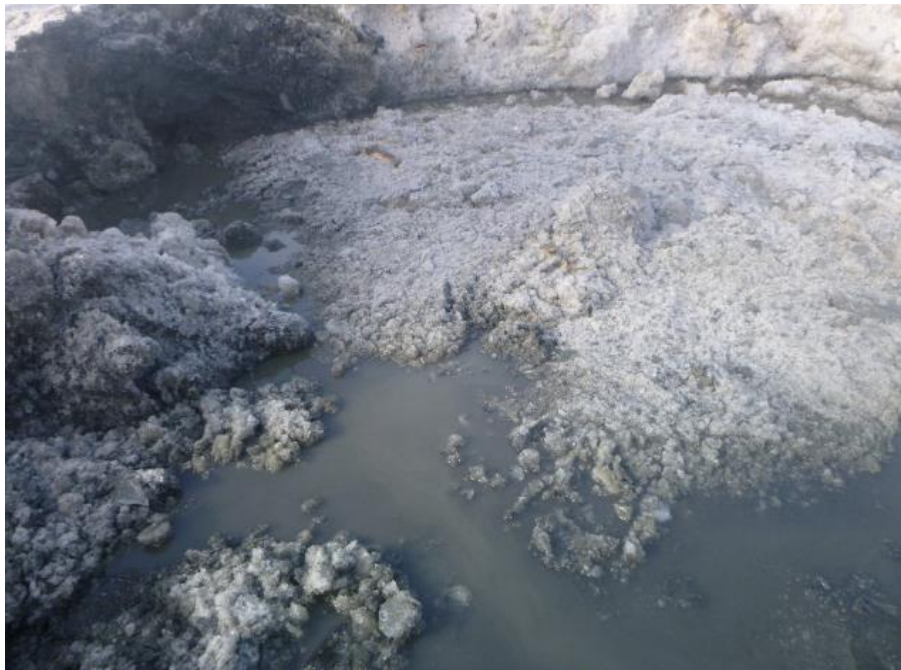
Figure 1: No oil or sheen remains within drill site

Absorbent sheets and booms have been changed and removed from drill site to finish cleaning the site.

Drill 3 was removed from the spill location May 24th when final inspection was completed.

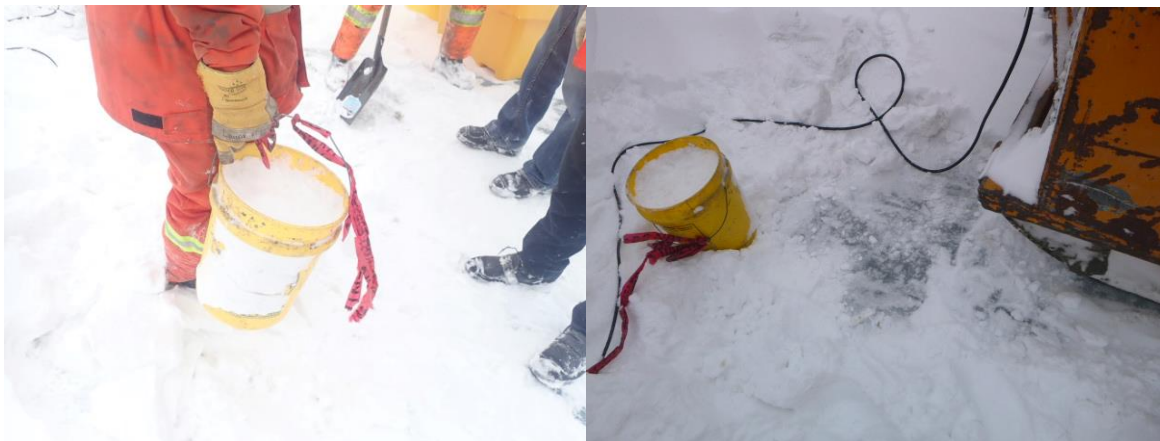
Figure 1: Contaminated snow removed from the surface of Lake B7.

Agnico Eagle's Environment department completed an investigation and determined the cause of the spill was human error. Diesel spilled to ground from a hose connected to the main fuel cache. Operators have since been instructed to take care to prevent diesel leaking from the hose between refueling events.

Contaminated snow was collected and transported to the snow cell, where it will be processed using an oil/water separator.

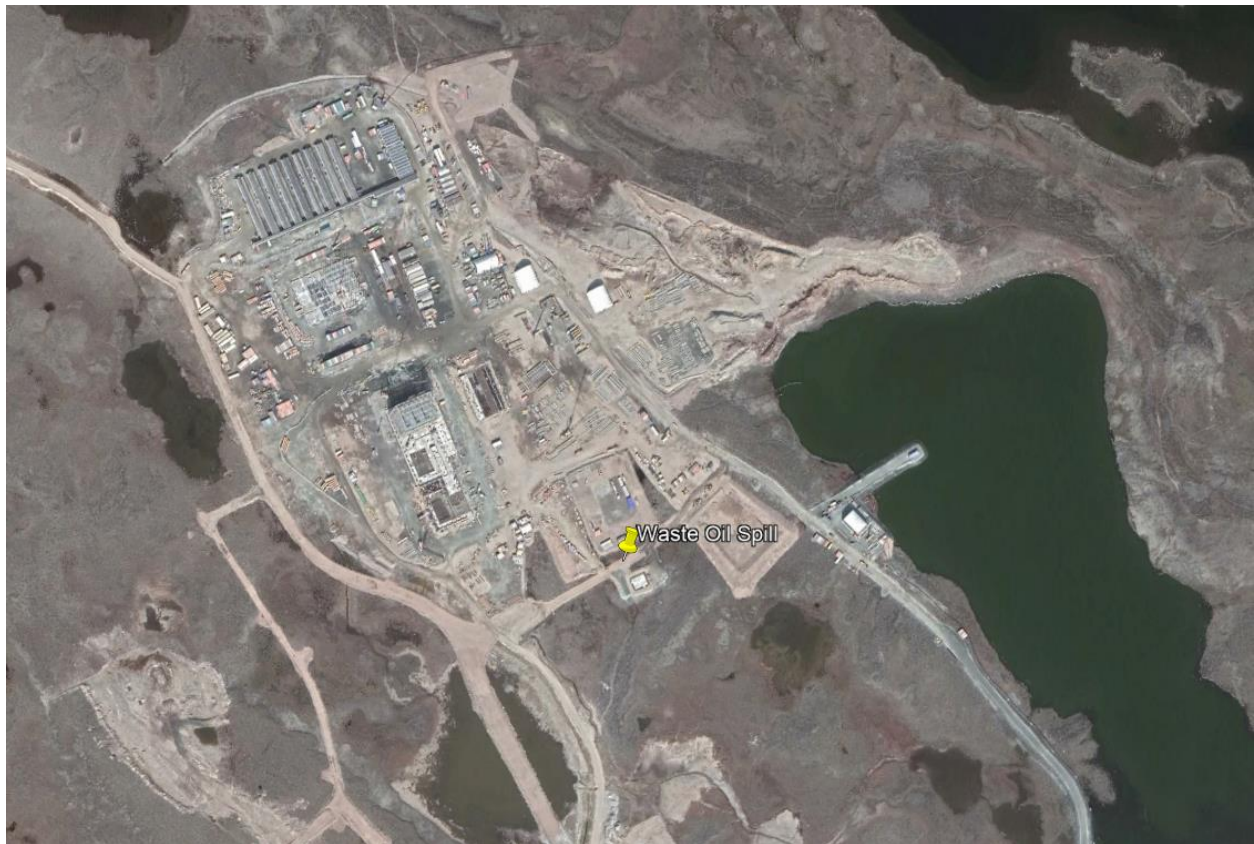
On May 18 2019, an operator was using a tele-handler to load waste oil totes into a seacan. The operator punctured a tote causing ~200L of waste oil to spill to ground. Waste oil was confined to a puddle on the access road. No water bodies were impacted by this release. The closest natural water body is approximately 560m away. The exact location of the spill was 63° 2'12.60"N, 92°13'12.41"W.

Figure 1: Waste Oil Spill at Hazmat laydown, opposite incinerator building.

Site personnel maneuvered the leaking tote to prevent further spillage. Waste oil, which had flowed into a puddle on the adjacent access road, was contained using a hydrocarbon absorbent boom. Waste oil was removed from the water surface using absorbent pads, which were disposed of as hazmat.

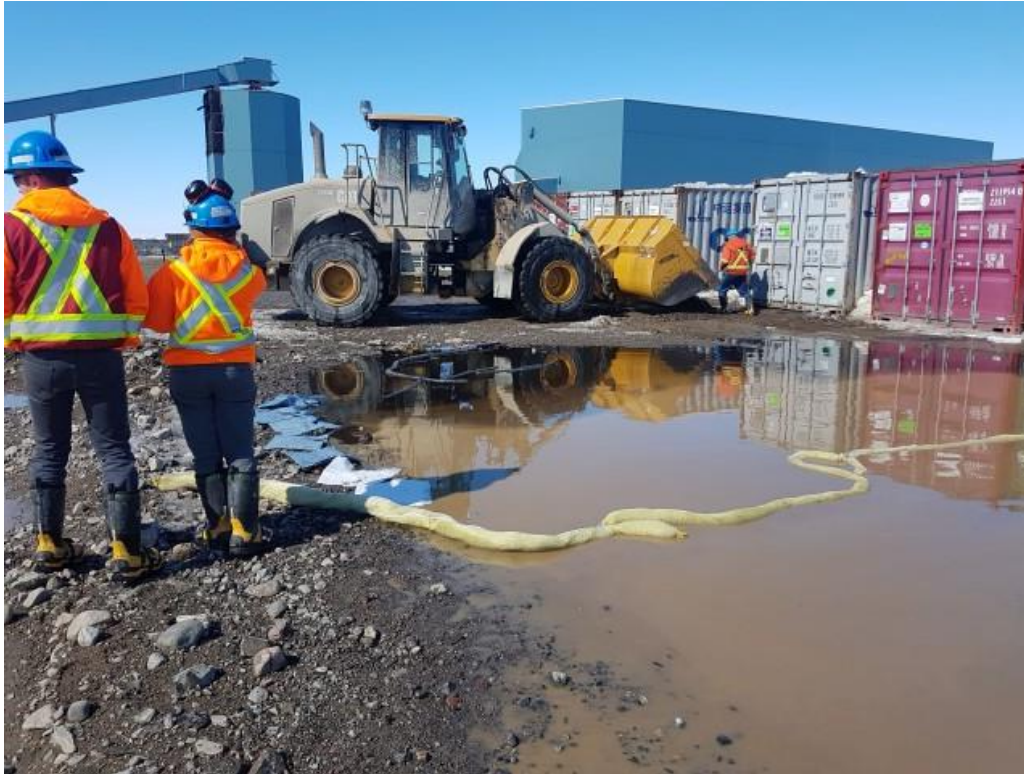
Figure 2: Waste oil contained by hydrocarbon boom at hazmat laydown.

The release occurred due to an operator pushing totes into a seacan, which crushed a tote at the rear, causing a puncture. Operators will be briefed on how to avoid this type of incident in future. Spill response materials used in the clean-up will be restocked. Additional spill response equipment will be purchased, to improve response time.

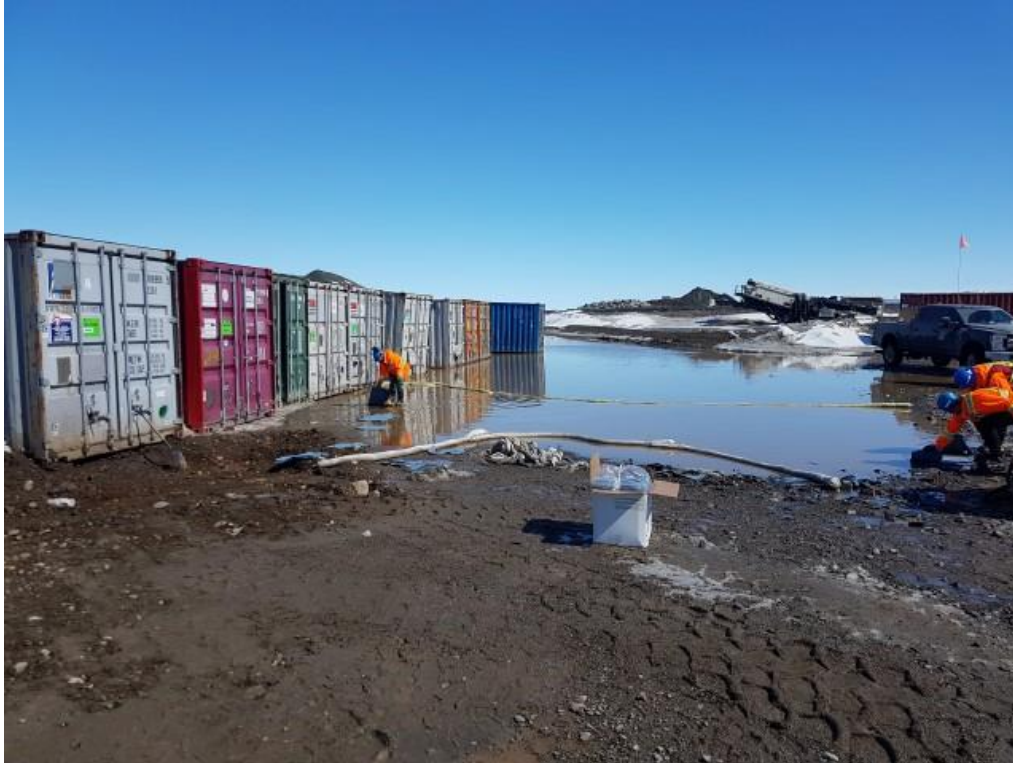
Figure 3: Waste oil was absorbed using spill response supplies.

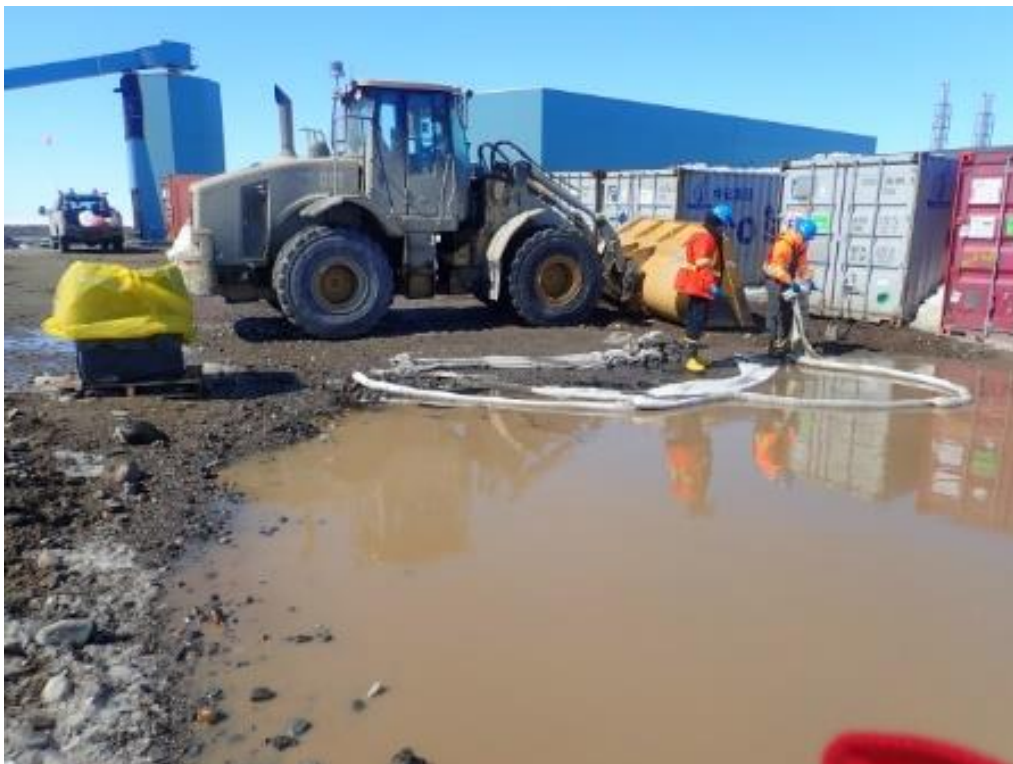
Figure 4: Loader used to transport waste oil contaminated road base to landfarm.

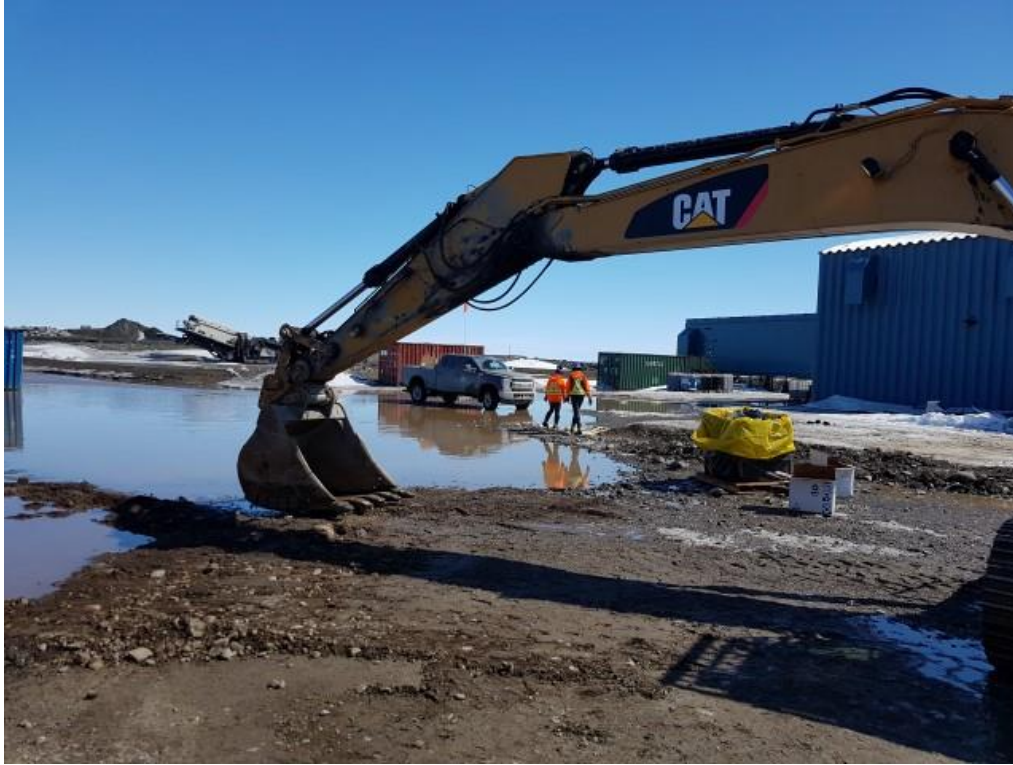
Figure 5: Sump used to collect floating waste oil was backfilled.

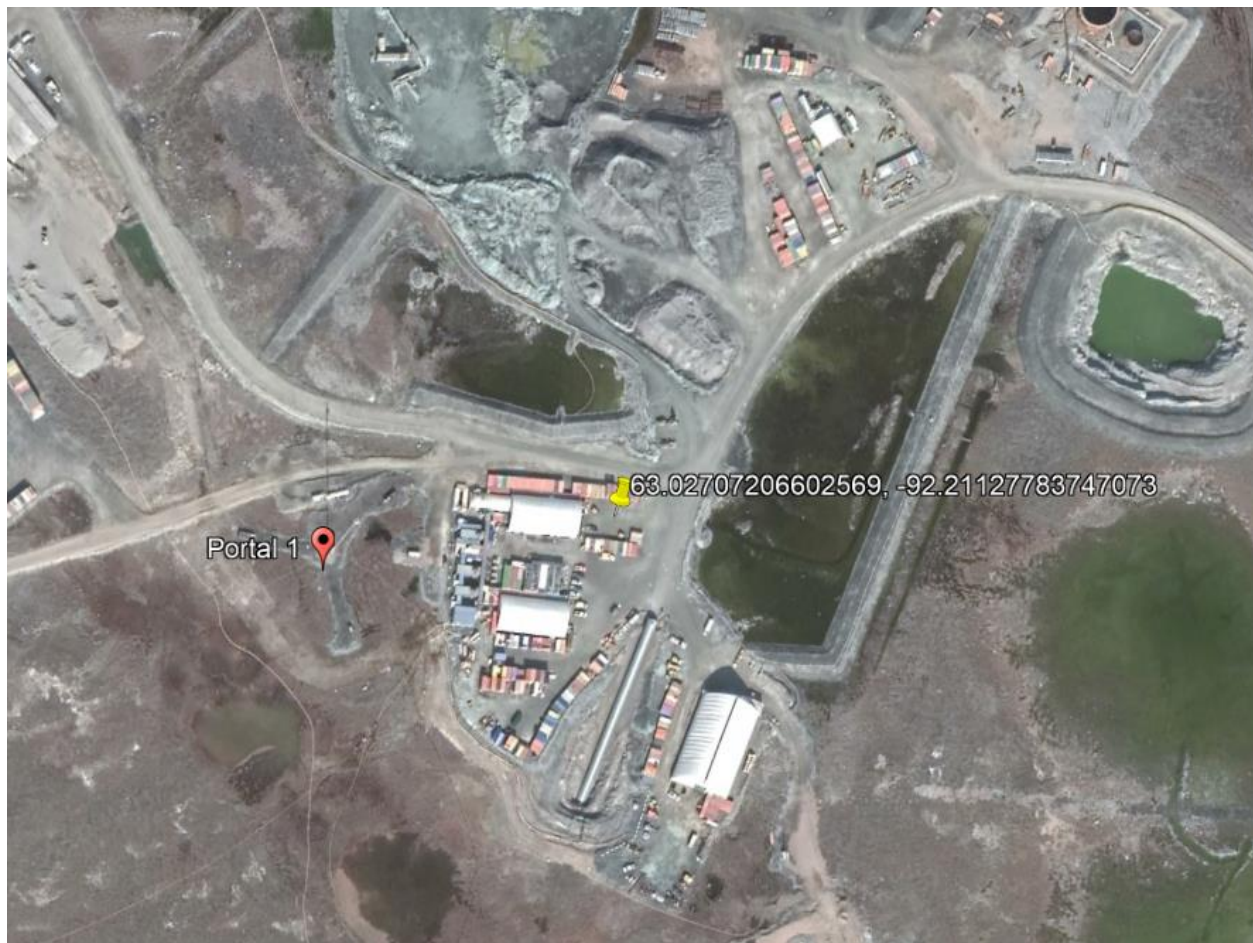
On July 7 2019, a tote of diesel exhaust fluid (DEF) was found laying on its side. Some of the contents had leaked out to the level of the cap (approximately 150L). No water bodies were impacted by this release. The closest natural water body is approximately 700m away. The exact location of the spill was 63.02707206602569, -92.21127783747073.

Figure 1: Waste Oil Spill at Hazmat laydown, opposite incinerator building.

The environment department was contacted and the contaminated gravel was placed in a quatrex bag to be disposed of as hazmat. Site personnel maneuvered the leaking tote to prevent further spillage and transferred the remaining contents for later use.

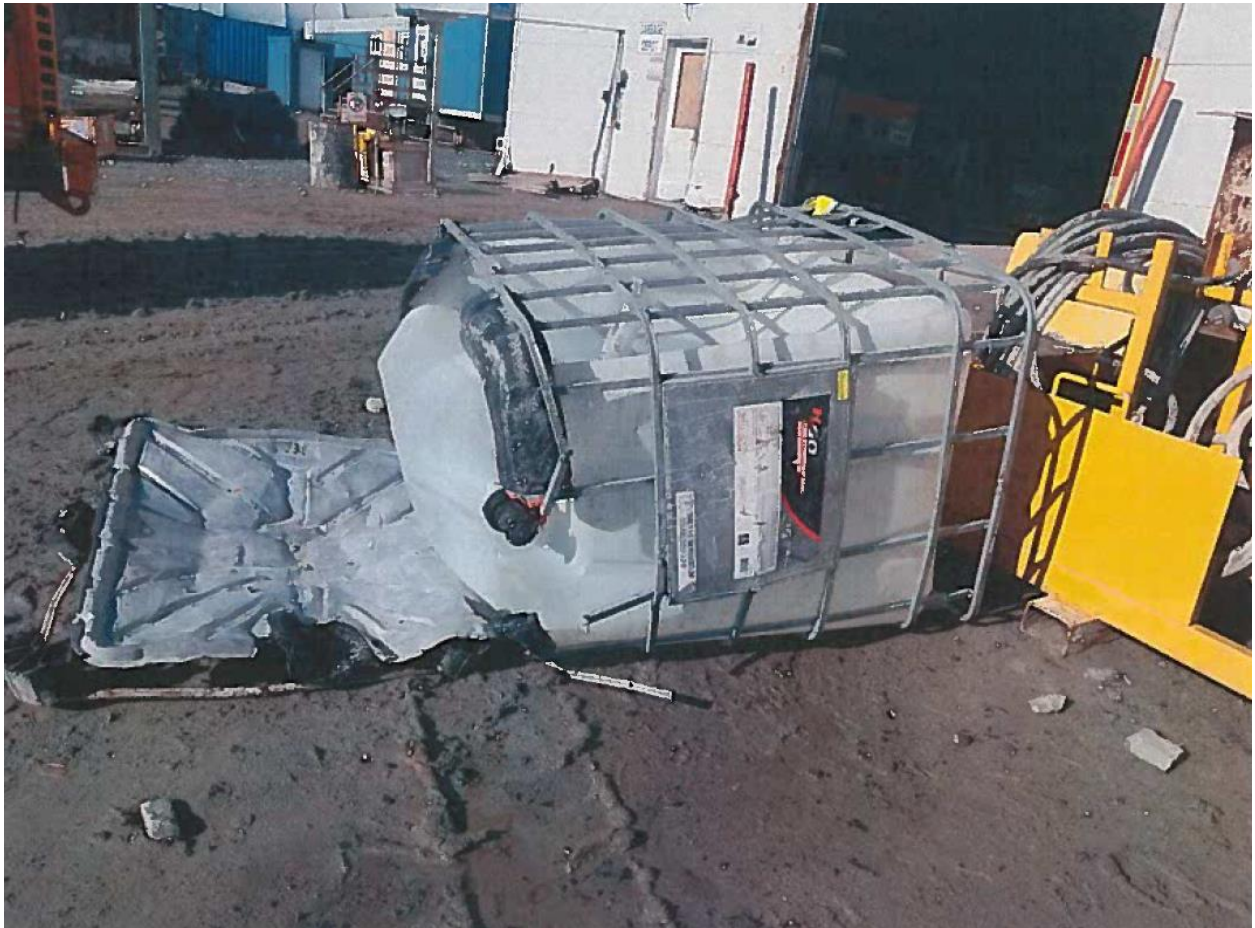
The root causes of the spill were improper storage and human error. Staff were advised to follow product transfer procedures. Spill response materials used in the clean-up will be restocked.

Figure 2: Damaged DEF tote outside of workshop, prior to clean-up.

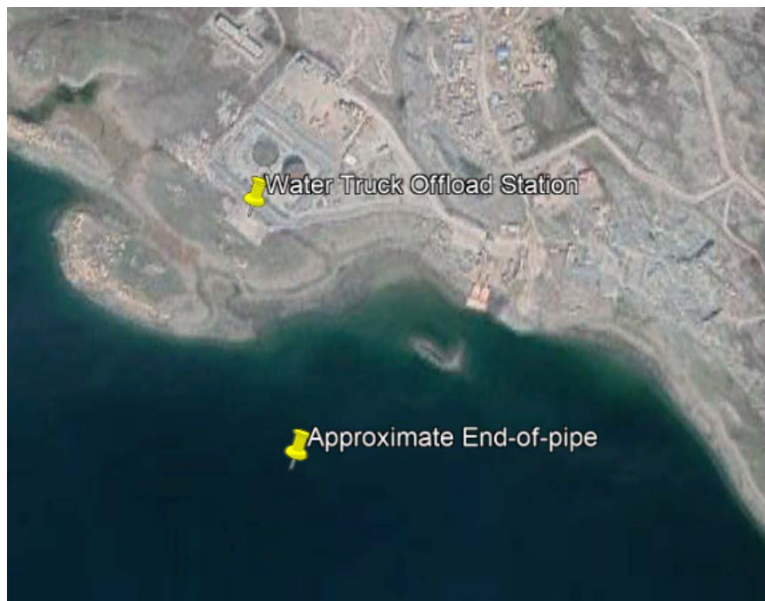
Figure 1: Location of the truck offloading station of treated saline water, and the end of the pipe where discharge enter Melvin Bay.

During the saline water discharge to sea, the Itivia location (Figure 1) experienced a power issue, which reset the daily volume allocation on the Human Machine Interface (HMI). The operators were relying only on this system to determine when they reached the 800m³ discharge limit for the day. When operators offloaded the saline water, the value on the HMI was incorrect which lead operators to discharge an additional 52 m³ of water into Melvin Bay. In Meliadine's NIRB agreement, the permitted limit is 800 m³/day. This was not apparent until the following evening when the Energy and Infrastructure team (E&I) produced the daily histogram (Figure 2).

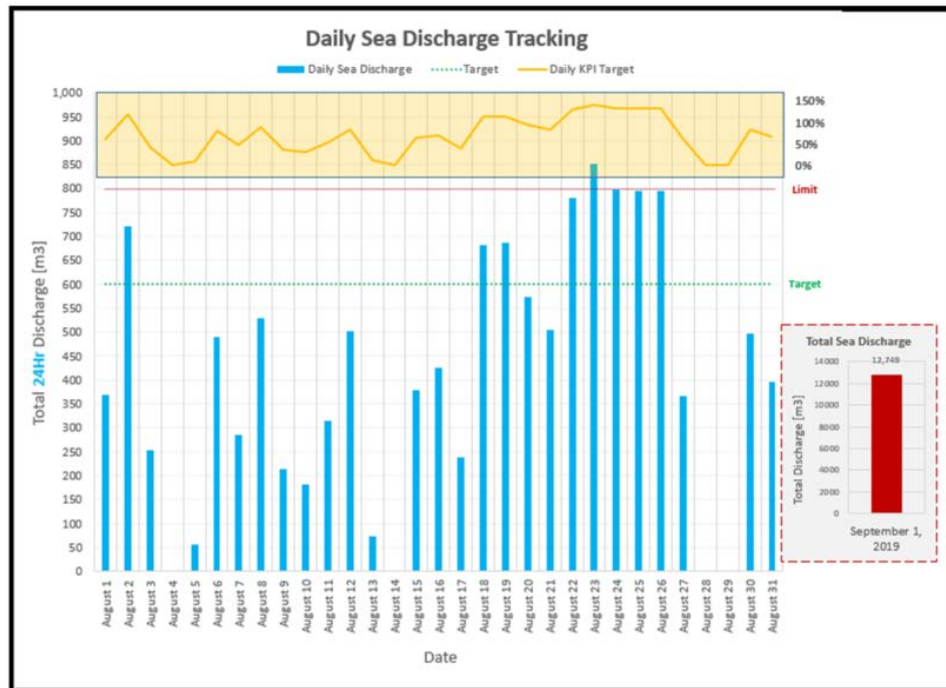
Figure 2: Daily discharge to sea volumes for the month of August, 2019. 800m³ exceedance on August 23.

The root cause of the discharge volume exceedance was that there was no back-up measure in place to monitor how much water was discharged. The operators continued hauling water to Itivia and over the 24 hour period and approximately two additional trucks were offloaded. As a mitigation measure, a manual log sheet has been created and placed in the offloading station (Figure 3). When an operator arrives and begins offloading water, they must record the time, date, truck number, etc. No more than 22 trucks are to be offloaded during a single day. Furthermore, next year a cutoff system is planned to be installed at the offloading station. This will be programmed to divert water from being discharge to Melvin Bay, and store it in a holding tank, when the daily limit is reached.

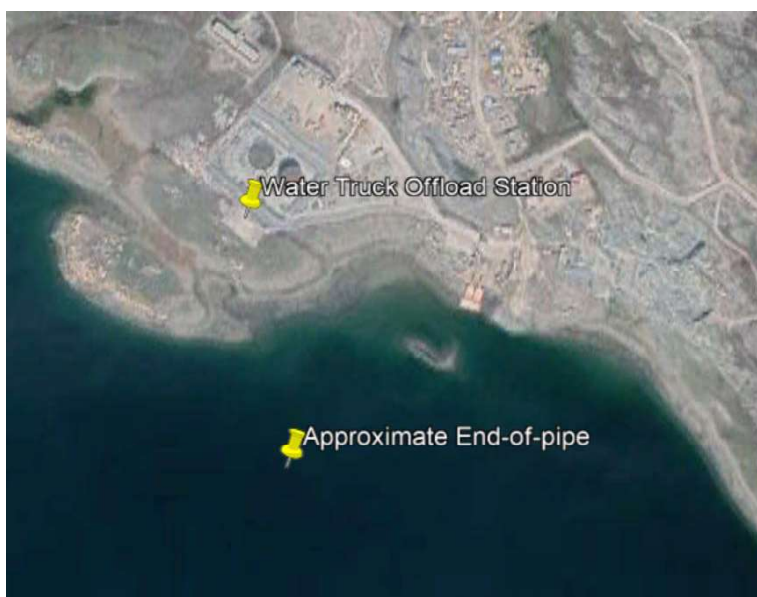
Figure 1: Location of the truck offloading station of treated saline water, and the end of the pipe where discharge enters Melvin Bay.

While investigating the cause of the TSS exceedance, an internal confirmation sample was collected from the SETP outflow 19th August. On August 26th, technicians noticed the smell of chlorine, suggesting the Saline Effluent Treatment Plant (SETP) was unable to remove the chlorine used in the treatment process. Field readings indicated chlorine was present in Saline Pond 3 (SP3). It was anticipated chlorine levels would be diluted within SP3 following adjustments to the SETP process, and any remaining chlorine would degrade prior to discharge. The Environment Department began conducting in-house testing for TSS and chlorine levels in order to monitor the situation. A conservative estimate of the volume of chlorine released to Melvin Bay, Arctic Ocean between August 26th and September 11th is approximately 0.3 L/day.

An acute toxicology sample was collected September 2nd, and failed on September 5th. Toxicology sampling frequency was increased to include September 9th, September 23rd and October 7th, with characterization samples to be taken at the same time for all three samples. Acute toxicology samples collected on September 9th, failed on September 12th. Discharge to sea was immediately stopped. Volumes discharged to sea were 864 m³ on September 2nd and 794 m³ on September 9th.

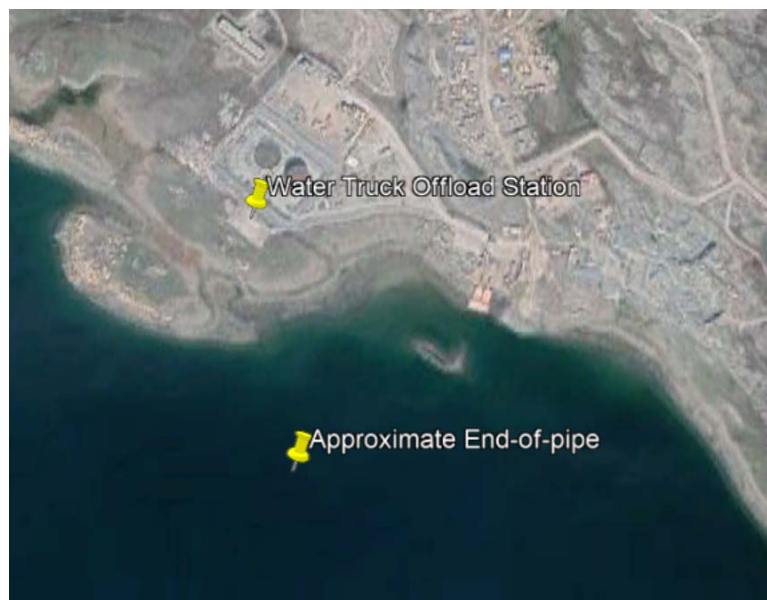
Figure 1: Location of the truck offloading station of treated saline water, and the end of the pipe where discharge enter Melvin Bay.

The daily permitted limit of 800m³ of treated water discharged to Melvin Bay was exceeded by 64m³. Two trucks were loaded at Meliadine before midnight on September 1st and offloaded at the Itivia offload station (Figure 1) after midnight (September 2). The operators for the contractor involved (KCG) assumed these two truck loads would count for the September 1st offloading, when in fact the discharge volumes are monitored from Midnight to Midnight for any given calendar day. This exceedance was detected when the values for the histogram (Figure 2) were reviewed the following afternoon September 3rd. In Meliadine's NIRB agreement, the permitted limit is 800 m³/day.

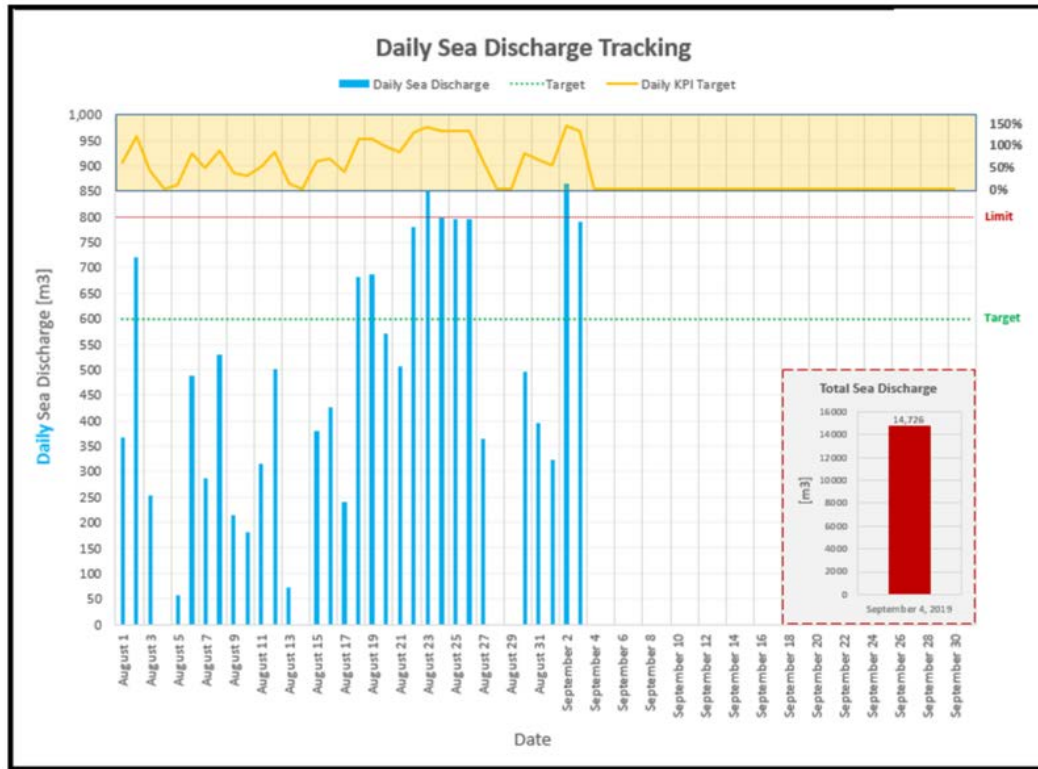
Figure 2: Daily discharge to sea volumes for September 2019. 800m³ limit exceeded on September 2.

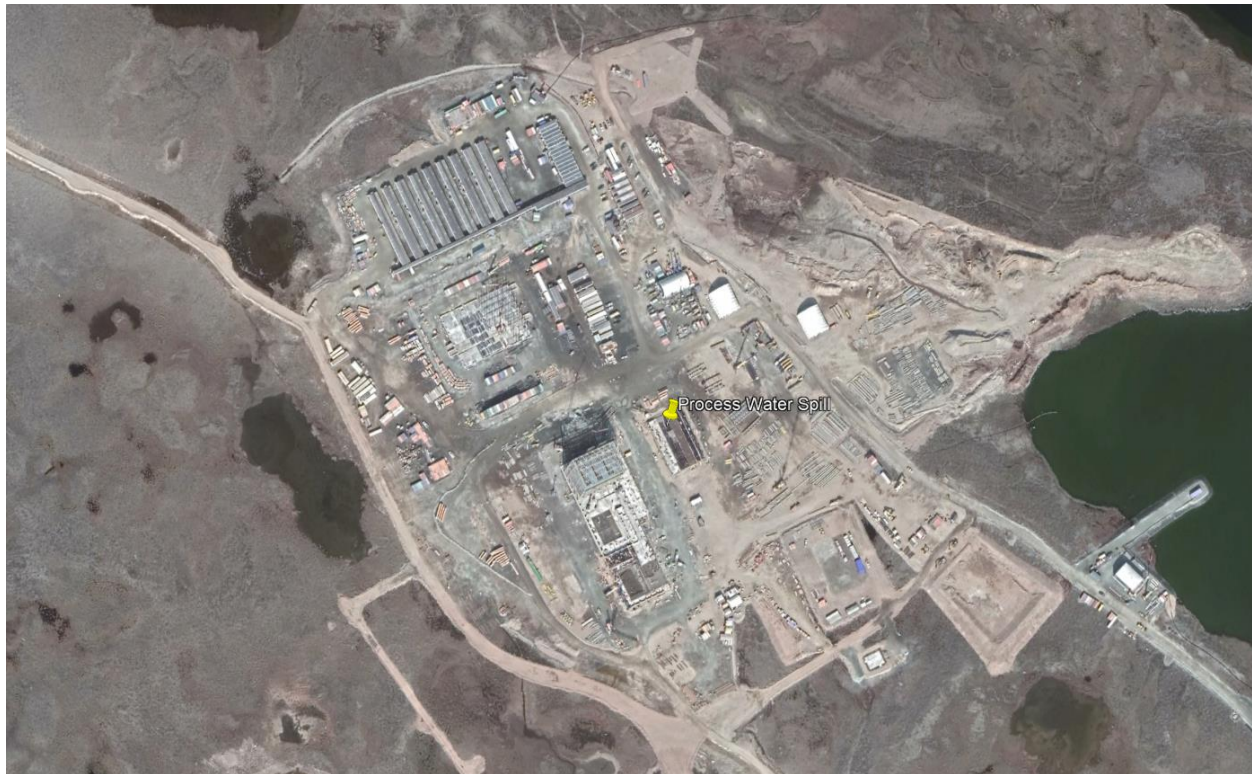
Figure 1: Location of process water spill within Meliadine's managed catchment area.

At 12:30pm, Saturday 14th September 2019, during start-up of the cyclone system in the process plant, a blockage occurred preventing slurry and process water from passing through the cyclone unit. The system backed up causing process water and slurry to overflow to the floor of the process plant. Approximately 8m³ of process water and slurry flowed outside of the building, onto the industrial pad. The majority of the slurry remained on the plant floor. The spill volume was estimate based on the area and depth of the spilled material.

The nearest natural water body (G2), 600m to the north, was not impacted. The spill occurred at 63° 2'13.63"N, 92°13'33.84"W, within the Meliadine managed water catchment.

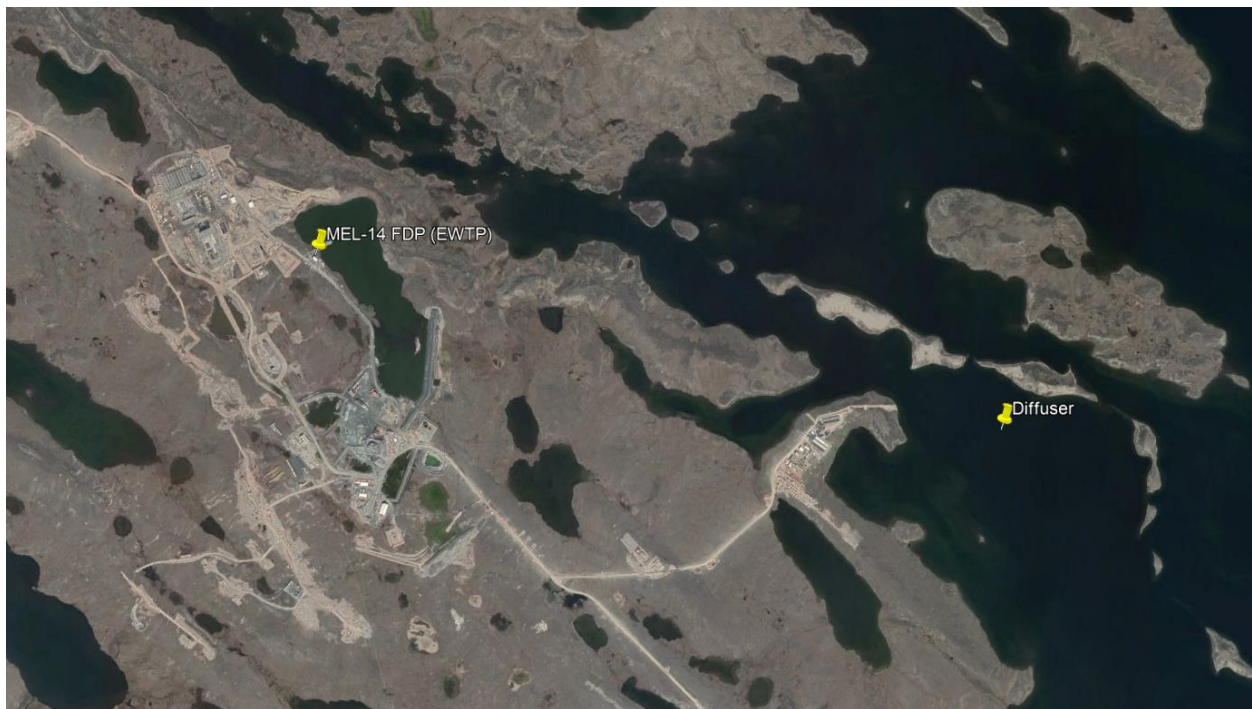
Figure 1: Location of effluent water treatment plant and diffuser in Meliadine Lake.

On September 13th, 2019, samples were taken at the MEL-14 FDP (63° 2'11.41"N, 92°12'58.95"W). Results received on September 25 2019, indicated an exceedance of NWB Water License 2AM-MEL1631, part F, item 3 criteria for Total Dissolved Solids (TDS) of 1400mg/L. The TDS of the sample was 1430mg/L. The quantity of effluent exceeding discharge criteria is estimated to be 11,131m³, based on previous probe calibration and water quality analysis.

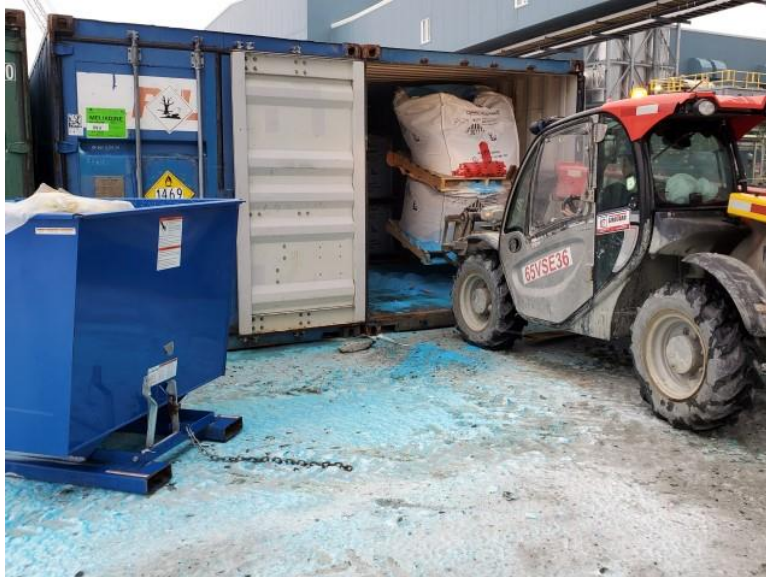
Figure 2: Forklift operators removing the torn bag/pallet to bring inside the Mill.

The torn bag of CuSO_4 was patched and removed from the sea-can. The sea-can was unloaded and the pallets were brought inside the Mill. The spilled material in the sea-can was shoveled into buckets and replaced into the original bag. The material outside the sea-can was scraped up and brought to the Mill to be disposed of within the process plant. Figure 6 shows the cleaned up area where the spill had occurred.

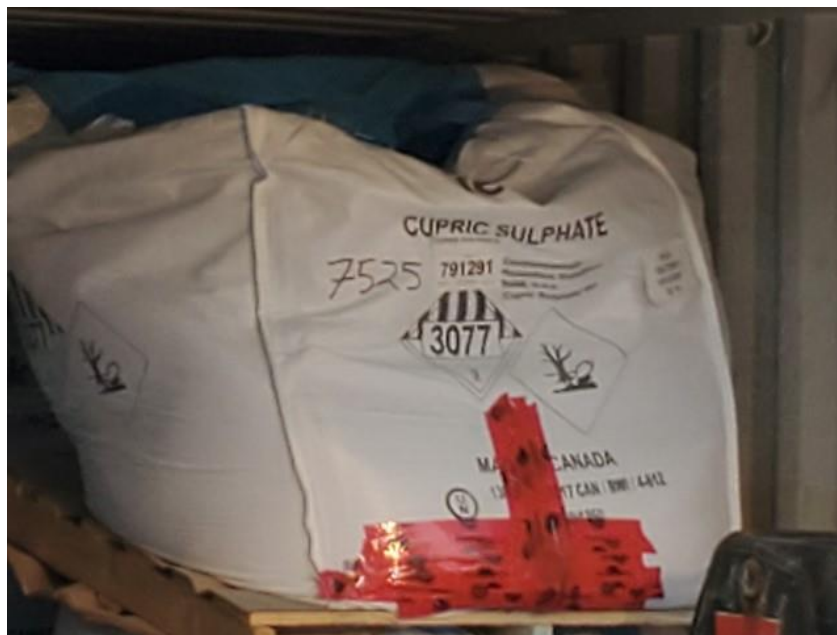
Figure 3: Damaged pallet which has been patched so that no more material is released during transport.

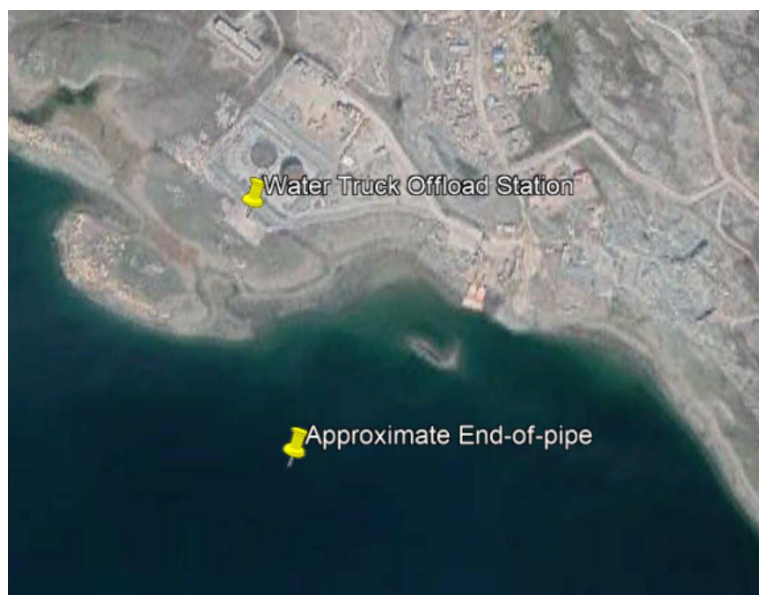
Figure 1: Location of the truck offloading station of treated saline water, and the end of the pipe where discharge enters Melvin Bay.

Weekly effluent samples at the MEL-26 final discharge point (Figure 1) for treated saline water were taken on October 1st and October 7th, 2019. Due to winter conditions, the discharge to sea ceased October 11th

Total Suspended Solids (TSS) results from these samples were 14 mg/L and 17 mg/L, which are below the MDMER "Maximum authorized concentration in a grab sample" but above the maximum allowable value of 15 mg/L (actual measured value was 15.5 mg/L)

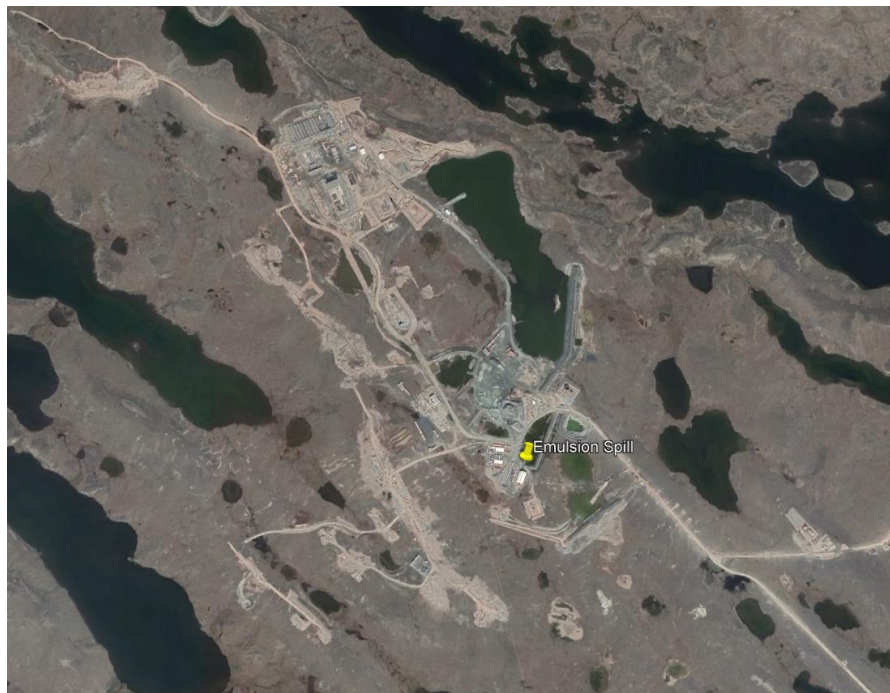
Figure 1: Location of 330L emulsion spill and proximity to water bodies.

On November 25th at approximately 14:30pm, an estimated 330L of emulsion was spilled on surface near Portal 1. While transferring a full tote of emulsion from the flat rack to the boom-truck, the tote slid off of the forks of the telehandler and fell onto its side. Approximately one third of the tote spilled out onto the ground.

No water bodies were impacted by this spill. The closest natural water body is over 900m from the spill location. The coordinates of the spill are 539975.00 m E, 6988777.00 m N.

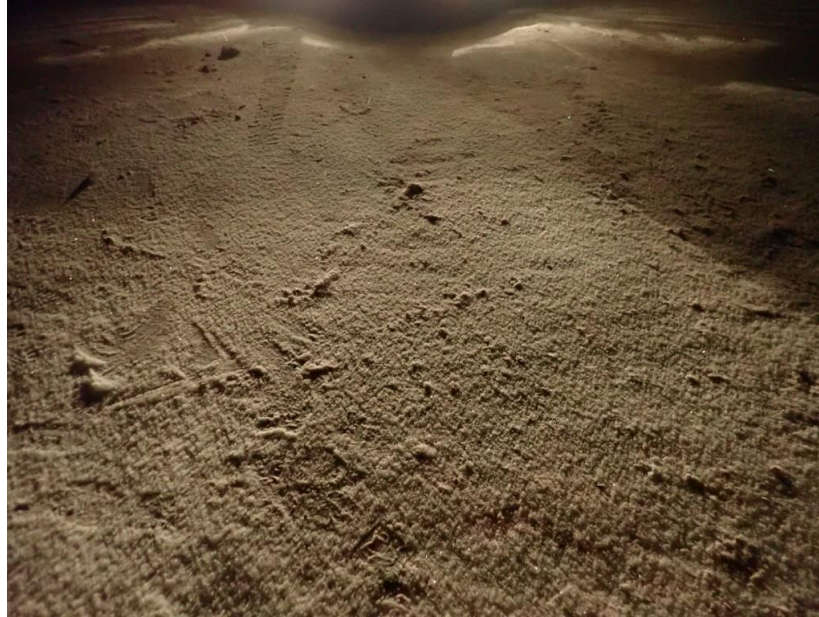
Figure 2: Spill location following clean-up.

The operators involved used a scoop and shovels to remove the contaminated material which was placed into quatex bags. The contaminated material was sent to the emulsion plant. Emulsion suitable for salvage will be reused. Unsuitable material will be neutralized using an emulsion destruction process, and shipped as hazmat.

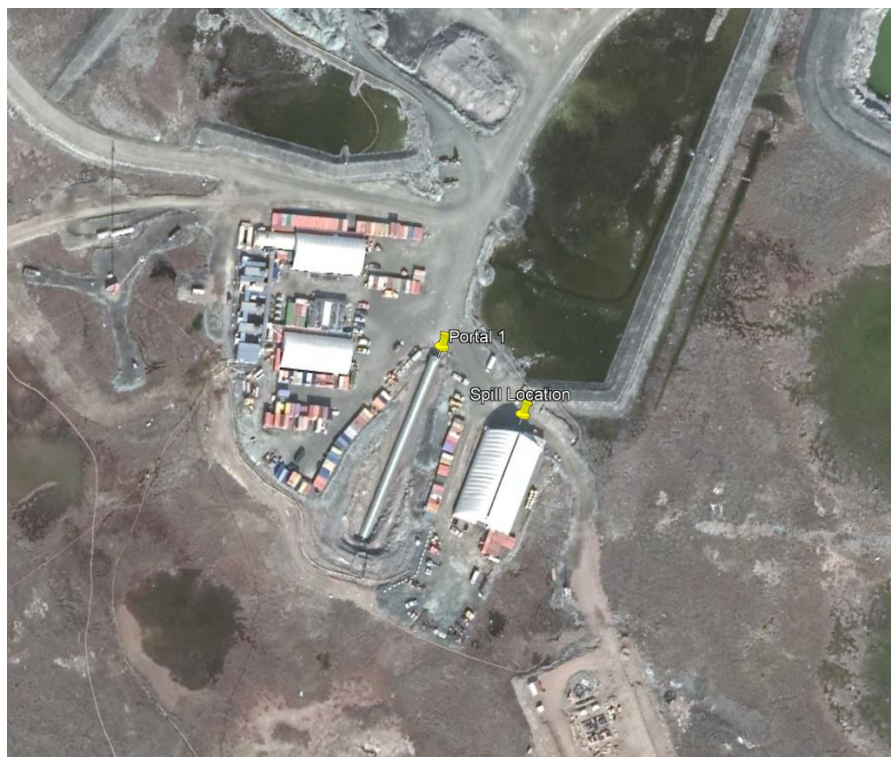
Figure 1: Location of powdered caustic soda spill near portal one and SWTP.

On December 21st the Environment Department was contacted by a worker at the Saline Water Treatment Plant informing that two bags of powdered sodium hydroxide had torn open and partially spilled to the ground. While unloading a pallet, the load shifted and the bags slid off. Each bag contains 22.68kg (50lbs).

No water bodies were impacted by this spill. The closest natural water body is over 900m from the spill location. The coordinates of the spill are 63°1'34", 92°12'38".
