Appendix F-3

Reportable Spills and Follow-up Reports

Follow Up Report: #19-020

January 18, 2019 Emulsion Tote Spill

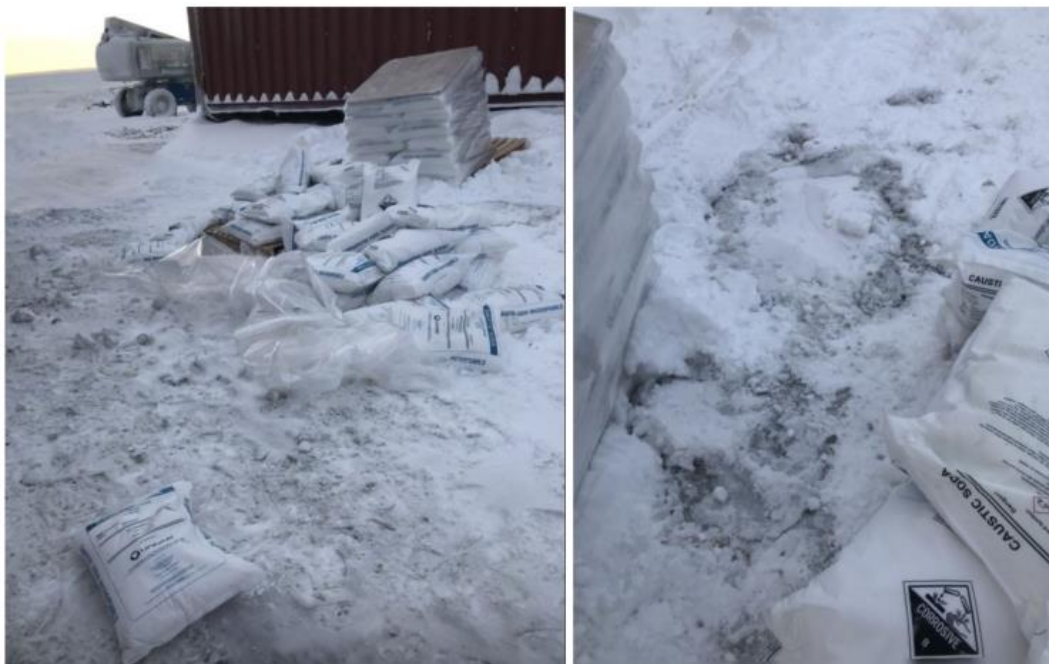
Figure 2: Two bags of Sodium Hydroxide powder spilled near portal one.
