# MEADOWBANK MINE

## 2019 WILDLIFE MONITORING SUMMARY REPORT

### 2019 Migratory Bird Protection Report

**2019 Migratory Bird Protection Report**

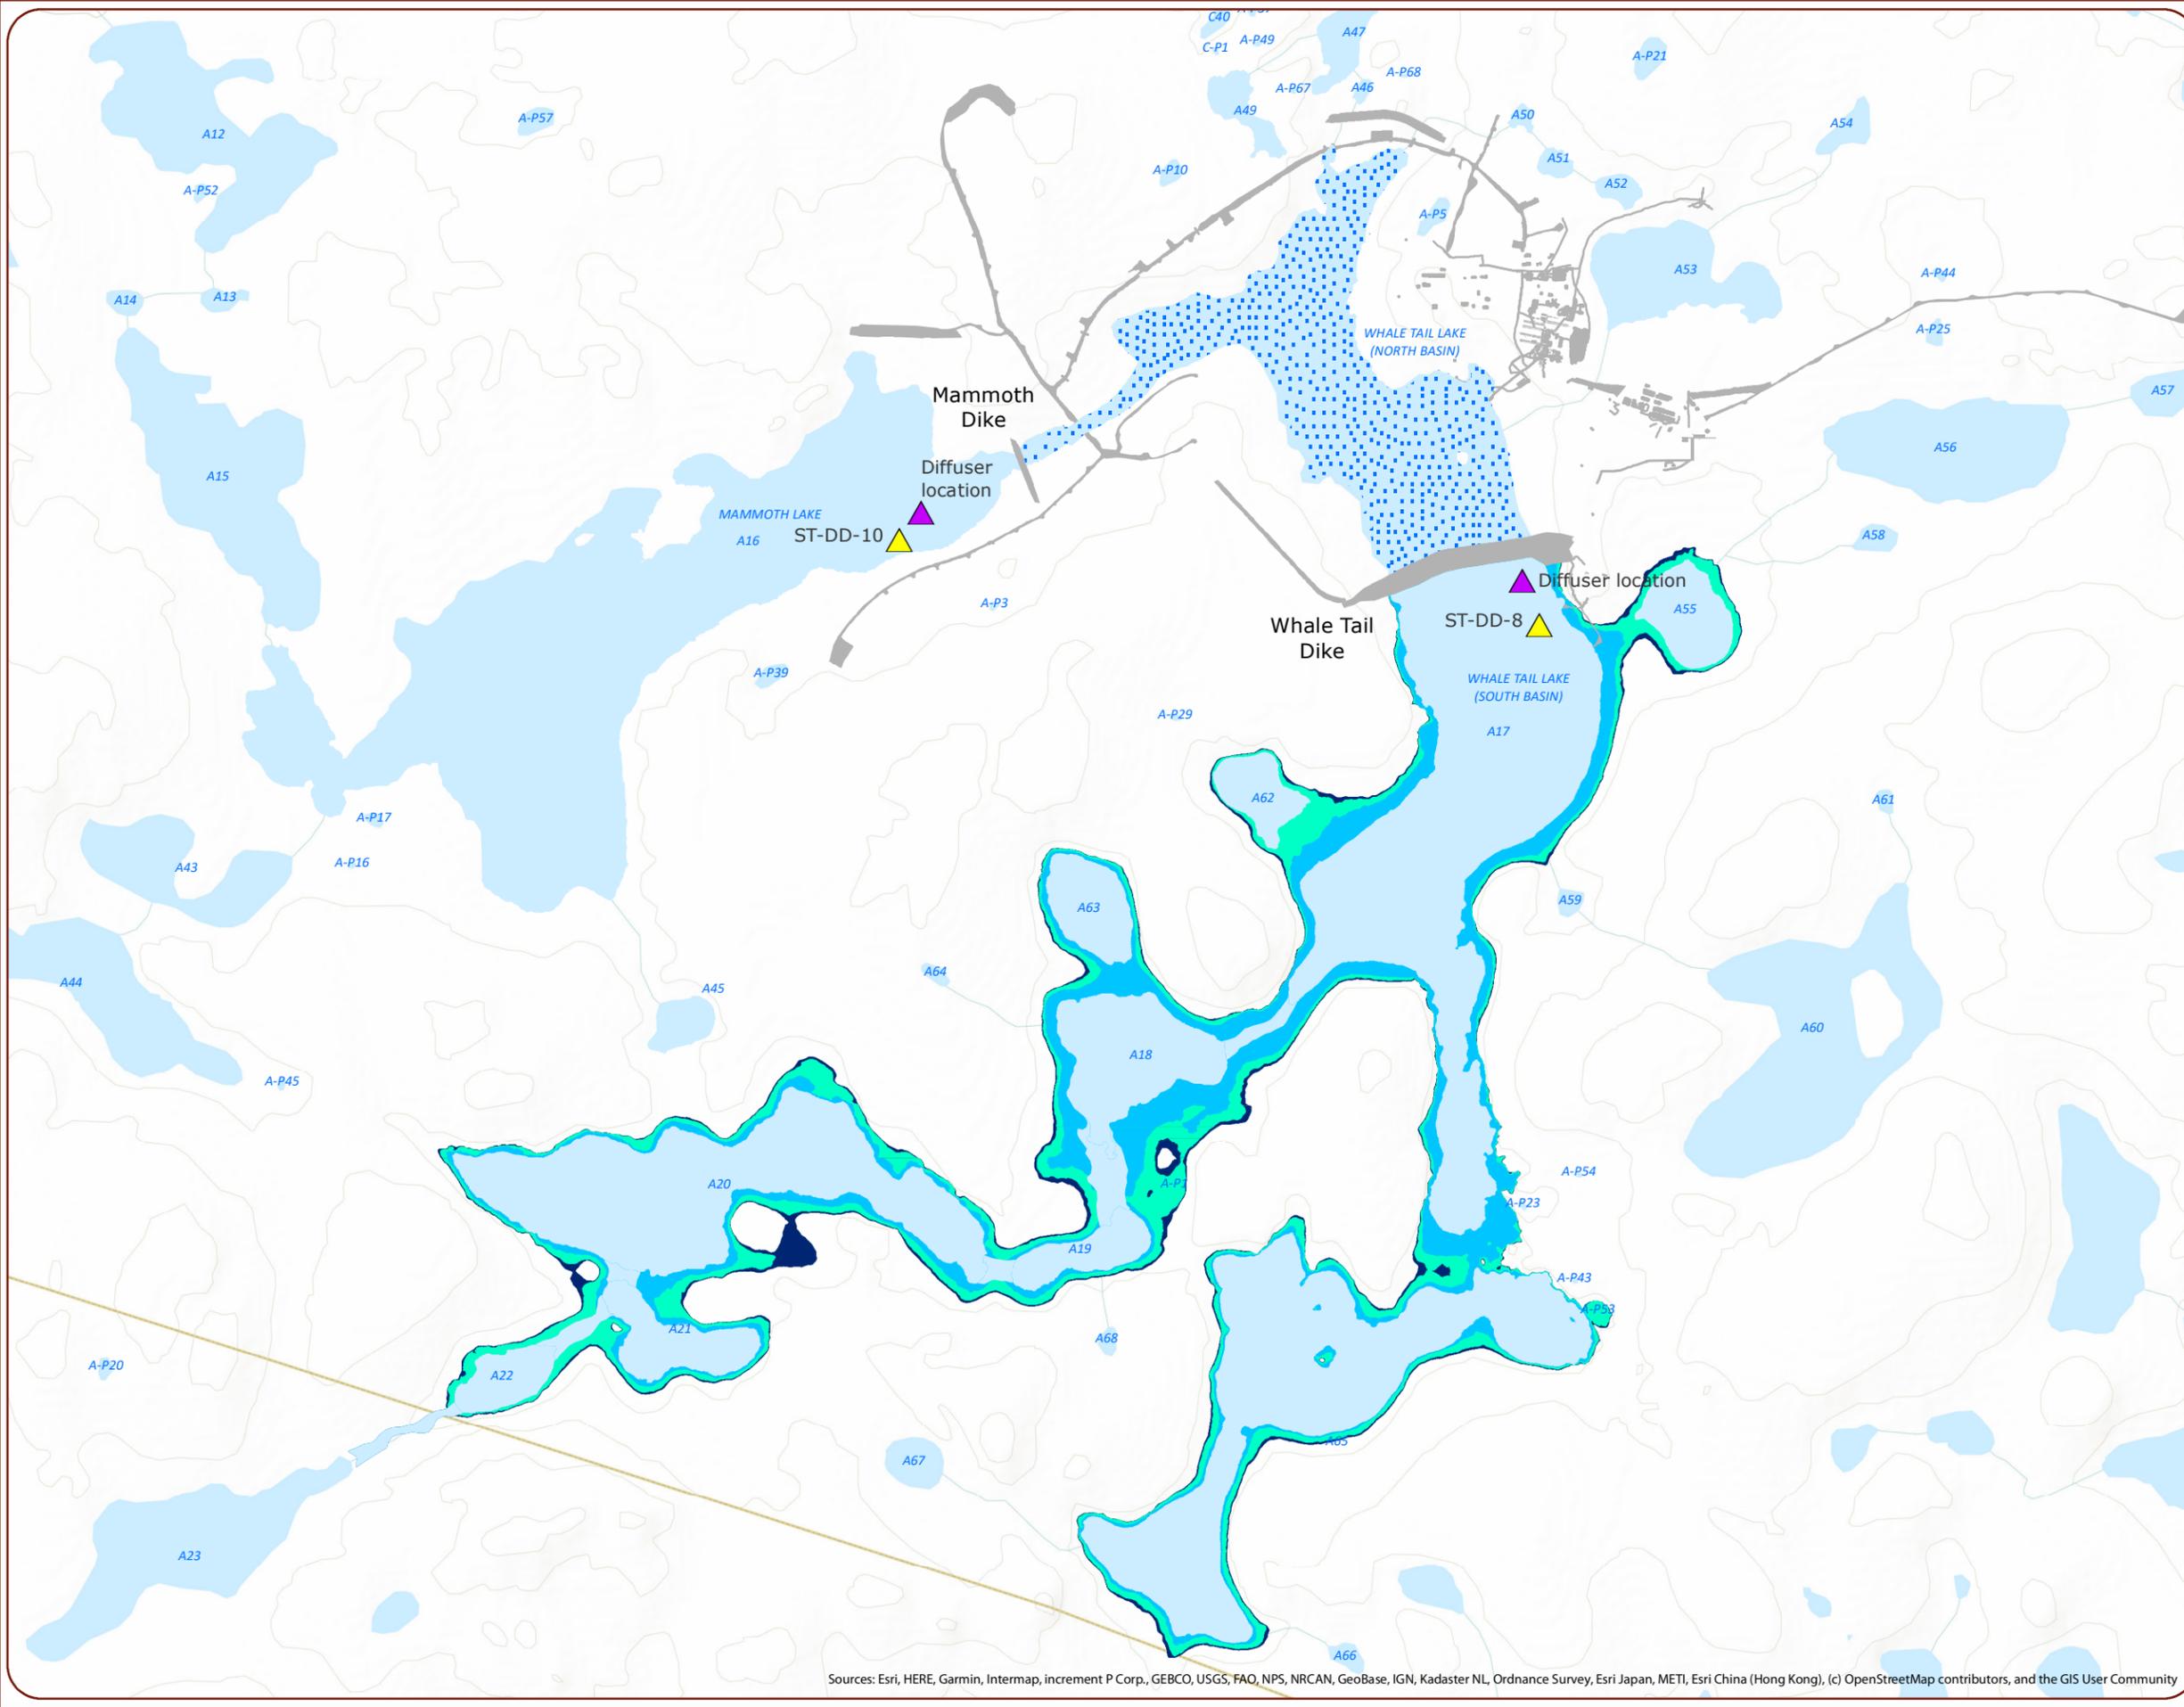
Figure 1: Whale Tail South Flood Zone Water Levels

2019 Final Water Level (155.17 mas)
-

2019 Peak Water Level (155.84 mas)
-

Max Predicted Water Level (156 mas)

The Whale Tail Lake (South Basin) diversion (Figure 1) was initiated through construction of the Whale Tail Dike to divert flow from Whale Tail Lake and tributary lakes through Lake A45, just south of Lake A16 (Mammoth Lake). Flooded tributary lakes include Lake A18, Lake A19, Lake A20, Lake A21, Lake A22, Lake A55, Lake A62, Lake A63, Lake A65, Pond A-P1, and Pond A-P53. In-water construction of the Whale Tail Dike was completed September 2018, and dewatering of the North Basin of Whale Tail Lake to advance flooding began in March, 2019. The rise in water levels from baseline (~152.5 masl) to 156.00 masl of this area will occur in 2019 and 2020, causing approximately 157 ha of terrestrial flooding.

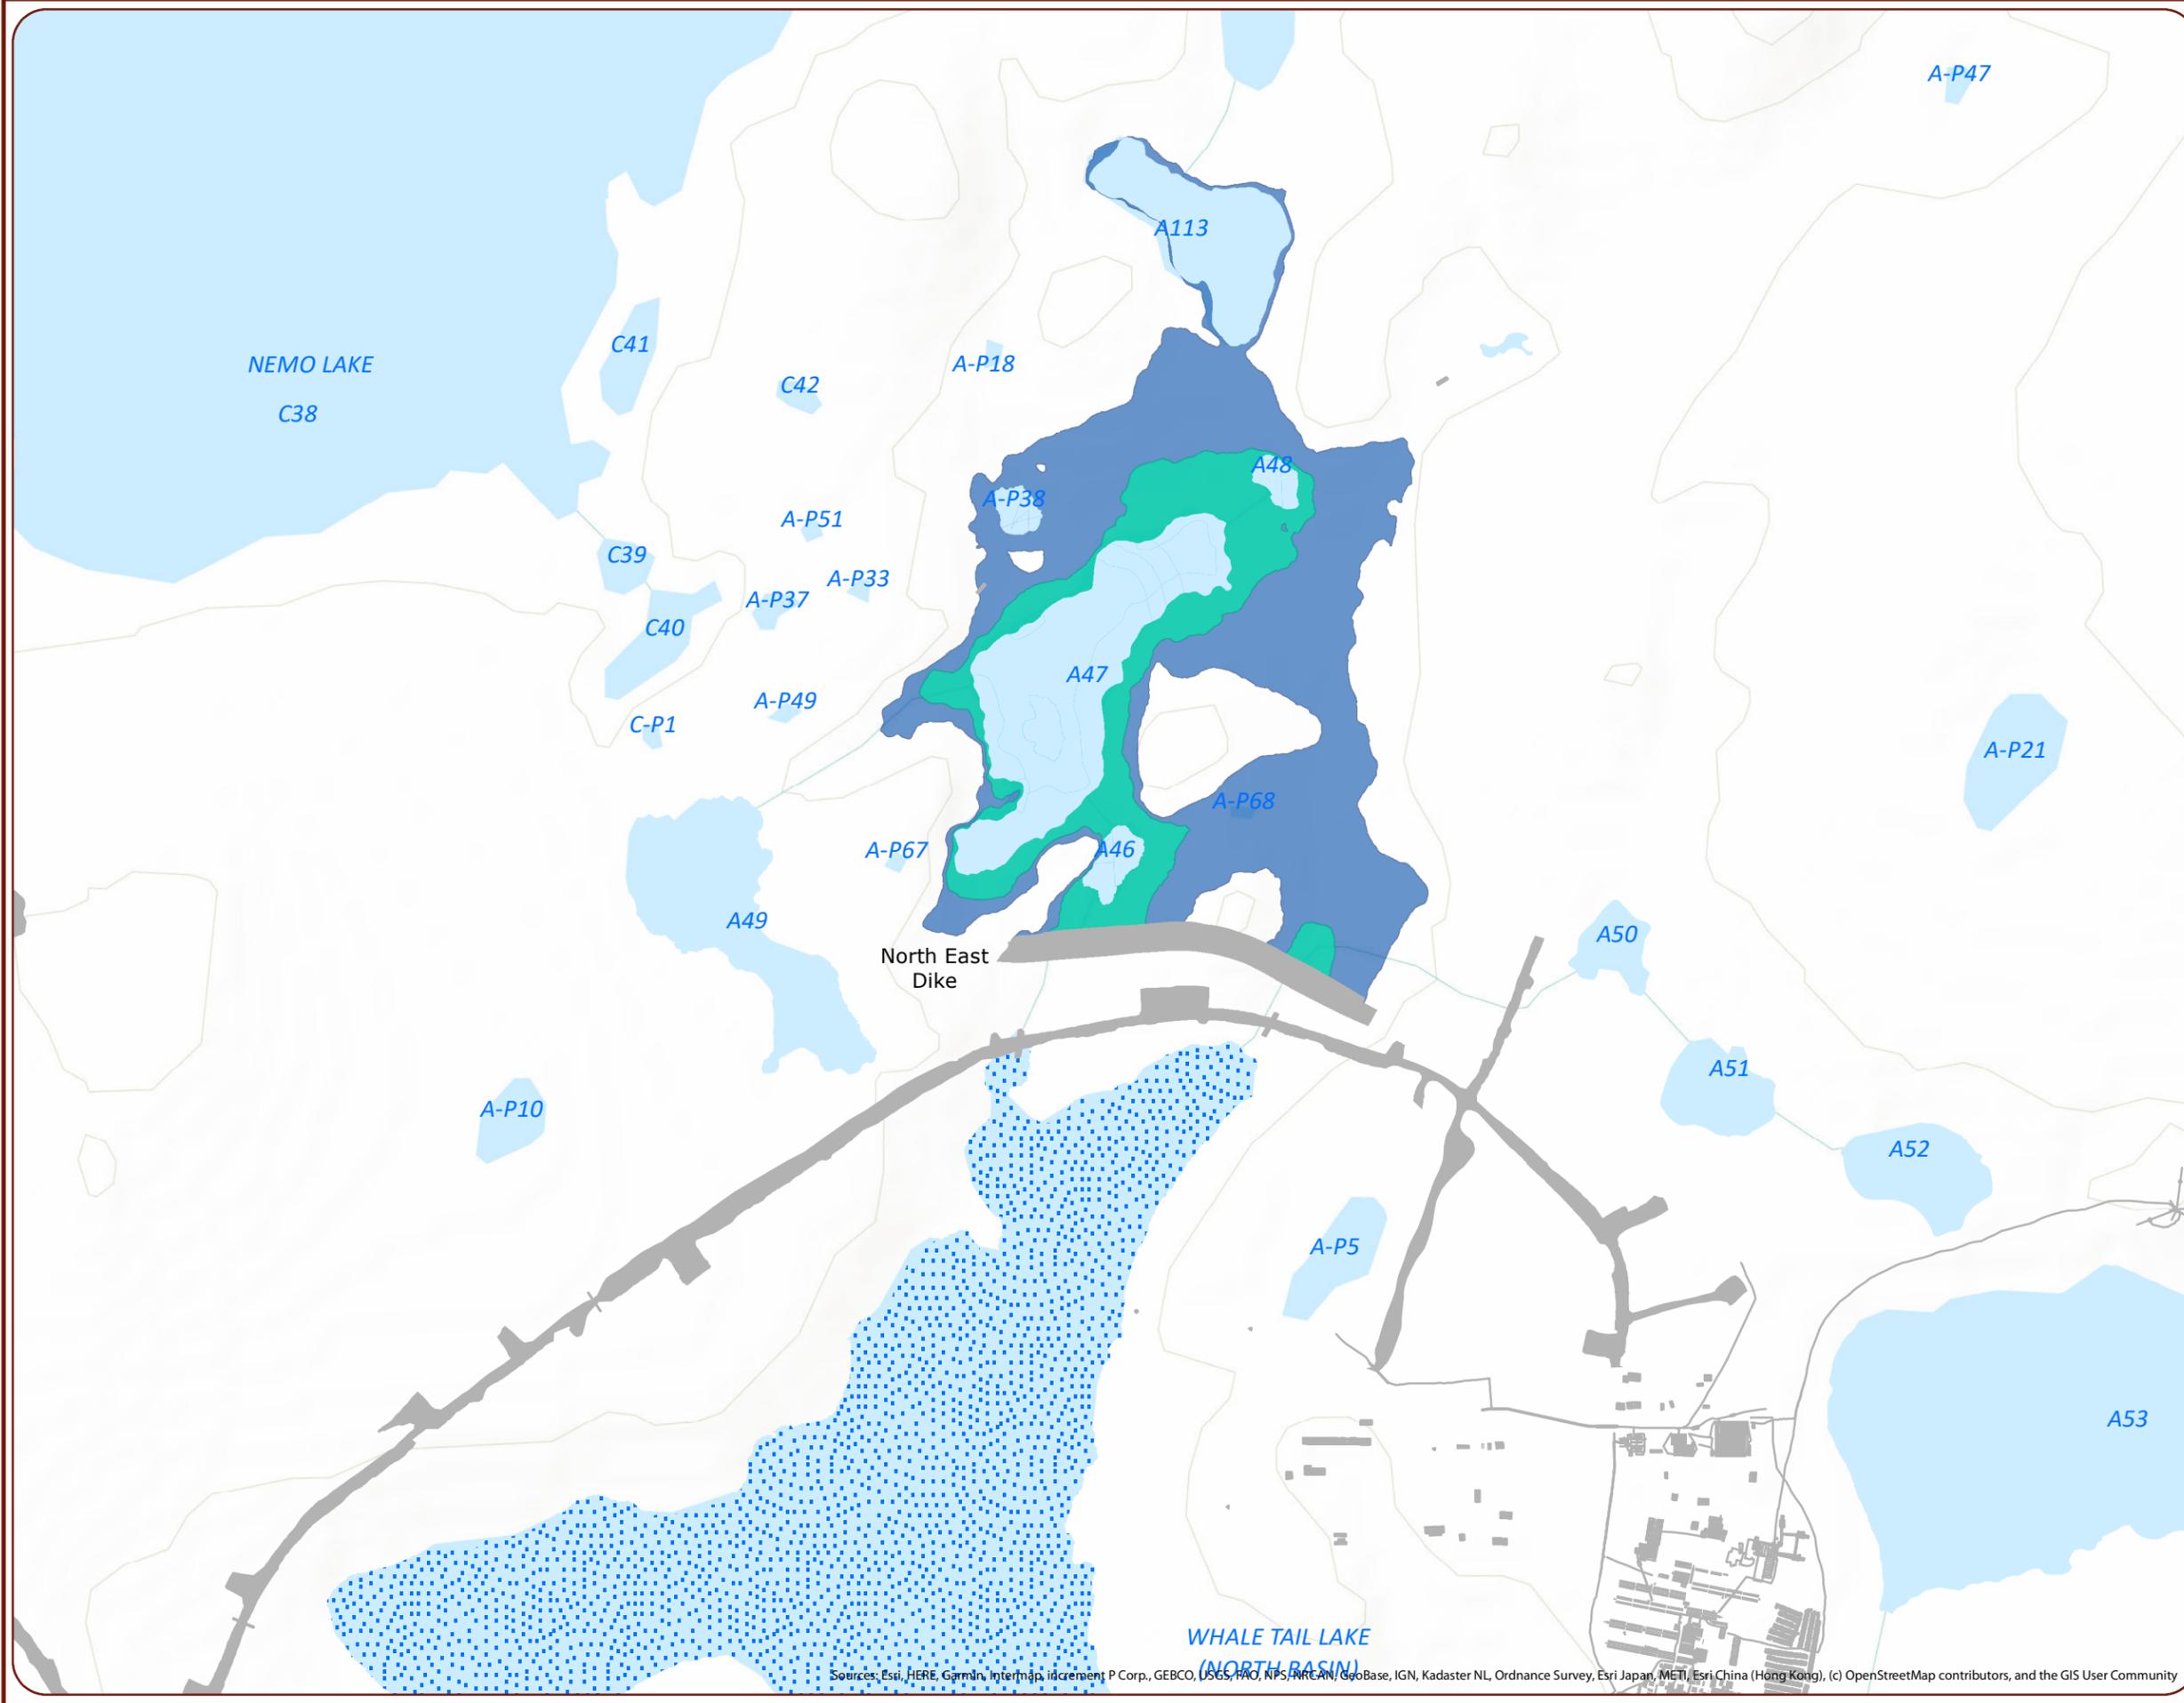
Figure 2: North East Diversion Flood Zone Water Levels

Final 2019 water level (155.66 masl)
  -

Final predicted water level and peak 2019 water level (156.66 masl)

The Northeast diversion (Figure 2) consists of construction of the Northeast dike to divert Lake A46 and tributary lakes through Lake C44 in the Lake C38 (Nemo Lake) watershed. Flooded tributary lakes include Lake A47, Lake A48, Lake A113, Pond A-P38, and Pond A-P68. The main construction activities for the Northeast dike were carried out from September 2018 to February 2019. Flooding of this area began in spring 2019, and the estimated total flooded terrestrial area is 18 ha.

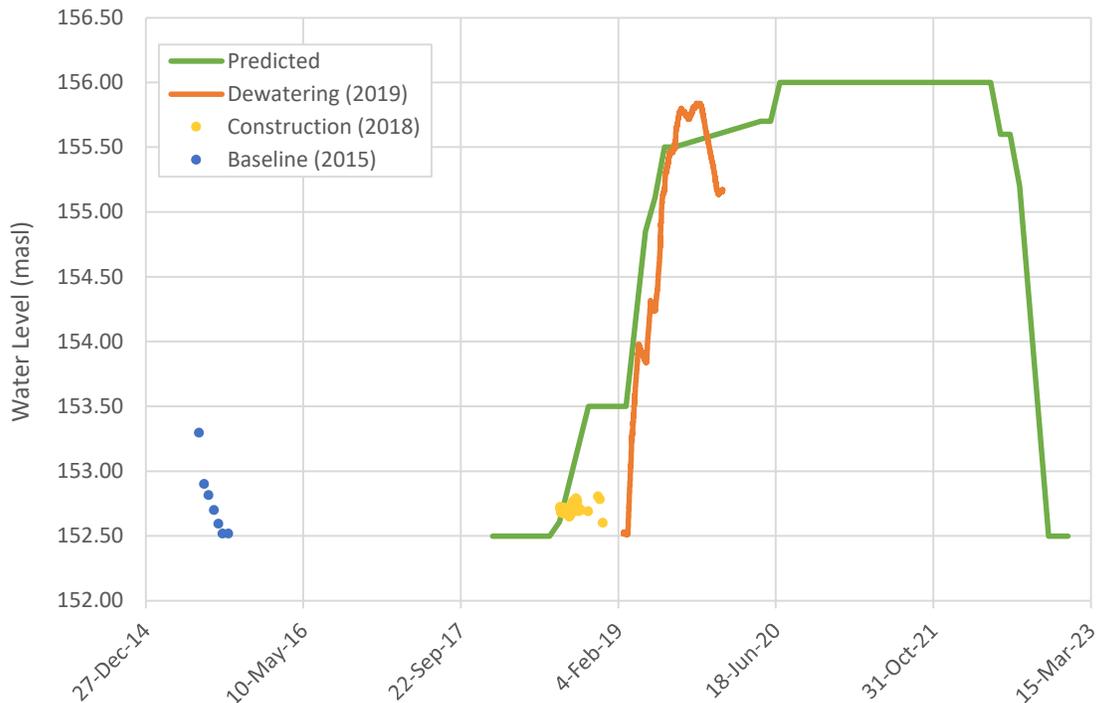
**Figure 3. Measured and FEIS-predicted water levels in Whale Tail Lake South. Predicted water levels from FEIS Appendix 6-F.**

Maximum predicted water levels in the Whale Tail South flood zone are shown in Figure 3, along with measured peak flood levels in 2019, and final water levels (December, 2019). The progression of flooding in 2019 (measured water levels) is shown in Figure 3, in relation to FEIS predictions.

Due to record rainfall, peak water levels in 2019 exceeded predictions in July, but did not reach the maximum predicted final flood level of 156.0 masl, which is planned to occur in 2020. Following discussions with NWB, Agnico temporarily pumped non-contact water from the Whale Tail South (WTS) flood zone directly to Mammoth Lake, from October 21 to December 18, 2019. Construction of the South Whale Tail Channel (SWTC) began in late 2019, and is expected to be completed prior to freshet in 2020, which will ensure water levels remain within the maximum predicted range of 156.0 masl.

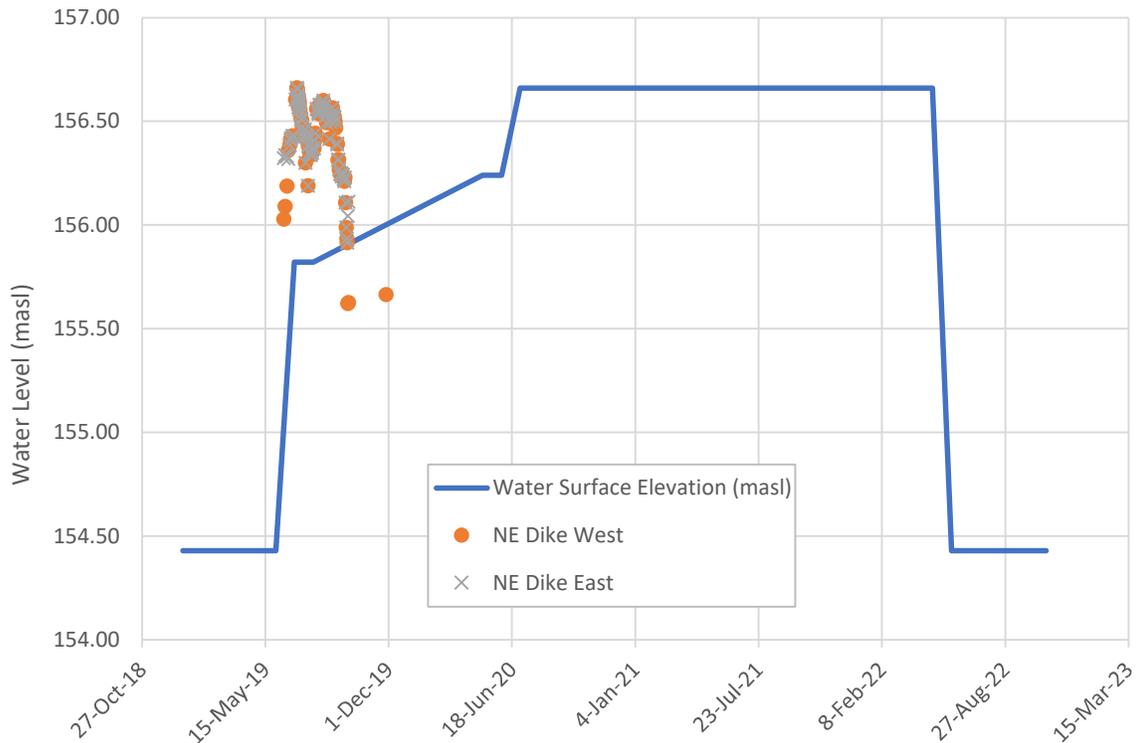
**Figure 4. Measured and FEIS-predicted water levels in the Northeast Diversion flood zone. Predicted water levels from FEIS Appendix 6-F.**

The Northeast Dike was constructed from September 2018 to February 2019. Maximum predicted water levels in the Northeast flood zone are shown in Figure 4, along with measured peak flood levels in 2019, and final water levels (December, 2019). FEIS water management plans indicated that this flood water would increase to the maximum elevation of 156.6 masl, and then flow naturally through a tundra pond system to Nemo Lake.

The maximum predicted flood level in this area (156.6 masl) was reached on July 6, 2019 (Figure 4). At that point, it was observed that the topography toward Nemo Lake would not allow water to overflow naturally before overtopping the dike liner. As a result, water has been pumped out of that area since July 2019 (initially towards Whale Tail Lake North Basin and A-P5 Stormwater Management Pond, but then to Nemo Lake as non-contact water, beginning in August, 2019).

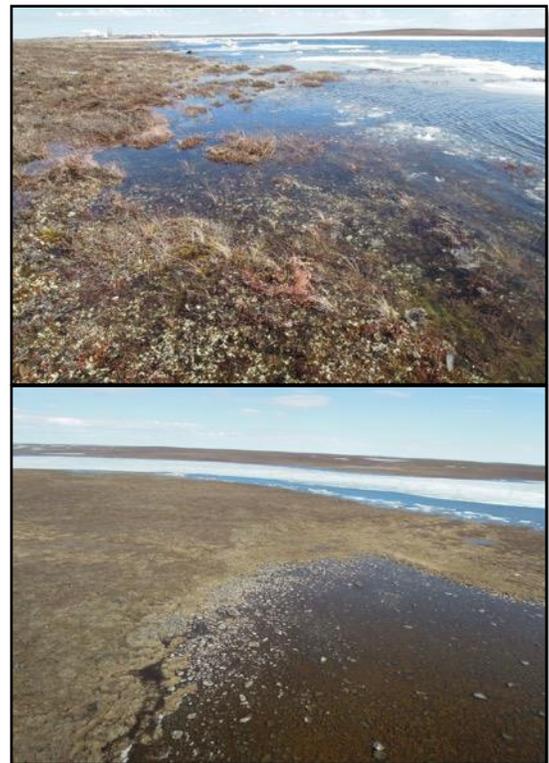
Figure 1: Examples of the shoreline flooding due to the diversion into the southern basin of Whale Tail Lake. Top: A view ground view of the flooding at WT3 site, Amaruq Camp in the background. Bottom: An above view of the flooding at WT3 site.

obvious signs of water level changes on the land (Figure 1). Deterrent deployment was delayed due to late arrival of gear and the heavy snow fall. All deterrents were deployed between 6<sup>th</sup> and 17<sup>th</sup> of June. The field season ended on 19<sup>th</sup> of July with the entire Waterbird Mitigation Project crew, departing Meadowbank. The field season was a total of 57 days.

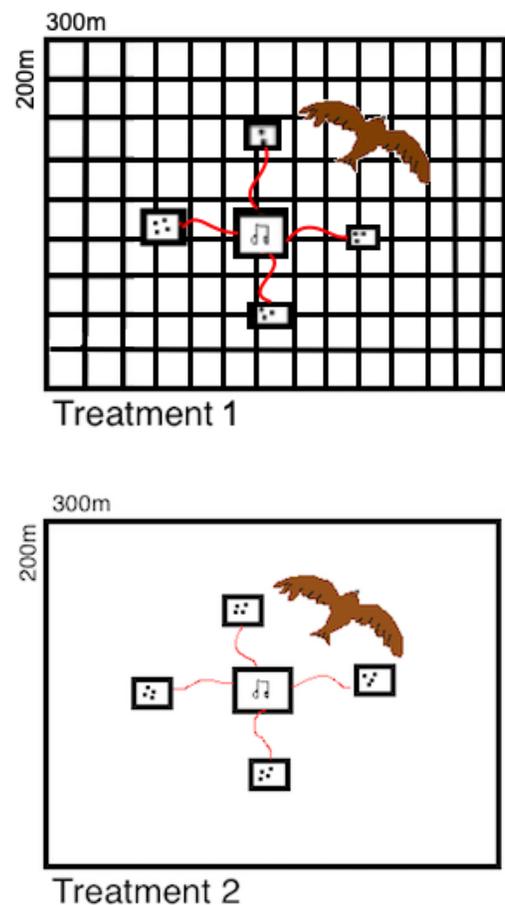
Figure 2: Illustrations of the two types of Treatment: Treatment 1 (top): audio deterrents, Jackite® predator effigy and 20 x 20 m grid of Flash Tape, and Treatment 2 (bottom): audio deterrents and Jackite® predator effigy. Used during the 2019 field season.

Deterrents were placed in experimental plots (300 m x 200 m, 6 ha) established during 2018 (n = 15). These plots were placed within 1 km of the Amaruq road between the 5<sup>th</sup> of June and 14<sup>th</sup> of June (Appendix 1). Experimental plots were divided into five sets of plots, with each set containing two treatment plots (Treatment 1 and 2) and one set of control plots. Treatment 1 consisted of audio deterrents playing a mix of predatory and distress calls paired with a Jackite® predator effigy placed in the centre of the plot, and Flash Tape covering the entire plot, with tape deployed every 20 m in both directions (Figure 1). Treatment 1 was chosen to potentially be the most effective at deterring breeding birds but was also the most labour-intensive. Treatment 2 consisted of audio deterrents and an effigy only and was selected as a less labour-intensive option (Figure 2). Control plots contained no deterrents.

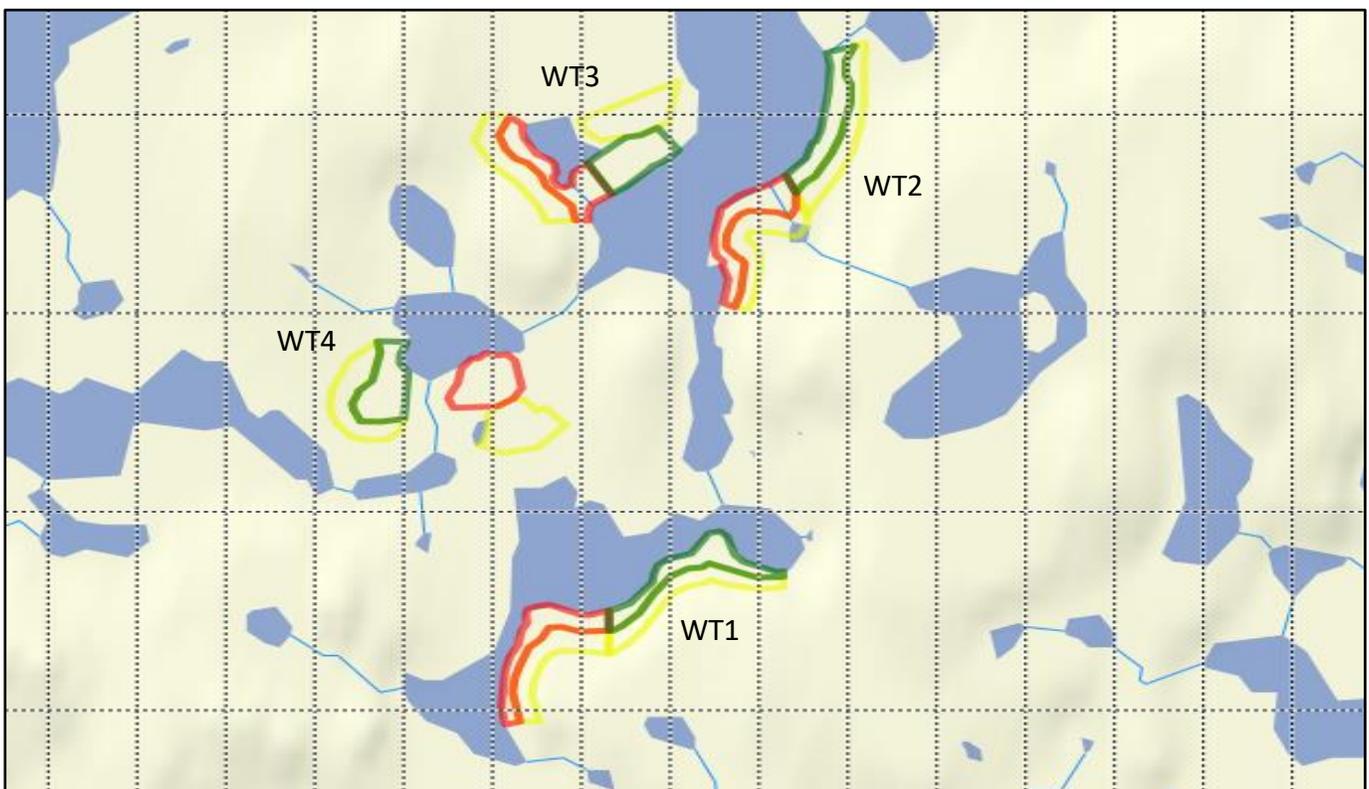
**Figure 3: Map of the four main study sites (WT1, WT2, WT3, WT4) around Whale Tail Lake and its connecting lakes and tributaries. The Flood plots (red) and Treatment plots (green) are within the proposed flood zone, and the Control (yellow) plots are adjacent to the proposed flood zone.**

The crew from Trent University deployed audio and visual deterrents throughout selected plots within the Whale Tail South flood zone (Appendix A, Figure 3) between June 16 and 17, 2019. These were the earliest dates logistically feasible, based on weather conditions (primarily the need to wait for snowmelt). At this time, water levels were at 154.68 masl in Whale Tail South Basin, or approximately 2 m above baseline levels.

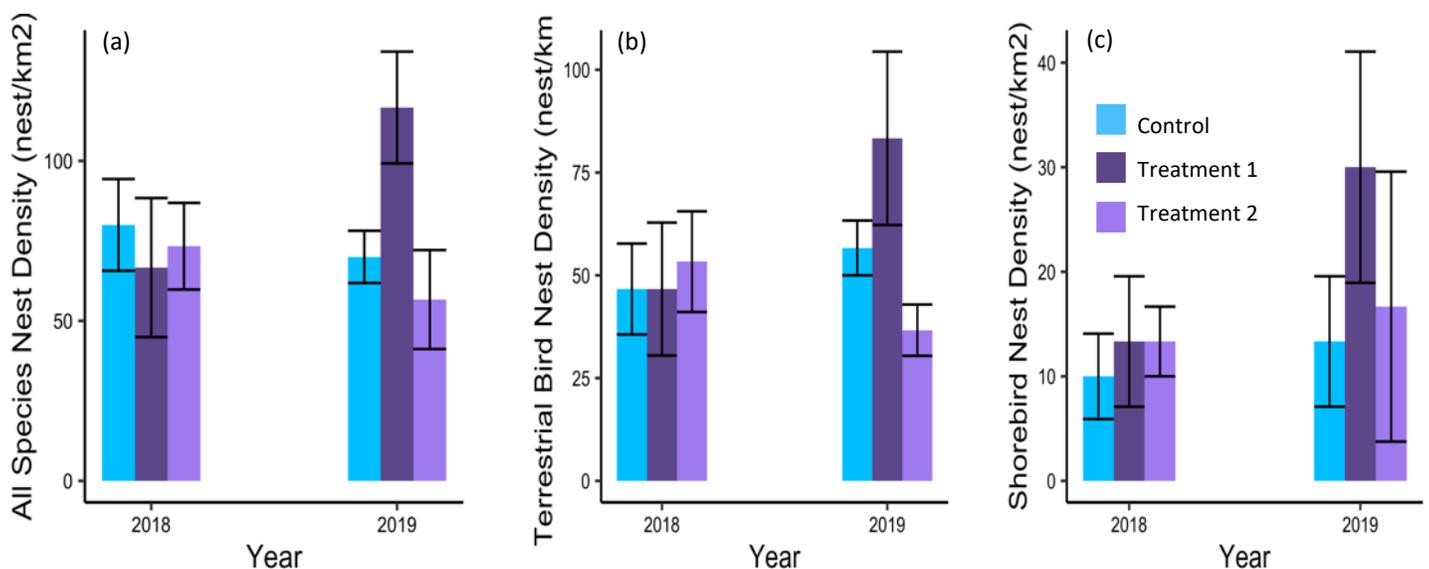
Figure 5: Nest densities (nests/km<sup>2</sup> ± SE) before (2018) and after (2019) deterrent deployment of two deterrents treatments, for all species present at the study site (a), only terrestrial bird species (b), only shorebird species (c) only.

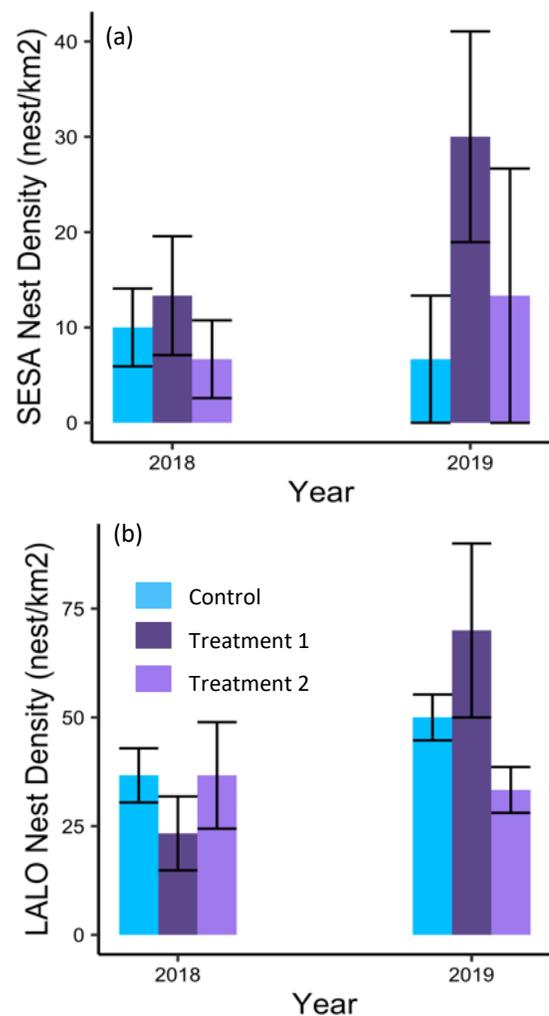
Figure 6: Nest densities (nests/km<sup>2</sup> ± SE) before (2018) and after (2019) deterrent deployment of two deterrents treatments for Lapland Longspur (a) or Semipalmated Sandpiper (b) only.

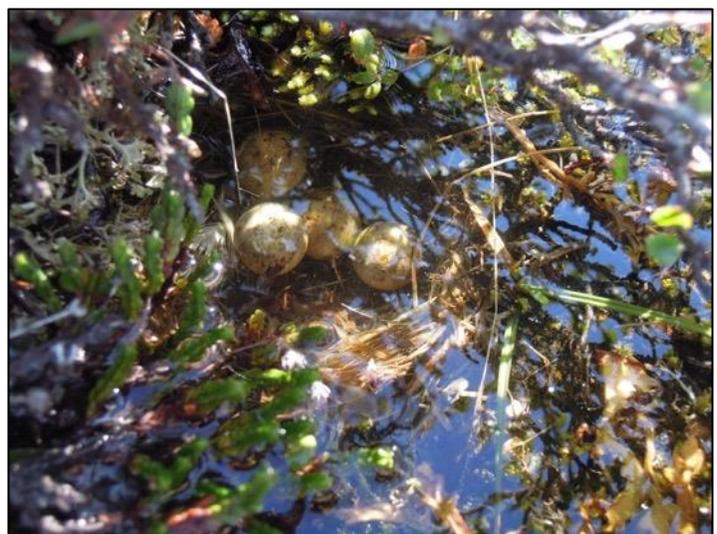
Figure 7: A Lapland Longspur nest with four eggs that was found within the Whale Tail Lake flood zone. It was found active, but later in the season became flooded.

During the flooding, we documented 6 nests of 3 species that were lost due to direct impacts of the high water (Figure 7). We estimate an average loss of 3.8 nests per km<sup>2</sup> by taking the number of nests observed to be lost and dividing it by the total proposed flood zone of Whale Tail Lake (1.575 km<sup>2</sup>). The species that lost nests were Lapland Longspur (4), Semipalmated Sandpiper (1) and Herring Gull (1). Despite nest loss due to flooding and a significant amount of habitat loss, nests in the proposed flood zone had an estimated success rate of 56%.

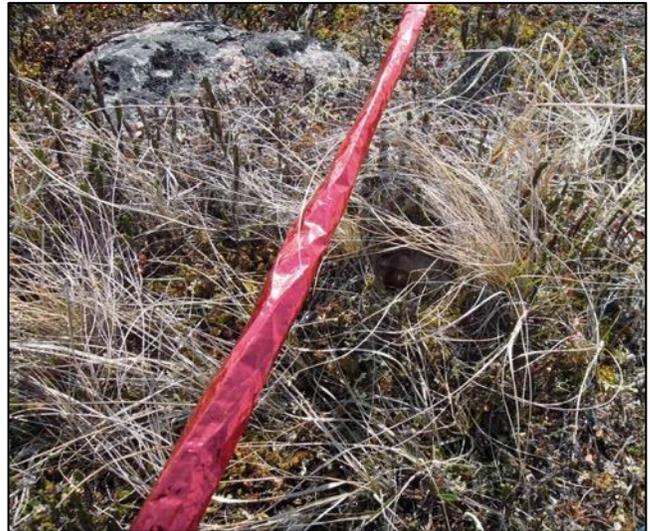
**Figure 8: An extremely concealed Lapland Longspur nest with a piece of flash tape draped over it.**

Our sample is dominated by small, short-lived species such as Lapland Longspur. These species may be especially reluctant to abandon or forgo a breeding attempt in the presence of novel objects such as our deterrents, as they have fewer breeding opportunities compared to long-lived species. Previous studies have demonstrated the ability to deter birds from nesting with the use of a flash tape grid and other visual deterrents, such as done by Marcus et al. (2007) where these authors were successful in deterring Piping Plover and Least Tern from nesting within gravel pits. In the case of our study, Lapland Longspur showed no signs of obvious distress or disturbance during deterrent use. There were multiple occasions where a nest was found within 5 m of an audio deterrent speaker or directly under a piece of flash tape (Figure 8).
