AGGREGATE RESOURCE STUDY RANKIN INLET, NUNAVUT

*Report No. L-15-1860
November 23, 2016*

EXECUTIVE SUMMARY

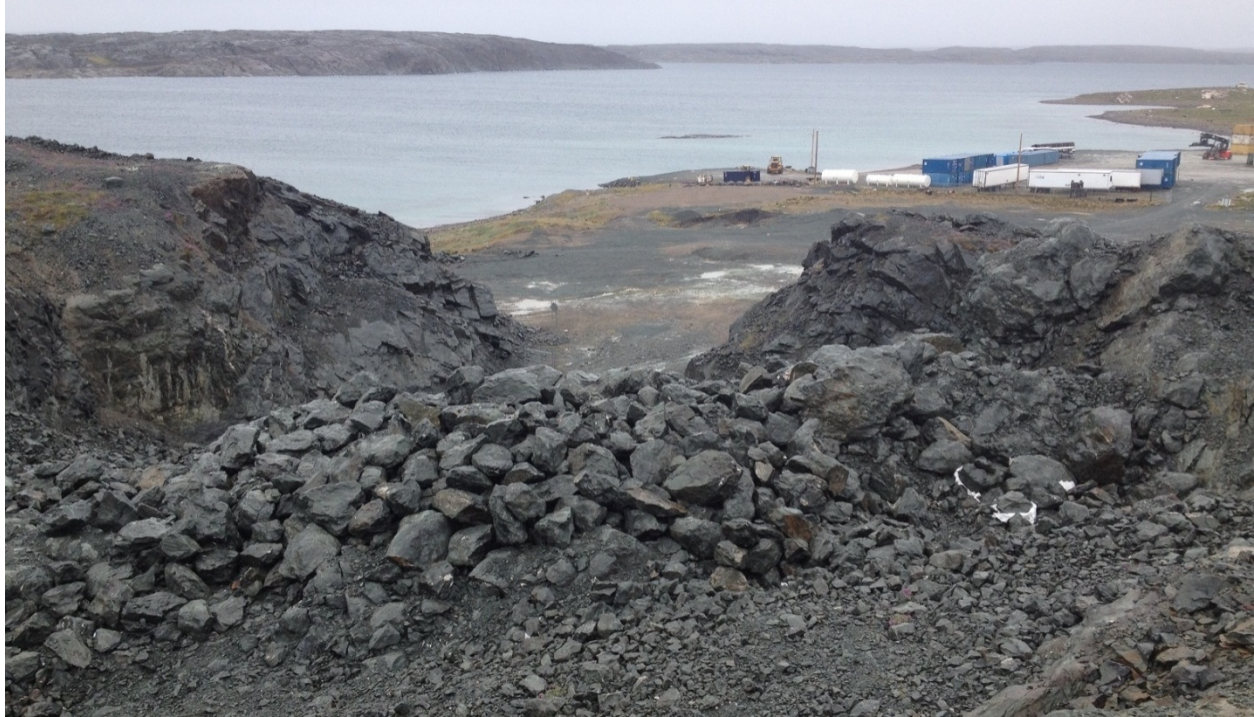
Figure 3-3: Existing bedrock quarry at the harbour south of the airport. It was initially used in 2007 to produce aggregates for the Hamlet. (Photo: July, 2016).

Alternatively, expensive bedrock drilling, blasting, and crushing operations are used to meet aggregate needs, as was done in 2007 in a quarry south of the airstrip adjacent to the harbour. This quarry was developed by a contractor to produce maintenance aggregates, concrete and asphalt aggregates for the Hamlet (see Figure 3-3 below).

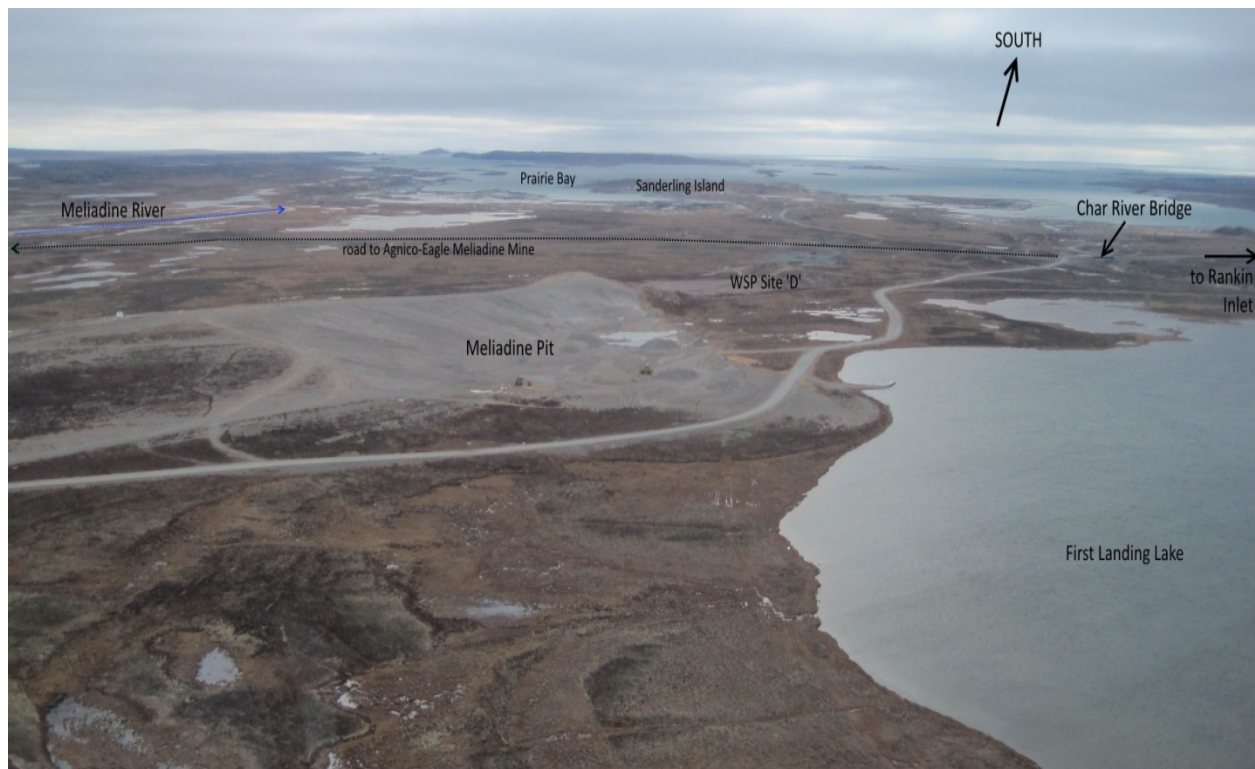
Figure 4-3: Overlooking the existing Meliadine Pit area and WSP Site D (Photo: Sept., 2014)

Site D is south of the existing Meliadine Pit (Figure 4-3) and is part of the same long esker deposit that also extends north into the Territorial Park. It has been deemed too sand-rich and lacking in required coarse aggregate composition, although it would be still be suitable for building pad fills, road subbase material, landfill cover, and the anticipated new baseball diamond and graveyard expansion.

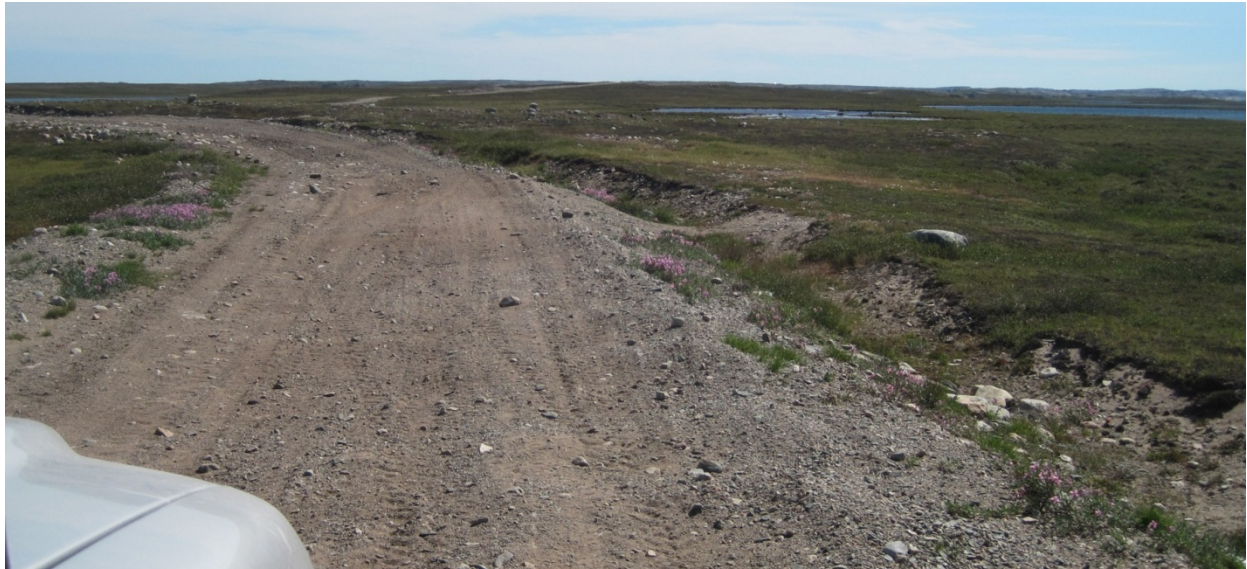
Figure 5-1a: The Diane River Rd. is an example of a narrow penetration road built with material from a drainage ditch with a thin sand and gravel running course where required.

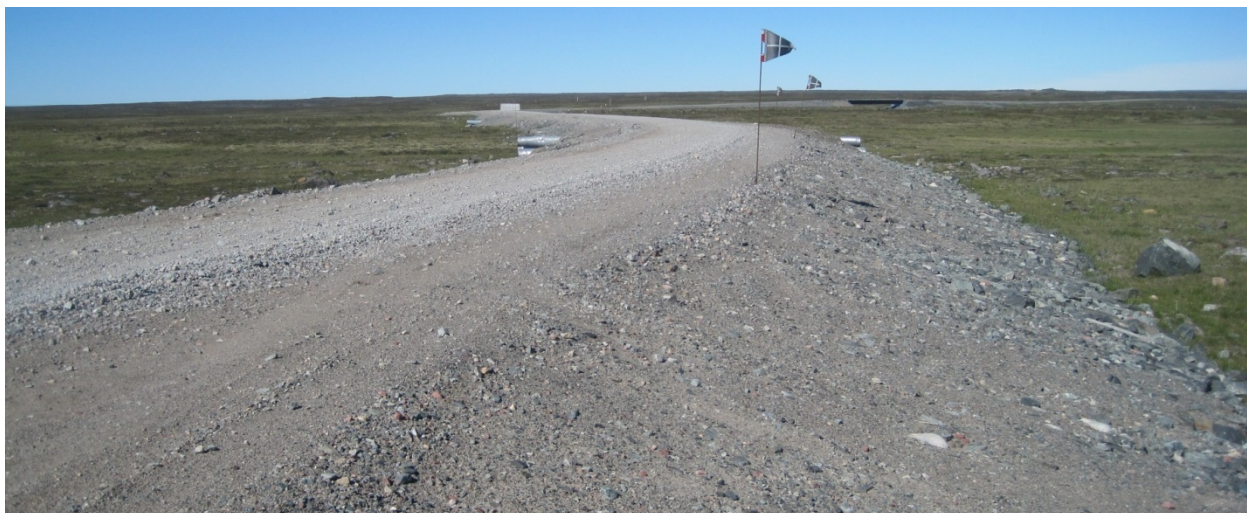
Figure 5-1b: The wide Meliadine Mine Road is 2+ m thick and built entirely from hauled and placed material, with no ditches.

Road construction generally requires the largest quantities of granular material, although careful attention to effective construction methods and route selection can greatly reduce the amount of granular material required. Figure 5-1 shows examples of the variable gravel quantities needed in road construction, which can greatly be reduced by careful route selection.

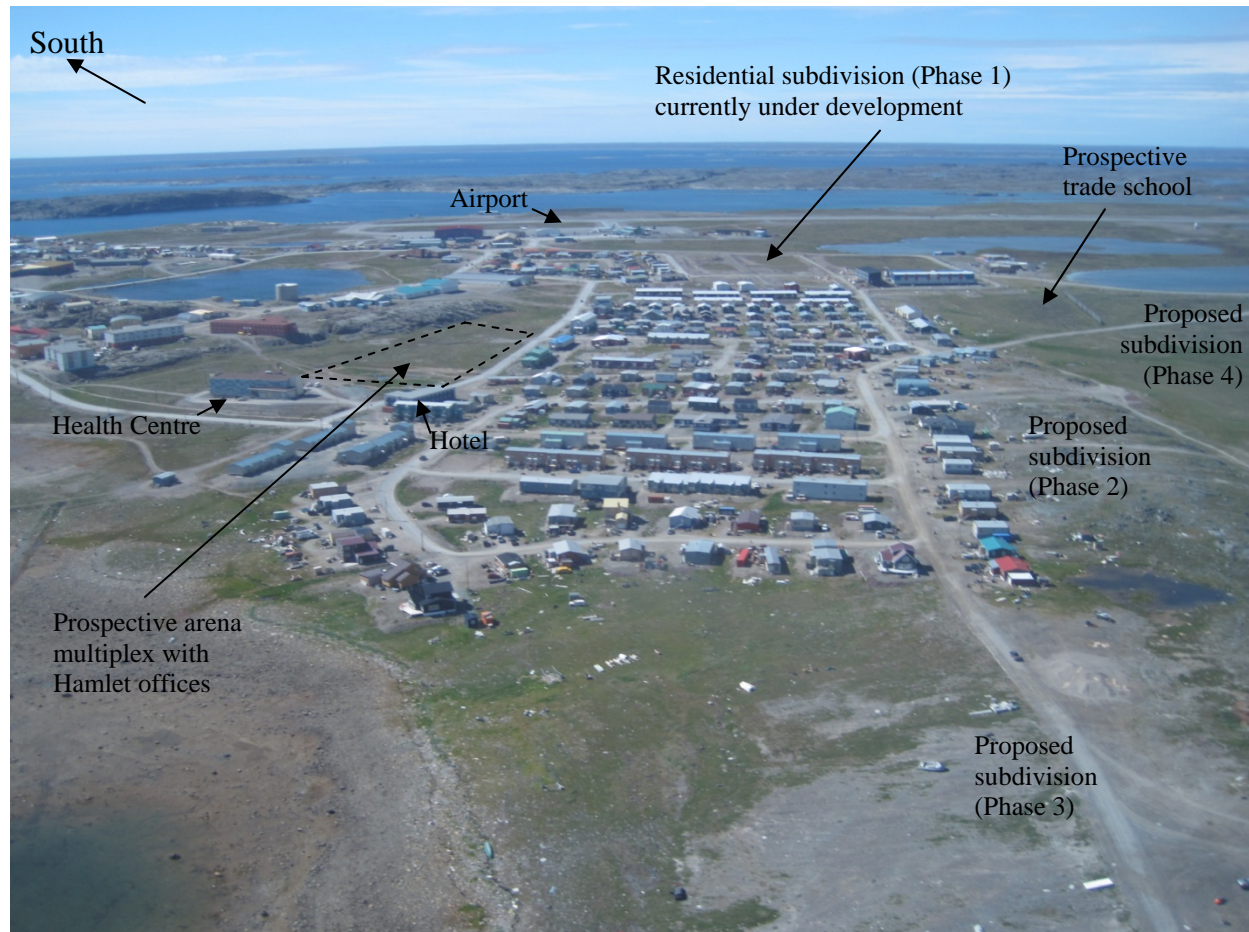
Figure 5-2: Looking southwest over the north end of Rankin Inlet. Numerous proposed development areas requiring aggregate fills are shown on the photo. (Photo: July, 2016).

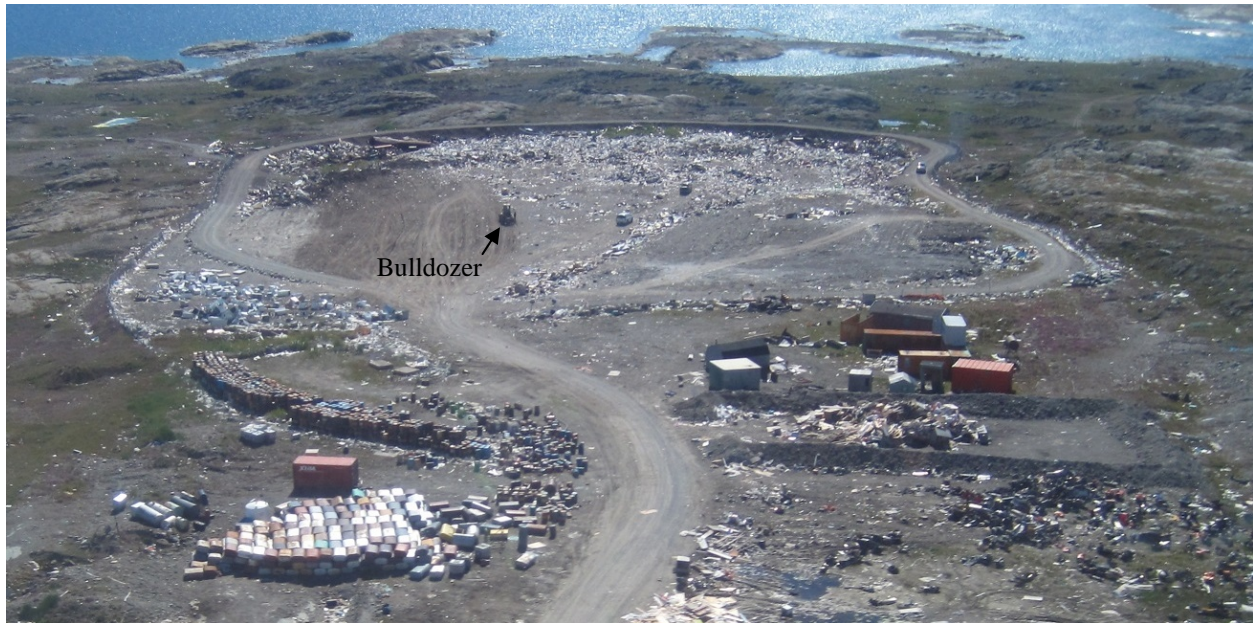
Figure 5-3: Rankin Inlet's current landfill site. A bulldozer can be seen spreading a thin cover of soil over a portion of the landfill (Photo: July, 2016).

The granular volume needs assessment in Table A-1 in Appendix A assumes an average of 2,500 m² annually to be covered with 0.3 m of sandy reject overburden. The approximate 40,000 m² existing landfill area and projected 20-year additional area of 40,000 m² are expected to receive a final granular cover of 0.6 m in 5 years and in 20 years, respectively, or 50,000 m³ for the final cover unless additional layers or lifts are considered to extend the life of the landfill. Bulk waste (vehicles, appliances, etc.) and hazardous waste are not buried in the landfill and are therefore not included.

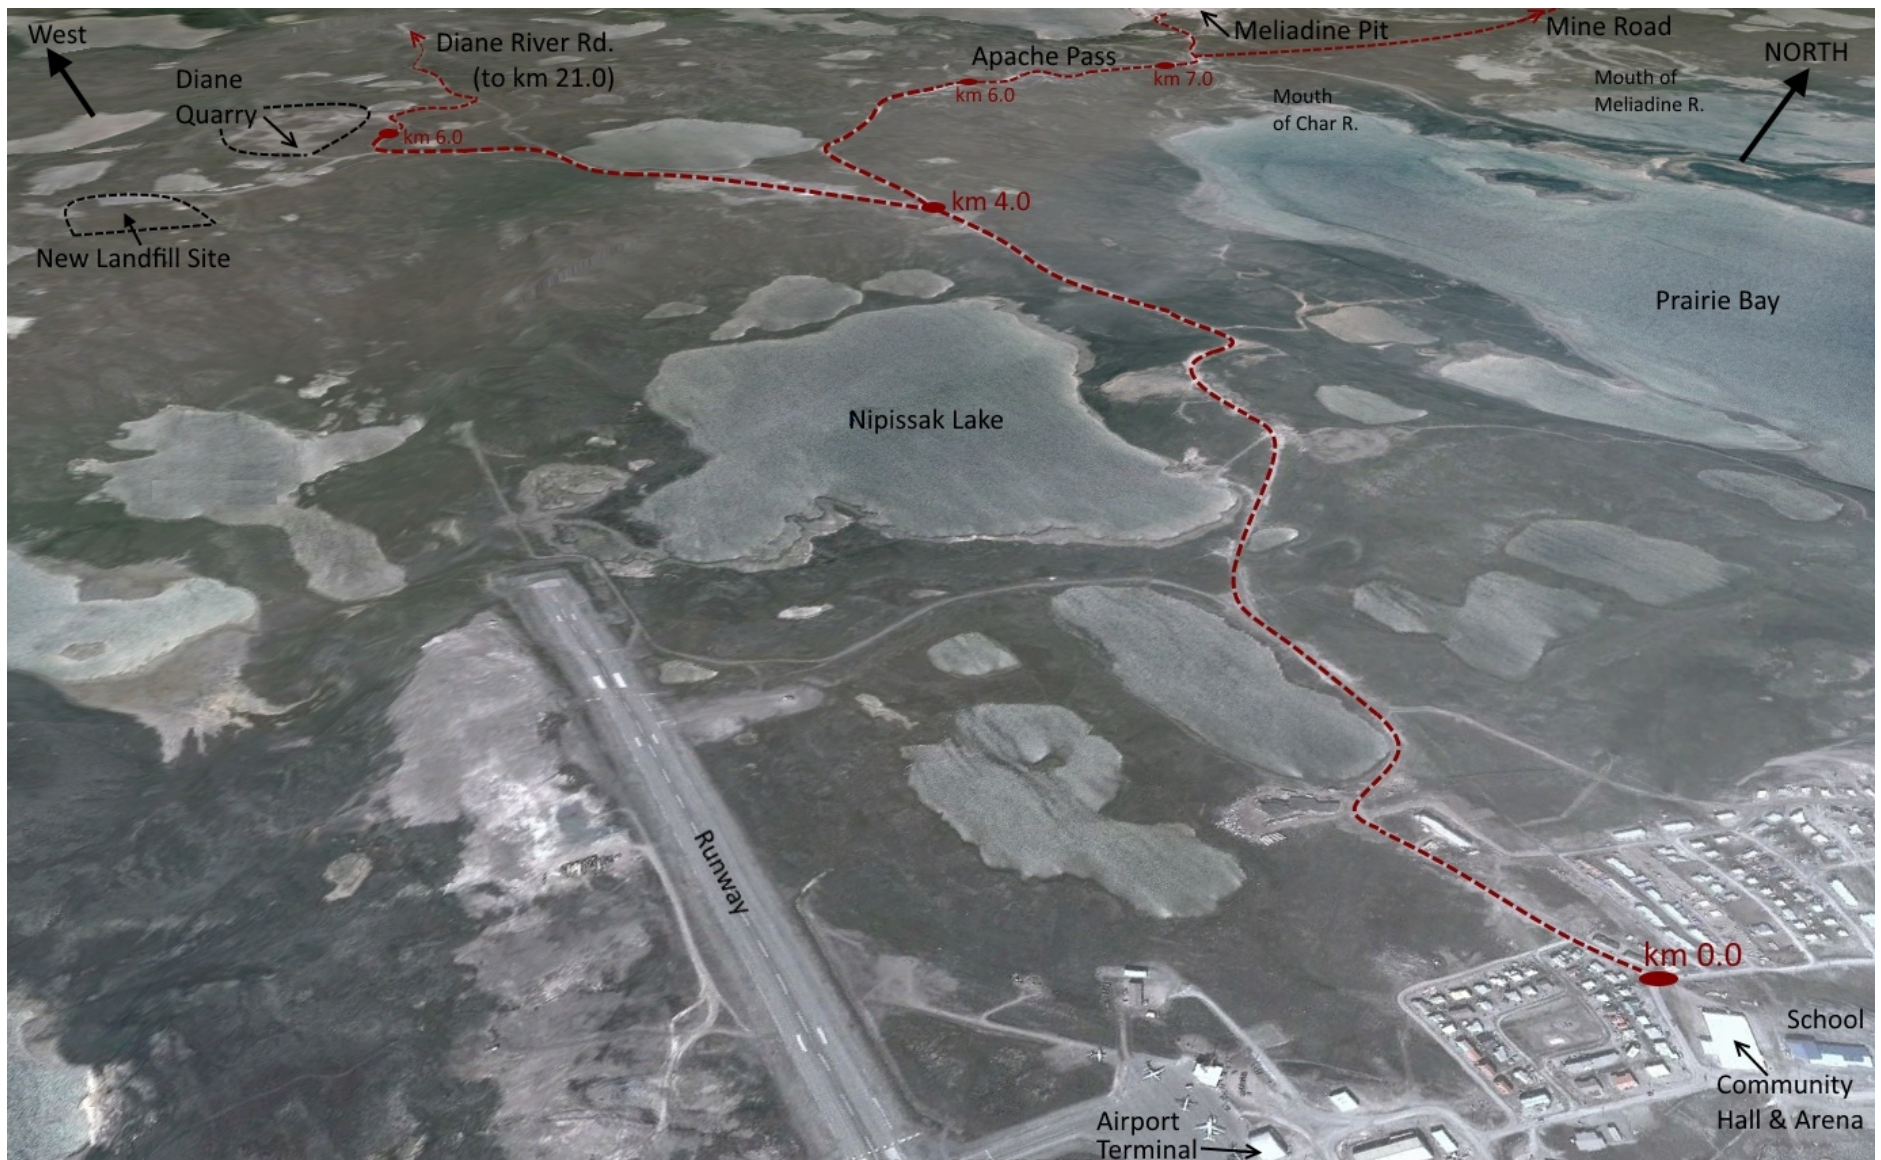
Figure 6-1: Location of reference km 0.0 used to identify sites by distance from Rankin Inlet (base map: Google, DigitalGlobe, 2016)

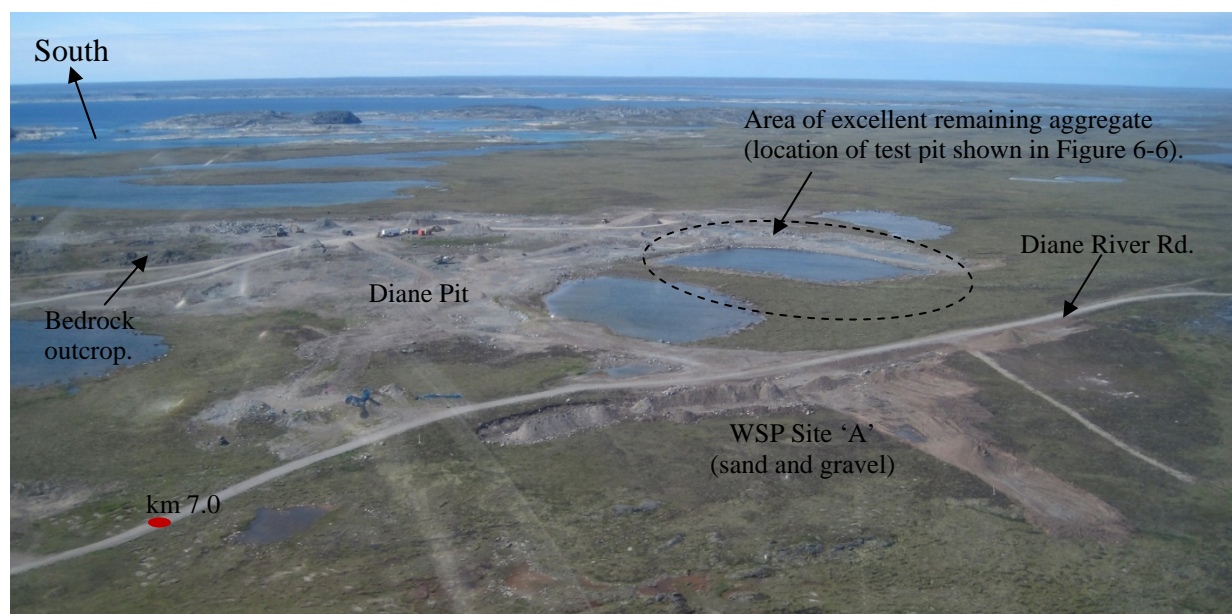
Figure 6-3: The Diane Pit and WSP sand and gravel source Site 'A', as of July, 2016.

This previously described borrow area is located between km 6.0 and 7.5 on the Diane River Road (Figure 6-3) and has been fully developed, with numerous stockpiles of various select crushed and screened materials remaining. The hamlet-owned screener currently sits in this pit, along with numerous pieces of equipment belonging to Inukshuk Construction. According to the contractor, the extracted sand and gravel material has varied across the pit area over the years.

Site 'A', investigated by WSP in 2014, is essentially an extension of the pit on the north side of the Diane River Road and reportedly contains 86,000 m³ of aggregate. The local contractor has begun excavating and stockpiling the material, as can be seen in Figure 6-3 and in Figure 6-5, below. The material closest to the road contains significant coarse aggregate, but appears to become increasingly sandy farther from the road (to the north).

A significant quantity (~40,000 m³) of high quality coarse aggregate also remains south of the road in the active pit, beneath and immediately west of the middle of three small lakes. Much of the gravel is below the water table. This area is circled in Figure 6-3 above and the quality of material is shown in Figure 6-6 below. A grain-size curve representing the minus 2" material is presented in Appendix D. The coarse fraction (minus 6") is estimated at 40% of the deposit.

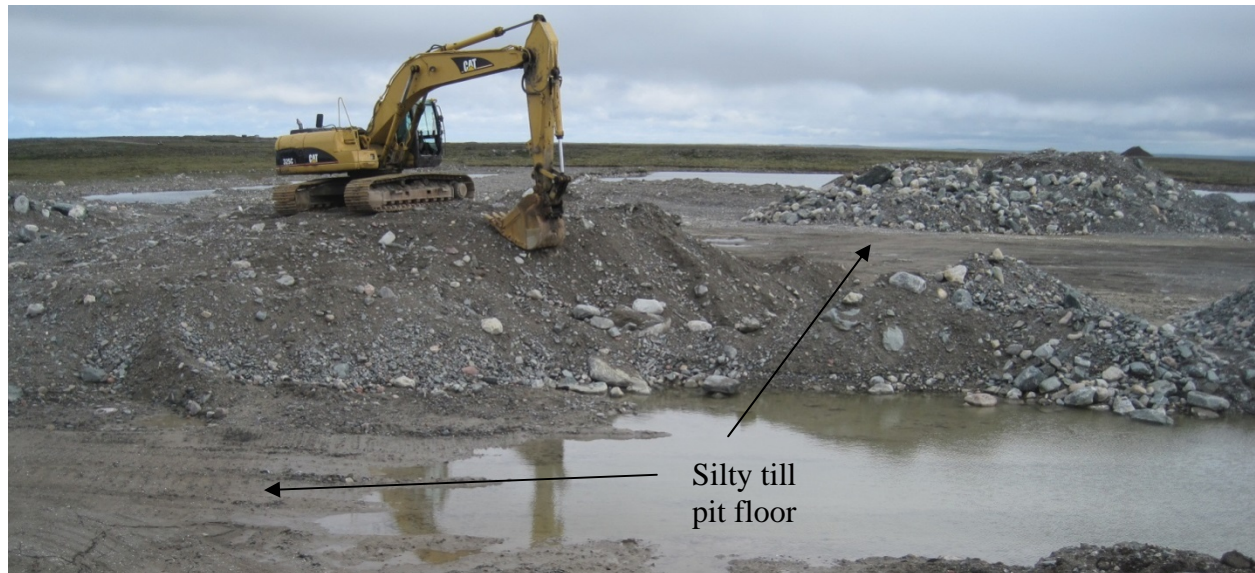
Figure 6-4: Excavated, unprocessed material in the Diane Pit. The silty till pit floor is visible, coinciding with the local groundwater table (Photo: July, 2016)

Excavation throughout the Diane Pit has reached the underlying silty till and/or groundwater table in most areas, as can be seen in Figure 6-4 below.

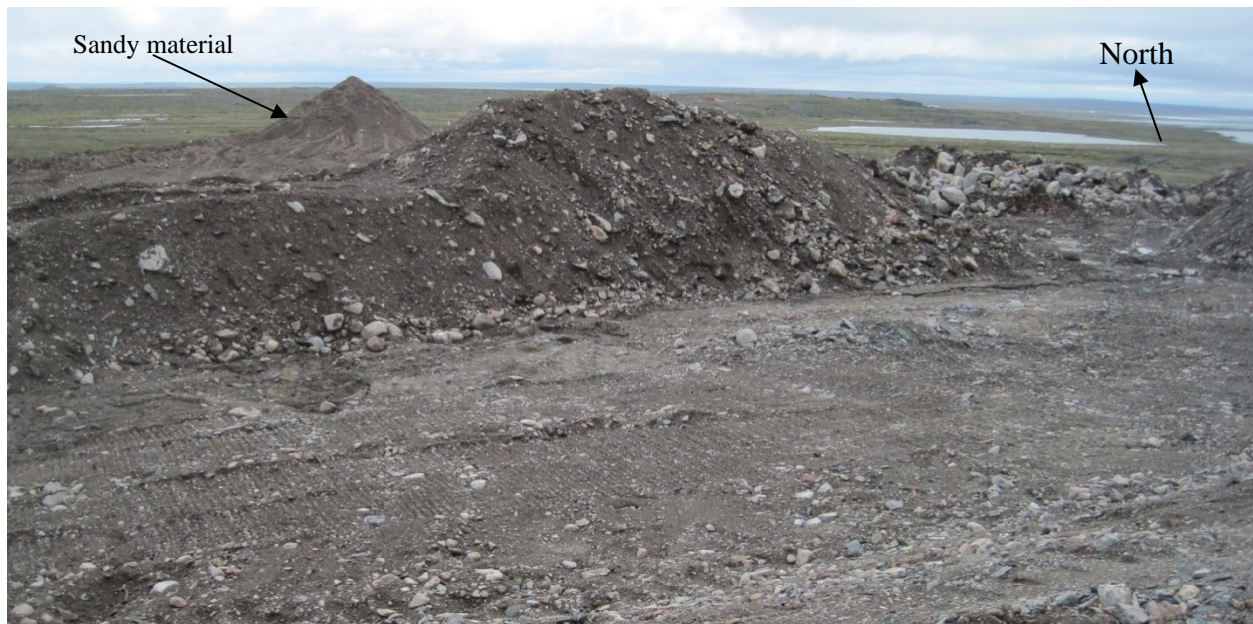
Figure 6-5: Recently excavated material from WSP Site 'A', which reportedly contains 86,000 m³ of aggregate. View is north at KM 7.0 Diane River Road. (Photo: July, 2016).

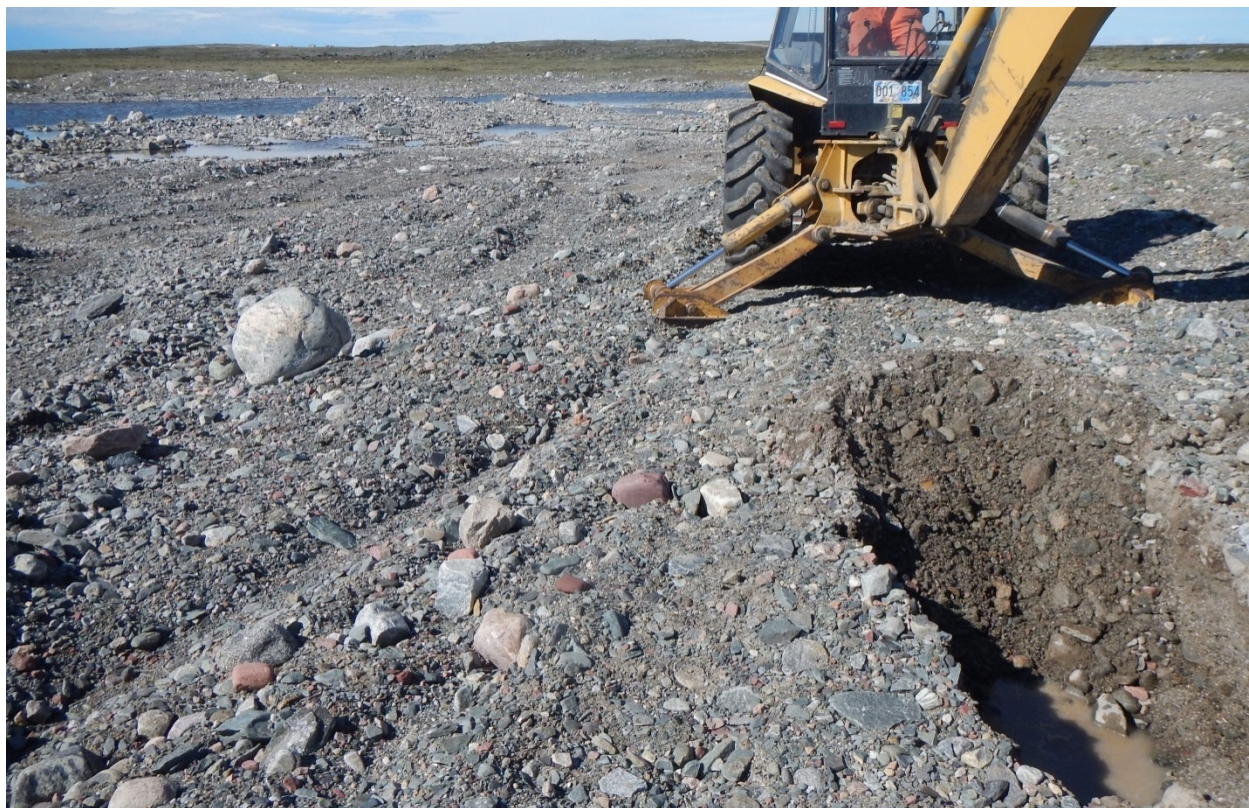
Figure 6-6: Excellent course aggregate (~40,000 m³) remaining alongside and beneath the small middle lake at the north end of the existing Diane Pit (Photo: July, 2016).

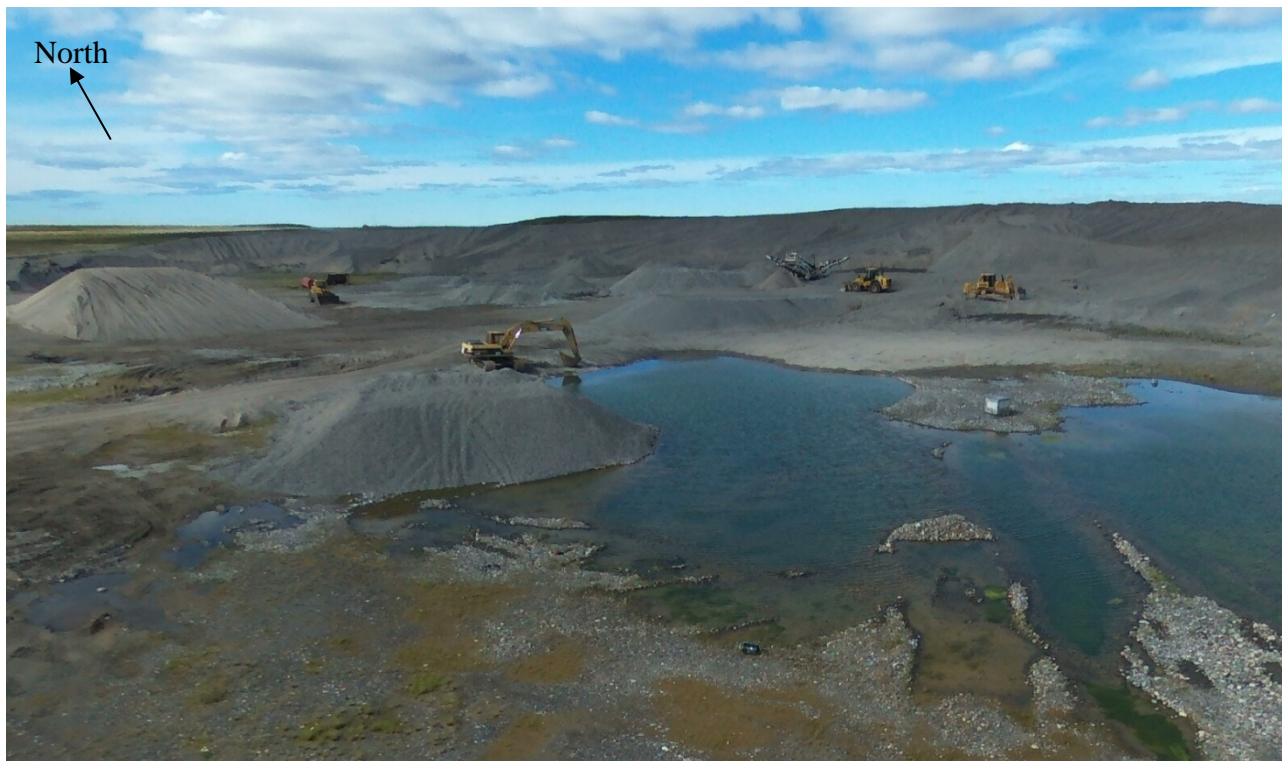
Figure 6-8: Drone photo of Meliadine Pit stockpiles and equipment (Photo: July, 2016).

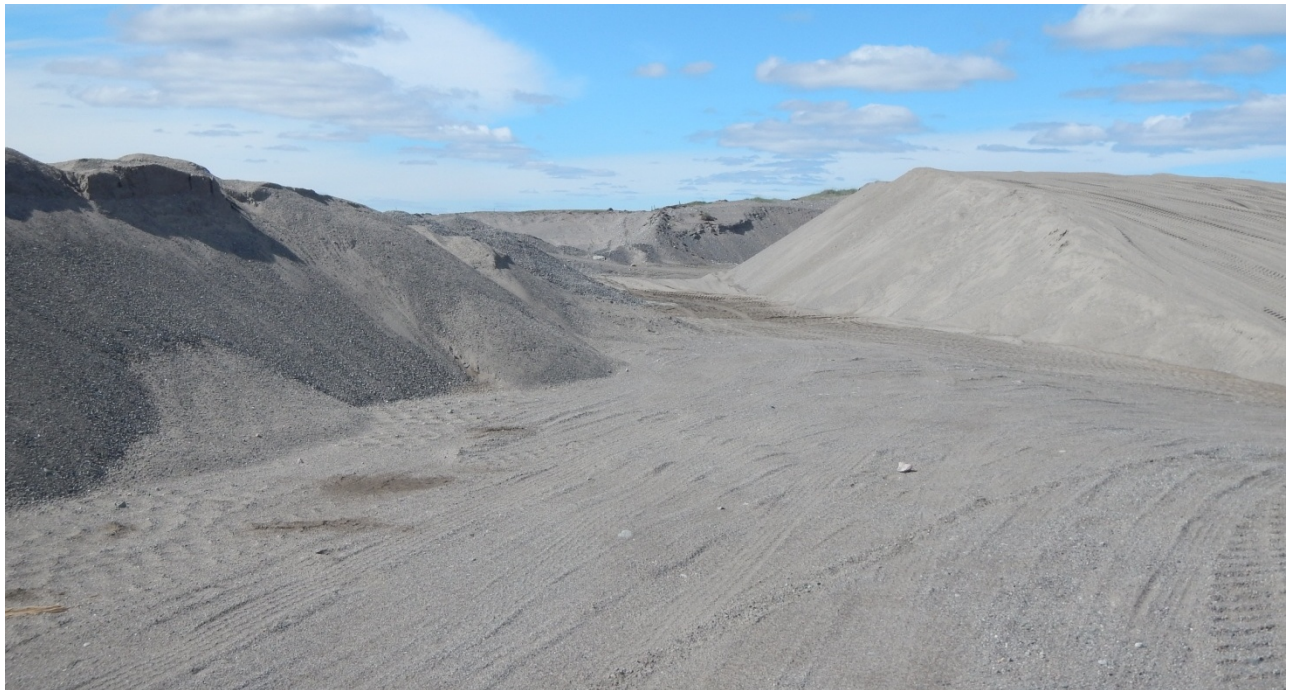
Figure 6-9: Screened stockpiles of fine gravel (left) and clean sand (right) in the Meliadine Pit (Photo: July, 2016).

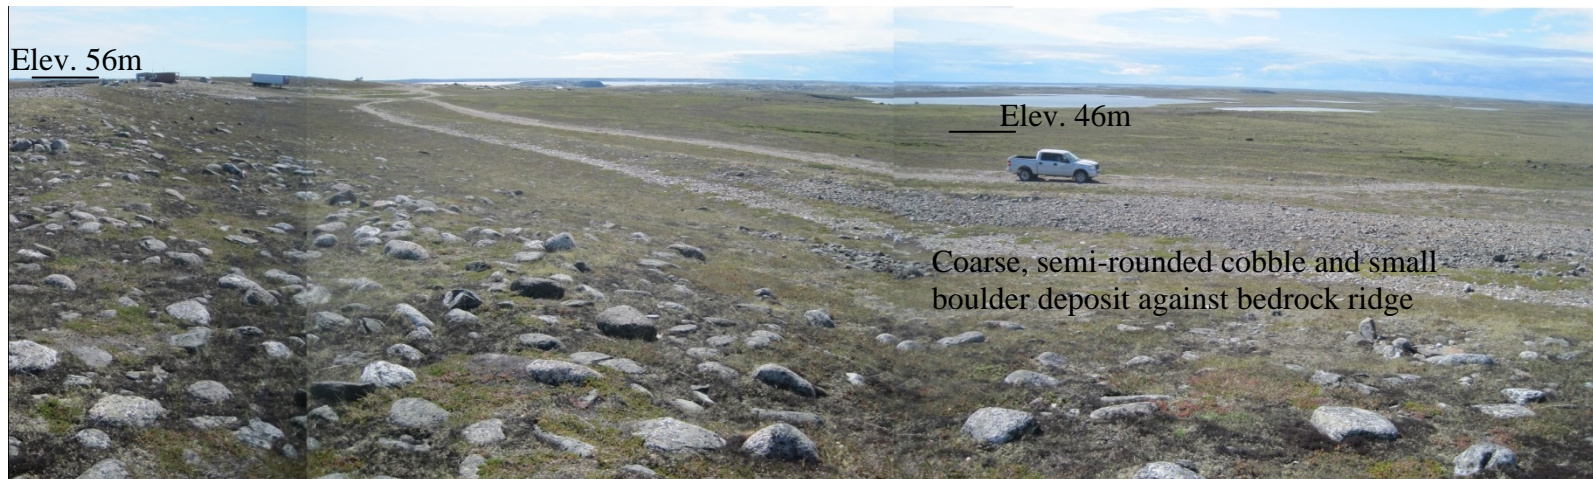
Figure 6-13: view downslope from ridgetop towards the southwest across the deposit (Photo: July, 2016).

Development of this deposit as a borrow source would require some level of mixing of the sand and gravel/cobble deposits. The tested samples contained less than 1% fine-grained soils.

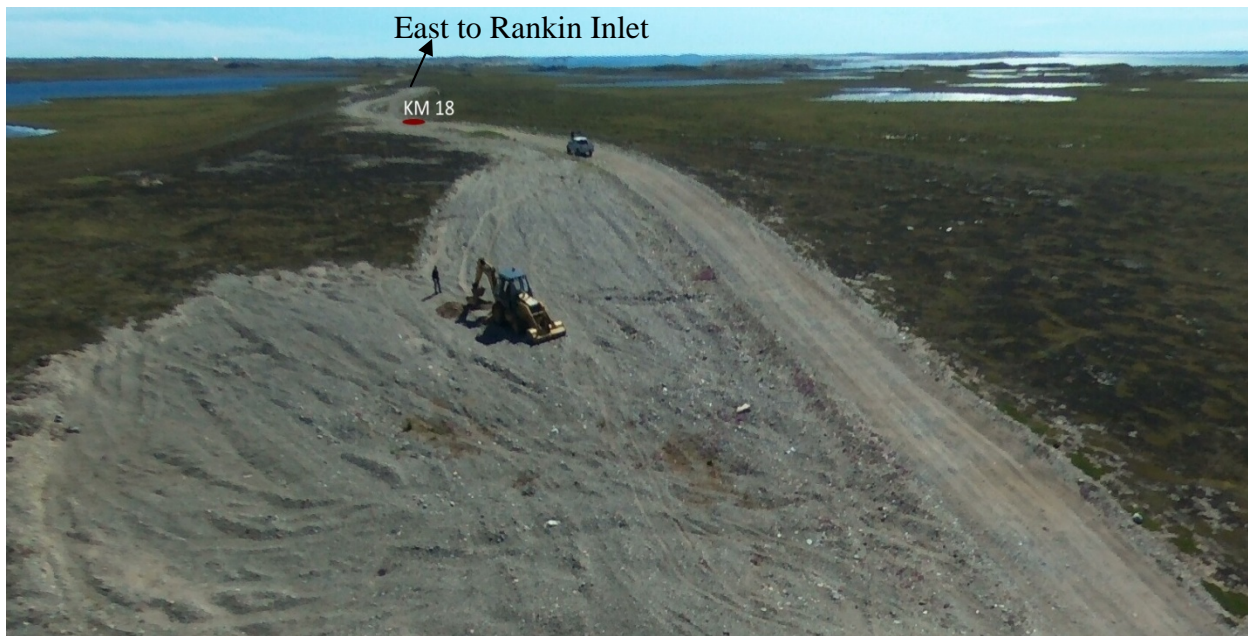
Figure 6-18: A test pit being excavated in the stripped area at the west end of the deposit at KM 18.0. The long narrow ridge can be seen extending eastward in the background, with the steep slope down to the north (left). (Photo: July, 2016).

Both test pits encountered gravel with sand and occasional cobbles that extended to at least the depth of the permafrost table, which was encountered between 1.2 m and 1.4 m below grade. Based on the grain size curve (Appendix D), the material in the minus 2" range is generally poorly-graded with roughly 52% gravel, 40% sand and 8% fine-grained silts and clay. Moisture content of the tested sample was 3%. The coarse gravel component contained a substantial amount of flat, elongated shale and slate rock (roughly 10 - 20%). This material could be screened to meet select-grade gravel although a crusher would be needed to process the 30-40% in the gravel range that is greater than 20 mm in size depending on application.

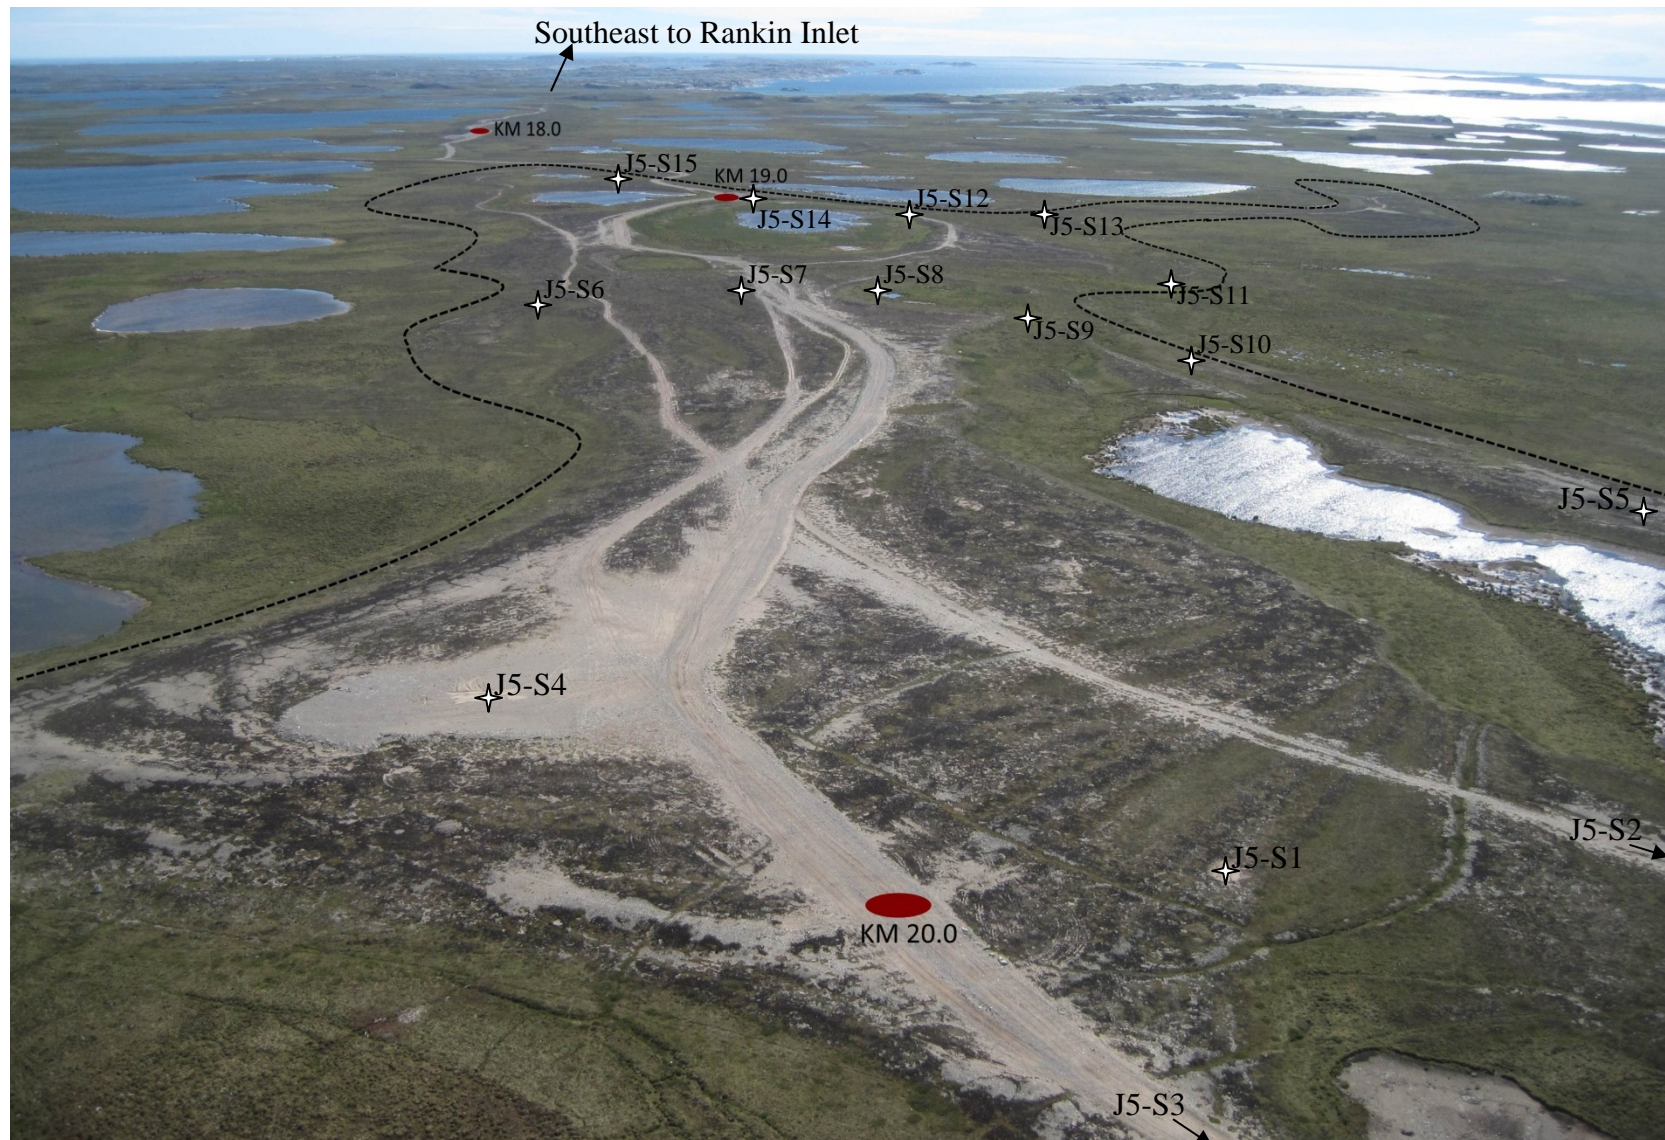
Figure 6-19: The extensive deposit (with test pit locations) between KM 18.5 and 21 on the Diane River Rd. (Photo: July, 2016)

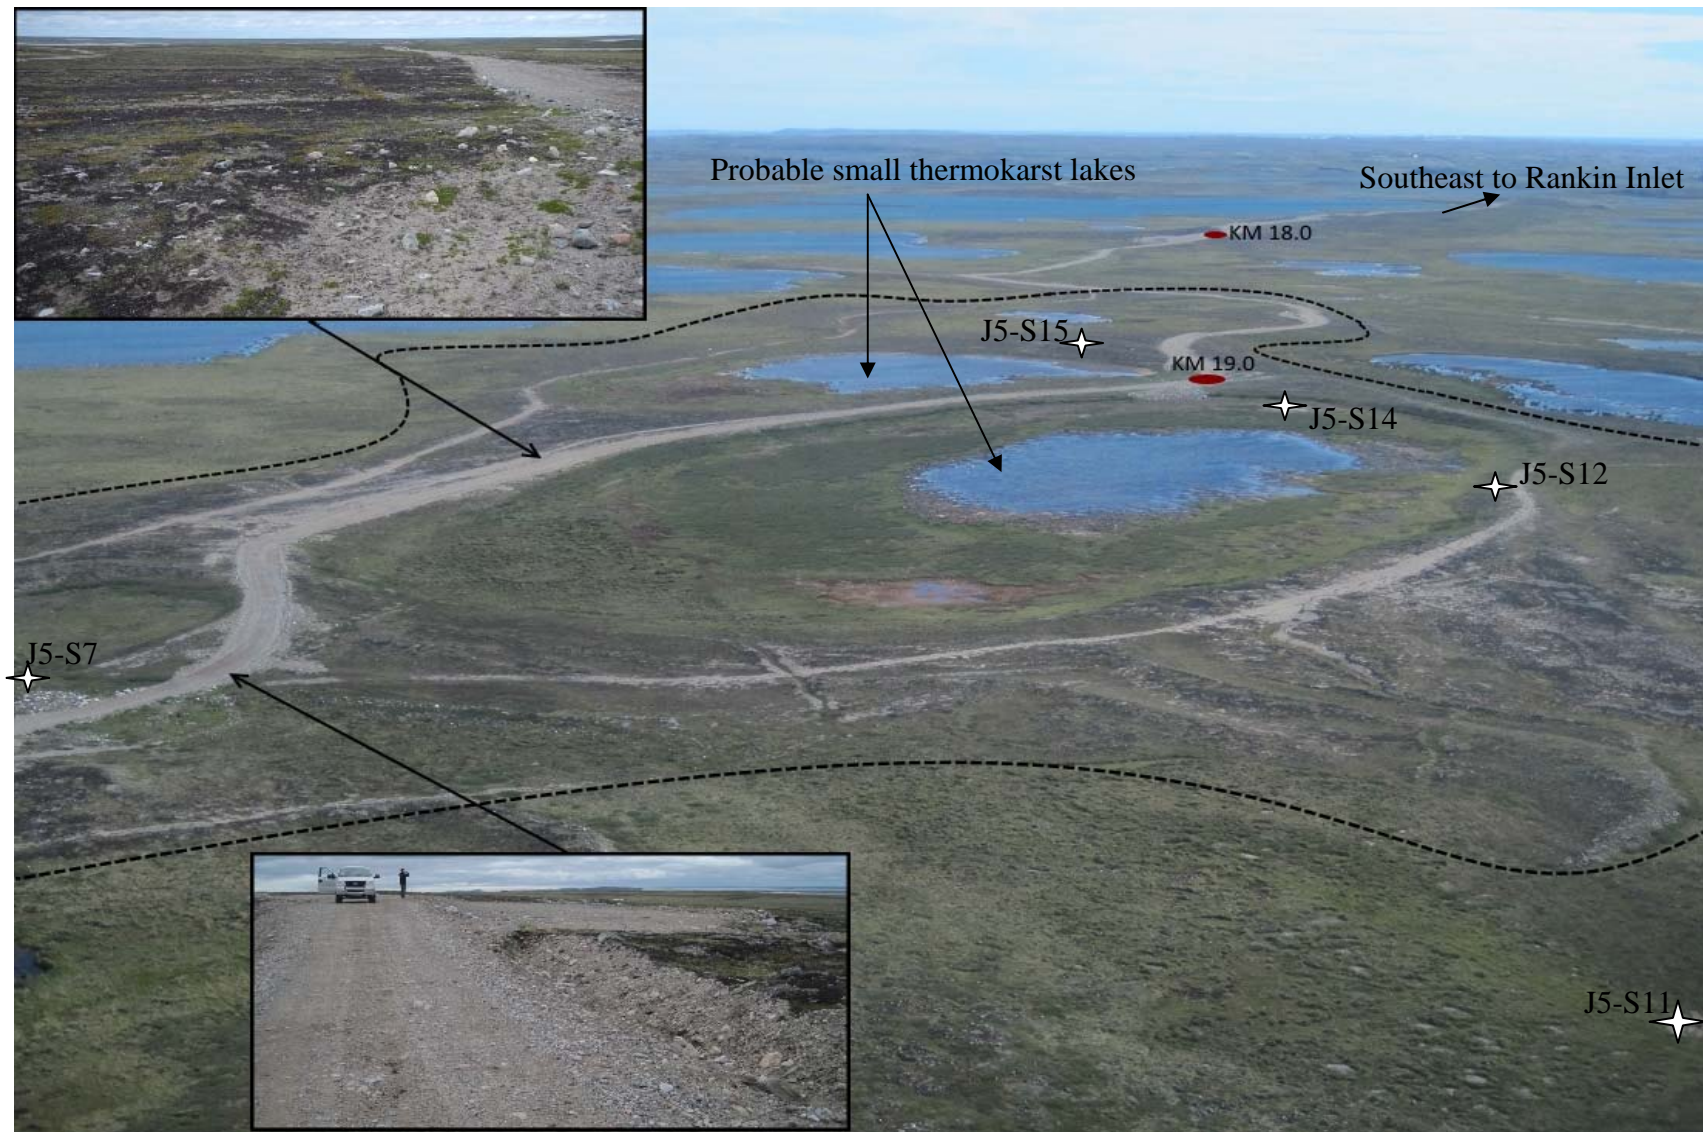
Figure 6-20: The east end of the deposit, around KM 19.0 surrounding two small thermokarst lakes that have mostly drained.

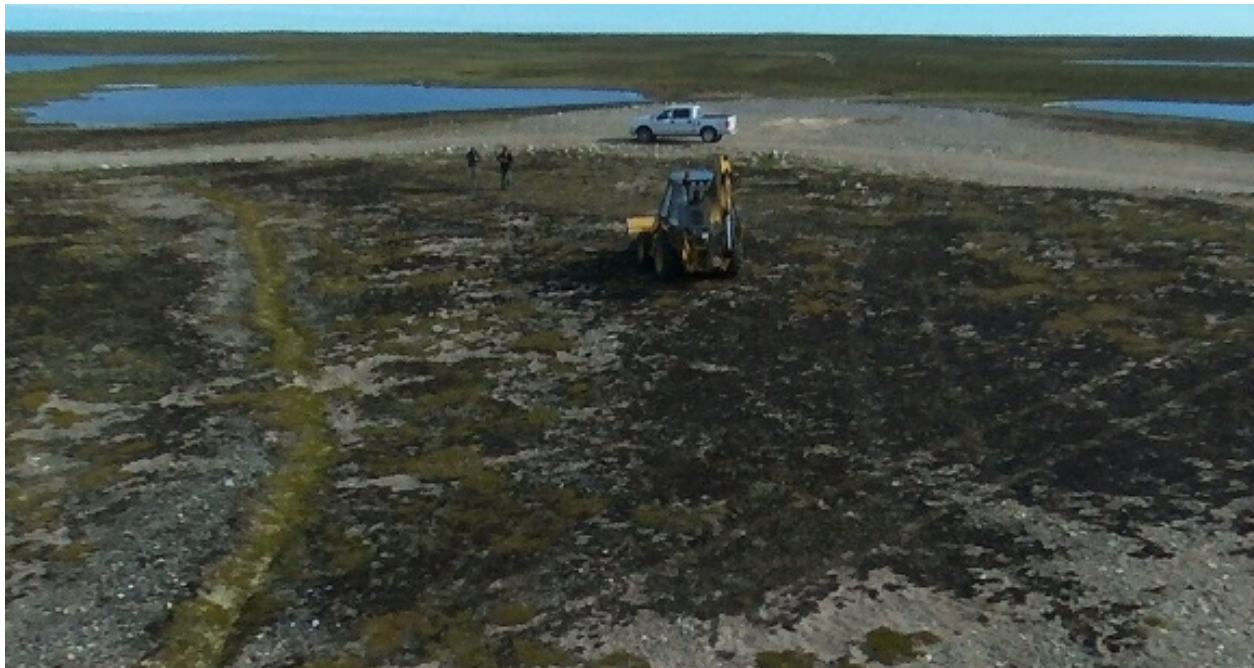
Figure 6-21: Drone photo of the gravelly sand soils exposed at the surface at the west end of the deposit, near test pit J5-S4 (Photo: July, 2016).

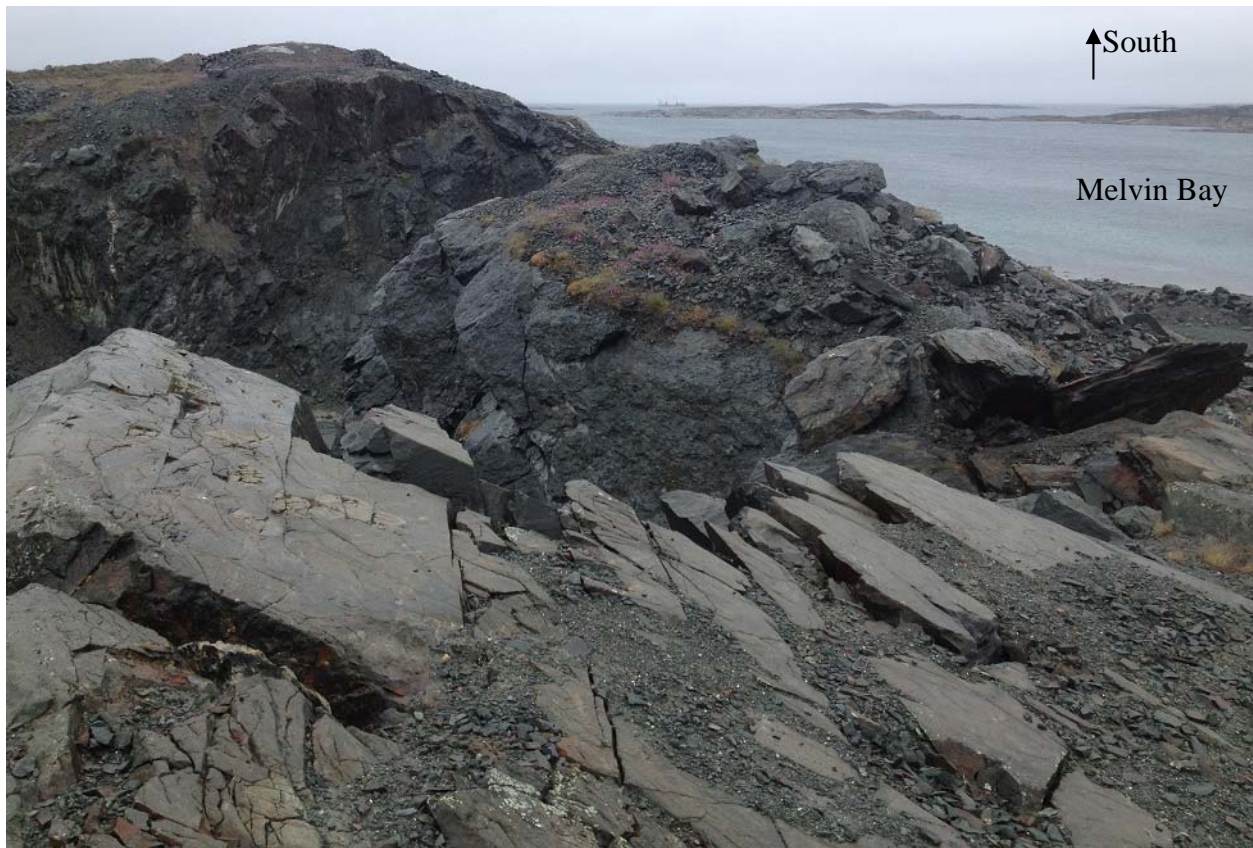
Figure 7-3: The bedrock lithology as viewed to the south across the top of the quarry.
