AGGREGATE RESOURCE STUDY RANKIN INLET, NUNAVUT

*Report No. L-15-1860
November 23, 2016*

EXECUTIVE SUMMARY

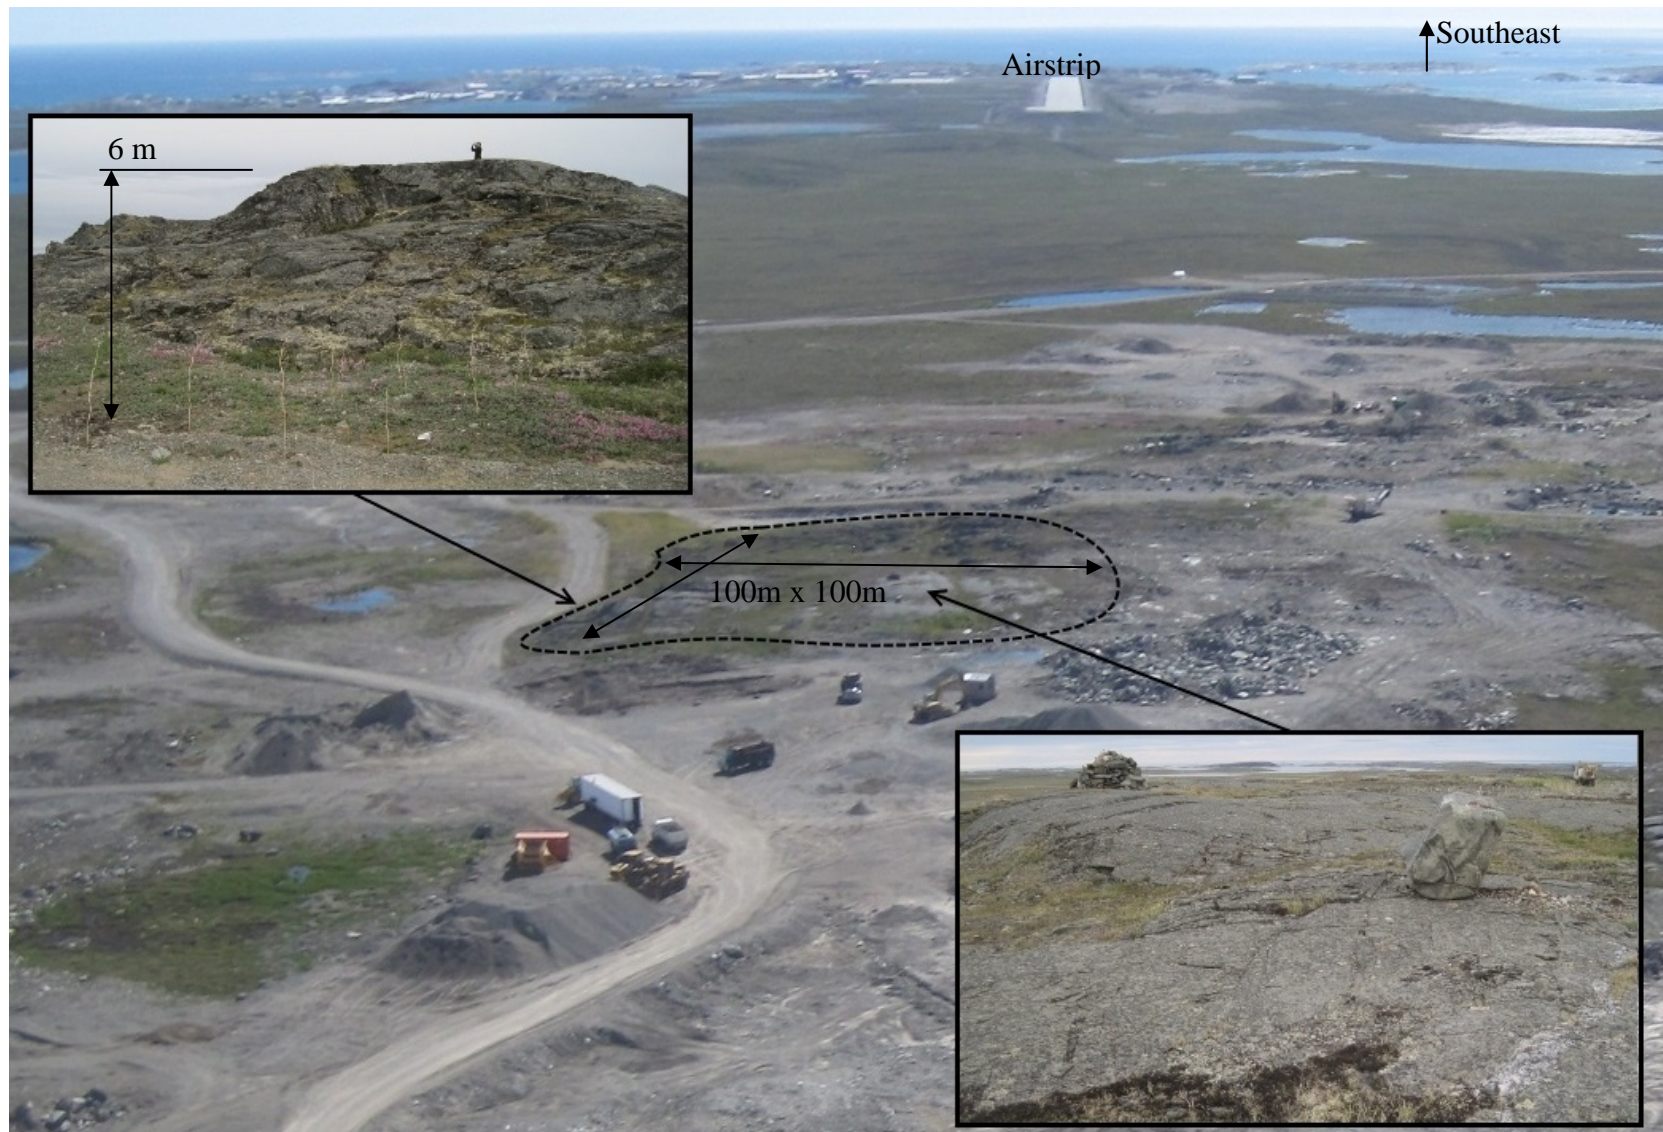
Figure 7-4: The 6 – 10 m tall bedrock outcrop near the centre of the active Diane Pit (Photo: July, 2016).

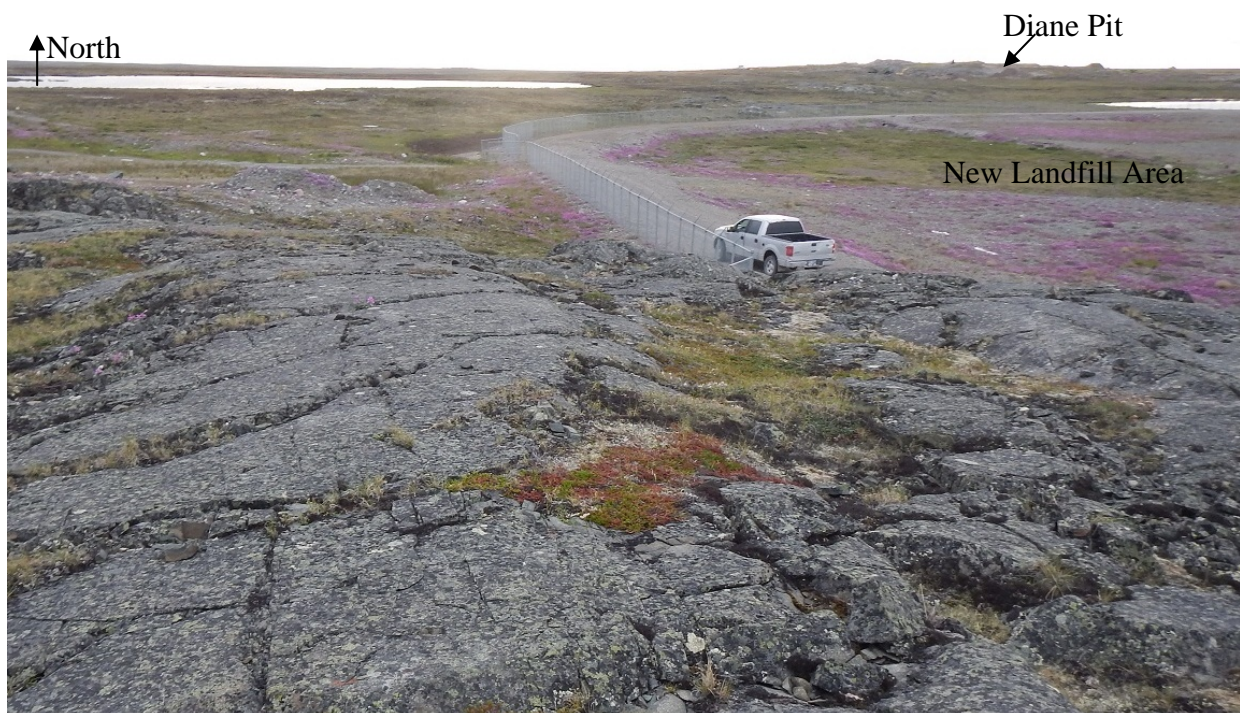
Figure 7-5: looking north from the top of the new dump outcrop towards Diane Pit.

A prominent bedrock outcrop can be accessed adjacent to the newly constructed landfill site south of the Diane Quarry pit, as shown in Figure 7-5. The prominent outcrop is approximately 150 m in length and 8 m in height as shown in Figure 7-6. Dimensions and geographic coordinates for the outcrop are given in Appendix B and additional photos are presented in Appendix C.

The outcrop could be quarried for approximately 75 m to the west before dropping off down to the lower terrain to the west. This outcrop could produce roughly 140,000 m³ of crushable aggregate (based on a bulking factor of roughly 50-60%).

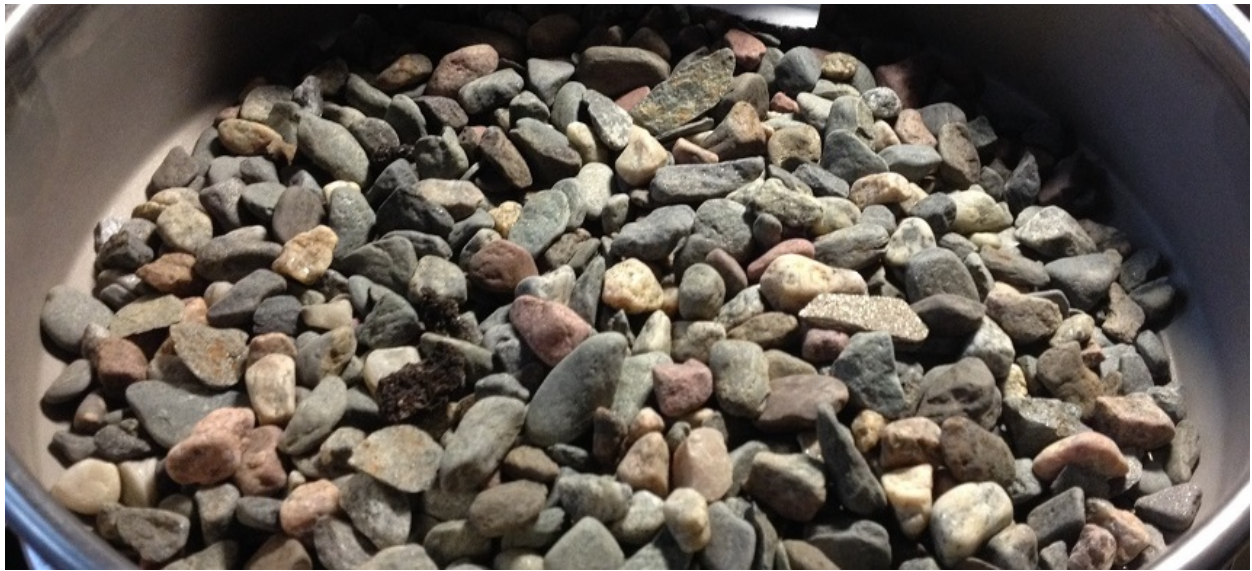
Figure 8-2: Coarse gravel fraction (retained on 10 mm sieve) from test pit S2 at KM 8.0 deposit, demonstrating sub-angular to rounded particles of hard, resistant rock that have been transported long distances and/or continually exposed to years of wave action.

The coarse gravel fraction at the KM 8.0 beach deposit consisted entirely of hard, rounded to sub-angular igneous rock as shown in Figure 8-2 below, and the tested samples from the deposit all had less than 1% fine-grained silts, indicating that this material was transported long distances by rivers and/or worked continually by the waves that formed the beach.

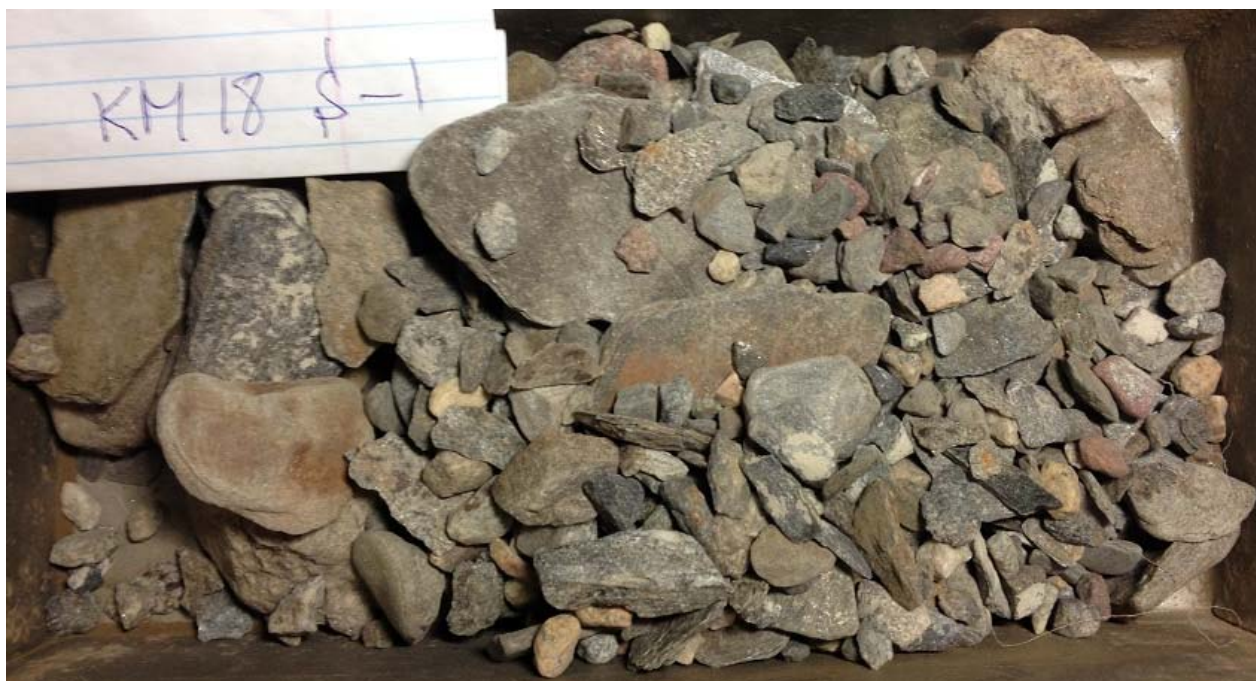
Figure 8-3: Coarse gravel fraction (retained on 10 mm sieve) from test pit S1 at KM 18.0 deposit, demonstrating angular to sub-angular particles of hard, resistant rock mixed with roughly 20% flat, elongated shale and/or slate.

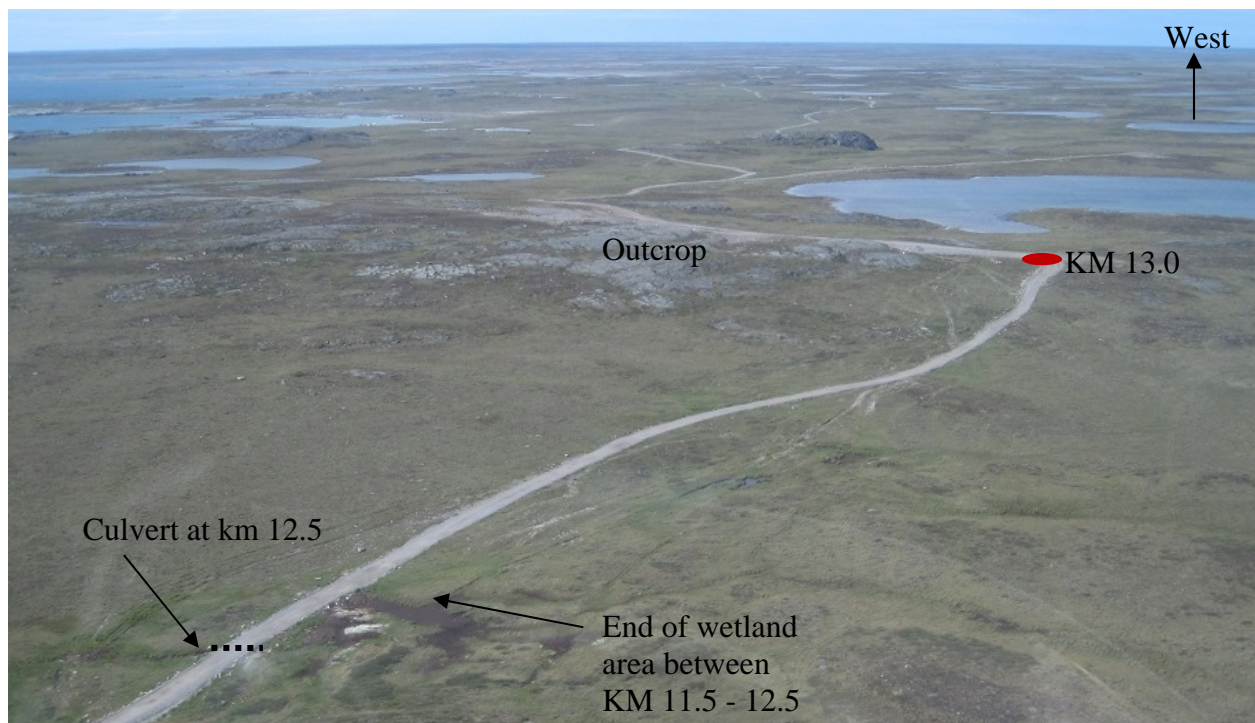
Figure 10-2: The present 3-4 m wide Diane River Road, looking west near KM 13.0. The sharp turns around the prominent outcrop slow traffic speeds (Photo: July, 2016).

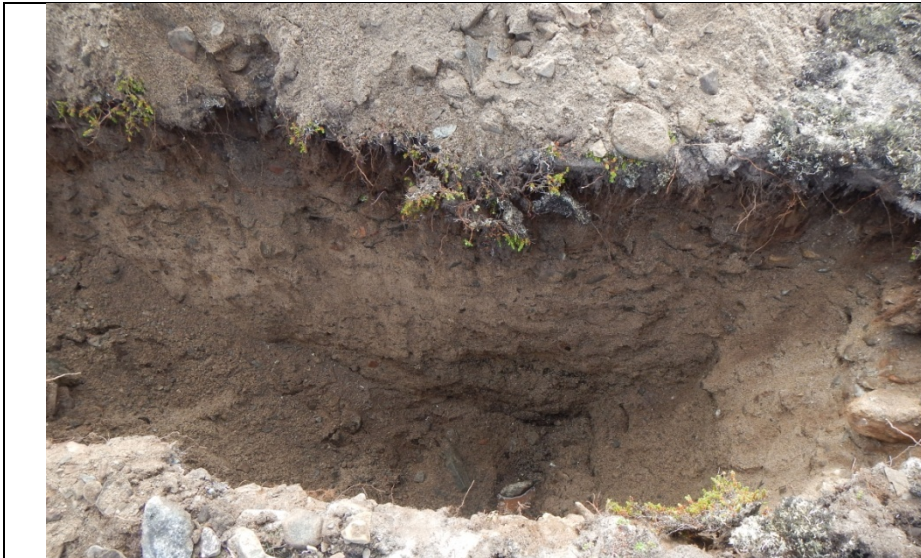
KM 19.0 on Diane River Road - Test Pit J5-S1: Gravelly sand (medium grain). No flat shale fragments noted. Water table encountered at 5'0" below grade atop permafrost. No silty till encountered

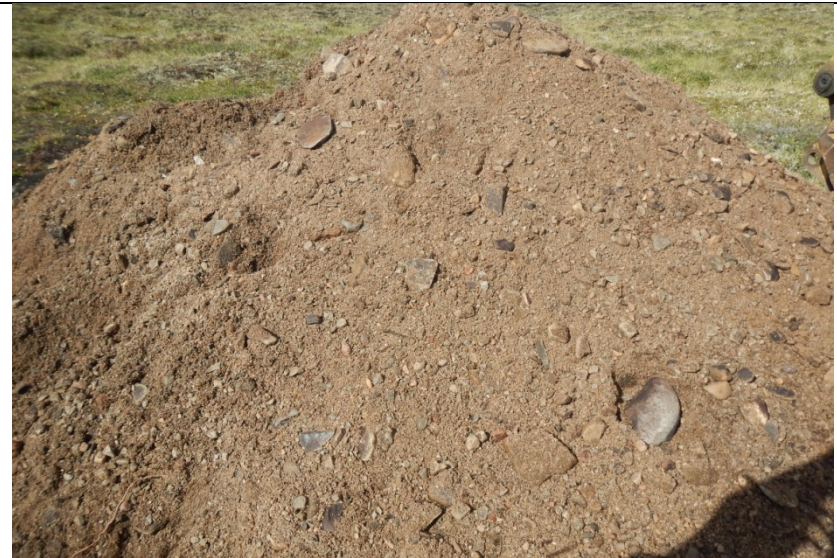
KM 19.0 on Diane River Road - Test Pit J5-S2: Gravelly sand (similar to TP J5-S1), trace cobble and trace shale fragments in gravel component. Permafrost at 3'10". No silty till encountered.

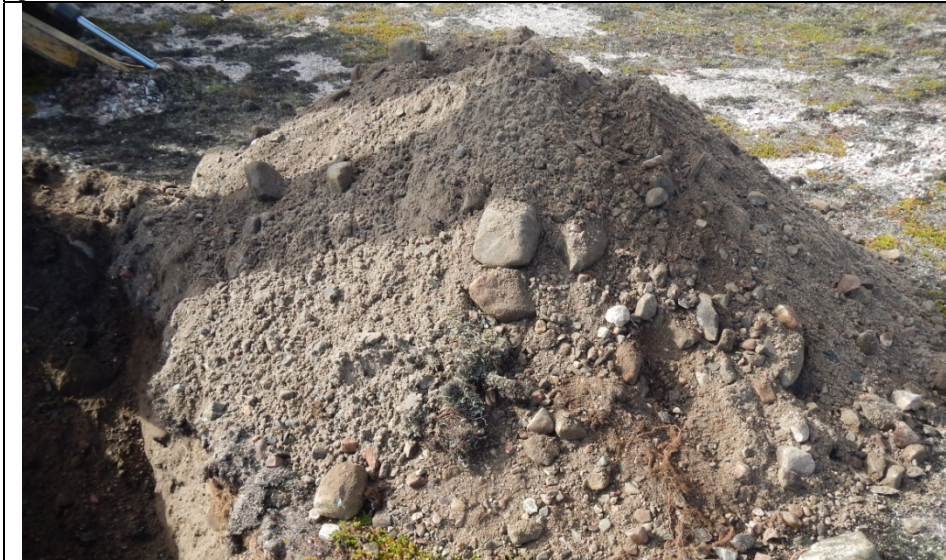
KM 19.0 on Diane River Road - Test Pit J5-S3: Gravelly sand with cobble. Very similar to J5-S1 and S2. Permafrost at 3'11". No silty till encountered.

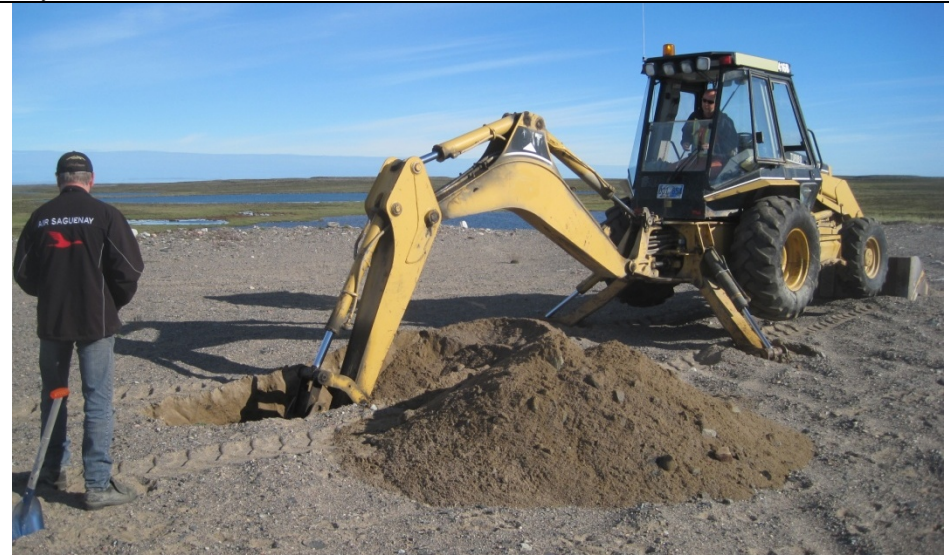
KM 19.0 on Diane River Road - Test Pit J5-S4: Sand (fine to medium grain) with some gravel and trace cobbles. Permafrost at 6'3". No silty till.

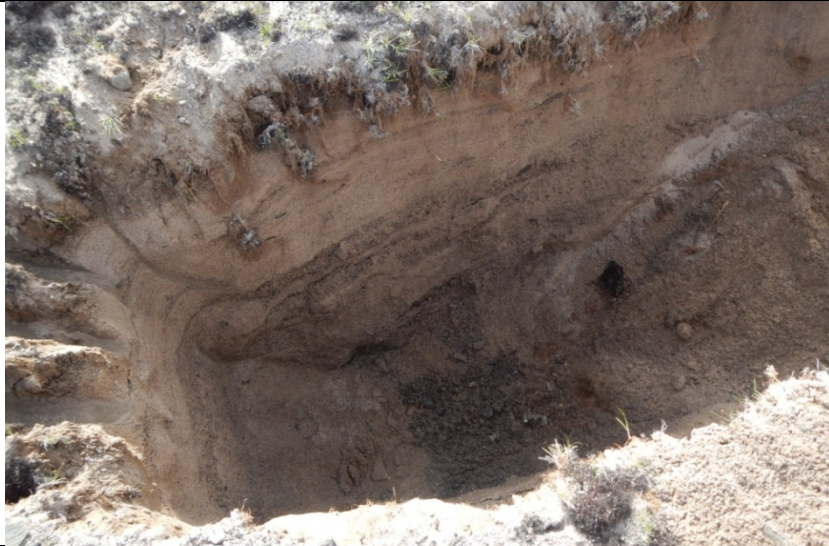
KM 19.0 on Diane River Road - Test Pit J5-S5: Stratified sand with trace to some gravel. Very similar to material in J5-S4 but even higher sand component (~70%). Permafrost at 4'10". Increased gravel can be seen at the permafrost table.

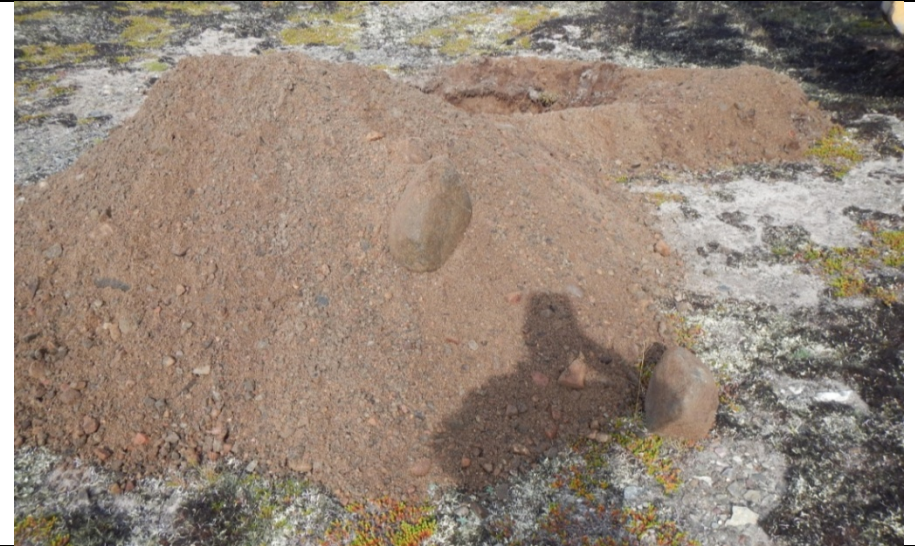
KM 19.0 on Diane River Road - Test Pit J5-S6: Sandy gravel with trace cobbles. Appears well graded. Generally minus 2" gravel. Permafrost at 4'0". No silty till encountered.

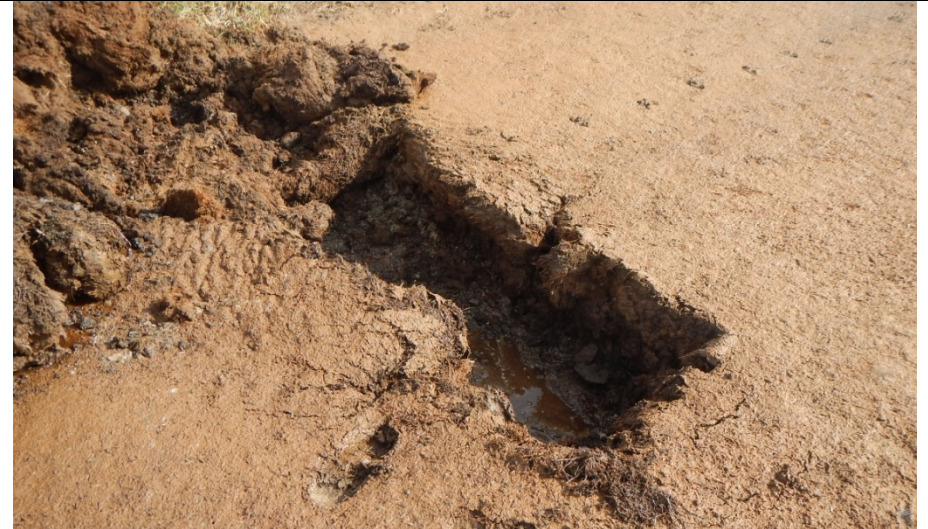
KM 19.0 on Diane River Road - Test Pit J5-S8: This test pit in the bottom of a dry pond revealed sandy gravel similar to that of J5-S6 beneath 21" of peat and silt. Permafrost was shallow at 24" with groundwater perched atop it in the gravel.

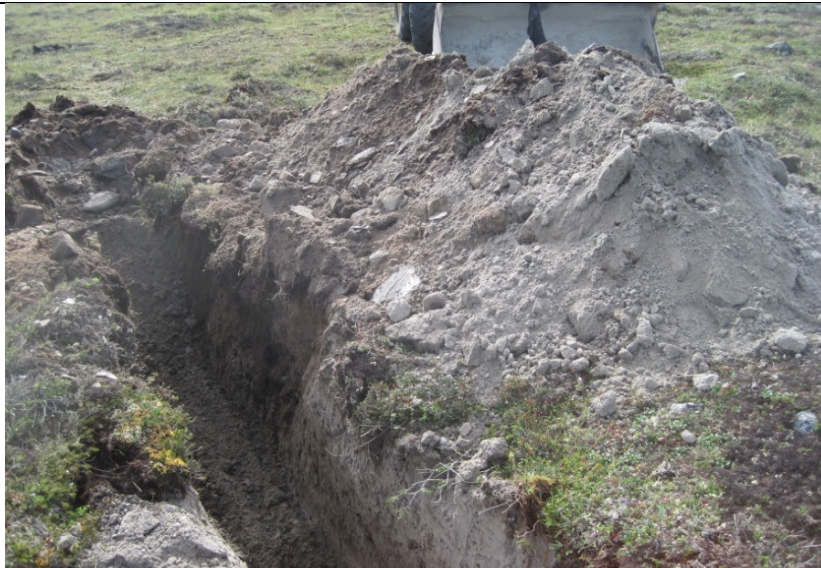
KM 19.0 on Diane River Road - Test Pit J5-S9: Grey sandy silt with trace-little gravel and cobble. Permafrost at 3'10".

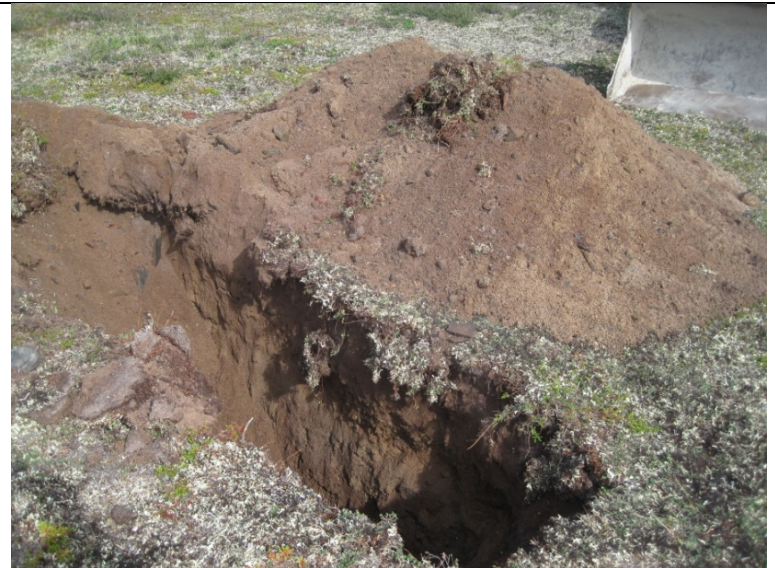
KM 19.0 on Diane River Road - Test Pit J5-S10: Reddish-brown sand with little gravel. Permafrost at 3'10".

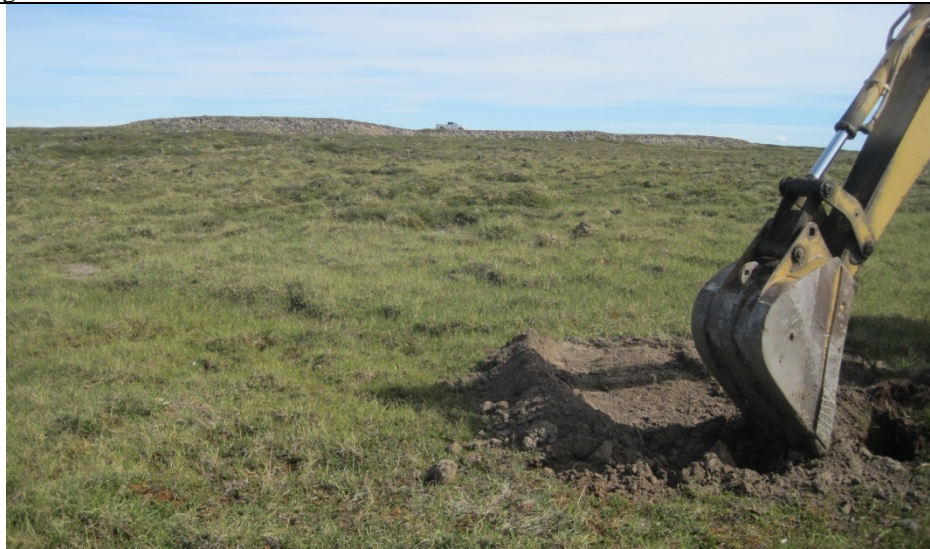
KM 19.0 on Diane River Road - Test Pit J5-S11: Grey silt with trace to some sand. Stopped test pit at 2'4". Note distant gravel ridge below truck (area of J5-S7)

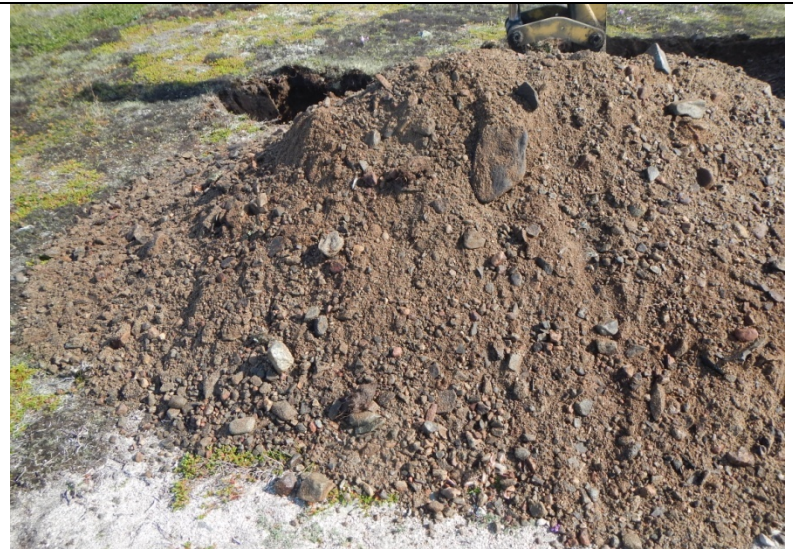
KM 19.0 on Diane River Road - Test Pit J5-S12: Sandy gravel with trace cobble. Generally minus 4" gravel. Appears well graded. Minimal shale component (<10%). Permafrost at 4'6". No silty till encountered.

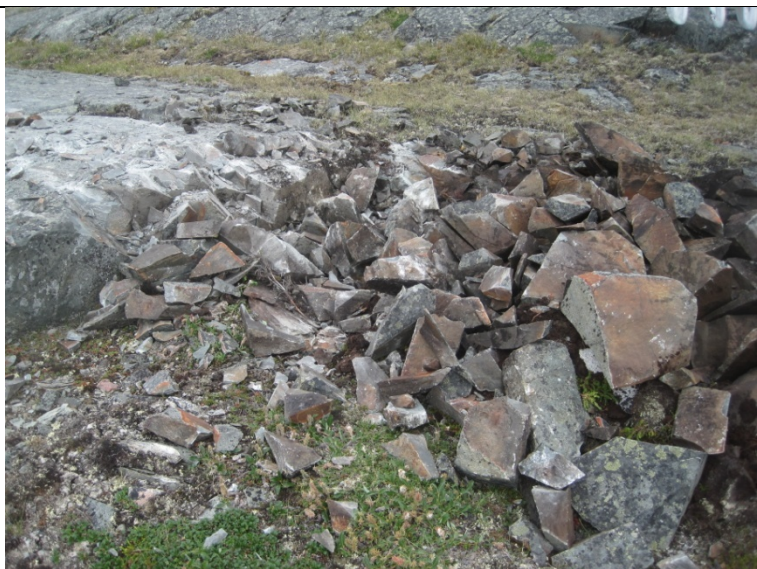
Diane Quarry Outcrop (excavating at top of outcrop – very hard rock on left)
