2020 Site Update Report

Jericho Diamond Mine

Shear Diamonds (Nunavut) Corp.

Report Title: The 2020 Site Update Report for the Nunavut Impact Review Board's Monitoring of the Jericho Diamond Mine Project

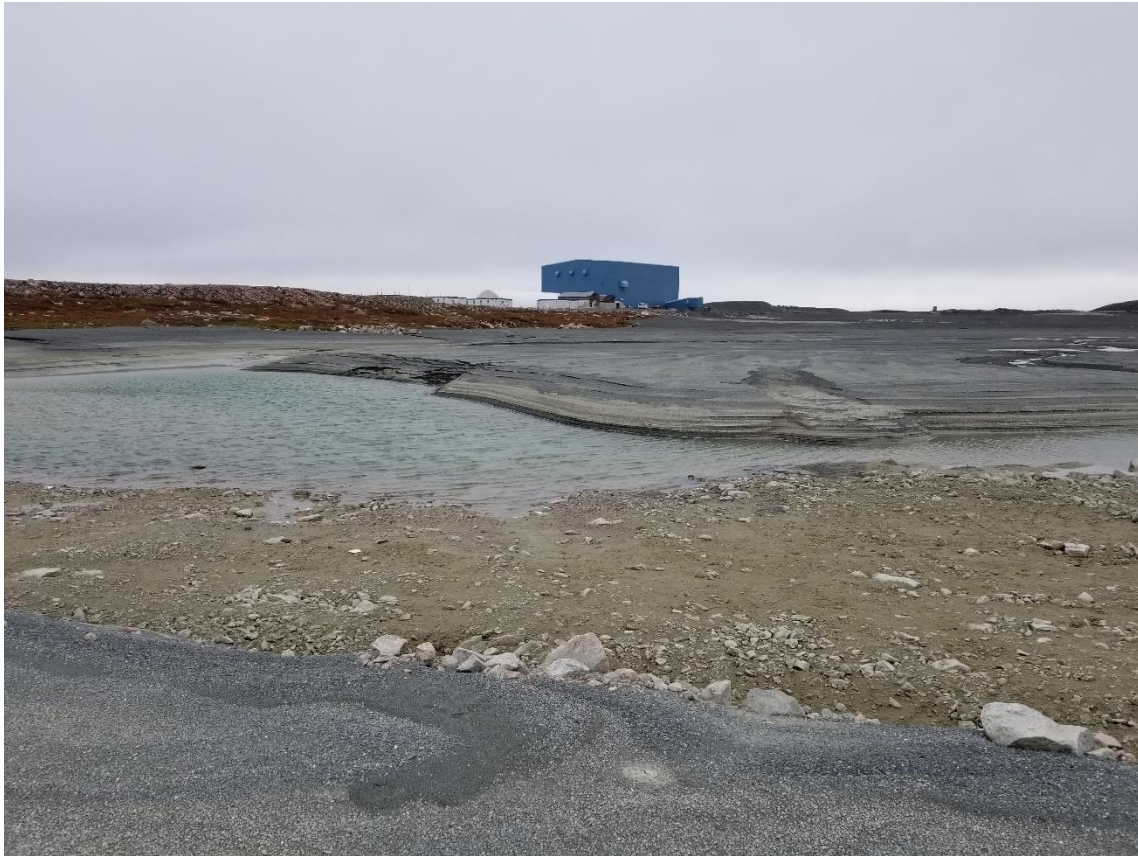
Photo 1: PKCA Water Ponding and Erosion

The Processed Kimberlite Containment Area (PKCA) was capped with course tailings in 2017 to prevent erosion; however, during the 2019 site visit it was observed that there are some surface melt erosion channels, potholes, and a large ponded area before Divider Dyke A. Imagery from 2020 shows continuing erosion of the PKCA, sinkholes/potholes indicating subsurface erosion, and ponding of water at the foot of the PKCA near Cell A. (Photo 1, Photo 2, Photo 3, Photo 4).

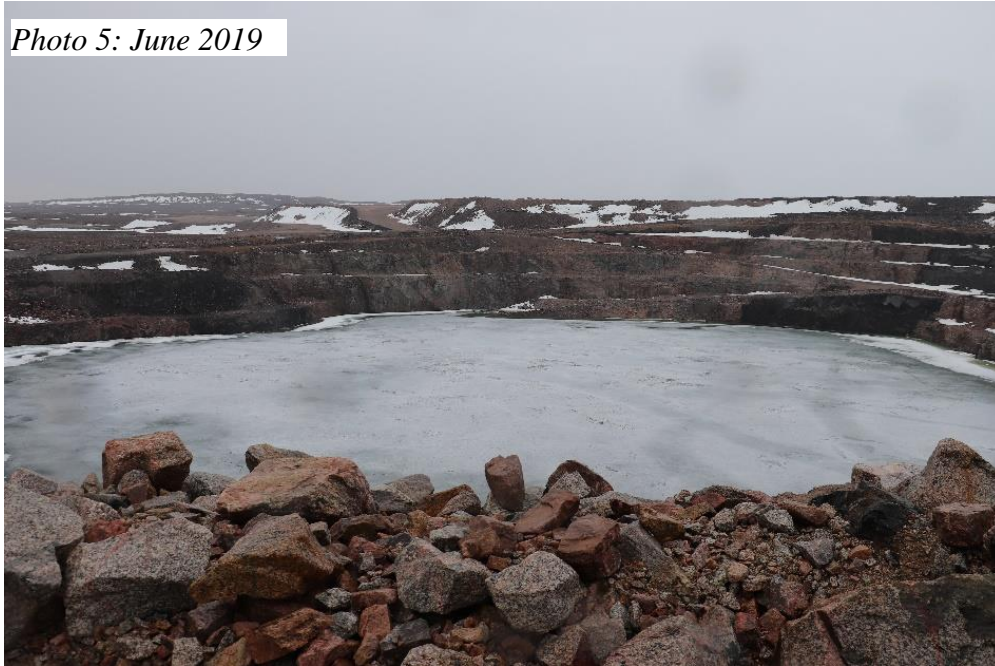
Photo 5: June 2019

The water level in the Jericho pit continues to rise. Photos 5 and 6 demonstrate the water level rise in the pit between June 2019 and September 2020.

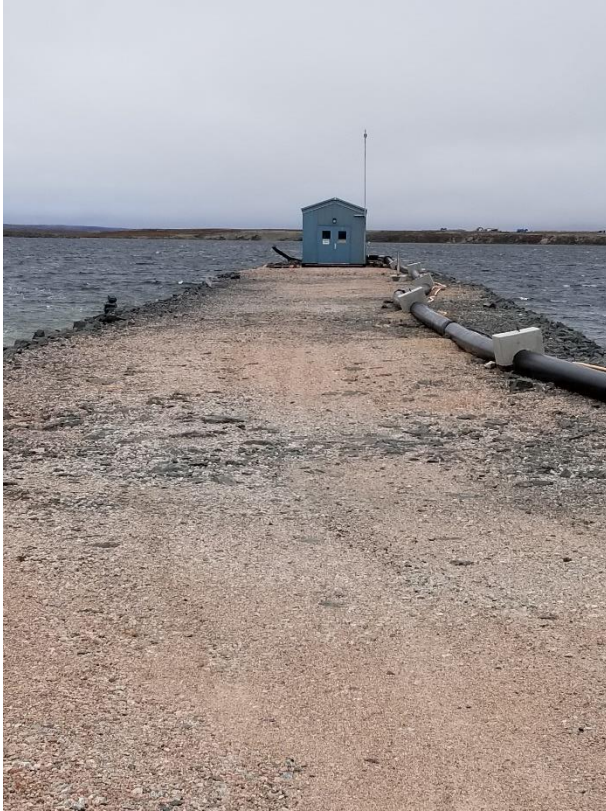
Photo 6: Carat Lake Jetty

Photos taken by CIRNAC show damage caused to the pumphouse on the Carat Lake Jetty and displacement of rocks used to prevent erosion of the jetty. (Photo 7, Photo 8)

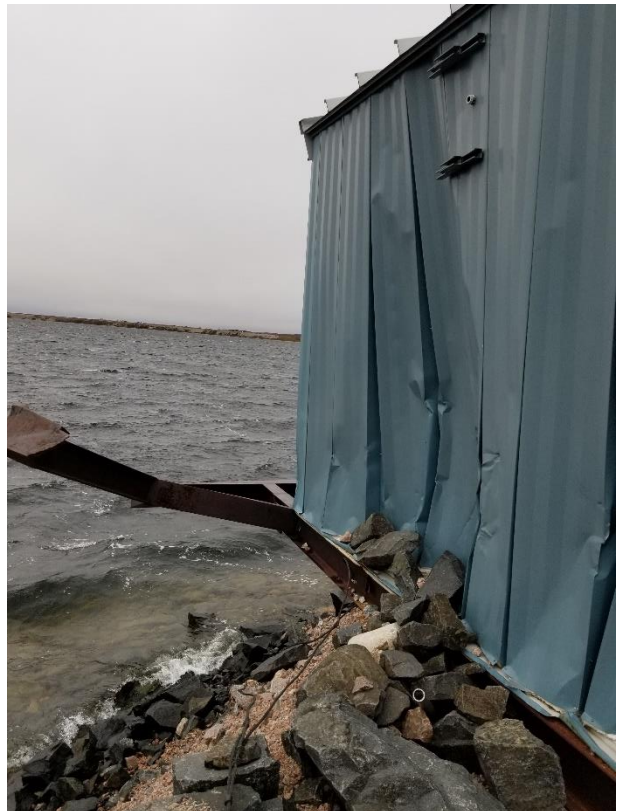
Photo 5: Damage to Pumphouse

It is unknown when this damage occurred, but presumably was due to pressure caused by ice buildup.
