MELIADINE GOLD MINE PROJECT

2020 Annual Report

Agnico Eagle Mines Limited – Meliadine Division

March 2021

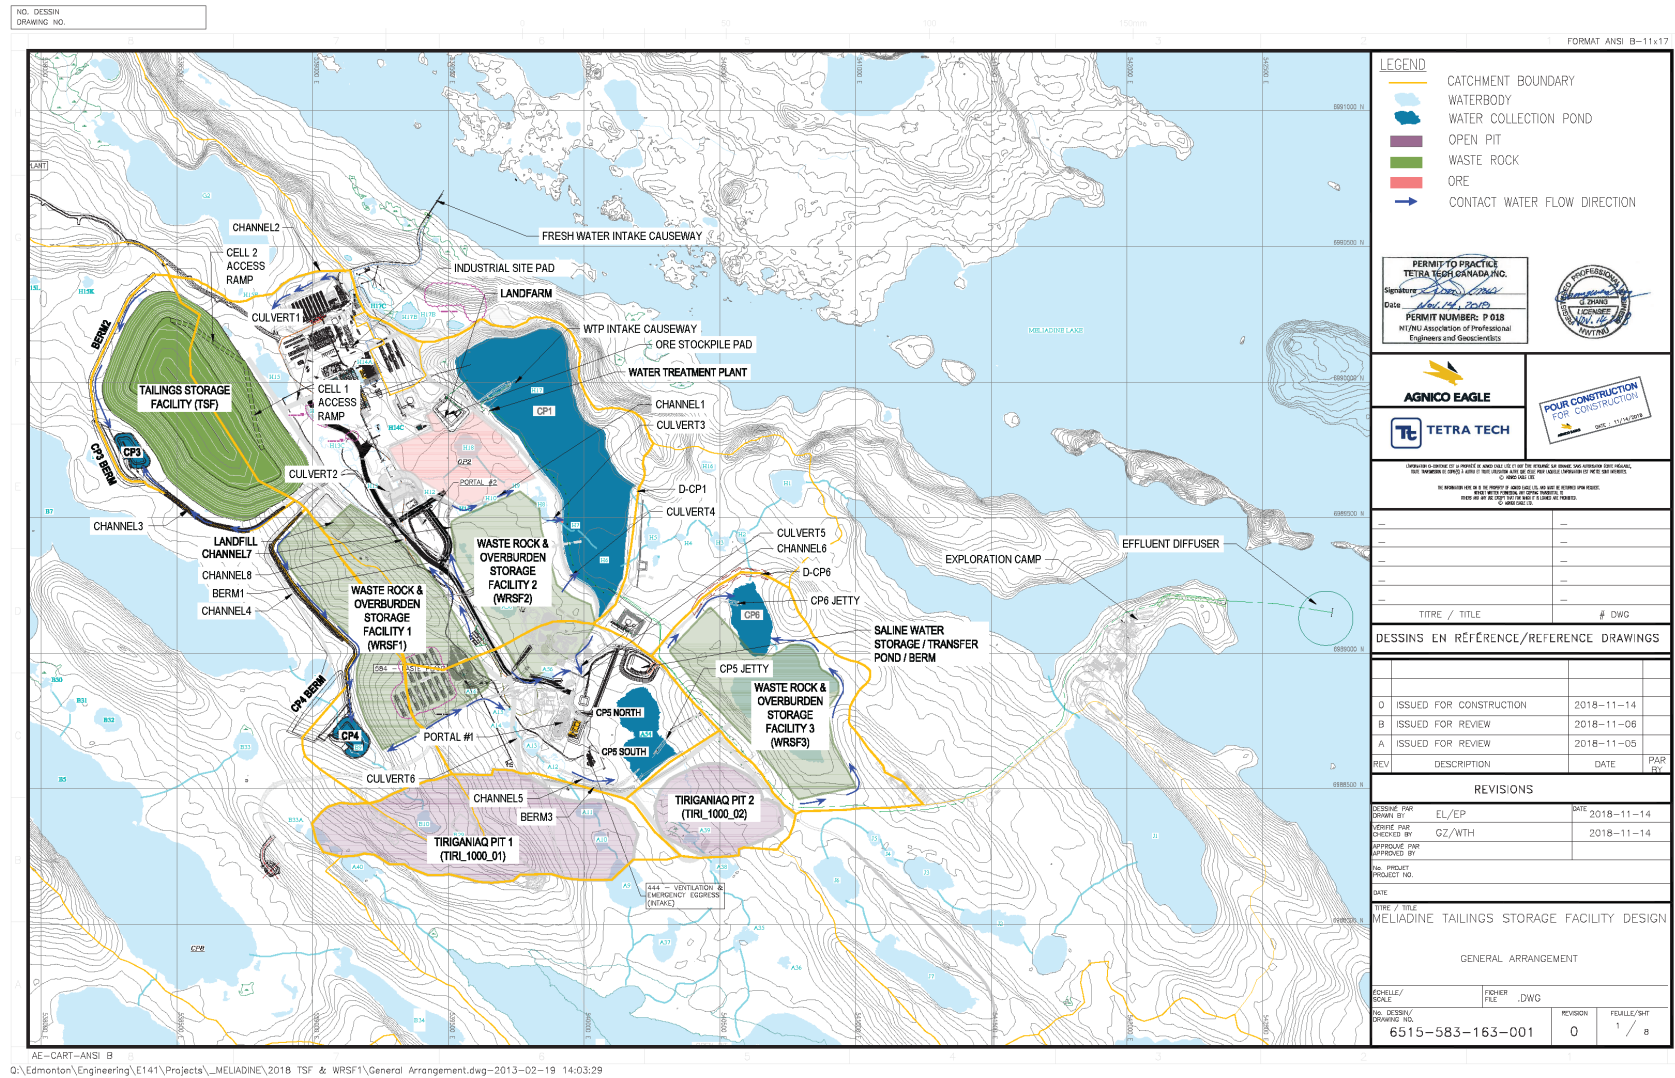
Figure 1. Meliadine Site

The following Figure 1 shows the Meliadine site.

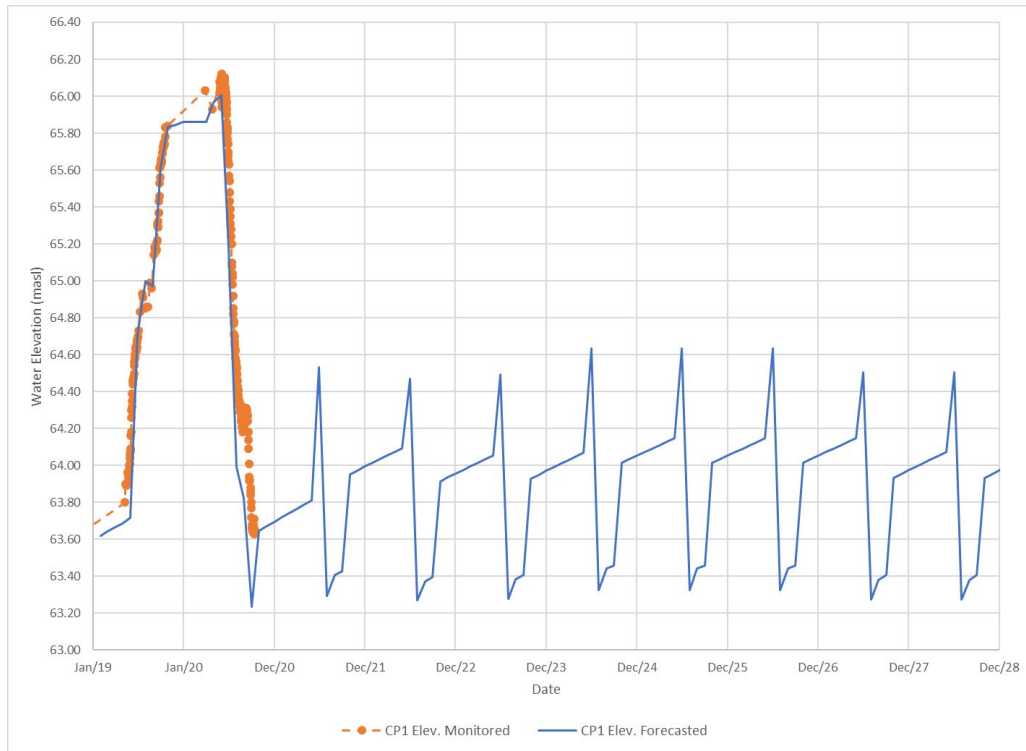
Runoff inflows are calculated by applying monthly precipitation values to the areas of the non-facility surface types described in the assumptions list above. The resulting impact on CP1 water elevations is presented in Figure 2.

Figure 2. CP1 water elevation forecast. Calibration of the runoff coefficients allowed for alignment of 2020 forecasted water elevations with actual monitoring data.

The model results indicate a cyclical water elevation and volume response in CP1 each year, characterized by a slight increase via winter inflows and a rapid increase during freshet. Water elevations are then drawn down through each discharge season before freeze-up in Q4 of each year. The maximum annual water volume requiring management in CP1 is approximately 633,000 m³. Table 7 presents this metric for other facilities on site captured in the model. Tabular data for the inflows and outflows of each facility are available in Appendix 5.

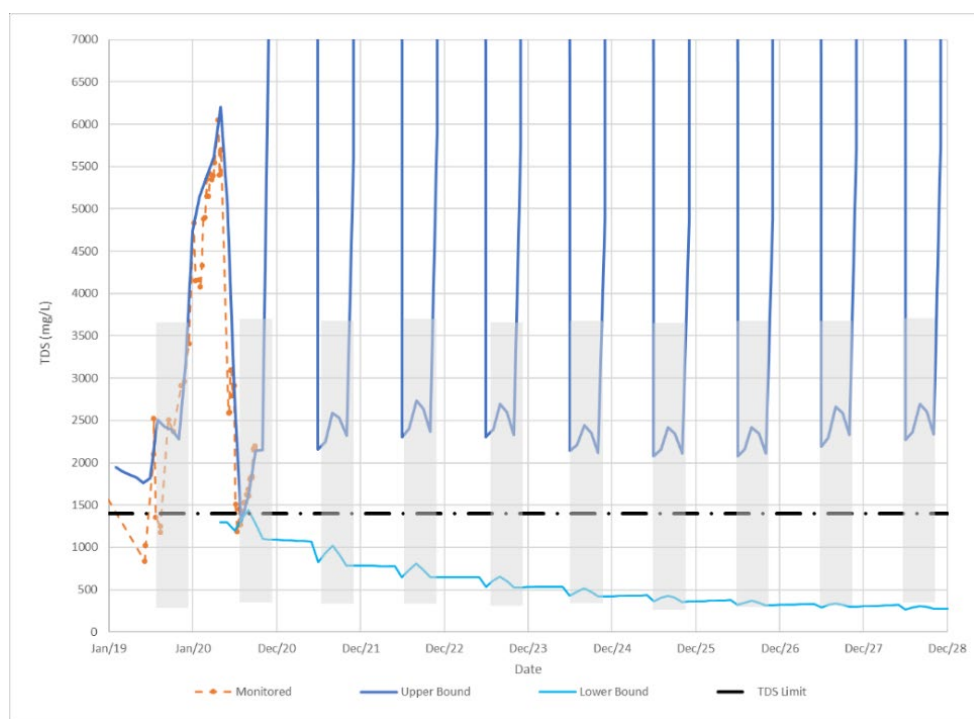
Figure 3. Forecasted upper and lower modeled CP1 TDS concentrations for life of mine and closure. Monitored 2019 and 2020 TDS concentrations demonstrate model alignment. Vertical grey bars represent periods of discharge.

Under the upper bound scenario, CP1 TDS concentrations consistently exceed the currently Licenced maximum allowable concentration of 1400 mg/L during the annual discharge season. To address this, Agnico Eagle submitted a request to the Nunavut Water Board to permanently amend the Type A Water Licence 2AM-MEL-1631 with an increased maximum average concentration (MAC) for TDS of 3,500 mg/L and a maximum grab concentration (MGC) for TDS of 5,000 mg/L. More detail regarding the proposed amendment and supporting Water Quality and Monitoring Optimization Program (WQ-MOP) can be found in section 3.4. Concentrations of total aluminum and total ammonia are not expected to exceed the monthly average or sample grab limits during the annual discharge season.

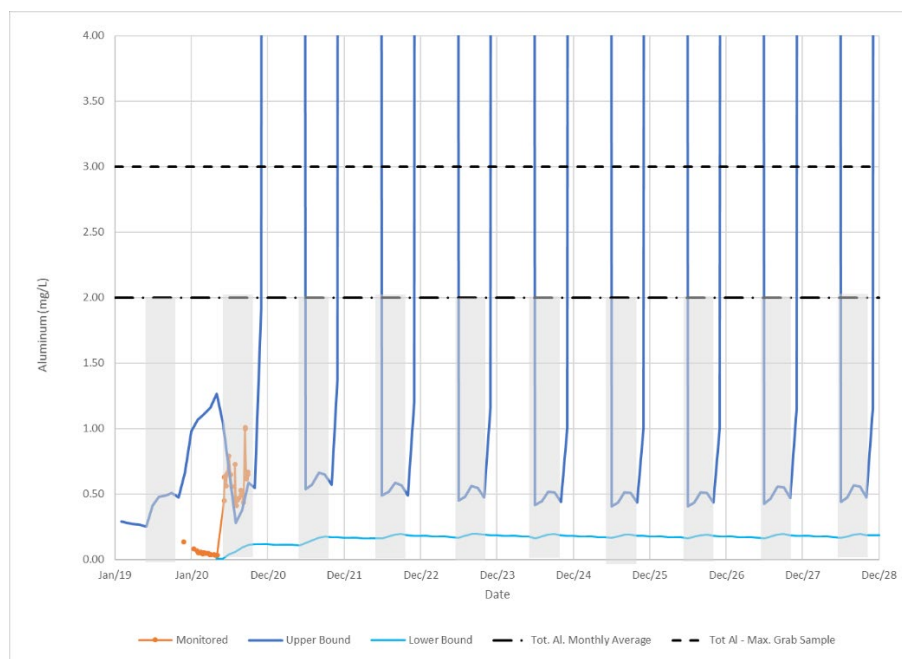
Figure 4. Forecasted upper and lower modeled CP1 total aluminum concentrations for life of mine and closure. Monitored 2019 and 2020 total aluminum concentrations demonstrate model alignment. Vertical grey bars represent periods of discharge.

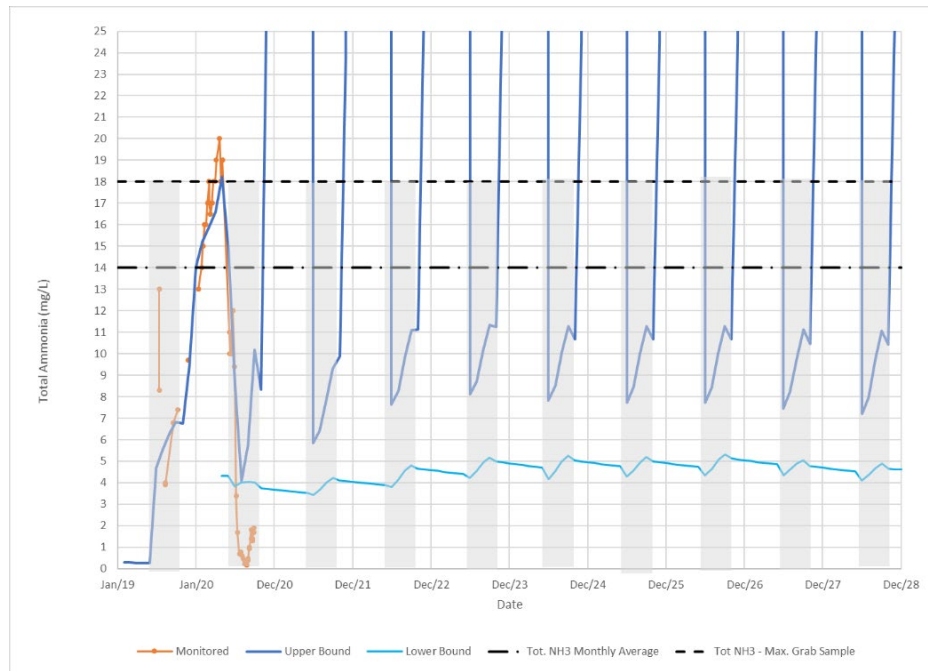
Figure 5. Forecasted upper and lower modeled CP1 total ammonia concentrations for life of mine and closure. Monitored 2019 and 2020 total ammonia concentrations demonstrate model alignment. Vertical grey bars represent periods of discharge.

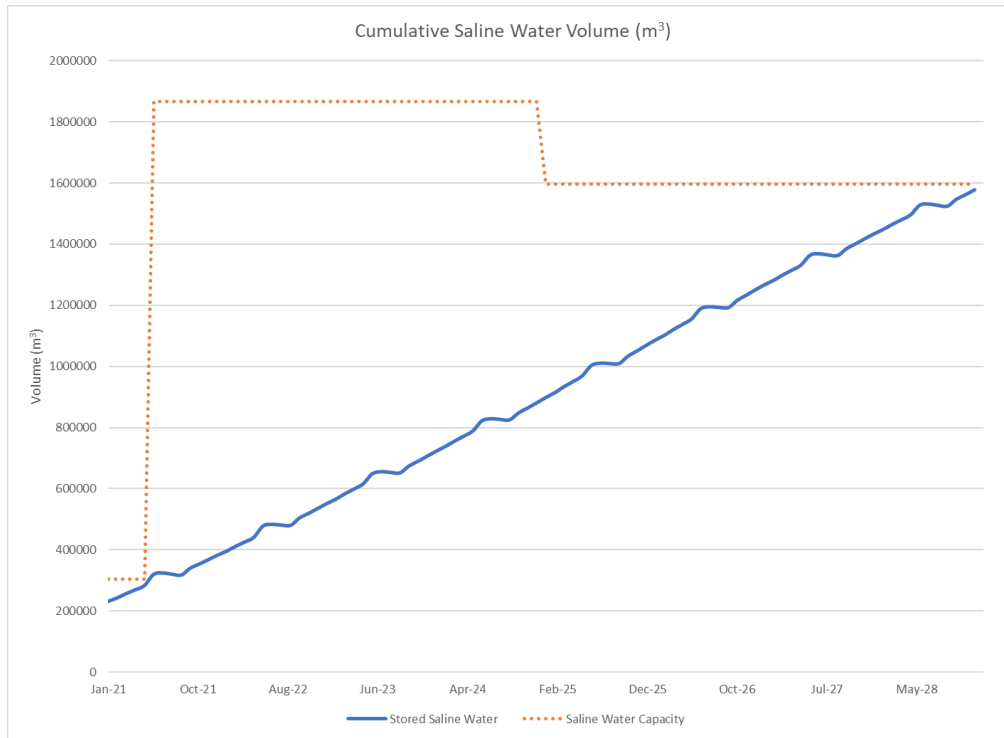
The model assumes a daily trucking discharge rate over the open water season of 1,600 m³/day. The trucking discharge rate of 1,600 m³/day has been approved by the authorities for 2021, however, requires approval by the Nunavut Planning Commission (NPC) in future years. The model assumes a discharge availability of 90% over the open water season. A waterline (application ongoing under NIRB process) and associated increased discharge rate relative to trucking is not considered in this model.

Figure 6 Forecasted saline water storage requirement (blue line) versus actual storage capacity available.

The resulting forecast shows a steady growth rate in saline water accumulation on site over LOM. Activation of Tiriganiaq Pit 2 storage capacity in June 2021 is shown to provide adequate saline storage capacity over LOM under the assumed inflow and discharge conditions until 2028 at which point Tiriganiaq Pit 2 reaches capacity. Although this occurrence is at the end of mine life, these trends are not sustainable due to the year-over-year increase in stored water and saline water storage capacity being at maximum capacity at end of mine life. To allow successful and sustainable management of saline water over life of mine, the long-term strategy of discharge through a waterline, and thus removal of year-over-year storage, is required. This long-term strategy is discussed in further detail within the Groundwater Management Plan. As stated above, the regulatory application for a waterline and associated increased discharge rate is currently ongoing under the NIRB process. Further details discussing the viability and suitability of the trucking discharge to sea strategy in comparison to the waterline discharge to sea strategy can be found in the Groundwater Management Plan.

It should be noted that there is approximately 21,700 m³ of buffer capacity in May 2021 between the stored saline water and available saline water capacity prior to the activation of Tiriganiaq Pit 2 as saline storage. Tabular data for the inflows and outflows of each storage pond are available in Appendix 5.

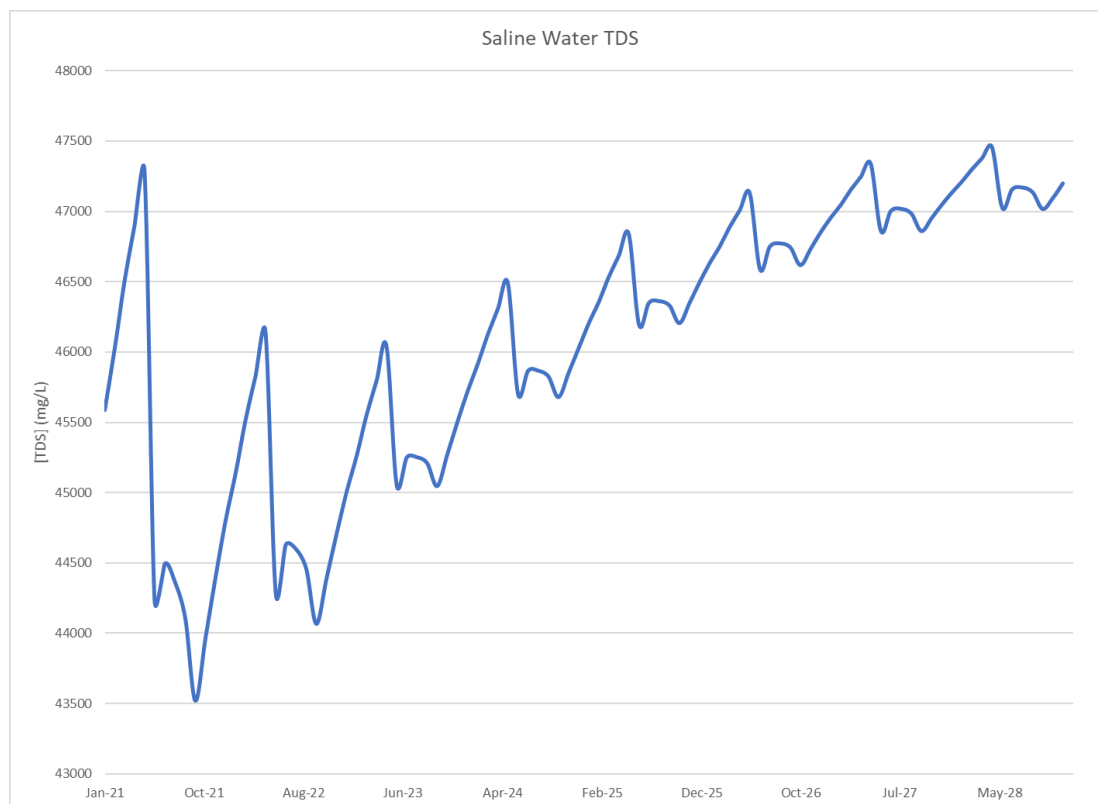
mg/L through LOM. Figure 7 presents the forecasted combined saline water TDS in storage. Tabular data for TDS in each storage pond along with combined saline water TDS is presented in Appendix 5.

Figure 7. Forecasted TDS concentrations across all combined saline water stored on site.

Despite groundwater inflows transporting a consistent 55,000 mg/L of TDS to saline water storage, the combined forecasted TDS concentrations typically remain below 47,500 mg/L due to both lower starting concentrations of each pond (pre-existing runoff being present in the ponds from past years) and the effect of future precipitation runoff inflows to saline ponds. The latter can be characterized by the steep downward trend in concentration at the start of each freshet period. Subsequently, a brief increase in TDS concentrations each year is due to evaporative processes and reduced precipitation runoff (post-freshet) before again dropping due to increased runoff later in each open water season. The increasing TDS observed each winter season is due to continuous delivery of groundwater to storage while precipitation remains locked as snow and ice.

Overall, an increasing trend in TDS concentrations with smaller fluctuations is observed due groundwater inflows making up an increasingly large portion of the overall saline water volume in storage as time progresses.

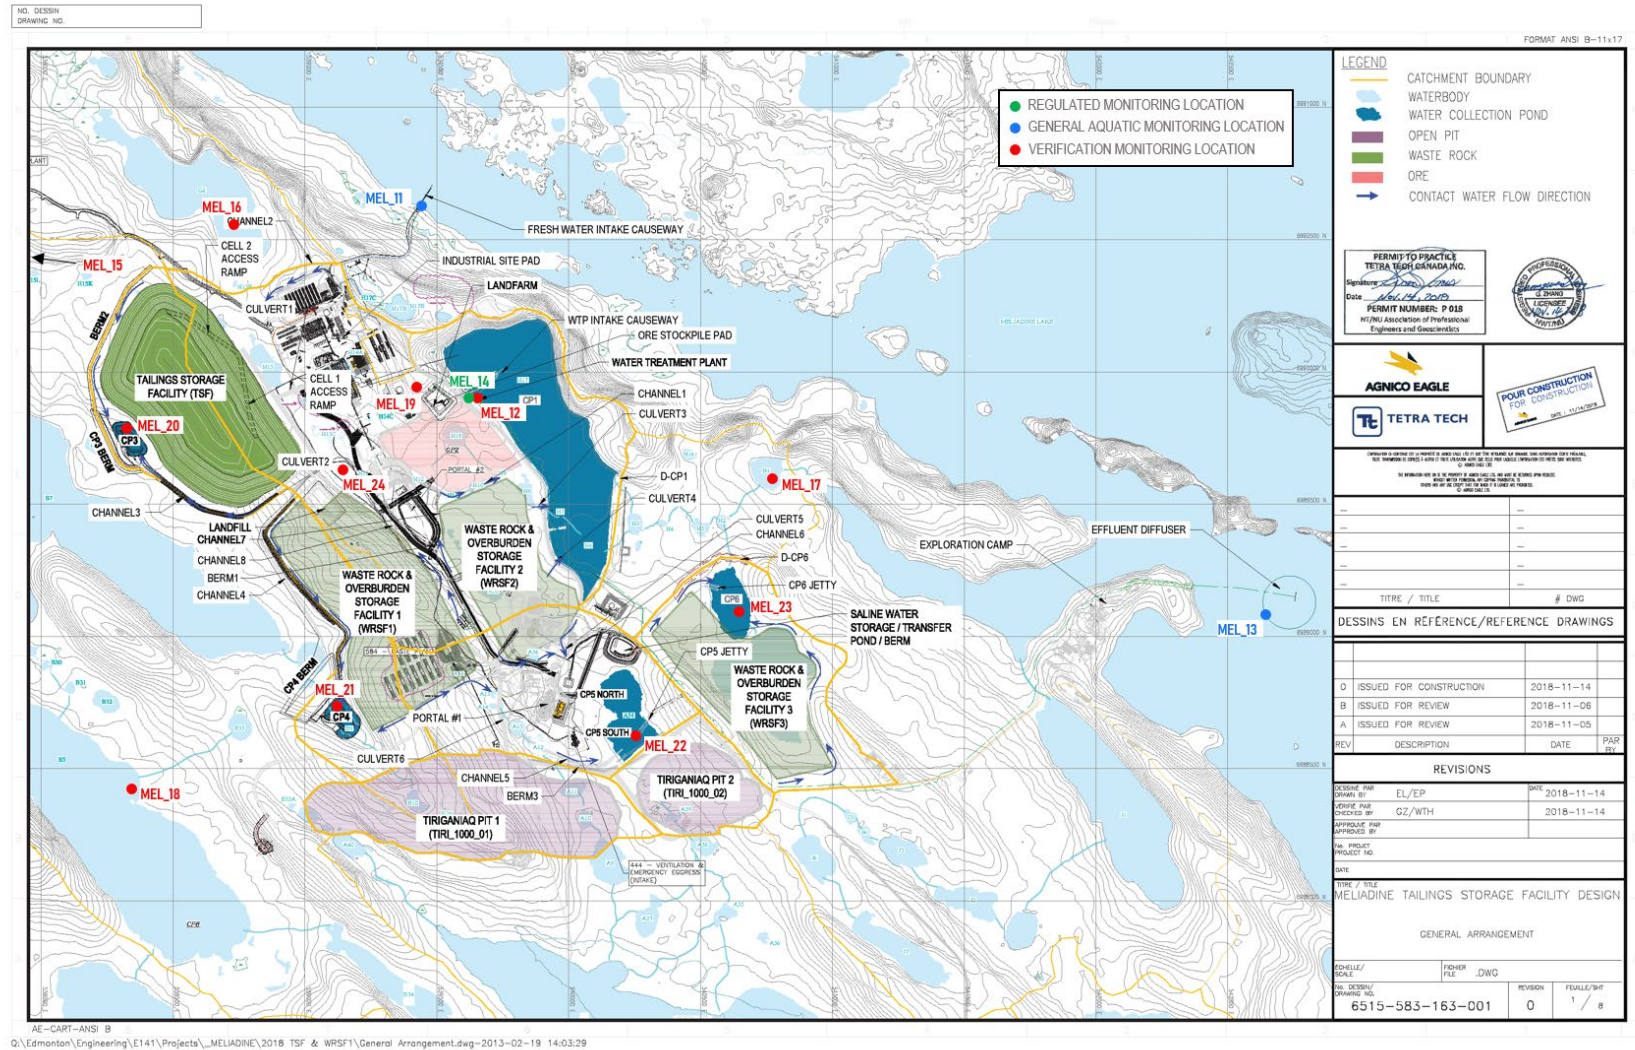
Figure 9. Meliadine Site Sampling Locations

Site Sampling Stations and EEM Receiving Environment Sampling Locations are illustrated in Figure 9 and Figure 10.

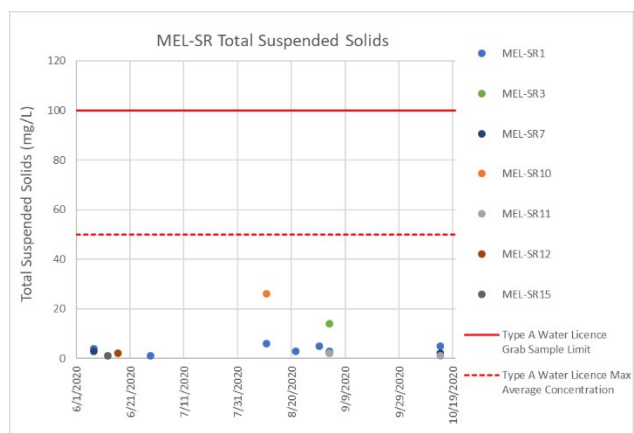
Figure 11. Total Suspended Solids (TSS) results for MEL-SR samples

In 2020, no TSS exceedances occurred at stations MEL-SR-TBD. All TSS concentrations were below the Type A Water Licence maximum concentration of any grab sample of 100 mg/L. Furthermore, average concentrations for each MEL-SR station sampled in 2020 did not exceed the allowable maximum average concentration of 50 mg/L TSS.

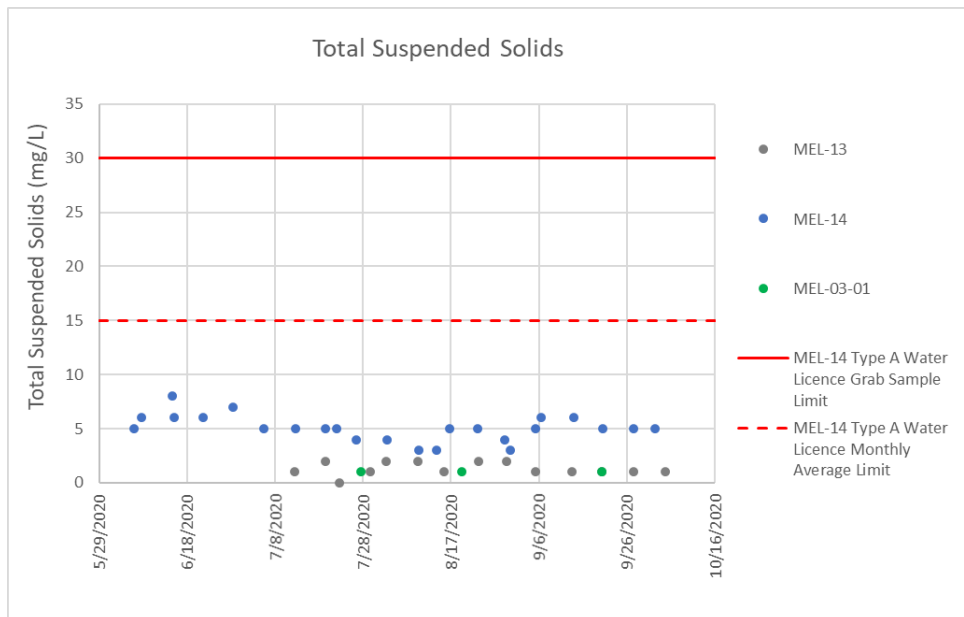
Figure 12. Total Suspended Solids (TSS) results for MEL-03-01, MEL-13 and MEL-14 samples

In 2020, TSS results for MEL-14 did not show any particular trend, with no significant increase or decrease of concentration. The yearly average concentration was 5 mg/L and the highest result was 8 mg/L. No exceedance occurred in 2020 for this parameter with all grab sample and average concentrations within permitted limits (of 30 and 15 mg/L, respectively). For MEL-13 and MEL-13-01 monitoring stations, the TSS results ranged between <1 mg/L (below the laboratory detection limit) and 2 mg/L.

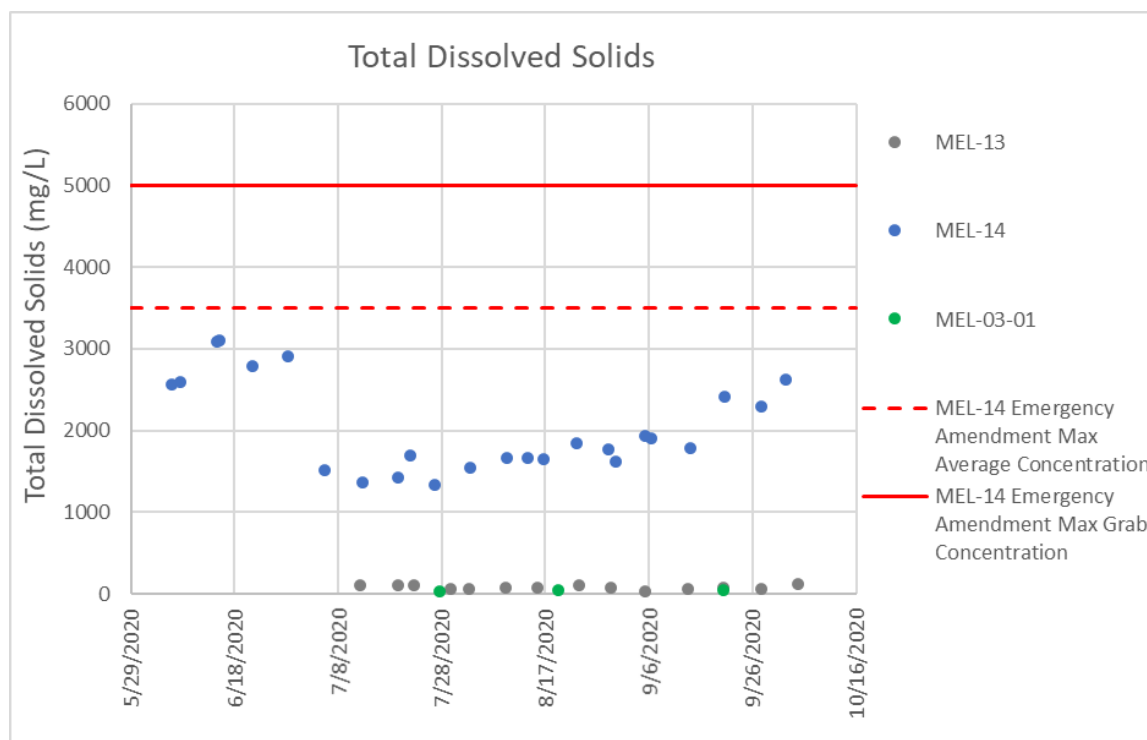
Figure 13. TDS results for MEL-03-01, MEL-13 and MEL-14 samples

With regards to TDS, all MEL-14 samples were compliant with the 3,500 mg/L maximum average concentration and 5,000 mg/L the maximum grab concentration from the Emergency Amendment No. 1 to the Type A Water Licence. The average TDS concentration at MEL-14 in 2020 was 2055 mg/L (not including pre-discharge sampling) and the highest measured concentration was 3,100 mg/L. The TDS concentration decrease observed in July can be correlated to an influx of snow and ice melt directly within the pond. Increasing TDS over the remaining discharge period is likely due to a combination of factors, including concentration through evaporation and TDS loading at upstream inflow sources.

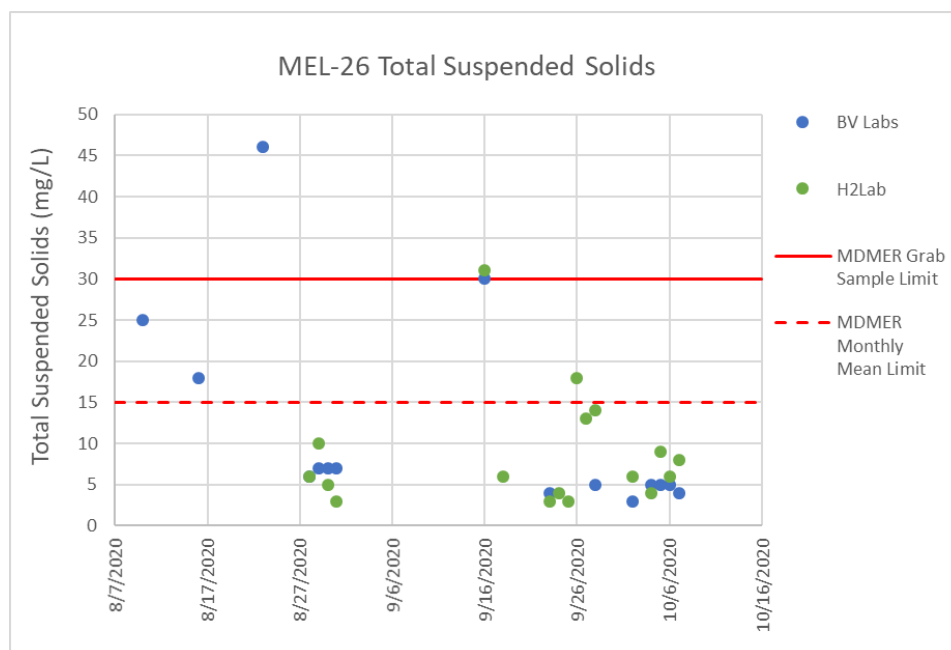
Figure 14. TSS results for MEL-26 samples

As seen in Figure 14, MEL-26 samples collected on August 23rd and September 16th were reported with TSS concentrations of 46 mg/L and 31 mg/L, respectively, which exceeded the limit of 30 mg/L for any given grab sample to comply with MDMER authorized limits.

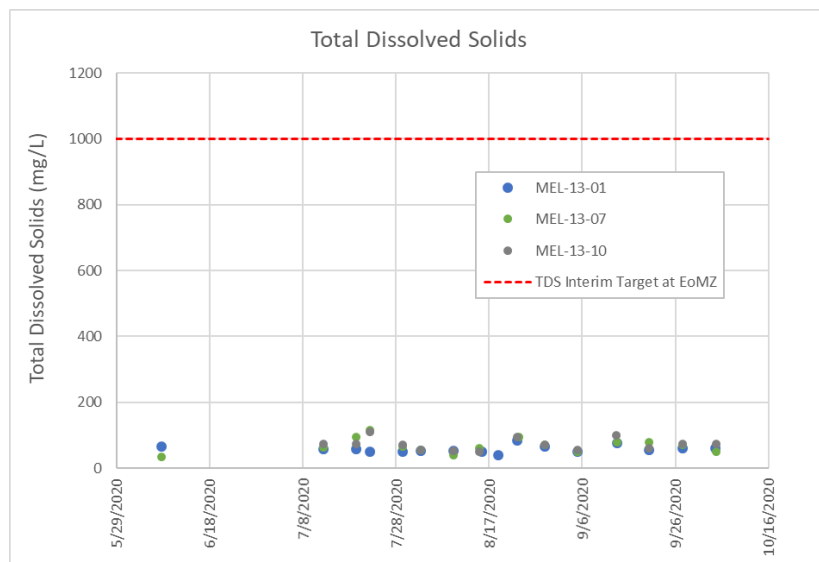
Figure 15. TDS results for Edge of Mixing Zone (EoMZ) in Meliadine Lake

The WQ-MOP TDS interim target applicable in the receiving environment at the edge of the mixing zone for the protection against chronic toxicity to representative aquatic species was set at 1,000 mg/L as part of Emergency Amendment No. 1 of the Water Licence. As shown in Figure 15, all TDS concentrations for samples collected at EoMZ stations are well below that target, with a maximum of 115 mg/L.

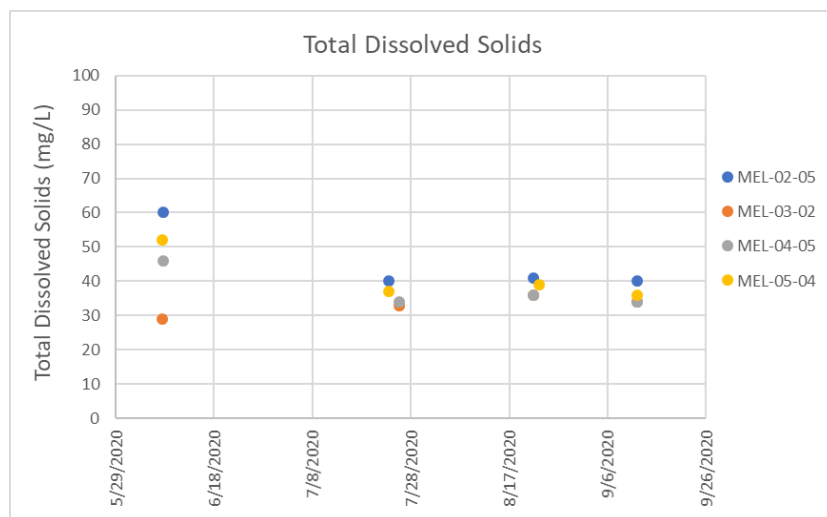
Figure 16. TDS results for Mid-field and Reference stations in Meliadine Lake

The average TDS concentration at mid-field and reference stations in Meliadine Lake was 39 mg/L, and the maximum 60 mg/L.

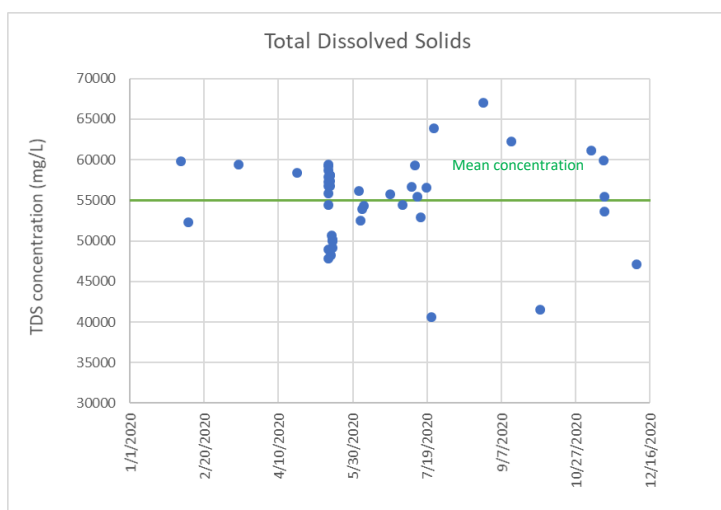
Figure 17. TDS concentration in DDH water intersect samples – 2020

Results showed an average TDS concentration of 55,000 mg/L, with values ranging from 40,600 mg/L to 67,000 mg/L.

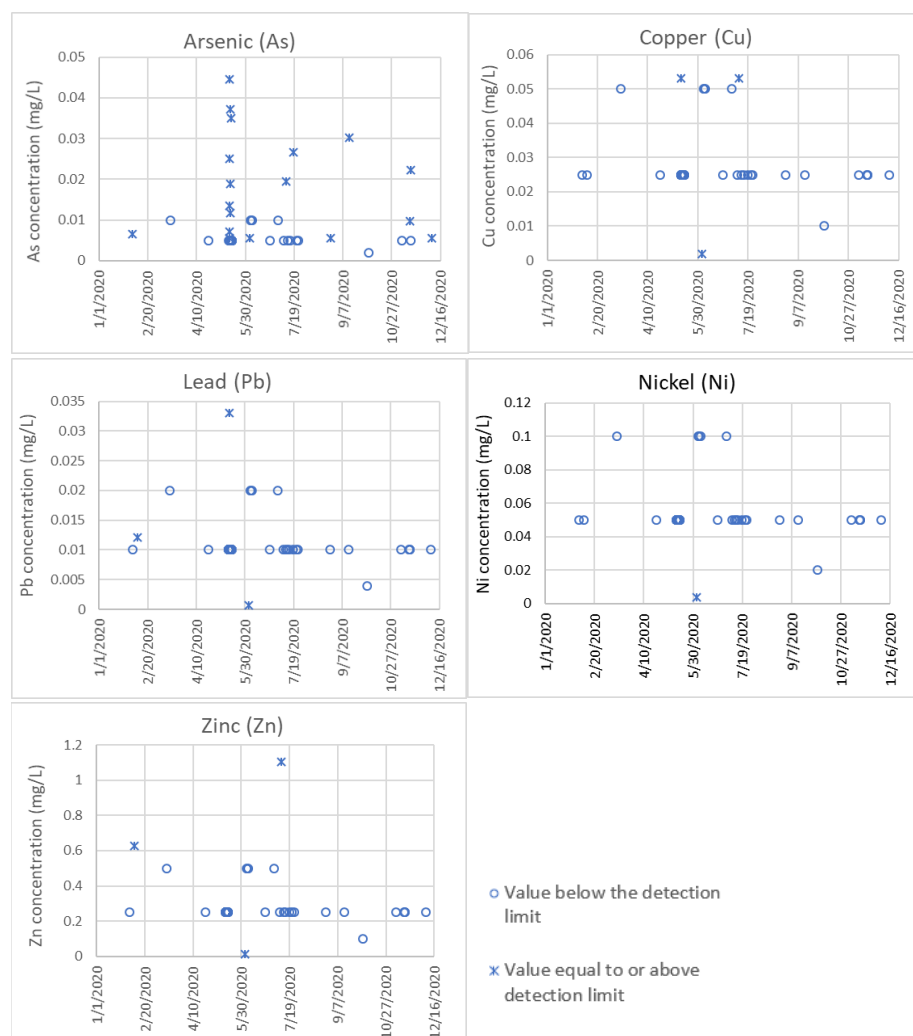
Figure 18. Total metals (As, Cu, Pb, Ni, Zn) concentration in DDH water intersect samples – 2020

Concentrations for MDMER Schedule 4 total metals (As, Cu, Pb, Ni, Zn) are mostly below the laboratory detection limits for the 2020 DDH water intersect samples. Few samples showed total metal concentrations equal to or slightly above the laboratory detection limits; those samples are indicated by the “x” in the graphs above.

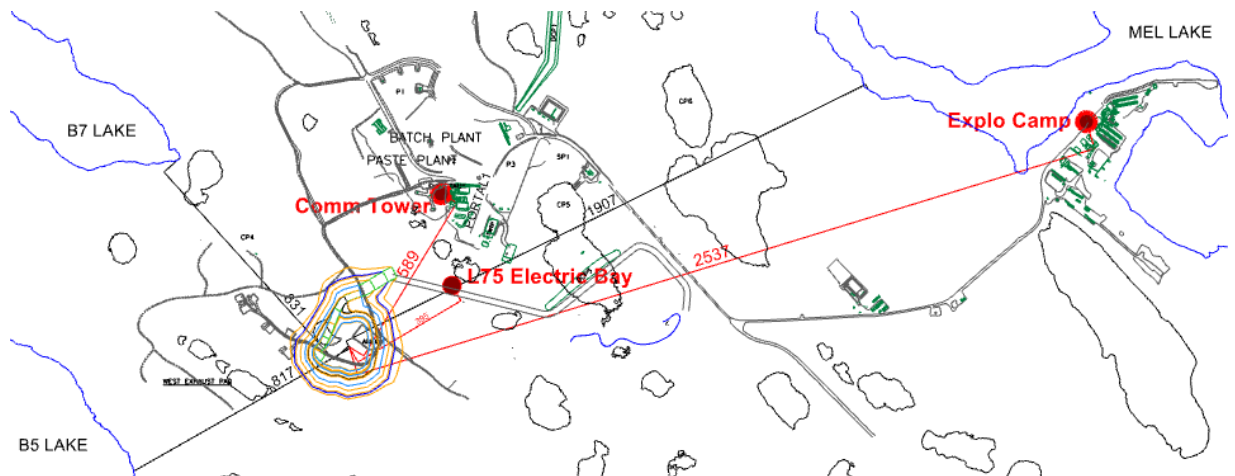
Figure 19. Surface Blast Monitoring Station Locations used for Tiri01 Blasts (Distance in Meters)

LOCATION	EASTING	NORTHING	DESCRIPTION
Location #1	539427.536	6988596.942	Temporary location used for TIR02
Location #2	541938.477	6989017.942	Temporary location used for TIR02
Location #3	540262.772	6988922.029	Temporary location used for TIR02
L75 Electrical Bay	539839.028	6988534.308	Permanent location used for TIR01 & TIR02
Explo Camp	541927.162	6989073.053	Permanent location used for TIR01 & TIR02 (installed 2020-08-20)
Comm Tower P1	539803.785	6988836.212	Permanent location used for TIR01 & TIR02 (installed 2020-08-20)

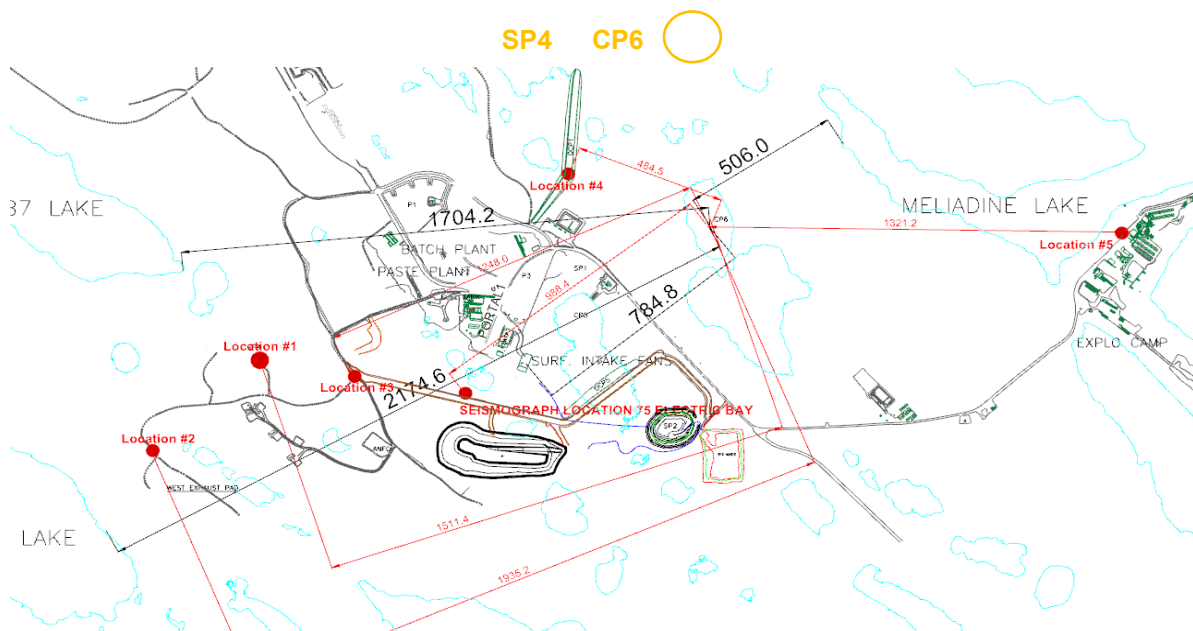
Figure 21. Surface Blast Monitoring Station Locations Used for CP6 and SP4 Blasts (Distance in Meters)

LOCATION	EASTING	NORTHING	DESCRIPTION
Location #1	539183.702	6988648.508	location used for CP6 and SP4
Location #2	538842.913	6988344.787	location used for CP6 and SP4
Location #3	539486.166	6988594.147	location used for CP6 and SP4
Location #4	540166.527	6989275.260	location used for CP6 and SP4
Location #5	541930.569	698,076.405	location used for CP6
L75 ELECTRICAL BAY	539839.028	6988534.308	Permanent location used for CP6

To improve vibration monitoring practices and data accuracy, permanent monitoring installations were commissioned on August 20th 2020, which allow the seismograph to be directly anchored into the bedrock via attachment to a steel rod drilled through the tundra. These permanent stations thereafter replaced the temporary locations used earlier in the year and throughout 2020. The L75 Electric Bay station has always been anchored in the bedrock as it is installed underground.

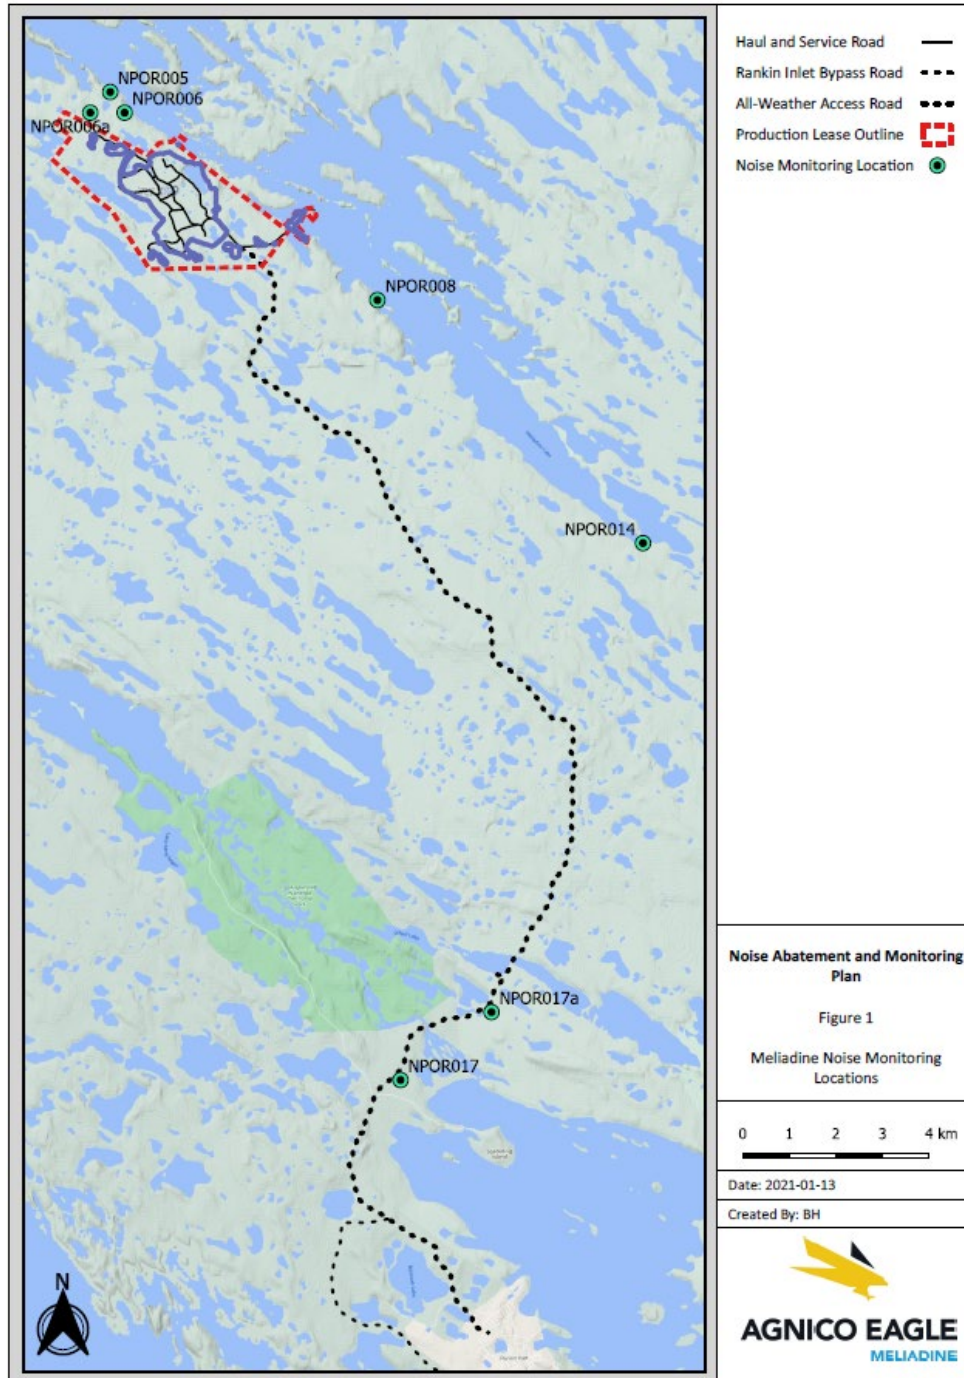
Figure 22. Meliadine Noise Monitoring Locations

Noise monitoring stations are illustrated on following Figure 22.

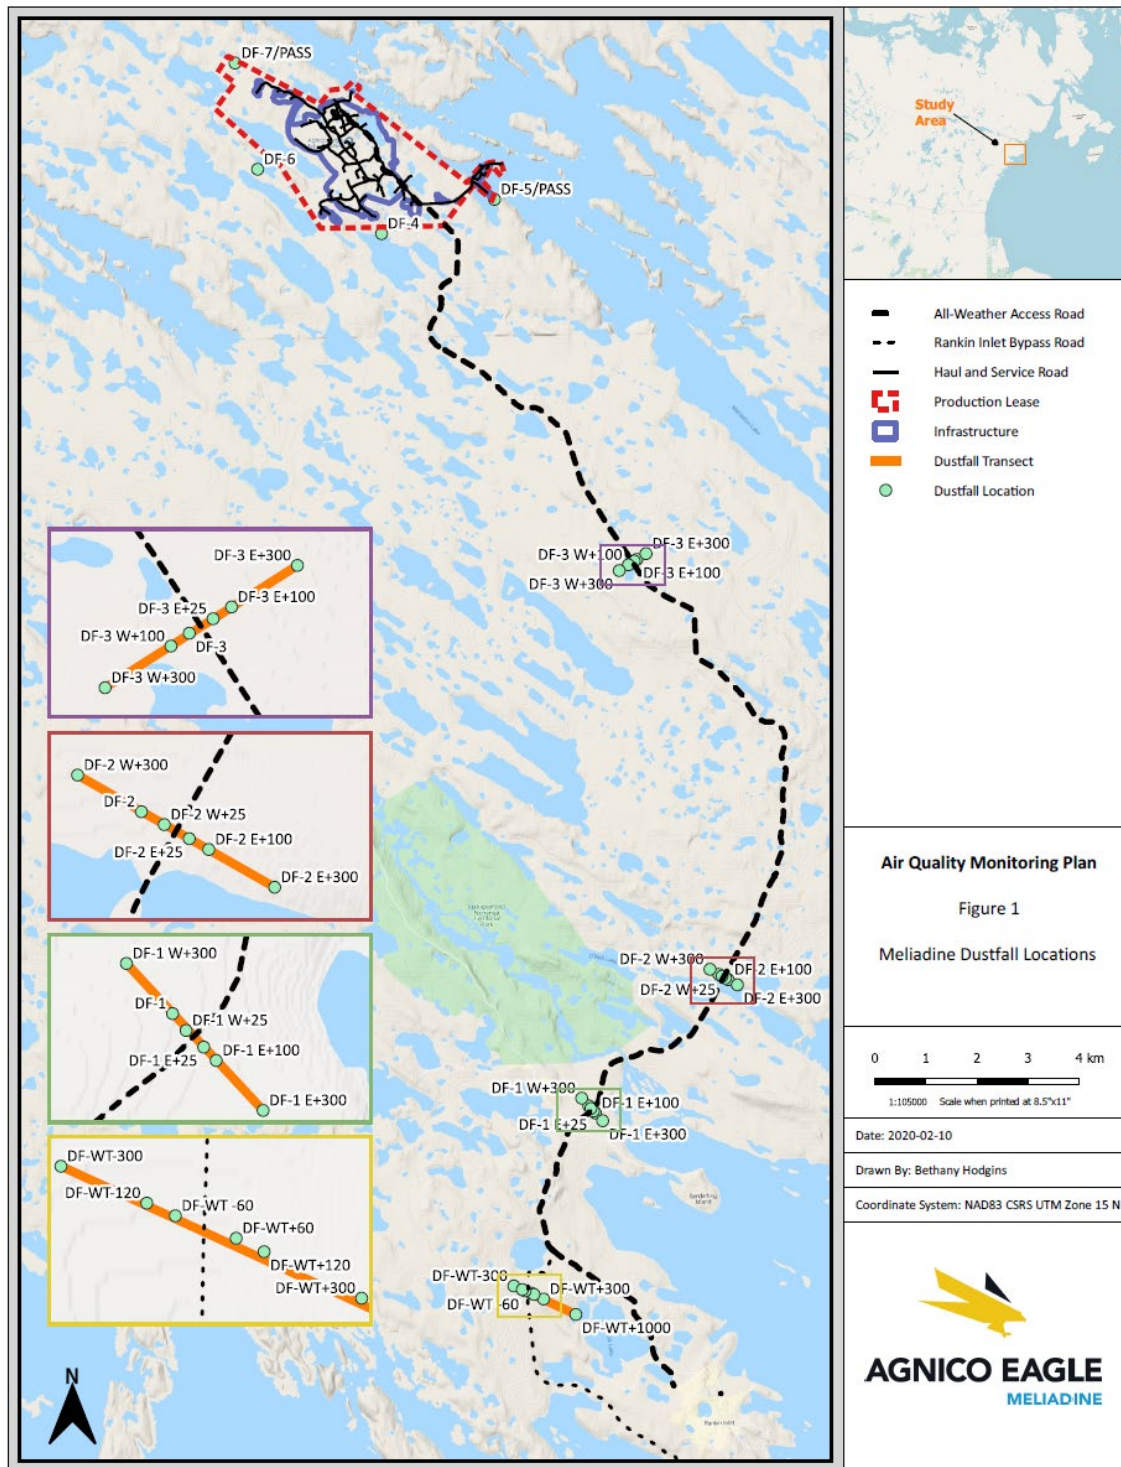
Figure 23. Dustfall Locations

Dustfall Locations are identified in Figure 23.
