## Appendix 27 : 2020 Caribou Trail Camera Study

## Meliadine Project

### Caribou Trail Camera Study, 2020

Project No.: 0544016-WP4

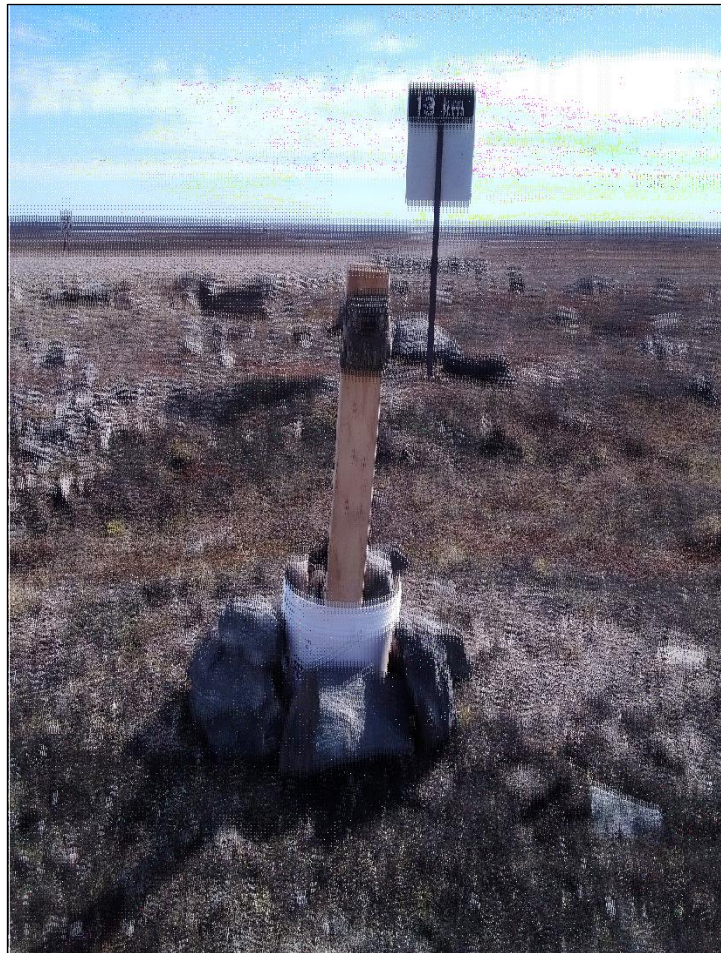
**Figure 5.1-2: Typical Camera Setup from the Meliadine 2020 Study**

Cameras were installed at a height of 50 centimetres, which was determined to be the optimal height for detecting movement of a passing caribou (ERM, unpublished data). Cameras on the AWAR were positioned to capture part of the road in the field of view, but were not explicitly set up to capture vehicle traffic. The installation setup was a simple bucket-and-stick design, where the camera was strapped onto a 2" x 4" piece of lumber that was stabilized in a bucket full of quarry rock (Figure 5.1-2). This setup was designed to be temporary and to minimize impact on the ground where it was placed. When the cameras were removed at the end of the study, all setup materials were returned to the Mine Site.

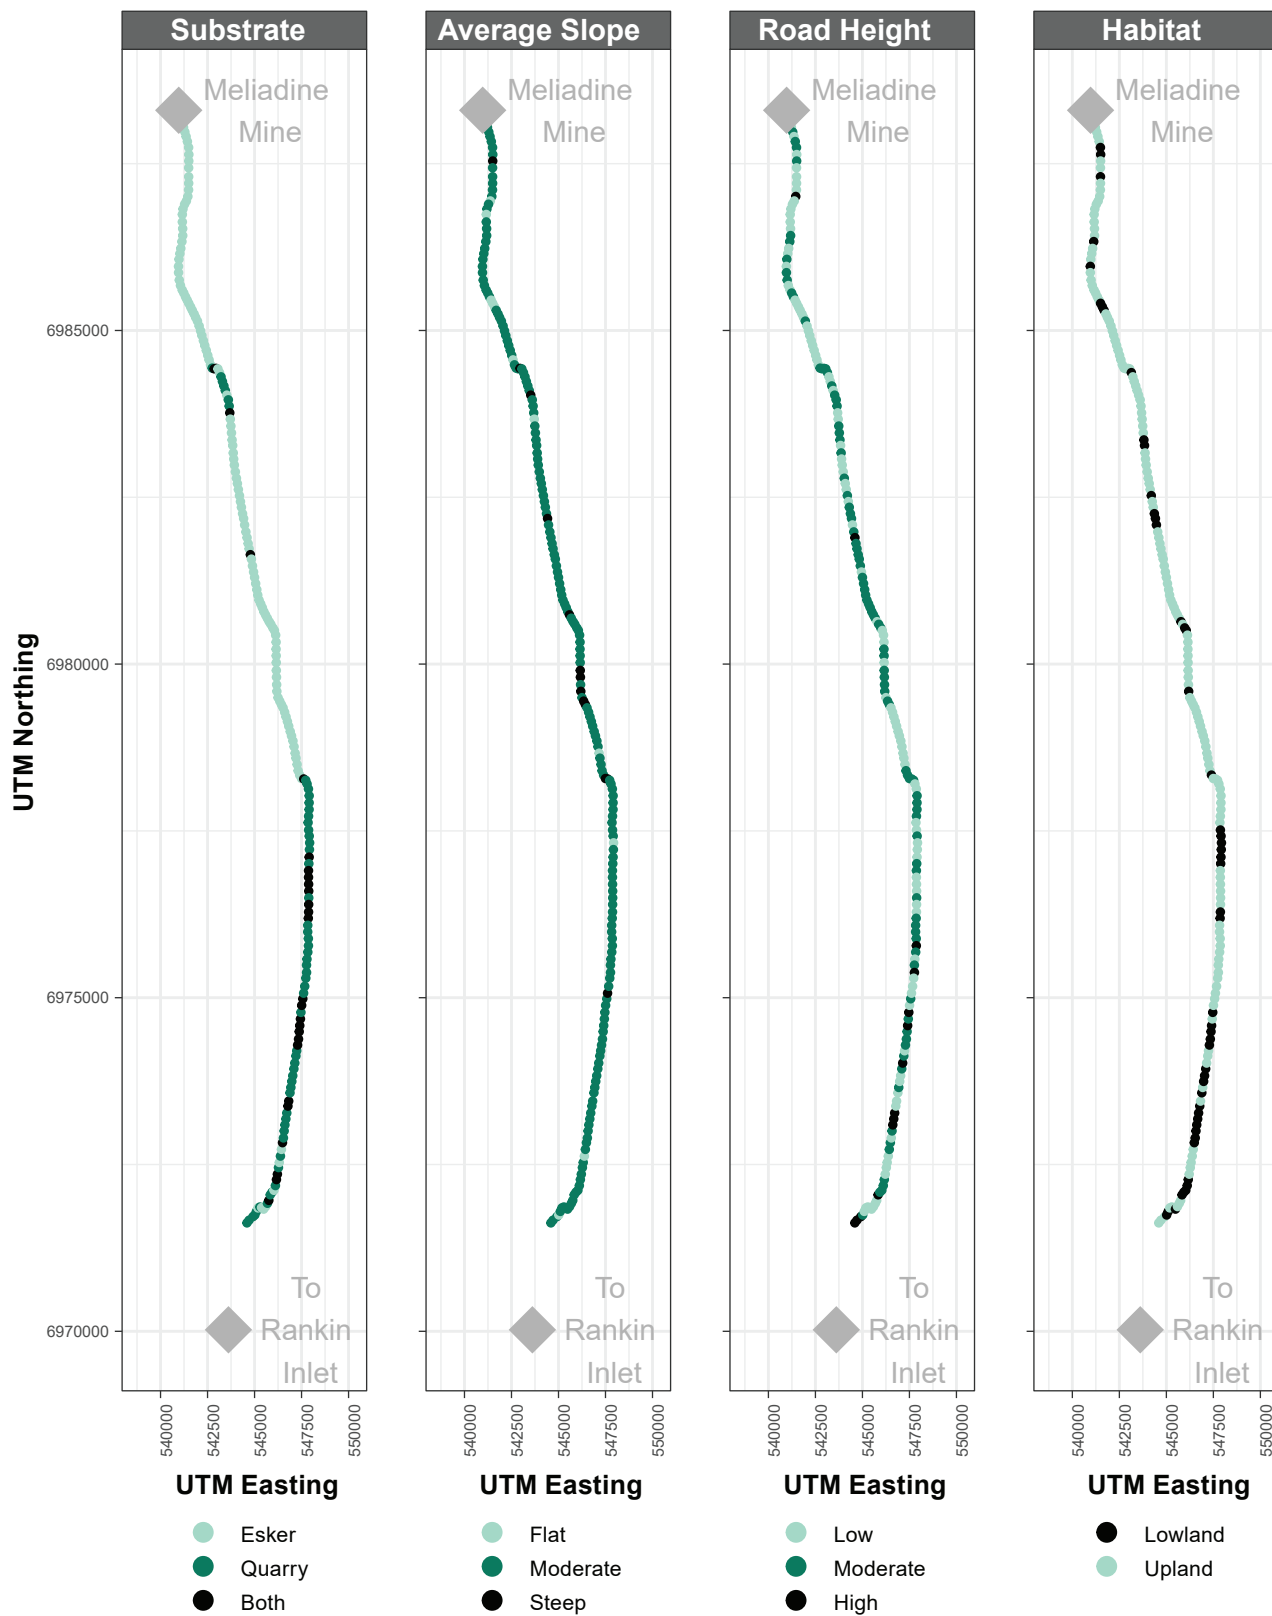
**Figure 6.3-1: Road Structure Survey Results**

Road surveys for structure and substrate type were completed every 100 m along the length of the AWAR from KM 8 (at the gatehouse) to the mine entrance at KM 30, totalling 210 surveys. The results of these surveys are presented in Figure 6.3-1. Road structure was generally consistent, with 88% of the roadside slope measurements falling within the “moderate” category (3.7:1 to 1.7:1 or 15-30 degrees), and only 6% classified as steep (<1.7:1 or 30 degrees). Similarly, 92% of road height measurements were either low (<1 m from the tundra; 48%), or moderate (between 1-2 m from the tundra; 44%). The maximum road height measured was 4.9 m, but this value represented an outlier as it was measured on a bridge ramp.

The surveys indicated there was a higher proportion of road with esker as the substrate material in the northern two-thirds of the AWAR, and a higher proportion of quarry rock as the substrate material in the southern third of the AWAR (Figure 6.3-1). This was likely because there is a large esker at approximately KM 18 that was used to construct the majority of the northern part of the road. There was also a higher proportion of lowland habitat in the southern third of the AWAR.

Note: Flat slope is < 15 degrees or 3.7:1; moderate slope is 15-30 degrees or 3.7:1 - 1.7:1; and steep slope is >30 degrees or 1.7:1  
Low height is < 1 meter; moderate height is 1-2 meters; and high height is >2 meters
