Appendix 15 : 2020 Reportable Spills

Appendix F-3
Reportable Spills and Follow-up Reports

Follow Up Report: #20-010

January 14, 2020 Hydraulic Oil Spill

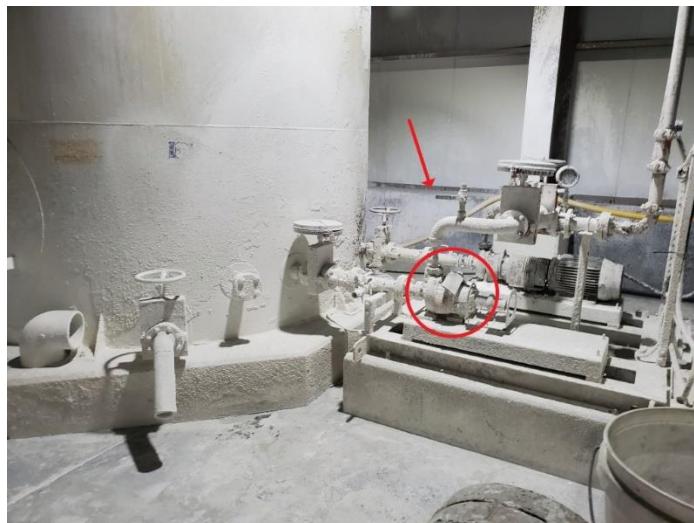
On January 24th the Environment Department was contacted by a worker at the Process Plant informing that 50 L of 20 % liquid calcium hydroxide had spilled to the ground. A dosing pipe seal ruptured on a pressurized line, causing the solution to spray onto the interior wall of the process plant above the concrete secondary containment. As the solution flowed down the aluminum cladding walls to the concrete containment, some seeped out between the cladding and the concrete, which then flowed onto the industrial pad.

Figure 2: Calcium Hydroxide solution sprayed from the ruptured seal (circled) and seeped out between the cladding and concrete (arrow).

Parts are on order to replace the damaged seal. The pump was removed and reinstalled on the backup dosing line. The installation of spray guards has been recommended and feasibility is being evaluated.

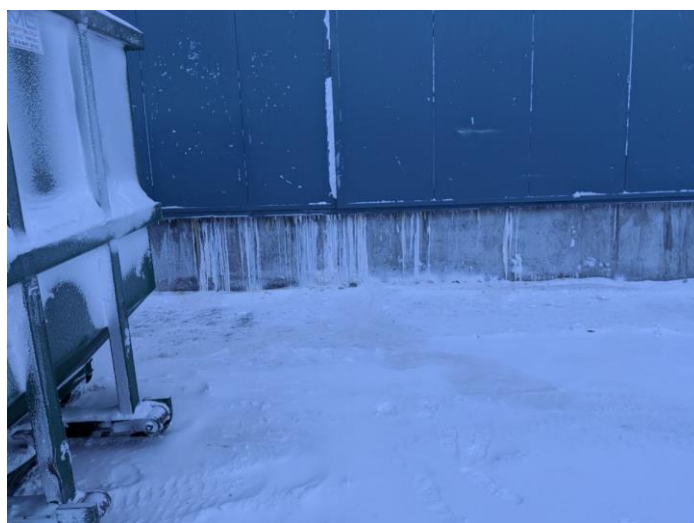
Figure 3: 50 L of 20 % Calcium Hydroxide prior to clean-up.

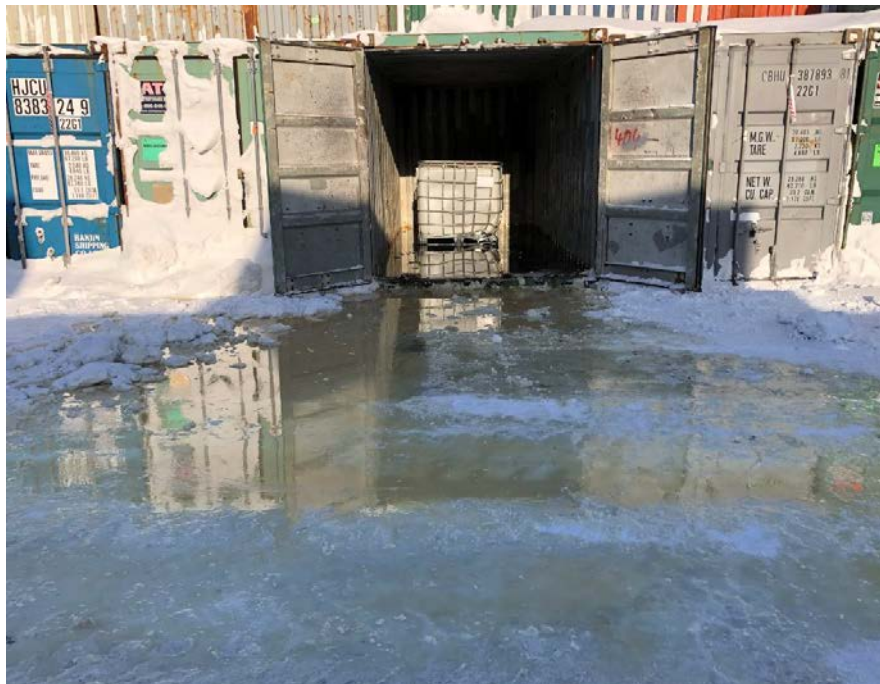
The incident occurred when a warehouse worker was attempting to retrieve a full, 1000 L tote containing engine oil, from inside a sea-can. While attempting to align the equipment's forks into the tote, the operator accidentally crushed and punctured a corner of the tote, which led to the release of the contents inside the sea-can. The tote was located in the back of the sea-can, so a large amount of oil settled on the floor inside, while the rest slowly flowed outside onto the gravel pad.

Figure 1: Spill site the morning of March 9, 2020.

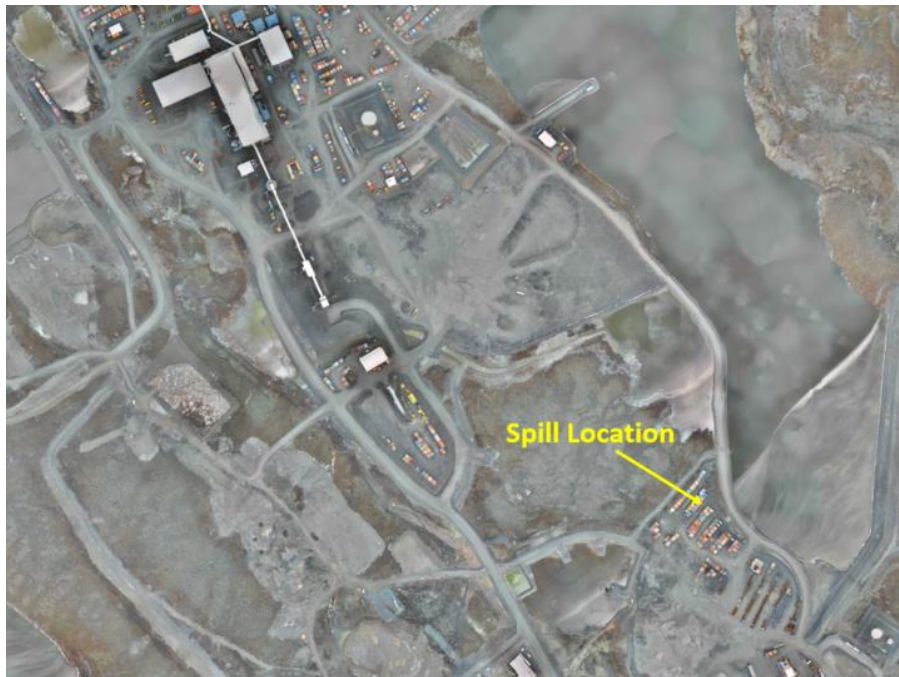
No water bodies were impacted by this spill. The closest natural water body is over 900 m from the spill location. The coordinates of the spill are 63° 01'53"N, 92°12'44"W (Figure 2).

Figure 2: Spill location at warehouse sea-can laydown.

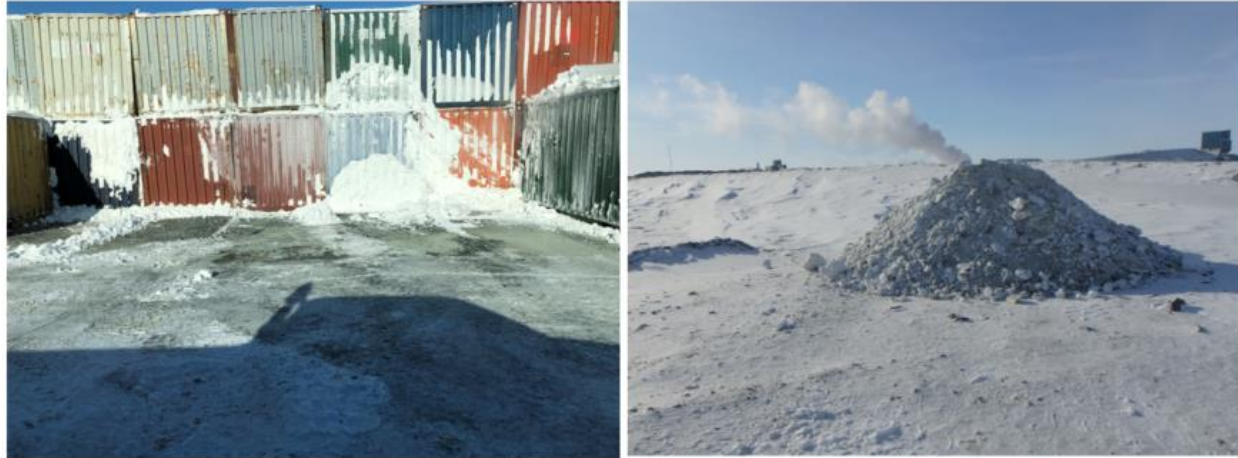
Used absorbent pads and Oil-Dri Quicksorb was disposed of as hazmat in Quatrex bags. Sea-cans impeding the clean-up were removed from the area. A loader was used to scrape the surface and remove 7 m³ of contaminated material from the spill site. The contaminated material was placed in the landfarm.

Figure 4: Initial clean-up of the area after sea-cans removed and loader began removing material (Left). Contaminated material brought to the landfarm (Right).

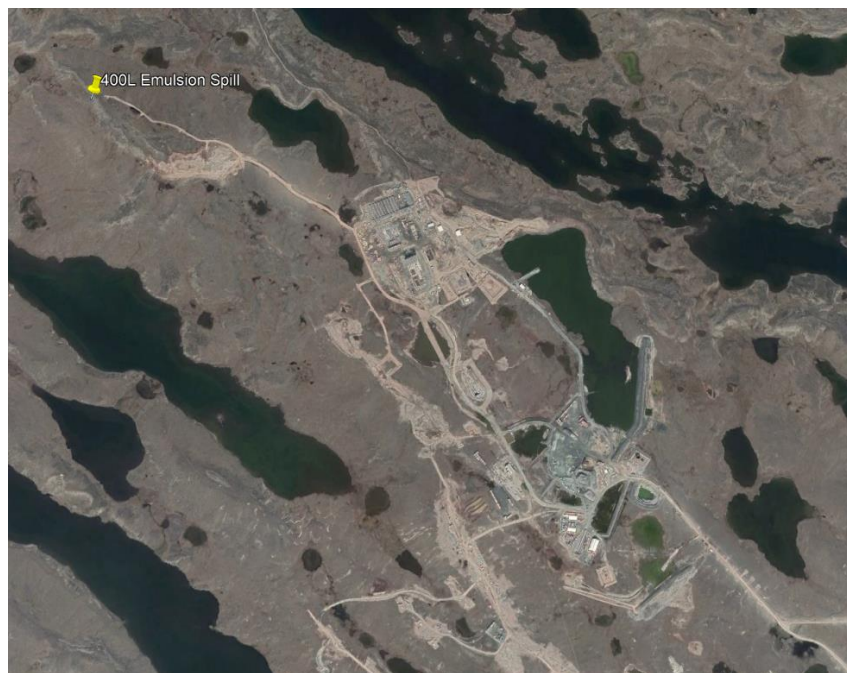
On March 28th at approximately 3:00 pm, an estimated 400 L of emulsion was spilled on the western side of the emulsion plant. A tele-handler operator punctured an empty emulsion bin while loading it onto the flat-bed truck for transport from underground to surface. The damage was not reported by the operator and was not seen by emulsion plant personnel prior to refilling. As the emulsion plant operator began refilling the bin he noticed the leak and shut down the system immediately. Approximately 400 L of emulsion spilled to the compacted gravel industrial pad, which was frozen at the time of occurrence, preventing residue infiltrating the ground. The spilled emulsion was contained within a 5 m² area due to the viscosity of the product.

No water bodies were impacted by this spill. The closest natural water body is over 550 m from the spill location. The coordinates of the spill are 63° 2'41.91"N, 92°15'26.42"W (Figure 1).

Figure 1: Location of 400 L emulsion spill and proximity to water bodies.

The Environment Department held a follow-up meeting with the Mine Department and Dyno Nobel (Emulsion Contractor) to discuss the cause and corrective measures. Operators loading and unloading emulsion bins will now require a spotter to ensure forks are correctly positioned under emulsion bins. Flat-racks used to transport emulsion bins between the emulsion plant are now equipped with dividers, to ensure all sides of the bin can be thoroughly inspected prior to filling (Figure 6). Bins must be placed on the flat-rack with valves facing out to provide quick access in the event of a hose connection failure.

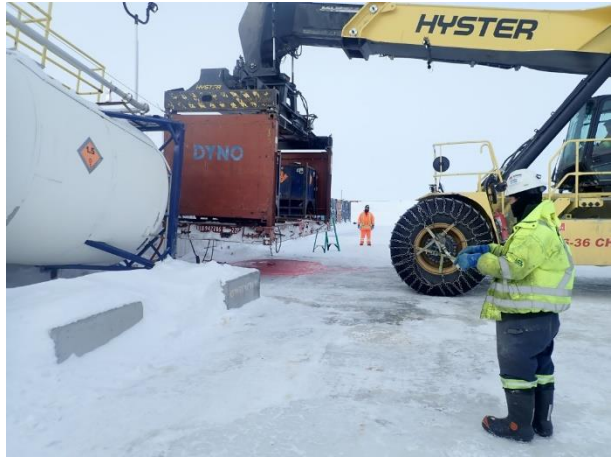
Emulsion plant personnel removed the damaged bin from the flat-rack using a forklift, and drained the emulsion from the damaged bin into another bin (Figure 2). The flat-rack was moved using a hyster, to provide access to the spill (Figure 3). Spilled emulsion was pumped into an emulsion bin for reprocessing and reuse (Figure 4). A bobcat was used to scrape remaining emulsion residue from the ground. This material was brought back into the emulsion plant and neutralized.

Figure 3: Hyster removing flat-rack from spill area.

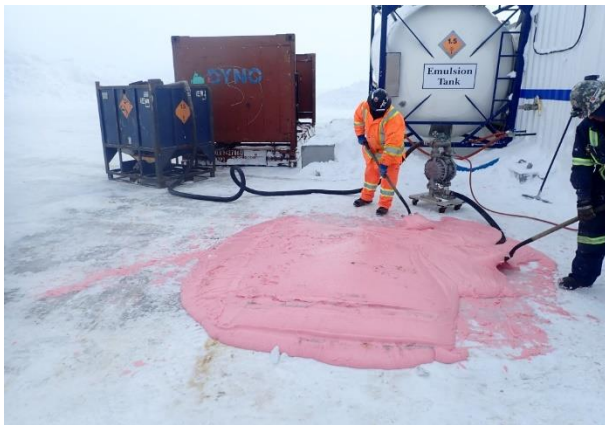
Figure 4: Spilled emulsion being pumped to emulsion bin.

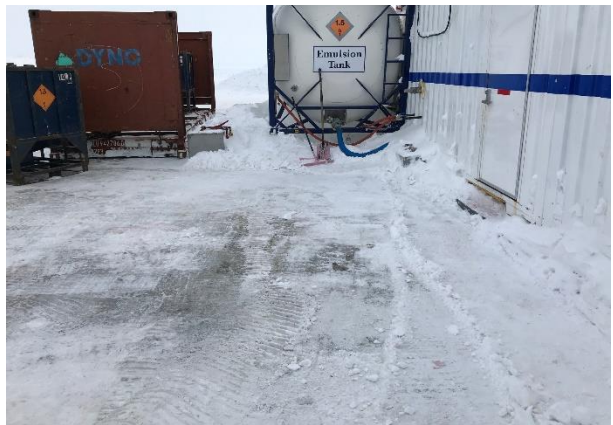
Figure 5: Spill area following clean up.

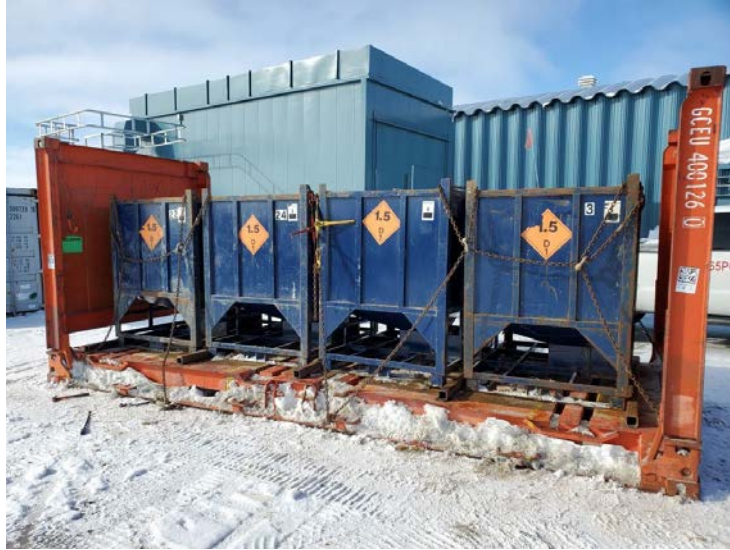
Figure 6: Steel dividers installed to improve visibility during pre-loading inspection.

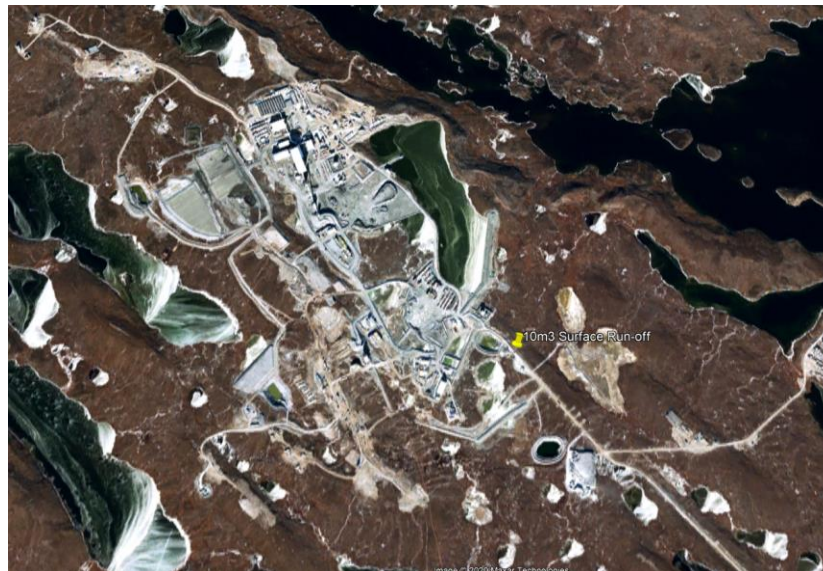
On June 3rd, at approximately 6:00 pm, an estimated 10 m³ of surface water run-off was spilled as water was being conveyed via a waterline in preparation for freshet. An accidental release occurred from a cracked flange, resulting in water spilling to the ground and flowing towards Containment Pond 6 (CP6). No water migrated off-site. The closest water body is approximately 480 m away. The coordinates of the spill are 63° 1'39.00"N, 92°12'11.00"W (Figure 1).

Figure 1: Location of spill.

No clean-up was required as the surface water flowed back into CP6, which is part of the sites' managed water system. The source of the surface water run-off was CP5 which is a licensed compliance monitoring location (Mel-22). A sample was collected from Mel-22 at the time of the spill, and showed no results of concern (Table 1). The flange was repaired and pumping continued.

The Energy and Infrastructure department replaced the cracked flange and completed a full inspection of the line prior to start-up. When the line was brought back into service, Mine personnel remained at the point of the spill to ensure that the replaced flange was operating properly. No issues were observed.

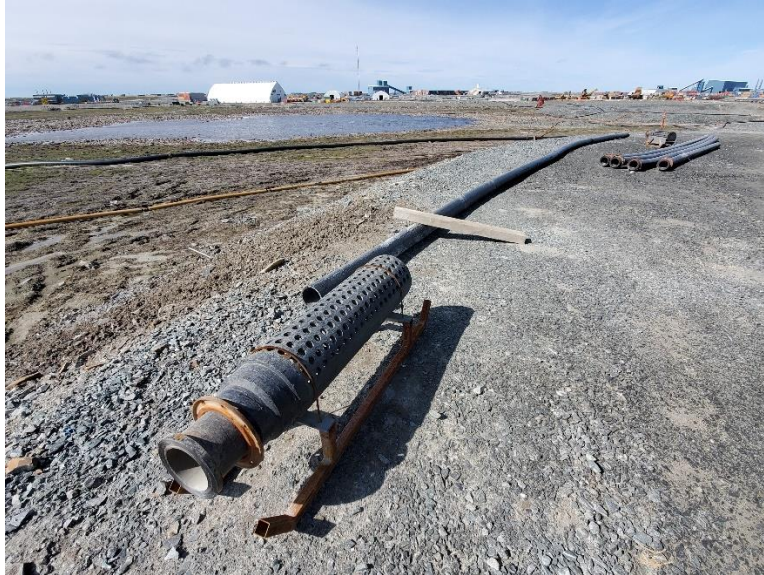
On August 9th, at approximately 3:00 pm, an estimated 1 m³ of treated saline water was spilled as water was being conveyed via a waterline from Saline Pond 3 (SP3) to the truck loading station. An accidental release occurred from a recently commissioned waterline, resulting in water spilling to the ground and flowing towards Containment Pond 5 (CP5). No water migrated off-site. The closest water body is approximately 925 m away. The coordinates of the spill are 63° 1'36.00"N, 92°12'10.00"W (Figure 1).

Figure 2: Piping removed from SP3 to loading station.

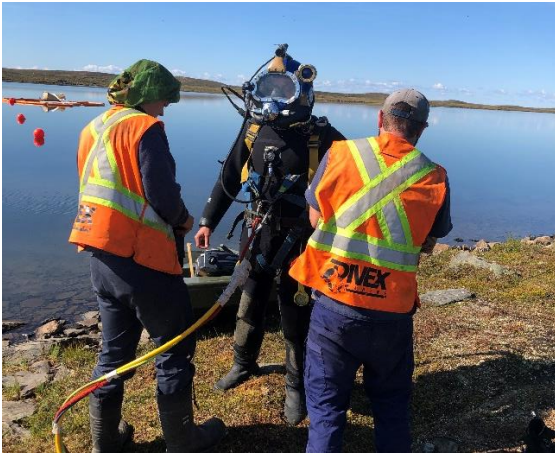
In preparation for the operation, a 4,500-liter water container was heliported and filled with water on the shore to be used as an anchor during the pivoting operation (see Figure 5). Straps were attached to the container and a chain block was installed. The cable was attached from the container to the side of the submerged tank and a slight tension was applied. Divers observed that only by this slight tension the tank was starting to rise. The skid that would act as a pivot point seemed to be anchored securely enough to the ground so that any other means to avoid its sliding during the lifting operation would be unnecessary.

Figure 5. Diver preparation

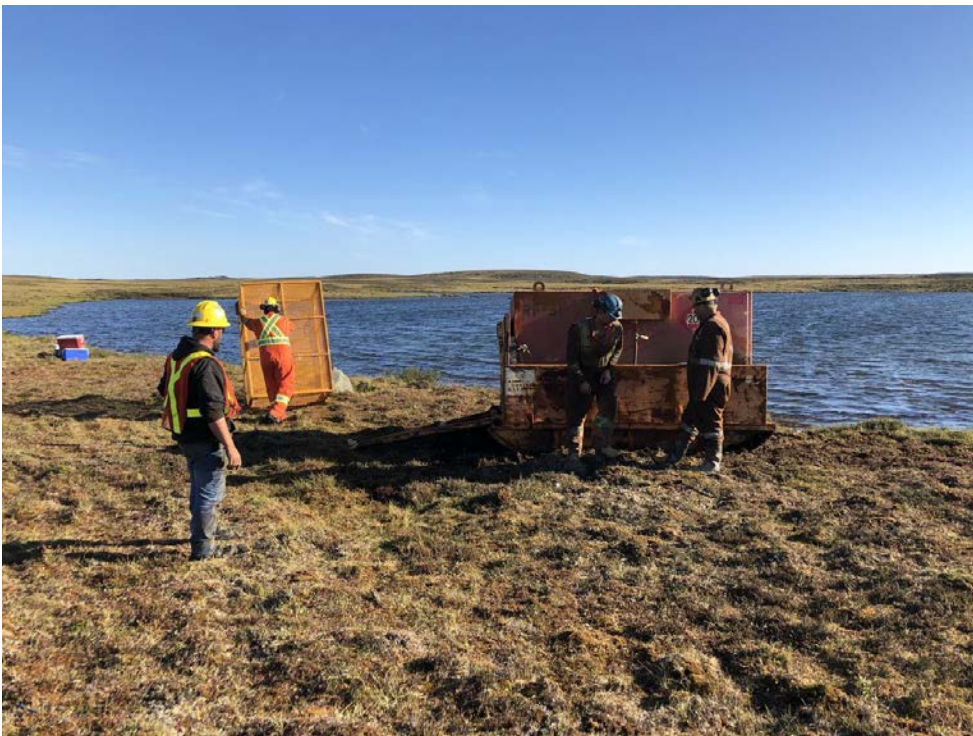
Figure 6. Fuel tank being extracted from the lake

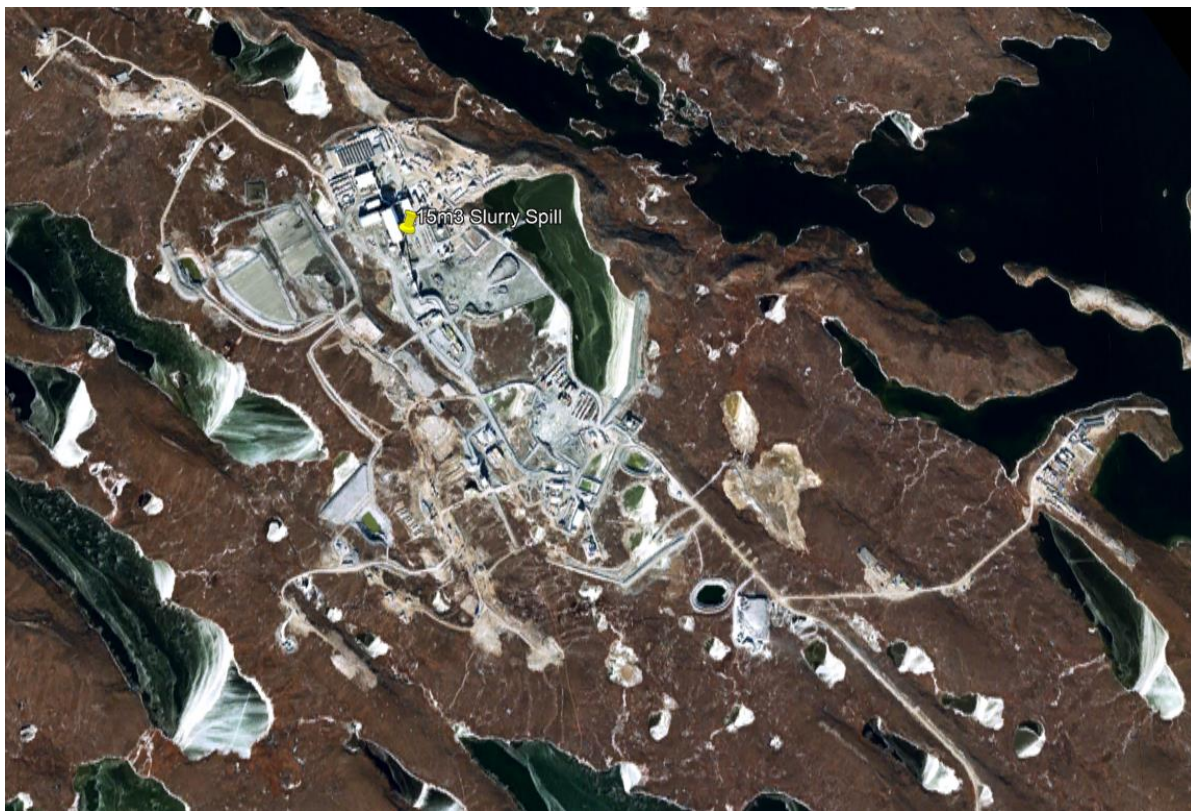
On August 23rd 2020, at 2:00pm an equipment failure on the Process Plant Trash Screen #2 and Human Machine Interface (HMI) occurred which led to approximately 15 m³ of slurry flowing outside the building onto the industrial pad. No bodies of water were impacted by this spill, the closest body of water, lake G2, is approximately 600 m away. The coordinates of the spill were 63° 2'11.02"N, 92°13'29.92"W (Figure 1).

Figure 1: Location of slurry spill at the process plant, and proximity to water bodies.

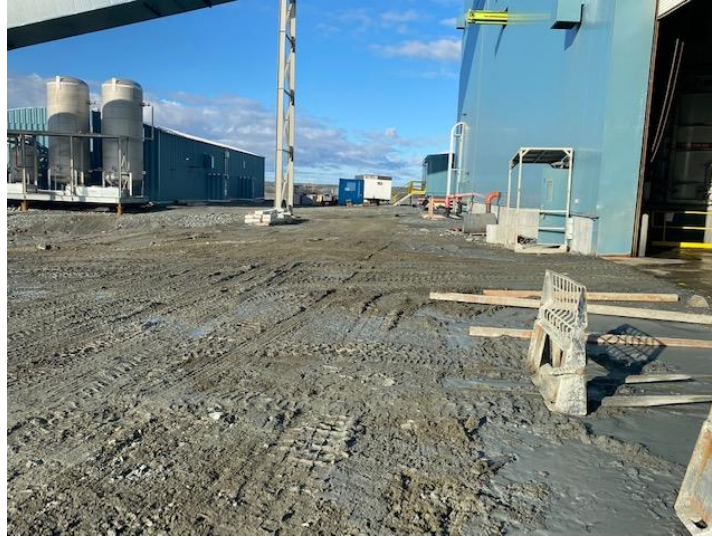
Figure 2: Spilled slurry outside of process plant door, during clean-up.

The process was stopped to correct the issue and the spill was cleaned up (Figure 2). The spilled material was collected and added to the ore feed for immediate reprocessing (Figure 3).

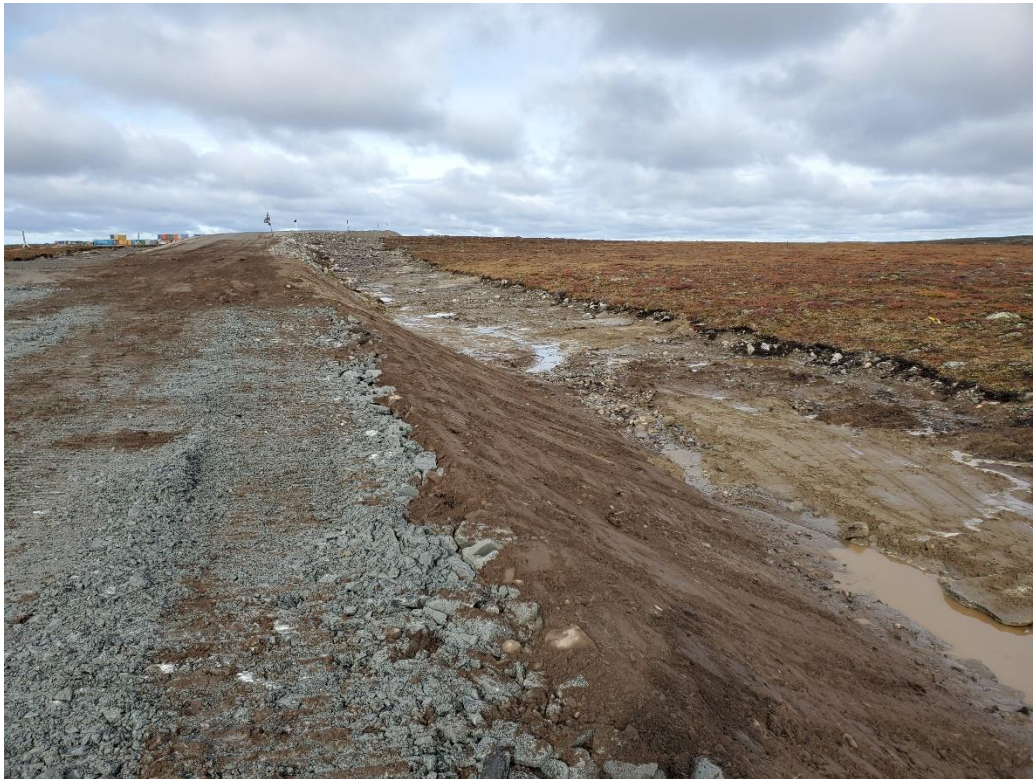
Figure 5: Road widened, and drainage channel restored.

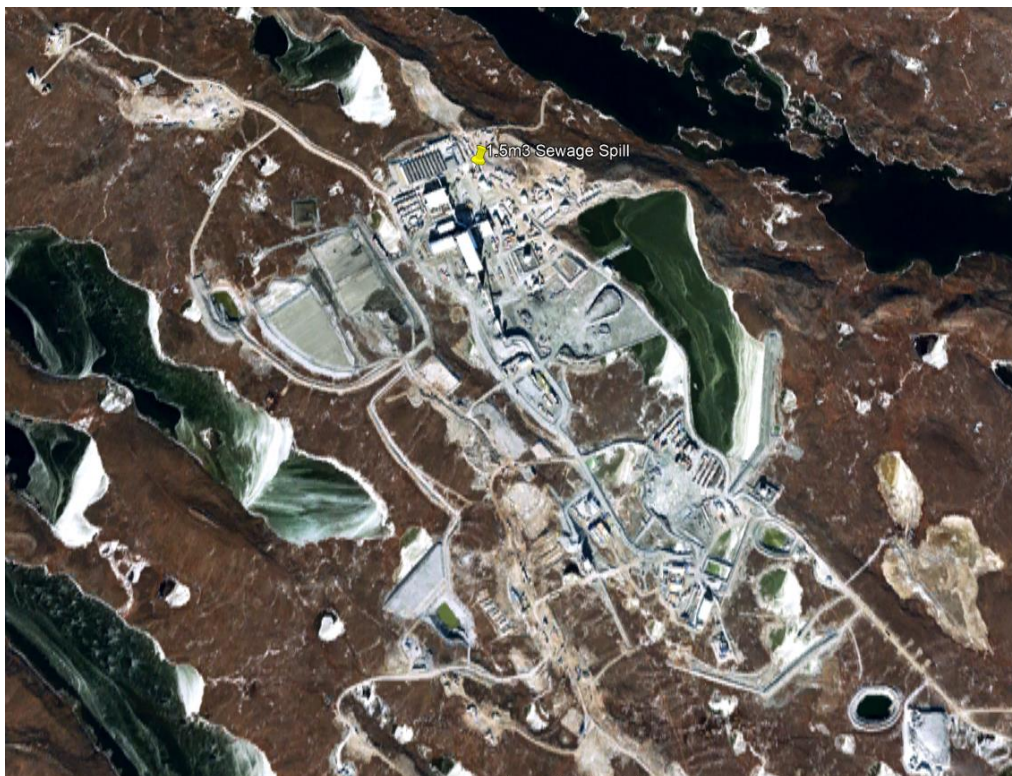
On September 11th 2020, at 11:45pm an overflow switch failed to trigger in the main camp sewage treatment plant, which caused a treatment tank to overflow, resulting in approximately 1.5m³ of untreated sewage to spill to the ground. No contaminants migrated off-site. The closest water body (Meliadine Lake) is approximately 420 m away. The coordinates of the spill were 63° 2'23.31"N, 92°13'41.07"W (Figure 1).

Figure 1: Location of main camp sewage treatment plant and proximity to Meliadine Lake.
