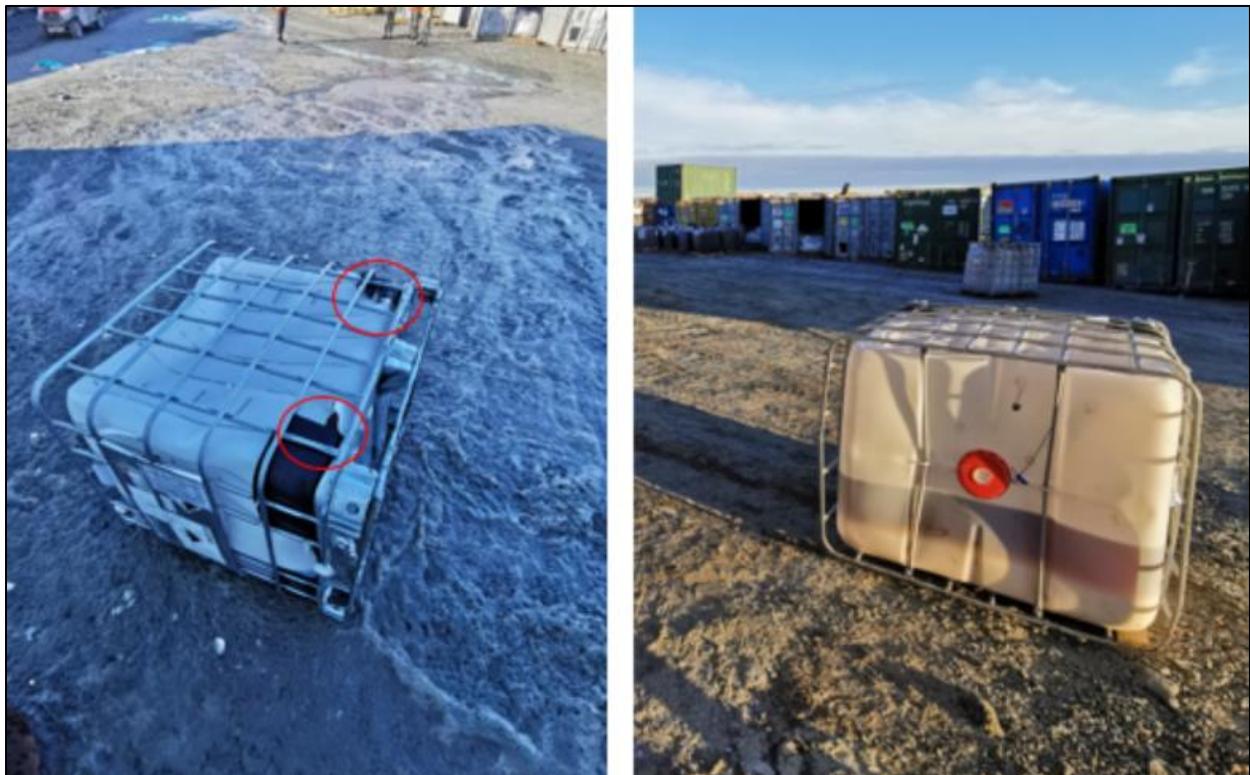
Figure 1: Punctured tote with remaining liquid inside.

On September 27, 2020, shortly after 17:00, the Environment Department received a call requesting assistance in spill response at the SWTP. Upon arrival, the supervisor of the employee involved informed us that the equipment operating was attempting to transport a $\frac{3}{4}$ full tote of coagulant, did not use a spotter, and accidentally punctured the tote (Figure 1). The spill occurred directly outside of the SWTP loading doors (Figure 2) at the following coordinates:

The root cause of the incident was the failure of the operator to follow the procedure of using a spotter to ensure the proper alignment of the forks. In the last year Meliadine has been pushing for the all departments to ensure that a spotter is used whenever forked equipment is required to transport hazardous materials (liquids, powders, etc.). Training material has been created and communicated to workers through toolbox meetings, and a site-wide reminder has been sent out following this most recent incident. Another round of toolbox meetings will be held as an additional reminder of the importance of the use of a spotter.

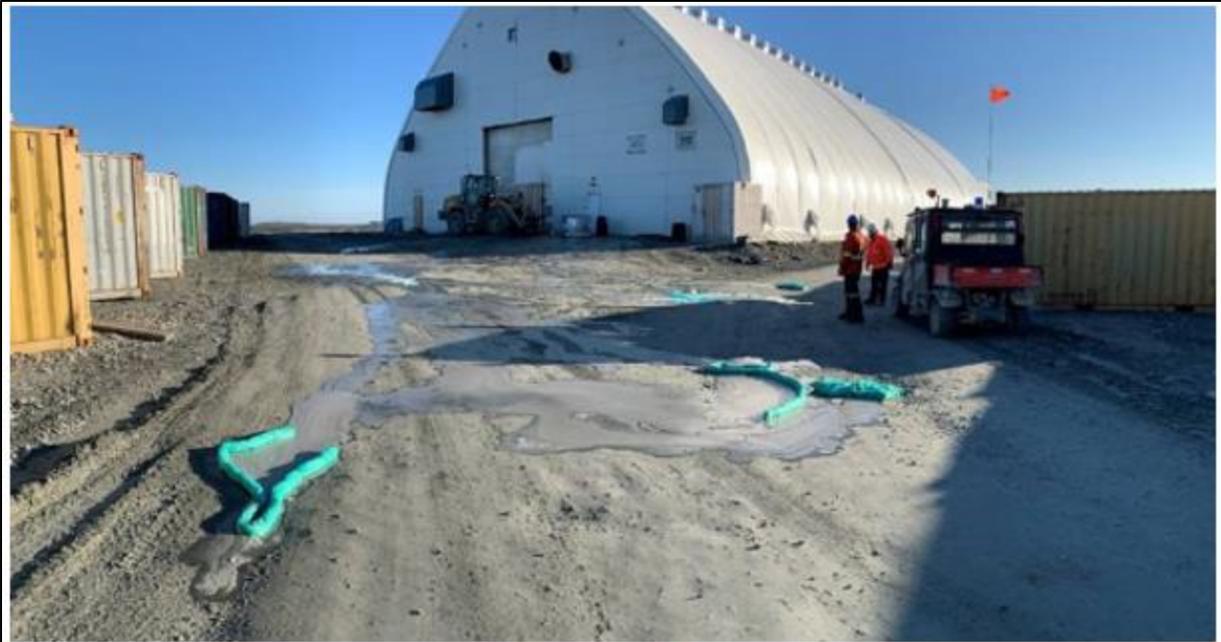
Figure 3: Initial effort to contain the spilled material from flowing away from the source.

Upon puncturing the tote, the operator acted quickly by using the loader to tip the tote onto its side, preventing it from emptying completely (Figure 3). Spill pads and absorbent booms were deployed in an initial attempt to prevent the spill from spreading (Figure 4). The material itself was a sludge-like consistency and did not absorb deep into the compacted pad. However, the spill occurred on a sloped area, so the material spread out over a large surface area.

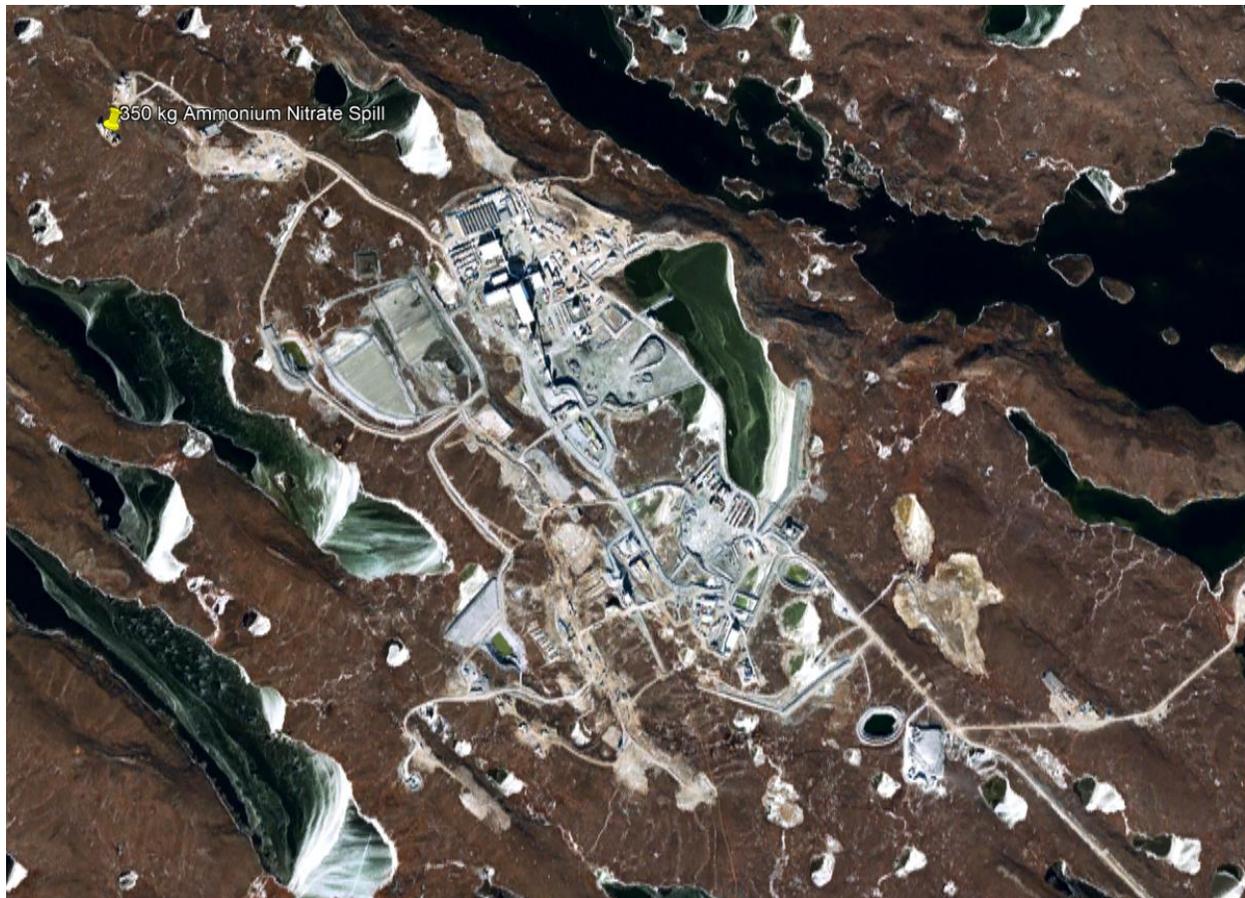
Figure 1: Location of 350 kg Ammonium Nitrate spill and proximity to water bodies.

No water bodies were impacted by this spill. The nearest natural waterbody (B7) is 500 m away. The coordinates of the spill are 63° 2'34.15"N, 92°15'26.20"W (Figure 1).

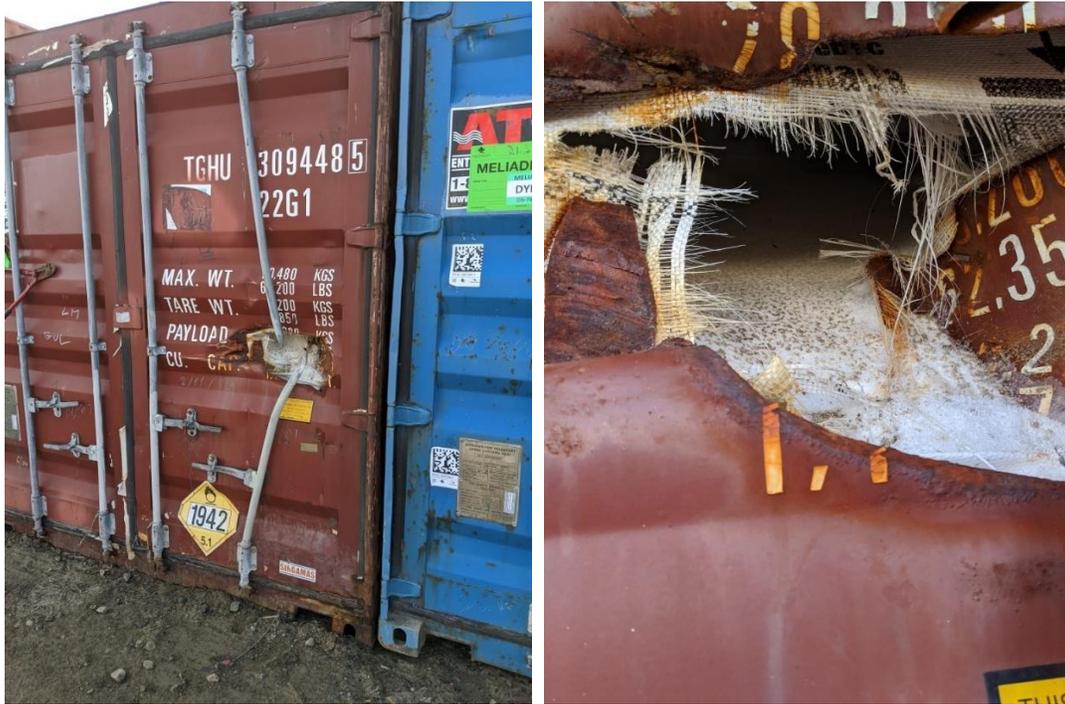
Figure 2: Damaged seacan containing Ammonium Nitrate.

A seacan containing bags of ammonium nitrate was punctured by heavy equipment causing approximately 350 kg of product to be released to the ground. The spill was initially reported as 400 kg. However, after weighing the remaining product inside the seacan, a more accurate estimate of 350 kg was calculated. The damage was discovered October 2nd and it is thought to have occurred during snow removal earlier this year.

The Environment Department held a follow-up meeting with the Energy and Infrastructure Department and Dyno Nobel (Emulsion Contractor) to discuss the cause and corrective measures. Equipment operators responsible for clearing snow will be reminded of the importance of following the snow management plan and standard operating procedures prior to resuming snow removal.

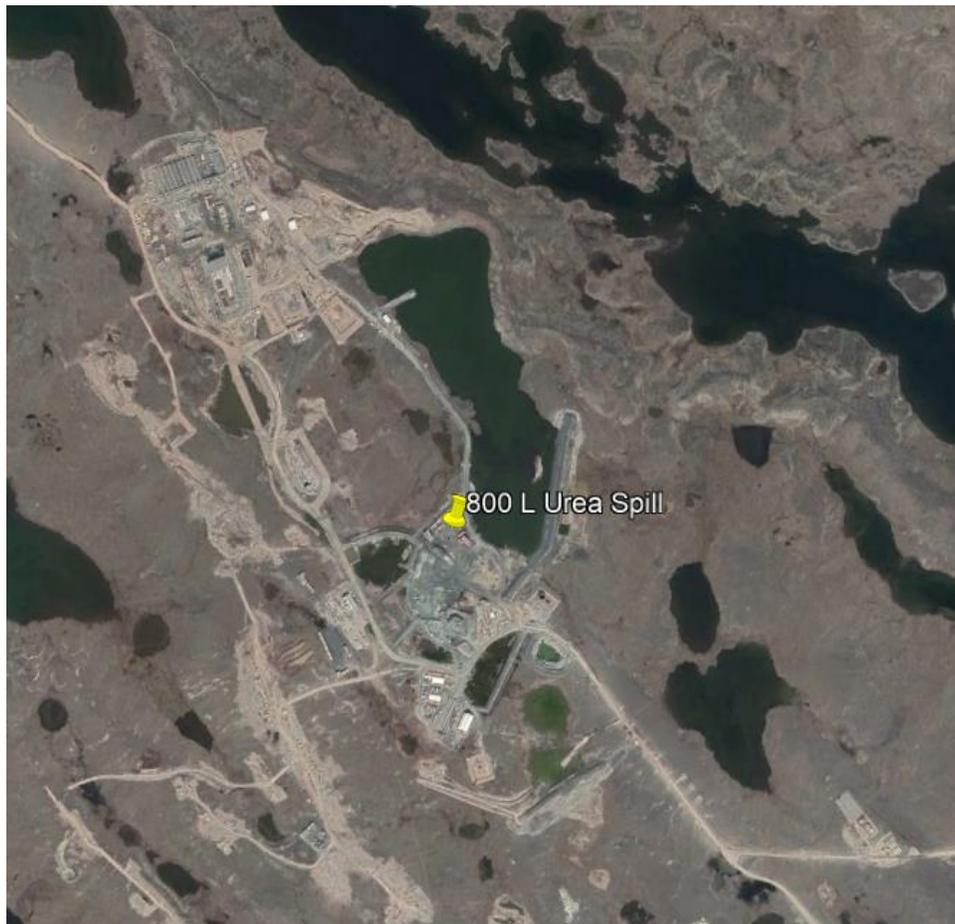
Figure 1: Location of 800 L Urea Spill and Proximity to Water Bodies

No water bodies were impacted by this spill. The nearest natural waterbody (H1) is 850 m away. The coordinates of the spill are 63° 01'51"N, 92°12'43"W (Figure 1).

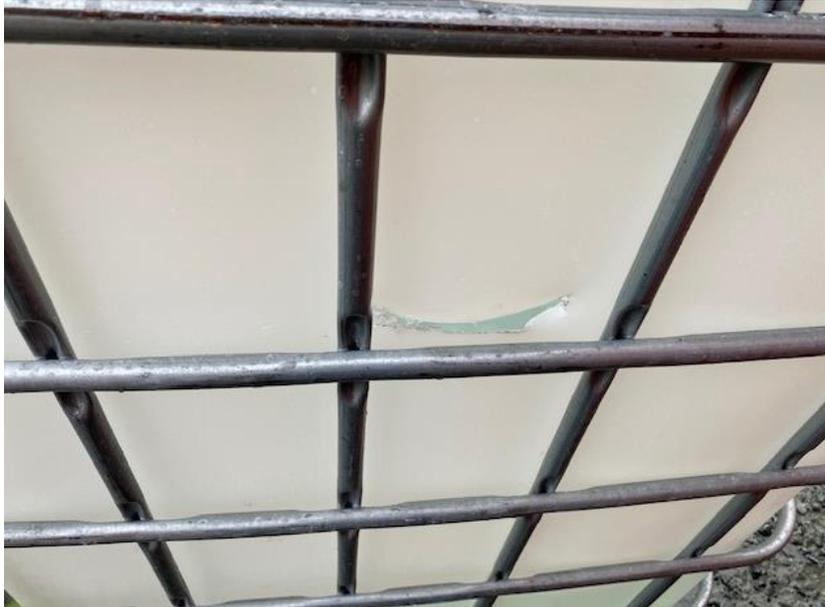
Figure 1: Punctured Urea Tote

A tote containing Diesel Exhaust Fluid (Urea) was punctured and approximately 800L was spilled onto a warehouse laydown pad. While moving a tote, the machine's forks were longer than the tote itself, which led to the puncturing of an adjacent tote.

The root cause of the incident was the operator failing to follow the procedure, which requires the use of a spotter to ensure proper alignment of the forks. As a corrective measure, the procedure mandating a spotter for the handling of totes, drums and chemical bulk bags is being updated and re-distributed to all departments. The updated procedure will be added to forklift training provided by Meliadine's training department. Departments who have operators using forked equipment are meeting to discuss the procedure.

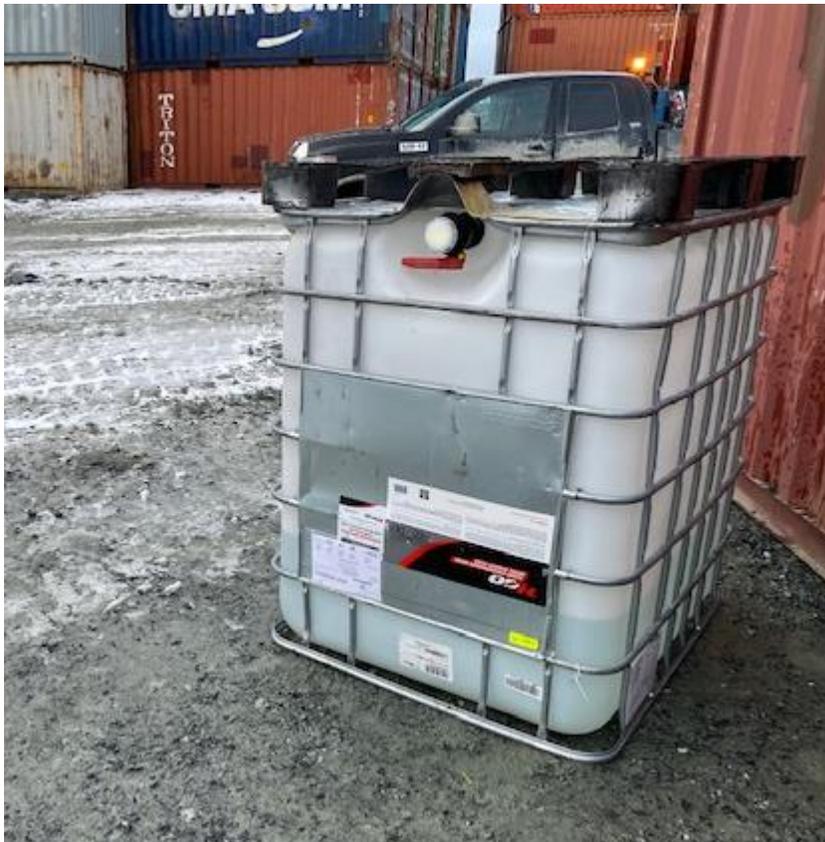
Figure 2: Tote Flipped to Reduce Volume of Urea Released

After the tote was punctured, the operator quickly flipped it upside down to stop the entire tote emptying onto the ground. As the spill occurred on an industrial pad in the middle of site, any migration of the product would be contained within the pad. According to the SDS, urea is low risk to the environment. As the risk to the environment was very low, it was determined a recovery attempt would not be made in a high traffic area.

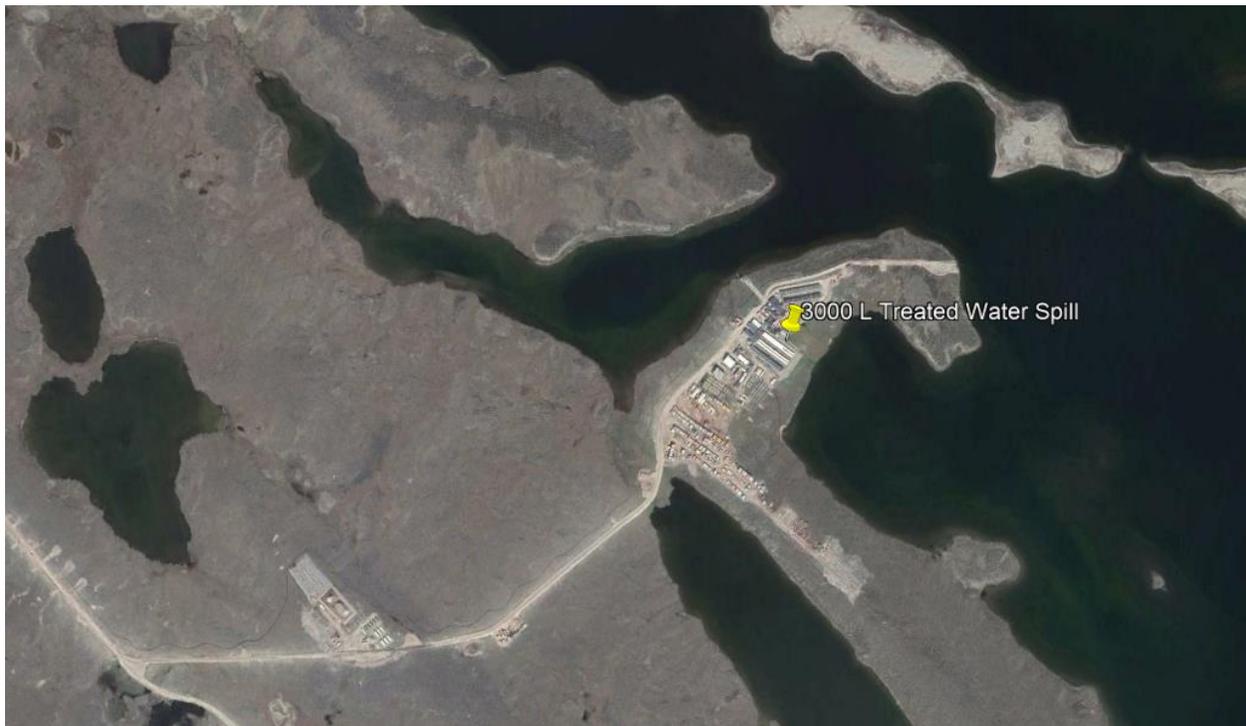
Figure 1: Location of Treated Water Spill

At 11:00 am Environment personnel responded to a call regarding release of treated water from the sewage treatment plant retention tank at the exploration camp. The operator of the water truck failed to close the outlet valve on the truck after his previous discharge to CP1. Upon returning to the retention tank to retrieve another load, pumping was initiated, and the operator sat in the truck to wait for it to fill. Five minutes later, the operator noticed the issue and shut off the pump. When the Environment Department arrived, they observed that a portion of the water had made its way into Meliadine Lake. A sample of this water was taken on 2020-10-19, the results (provided in Appendix A) were below the effluent quality limits established in Part D, Section 11 of the 2BB-MEL1424 license. The coordinates of the spill were 63° 01'43"N, 92°10'10"W (Figure 1).

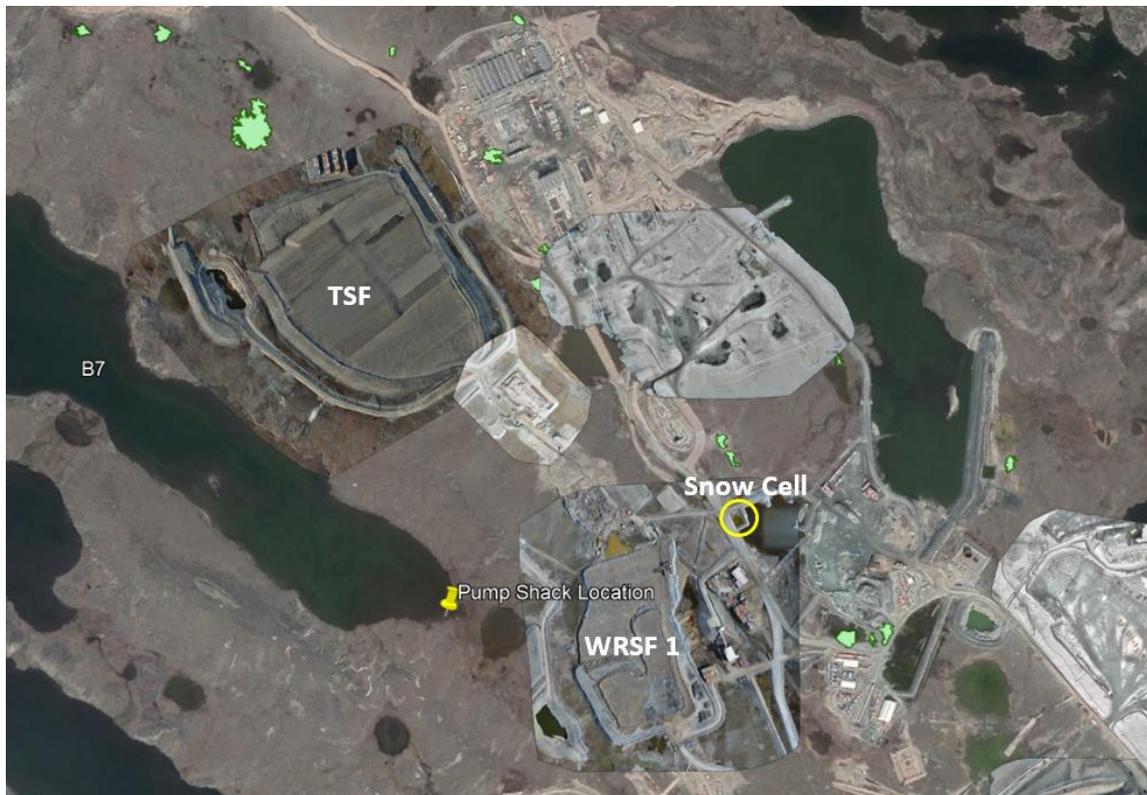
Figure 1: Location of the pump shack fire in proximity to lake B7.

At approximately 19:00 on November 17, drillers working at a surface diamond drill noticed flames inside the drill's fresh water pump shack, located on the shore area of lake B7 (Figure 1). The Emergency Response Team used the fire truck to suppress the fire with water. Snow was also packed into the shack afterwards to prevent re-ignition. Due to the nature of the shack, the interior contains oil or grease covered surfaces. The act of suppressing the fire with water led to the release of charred material onto the ground and ice, some of which was contained within the shack (Figure 2 and Figure 3).

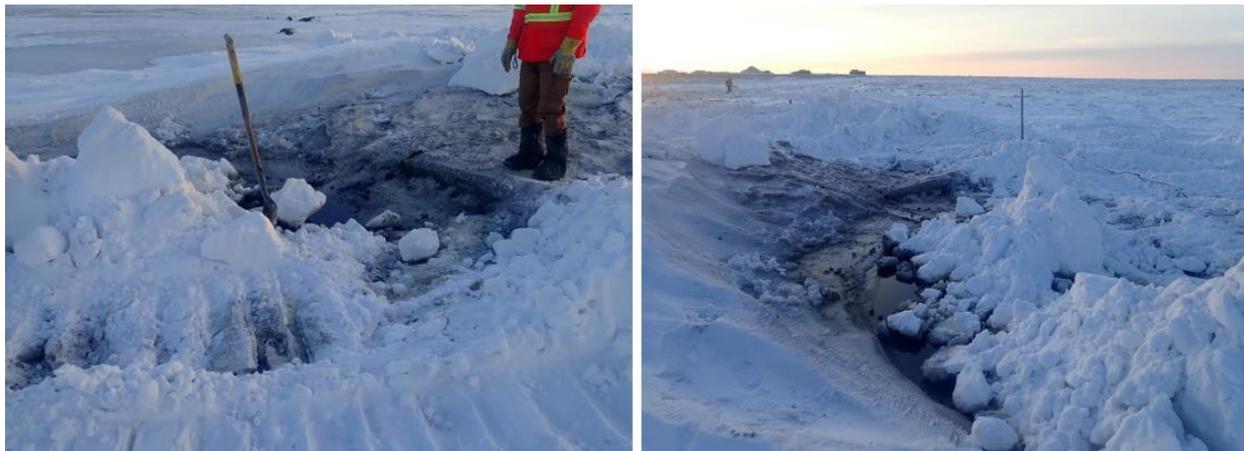
Figure 3: Fire suppression water which was not contained within the shack, absorbed into the surrounding snow and ice, and contained charred material.

The fire truck holds approximately 3,000L of water, and it is estimated that about 75% of the tank was used (2,250L) to suppress the fire. This would be the maximum amount of water that could have been released, assuming none of it was contained within the shack.

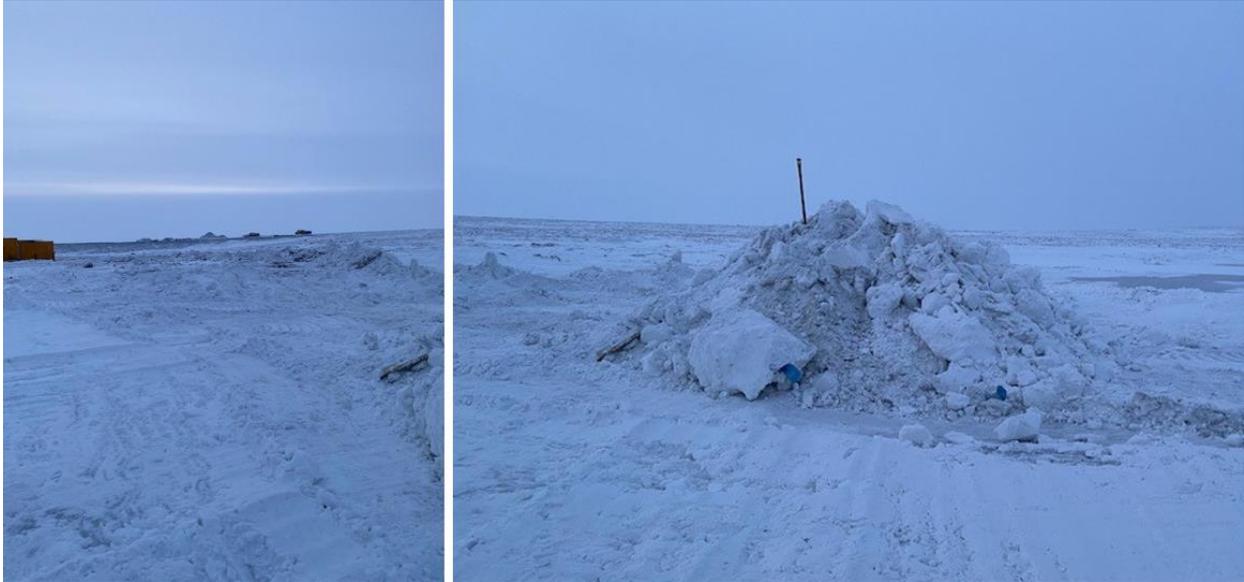
Figure 4: All contaminated snow and ice was scraped into a pile and brought to the snow cell.

On November 19 the Orbit Garant drilling team was able to plow all of the contaminated snow and ice into a large pile (Figure 4). This material was then brought to the Snow Cell (Figure 1) on site where it will be stored until the summer, and treated through the oil-water separator.

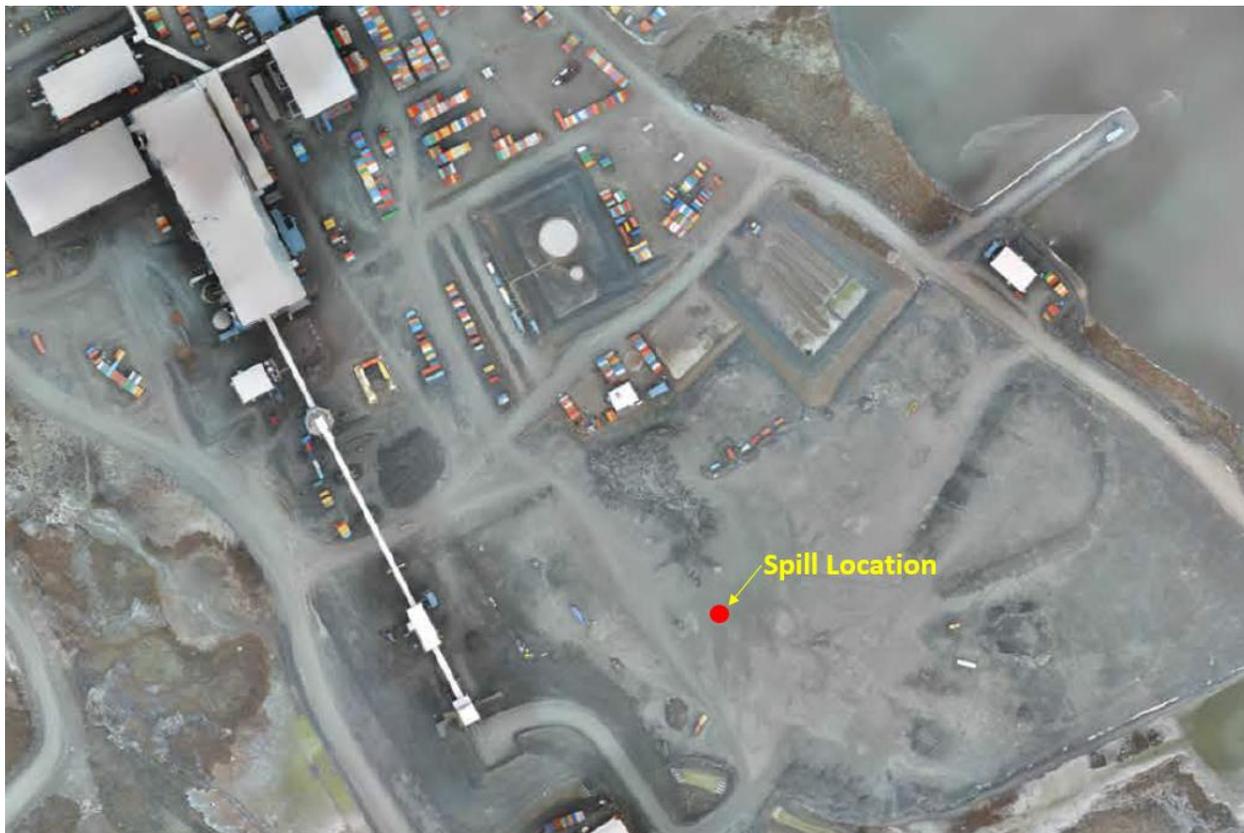
Figure 1: Location of the spill on OP2.

The coordinates of this spill are 63° 2'4.41"N, 92°13'16.04"W. No water bodies were impacted by this spill.

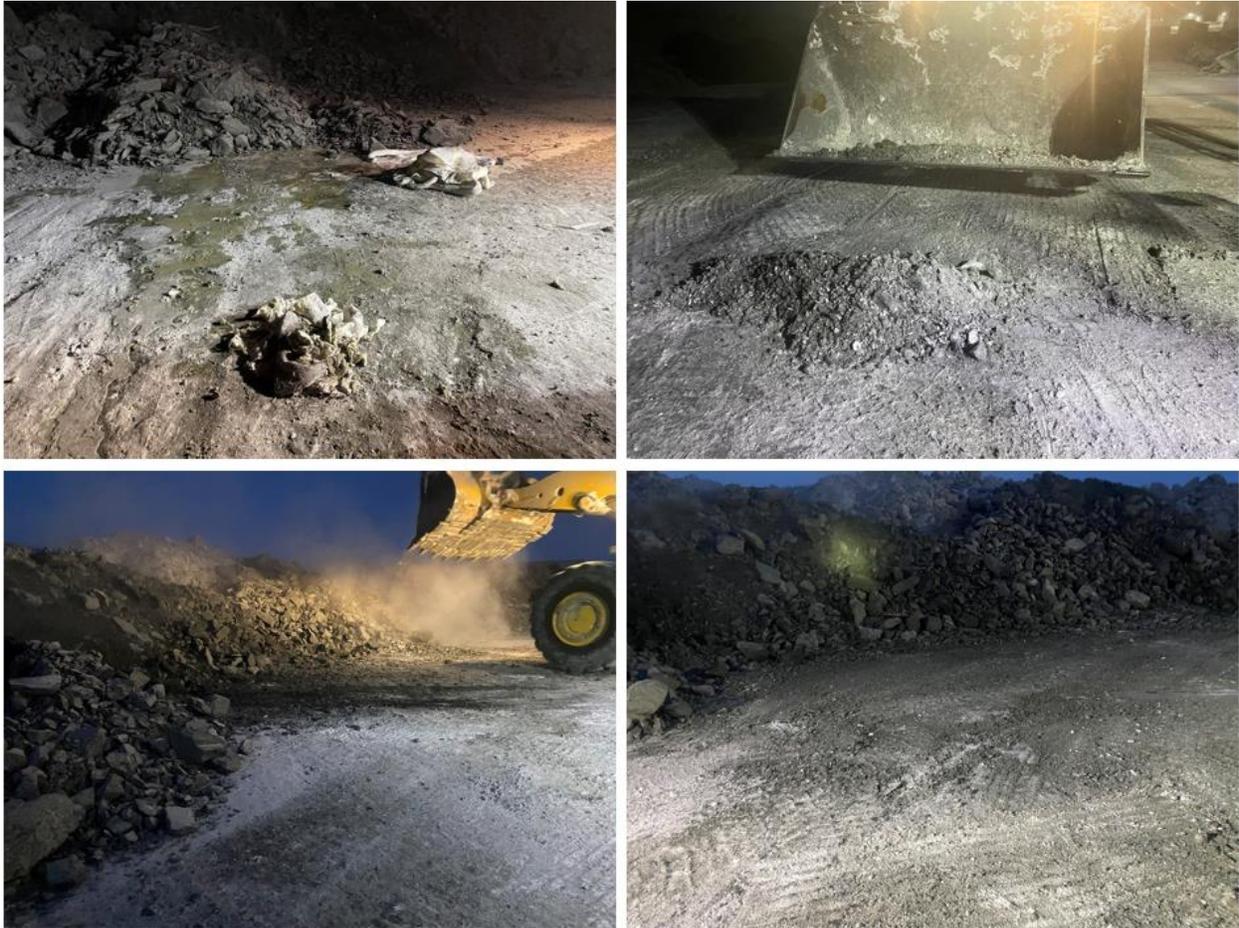
Figure 2: Process photos of the clean up of the contaminated ore.

Operators used absorbent pads to absorb as much of the oil as possible. The spill occurred adjacent to an ore pile and some of the oil made its way under the ore. The ore pile was pushed aside with a loader, and the affected ore was processed through the mill. The pad material below was scraped up with a loader, and approximately one cubic meter of pad gravel was removed and brought to the Landfarm A for future remediation.
