Qulliq Energy Corporation

PHASE I ENVIRONMENTAL SITE ASSESSMENT

Proposed Power Plant Location in Zone 13W
Cambridge Bay, Nunavut – Option 02

FEBRUARY 2021

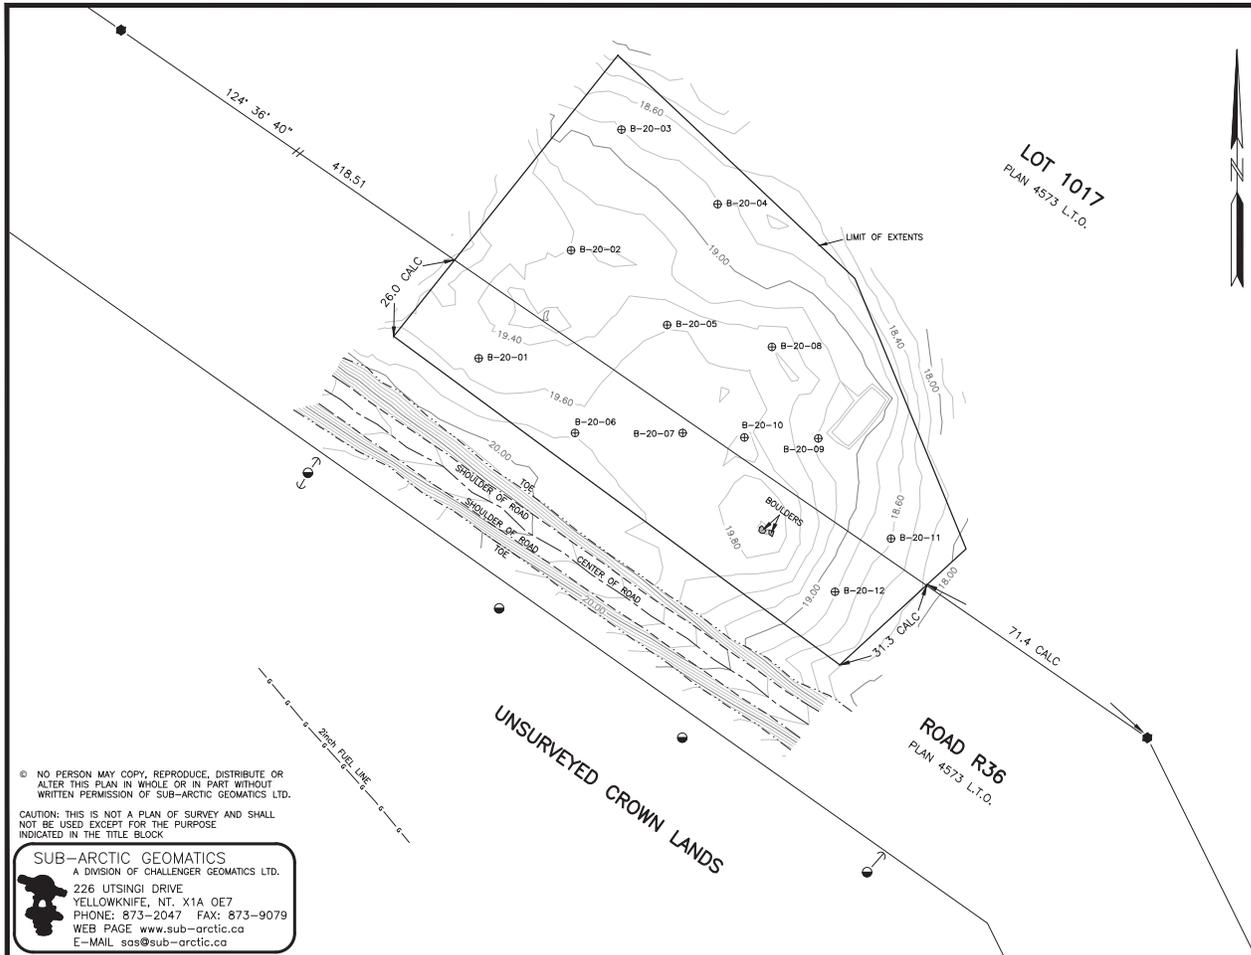
Appendix A Topographic Survey

NOTES:
 DATE OF SURVEY: SEPTEMBER 24 AND 25, 2020
 CONTOUR INTERVAL IS 0.20 METRES
 ALL ELEVATIONS ARE EXPRESSED IN METRES OR DECIMALS THEREOF.
 LOT STRUCTURE COPIED FROM N.T.S. ZONE MAPPING.
 ELEVATIONS BASED ON CSRS-PPP OBSERVATIONS
 UTM ZONE 13 NAD83
 CGVD2013 DATUM
 PROJECT# 501-7523

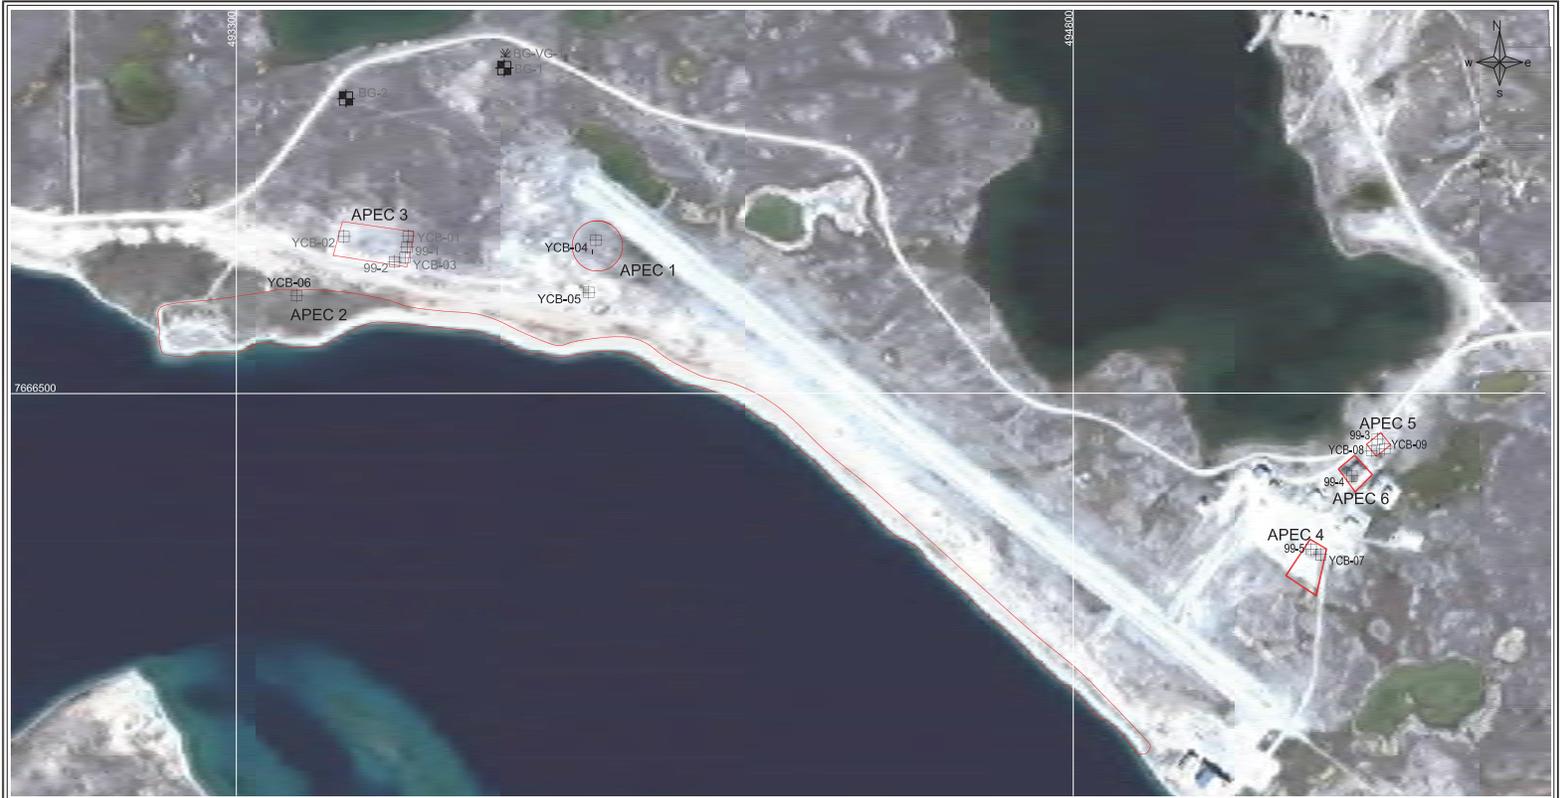
FRANZ ENVIRONMENTAL INC. CONSULTING • ENGINEERING • TECHNOLOGIES	Project:	CAMBRIDGE BAY AIRPORT PHASE II/III ENVIRONMENTAL SITE ASSESSMENT FINAL REPORT
	Date:	MARCH 2010
Client:	PUBLIC WORKS AND GOVERNMENT SERVICES CANADA TRANSPORT CANADA	
Scale:	1 : 6,600	FIGURE 2

- Area of Potential Environmental Concern (APEC)
- Background Soil Sampling Location (Franz 2009)
- Background Vegetation Sampling Location (Franz 2009)
- Soil/Groundwater Sample Location - Dillon 1995
- Soil/Groundwater Sample Location - AGRA 1999

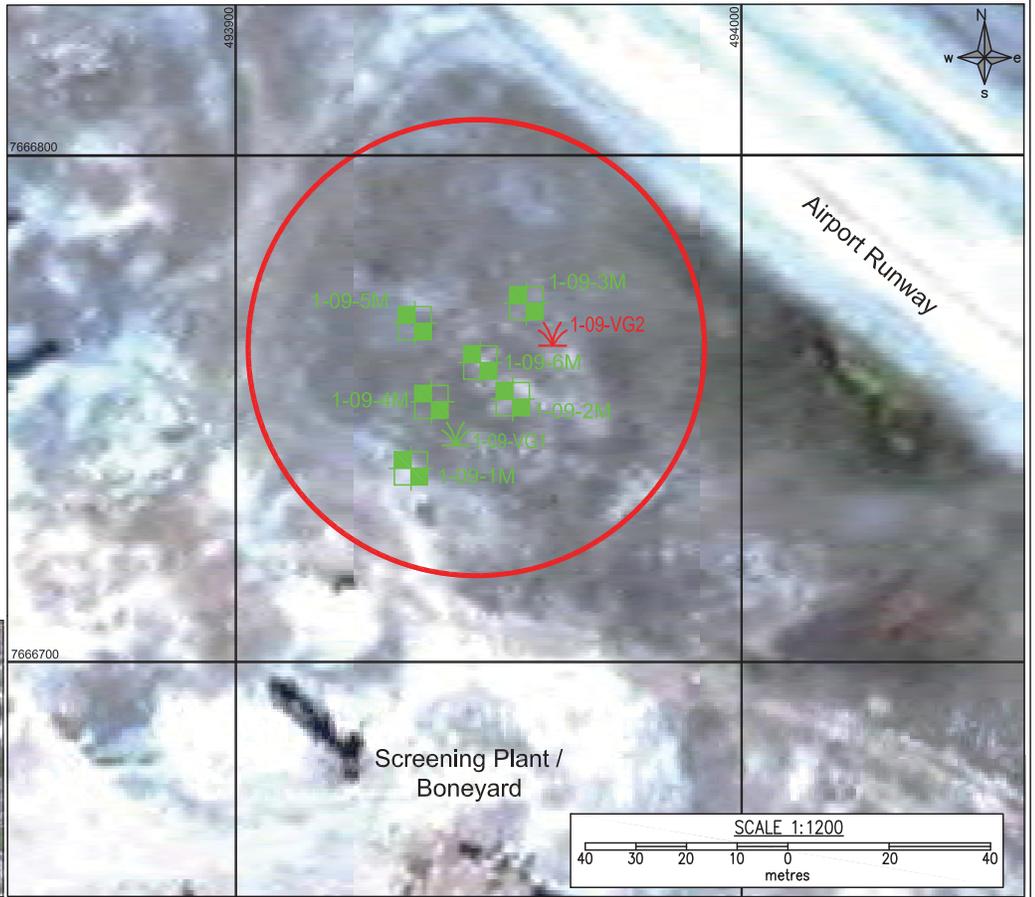
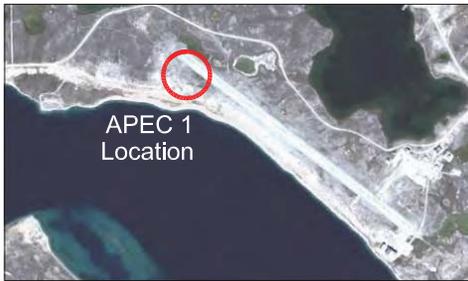
Scale: 1 : 1,200	FIGURE 3

VEGETATION		
Station ID		1-09-VG2
Duplicate ID		
Date	MOE Vegetation Guidelines (ppm)	2/Sep/09
Lab report ID		A948579
Molybdenum	1.5	2.6

- Extent of APEC
- Soil Sample (TP); compliant with CCME guidelines
- Vegetation Sample (VG); compliant with Ontario MOE guidelines
- ★ Vegetation Sample (VG); exceeds Ontario MOE guidelines

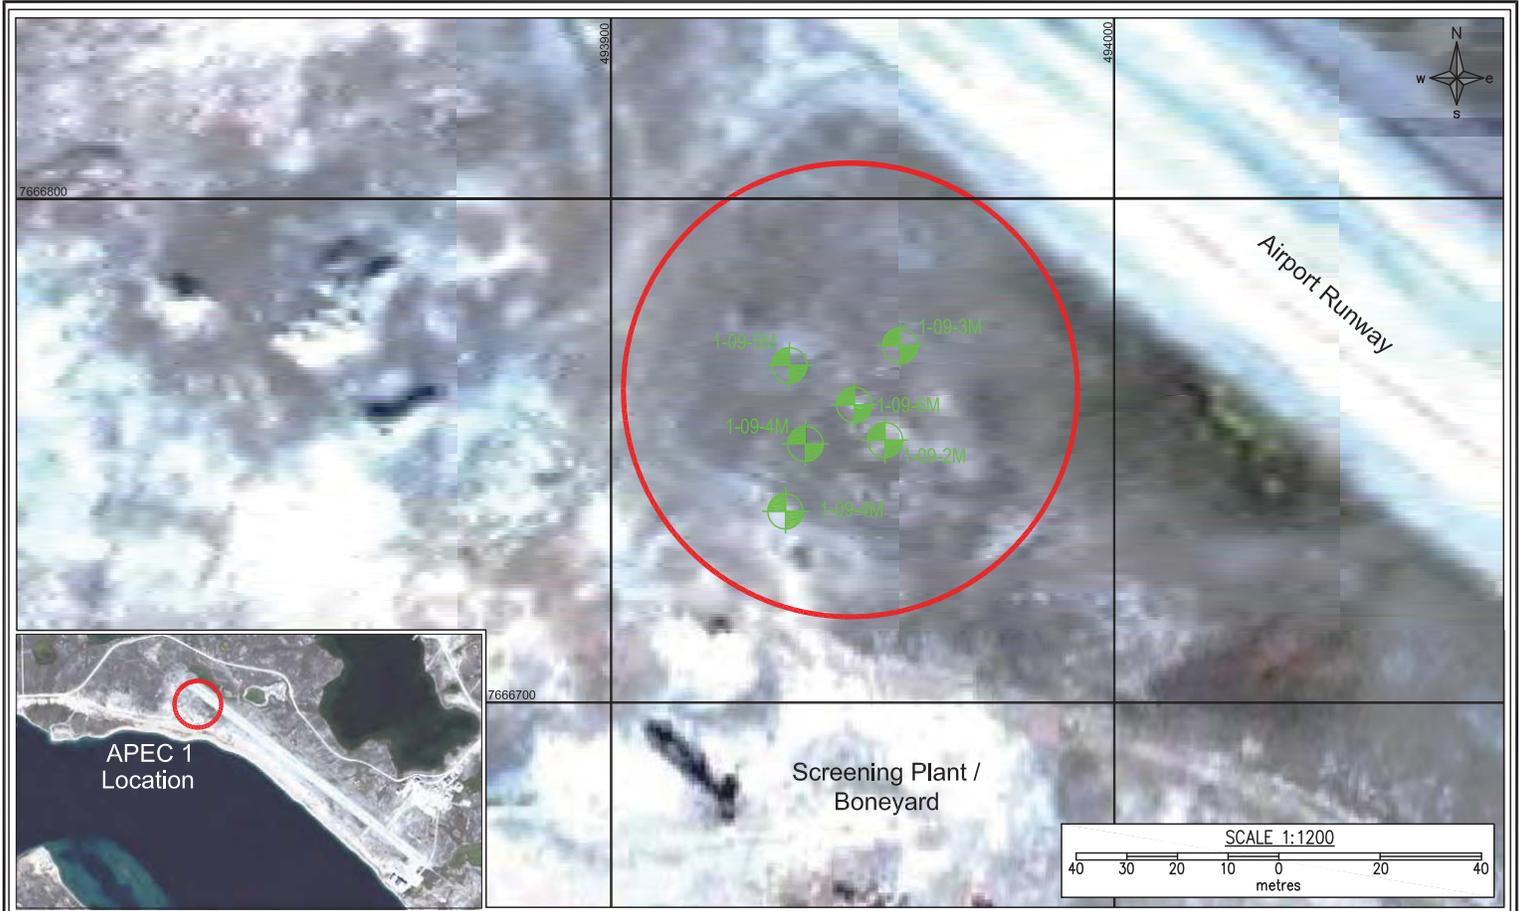
- Extent of APEC
- + Groundwater Sample (GW); compliant with BC-CSR guidelines

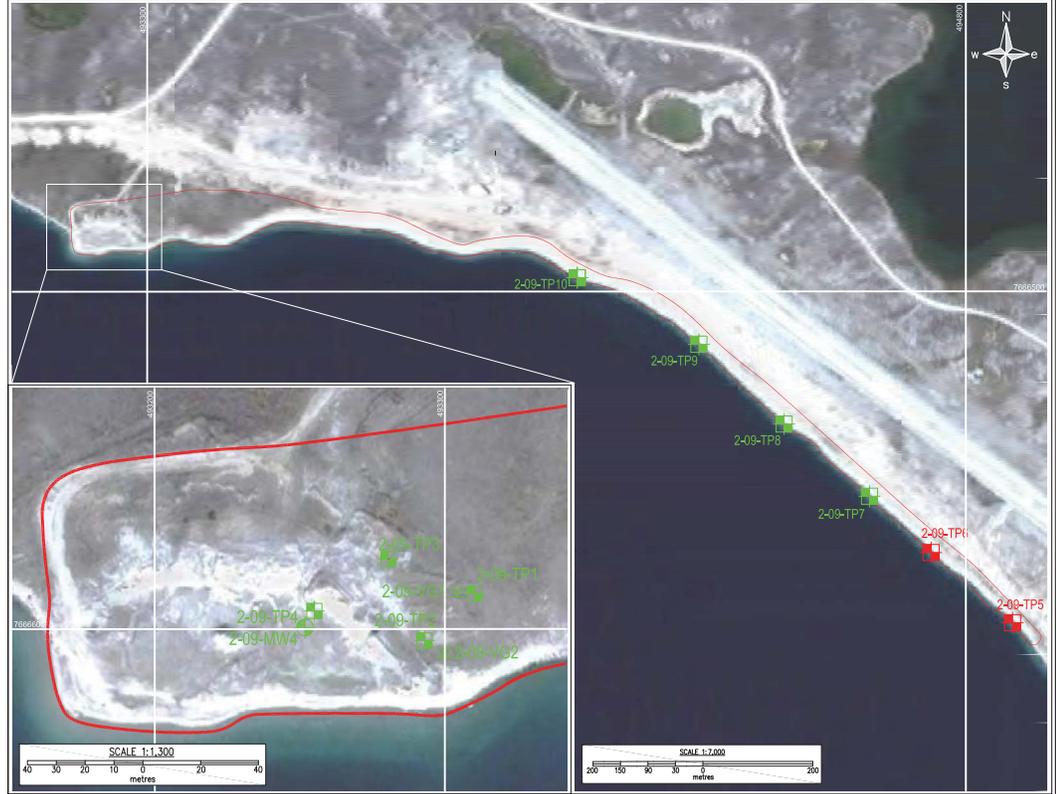
Title: APEC 2 - Shoreline Disposal Area Sampling Locations and Analytical Results - Soil, Vegetation & Groundwater

SOIL				
Station ID		2-09-TP5	2-09-TP5	2-09-TP6
Field label		2-09-TP5-1	GR2	2-09-TP6-1
Duplicate ID		GR2	2-09-TP5-1	
Date		29/Aug/09	29/Aug/09	29/Aug/09
Lab report ID		A947822	A947822	A947822
Depth (m)		0.4-0.6	0.4-0.6	0.2-0.6
Metals				
Arsenic	12	3.3	2.0	40.6
Copper	91	94.5	102.0	24.5

LEGEND	
	Extent of APEC
	Soil Sample (TP); compliant with CCME guidelines
	Soil Sample (TP); exceeds CCME guidelines
	Groundwater Sample (GW); compliant with BC-CSR guidelines
	Vegetation Sample (VG); compliant with Ontario MOE guidelines
