ANNUAL REPORT:
Ulu Gold Project
Exploration and Progressive Reclamation
20EN001
2BM-ULU2030

Kitikmeot Region, Nunavut

March 2021

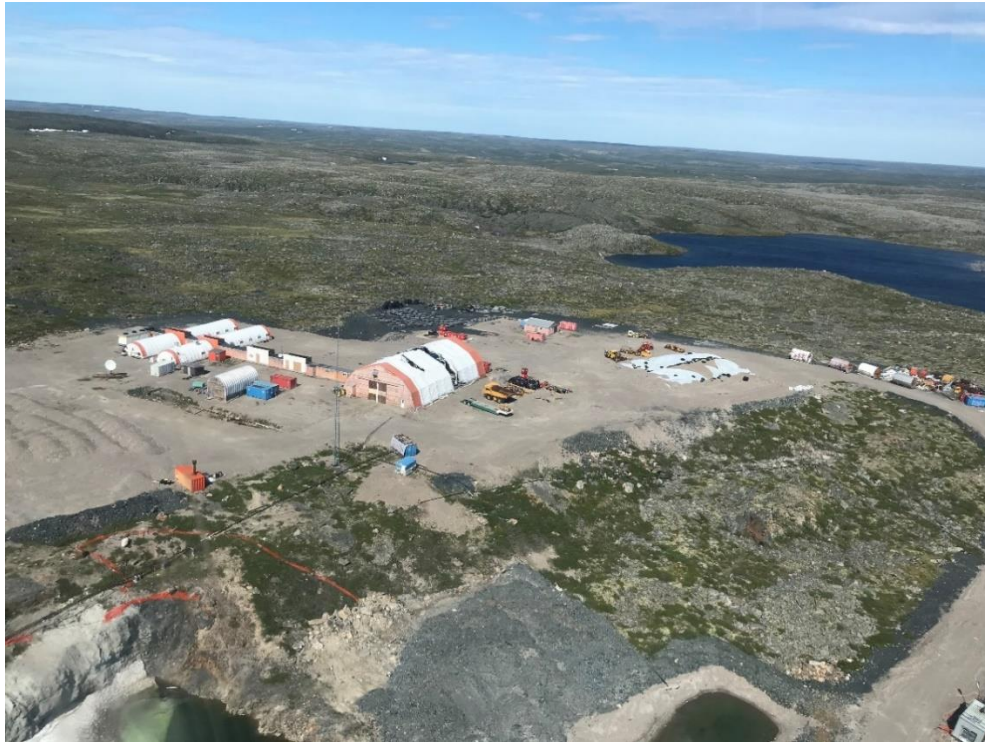
Photo 1. Ulu camp, July 2020

Upon accessing the Ulu camp on July 3 for the first time since its acquisition, the camp was found to be in very poor condition, damaged, largely uninhabitable and without a power supply. Blue Star rehabilitated parts of the Ulu camp and added five new temporary tents to provide adequate accommodations for the minimum workforce required to execute the 2020 program. Portions of the Ulu camp deemed safe for habitation were utilized from mid-July to early October. Primary and back-up power was installed. The Ulu camp remains on site and has been winterized.

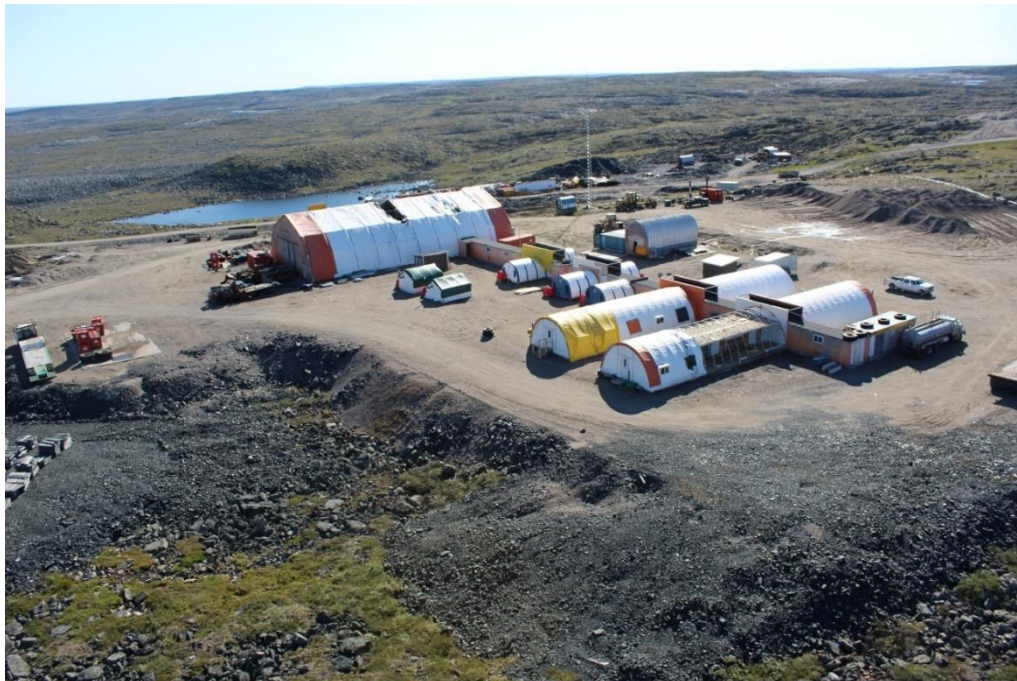
Photo 2. Ulu camp, with new sleepers, isolation tents, repaired mess tent and partially demolished sleeper wing.

In the event of COVID-19 symptoms or an outbreak, two isolation tents were established at Ulu. These tents remained in place for the duration of the field program and have since been decommissioned.

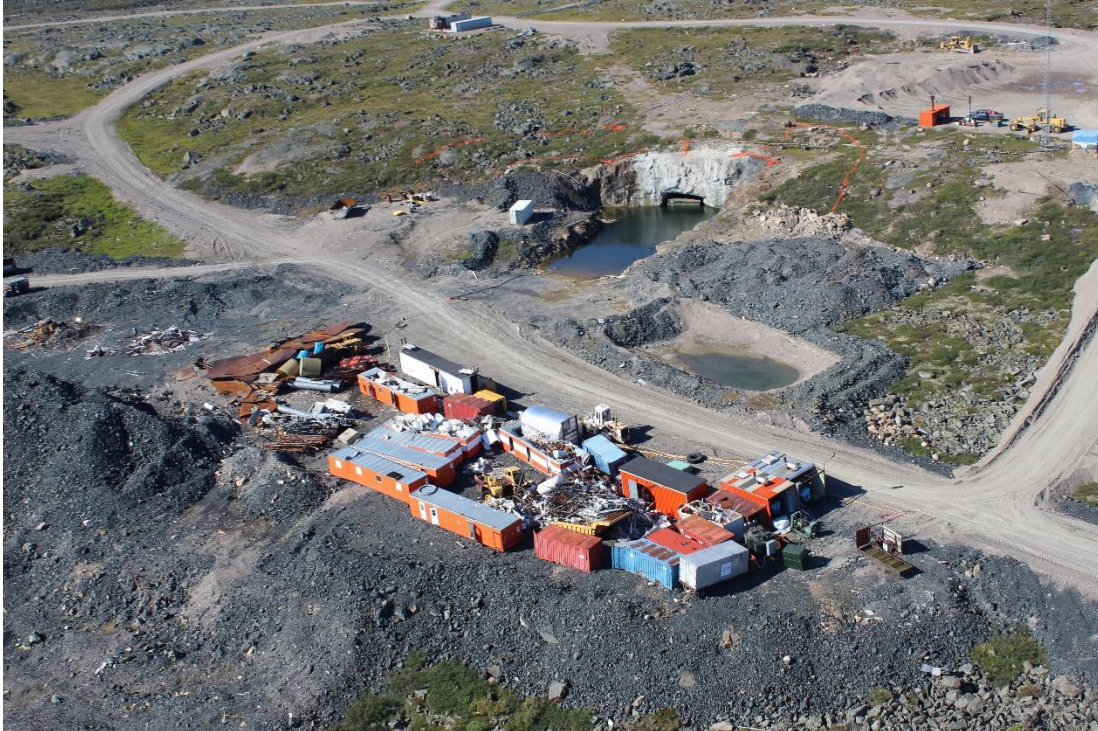
Photo 3. Ulu waste staging area, portal and mine sump

The existing liner in the mine sump was investigated and no indication failure was found. Accordingly, the liner was not replaced and approximately half of the ore stockpiled adjacent to the sump was relocated into the sump.

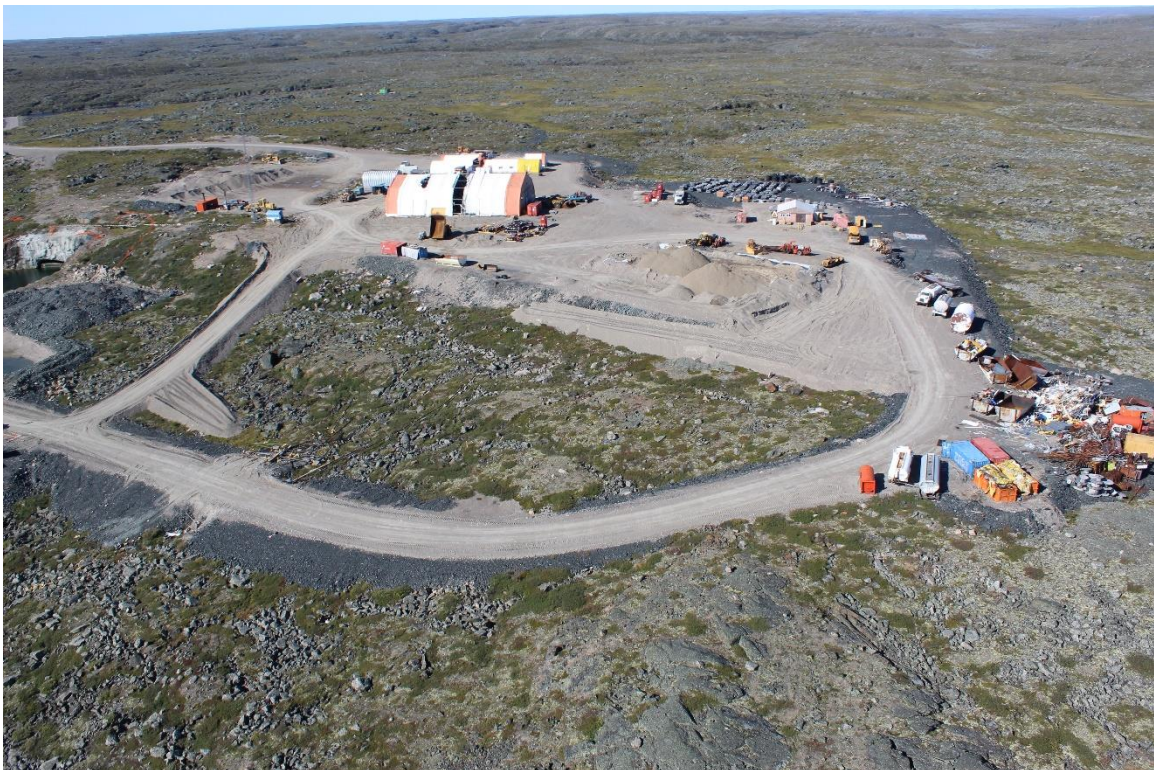
Photo 4. Ulu landfill area, access routes established

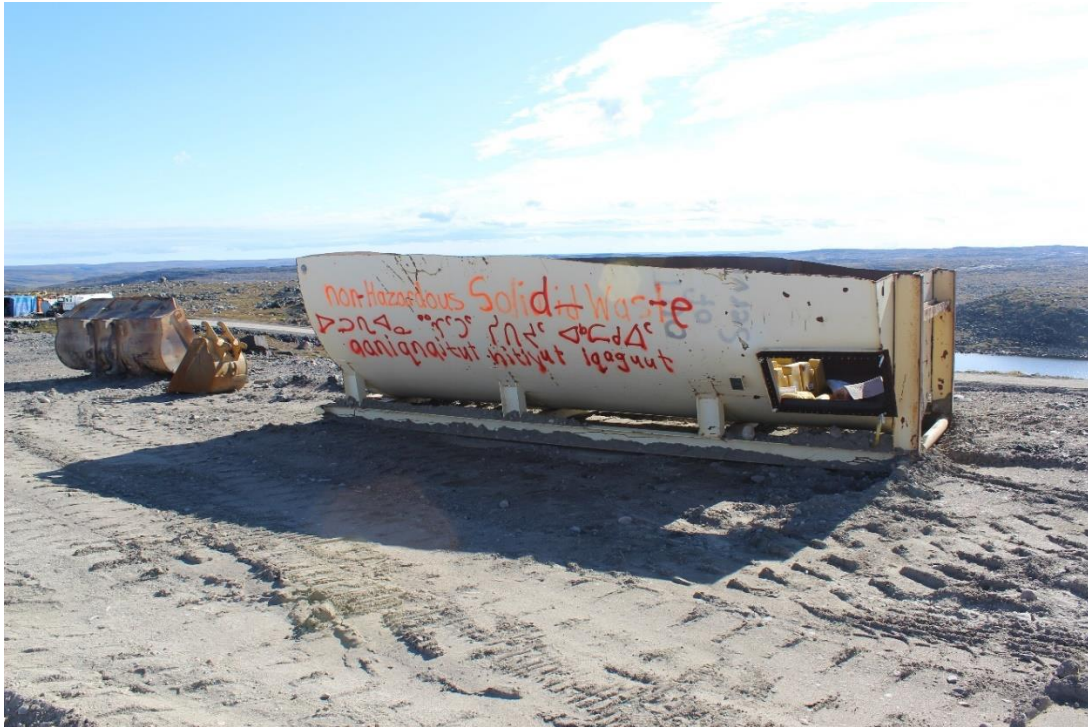
Photo 5. Waste staging

Much of the solid waste on site was comingled by the previous operator. This was sorted, with useful goods recovered and segregated. Approximately 25% of the non-hazardous waste materials have been staged for disposal in the future non-hazardous waste landfill. All buildings were cleaned out, removing unnecessary items. One uninhabitable 20-person bunkhouse was partially demolished. The surface water line and sewage water lines were removed. Access routes into the landfill area were established to support commencement of waste placement in upcoming years. Heavy equipment previously thought to be waste was inventoried, assessed, and valued. A significant number of repairs to necessary and functional equipment were completed.

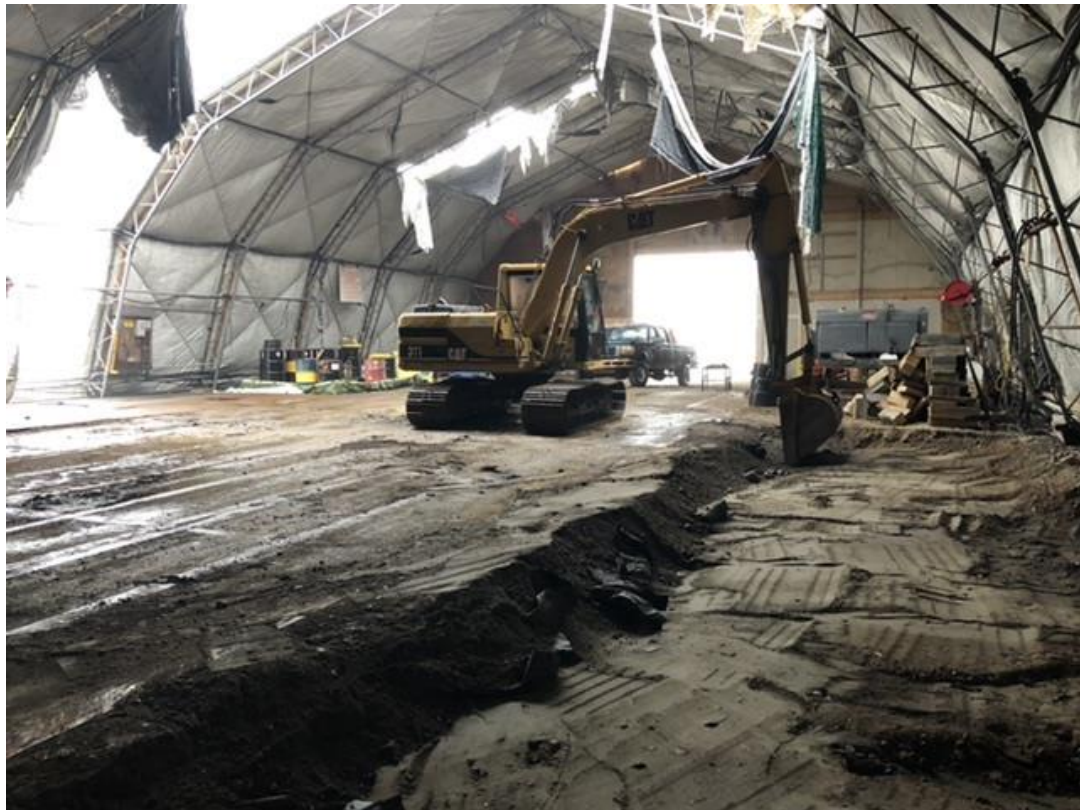
Photo 6. Excavating contaminated soil from the unlined portion of Ulu shop floor

- 6 m3 of soil recovered from the unlined/uncovered portion of the shop floor was shipped off site (see Table 2).
- Contaminated soil at the day tank area was excavated and relocated to the former main tank farm for interim storage.
- Contaminated soil stockpiled in the former fuel tank farm was separated into piles not more than 150 m3 and characterized, in preparation for treatment in the future onsite soil treatment facility and/or approved onsite beneficial reuse.

During vehicle maintenance, 12 L of hydraulic oil was released to the shop floor; this portion of the shop floor is unlined and composed of wood cribbing. Once detected, oil sorbent materials were applied to the spill area. Once the oil had been absorbed, the spent materials were placed in an appropriate container and backhauled to our hazardous waste receiver in Yellowknife for proper handling and disposal.

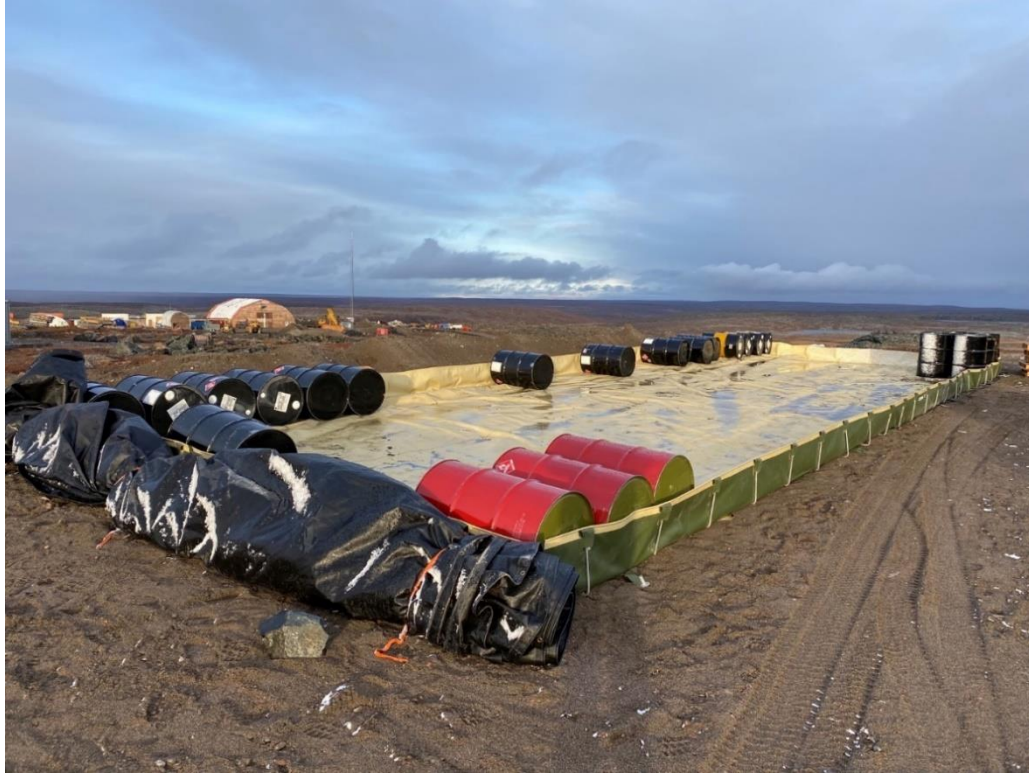
Photo 7. New Ulu camp fuel cache

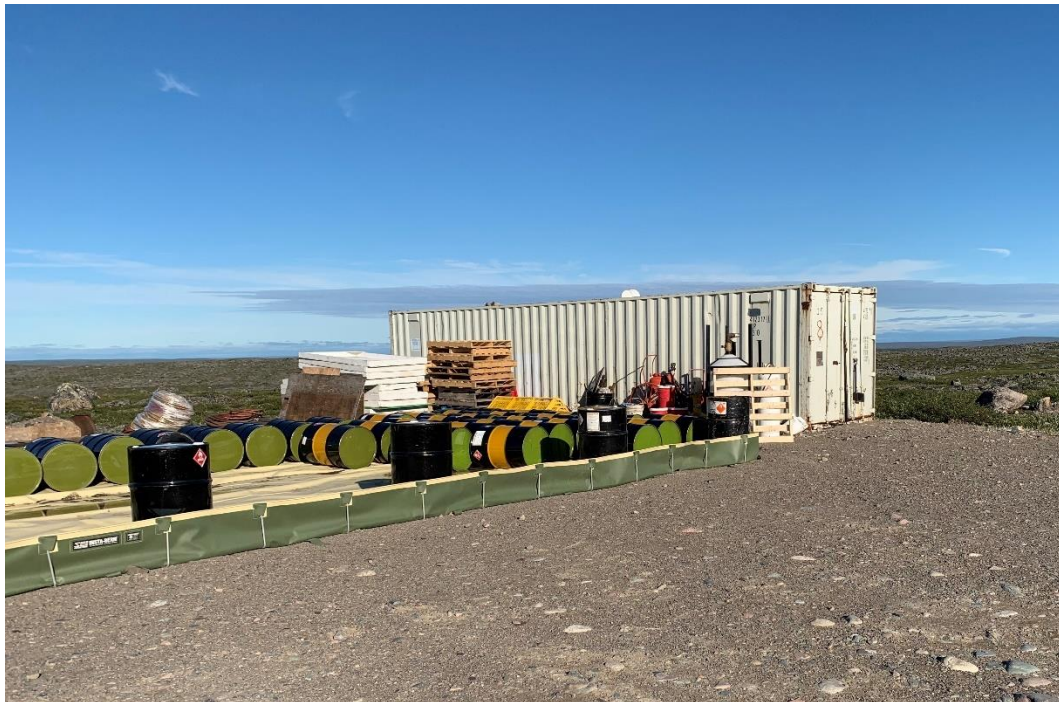
Photo 8. Ulu airstrip fuel cache and laydown area

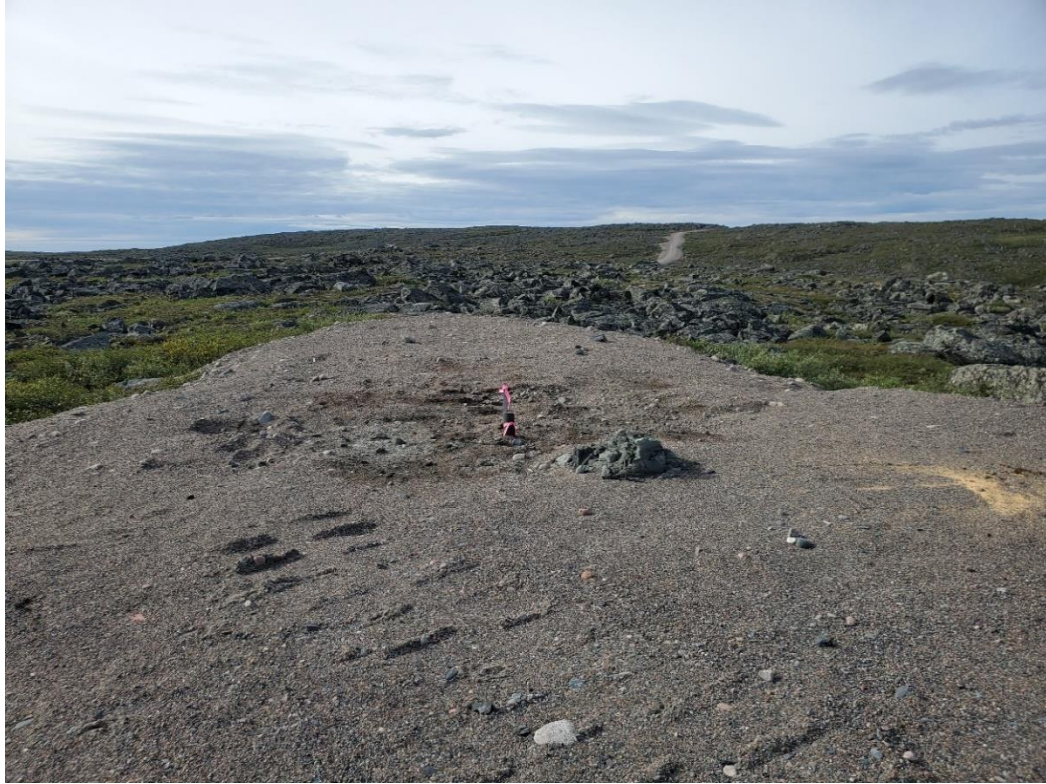
Photo 9. Reclaimed drill site
