Meadowbank and Whale Tail Bulk Fuel Storage Facility: Environmental Performance Monitoring Plan Version 6.1

**Baker Lake Bulk Fuel Storage Facility: Environmental
Performance Monitoring Plan**

In Accordance with Water License 2AM-MEA1530

Version 6.1
March 2022

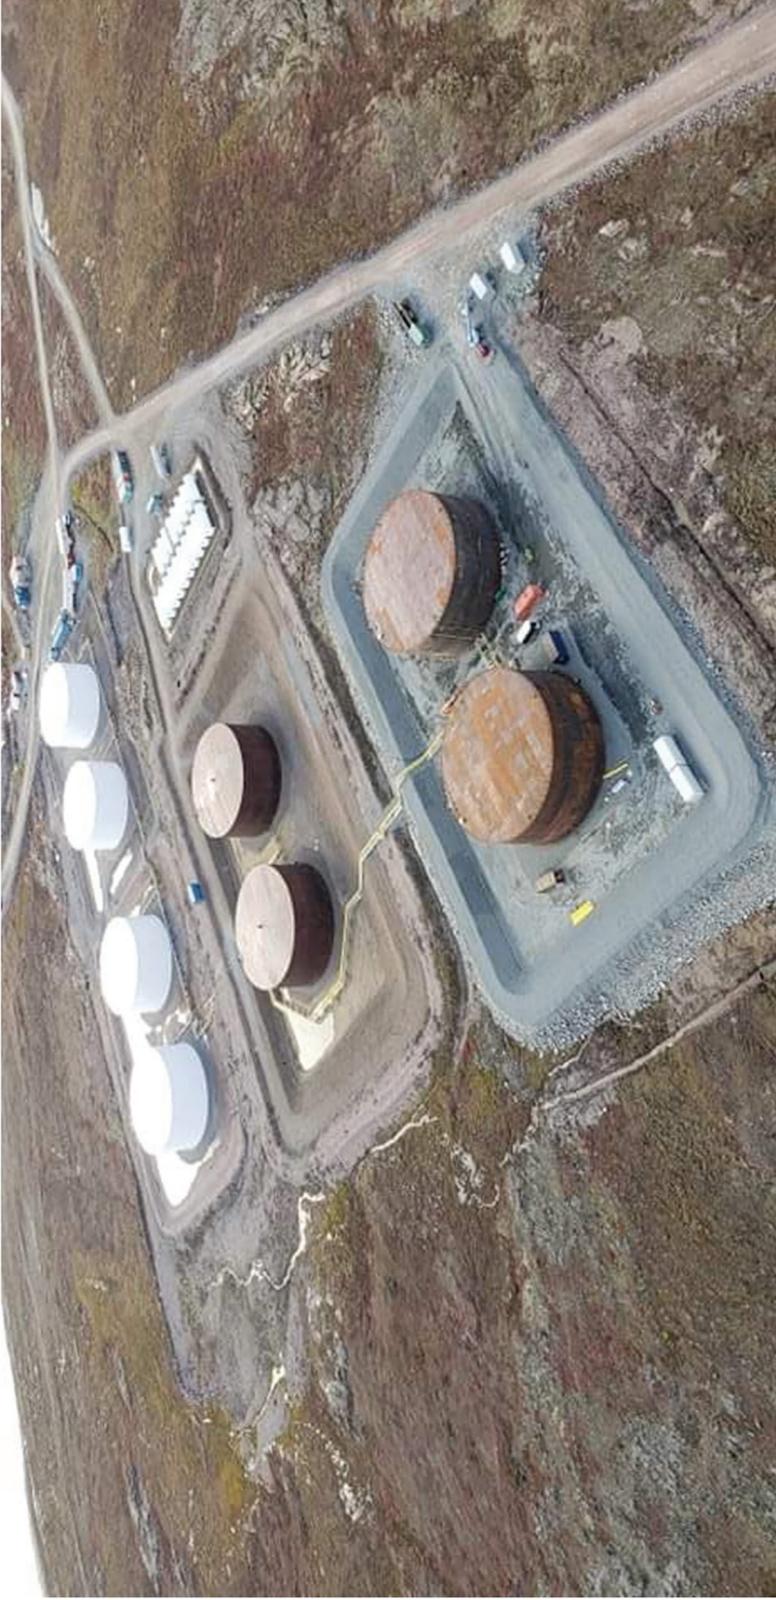
Figure 1-2: Baker Lake Bulk Fuel Storage Facility Site Layout

**Aerial photo taken in Summer 2021 during Tank 8 construction*

The Baker Lake Bulk Fuel Storage Tank Facility is located east of the hamlet of Baker Lake, on the north shore of Baker Lake. The GPS coordinates of these facilities is NAD 83 15W E 356874 N 7134486. A general site location is provided in Figure 1-1. An aerial photo depicting the site layout of the infrastructure and tanks is provided in Figure 1-2.
