**Updated Remedial Action  
Plan, Coral Harbour Site,  
Nunavut**

Final Report

March 31, 2022

Northern Contaminated Sites Group  
Public Services and Procurement  
Canada

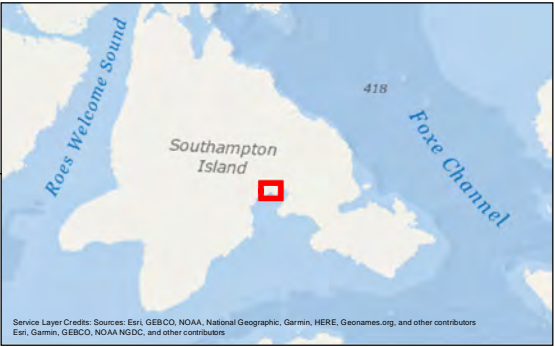
Figure No.	1	FINAL
Title		
Overview Map

The Site consists of 16 separate areas of potential concern (APEC)/AECs which included the original 5 AECs from previous studies and the newly identified Community Identified Additional Areas (CIAAs) as described in Table 2-1. The locations of the original 5 AECs included in the RAP are shown in Figure 1, Appendix A.

Five potential locations for a NHW facility were identified and assessed during the 2021 SA field program, identified as "Potential NHW Facility Locations" 1 through 5, as shown on Figure 1, Appendix A. A summary of the Potential NHW Facility Locations is provided in Table 8-3.

The Site is located approximately 10 kilometres (km) northwest of the Hamlet of Coral Harbour, NU, on Southampton Island (Figure 1, Appendix A). The former military base in Coral Harbour was used as a staging location by Canadian and American forces during the construction of the Distant Early Warning (DEW) Line in Northern Canada during the Second World War and for various other northern projects. The Site was active from the 1940s until the 1970s and the on-site infrastructure included an airstrip, hospital, and housing for military personnel. When the Site was decommissioned in the 1970s, most buildings were decommissioned, some waste materials were buried on site and remaining equipment and waste was abandoned.

Additionally, current access to AEC 1 requires crossing the active airstrip, as there are no alternative routes to access the area west of the runway. This practice is dangerous and may damage the airstrip. An access road should be developed around the airstrip to eliminate vehicles and equipment traveling over it during the pre-remedial activities and remedial program. Current access roads are illustrated on Figure 1, Appendix A.

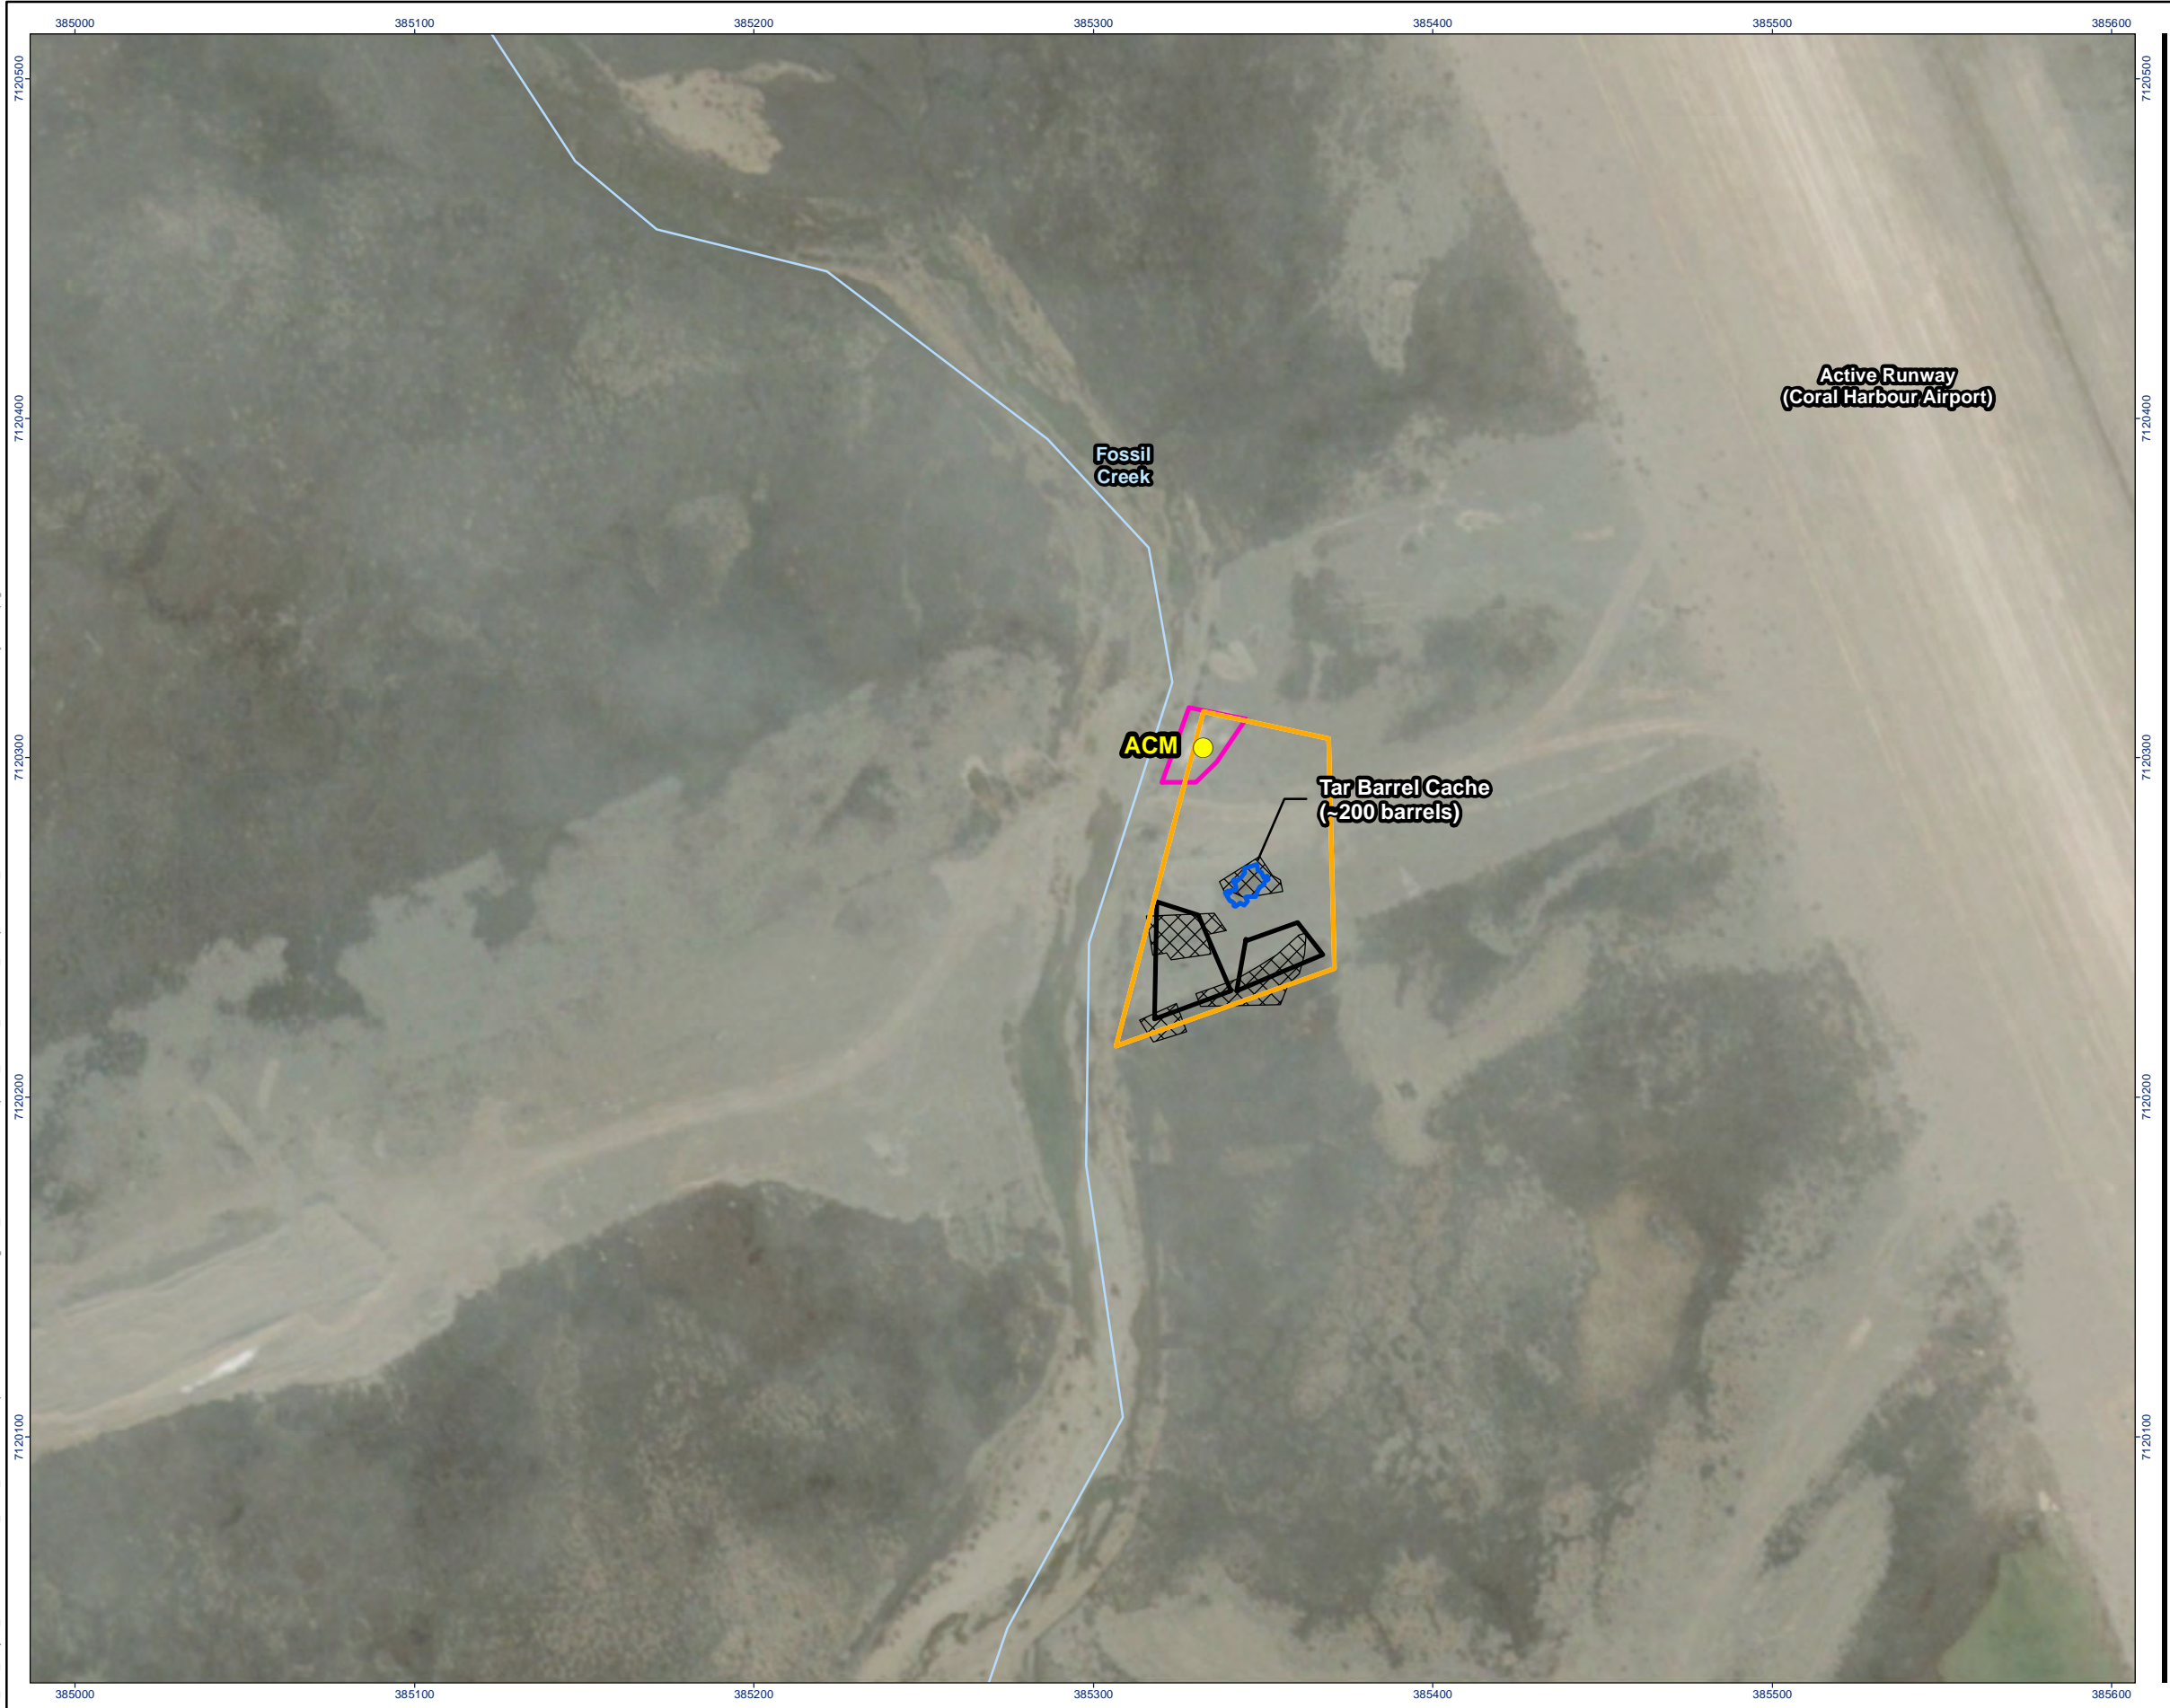
**Title**  
**Remedial Action Plan -  
AEC 1 Tar Barrels**

- Asbestos Containing Material (ACM)
- ▨ Approximate Area of Surficial Soil Staining
- ▭ Existing Waste Disposal Area
- ▭ Consolidated Surface Debris Area
- ▭ Buried Debris Area
- ▭ Barrel Cache Area
- Watercourse

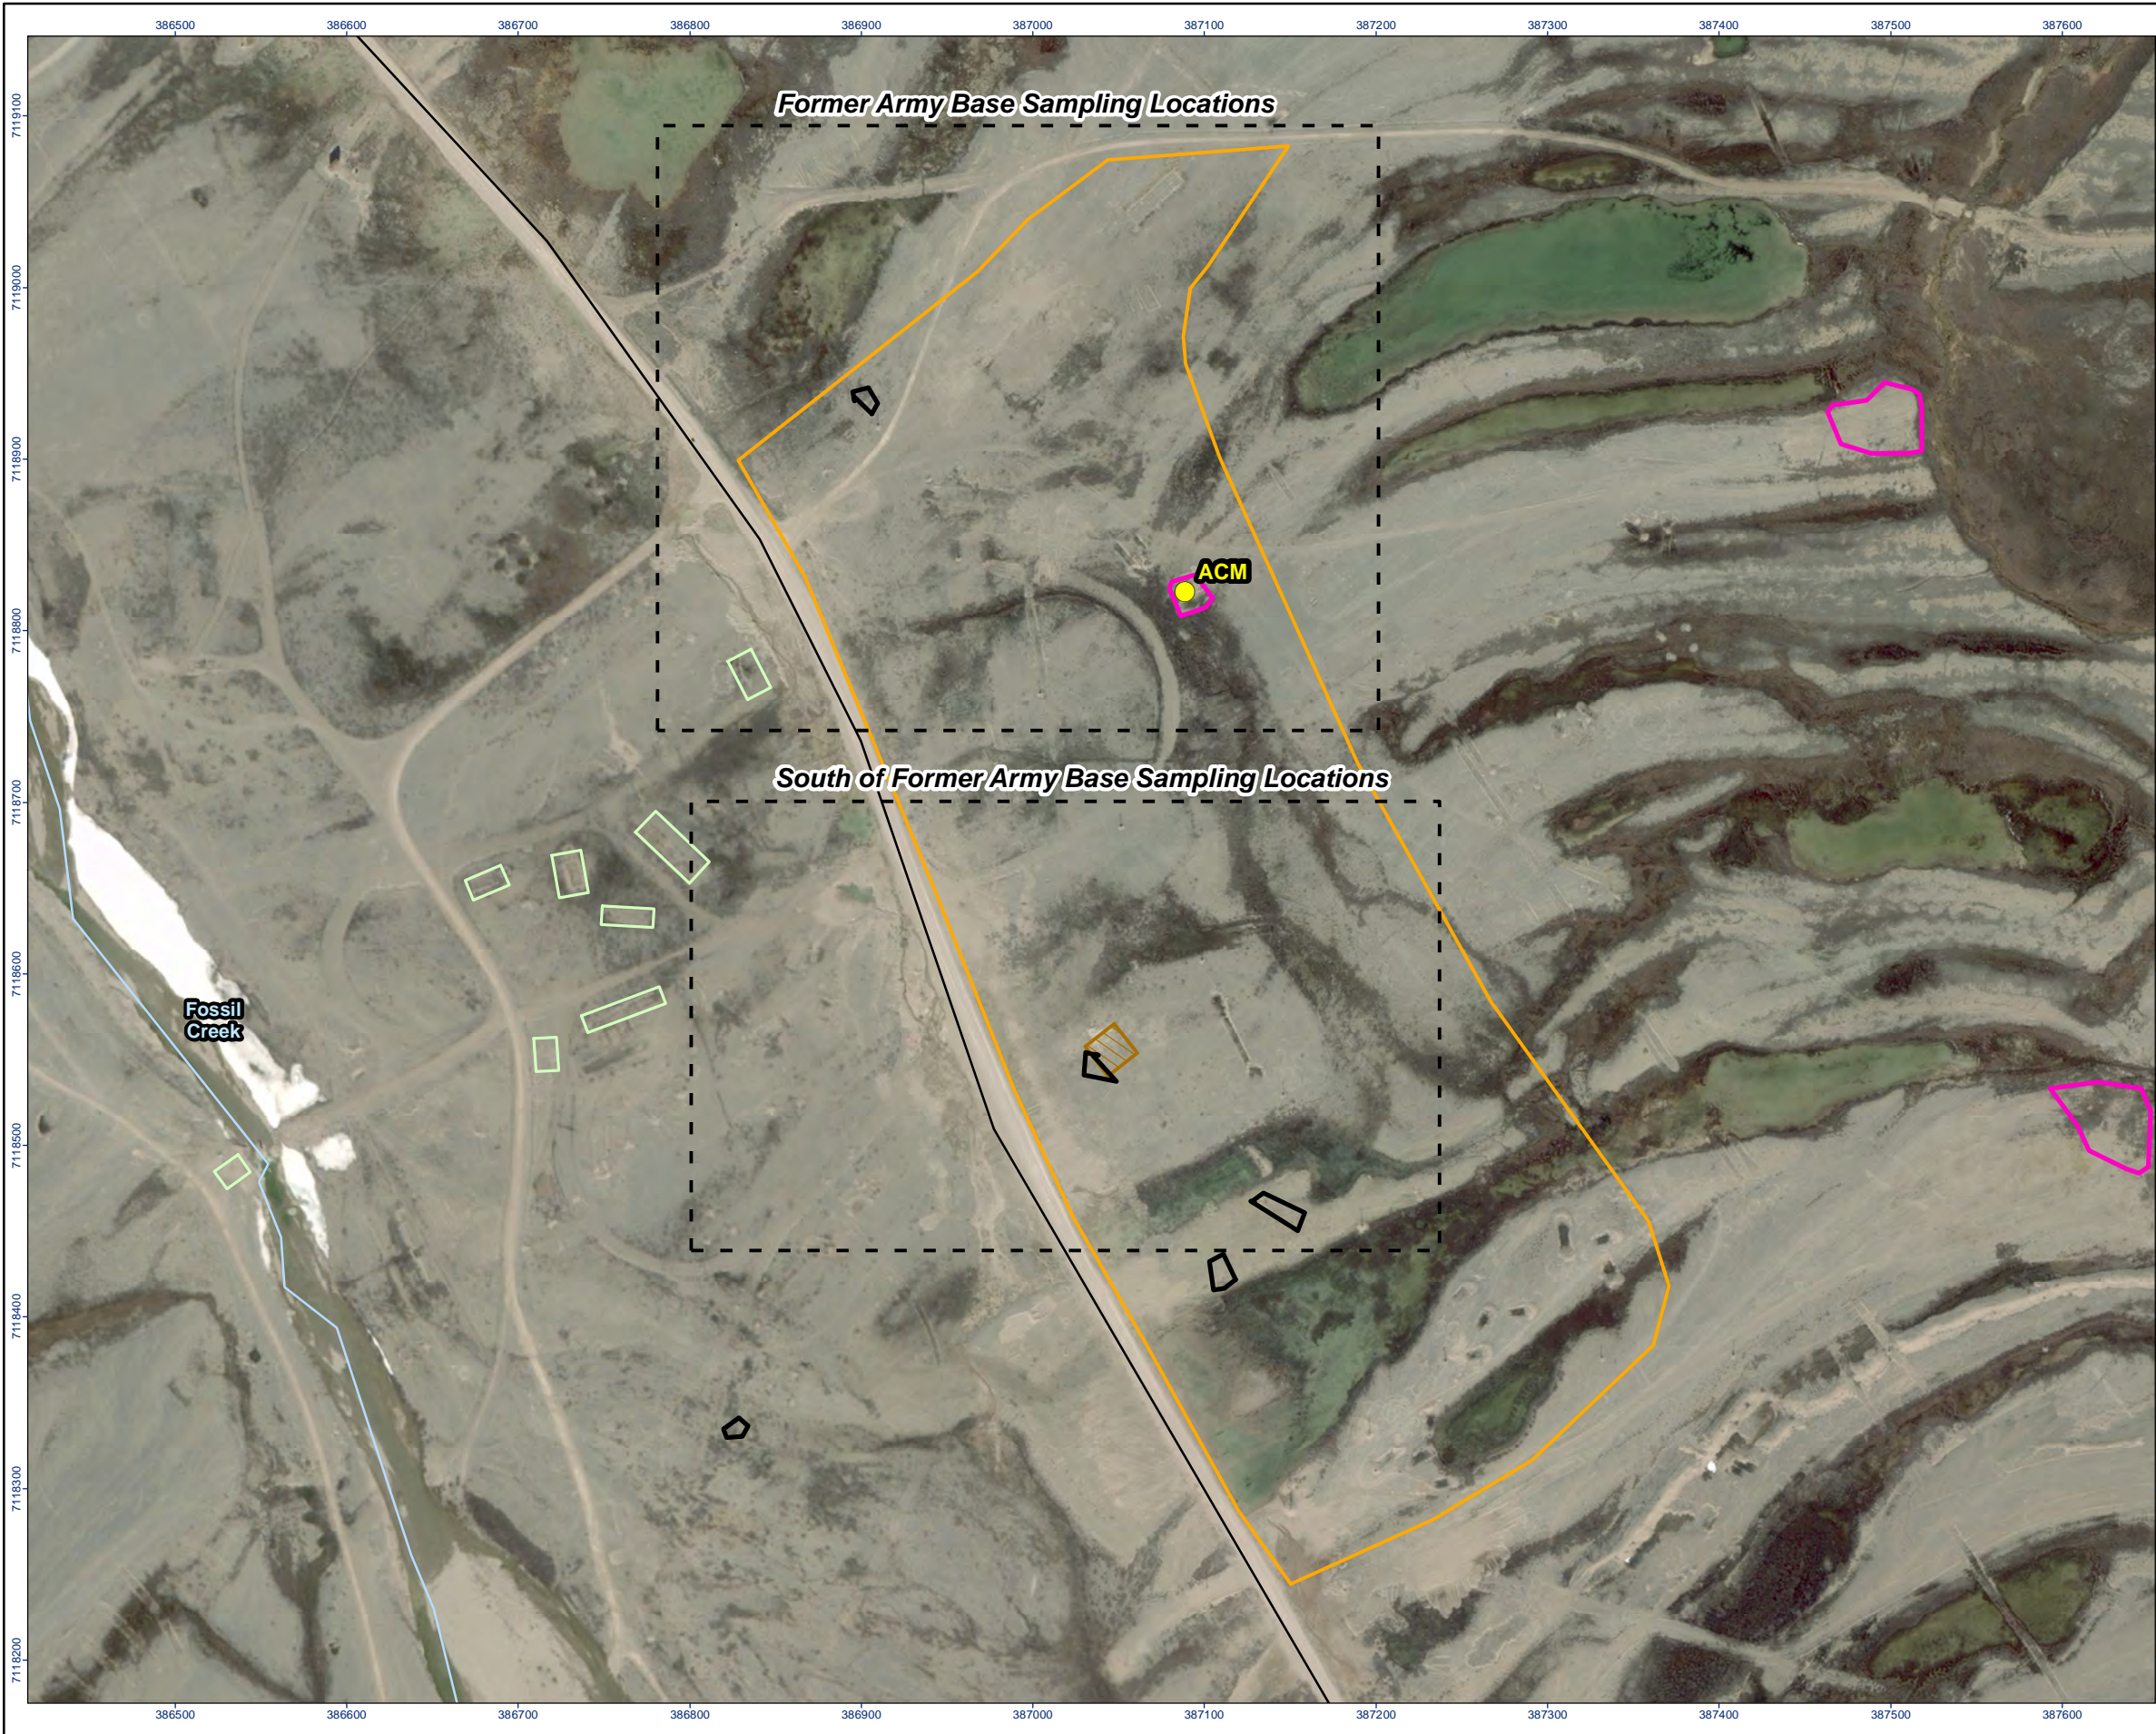
- Asbestos containing material (ACM)
- Remnants of historic infrastructure
- ▨ Buried Concrete Structure (location and size approximate)
- Buried Debris Area
- Existing Waste Disposal Area
- Consolidated Surface Debris Area
- Gravel Roads
- Fossil Creek

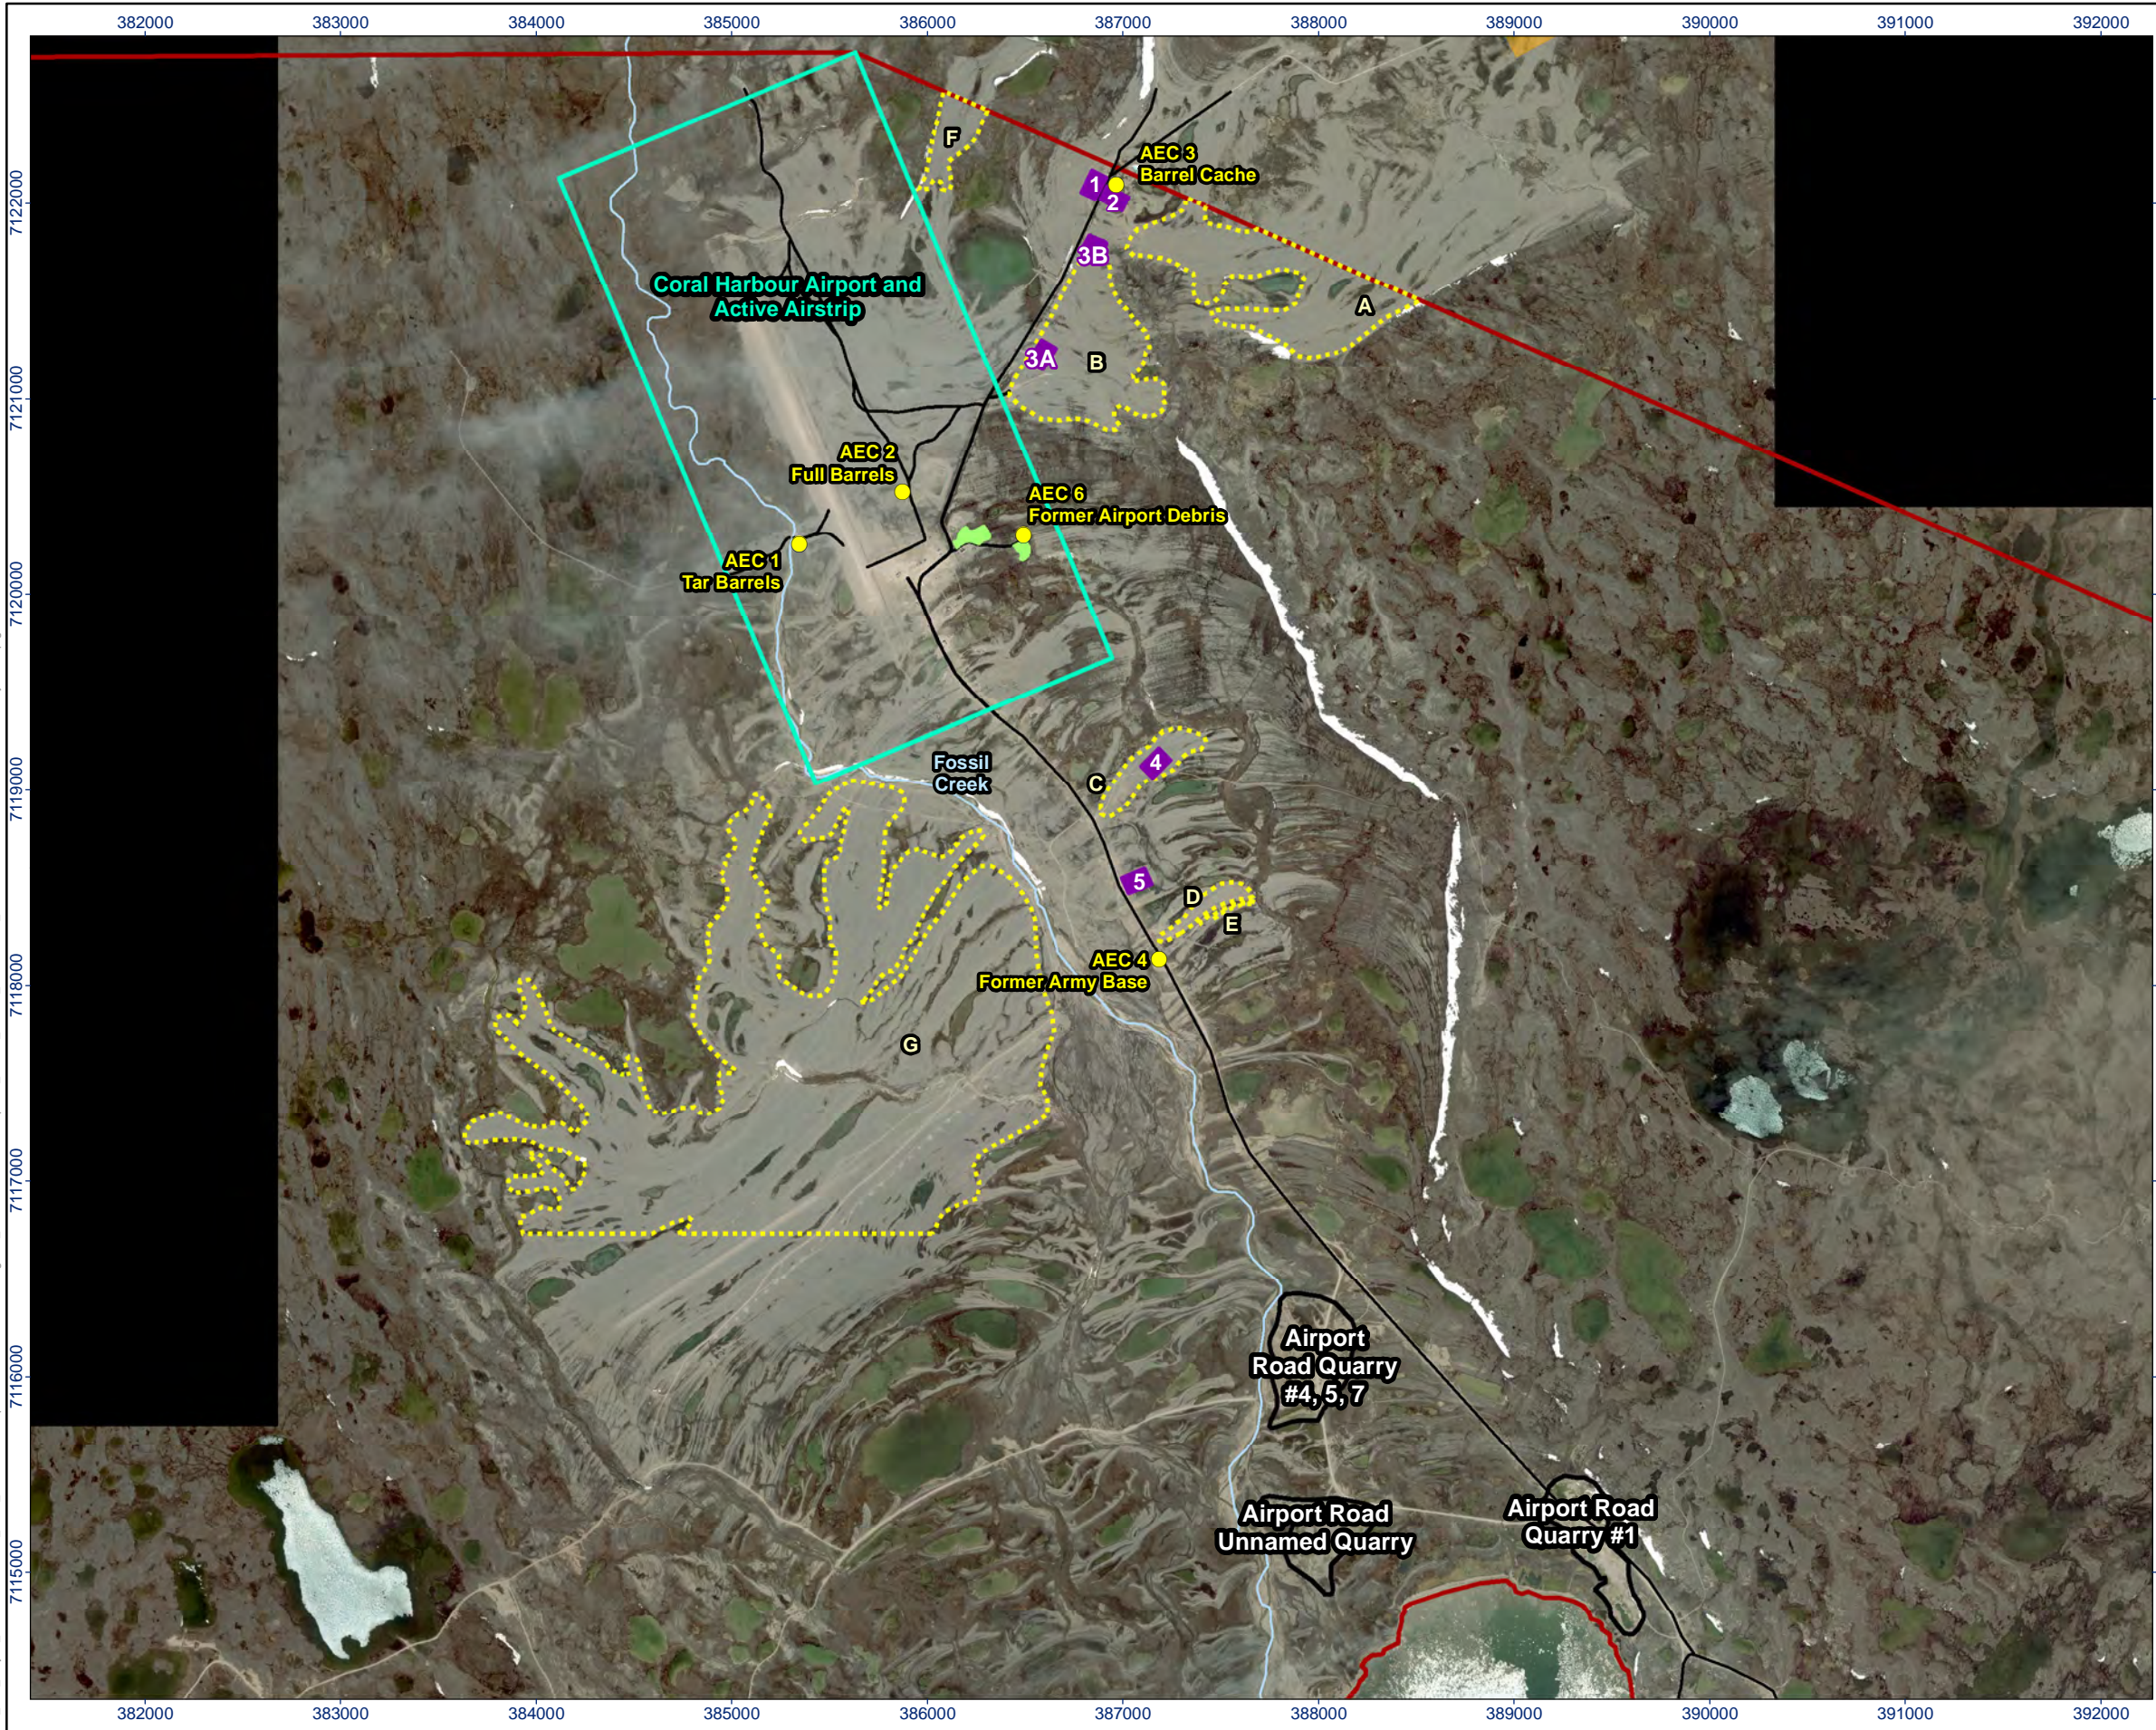
Borrow source field investigations were conducted at the Site in 2020 and 2021 to identify and characterize granular deposits for potential use as borrow sources for construction of the proposed NHW facility. There are three existing borrow sources and seven potential borrow sources that have been identified and assessed to date (Stantec 2021a) and (Stantec 2022b)). The location of the borrow sources are illustrated in Figure 7, Appendix A.
