**Re: Follow up to NIRB June 2022 Site Visit Report**

**Table 1 – Baffinland Responses to NIRB Finding and Recommendations - June 2022 Site Visit**

Baffinland Follow-Up Photos

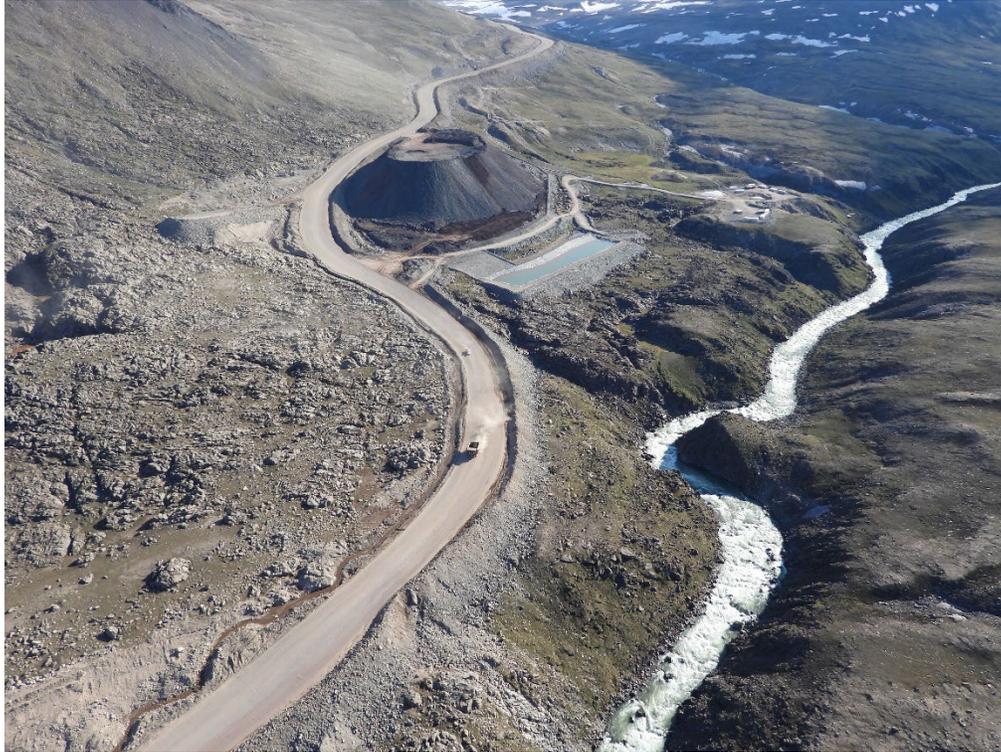
**Figure 1: Photo of Mine Haul Road on July 8<sup>th</sup> - 30 Hours of Road Closure from June 14<sup>th</sup>-15<sup>th</sup>, 2022**

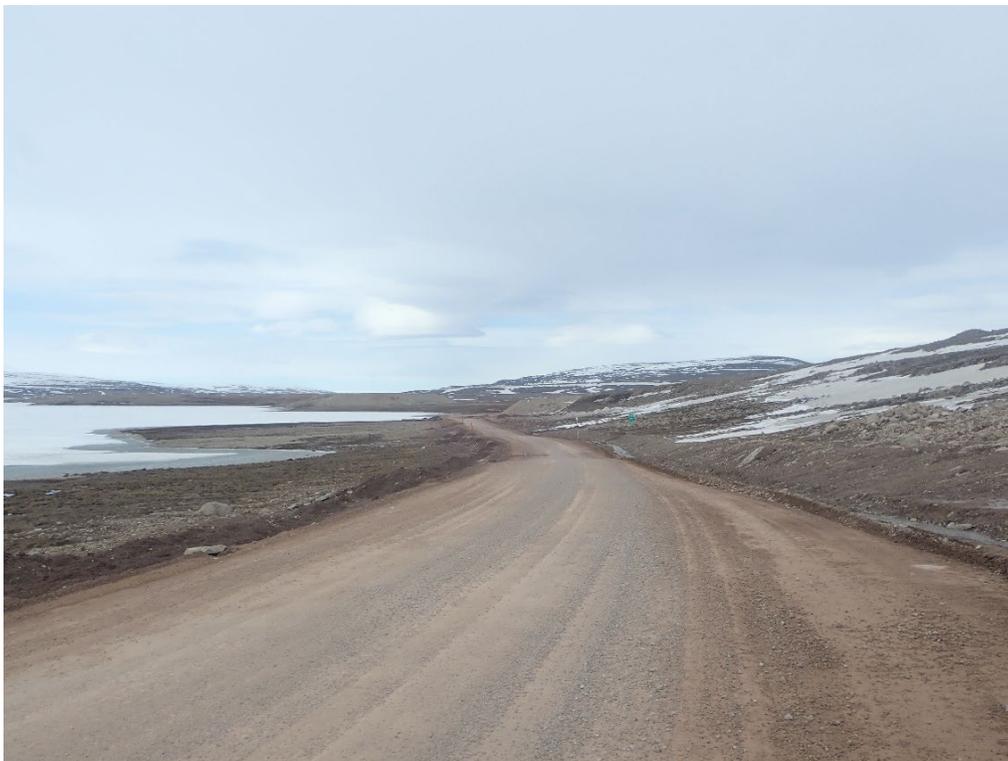
**Figure 2: Photo of Tote Road KM54 Open on June 16<sup>th</sup>, after 25 Hours of Road Closure from June 14<sup>th</sup>-15<sup>th</sup>, 2022**

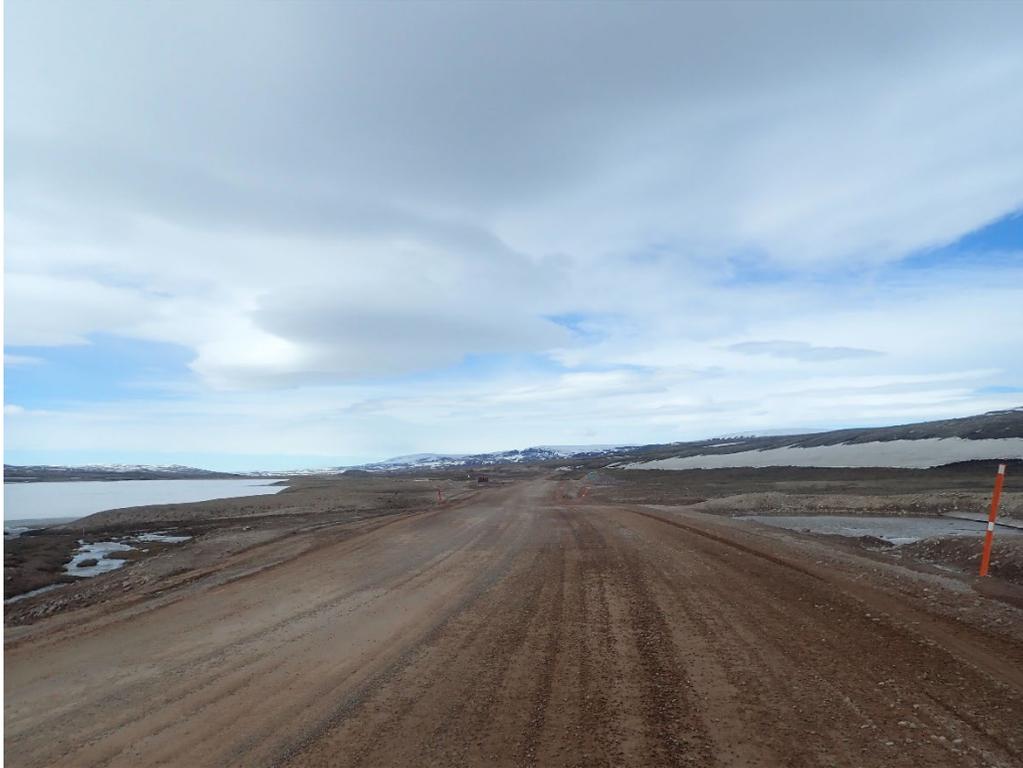
**Figure 3: Photo of Tote Road KM32 Re-Open on June 16<sup>th</sup>, after 25 Hours of Road Closure from June 14<sup>th</sup>-15<sup>th</sup>, 2022**

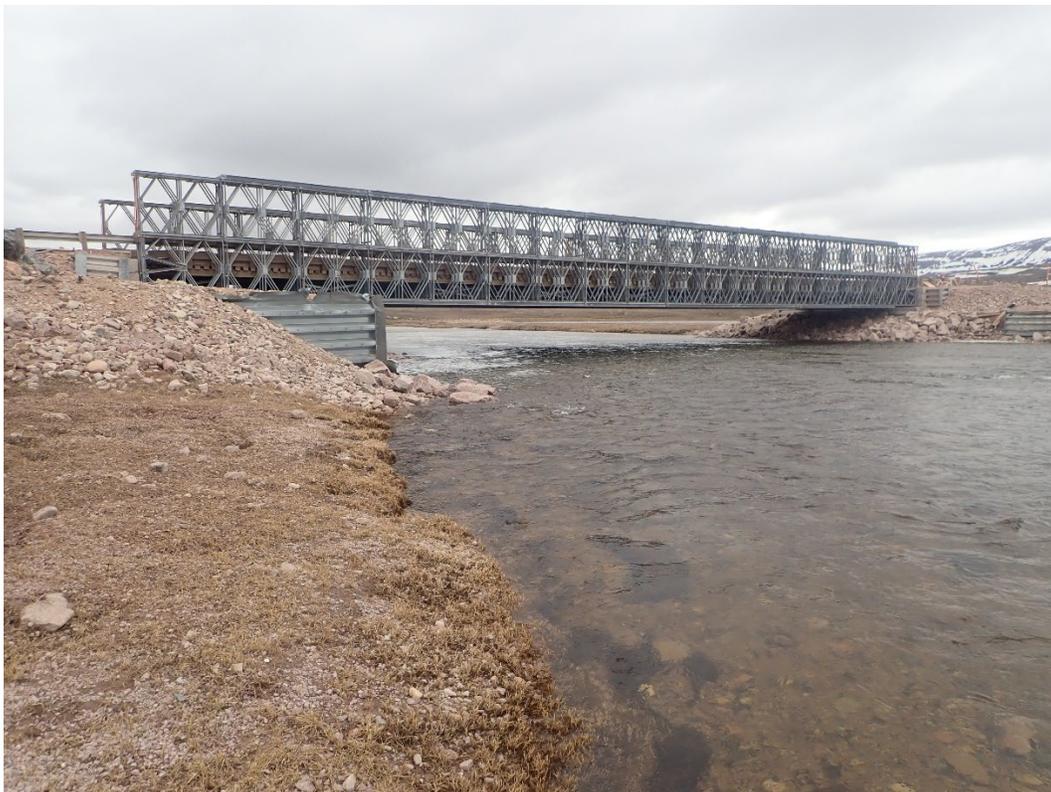
**Figure 4: Photo of Tote Road – KM17 Bridge – June 27<sup>th</sup>, 2022**

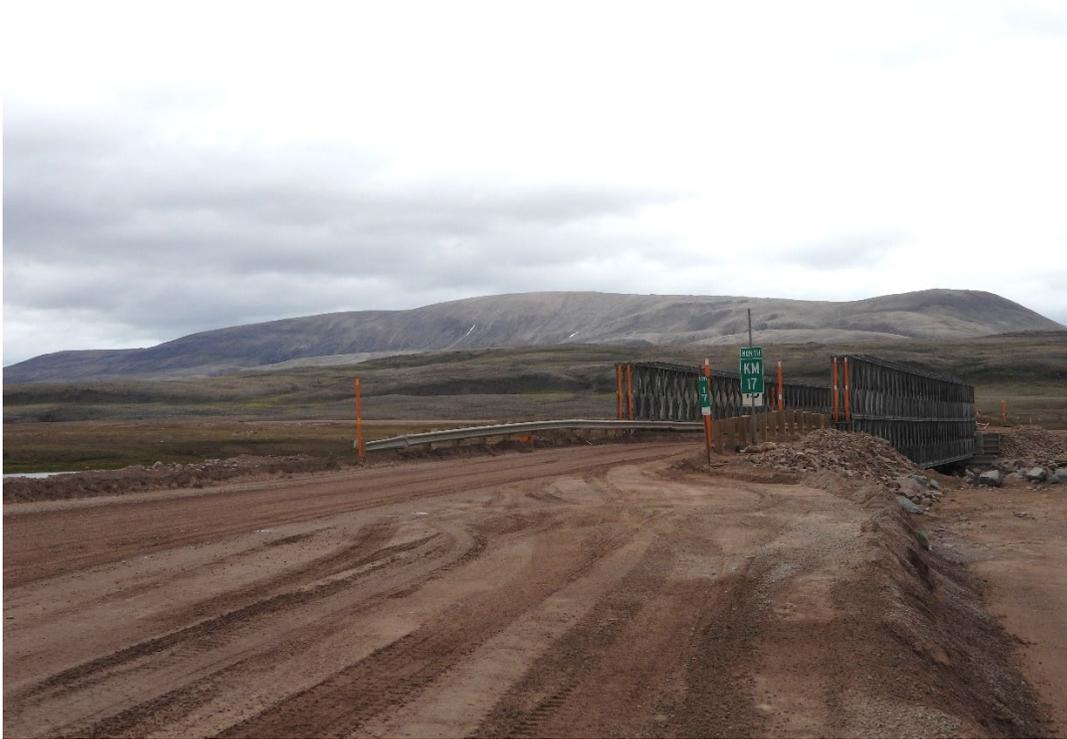
**Figure 5: Photo of Tote Road – KM17 Bridge – August 14<sup>th</sup>, 2022**
