Nunavut Impact Review Board

2022 Annual Report

Jericho Diamond Mine

NIRB File No. 00MN059

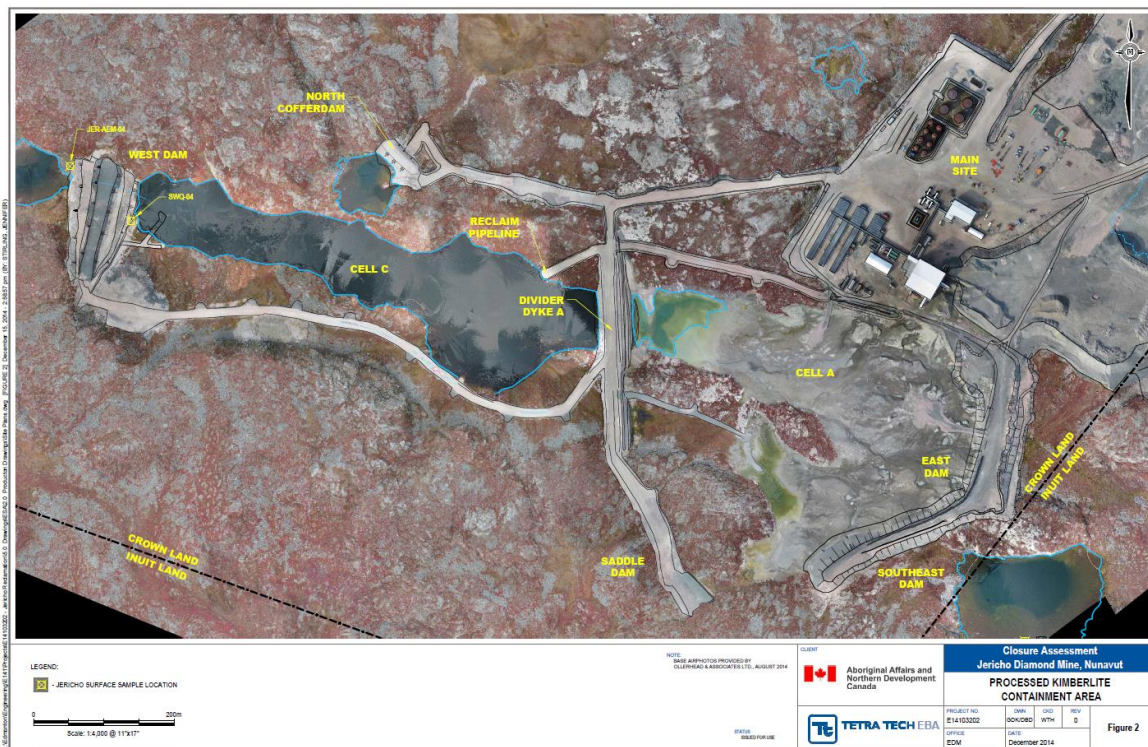
Figure 3: Processed Kimberlite Containment Area⁸

Remediation work in the Process Kimberlite Containment Area (PKCA) has included grading the existing tailings in Cell A to allow water to flow in its original direction (west) and capping the fine tailings with course-grained kimberlite tailings to prevent erosion and to prevent dust being transported by wind. In August 2022, as part of the OMS plan, visual inspections were conducted by CIRNAC. Minor erosion channels have developed in different areas of the PKCA though monitoring as well as “potholes”. These potholes have

changed, increasing and decreasing in size as snowmelt and water fills and washes them out, but overall the area is stabilizing.
