Appendix D. Sabina's Back River Blasting Plan for Plant Site and Portal Decline

SABINA BACK RIVER BLASTING PLAN FOR PLANT SITE AND PORTAL DECLINE

2022 VEGETATION MONITORING FIELD PROGRAM RESULTS - WINTER ROAD REALIGNMENT

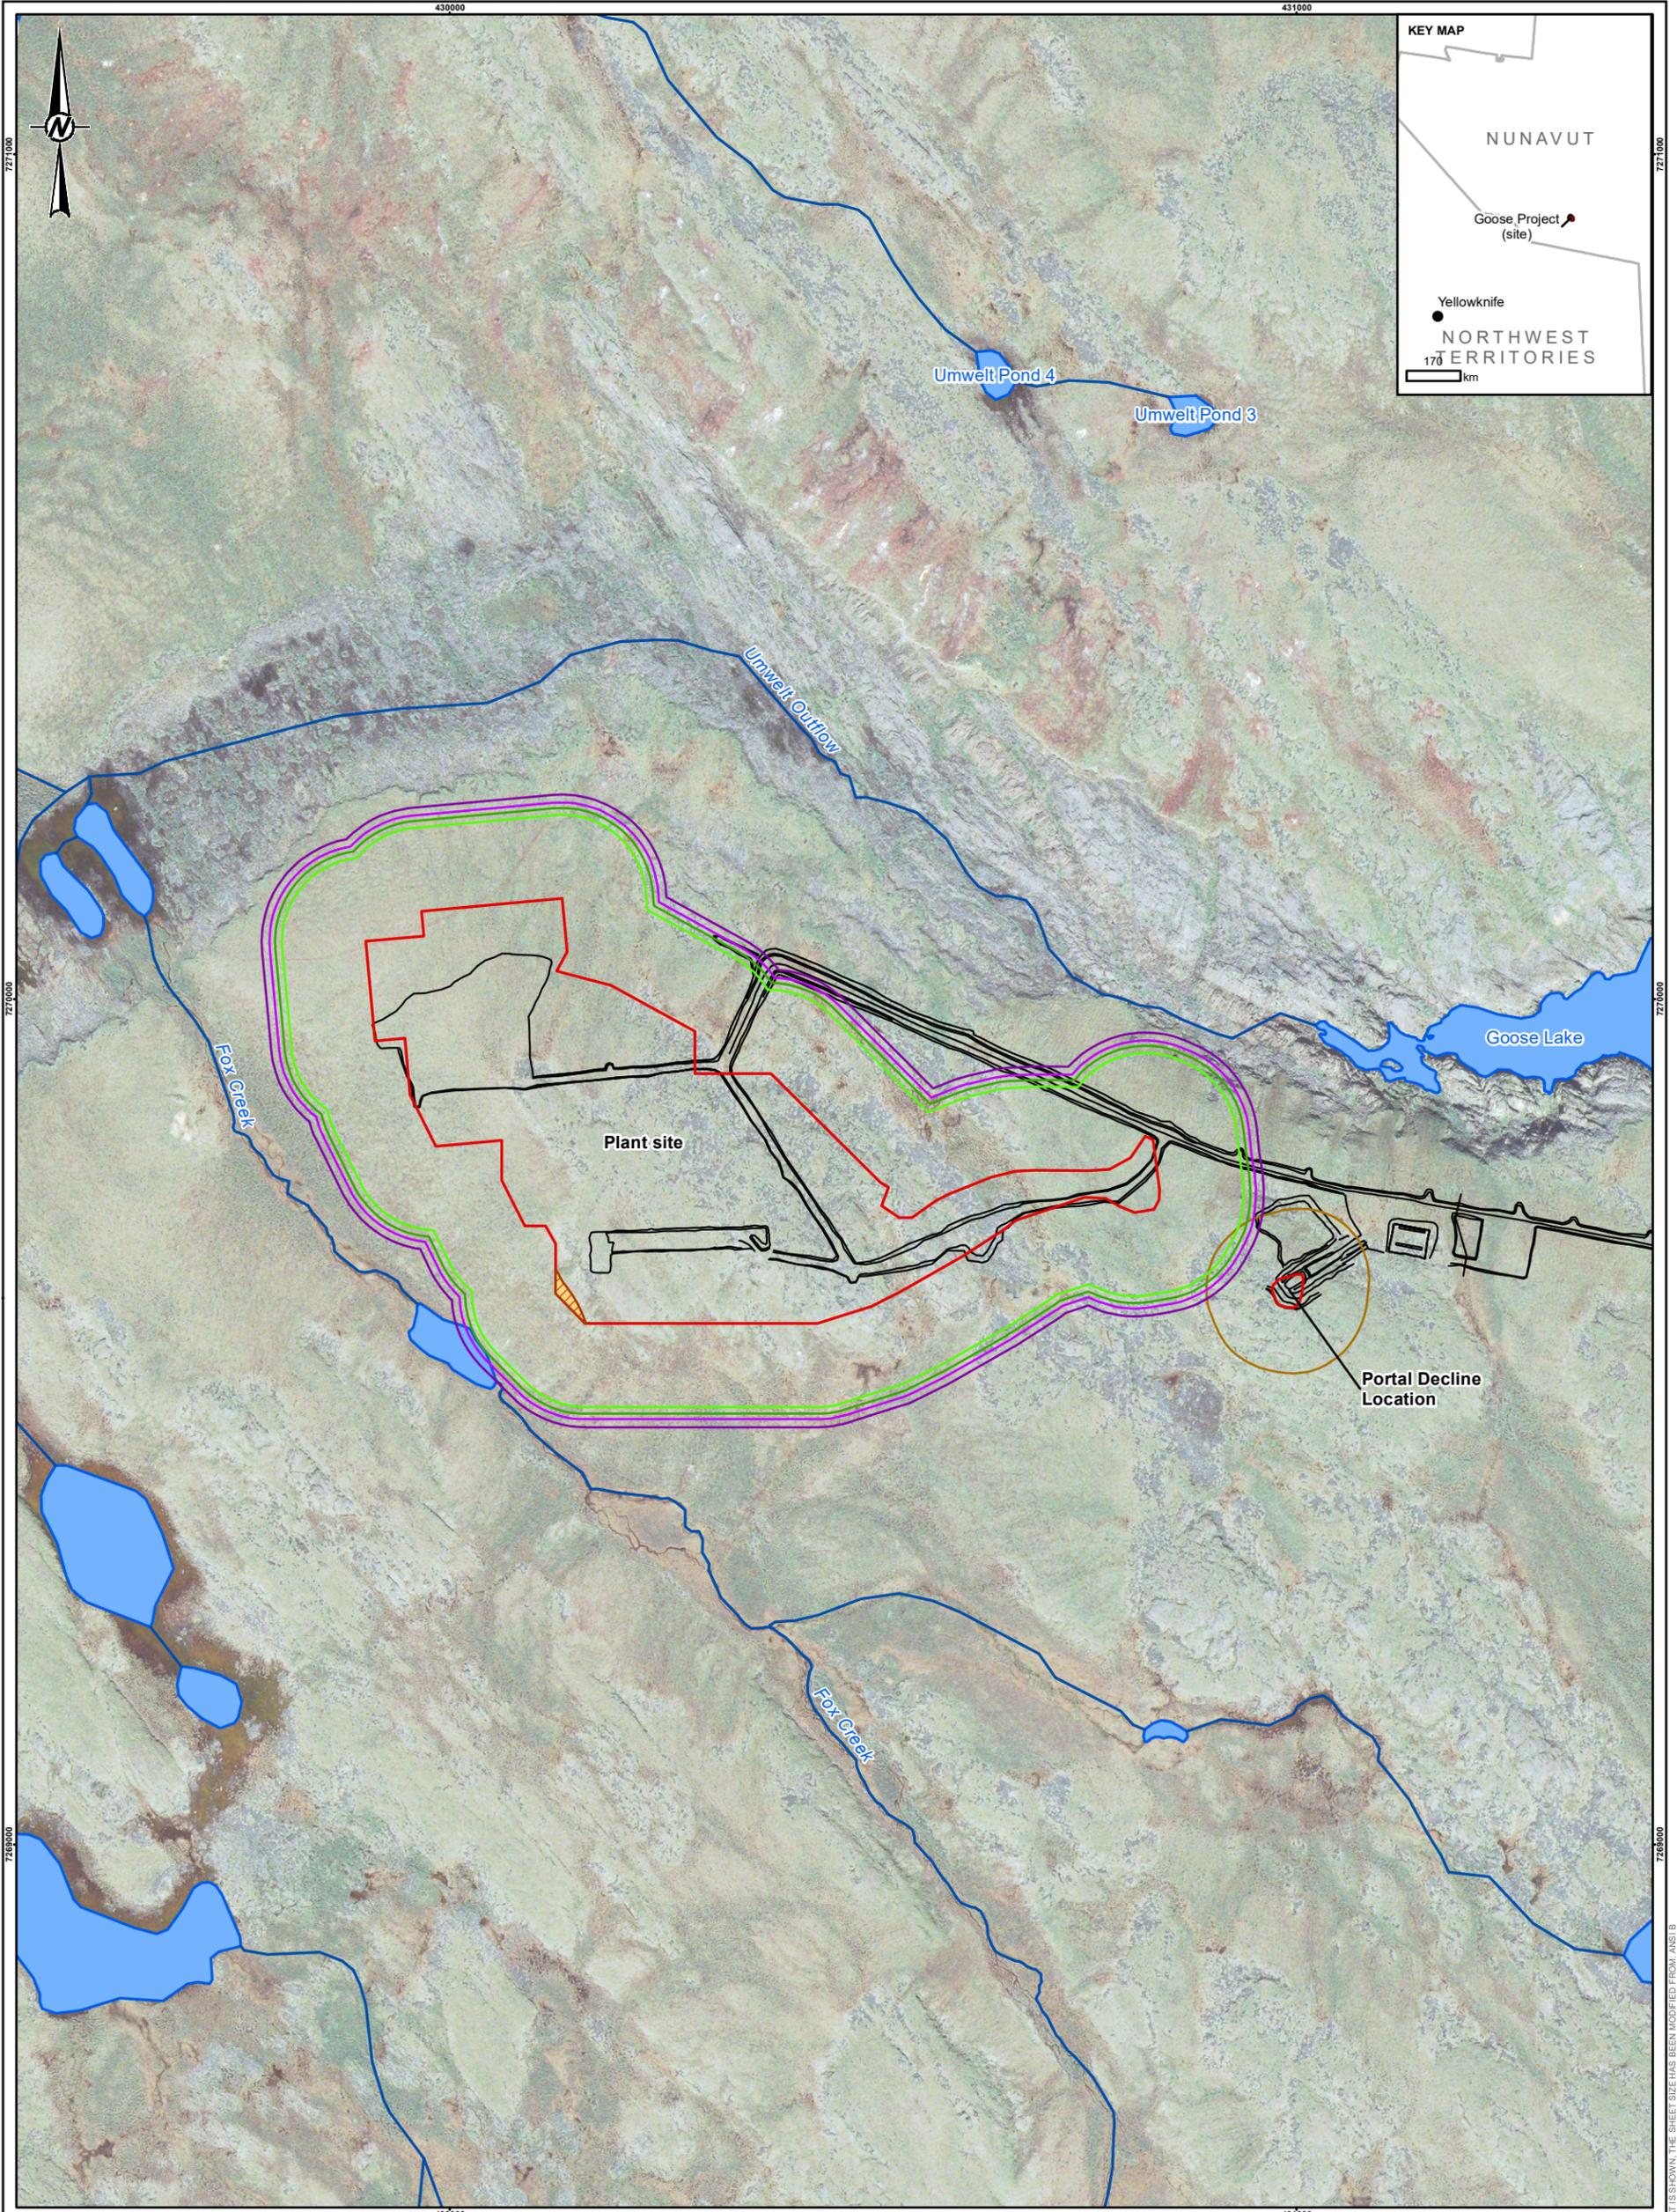
PROJECT NO.	CONTROL	REV.	FIGURE
20412211		0	1

PLANT SITE 122.8 m SETBACK FOR 250 kg CHARGE WEIGHT BLAST IN ROCK
-

PLANT SITE 113.5 m SETBACK FOR 250 kg CHARGE WEIGHT BLAST IN FROZEN SOIL
-

PLANT SITE 107.0 m SETBACK FOR 190 kg CHARGE WEIGHT BLAST IN ROCK
-

PLANT SITE 98.9 m SETBACK FOR 190 kg CHARGE WEIGHT BLAST IN FROZEN SOIL
-

PORTAL DECLINE LOCATION 77.6 m SETBACK FOR 100 kg CHARGE WEIGHT BLAST IN ROCK

TITLE
SETBACK DISTANCE FOR THE OVERPRESSURE GUIDELINE (50 kPa) TO PROTECT FISH

Calculations completed for the Plant Site blast location indicate that the setback distance for a 250 kg charge weight (per delay) is insufficient to avoid effects to fish and fish habitat in Fox Creek when detonated in rock (Table 1, Figure 1 and Figure 2). Manipulation of charge weights to achieve appropriate setbacks for the protection of fish and fish habitat are presented in Table 1, Figure 1, and Figure 2.

It is recommended that blasting in the western portion of the Plant Site be completed outside of the spawning window for Arctic Grayling (see “exclusion zones” marked on Figure 1 and 2). The DFO restricted activity timing window for the protection of spring spawning fish and fish habitat (Nunavut Zone 2) is 1 May to 15 July of any given calendar year (DFO 2013). This timing window covers all spring spawning species (e.g., Arctic Grayling and Northern Pike (*Esox lucius*)). However, the timing of the early part of the window in May is not applicable to the Plan (e.g., spring freshet does not start until June, Northern Pike do not occur in the study area), while the later part of the window may not be protective of later stages of egg development of Arctic Grayling based on field observations. As such, a restricted timing window was developed for the Plan based on Arctic Grayling life history and baseline data for the Goose Site.

- Within the open-water season, overpressure from blasting at the proposed charge weight of 250 kg per delay may affect a small area within Fox Creek (Table 1; Figure 1). Reducing the charge weight to 190 kg per delay within the southwest corner of the Plant Site (“exclusion zone” marked on Figure 1; Table 3) is recommended to provide an appropriate setback distance for fish in Fox Creek for periods outside the spawning and rearing window for Arctic Grayling (Table 1; Figure 1).

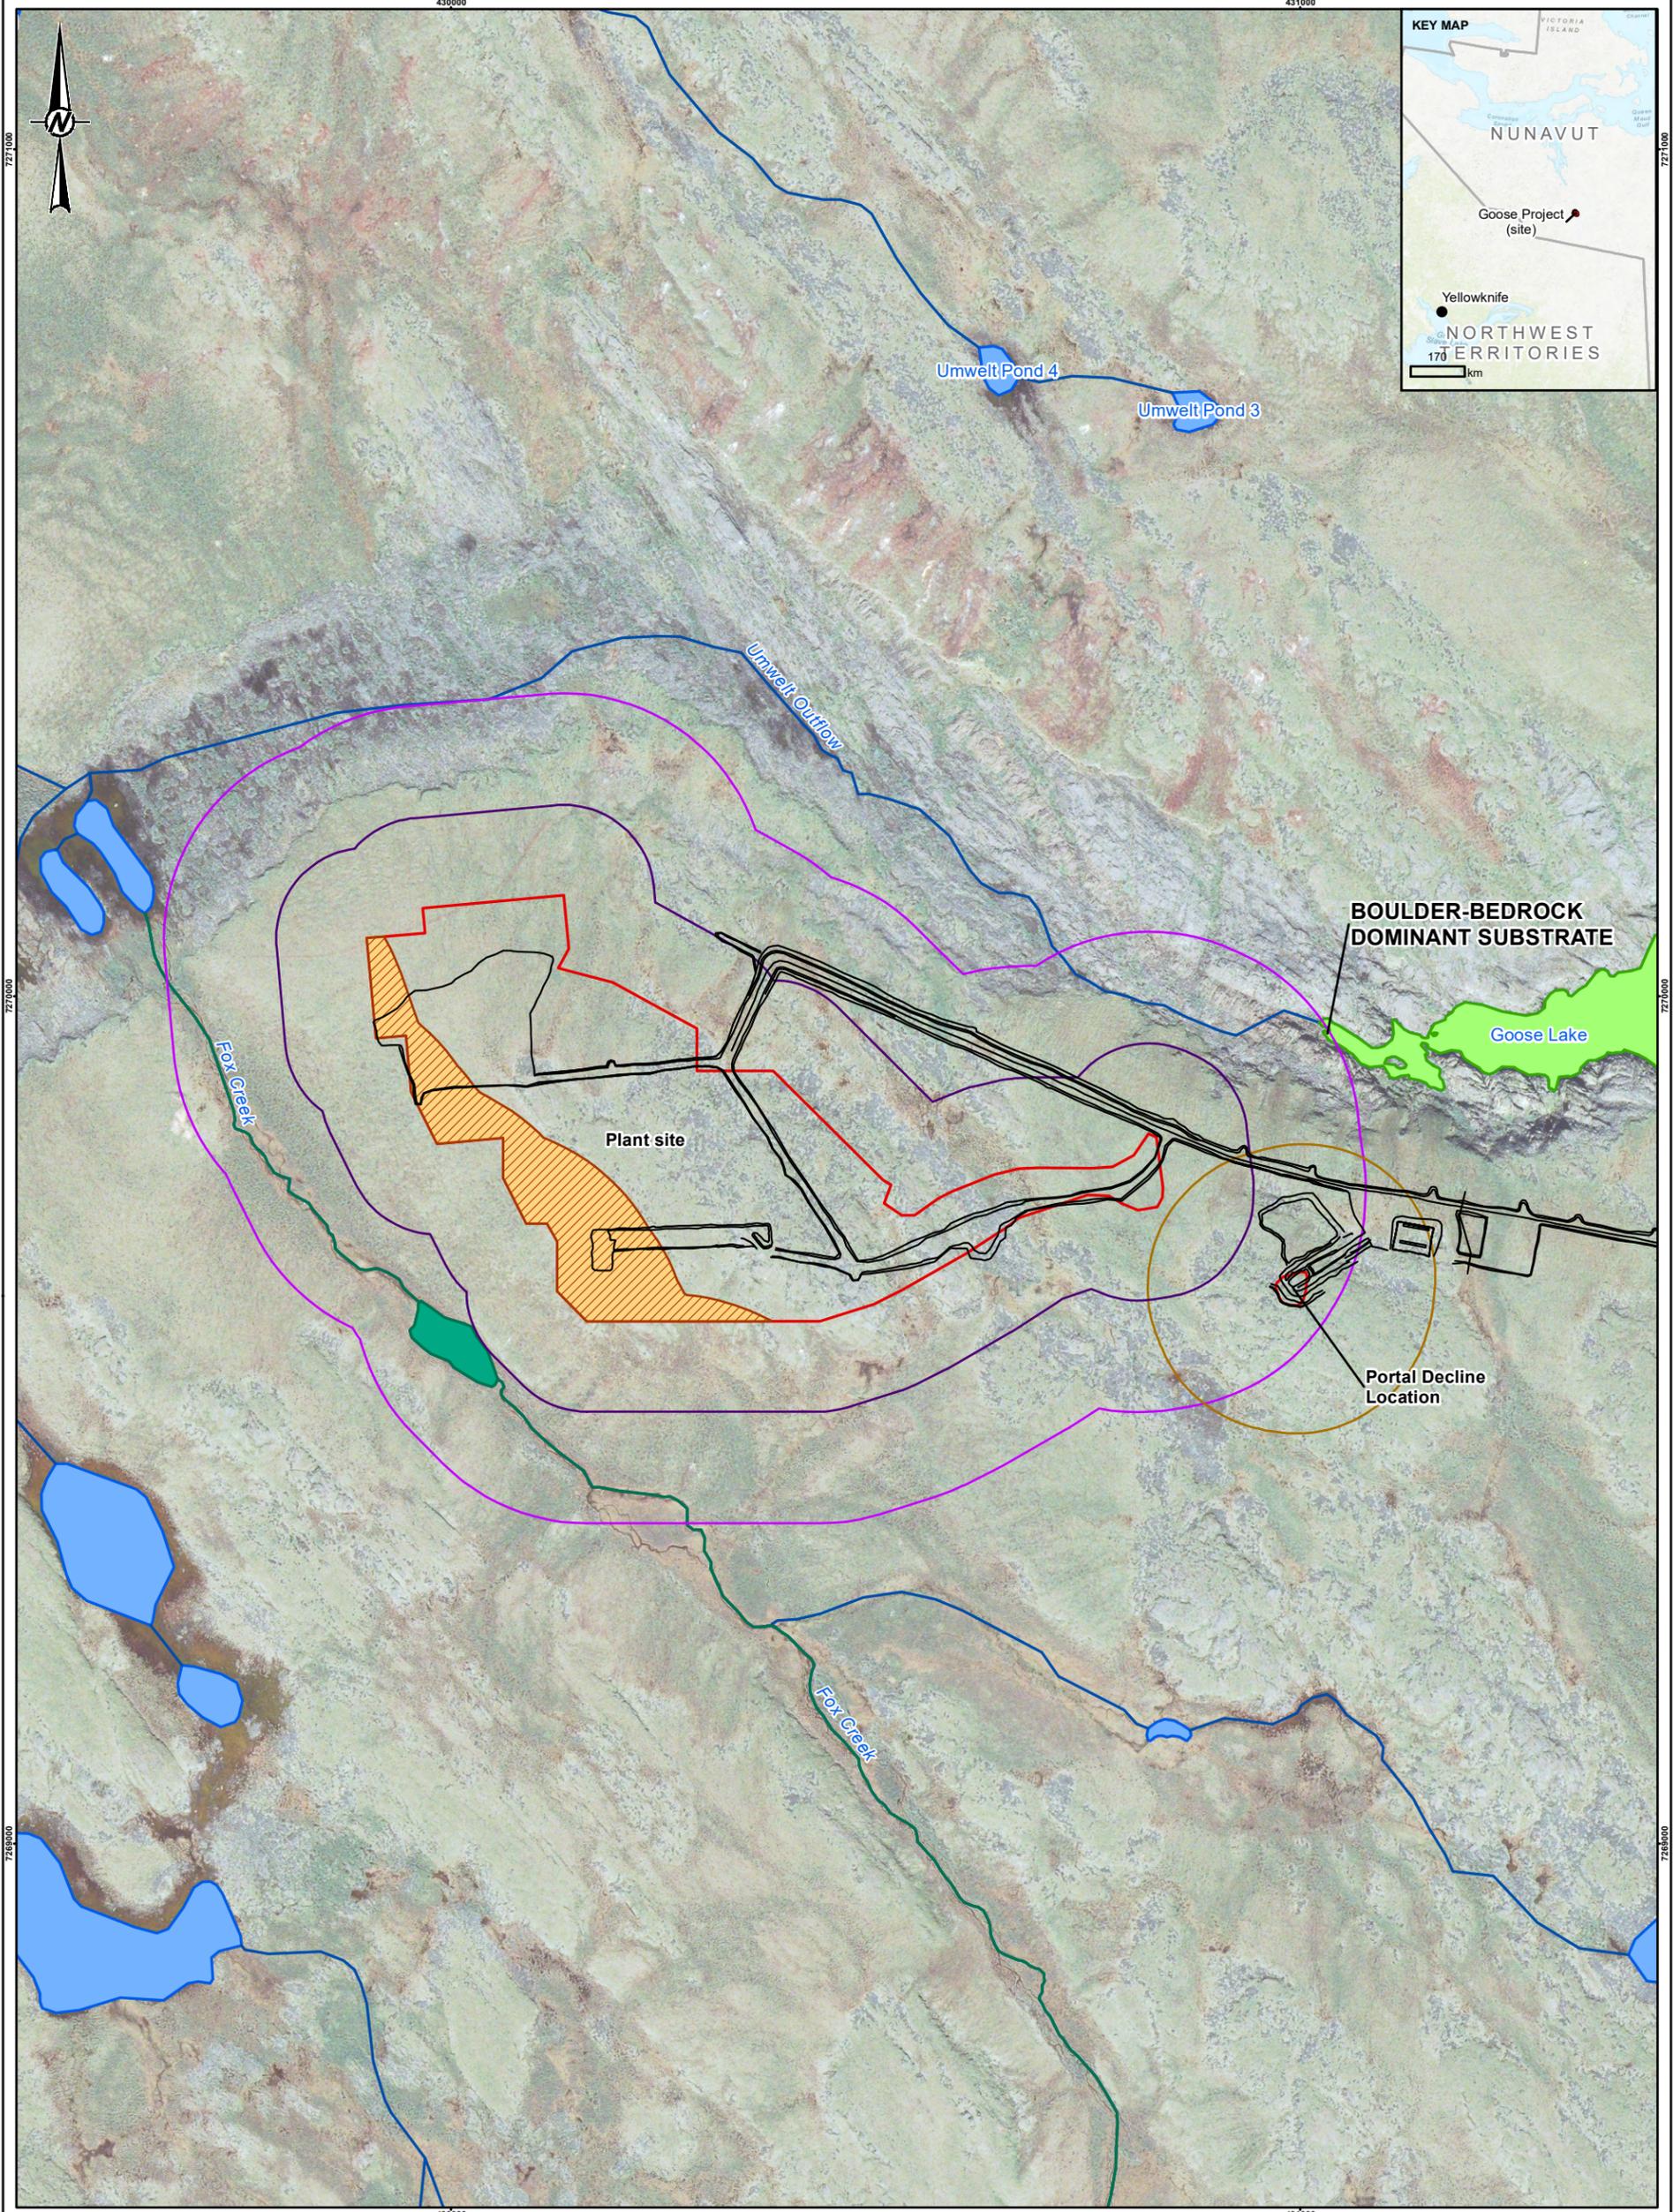
FIGURE
2

- PLANT SITE 106.7 m SETBACK FOR 50 kg CHARGE WEIGHT BLAST IN ROCK OR FROZEN SOIL
- PLANT SITE 238.6 m SETBACK FOR 250 kg CHARGE WEIGHT BLAST IN ROCK OR FROZEN SOIL
- PORTAL DECLINE LOCATION 150.9 m SETBACK FOR 100 kg CHARGE WEIGHT BLAST IN ROCK

TITLE
SETBACK DISTANCE FOR THE PEAK PARTICLE VELOCITY GUIDELINE (13 mm/s) TO PROTECT FISH HABITAT

- Because PPV from blasting at the proposed charge weight of 250 kg per delay has the potential to impact Arctic Grayling spawning habitat throughout Fox Creek, manipulation of charge weights is recommended to achieve an appropriate setback for blasting within the spawning window for Arctic Grayling. The reduction in weight is significant, and limits blasts to a 50 kg charge weight per delay (Table 1; Figure 2). This approach is recommended for blasting within the “exclusion zone” marked on Figure 2 and summarized in Table 3.

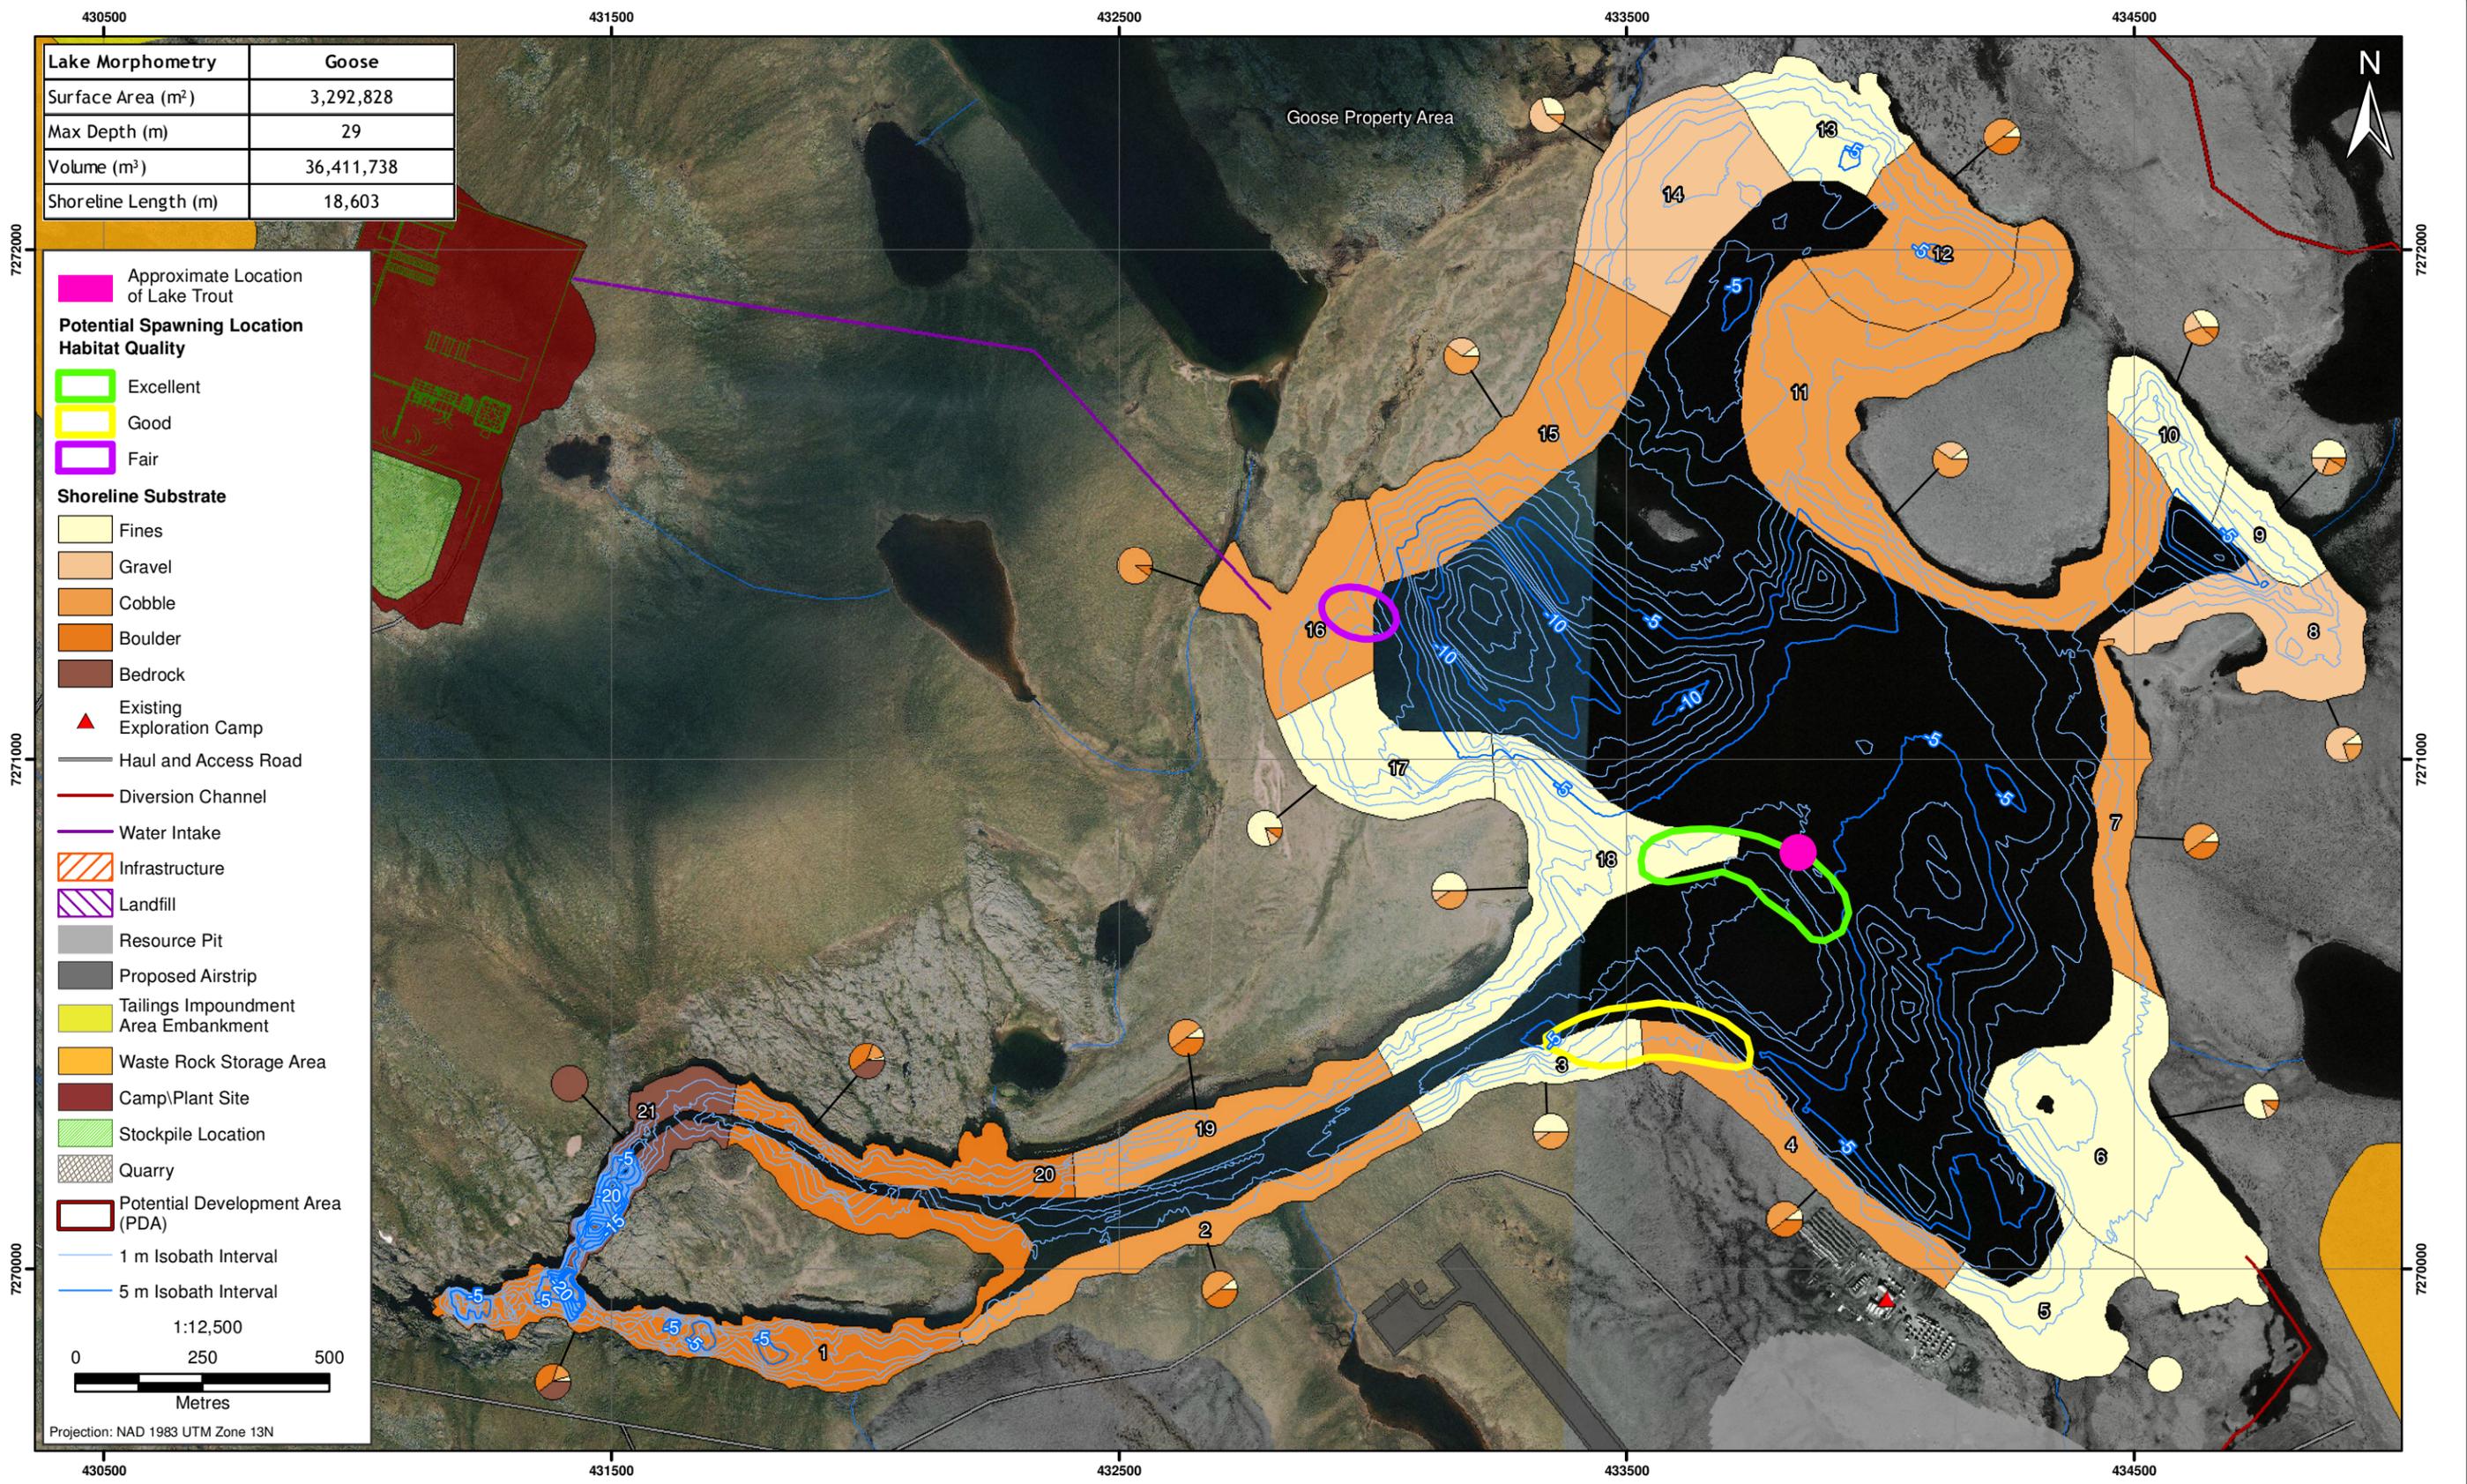
Figure 3.4-8

Lake Morphometry	Goose
Surface Area (m ²)	3,292,828
Max Depth (m)	29
Volume (m ³)	36,411,738
Shoreline Length (m)	18,603

Lake Trout Spawning Survey Observations, Goose Lake, 2013

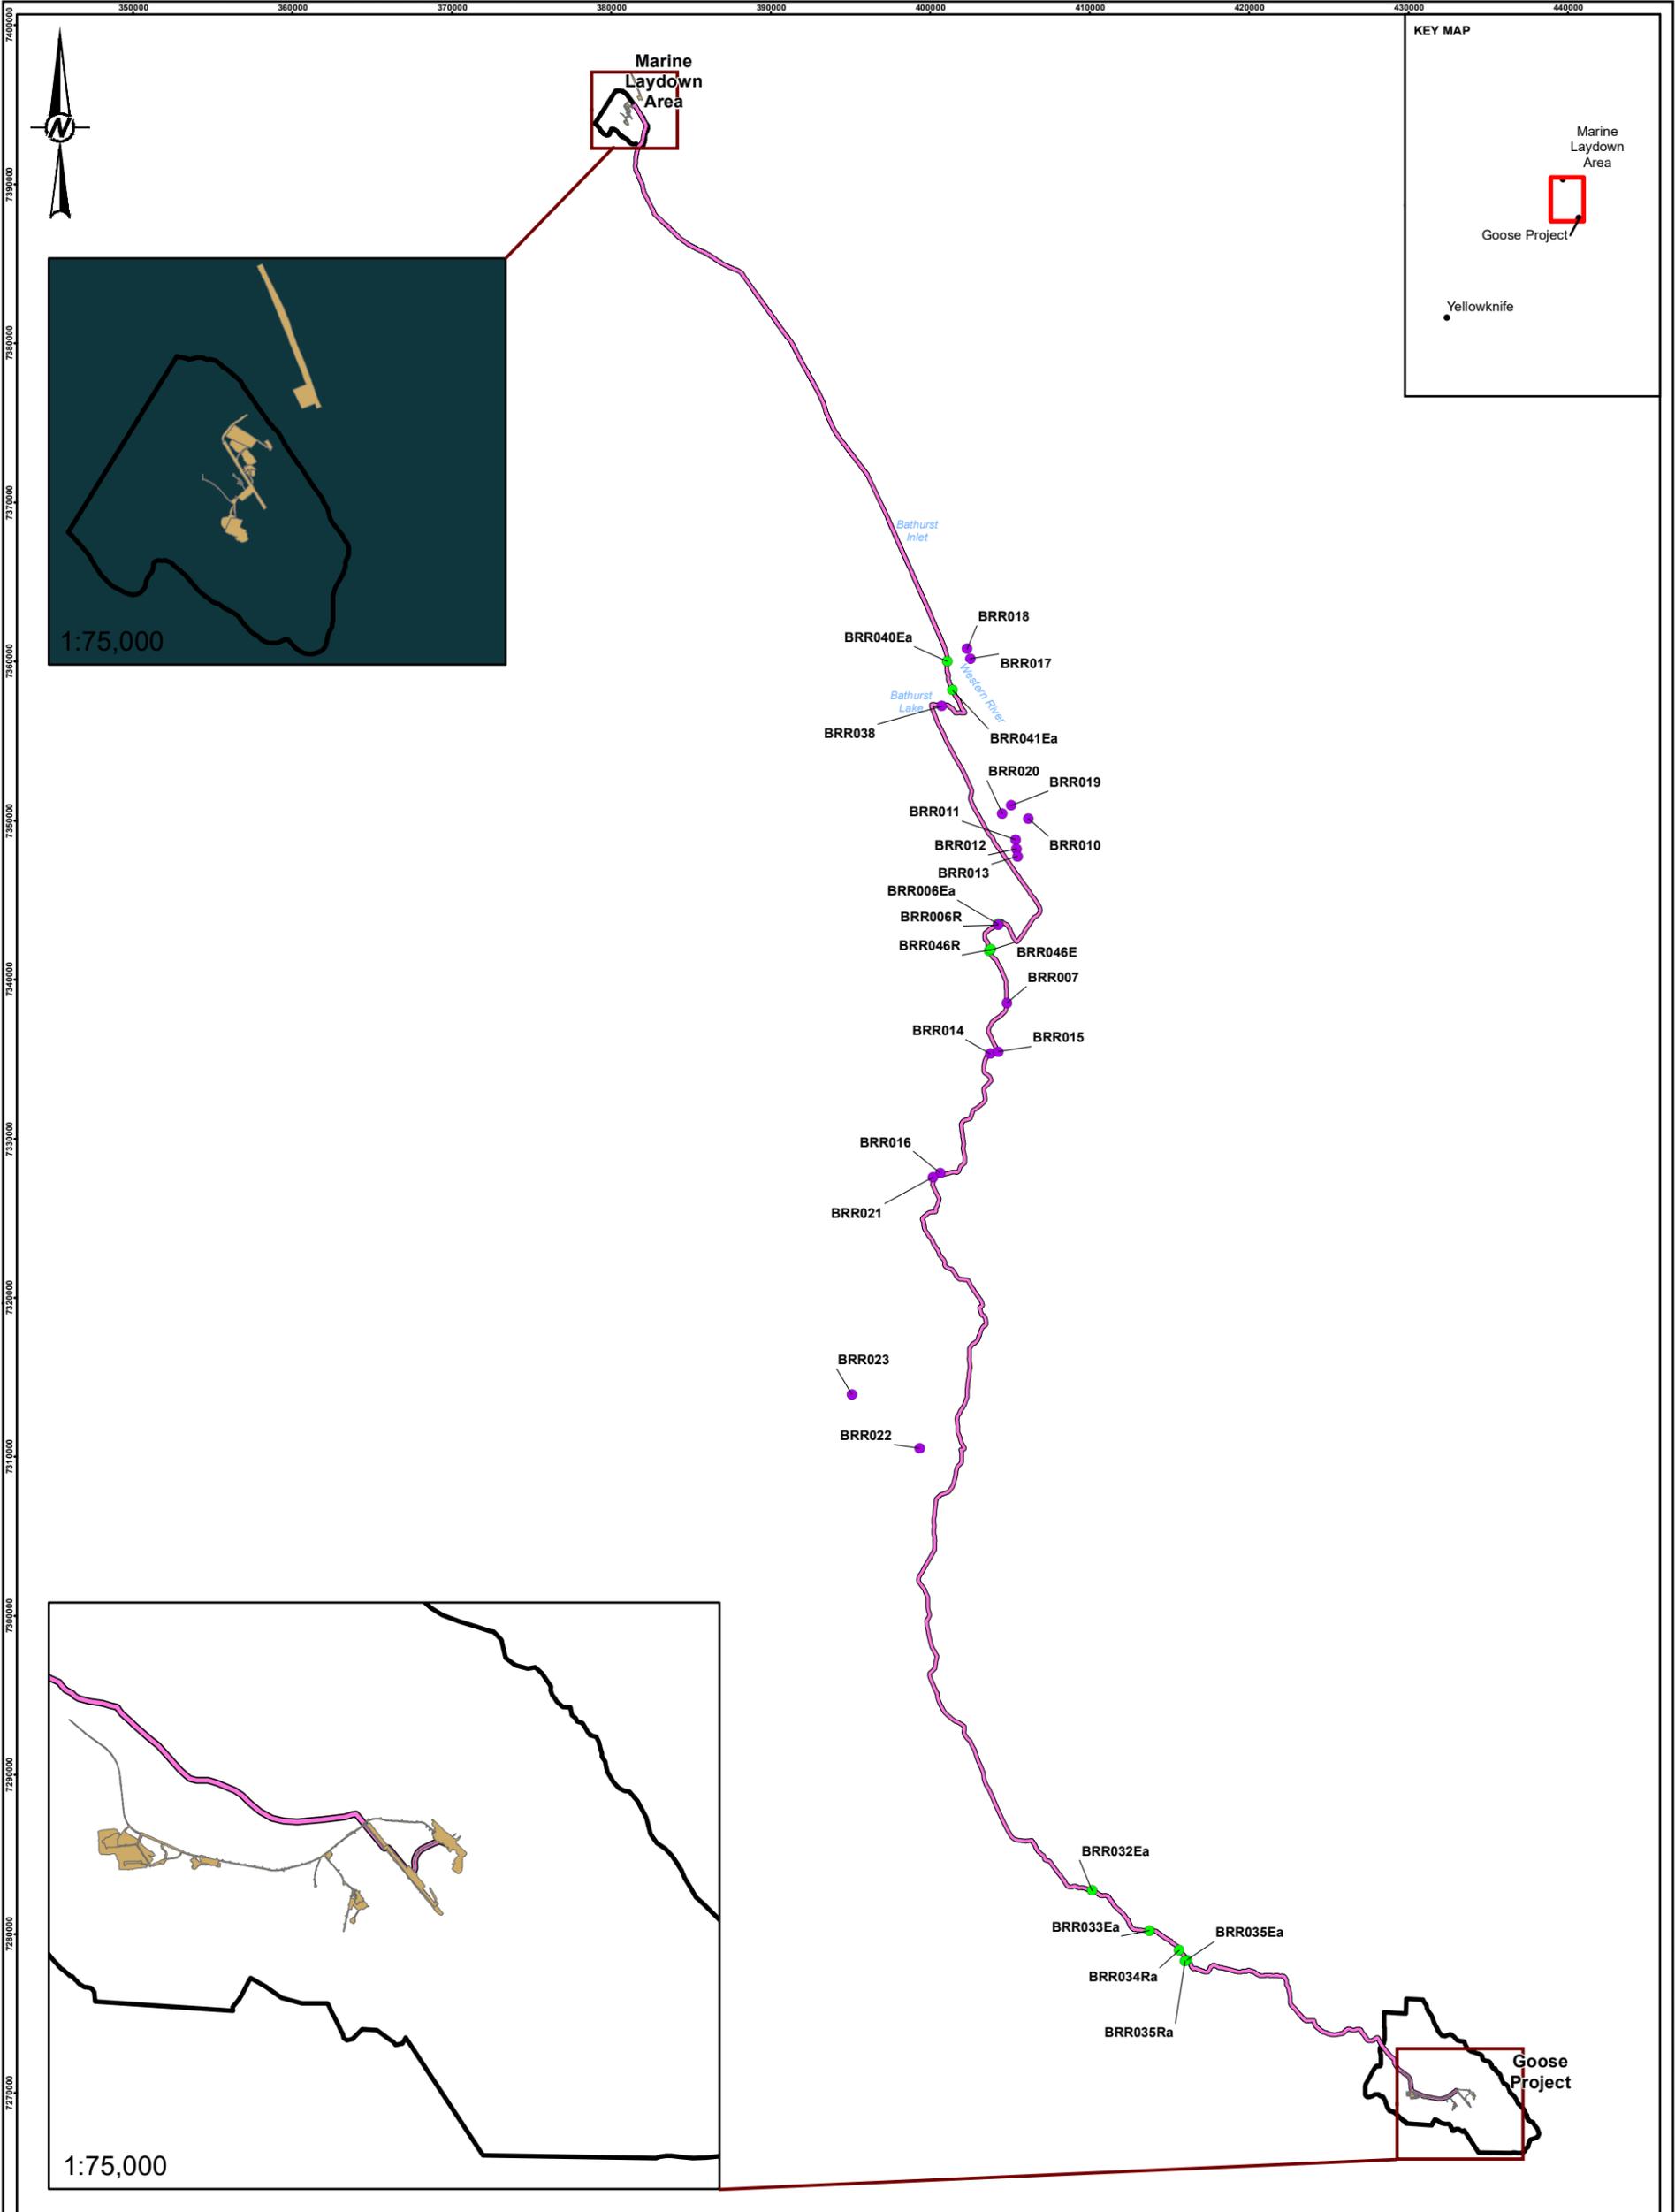
CLIENT	[REDACTED]	
PROJECT	SABINA BACK RIVER PROJECT	
TITLE	2022 VEGETATION MONITORING LOCATIONS	
CONSULTANT	YYYY-MM-DD	2023-01-06
	DESIGNED	CS
	PREPARED	AM
	REVIEWED	VC
	APPROVED	SO

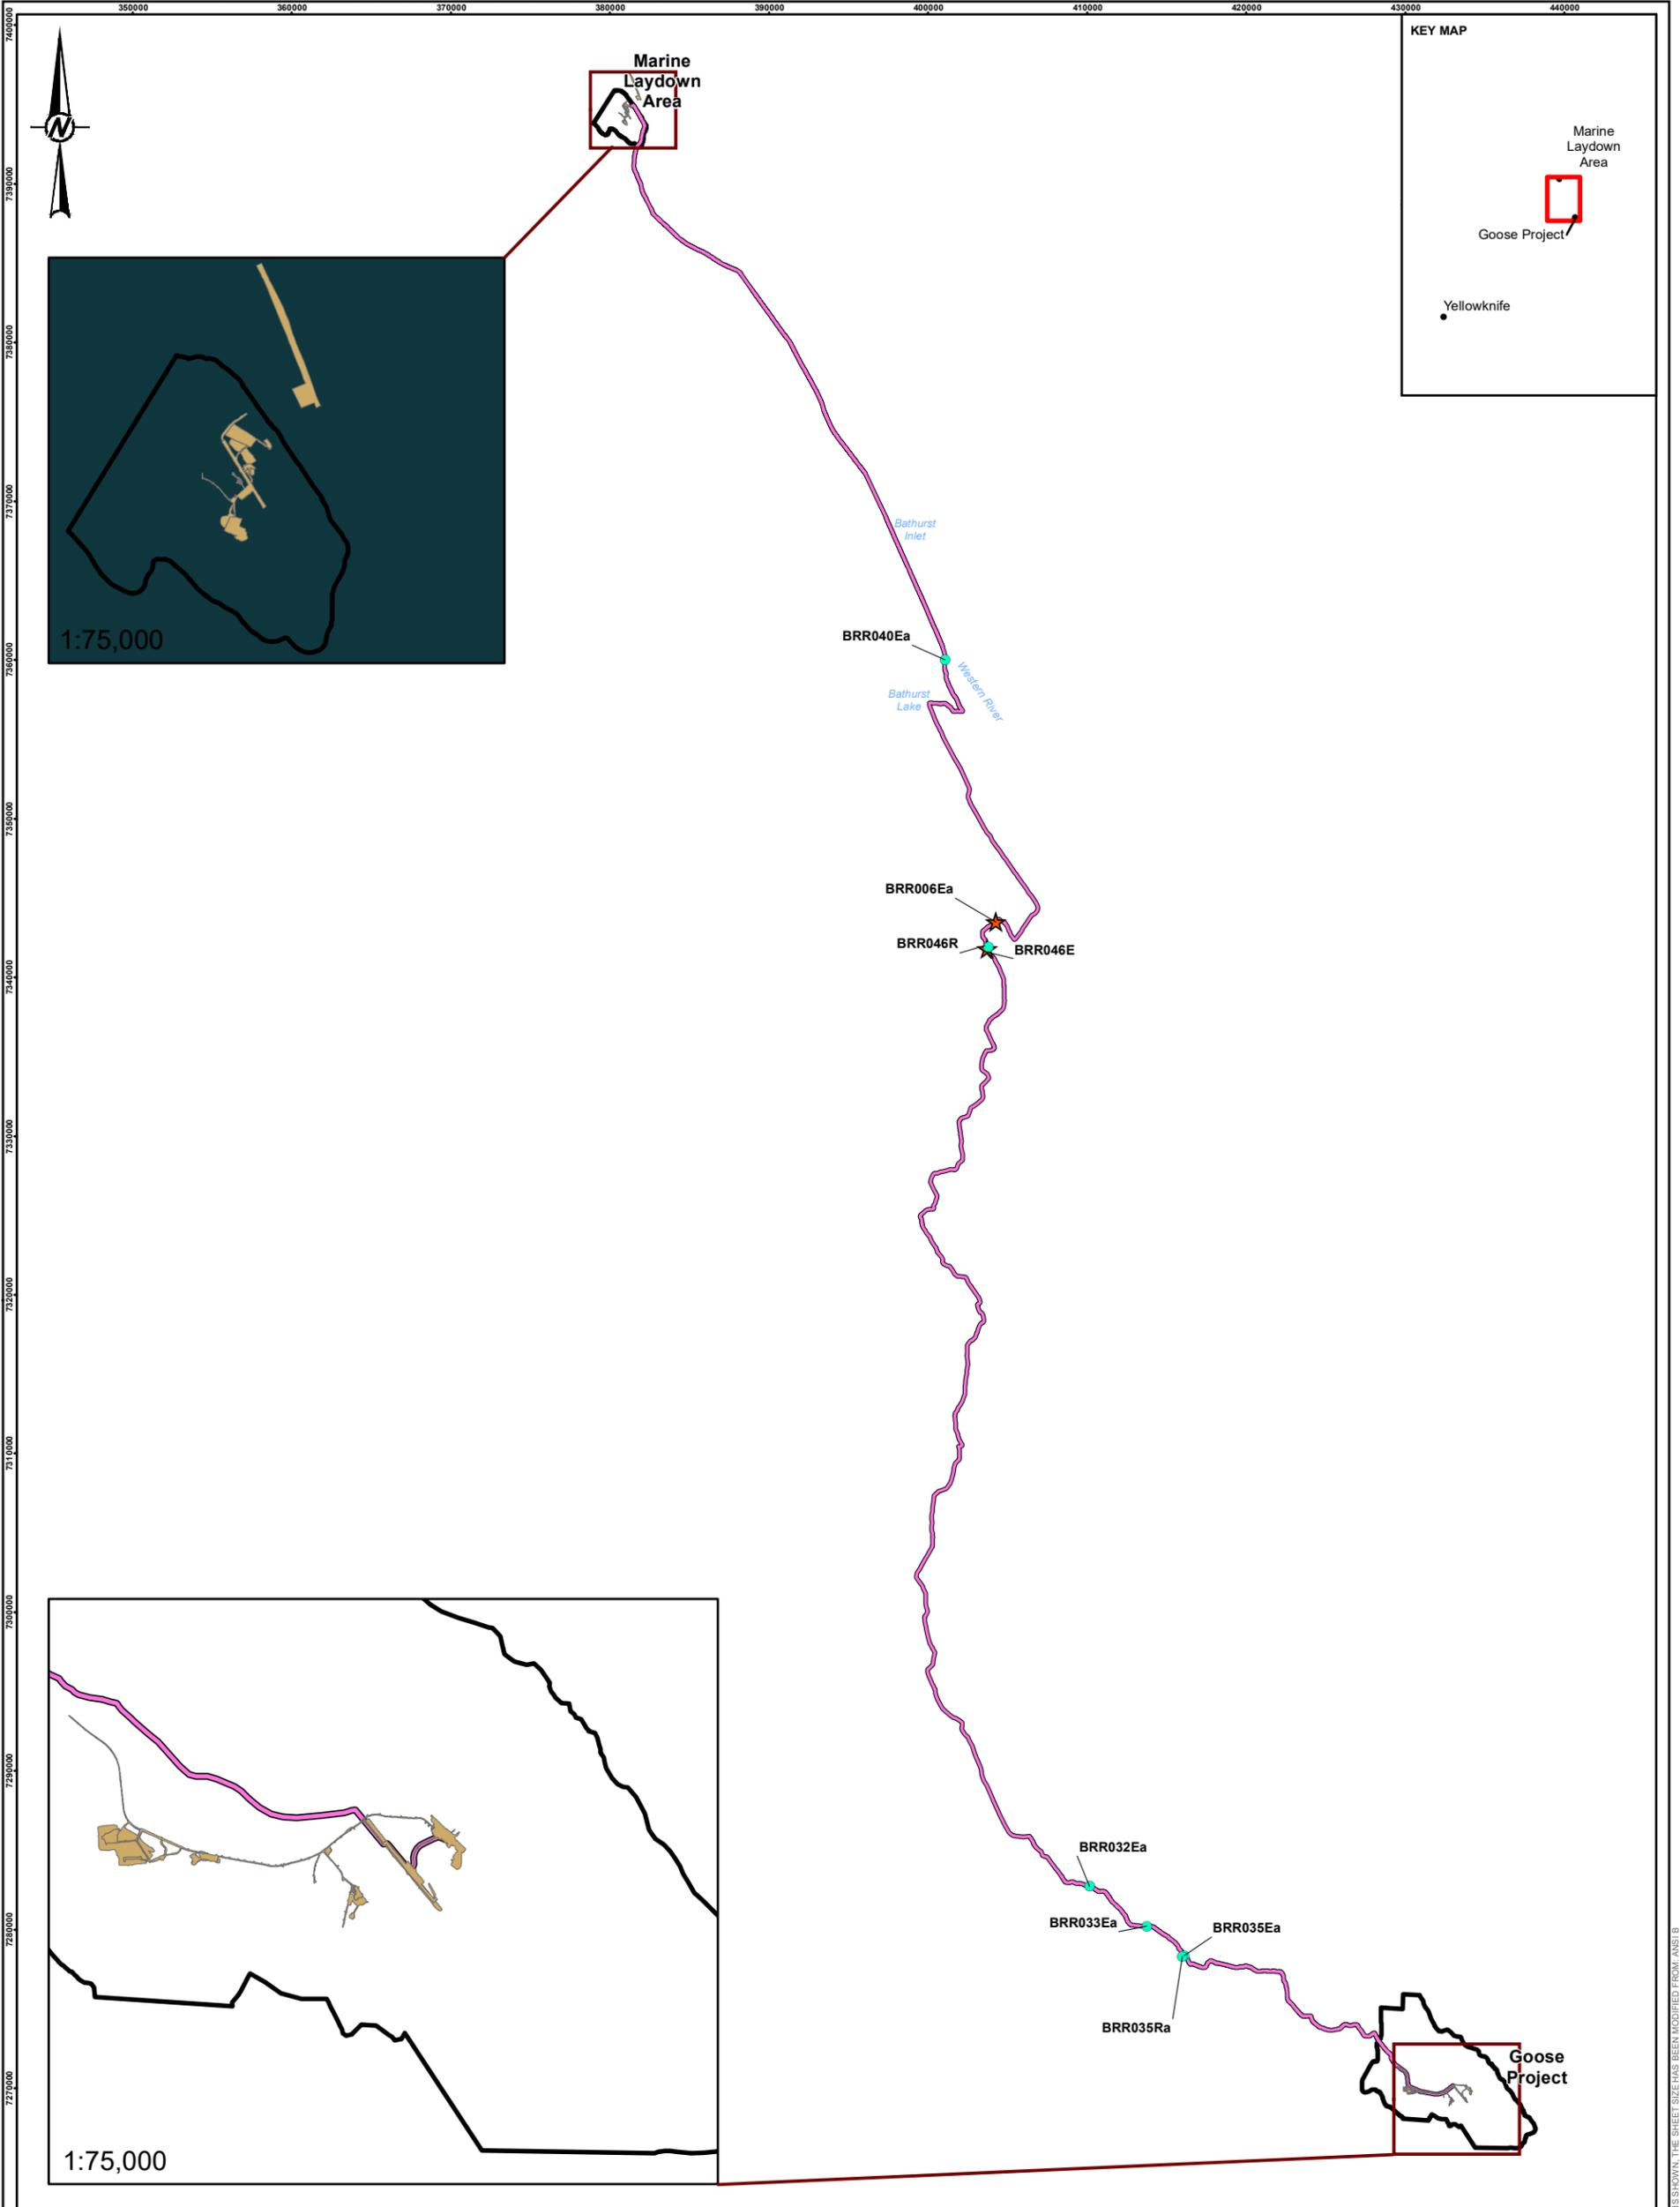
CLIENT	[REDACTED]		
PROJECT	SABINA BACK RIVER PROJECT		
TITLE	FEDERALLY LISTED SPECIES OBSERVED DURING 2022 VEGETATION SURVEYS		
CONSULTANT	YYYY-MM-DD	2023-01-06	
	DESIGNED	CS	
	PREPARED	AM	
	REVIEWED	VC	
	APPROVED	SO

The 2022 vegetation surveys identified 37 vascular plant species in the Project area, of which 35 were identified to species level, one was identified to genus level and one to strata level. A total of 25 non-vascular plant species (7 bryophytes and 18 lichens) were identified during 2022 field surveys. Of these, 22 were identified to species and 3 specimens were identified to genus level. Appendix B provides a complete vascular and non-vascular species list which were recorded during field surveys. The most common and widespread vascular species found were arctic dwarf birch (*Betula nana*), alpine blueberry (*Vaccinium uliginosum*), lingonberry (*Vaccinium vitis-idaea*) and arctic white heather (*Cassiope tetragona*). The overall findings indicate that the majority of the areas surveyed consist of low-diversity vascular plant communities with species richness averaging 20 species per plot. No non-native invasive species plant species were observed during field surveys. However, there were six observed species listed by CESCC (2022) in Nunavut as vulnerable (S3) and one critically imperiled (S1) (Table 2, Figure 3). See Appendix B for species ranking definitions.
