HOPE BAY PROJECT

Proponent's Response to Comments Received on the NIRB 2022 Annual Report

Agnico Eagle Mines Limited

September 2023

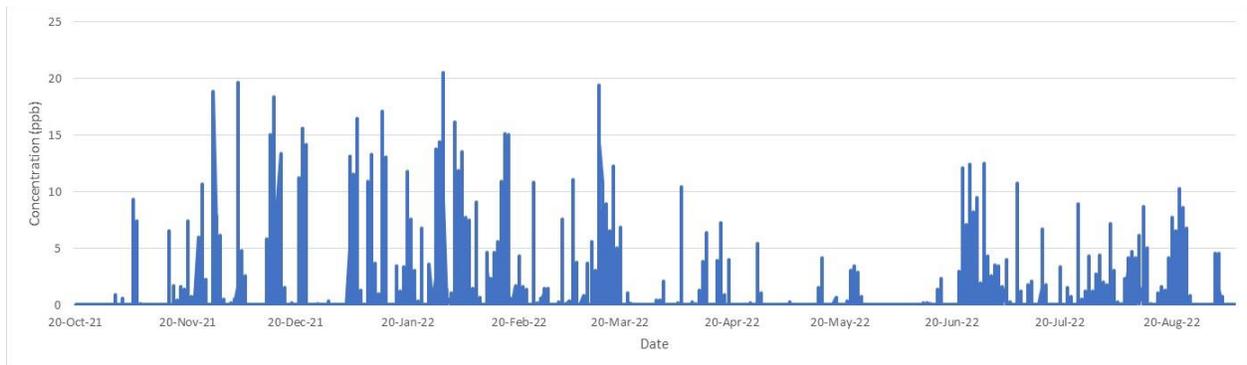
Figure 1 Time History of Measured 1-Hour Average NO₂ Concentrations (Oct 2021 - Sep 2022)

A time history plot of measured 1-hour average NO₂ concentrations for the period October 2021 to September 2022 is presented in Figure 1. NO₂ concentrations were generally low throughout the monitoring period.

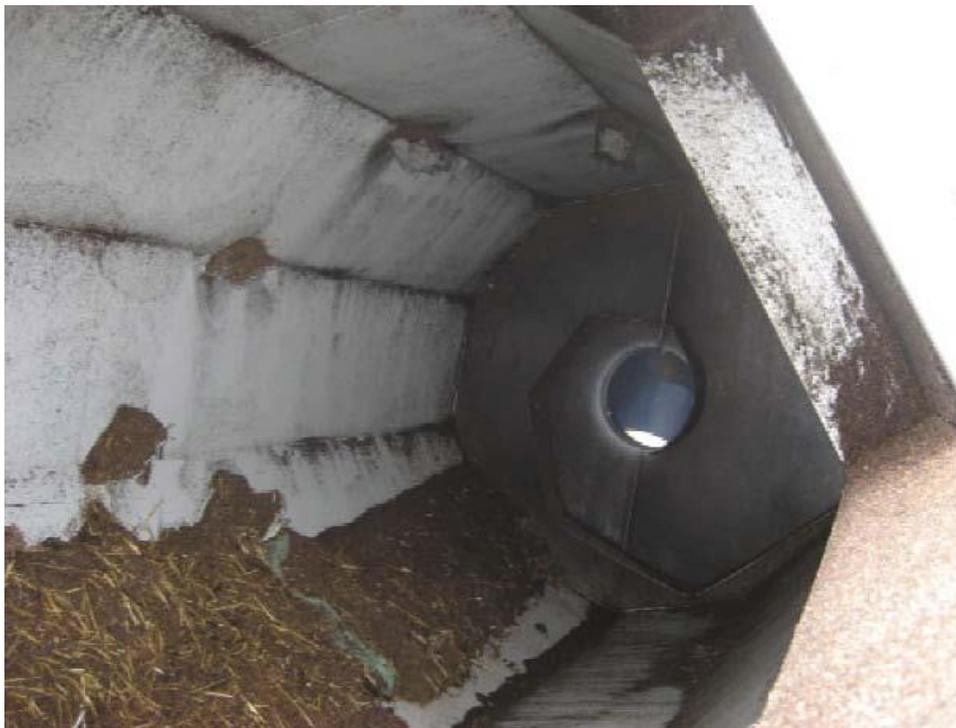
The composter is an insulated cylinder that self-rotates according to the user's pre-set time intervals. These rotations mix the contents while at the same time providing aeration, allowing the bacteria to breathe and break down the organic waste (O.W.) into compost more rapidly than other composting methods. The decomposition process produces heat. The cylinder is insulated with a 1½" insulating material (R 7.5) to preserve heat inside the cylinder during the winter months. The compost is discharged at the cylinder's extremity through an opening that also serves as an air inlet.¹ The rotation intervals and the amount of matter added regulate the amount of finished compost being discharged.

This composter is designed to work year-round, indoors or outdoors, and can compost a wide variety of O.W. In certain extreme conditions, adaptation may be required during the installation process.

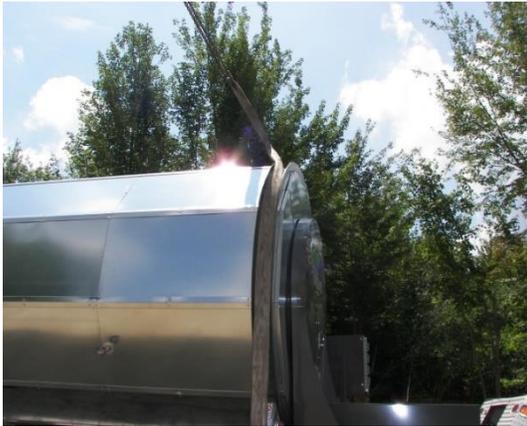
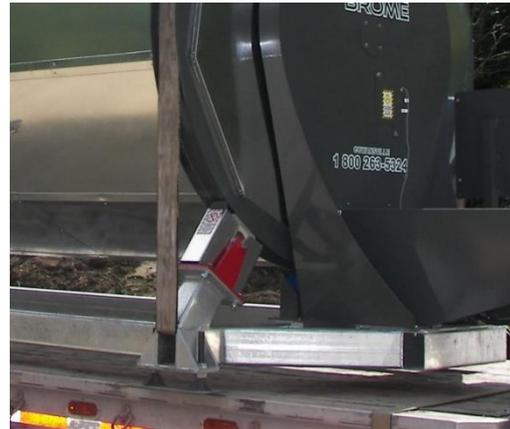
Place the strap firmly around the grooves by passing through the composter's support beams

- Transporting the composter from the manufacturer to the installation site is the responsibility of the client.
- The unloading, on-site transport and installation of the composter are the responsibility of the client. The client is responsible for providing the machinery needed to unload the composter and a foundation on which to place it according to the technical data sheet provided by *Brome Compost*.

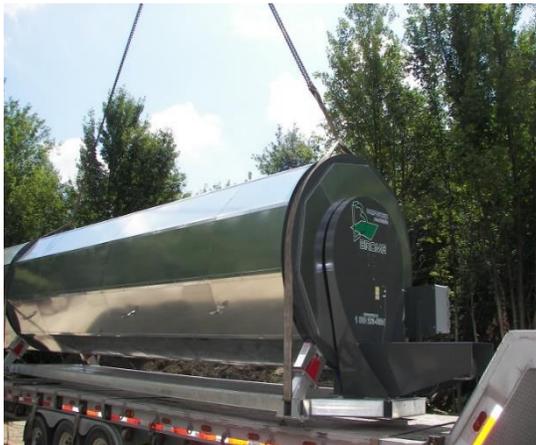
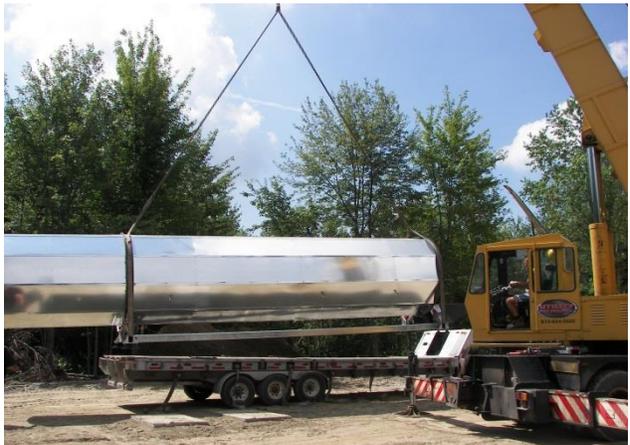
Lift the composter with the appropriate lifting equipment (ensure that the composter is empty first).

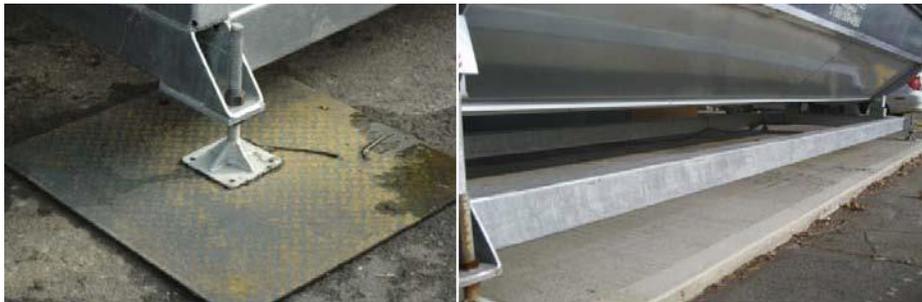
The client is responsible for choosing the layout for the composting site and providing the correct type of surface required for the equipment, as specified by Brome Compost. The composter must be installed on a flat and level surface. The surface or structure must be strong enough to support the composter with its full load and ensure it stays level at all times. For example and for information purposes only, a concrete slab or steel plate can serve as a foundation depending on the type of soil underneath it.

When the composter is used with mechanized loading equipment (e.g. a bin lift), we recommend securing the composter to the ground with an appropriate anchor depending on the type of surface it is resting on.

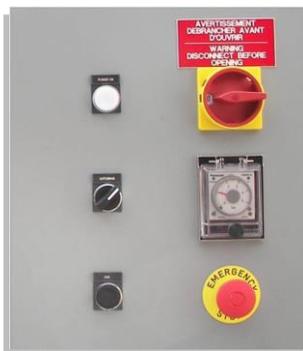
Figure 2 -- Brome Composter Control Panel

1. Ensure that the emergency stop button is in the OFF position;
2. Wear personal safety equipment such as a mask, safety goggles, gloves;
3. Ensure that the doors are open facing the operator
4. If necessary, use a platform to ensure a safe and ergonomic operation
5. Verify that the composter is free from all possible collisions with equipment or work tools when it is rotating

Always make sure the emergency stop button is pulled
(i.e. the composter is working) after each use.

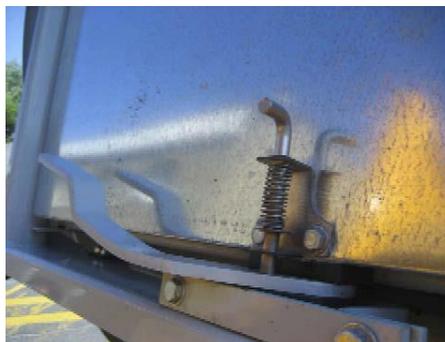
Sliding door:

Unlock the door padlocks (on both handles) if you have this option. Pull the door locks at the same time as you pull on the handles. Pull on both handles alternately for ease of opening. When the handles are completely free, slide the door to the right.

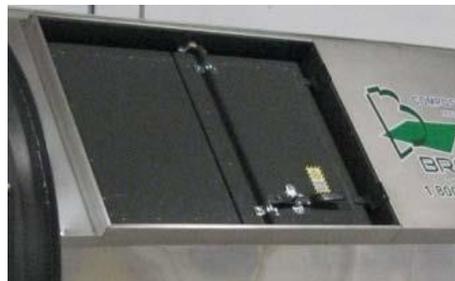
Out-swing doors:

Unlock the door padlock (located on the handle) if you have this option. Pull the handle slightly up and then towards you. Open both doors by pulling them towards you.

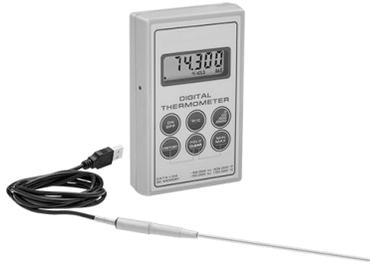
Figure 3 -- Composter Thermometer

Temperature is the best indicator of how the composting process is working and it is crucial to monitor it daily. The best temperature range for aerobic composting is between 45°C and 70°C².

- To read the temperature, check the thermometer(s) on the cylinder.

Using a portable thermometer is recommended for taking temperature readings at various locations through the door opening, especially during the initial start-up phase.

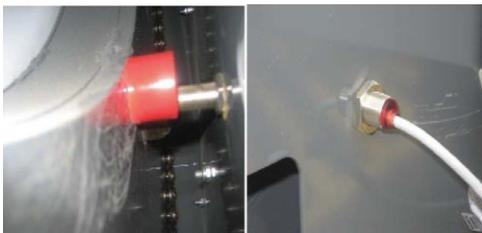
Figure 5—Red Magnet

- Press the red emergency stop button on the composter before you work on or near it.
- Unscrew the panel located to the side of the control box
- When you look inside the composter, on the right-hand side, you will see a red magnet. The magnet stops the composter after a full rotation when it passes in front of the sensor. Remove the magnet and put it aside.
