Re: Back River Project Update 2023

Please find a Back River Project Update for 2023 enclosed as requested. A construction update is provided as well as an update on key Project Certificate No. 007 term and conditions monitoring.

Project Certificate Term and Condition Update (key points from postponed NIRB 23’ inspection):

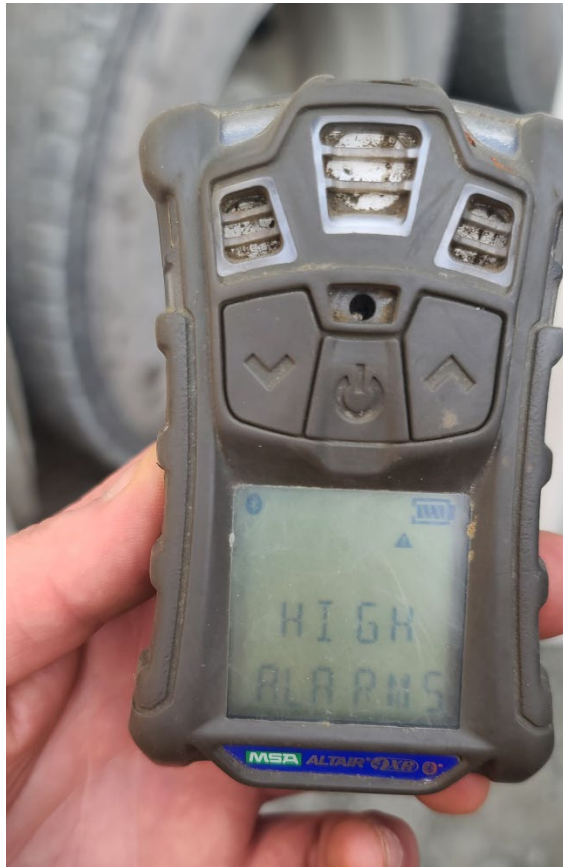
- Vegetation monitoring program sampling efforts were completed in August
- **Any mitigation measures for air quality (TC 2)**
 - Underground air quality mitigation measures are in place to protect the health of employees

Figure 2. Underground air quality monitoring device.

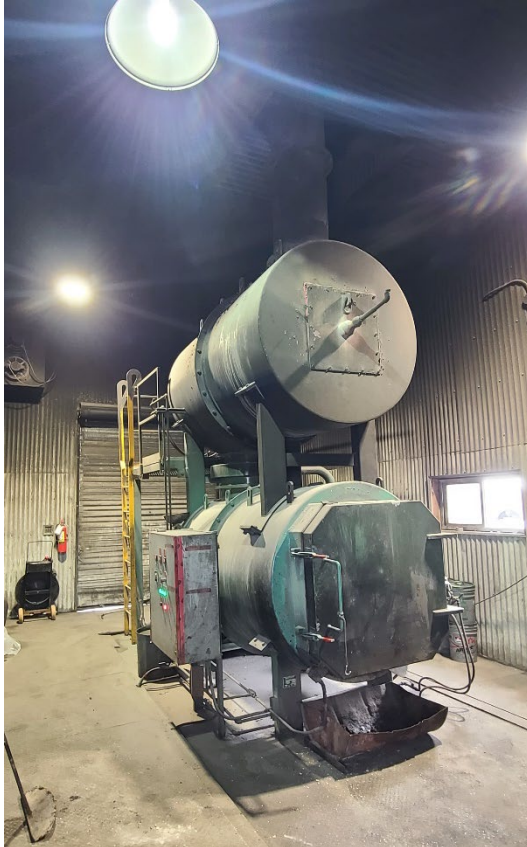
Figure 3. Active incinerator and waste management facility

- Waste management has improved sitewide over the past year. This has been achieved by interdepartmental collaboration and communication, education (toolbox meetings), waste audits/ inspections, improved signage, and dedicated waste management areas. We have purchased and are utilizing several 5-yard bins at our waste management areas to accommodate waste volumes. The environment team continues to work with our site services team to improve signage and communication with all relevant parties to ensure smooth and compliant waste management. Environment staff have made a point of attending several toolbox meetings on both shifts to answer questions, understand working group needs, and re-enforce waste management requirements on site.

- **How stack testing works, still no stack testing done (TC 5)**
 - Stack testing will be completed in 2024 when the new incinerator and new camp are commissioned

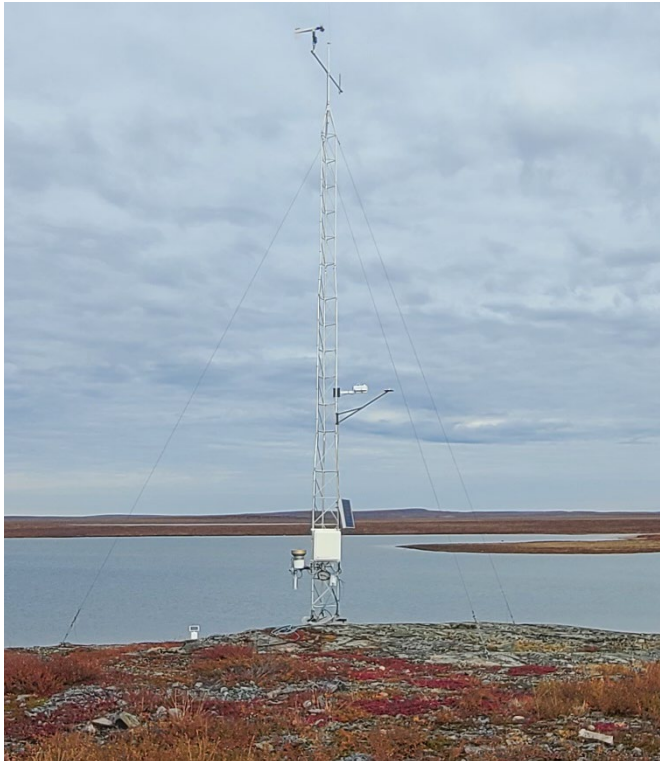
- **Any GHG reduction modification (TC 6)**
 - Heat recovery initiatives (waste oil furnaces)
 - Vehicles are driven at designated speeds and regularly maintained to ensure optimal fuel efficiency
 - Complete burns in incinerator at manufacturer recommended temps
 - Renewable energy center application
 - Process plant design, powerhouse, nothing but waste heat recovery – that’s how we heat that building
- **Local weather monitoring (TC 8)**
 - Weather monitoring completed 365 days, 24/7
 - Monthly downloads

Figure 4. Active meteorological station

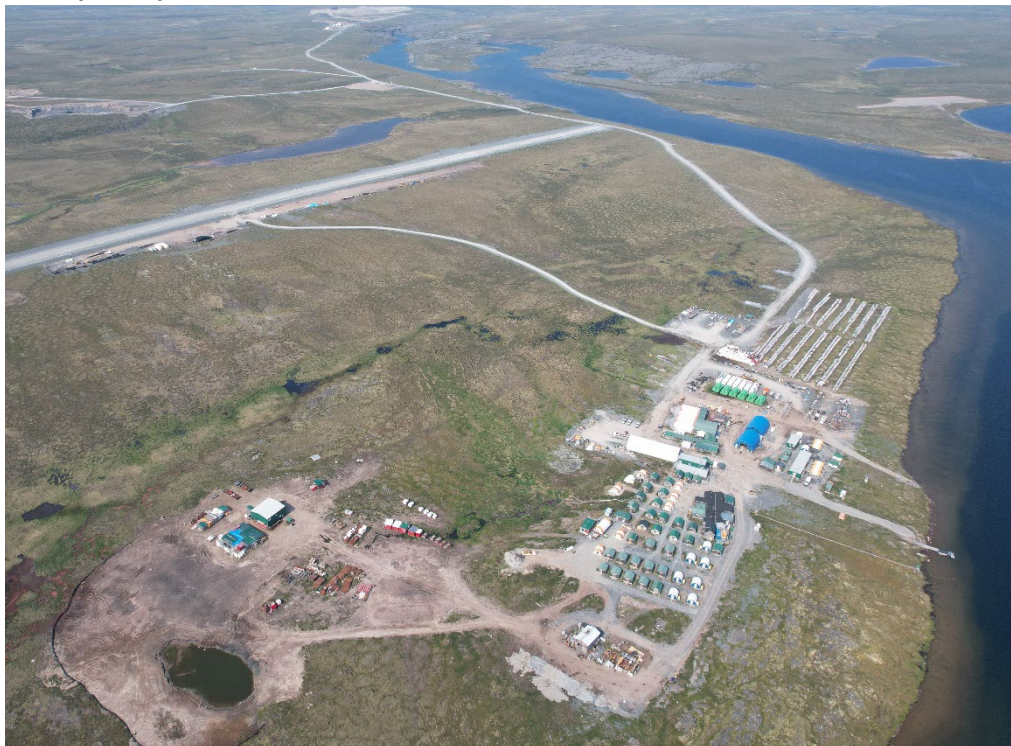
Figure 5. Borrow site in top right of photo

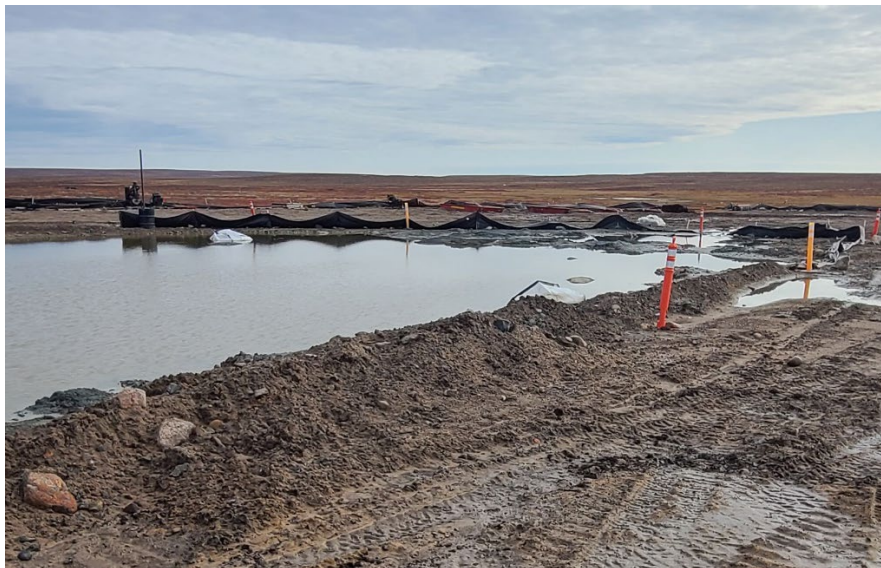
Figure 6. Sedimentation fence installed at exploration cuttings sump

- B2 Gold understands the importance of surface water monitoring and sedimentation control and mobilized third party consultants (WSP) onsite during construction of the RSW culvert specifically to monitor turbidity

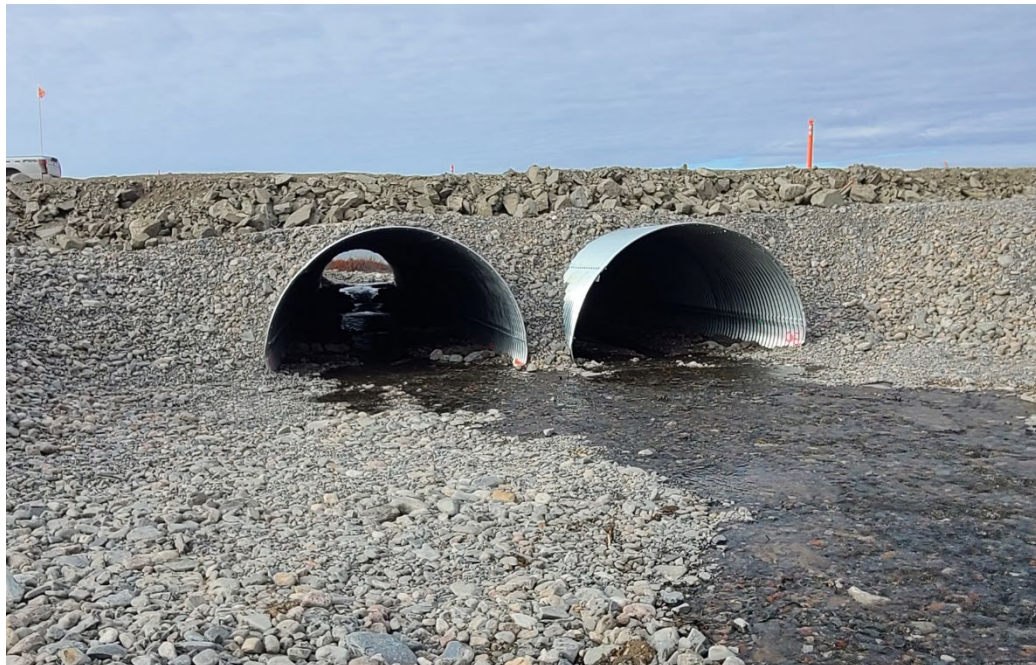
Figure 7. Culvert installation at Gander Outflow

- Weirs were successfully constructed in 2022 upstream of the water crossing to reduce and mitigate velocities that could impede fish migration
- Fisheries and Oceans Canada (DFO) were on site in 2023 and viewed the installations as well as reviewed the plans in advance of 2022 construction

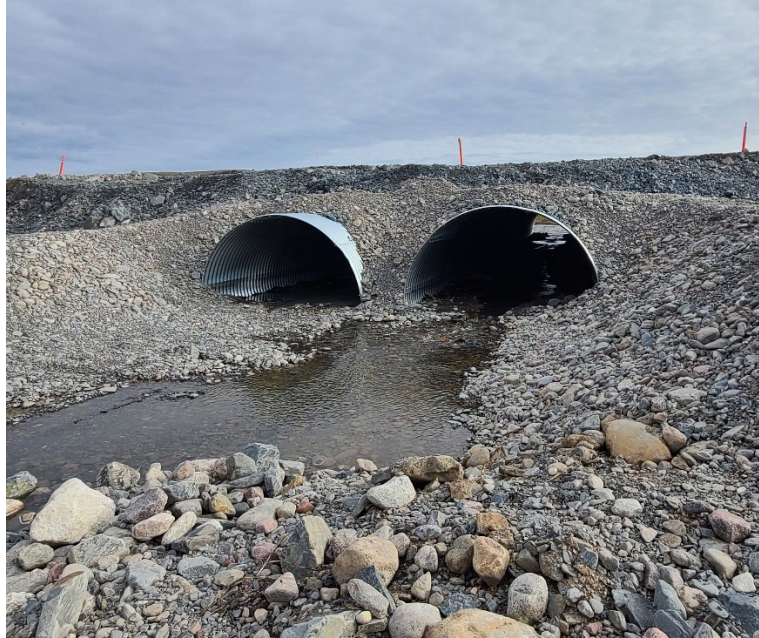
Figure 8. Culvert installation at Gander Outflow

- Monitoring occurred in 2023 by third party consultants (WSP), and those results will be provided in the 2023 annual report
- During 2024 freshet, B2 Gold will again have third party consultants (WSP) on site and this plan has been reviewed with DFO
