Summer 2022 Work completed and results obtained by Ausenco

2022 Field Program Summary Report – Angilak Environmental Baseline Monitoring Program

Project No. 106892-01

February 8, 2023

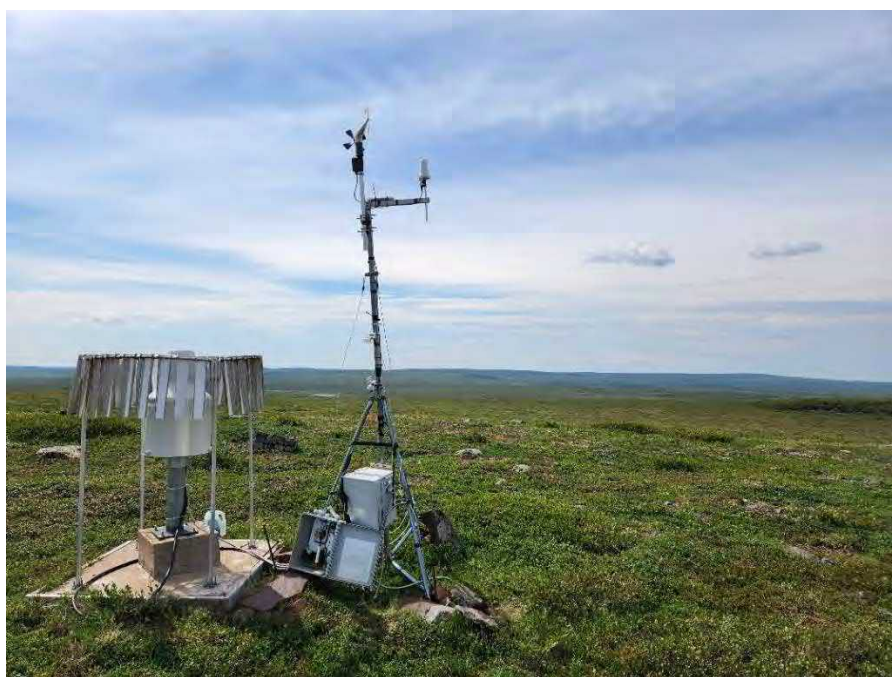
Photo 3 Rain gauge (left) alongside the climate station (right).

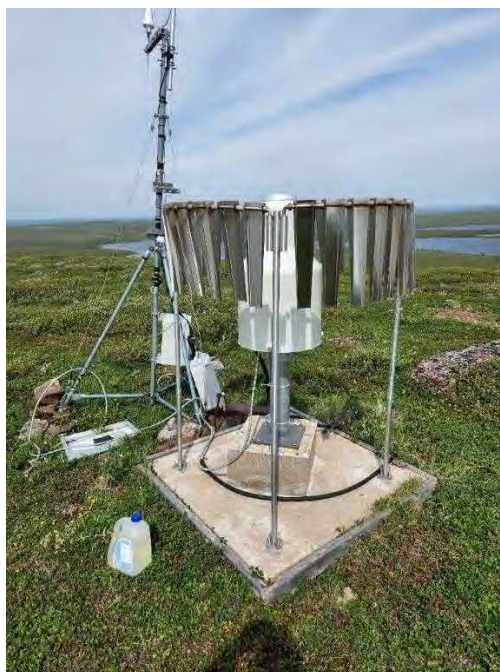
Photo 4 Rain gauge close up.

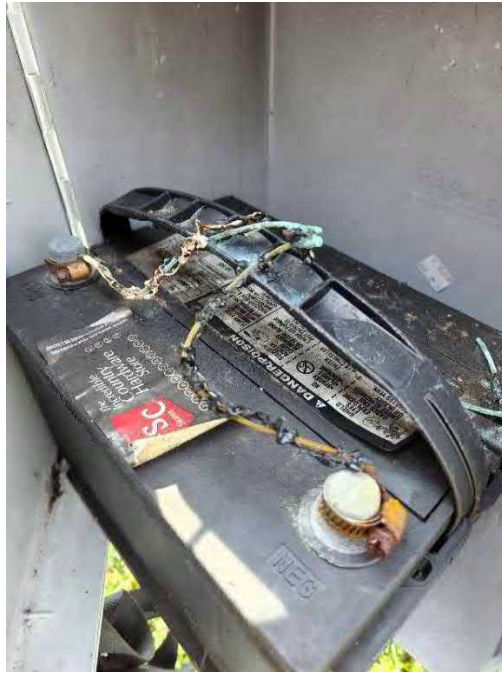
Photo 5 Climate station battery.

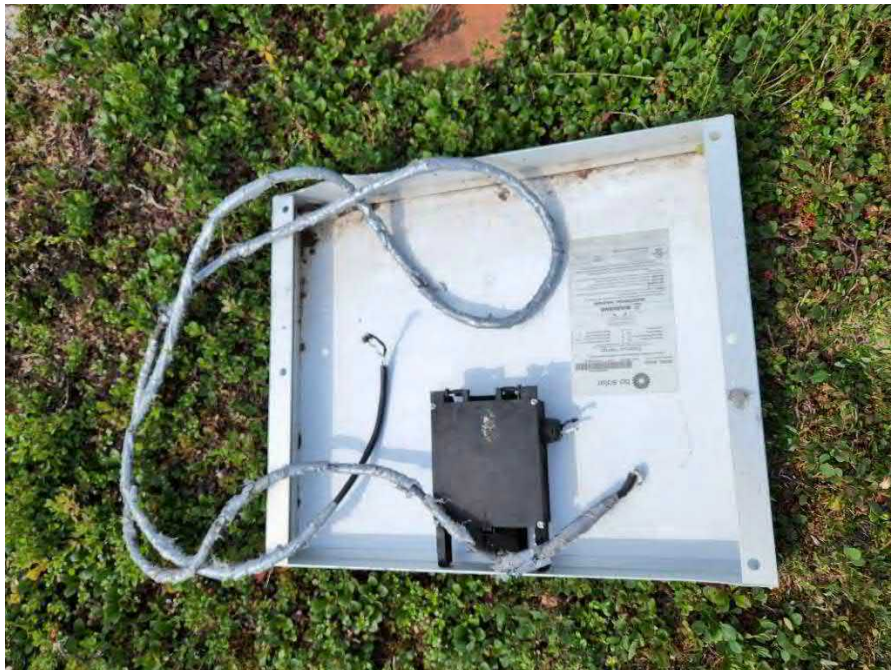
The climate station is in degraded condition. The HOBO logger external box was found detached from the climate station stand. The box door was partially ajar, exposing all electrical components within the protective box to weathering. Water has penetrated the logger box, impacting the logger, the satellite communication chip, and all connecting wiring leaving visible corrosion on all electronic components. The rain gauge is in good visual condition, but external wires linking the rain gauge to the weather station are severed. The solar panel is detached from the station and connecting wires are severed beyond repair. The solar radiation sensor cable is frayed and beyond repair. Battery cables are severed beyond repair and the battery is not in working condition. The temperature sensor cables are severed and beyond repair. The humidity or the barometric pressure sensor is destroyed; identification of which is difficult based on the remaining pieces. The climate station tripod guy wiring is no longer attached to surrounding anchor points and the station is standing askew. A set of representative climate station photos can be found in **Appendix A**.

Photo 6 Climate station solar panel – wiring has been severed from station. Upon inspection the panel was not cracked but has been weathered and exposed to harsh climate for a prolonged period of time.

Based on the visual inspection of the climate station, the station will require new parts including cables to each sensor, relative humidity and barometric pressure sensors, logger, sat-com link chip, battery, solar panel, guy wires and anchors, and a logger external box. The rain gauge appears to be in good physical condition, as does the tripod climate station stand. Ausenco proposes two options going forward with respect to getting the station operational:

Given the remote location of the Site, difficulty gaining access and short field season, Option 2 would be the most practical as it would be more likely for the climate station to be operational during the next field visit. See **Appendix B** for a quote from Hoskins Scientific to build a new weather station totalling **\$17,518.00**.

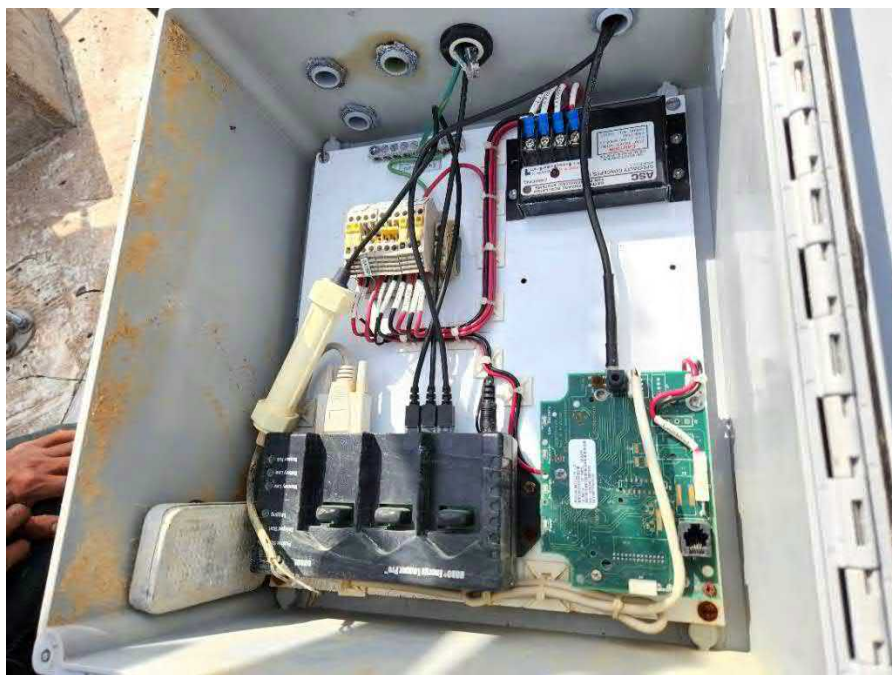
Photo 7 Inside logger box. HOB0 ONSET logger (black) shows significant corrosion damage as does the satellite communication chip (green).

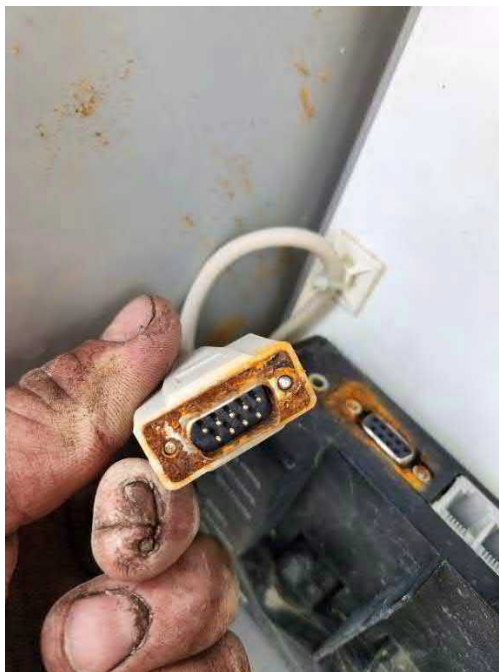
Photo 8 HOB0 logger corrosion from being exposed to elements over prolonged period of time.

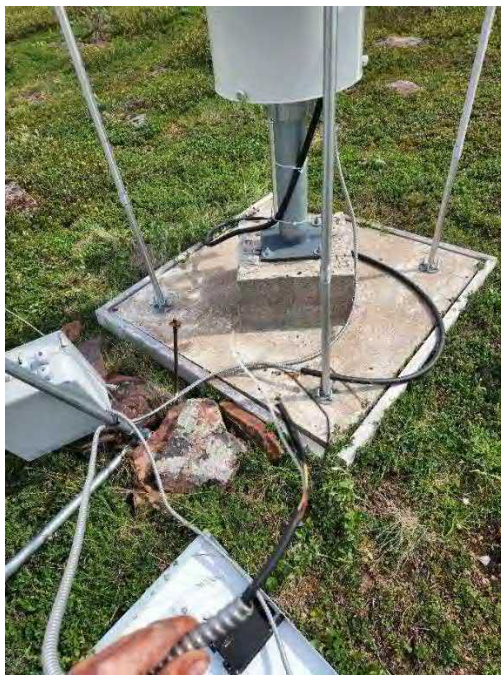
Photo 9 All logger sensor cables have been severed and destroyed over time.

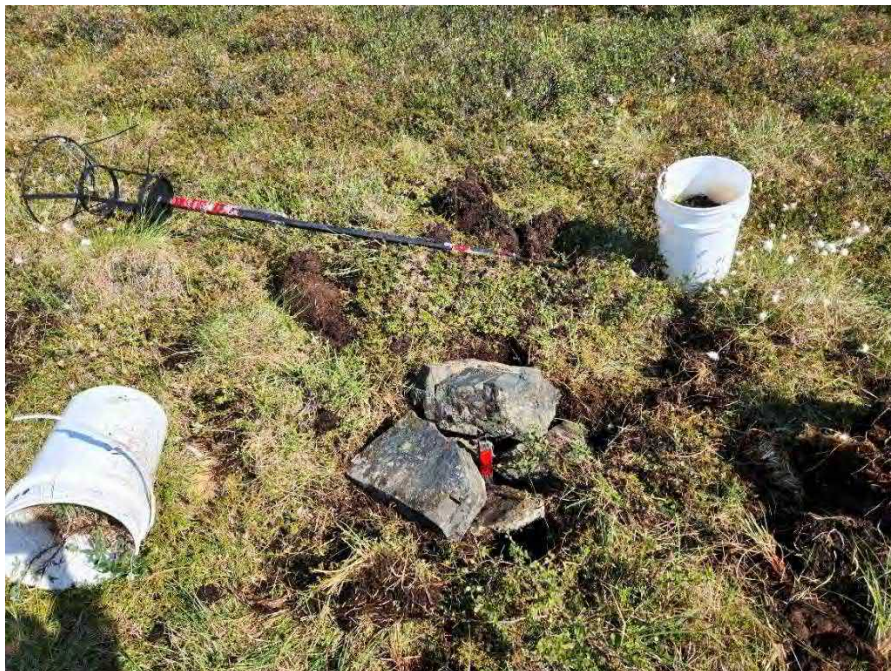
Photo 10 Dustfall installation process. Dug down to permafrost and laid a rock foundation. Station was then erected and as dirt / rock mound was laid for support.

Site ground conditions consisting of bedrock and permafrost make it difficult to establish permanent dustfall collection stations. The 2022 program followed the method to erect the stations used in monitoring programs before it: Dig down to permafrost and use rocks and overburden to keep the dustfall stations erect. However, during the 2022 program, a dustfall station was found to be knocked over. The cause is undetermined. To overcome this problem Ausenco suggests that the stations be cemented into five-gallon pails with quick setting concrete and placed into the overburden as deep as permafrost would allow. This would add stability to each station and decrease the risk of sample disruption from weather events.

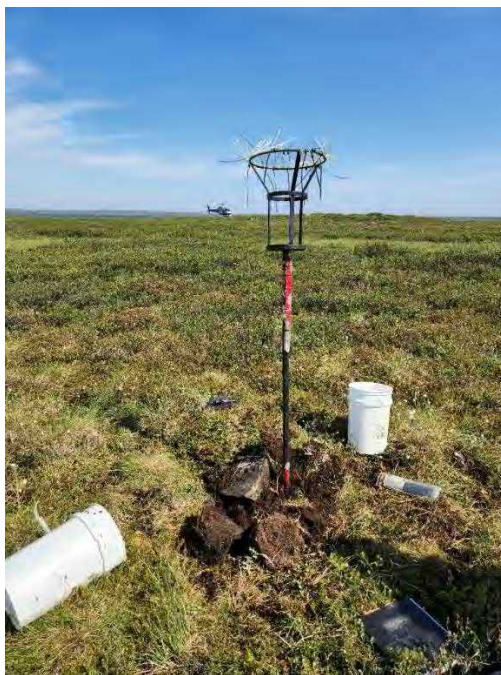
Photo 11 Erected dustfall station. Should the monitoring program continue, it is recommended that the stations be cemented in a 5-gallon pail and the pail be buried to permafrost.

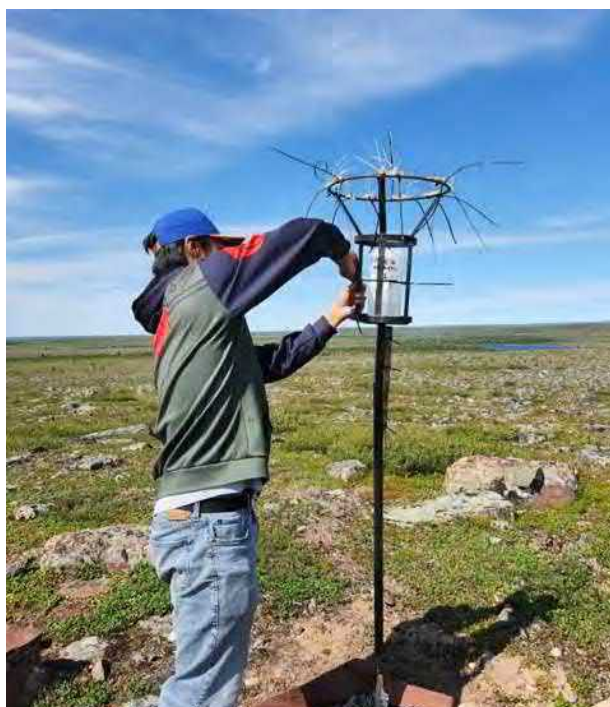
Notes: The lowest dustfall detection limit ALS can analyse is 0.11 mg/dm²/day. Low concentrations of total particulates at DF1 are likely attributed to the station being knocked over during the sampling period.

Photo 15 Dustfall station 1.

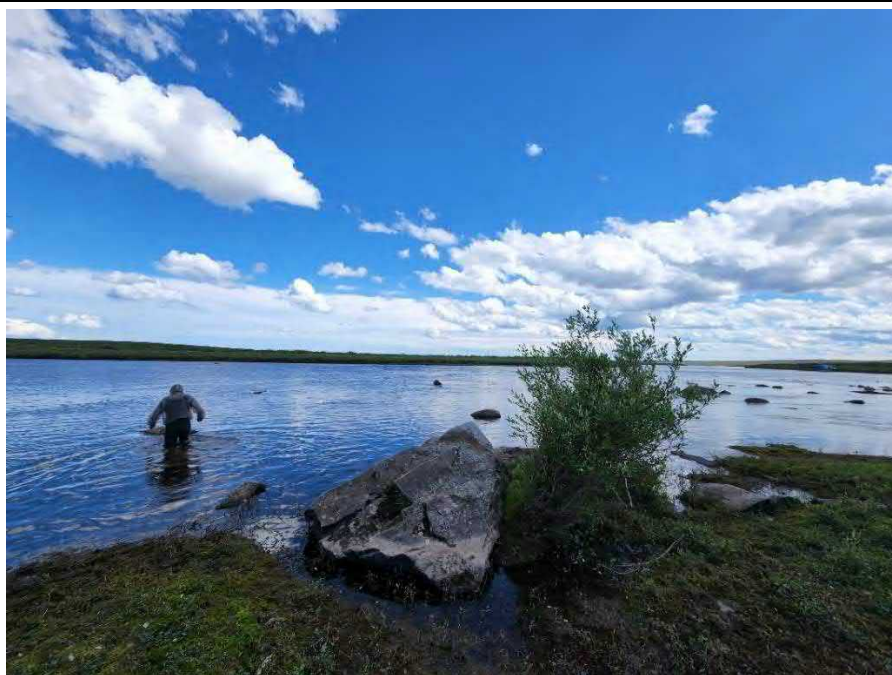
Photo 23 No flow collected at proposed hydrology station S1 due to wide waterway and deep water. This station will not be re-visited unless water levels drop significantly.

Ausenco recommends that each waterway should be further assessed throughout the project operating season to determine the flow method that would produce the highest accuracy. A tracer method such as salt dilution gauging can be used in response to seasonal water fluctuations (low water late in season). Each hydrology station can be assessed prior to conducting a flow measurement; should water levels not allow for an accurate velocity by area measurement, a salt flow may be feasible.
