Granular Materials Resource Study, Hamlet of Taloyoak, Nunavut

Draft

OTT-24008122-A0

December 12, 2024

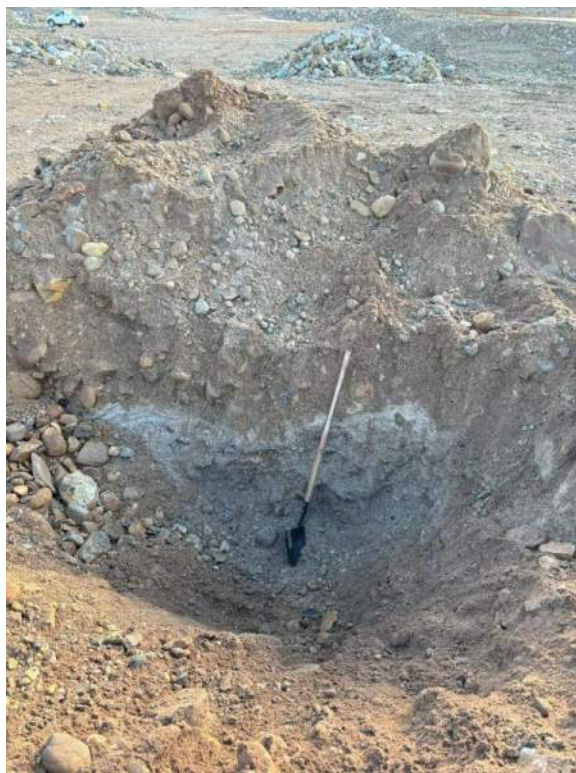
Photograph 5: Test Pit 2, Site 3, sand and gravel with cobbles and boulders

A total of fifteen (15) test pits were excavated in this area to a depth of 0.6 m to 2.3 m. In all the test pits, refusal to excavation with a rubber-tired backhoe was met on permafrost. The exception to this is Test Pits 3-13 and 3-14. In Test Pit 13, boulder rubble fill was encountered to 1.2 m depth with water table at 0.6 m depth. In Test Pit 3-14, boulder rubble fill was encountered at 0.6 m depth with the water table at 0.3 m depth. It is likely that this area was at one time used to extract sand and gravel and the excavation was backfilled with oversized boulders and rubble. In addition, it was observed that this site contained ten large stockpiles of granular material approximately 1.5 m to 3.0 m in height and approximately 20 smaller stockpiles. The dimensions of these stockpiles were estimated to facilitate computation of their volume. (Photos 5 to 14)

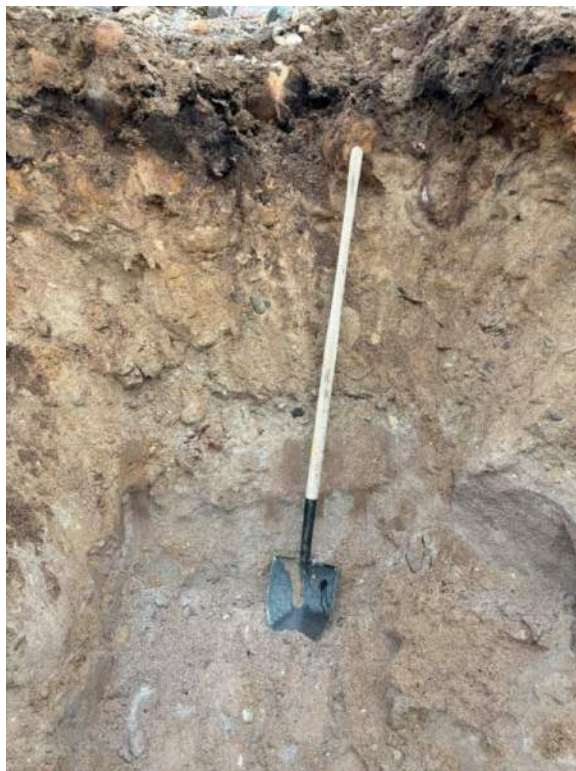
Photograph 7: Test Pit 3, Site 3, sand and gravel with cobbles

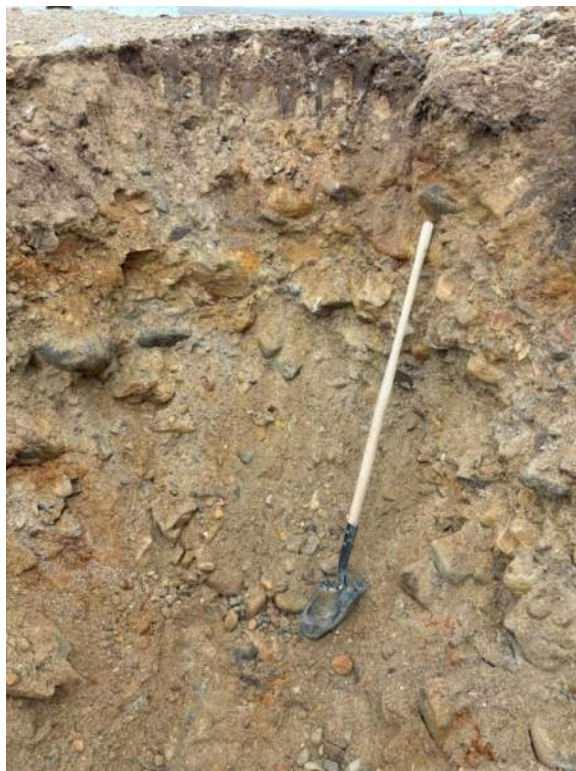
Photograph 9: Test Pit 7, Site 3, view of test pit wall

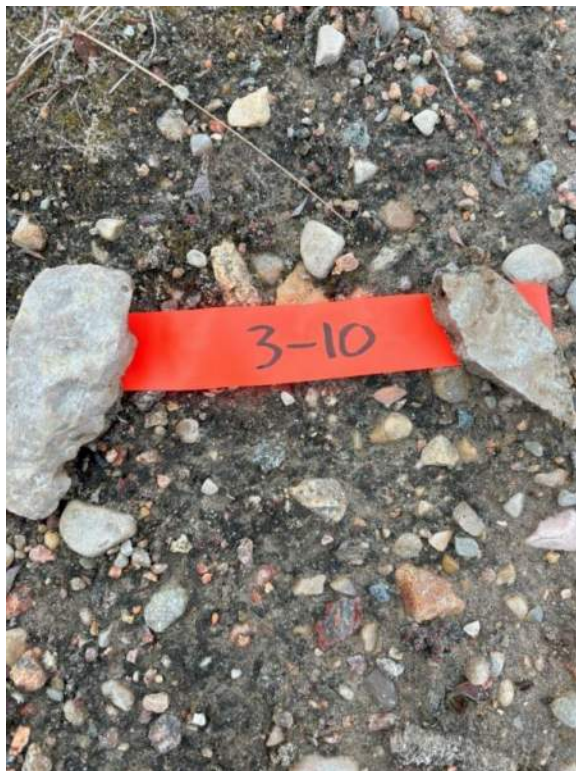
Photograph 11: Test Pit 10, Site 3, close up view of material in test pit

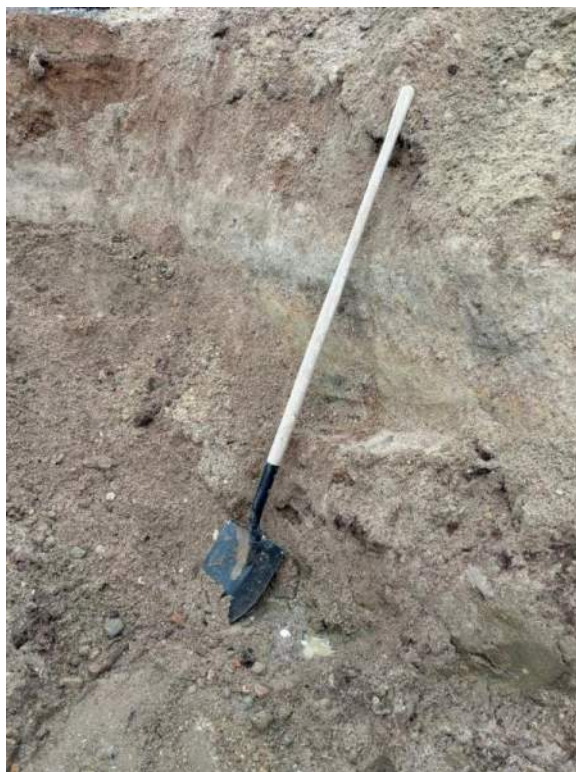
Photograph 12: Test Pit 10, Site 3, view of test pit wall

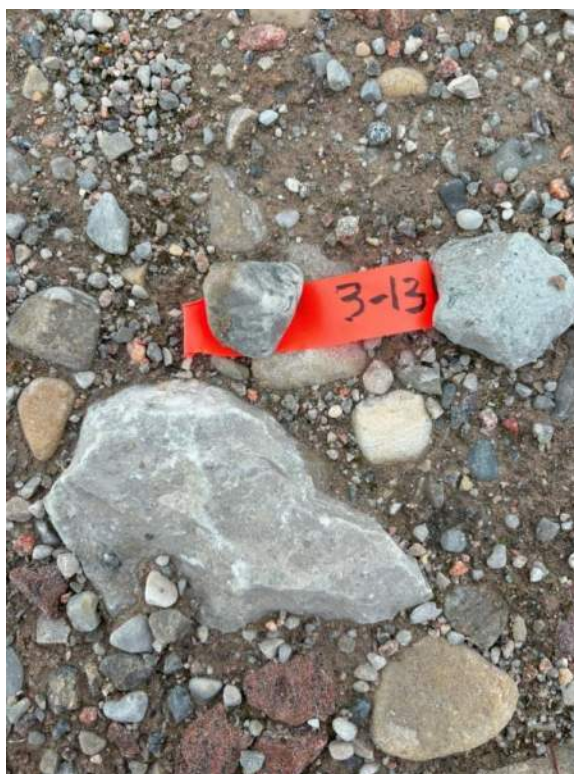
Photograph 14: Test Pit 13, Site 3, close up view of material in test pit

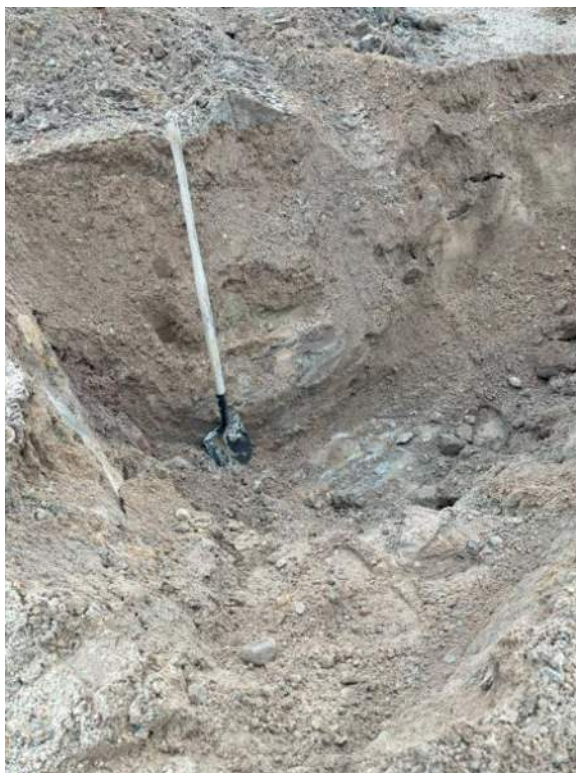
Photograph 15: Test Pit 1, Site 4, view of test pit wall

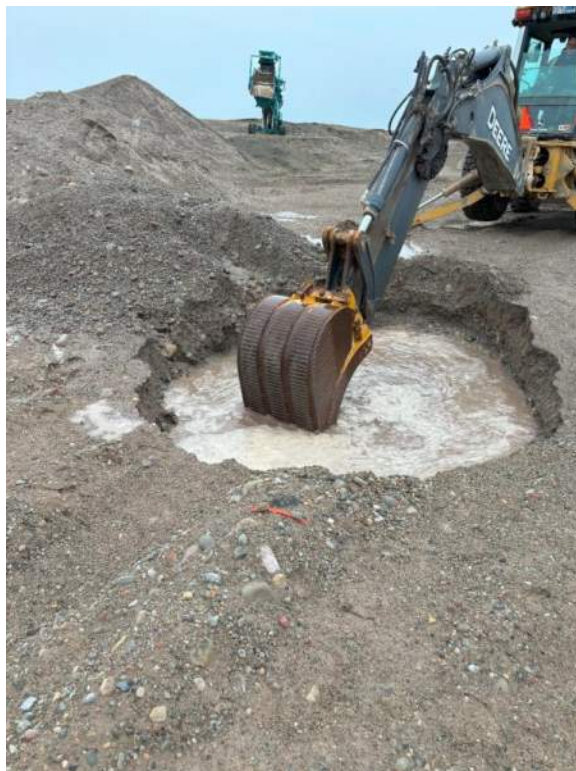
Photograph 17: Test Pit 2, Site 4, test pit excavation in progress. Note high groundwater table.

The fine sand to silty sand stratum comprised of 34 percent clay and silt, and 68 percent sand. This stratum was also non-plastic. It had a moisture content of 15.9 percent. Water level was recorded at a depth of 0.3 m in Test Pit 4-2 and at 1.5 m depth in Test Pit 4-3.

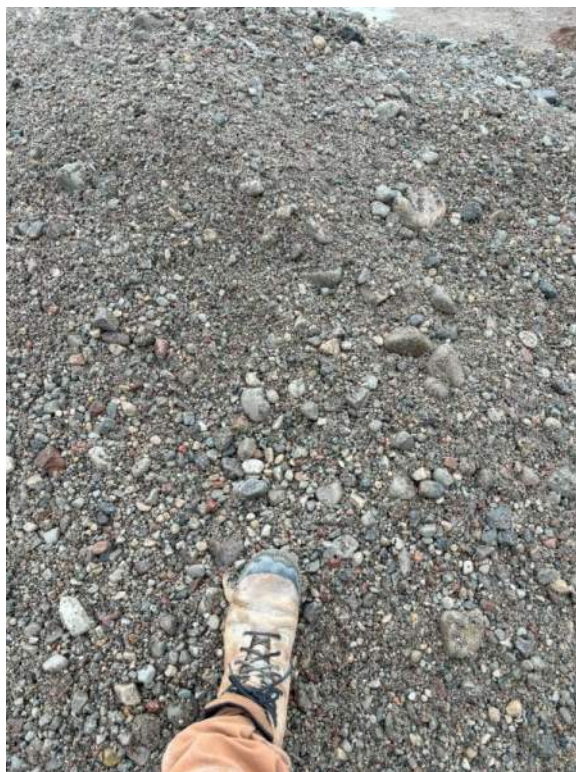
Photograph 18: Test Pit 2, Site 4, close up view of material in test pit

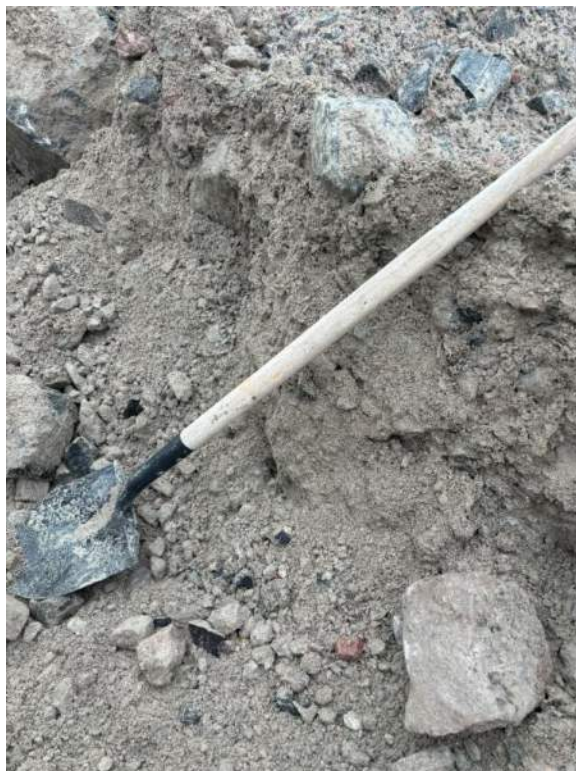
Photograph 23: Test Pit 2, Site 5, partial view of test pit wall

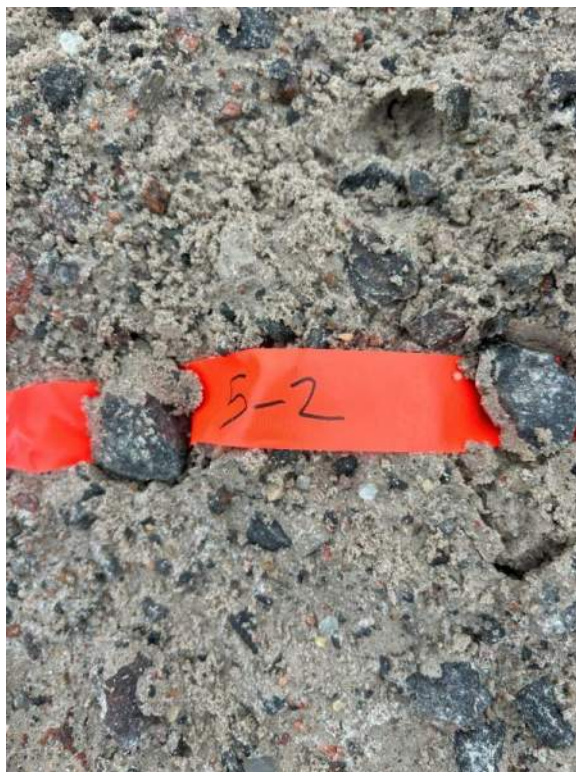
Photograph 24: Test Pit 2, Site 5, sand and gravel with cobbles and boulders

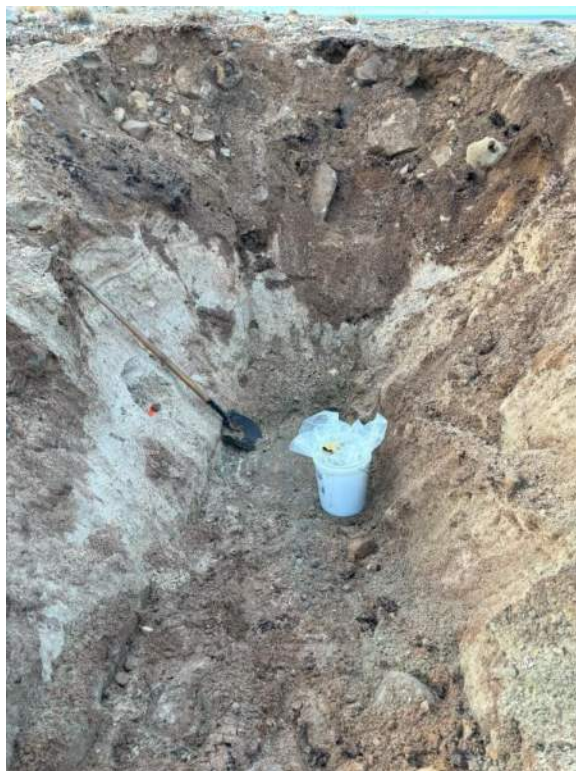
Photograph 25: Test Pit 5, Site 5, lower plateau. Note water in test pit.

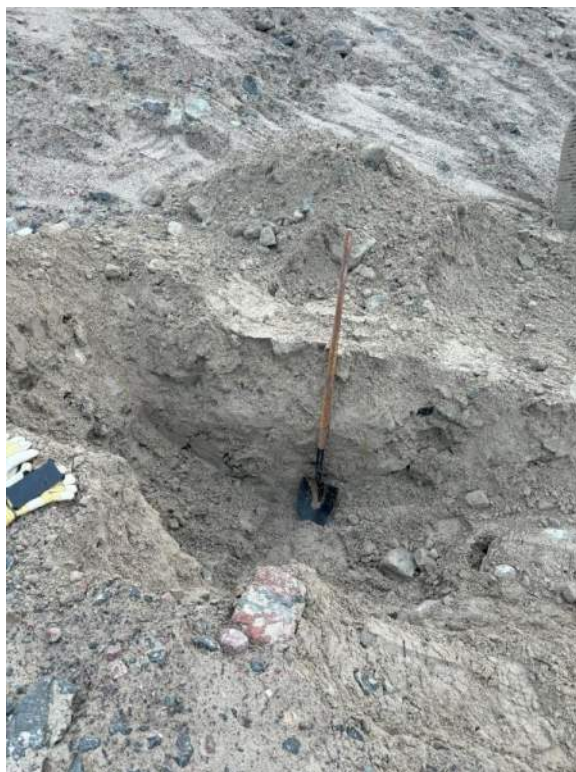
Photograph 26: Test Pit 6, Site 5, lower plateau. View of test pit wall.

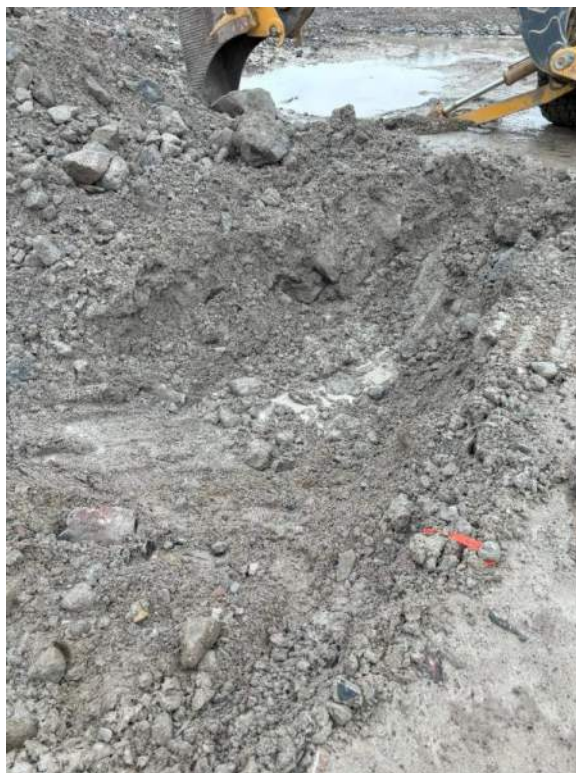
Photograph 27: Test Pit 6-2. Northeast corner of old clay pit

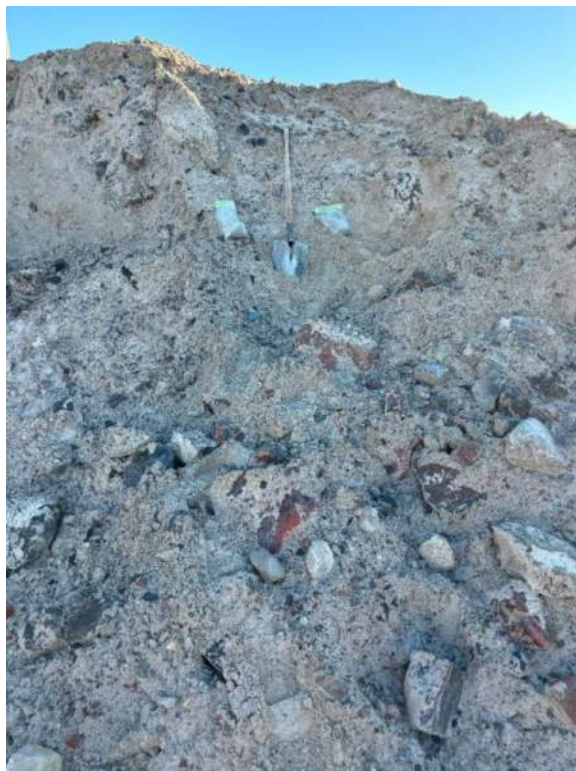
Photograph 31: Test Pit 7-1. Top of berm ridge, upper plateau, sand and gravel

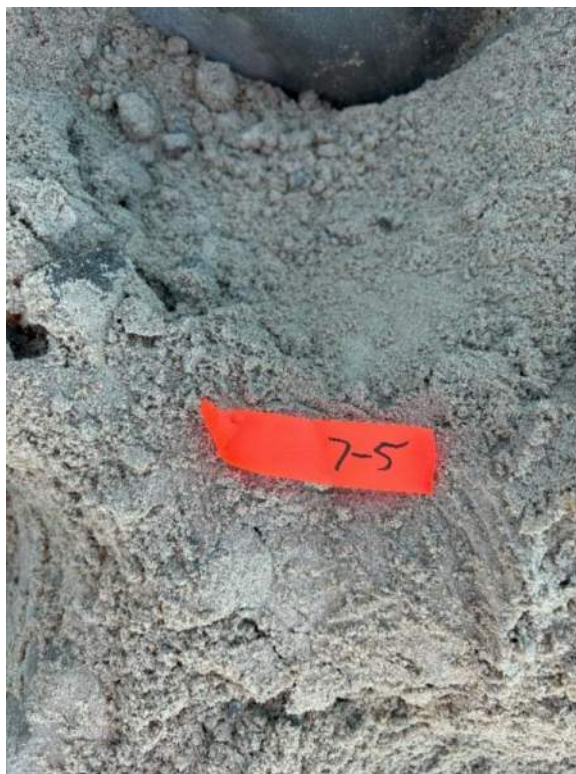
Photograph 32: Southeast Test Pit 5, Site 7. View of test pit wall.

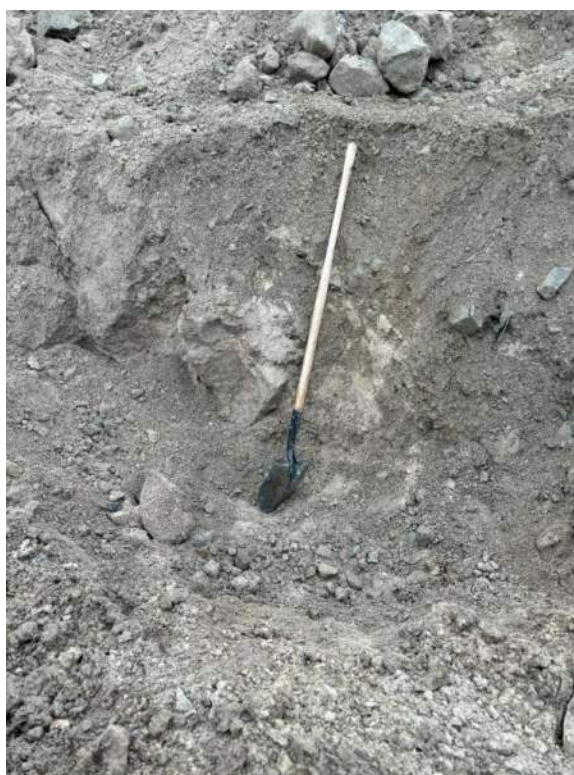
Photograph 34: Test Pit 3, Site 7. View of backfill in clay pit

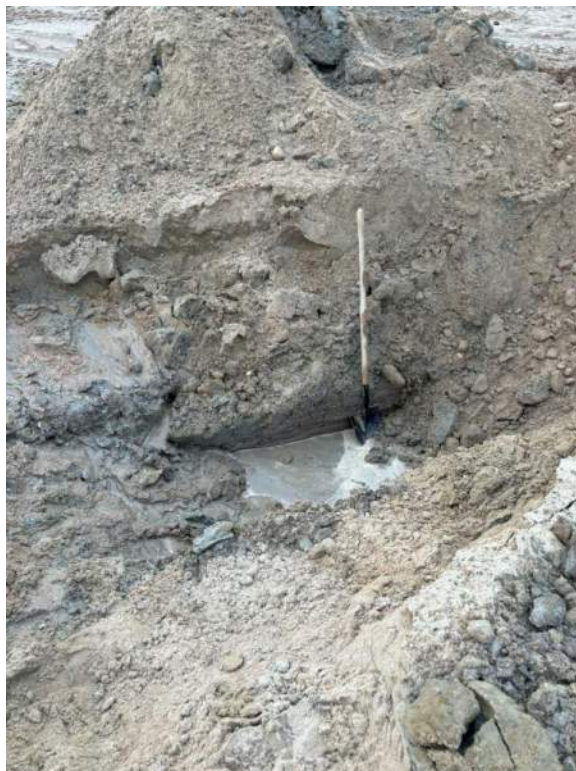
Photograph No. 37: Test Pit 3, Site 8, view of test pit wall

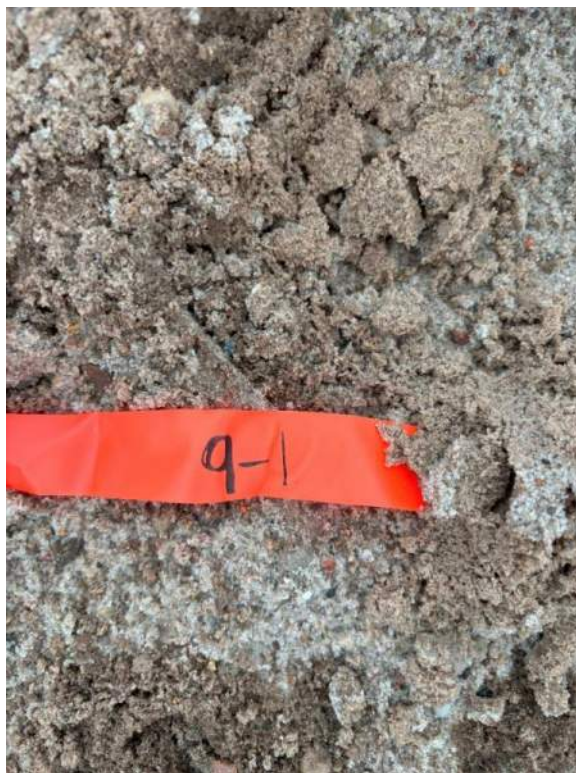
Photograph No. 39: Test Pit 1, Site 9, close up view of sample from test pit

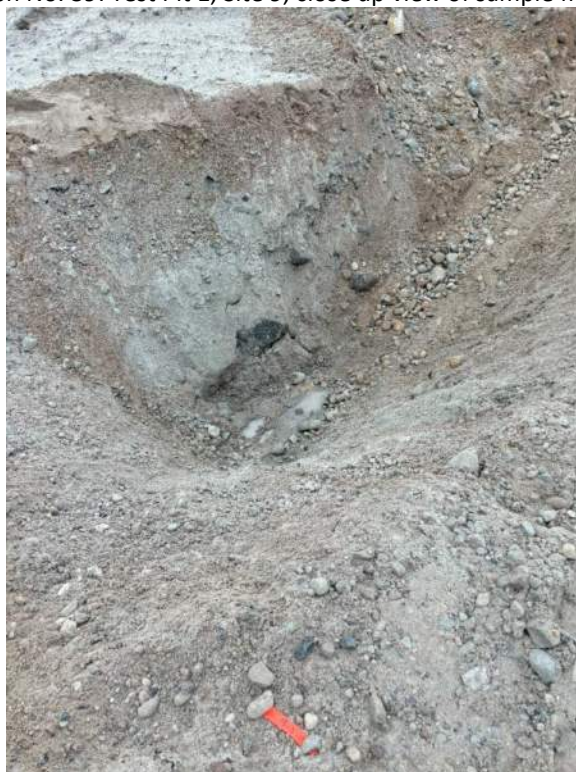
Photograph No. 40: Test Pit 3, Site 9, view of test pit wall

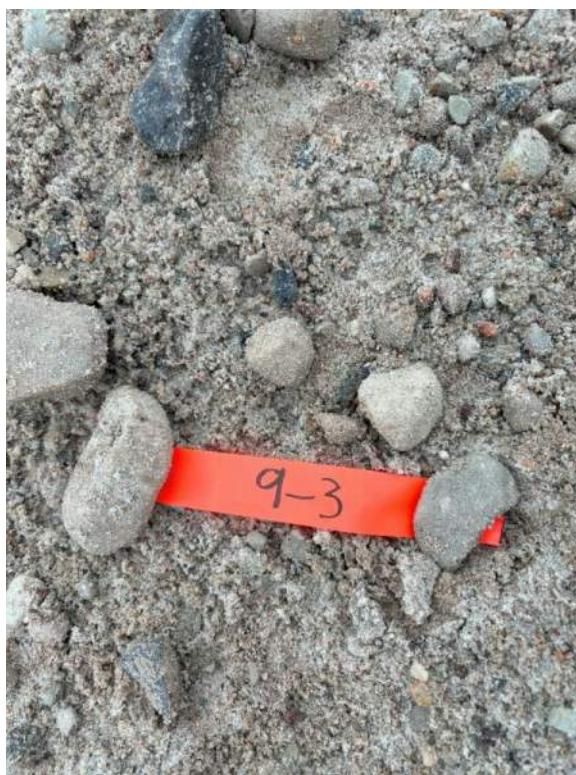
Photograph No. 41: Test Pit 3, Site 9, close up view of sample from test pit

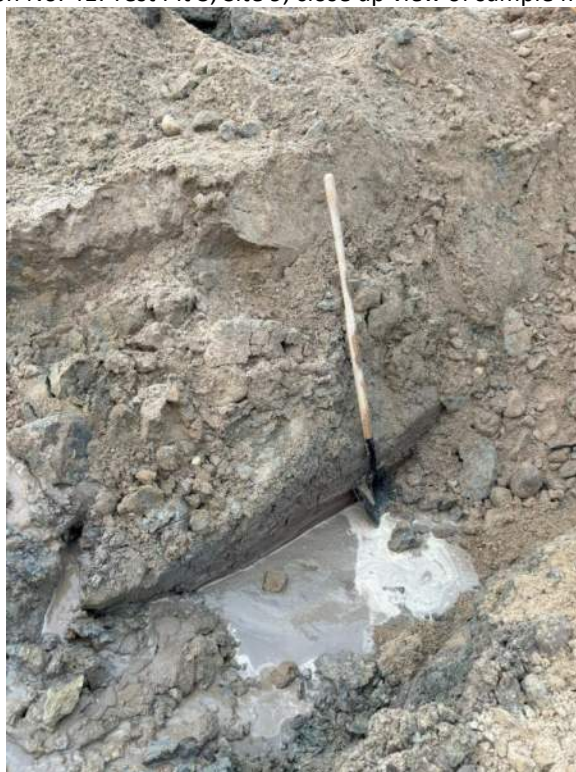
Photograph No. 42: Test Pit 9, Site 9, view of test pit wall

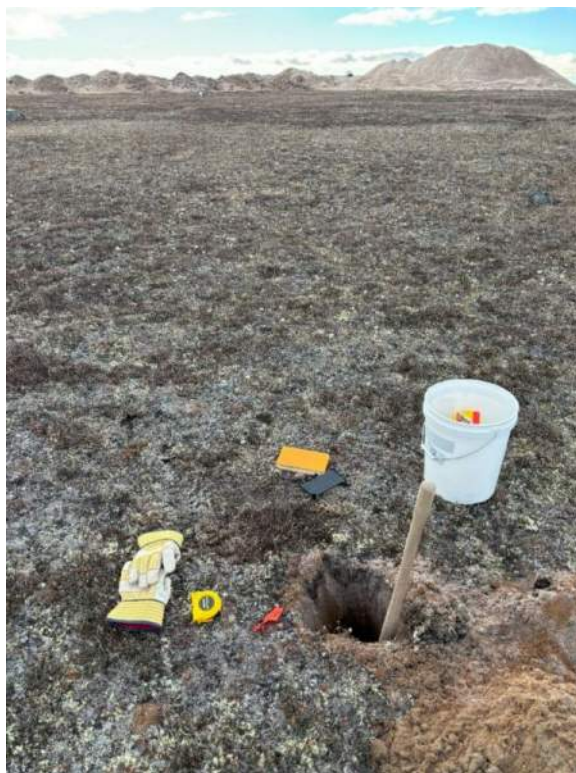
Photograph No. 43: View of Test Pit 10, Site 9 (manually excavated)

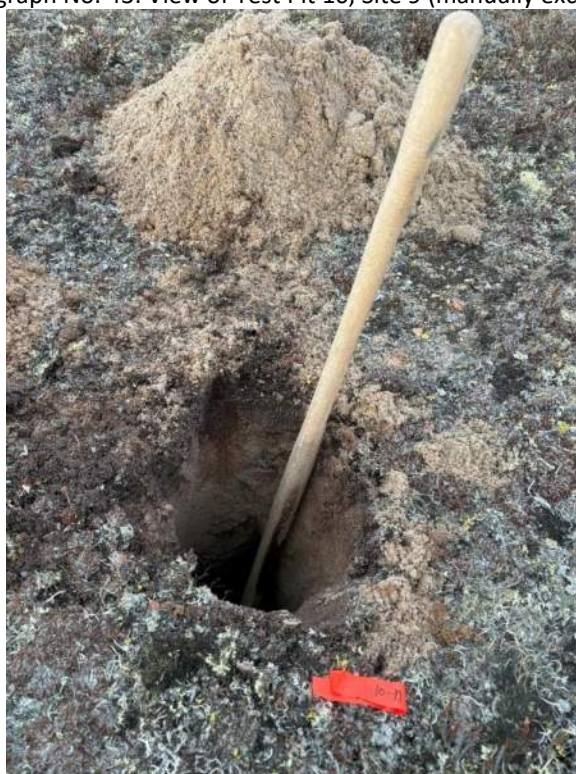
Photograph No. 44: View of Test Pit 11, Site 9 (manually excavated)
