Baffinland Iron Mines Corporation Mary River Project

Freshwater and Fish Habitat Survey: Mary River and Tributary F 2023

FRESHWATER FISH AND FISH HABITAT SURVEY:
MARY RIVER AND TRIBUTARY F 2023

April 2024

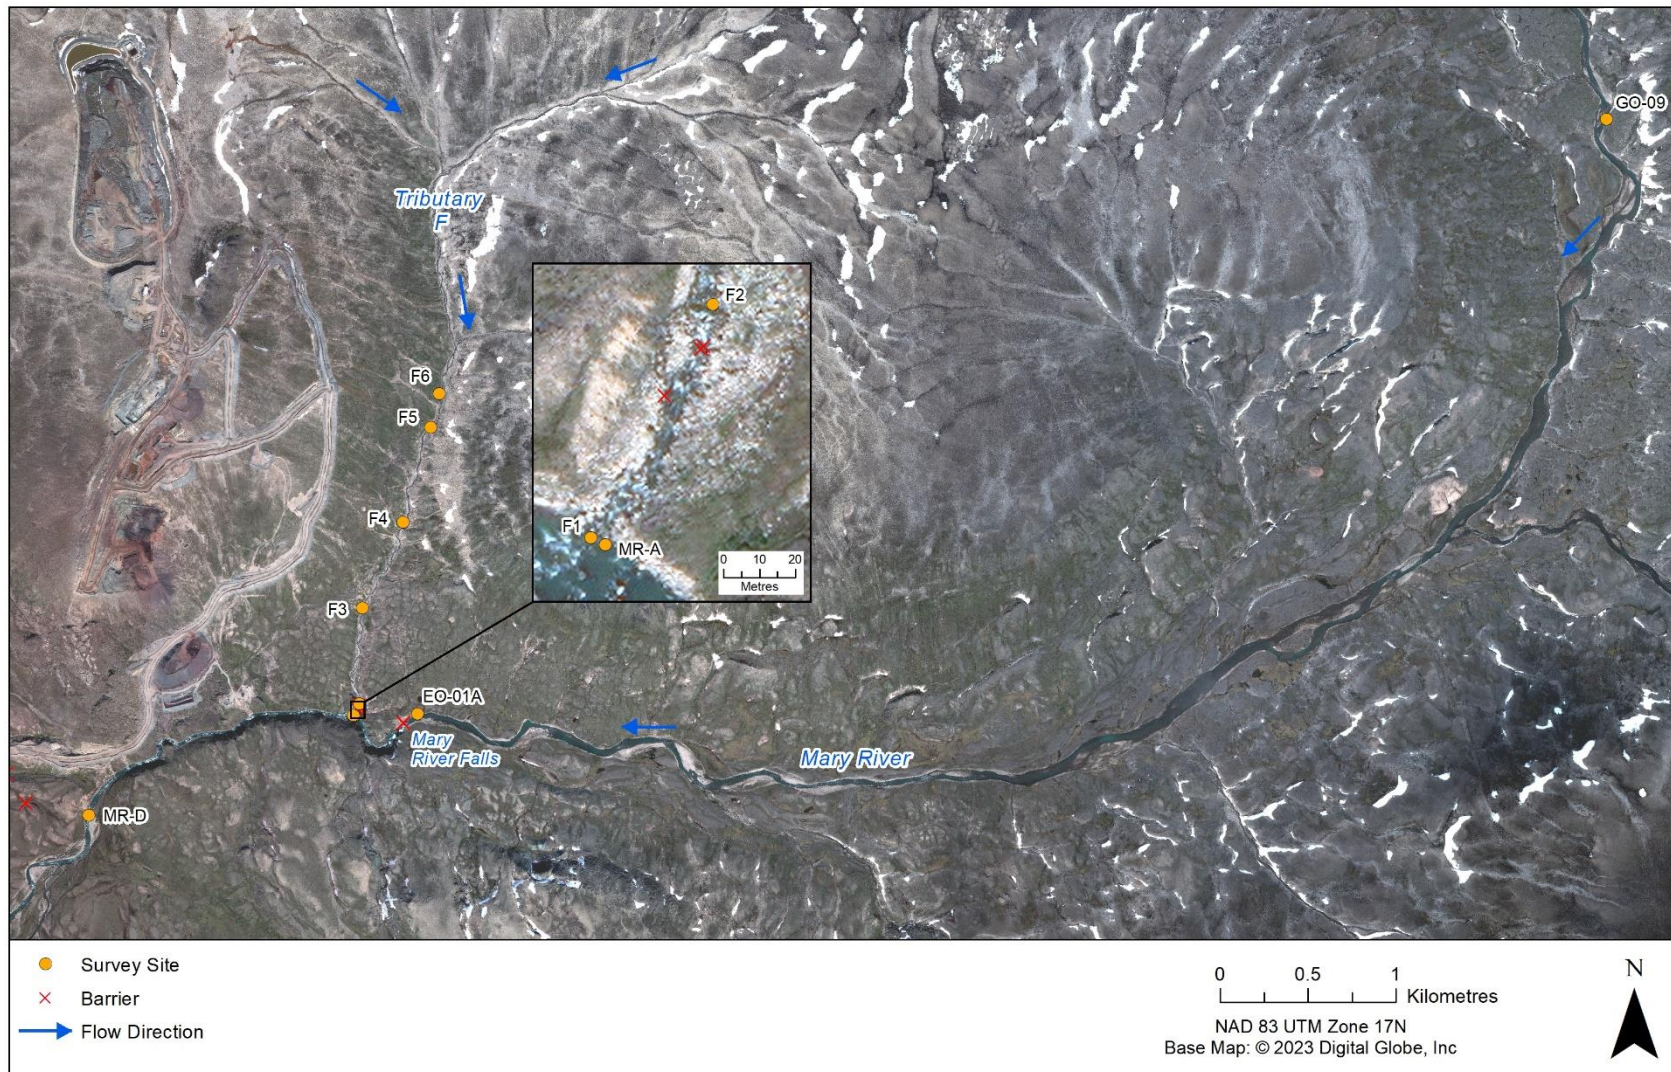
Figure 2. Aquatic habitat and fish survey locations in Tributary F and the Mary River: August 2023.

The field survey was conducted August 14-21, 2023. Aquatic habitat and fish use surveys were conducted at six sites in Tributary F as follows, moving in an upstream direction (Figure 2):

- Site F1: from the mouth to the barriers;
- Site F2: 100 meters upstream of the barriers; and
- Sites F3-8: four additional upstream sites separated by at least 500 m.

Four sites were surveyed in the Mary River as follows (Figure 2):

- Site GO-09: approximately 9.4 km upstream of Mary River Falls;
- Site EO-01A: immediately upstream of Mary River Falls;
- Site MR-A: at the confluence with Tributary F; and
- Site MR-D: downstream of the confluence with Tributary F.

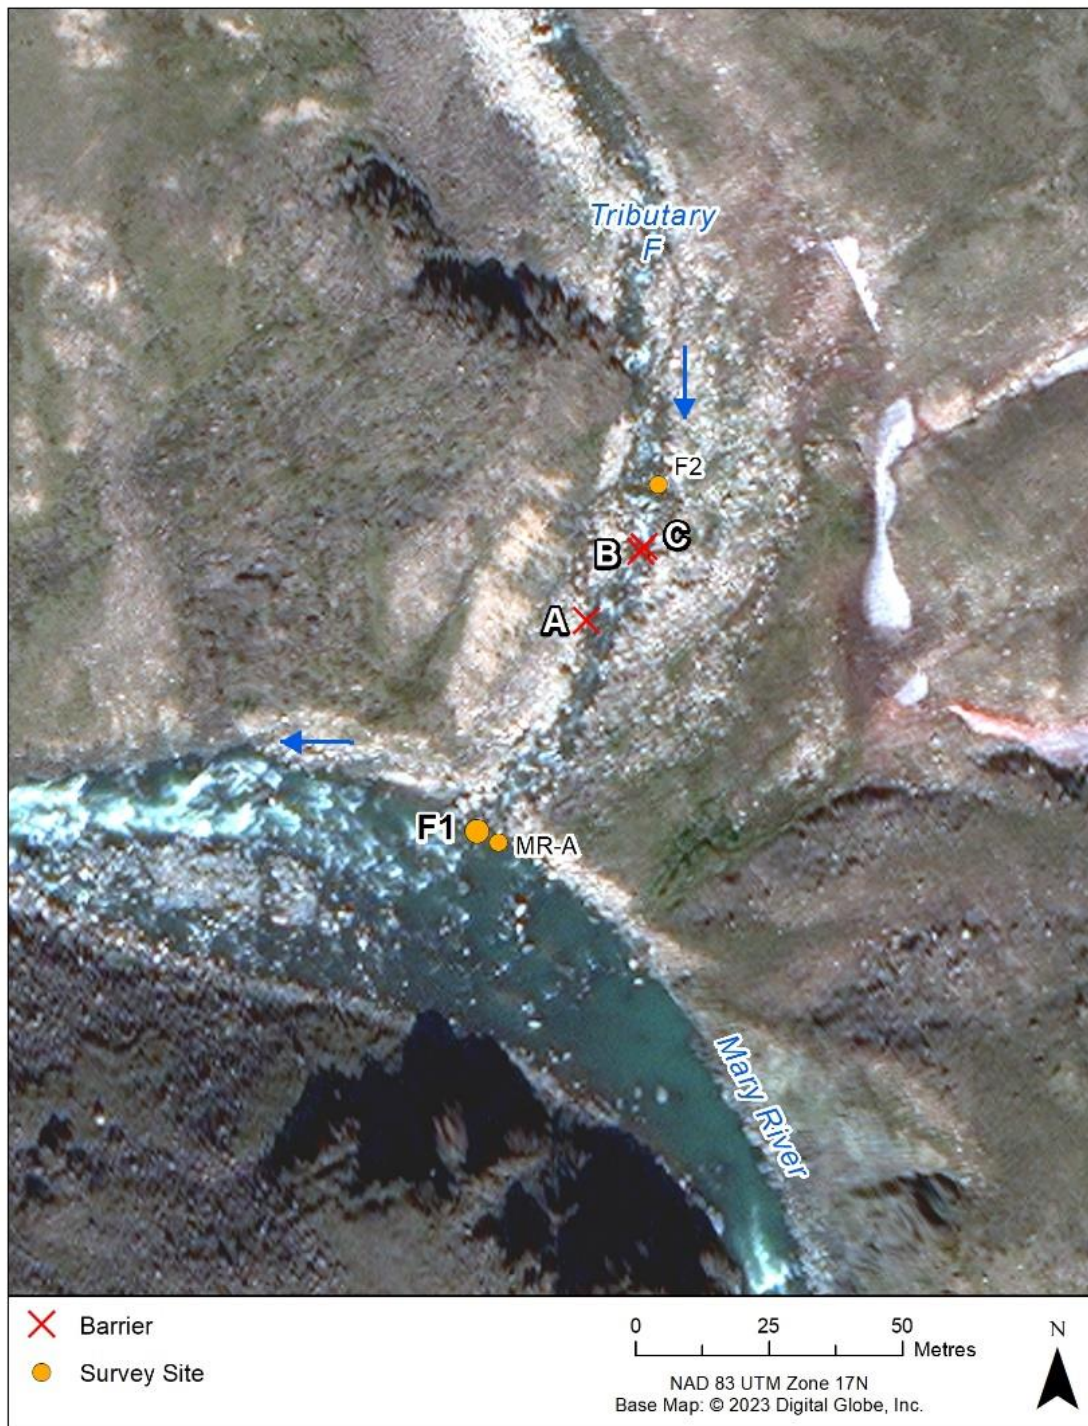
Figure 3. Locations of barriers on Tributary F.

The two vertical drop barriers identified near the mouth of Tributary F in a survey conducted in 2019 were confirmed as permanent barriers to fish passage in 2023 (Figure 3; Photographs 1 and 2). A third vertical drop barrier was also identified in 2023, 5 m farther upstream (Figure 3; Photograph 2). Due to the presence of permanent barriers, accessible habitat within Tributary F is restricted to the lowermost 45-50 m of the stream in the lefthand channel and lowermost 60-65 m of the stream in the righthand (main) channel (Site F1). There is no overwintering habitat in the Tributary F drainage.

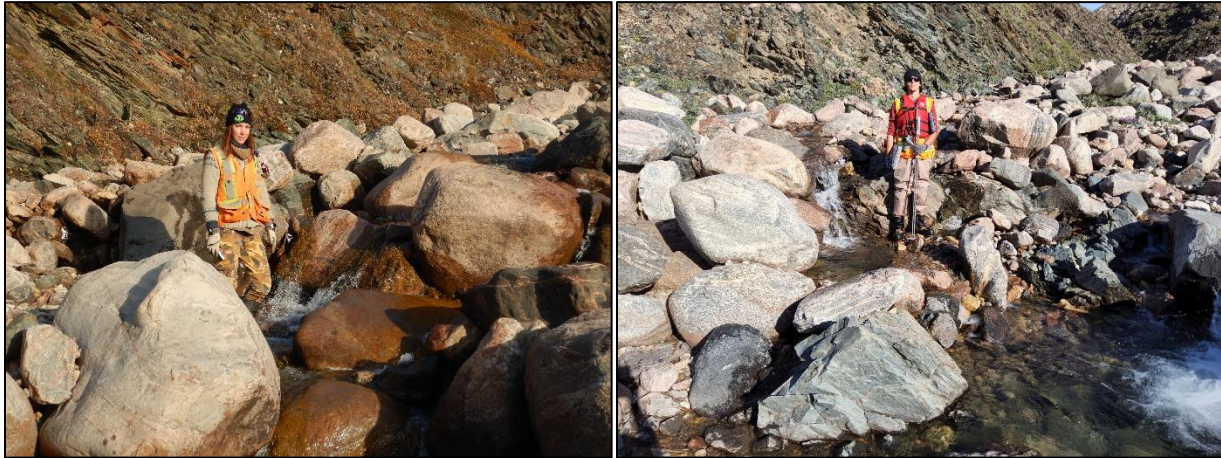
Photograph 1. Farthest downstream barrier on Tributary F: lefthand channel drop of 0.75 m (site depicted as “A” on Figure 3). Photos from September 2019 (left) and August 2023 (right).

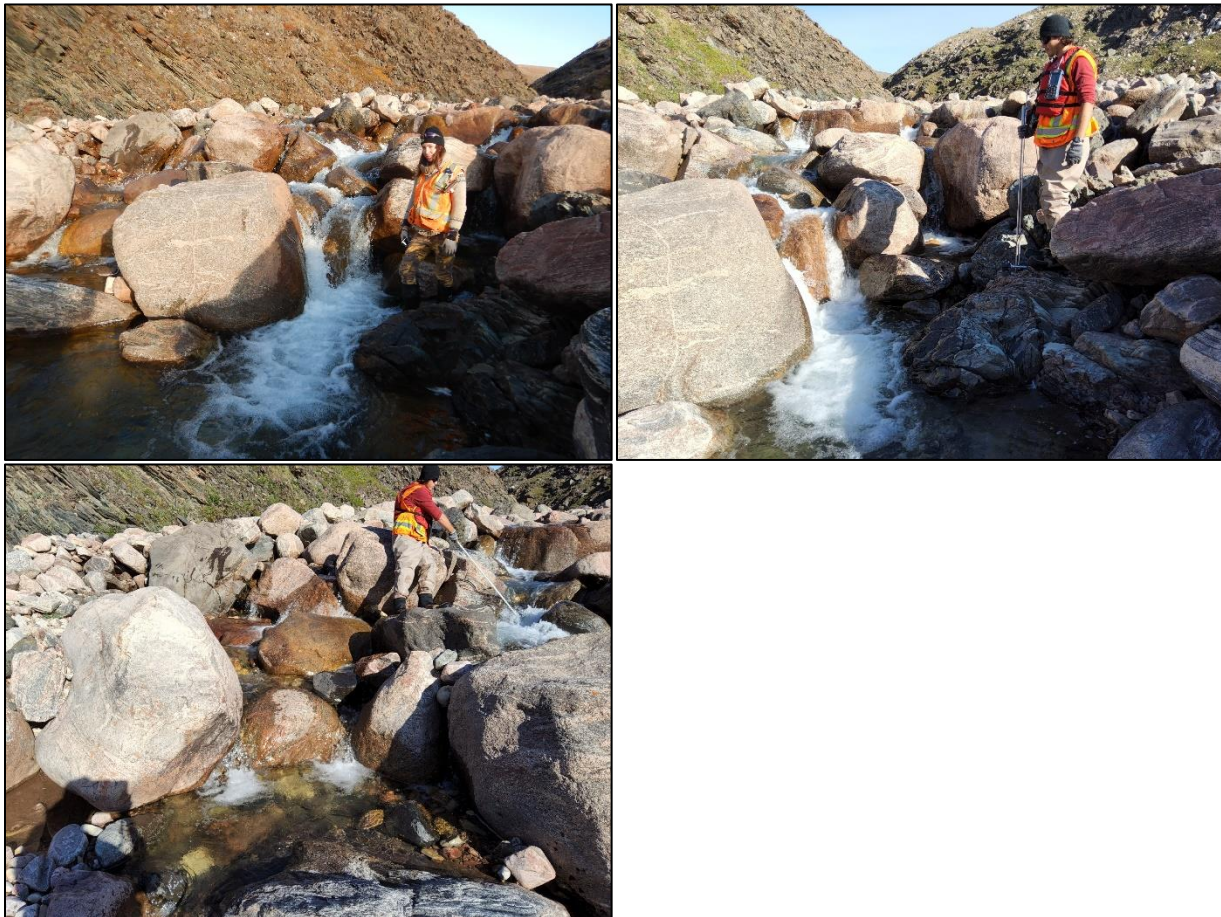
Photograph 2. Barriers on Tributary F: main channel drops of > 1 m (top photos) and 0.75 m (bottom photo; sites depicted as “B” and “C” on Figure 3). Photos from September 2019 (top left) and August 2023 (top right and bottom left).

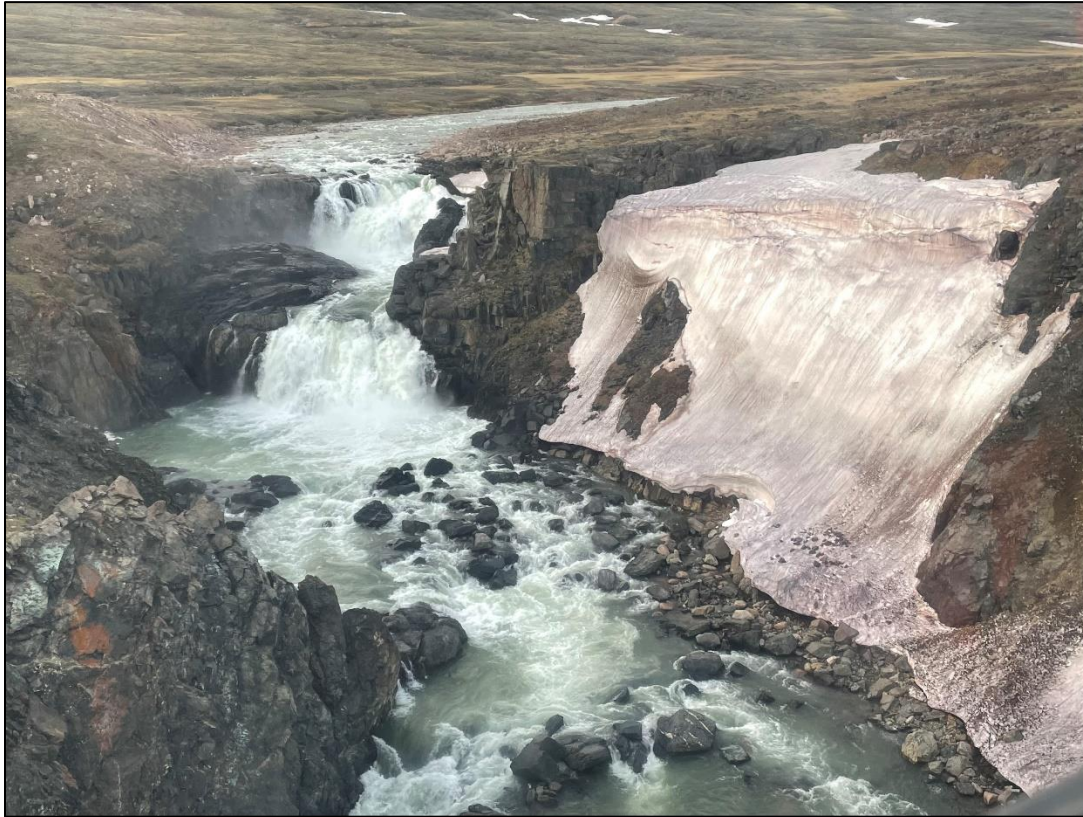
The set of falls on the Mary River (Mary River Falls) upstream of the Tributary F confluence represents a permanent barrier to fish passage on the Mary River (Photograph 3). No fish were captured or observed upstream of the falls and no lakes were identified with sufficient depth to potentially support overwintering of Arctic Char in the upper Mary River drainage. One site upstream of the Mary River Falls (GO-09) was fished on seven separate site visits in 2006 and 2007 during the Final Environmental Impact Statement (FEIS) baseline field studies, and fish were never captured or observed (Baffinland 2012).

Photograph 3. Mary River Falls. Photo from August 2022.
