Baffinland Iron Mines Corporation Mary River Project

Steensby Railway Freshwater Habitat Surveys:
Fish-bearing Sites 2021-2024

March 2025

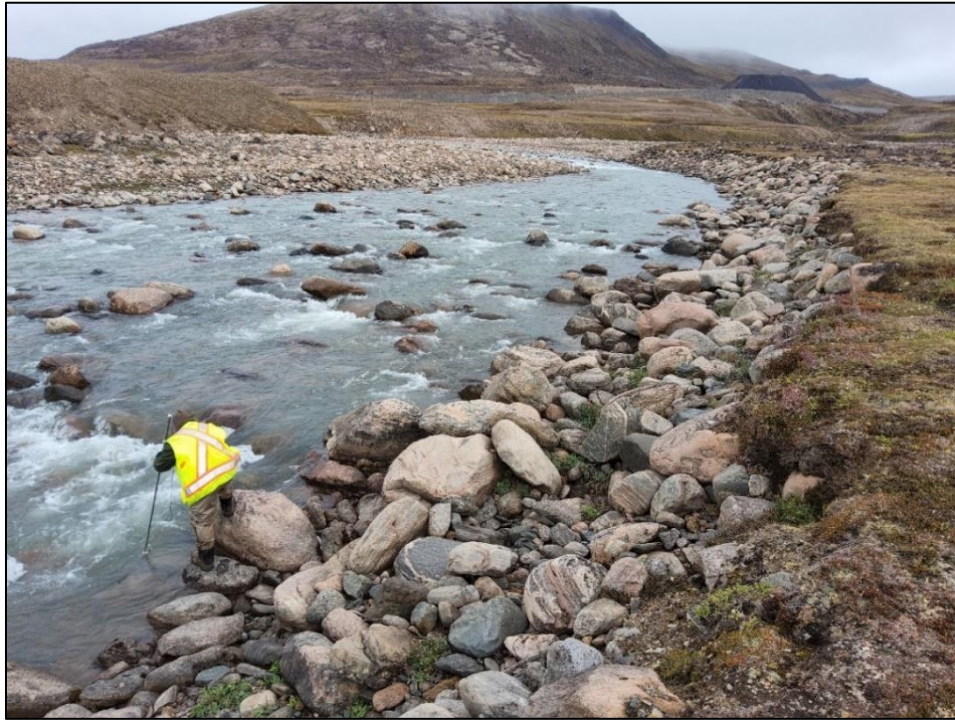
Photograph 1. Photo of the Mary River, a fish-bearing river, taken near the rail crossing in August 2022.

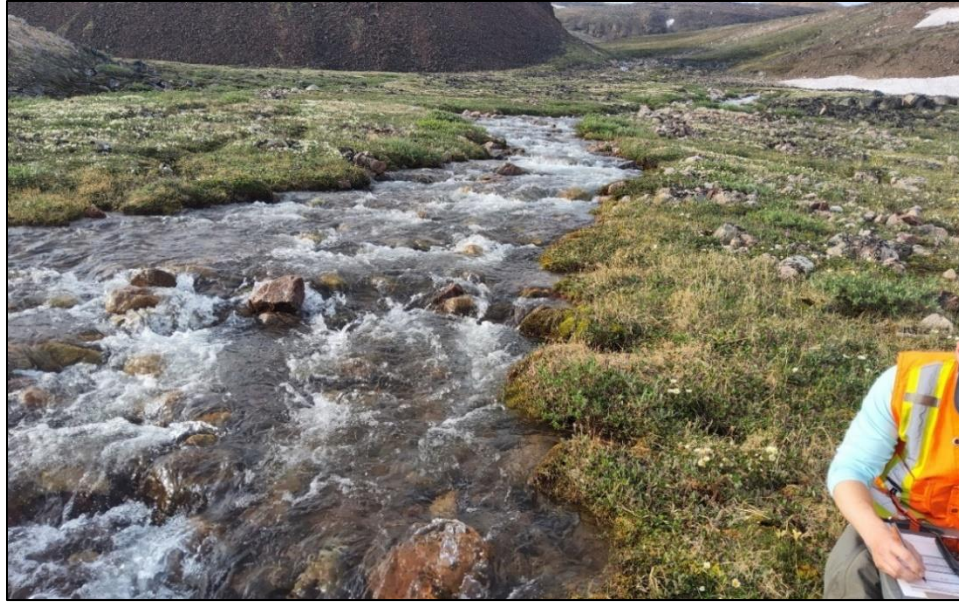
Photograph 2. Photo of rail site CV-006-1 at an unnamed fish-bearing stream taken near the rail crossing in spring 2022.

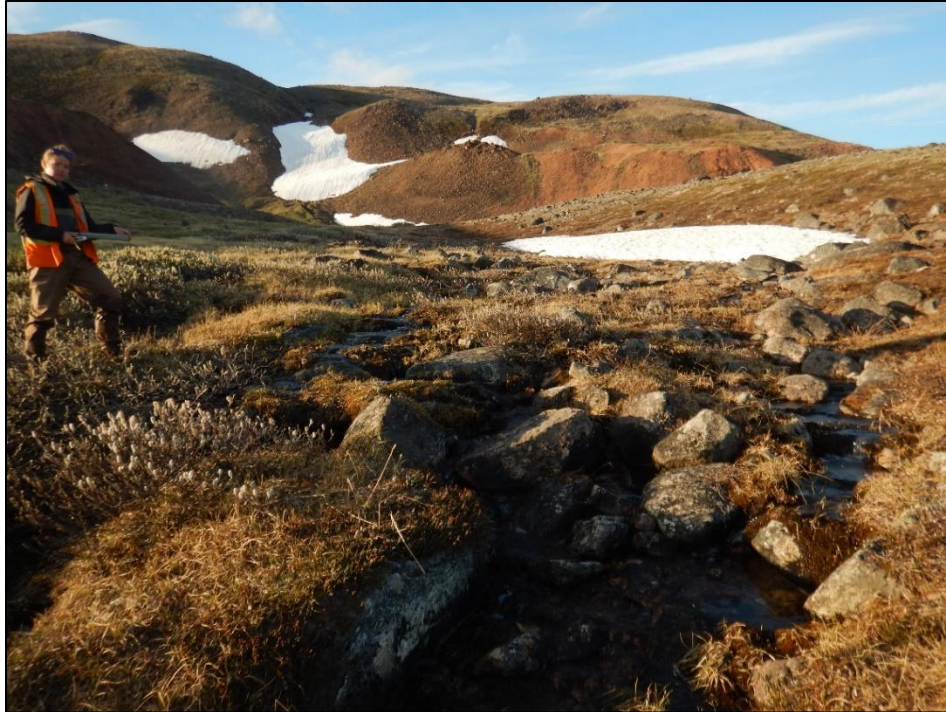
Photograph 4. Photo of rail site CV-009-0 at an unnamed non-fish bearing stream taken near the rail crossing in spring 2021.

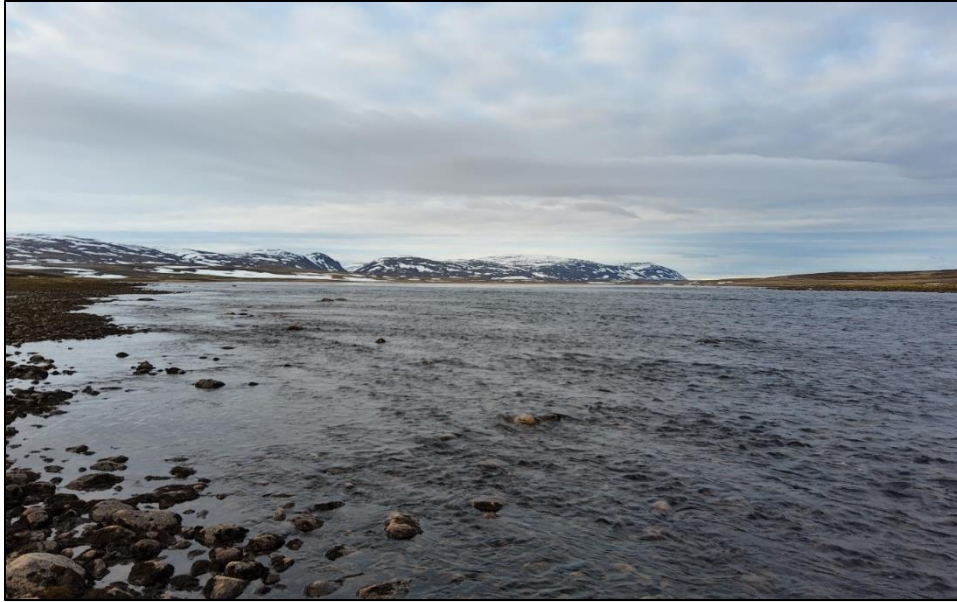
Photograph 5. Photo of the Ravn River, a fish-bearing river, taken near the rail crossing in spring 2022.

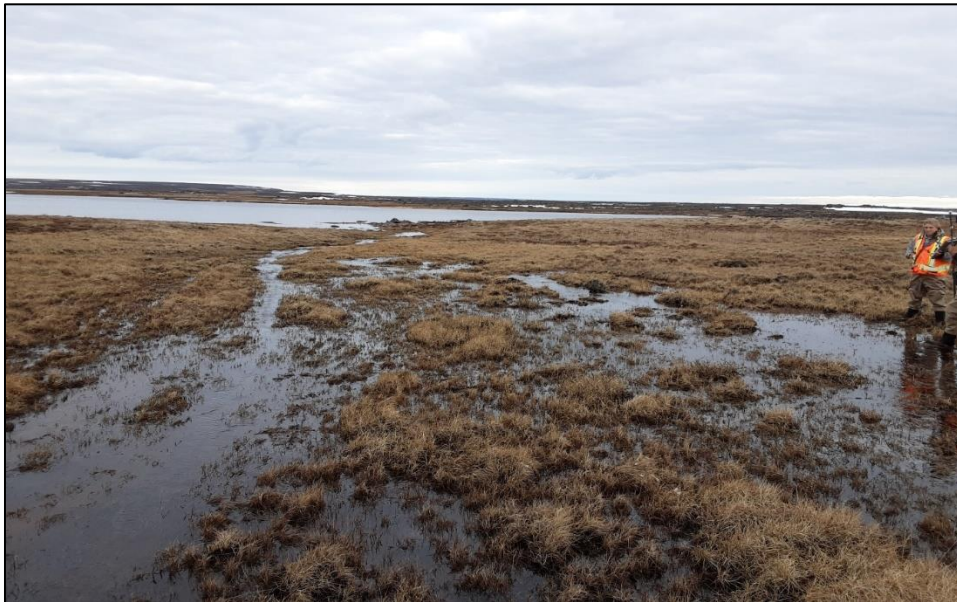
Photograph 6. Photo of rail site CV-049-2 at an unnamed fish-bearing stream taken near the rail crossing in spring 2022.

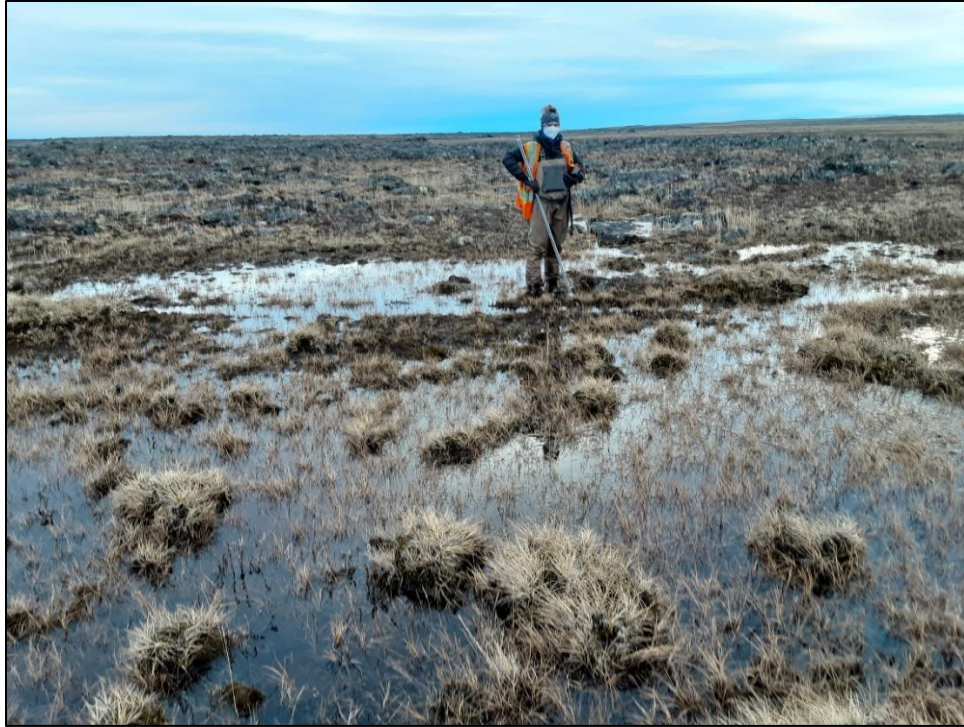
Photograph 7. Photo of rail site CV-052-1 at an unnamed non-fish bearing stream taken near the rail crossing in spring 2021.

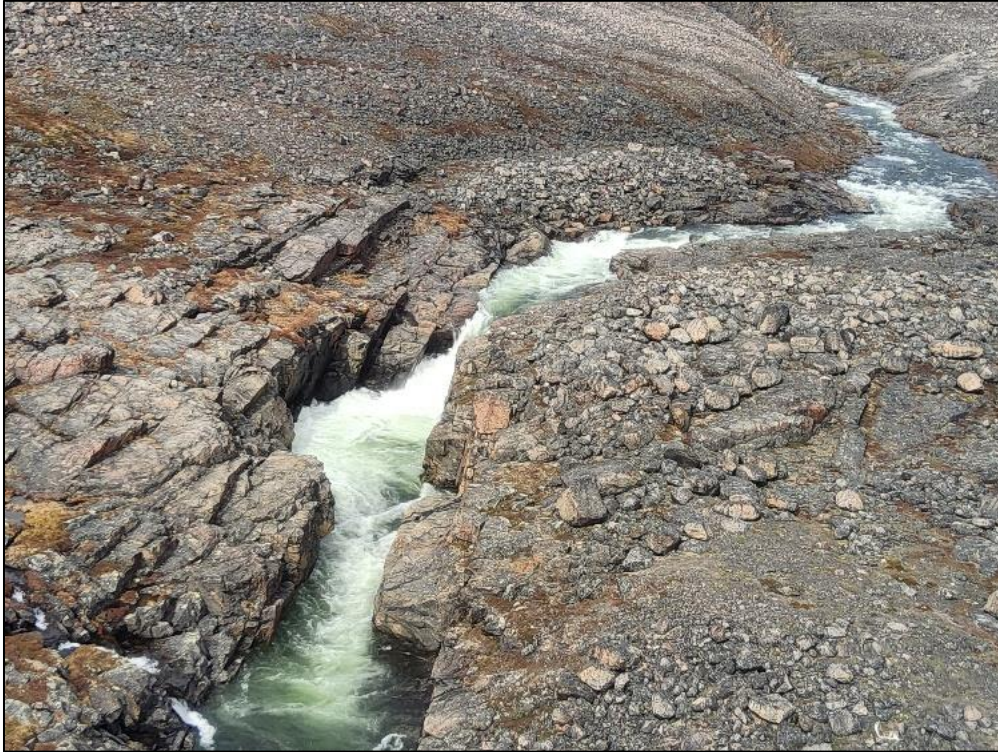
Photograph 8. Photograph of one of the sets of falls on the northwest branch of the Cockburn River taken in August 2023.

The Steensby Railway alignment interacts with 47 streams/ponds in this sub-catchment upstream of the falls. All of these waterbodies that are capable of supporting fish (i.e., suitable habitat with access from the northwest Cockburn River) have been surveyed a minimum of three times between the earlier FEIS field studies (2007-2011) and the recent field studies (2021-2024). Surveys have been conducted during various seasons and under low and high flow conditions. Char have never been observed or captured in any of

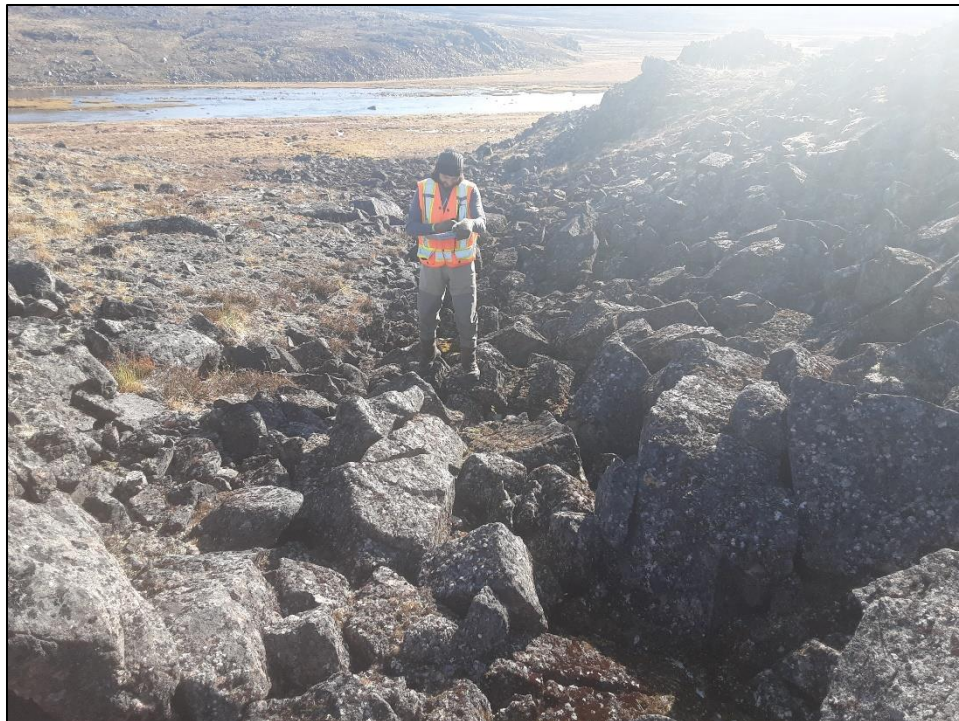
Photograph 10. Photo of rail site CV-078-3 taken at an unnamed non-fish bearing stream near the rail crossing in August 2021.

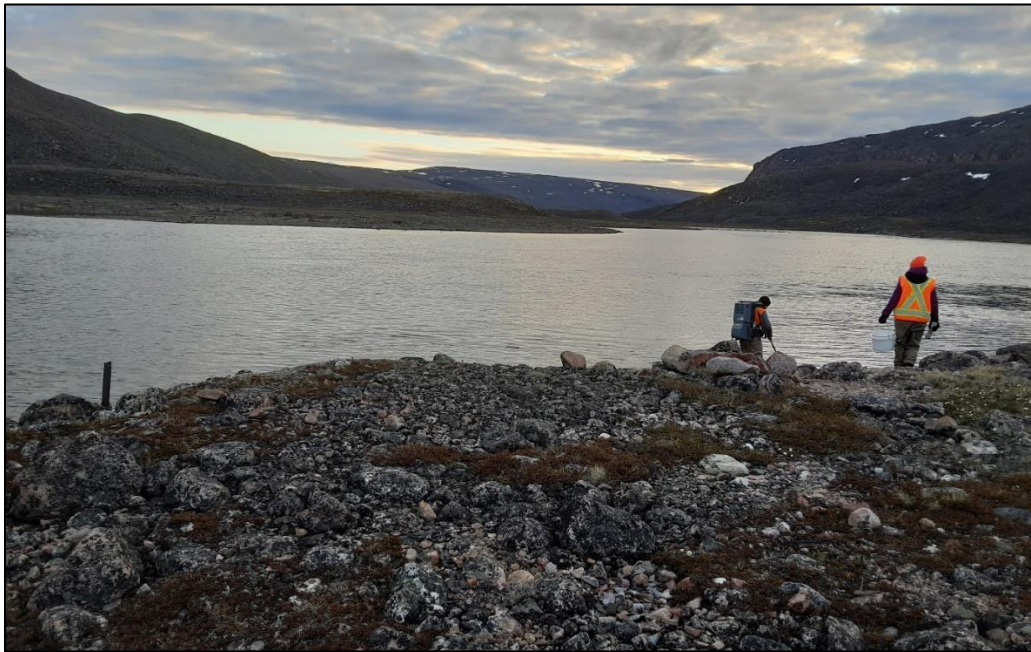
Photograph 11. Photo of the Cockburn Lake bridge crossing area (BR-095-1) taken in spring 2022.

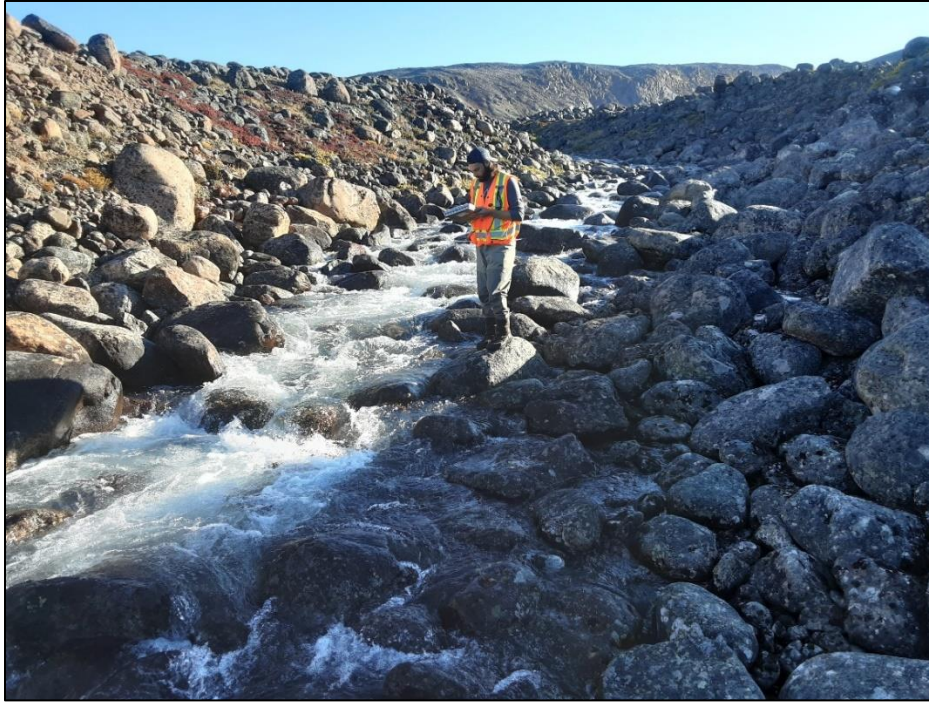
Photograph 12. Photo of a typical stream (at rail site BR-096-1) flowing into the east side of Cockburn Lake taken in August 2021.
