2021 Marine Fish and Fish Habitat Studies In Steensby Port Area

Field Summary Report

20252228-014-R-Rev0

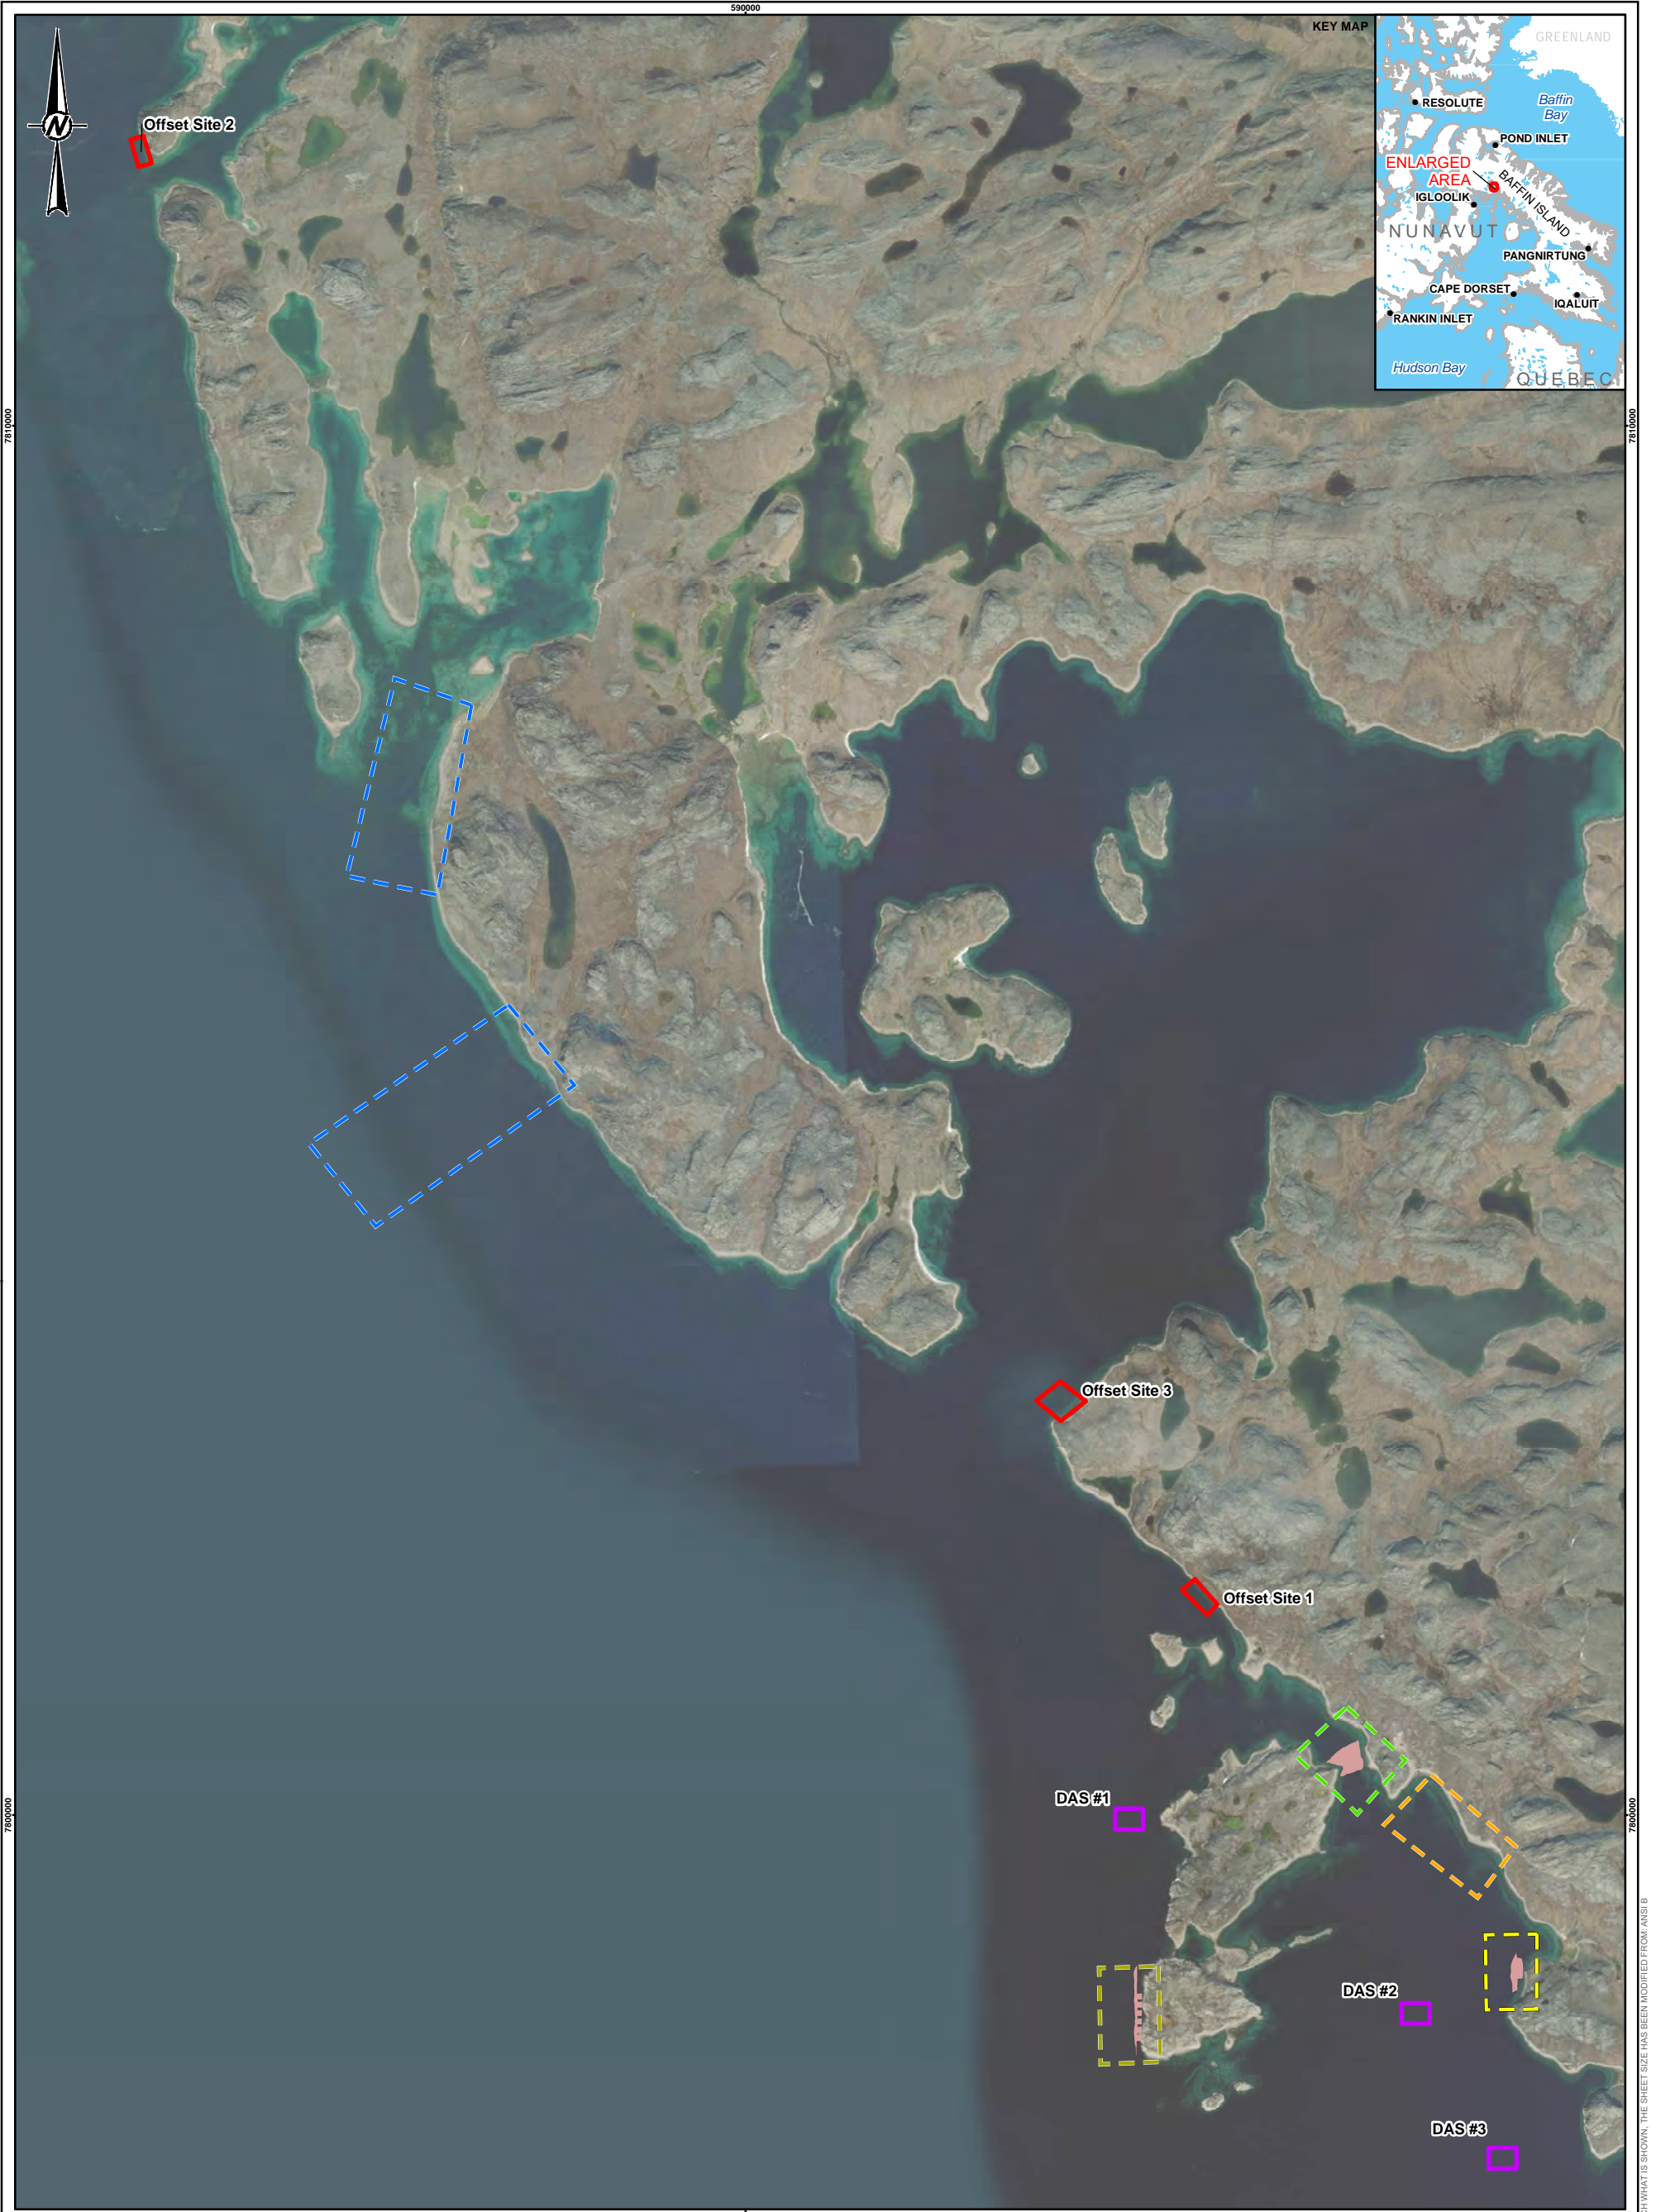
TITLE
PROJECT SAMPLING AREAS IN STEENSBY INLET DURING
STEENSBY 2021 FIELD PROGRAM

The field program consisted of the following components (Figure 1):

- A total of 21 surficial sediment samples were collected for characterization of three proposed dredge areas (Table 5; Figure 1), including:
 - Seven samples from the Freight Dock plus 2 duplicate samples.

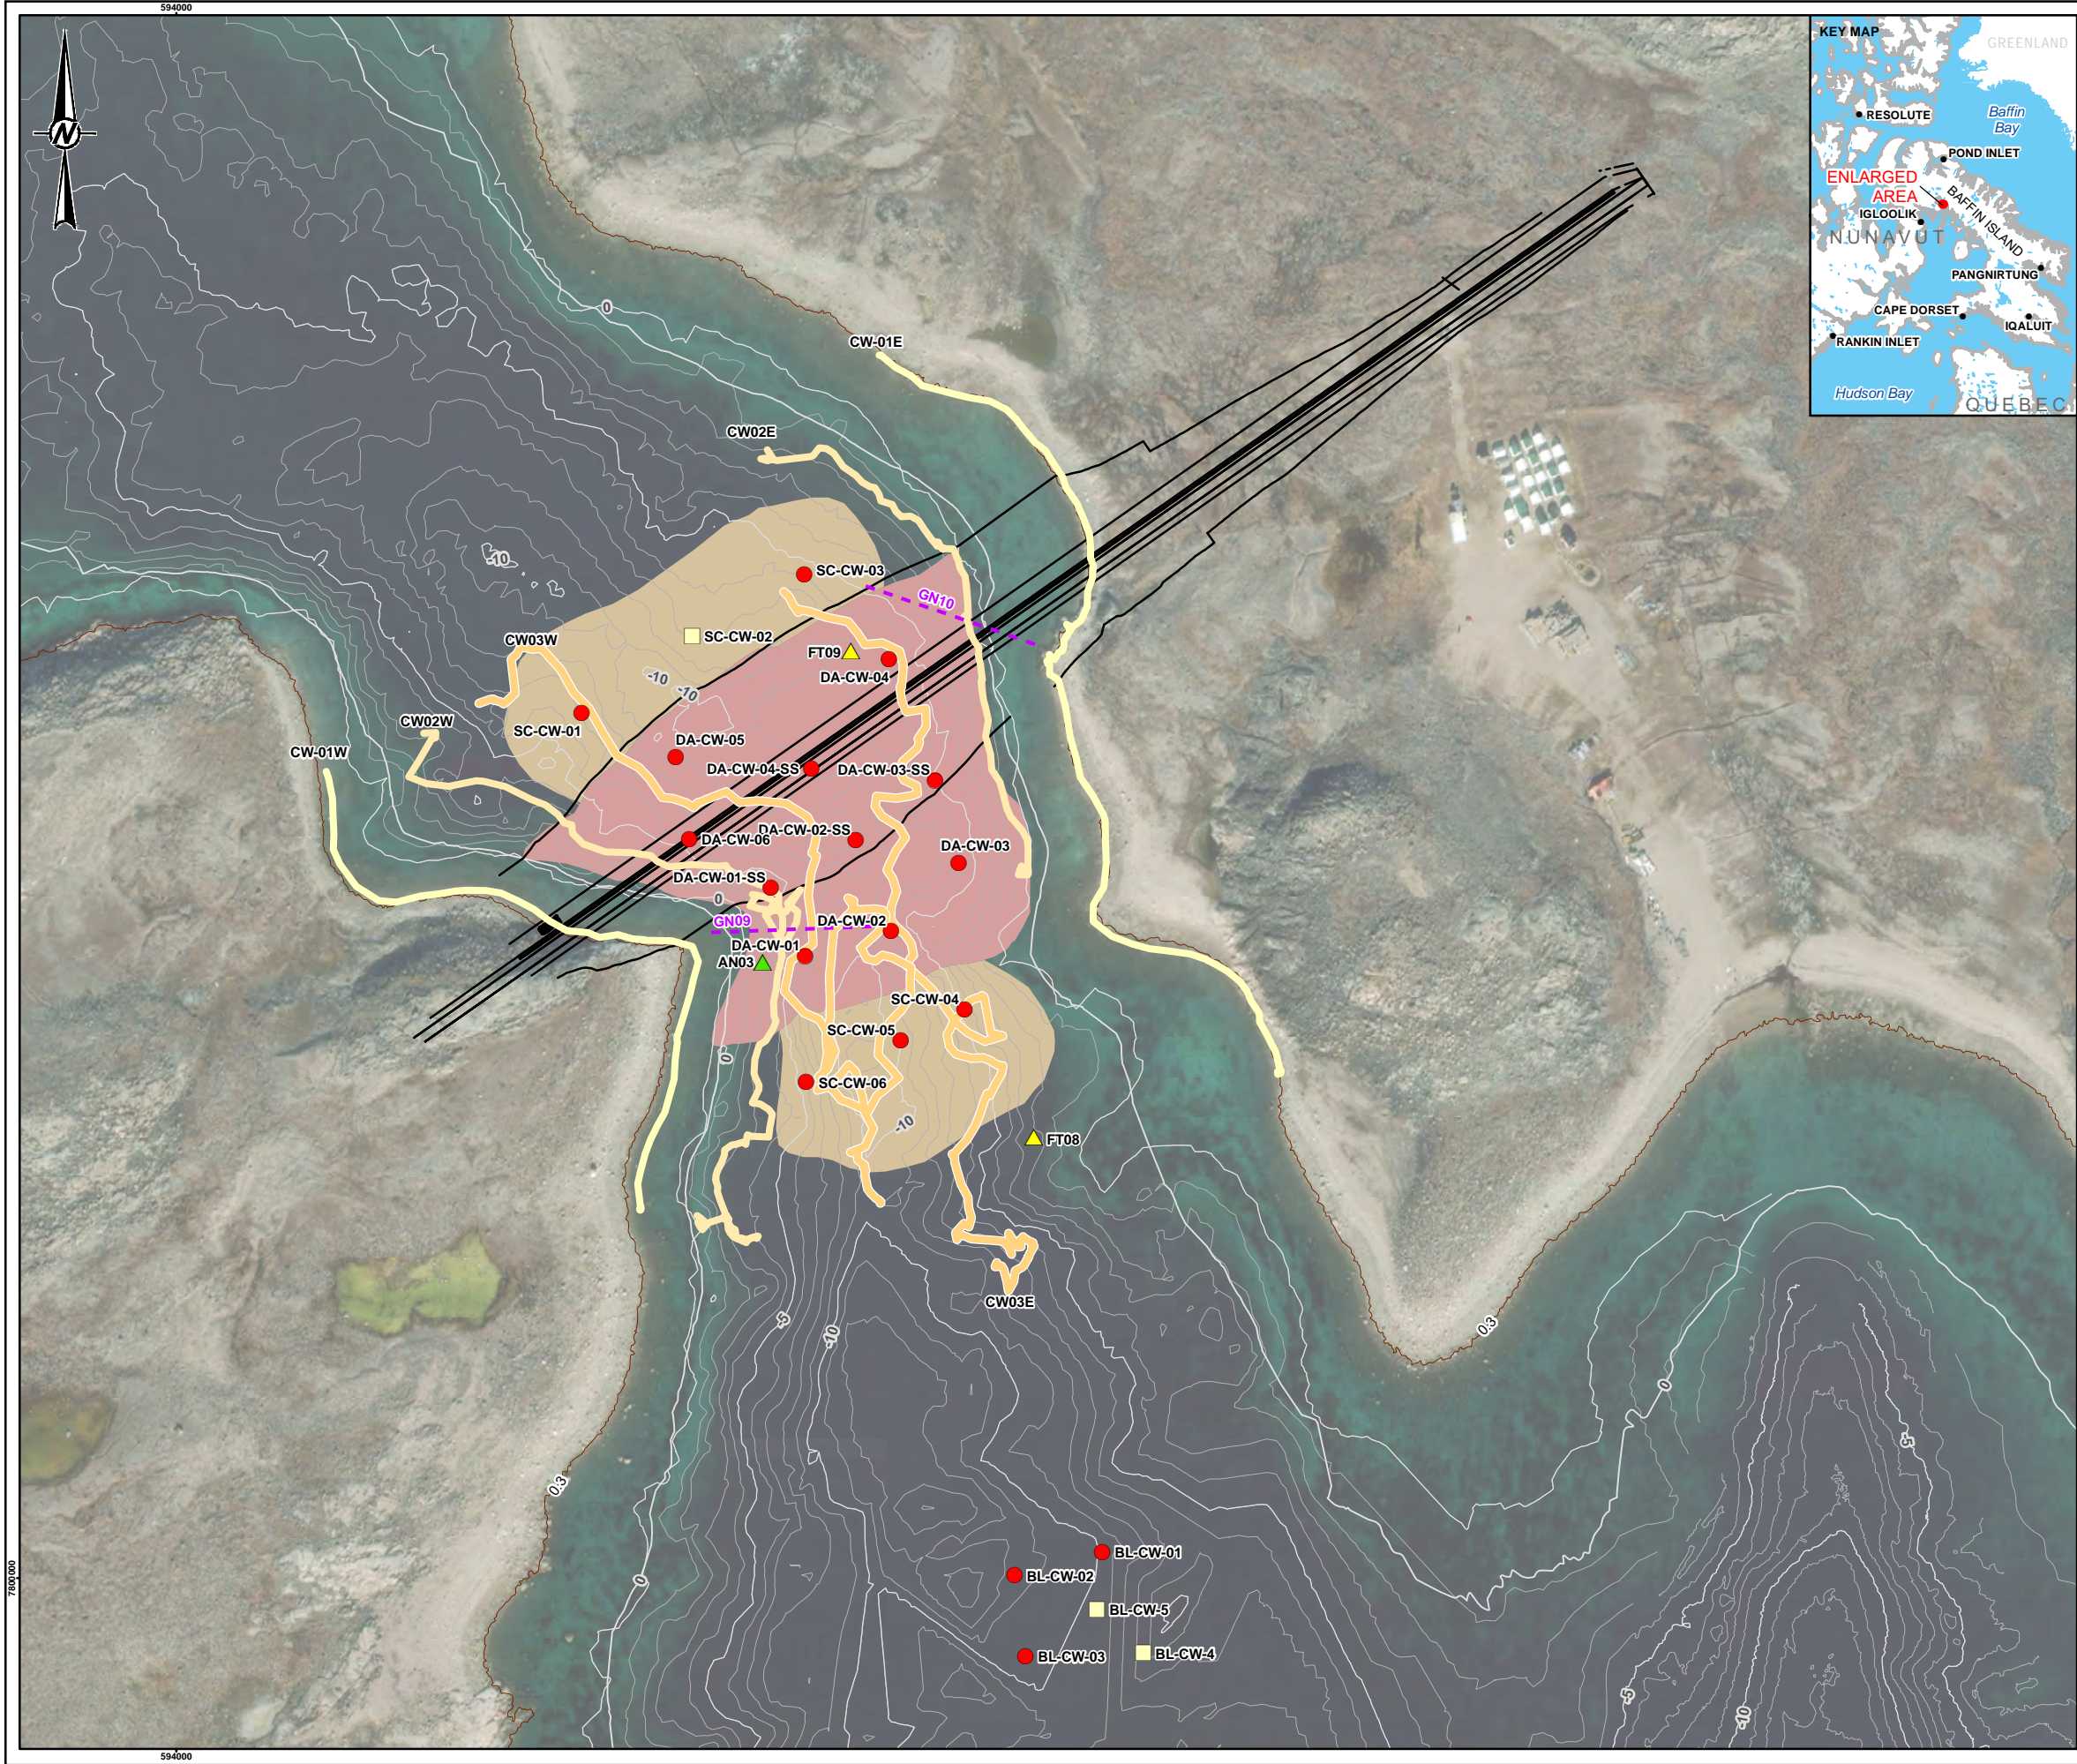
TITLE
SAMPLING WITHIN THE CAUSEWAY DURING STEENSBY 2021 FIELD PROGRAM

Sediment samples and benthic infaunal samples in the Causeway side cast disposal areas were unable to be collected due to existing hard substrate conditions resulting in unsuccessful grab attempts (i.e., hard bottom refusal) and rejected samples (inadequate penetration of grab, incomplete closure of grab) while deploying the Petite Ponar and/or Standard Ponar by hand (Figure 4). Rejected samples contained inadequate sediment volume (<25% full).

- The majority of the intended sediment and benthic infaunal samples in the Causeway area were unable to be collected due to existing substrate conditions resulting in hard bottom refusal and rejected samples during sediment grab sampling using the Petite Ponar and the Standard Ponar (both manually operated). Reason for sample rejection included inadequate sediment volume (<25% full) and/or incomplete closure of the grab sampler upon recovery (rocks and debris jammed in jaws of grab sampler).

- Causeway: Deployment of the Petite Ponar and Standard Ponar by hand failed to trigger the grab properly and/or did not allow for sufficient penetration of the grab to collect enough sample for analysis. A reasonable number of attempts were conducted throughout the Causeway with several alterations to the deployment technique before sediment sampling was suspended in this area in favor of other stations with a higher likelihood of retrieval.

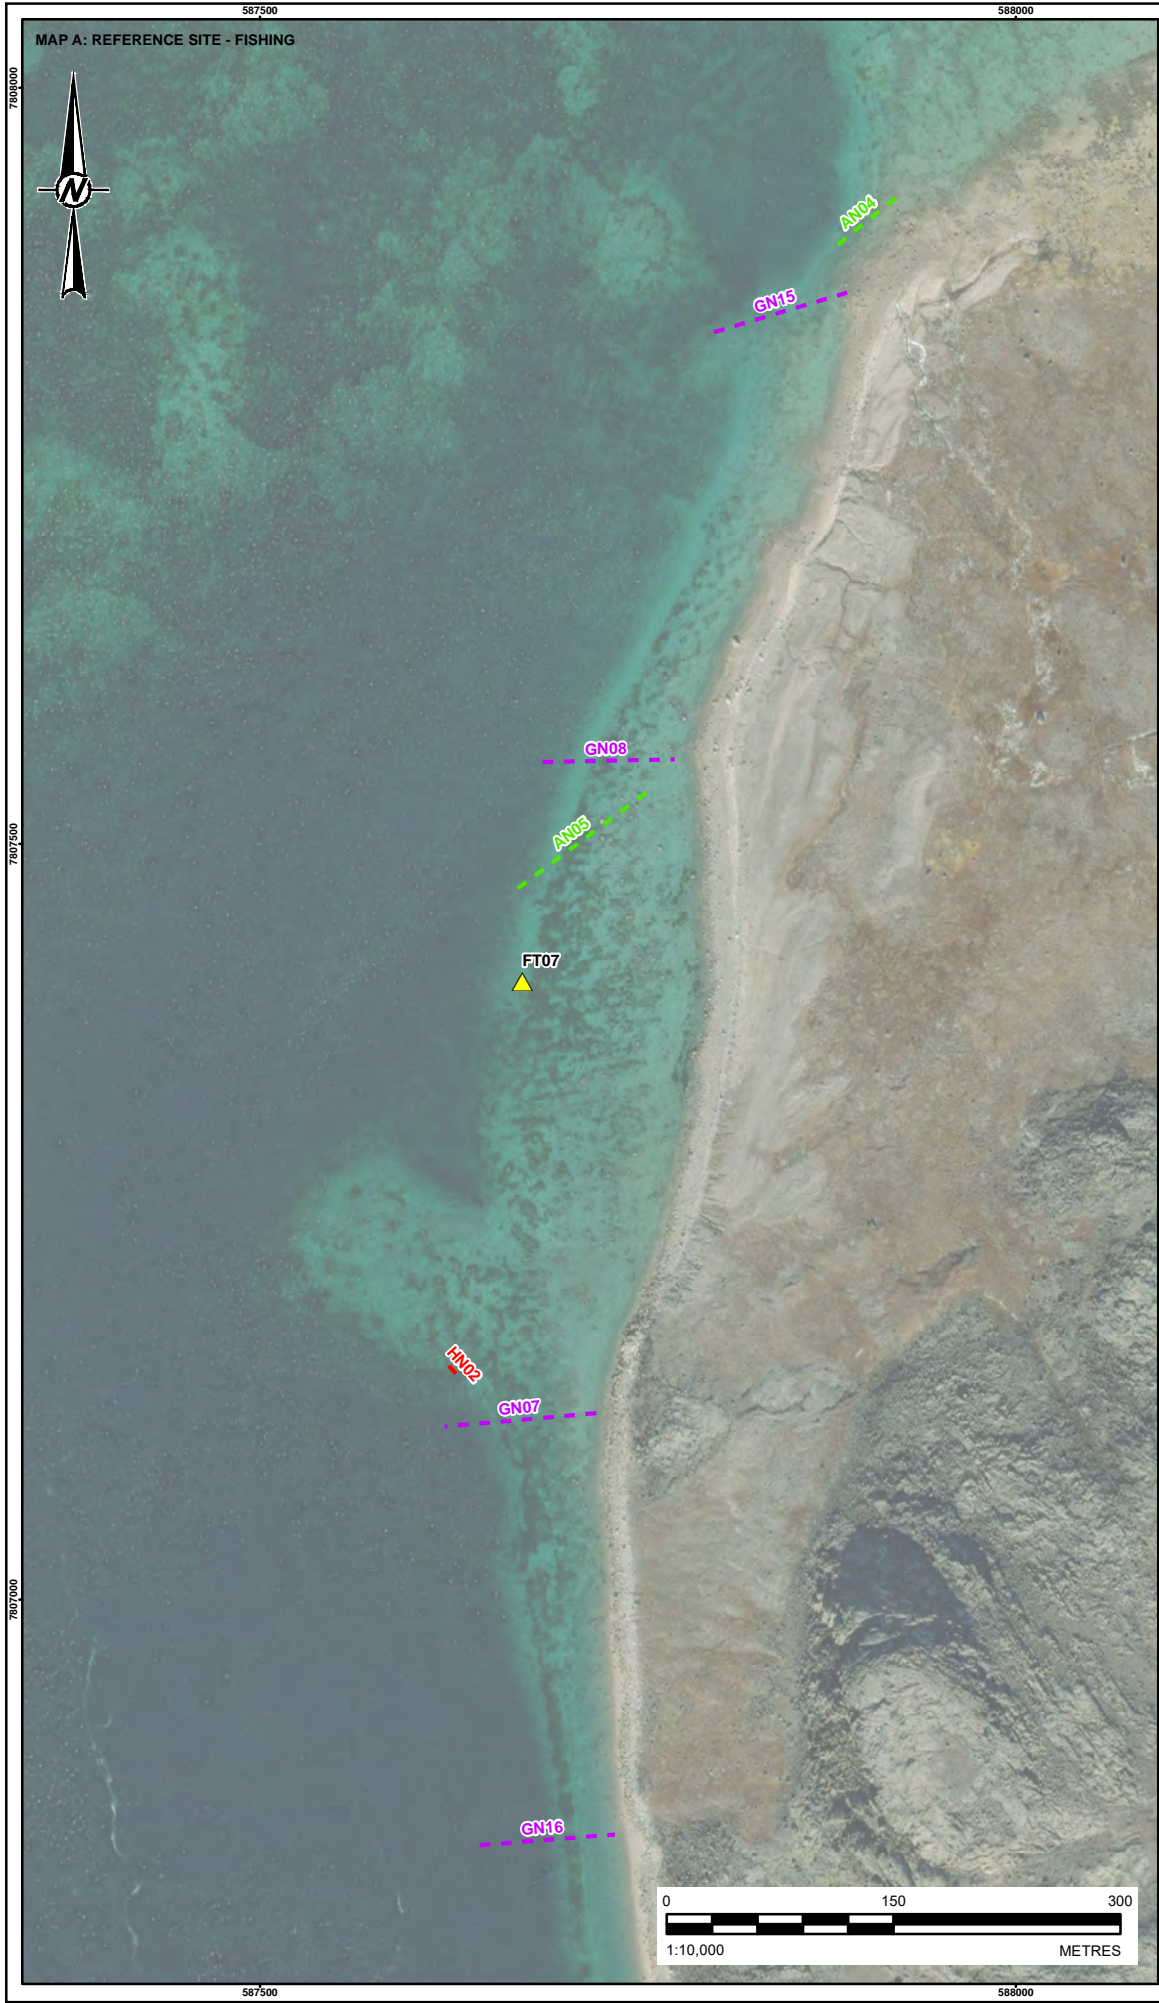
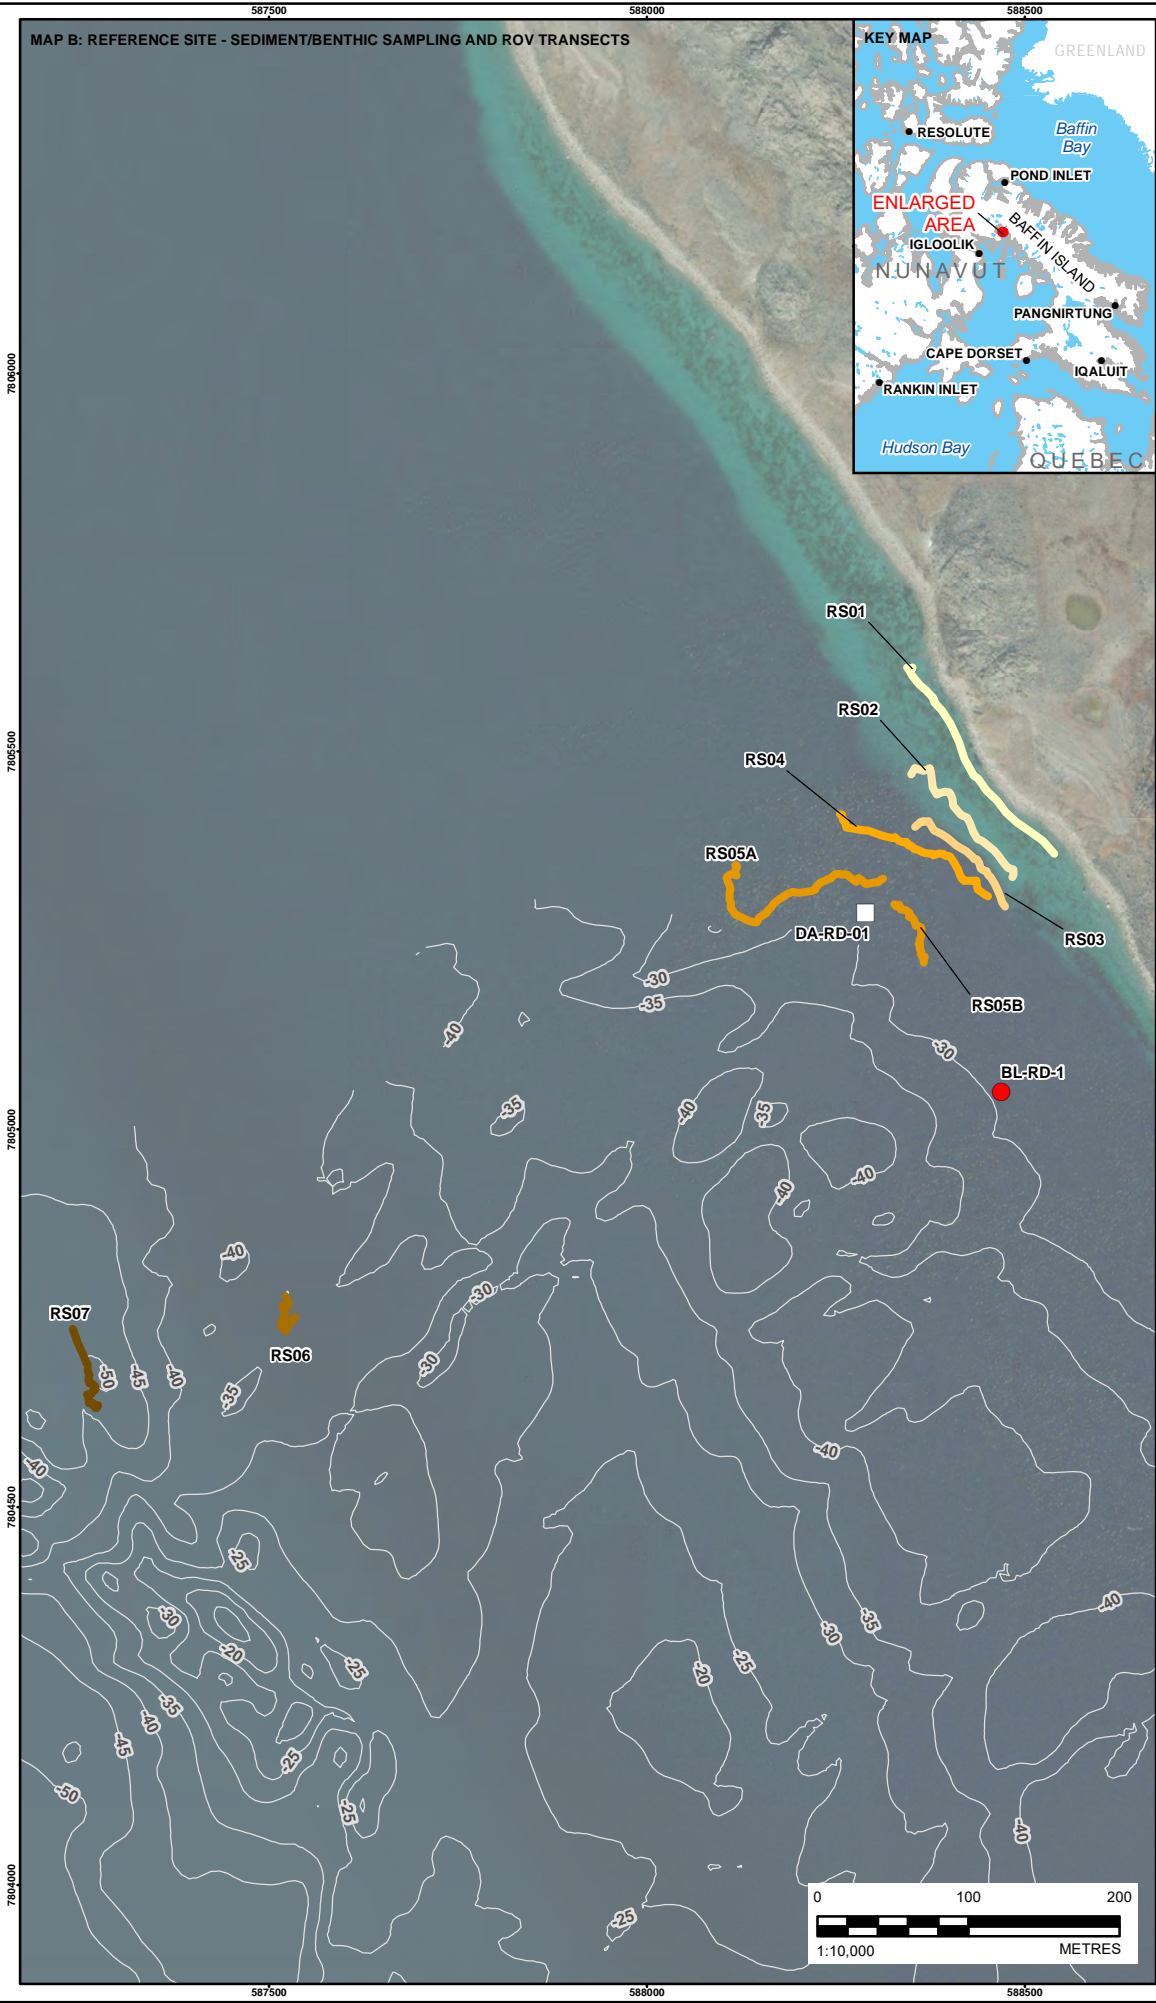
- One attempt was made to collect sediment and benthic infaunal samples in the Reference area (Figure 5) but this was unsuccessful due to inadequate penetration of the grab (i.e., hard bottom refusal) and/or incomplete closure of the grab sampler. No additional sampling was undertaken in this area due to accessibility issues with the site (tide conditions) and time constraints with the overall field program.

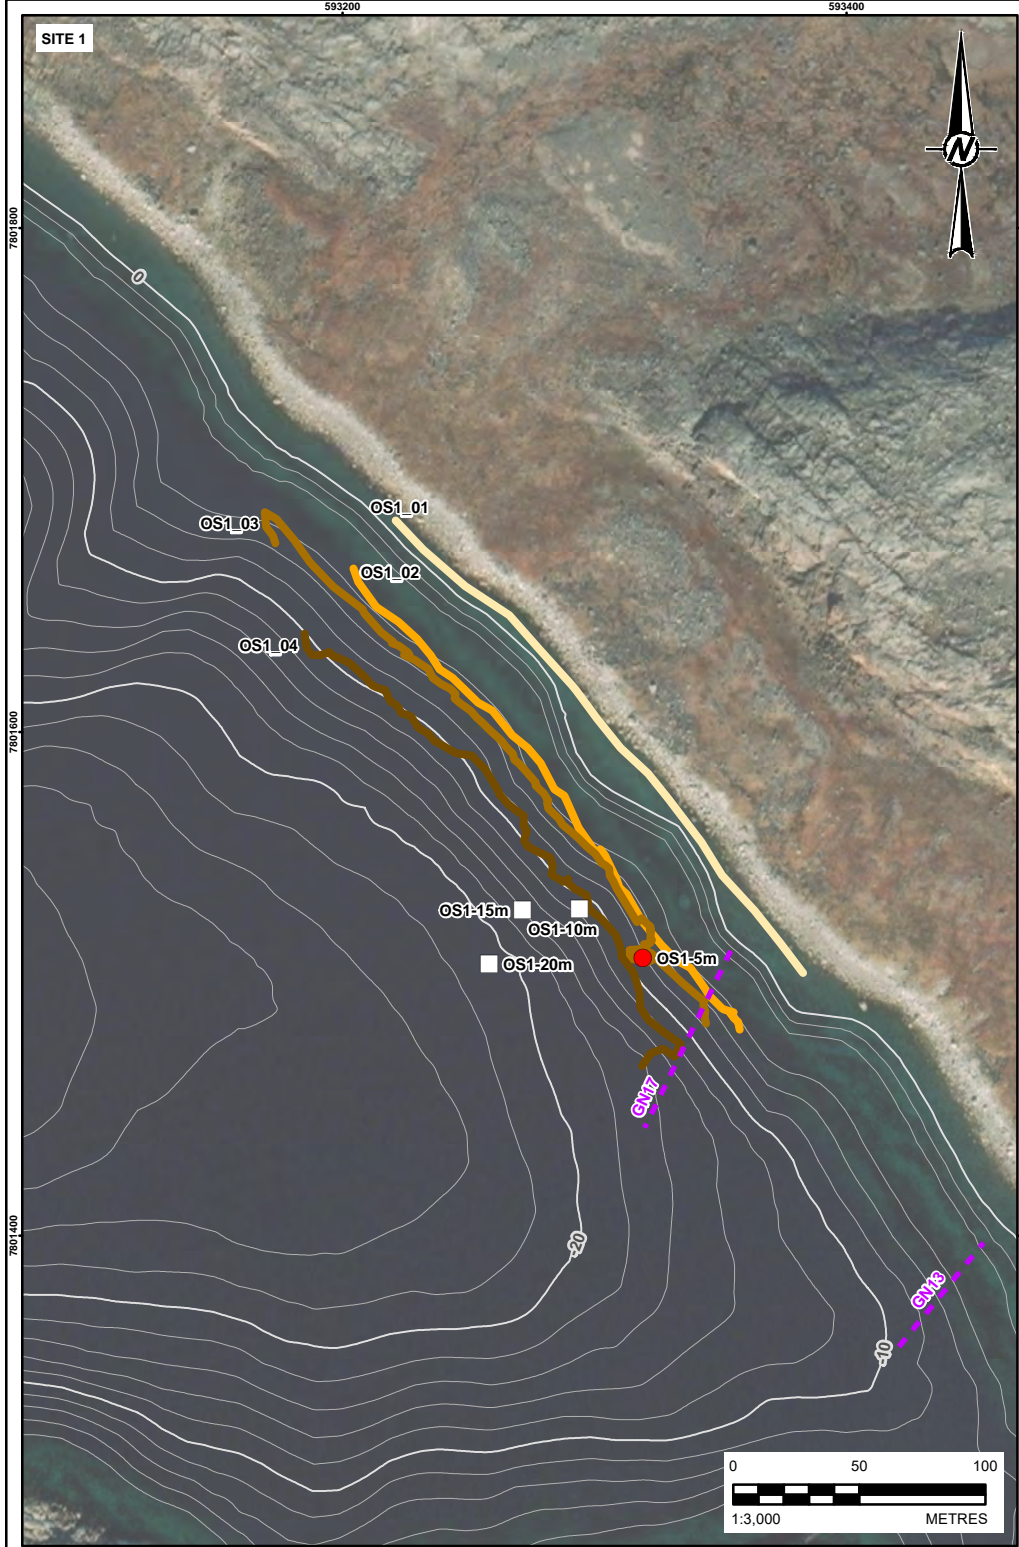
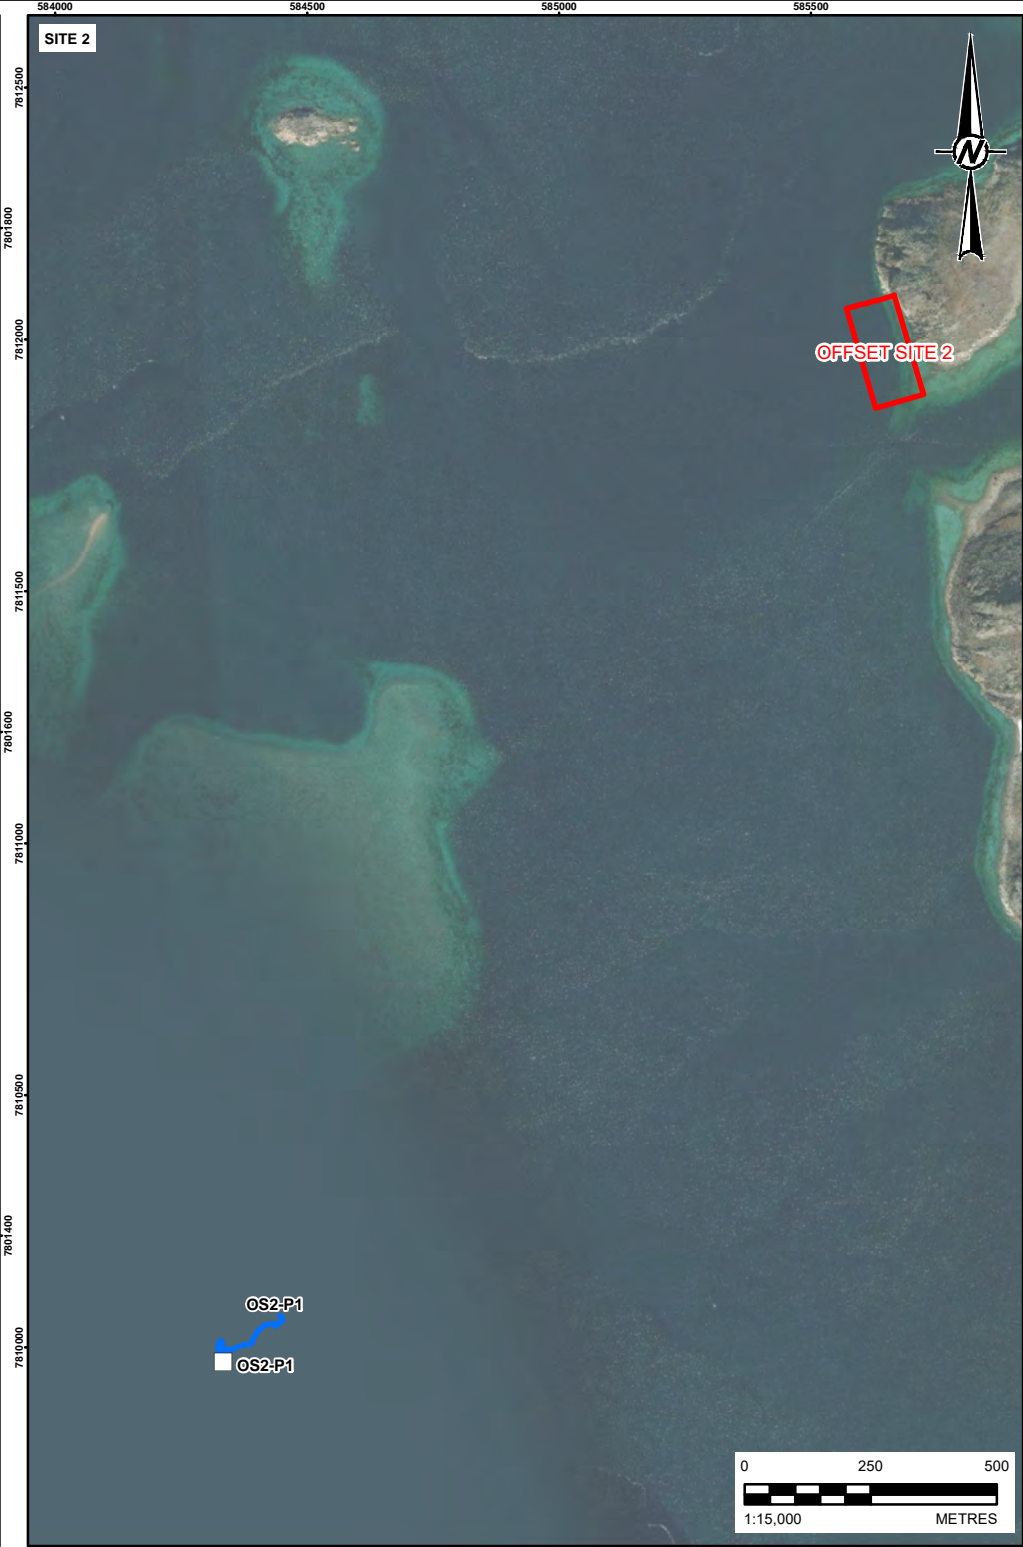
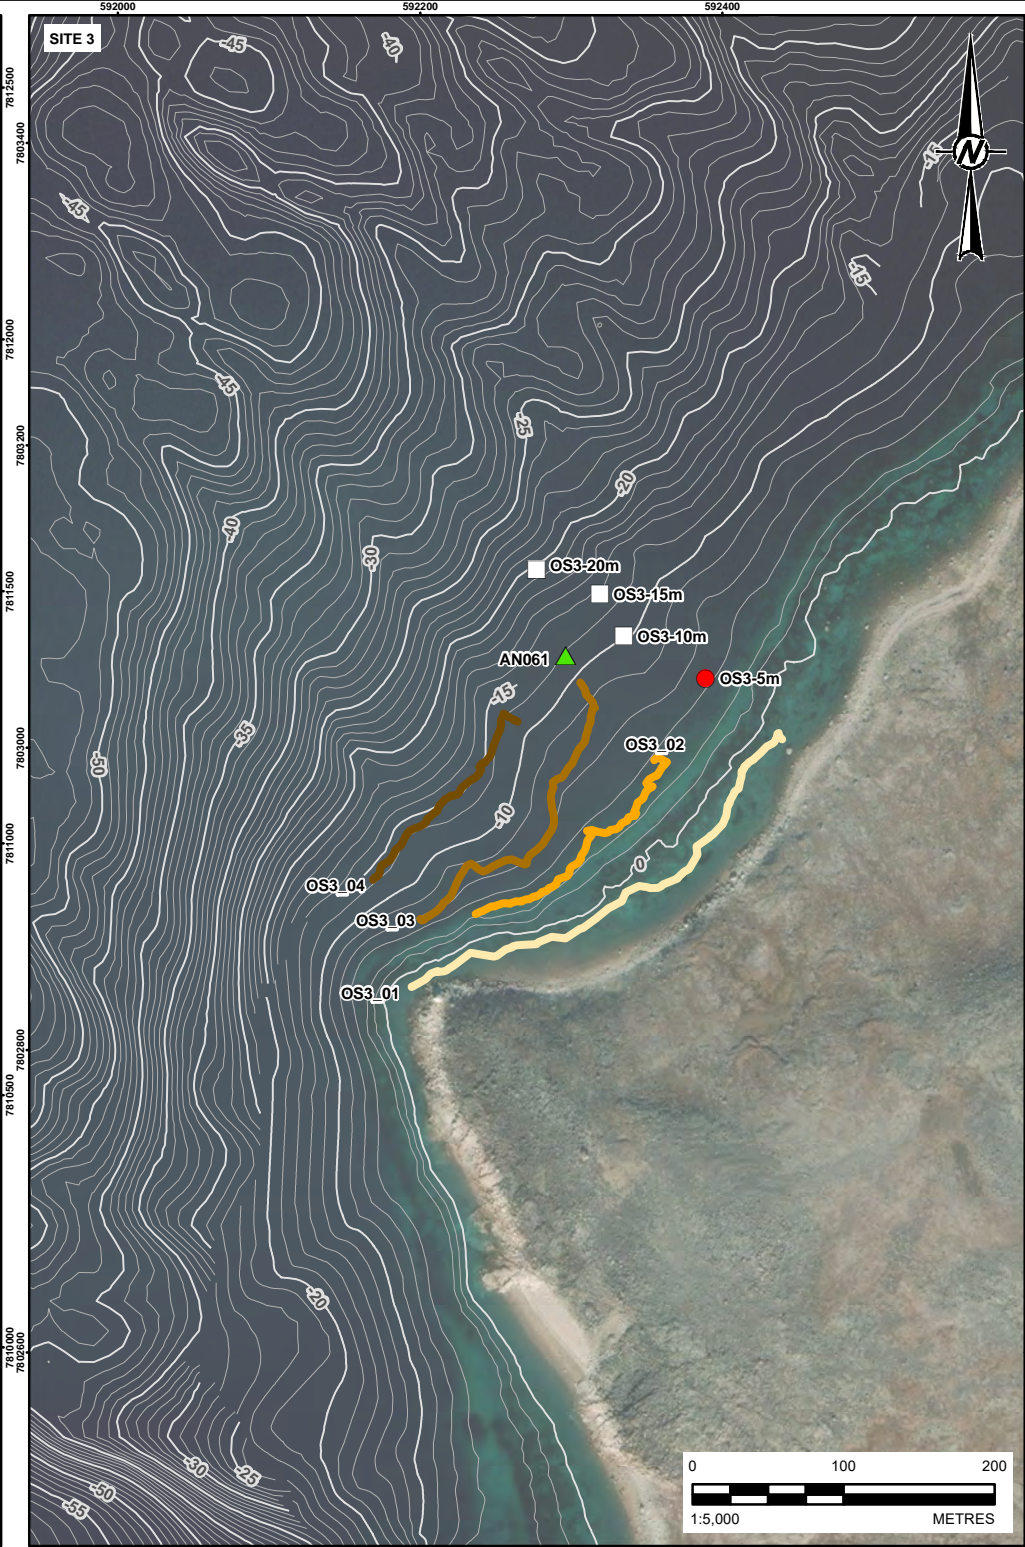
- Fish Habitat Offset Site #1 and #3 (Figure 6): Sediment samples along the -5m (chart datum) contour were unable to be collected following considerable effort due to inadequate penetration of the grab (i.e., hard bottom refusal) and sample rejection at multiple locations. Reason for sample rejection included inadequate sediment volume (<25% full) and/or incomplete closure of the grab sampler upon recovery (rocks and debris jammed in jaws of grab sampler).

- One sediment sample for grain size was collected at Habitat Offset Site #2 (Figure 6); however, the site was subsequently deemed unsuitable as a monitoring site due to lack of deep water accessibility by the RV Nuliajuk and was not sent for analysis.

- A total of six sediment samples were collected at two potential habitat offsetting sites and submitted to ALS for particle size analysis to inform the FAA application (Table 2; Figure 6).
