# TOTE ROAD CV-059

BAFFINLAND IRON MINES  
MARY RIVER PROJECT

**North/South Consultants Inc.**  
Aquatic Environment Specialists

## SITE SUMMARY

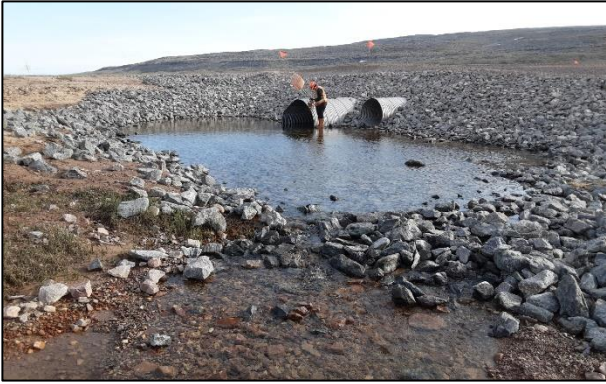
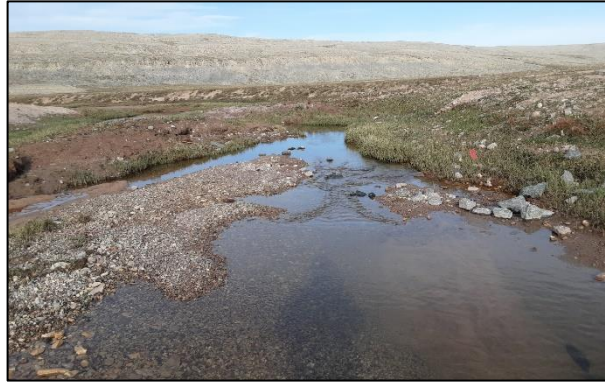
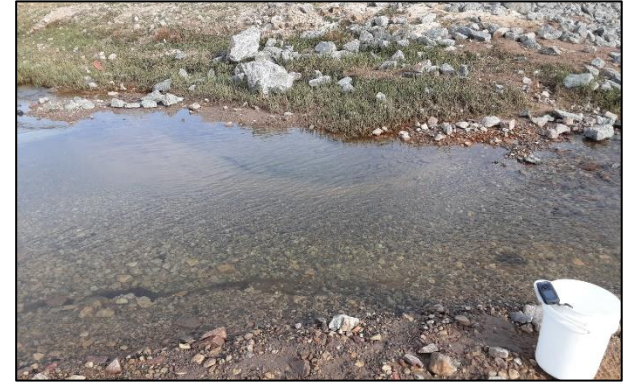
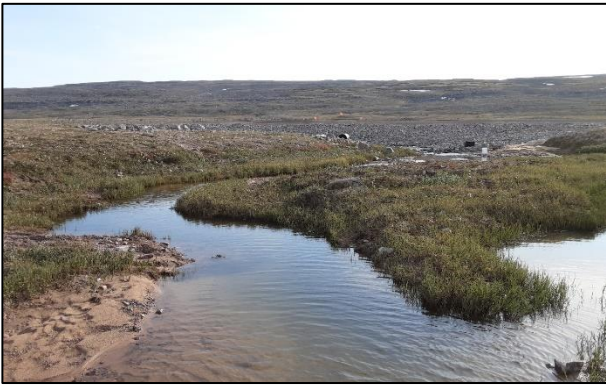
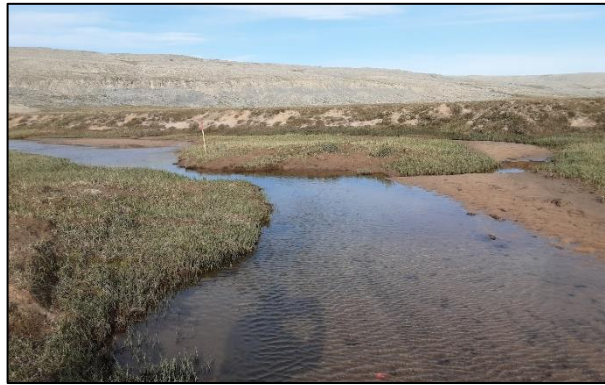
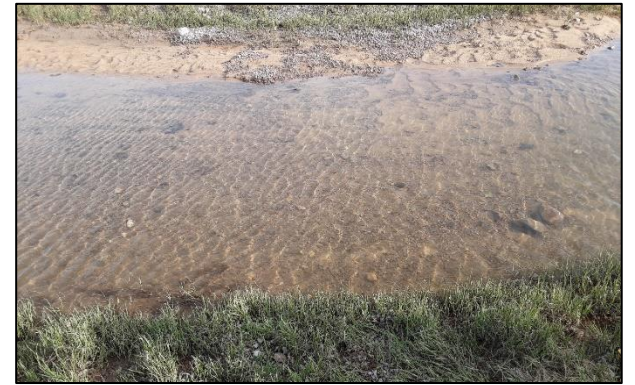
**Photos 1-1.** Photos taken 20 m downstream (top) and 60 m downstream (bottom) in spring 2024: (A,D) facing upstream; (B,E) facing downstream; and (C,F) across (left bank looking at right bank).

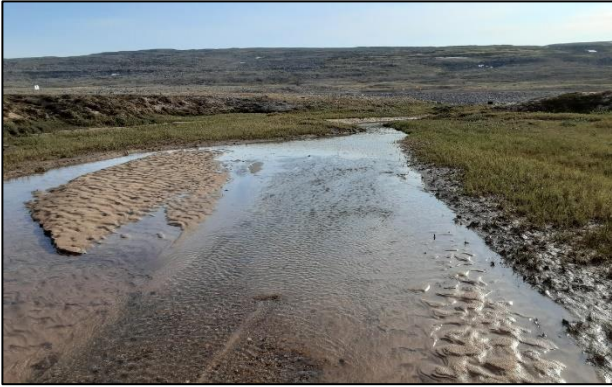
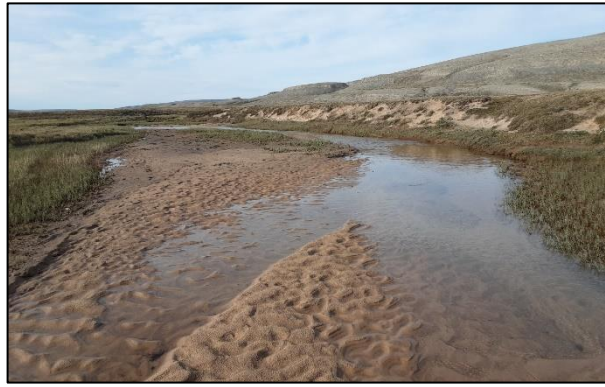
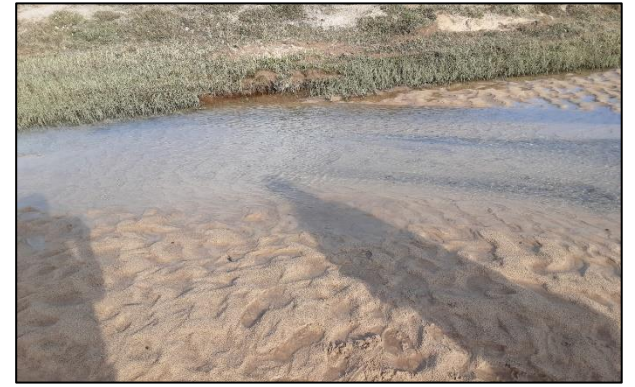
**Photos 1-2.** Photos taken 100 m downstream in spring 2024: (A) facing upstream; (B) facing downstream; and (C) across (left bank looking at right bank).

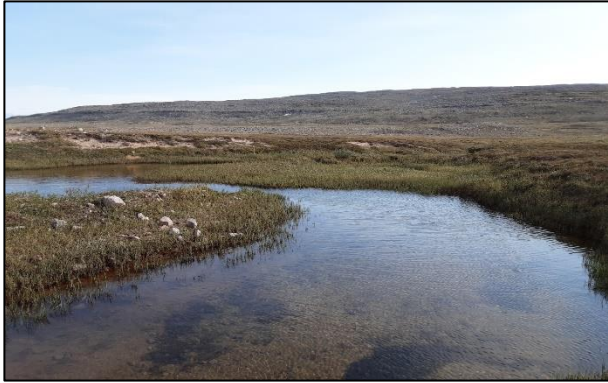
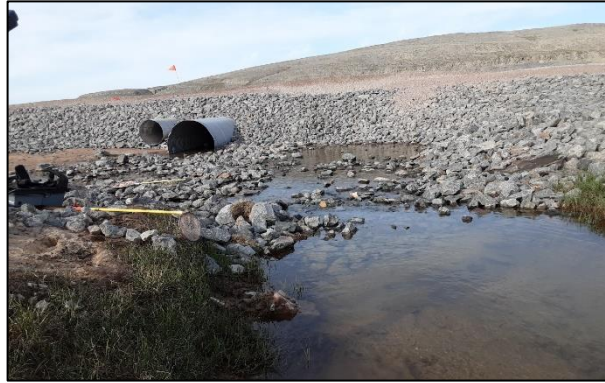
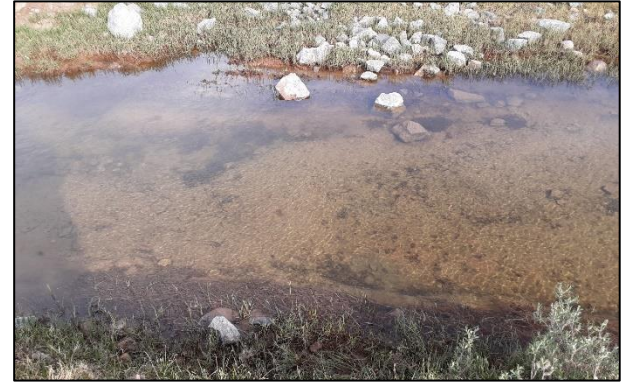
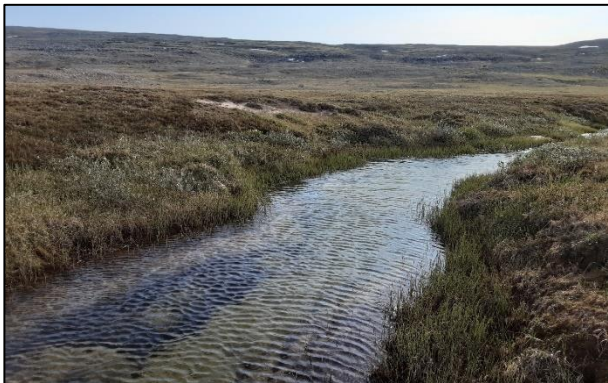
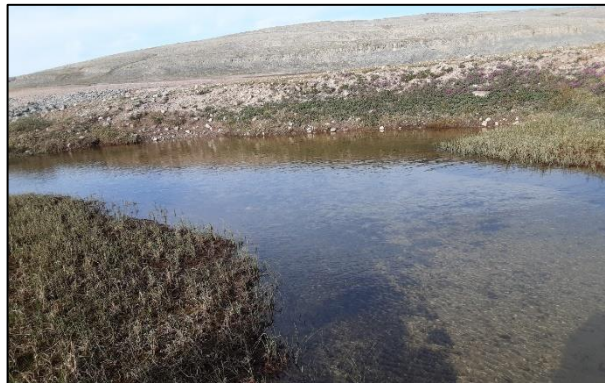
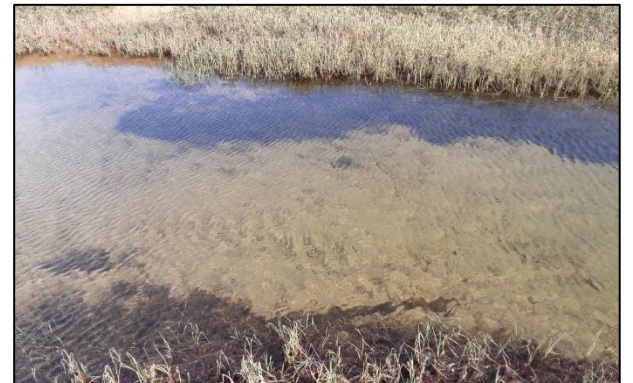
**Photos 1-3.** Photos taken 20 m upstream (top) and 60 m upstream (bottom) in spring 2024: (A,D) facing upstream; (B,E) facing downstream; and (C,F) across (left bank looking at right bank).

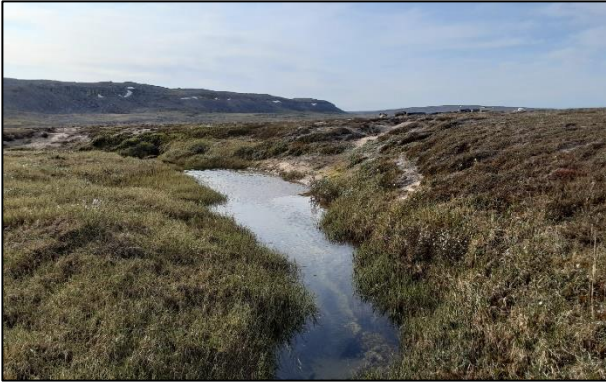
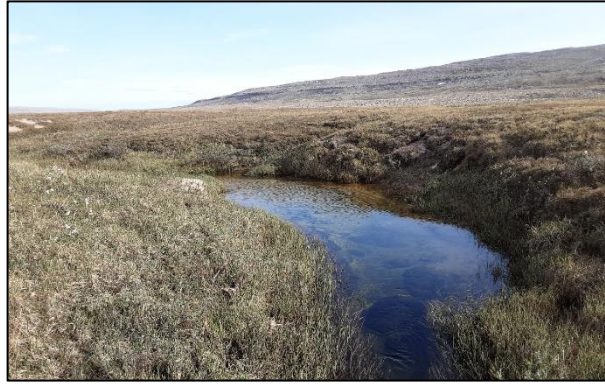
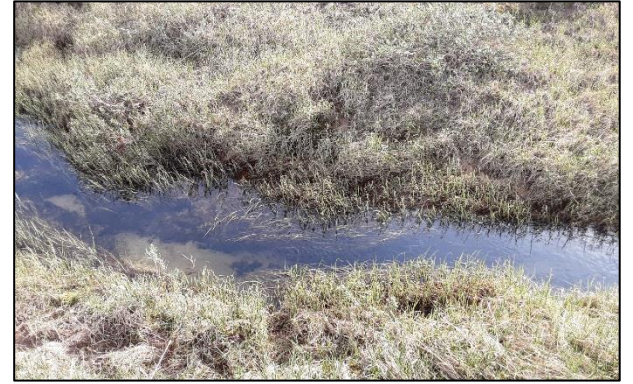
**Photos 1-4.** Photos taken 100 m upstream in spring 2024: (A) facing upstream; (B) facing downstream; and (C) across (left bank looking at right bank).

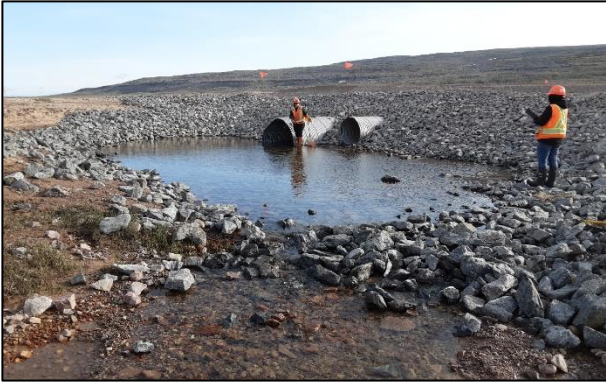
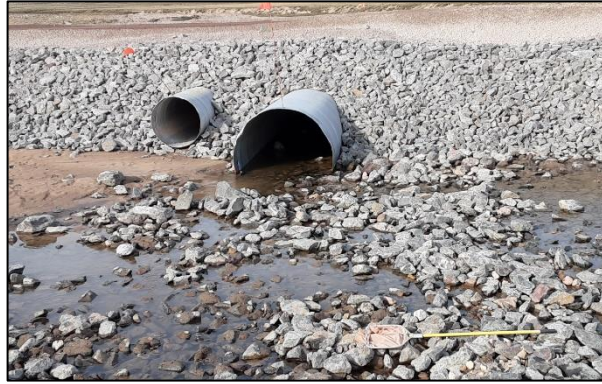
This stream is generally deep, and slow moving. Wetted widths in spring 2024 ranged from 1.1 to 6.6 m. Maximum depths reached as high as 0.96 m with a range of 0.3-0.96 m. Measured velocities ranged from 0.00-0.64 m/s. Stream morphology varied in accordance with wetted width. In wider areas, morphology tended to be primarily deep pools, whereas riffle-run was more common where the stream narrowed. Wider areas of the stream were nearly uniformly composed of fine substrate, with cobble/gravel dominating in the narrow areas. There are greater proportions of cobble within 20 m of the culvert since remediation due to the new cobble aprons.

**Photos 1-5.** Photos taken of the culverts in spring 2024: (A) downstream end; and (B) upstream end.

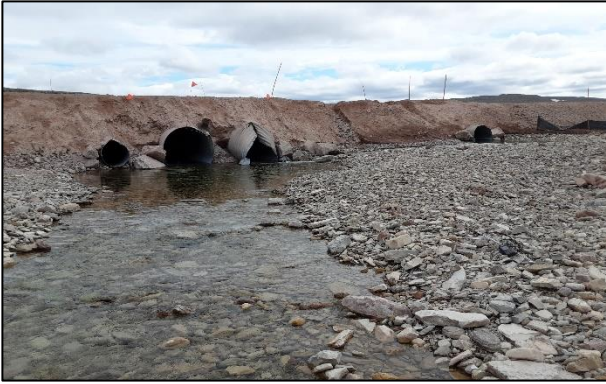
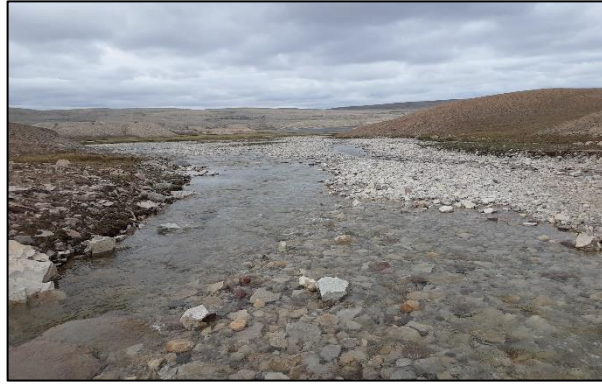
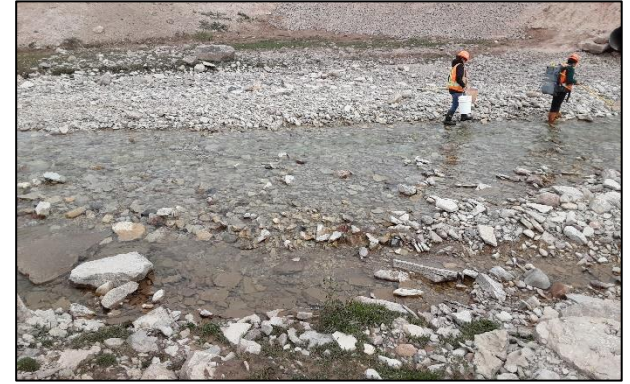
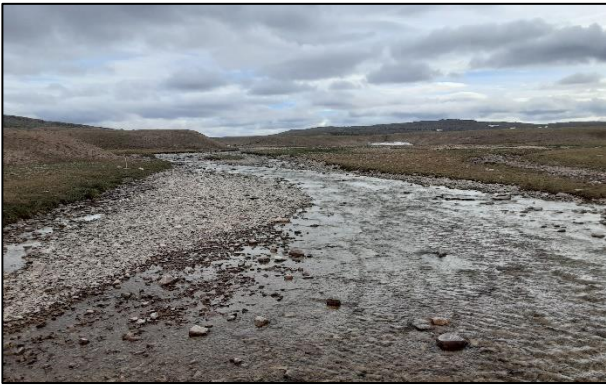
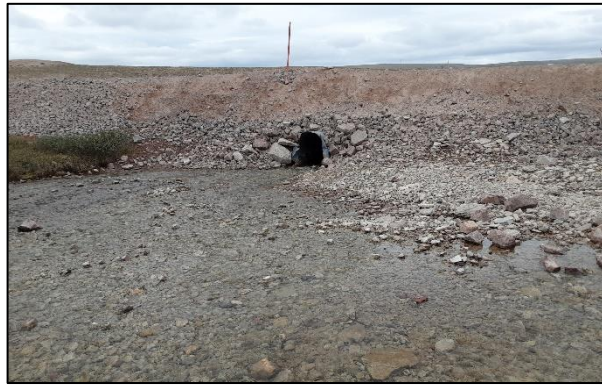
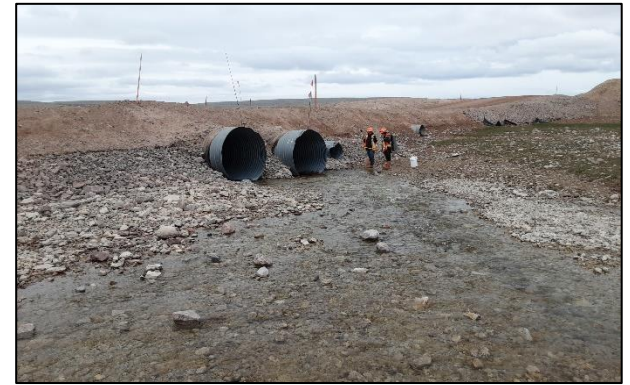
**Photos 1-1.** Photos taken 20 m downstream (top) and 20 m upstream (bottom) in spring 2024: (A,D) facing upstream; (B,E) facing downstream; and (C,F) across (right bank looking at left bank).

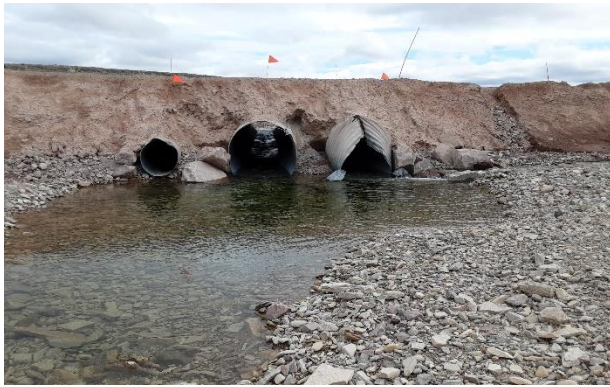
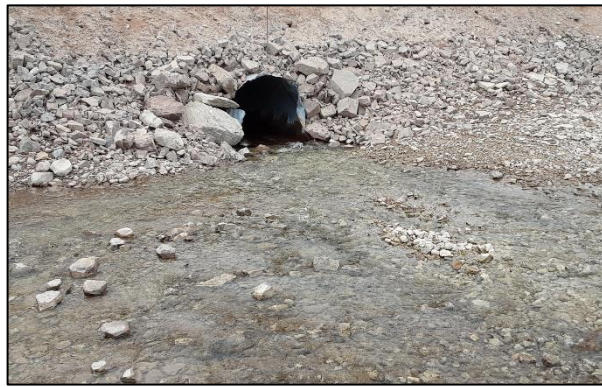
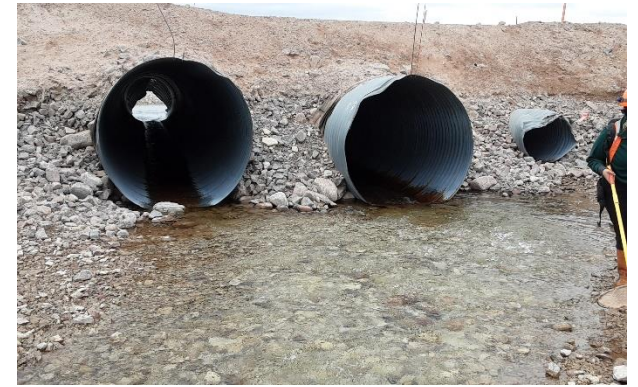
The Tote Road crosses an unnamed stream at site CV-078 that flows 100 m west before splitting into two main channels; one channel flows 640 m southwest to Phillips Creek at its outflow from Katiktok Lake and the other flows 700 m west to a small lake adjacent ,and connected, to Phillips Creek. Flows from the CV-078 stream merge with those from the stream crossed by the road at CV-079 prior to emptying into the small lake. Although a bathymetric survey has not been conducted, the lake is believed to be of sufficient depth to support overwintering of both species. Katiktok Lake is of sufficient depth to support overwintering. This site has been identified for remediation.

**Photos 1-2.** Photos taken of the culverts in spring 2024: (A) downstream end; and (B) upstream end.

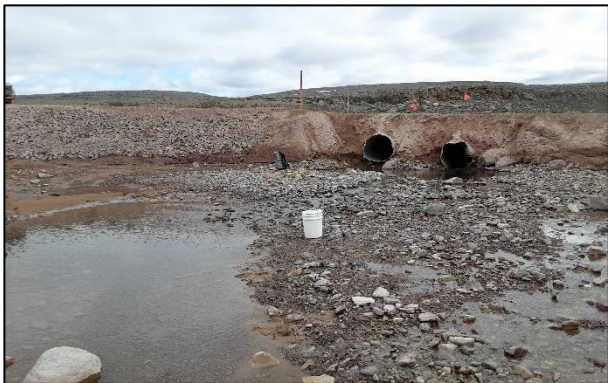
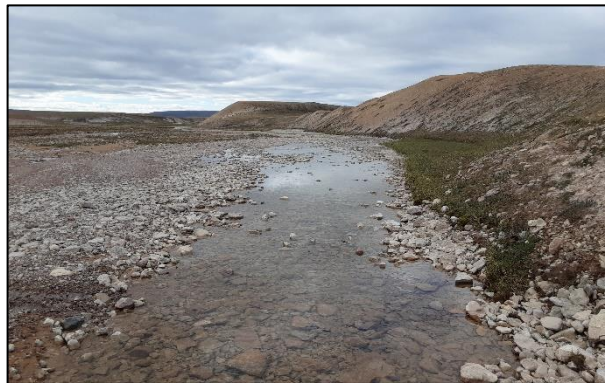
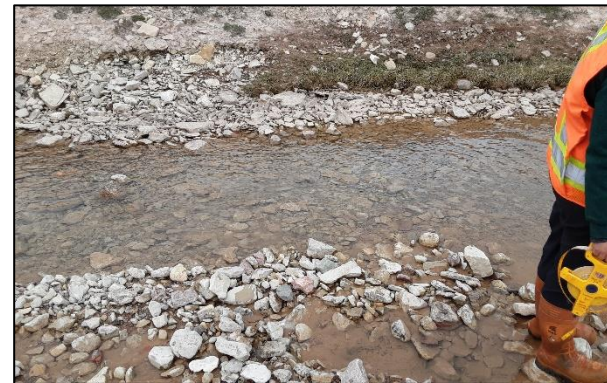
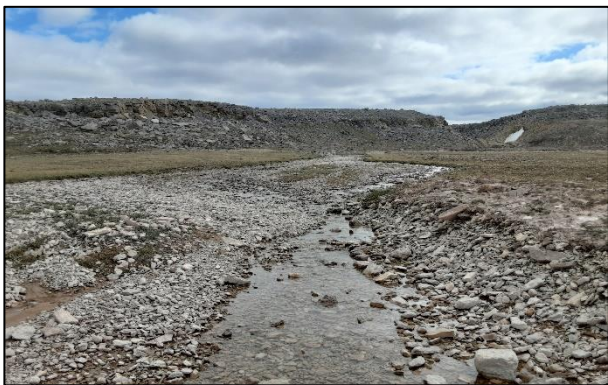
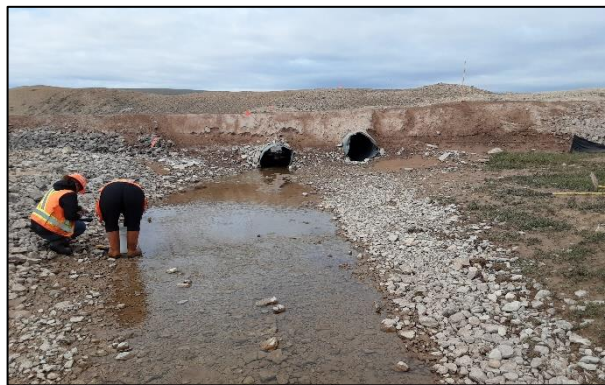
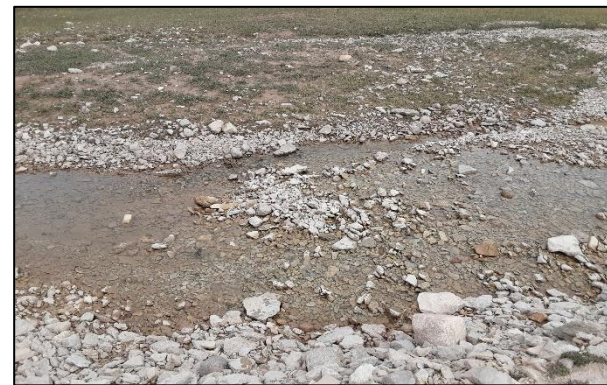
**Photos 1-1.** Photos taken 20 m downstream (top) and 20 m upstream (bottom) in the lefthand channel in spring 2024: (A,D) facing upstream; (B,E) facing downstream; and (C,F) across (right bank looking at left bank).

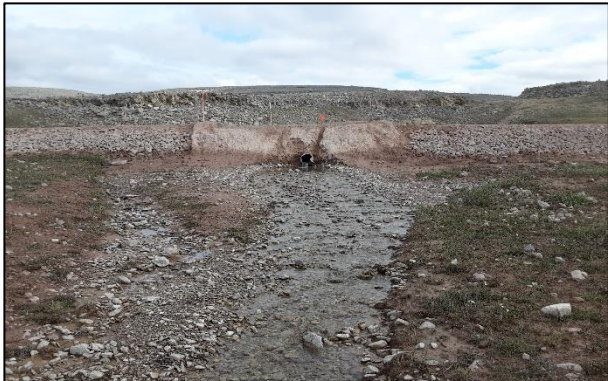
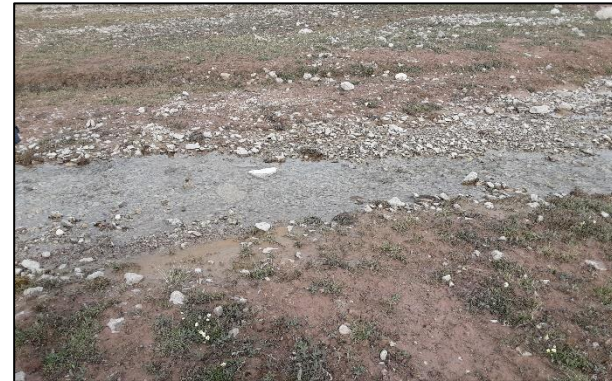
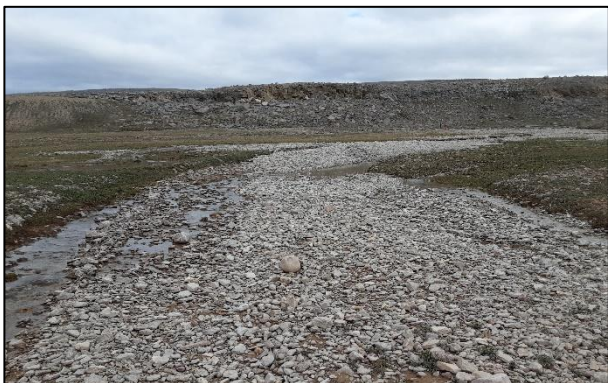
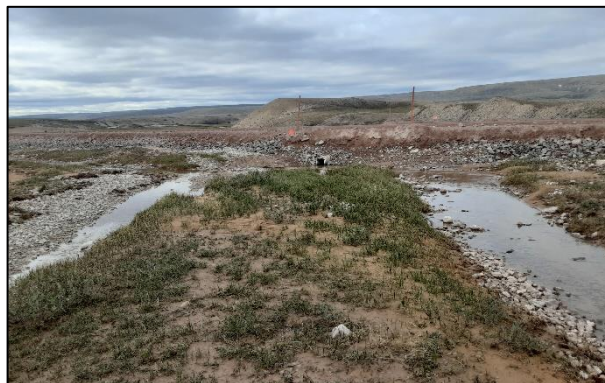
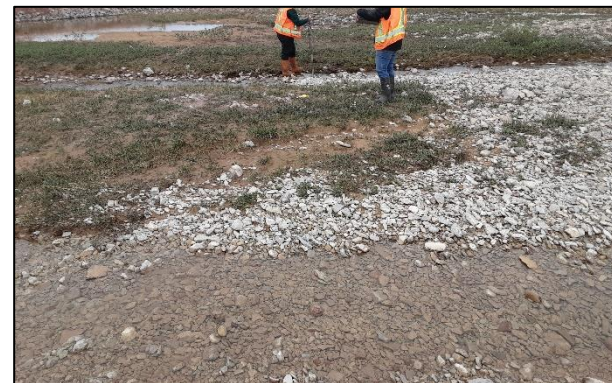
**Photos 1-2.** Photos taken 20 m downstream (top) and 20 m upstream (bottom) in the middle channel in spring 2024: (A,D) facing upstream; (B,E) facing downstream; and (C,F) across (right bank looking at left bank).

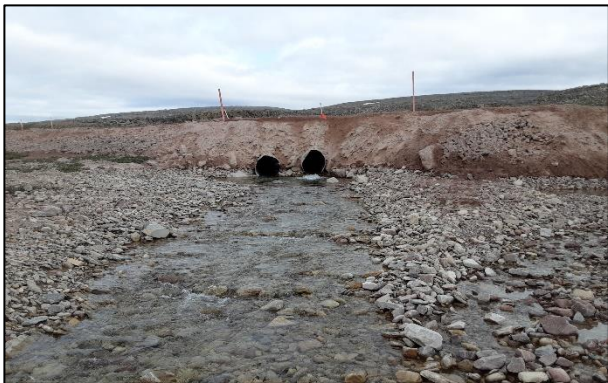
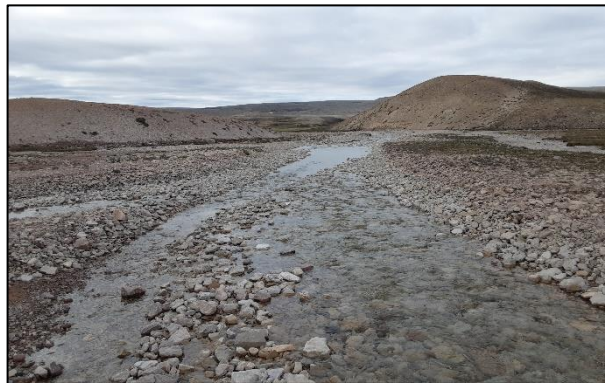
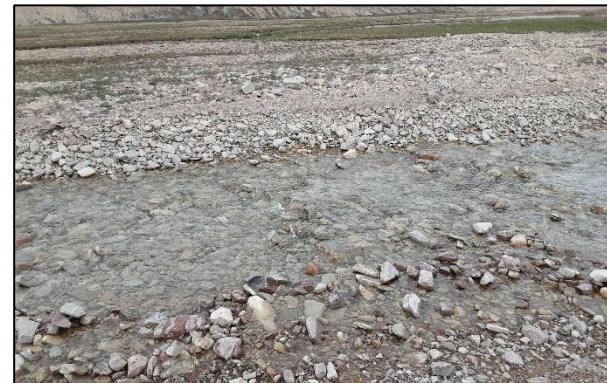
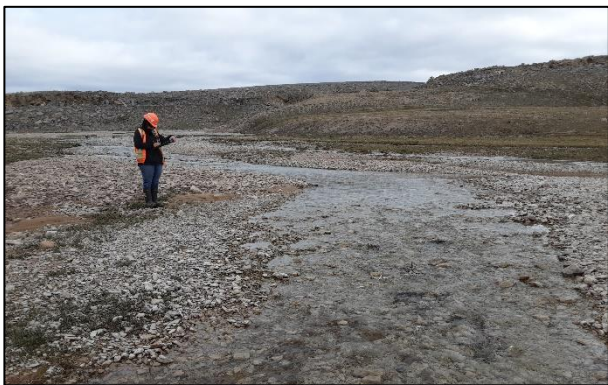
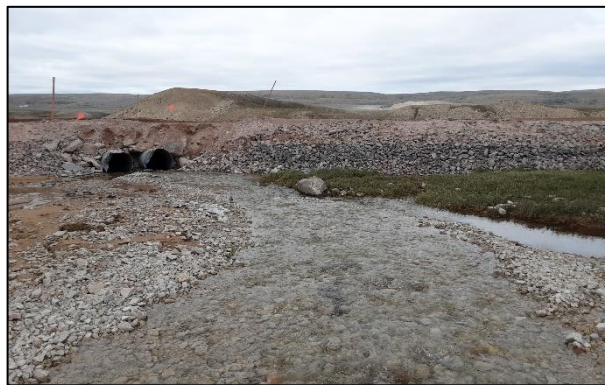
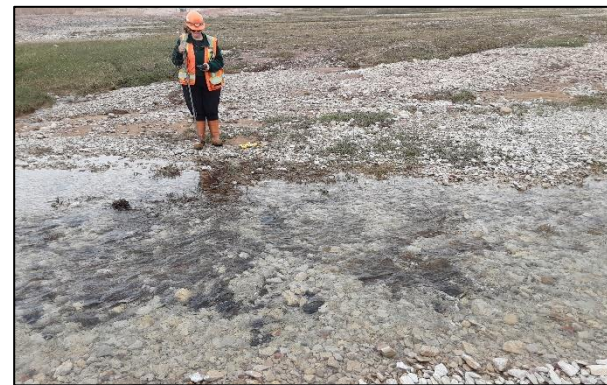
**Photos 1-3.** Photos taken 20 m downstream (top) and 20 m upstream (bottom) in the righthand channel in spring 2024: (A,D) facing upstream; (B,E) facing downstream; and (C,F) across (right bank looking at left bank).

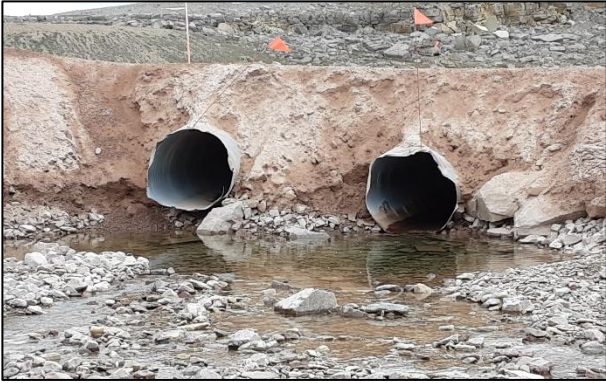
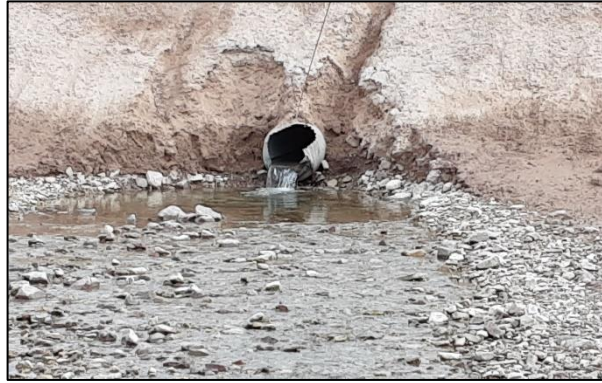
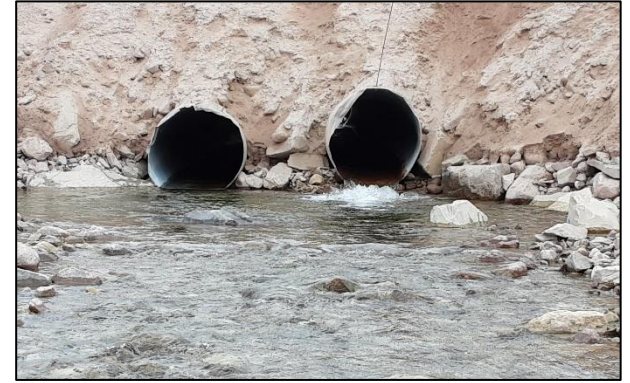
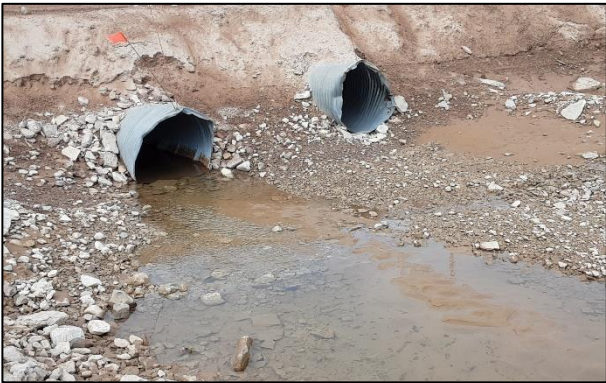
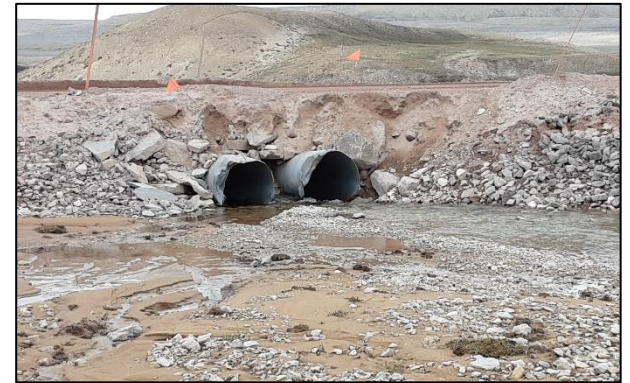
The Tote Road crosses an unnamed stream at site CV-079 that flows 700 m southwest into a small lake adjacent, and connected, to Phillips Creek. Flows from the CV-079 stream merge with those from the stream crossed by the road at CV-078 prior to emptying into the small lake. Although a bathymetric survey has not been conducted, the lake is believed to be of sufficient depth to support overwintering of both species based on review of available imagery. The stream is highly braided at the road crossing, with at least three channels that persist throughout the open-water period and several smaller ones that are intermittent. This crossing has been identified for remediation.

**Photos 1-4.** Photos taken of the culvert at the downstream end (top) and upstream end (bottom) in spring 2024: (A,D) lefthand channel; (B,E) middle channel; and (C,F) righthand channel.

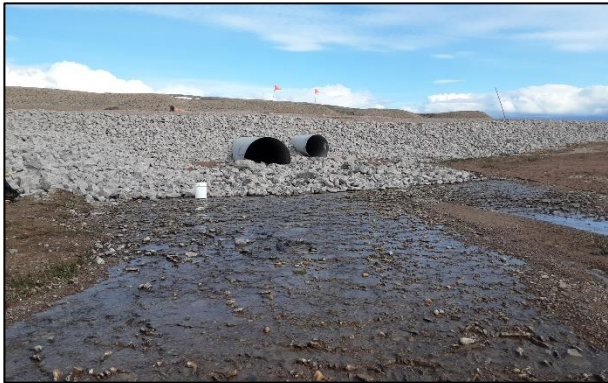
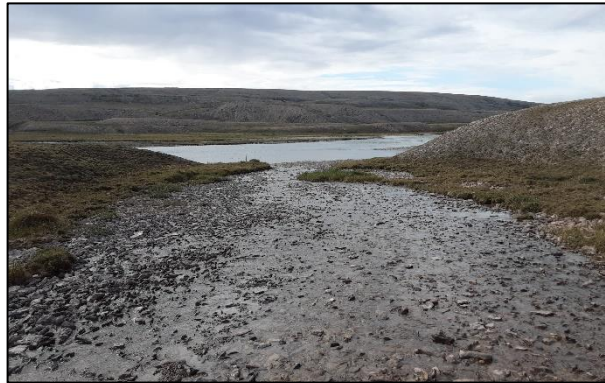
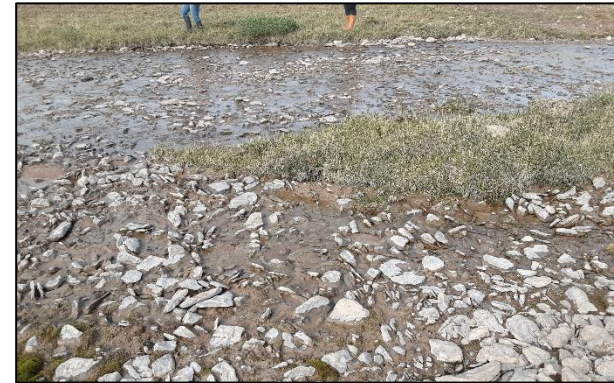
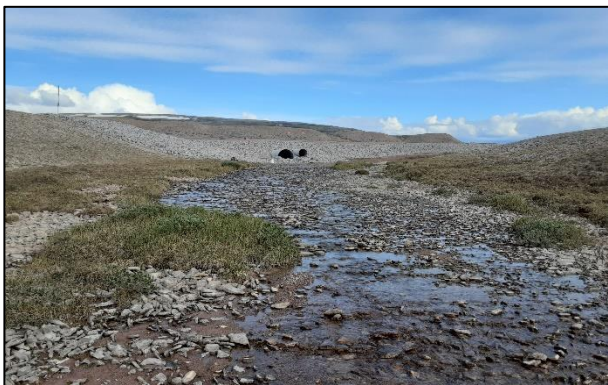
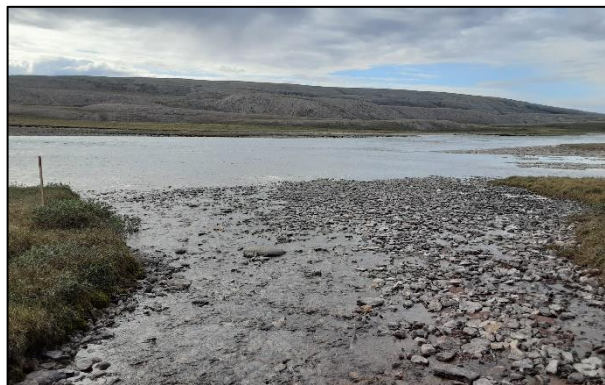
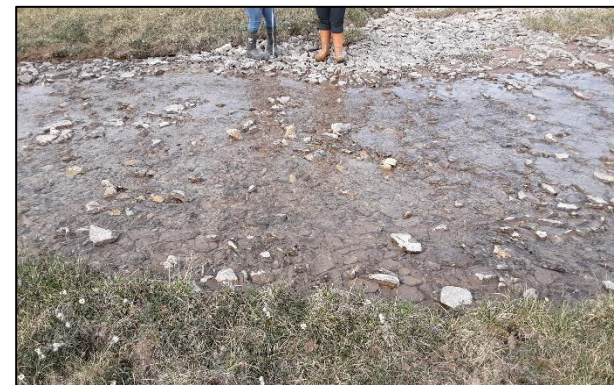
**Photos 1-1.** Photos taken 20 m downstream (top) and 60 m downstream (bottom) in spring 2024: (A,D) facing upstream; (B,E) facing downstream; and (C,F) across (left bank looking at right bank).

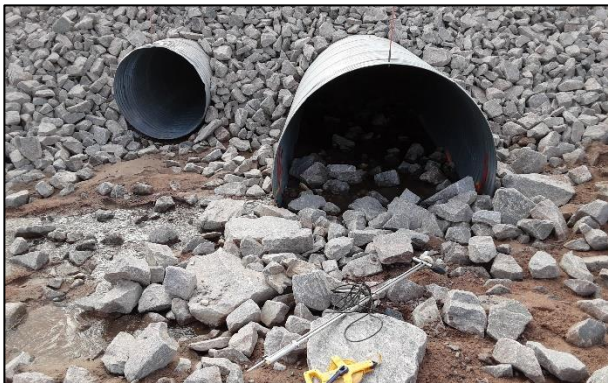
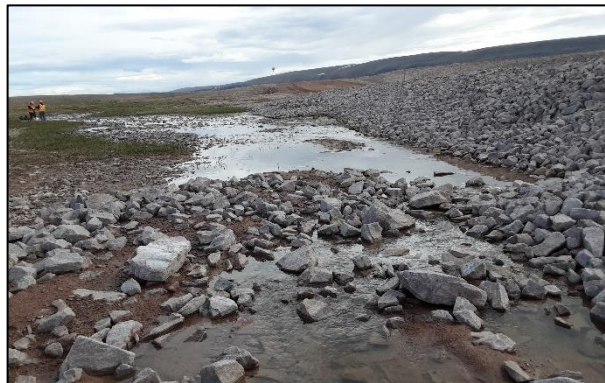
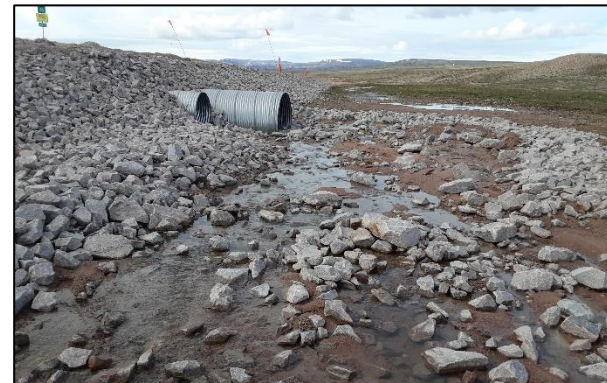
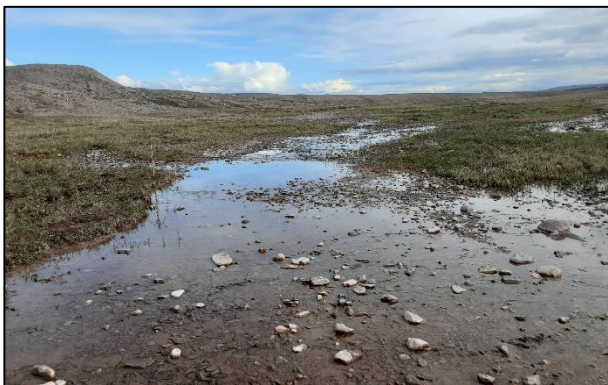
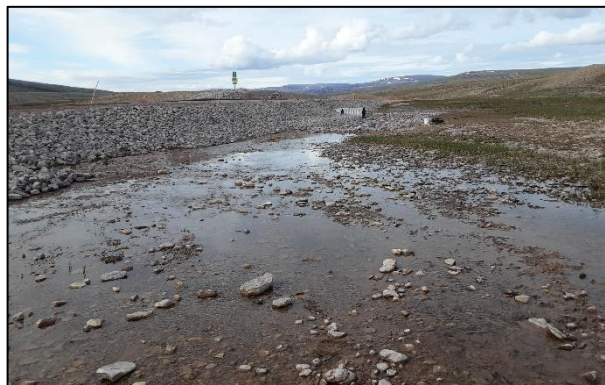
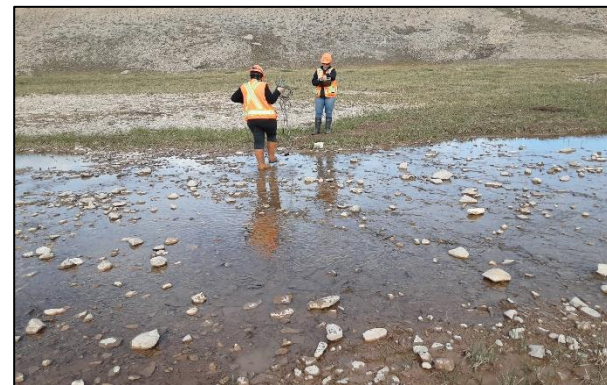
**Photos 1-2.** Photos taken 20 m upstream (top) and 60 m upstream (bottom) in spring 2024: (A,D) facing upstream; (B,E) facing downstream; and (C,F) across (left bank looking at right bank).

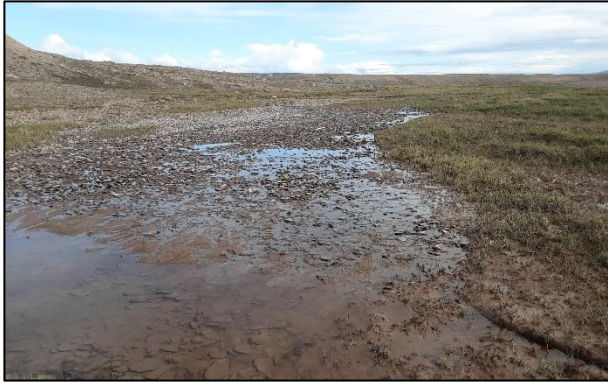
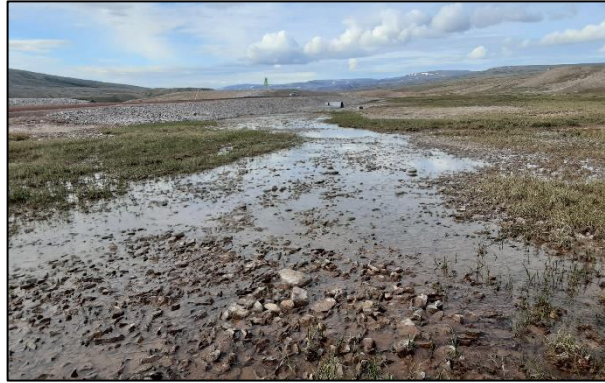
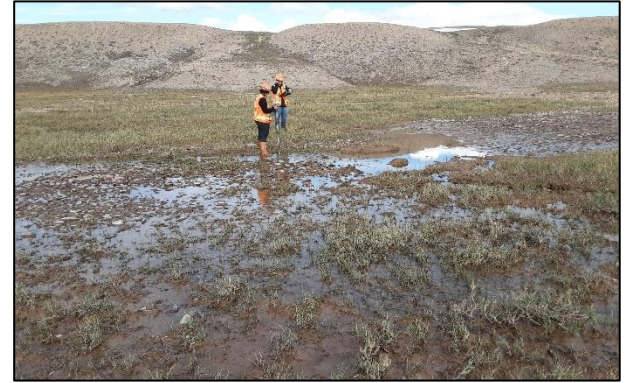
**Photos 1-3.** Photos taken 100 m upstream in spring 2024: (A) facing upstream; (B) facing downstream; and (C) across (left bank looking at right bank).
