TOTE ROAD CV-106

LOCATION AND CROSSING DESCRIPTION

BAFFINLAND IRON MINES
MARY RIVER PROJECT

**North/South Consultants Inc.**
Aquatic Environment Specialists

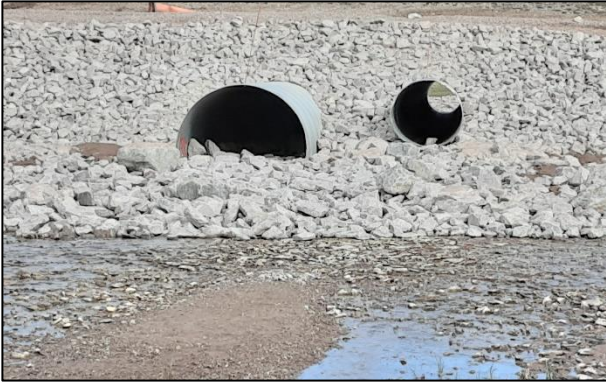
Photos 1-4. Photos taken of the culverts at the downstream end in spring 2024.

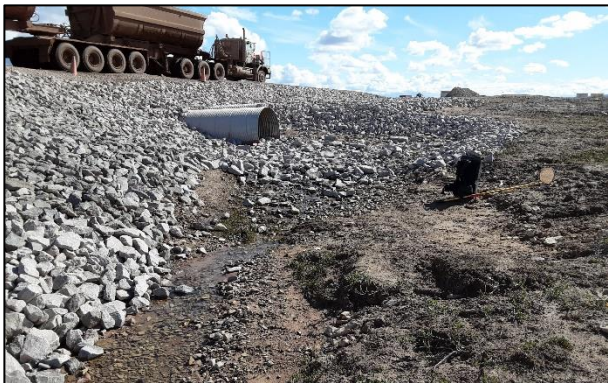
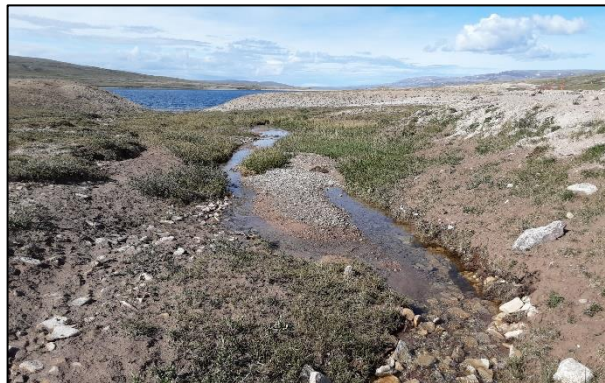
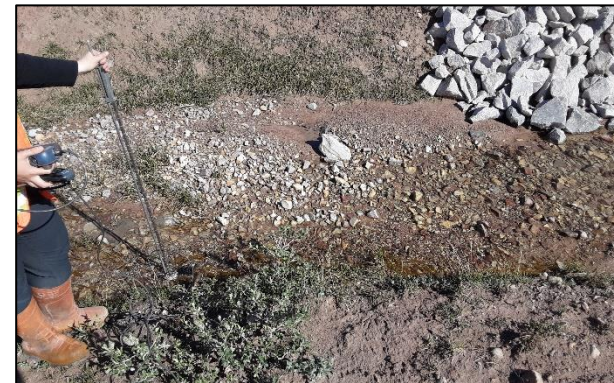
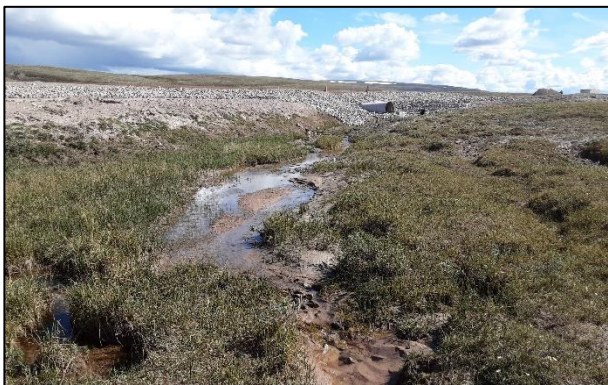
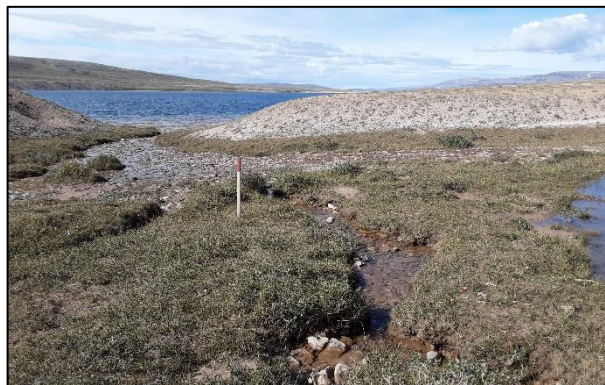
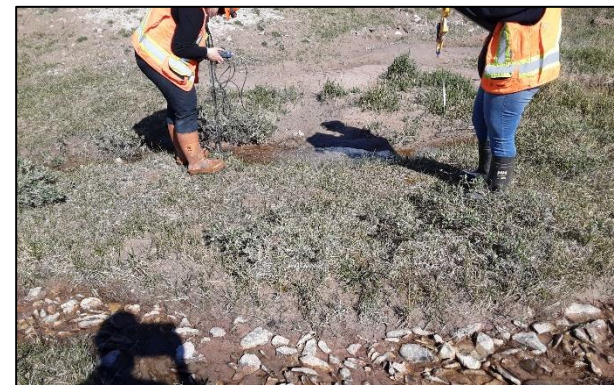
Photos 1-1. Photos taken 20 m downstream (top) and 60 m downstream (bottom) in spring 2024: (A,D) facing upstream; (B,E) facing downstream; and (C,F) across (left bank looking at right bank).

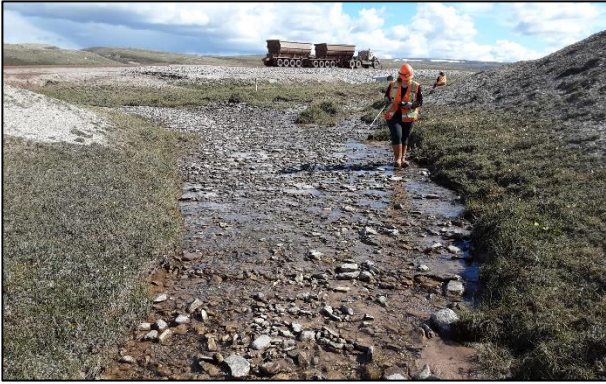
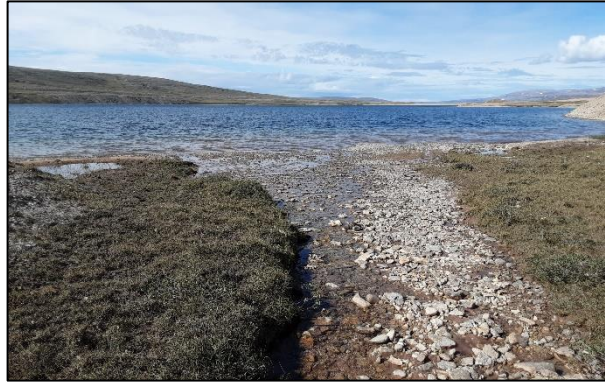
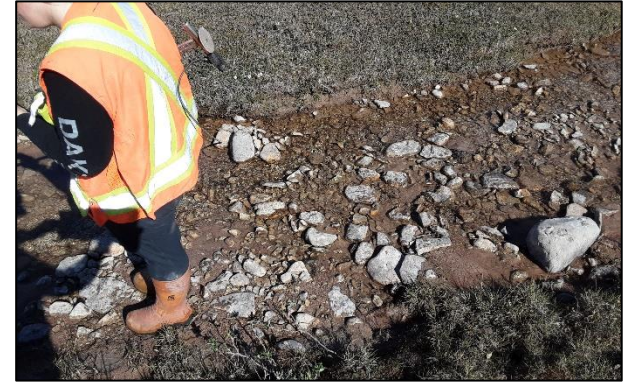
Photos 1-2. Photos taken 100 m downstream in spring 2024: (A) facing upstream; (B) facing downstream; and (C) across (left bank looking at right bank).

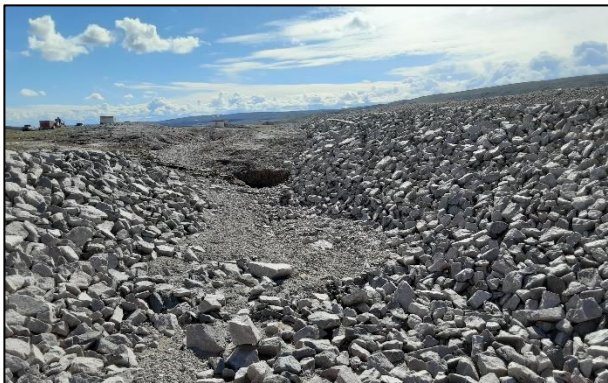
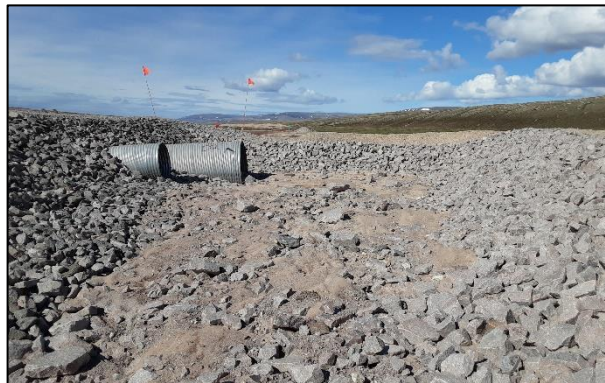
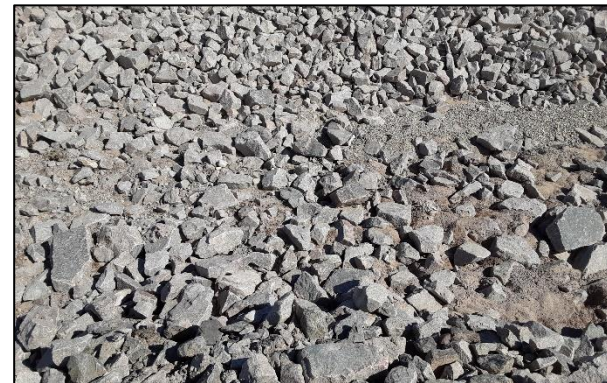
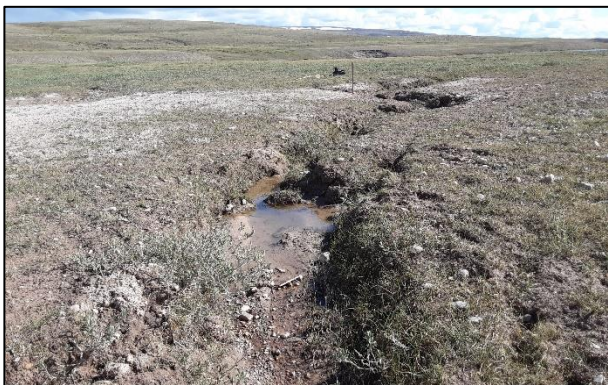
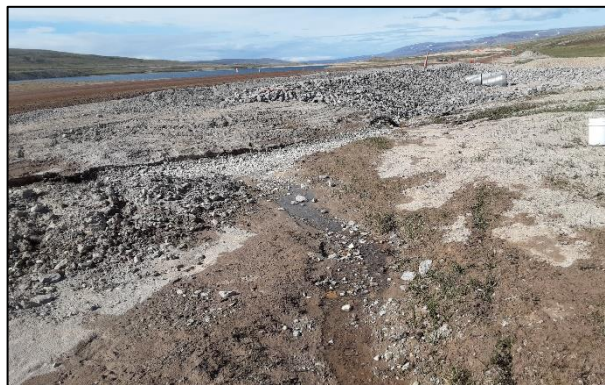
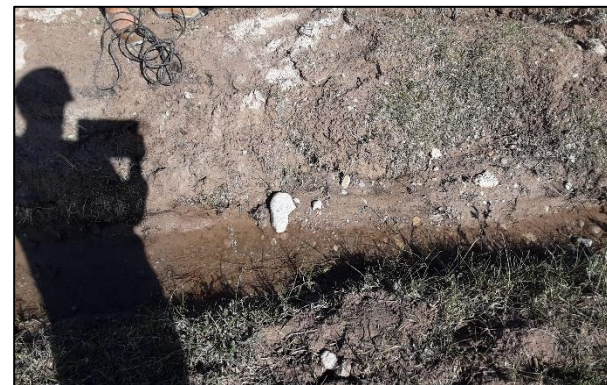
Photos 1-3. Photos taken 20 m upstream (top) and 60 m upstream (bottom) in spring 2024: (A,D) facing upstream; (B,E) facing downstream; and (C,F) across (left bank looking at right bank).

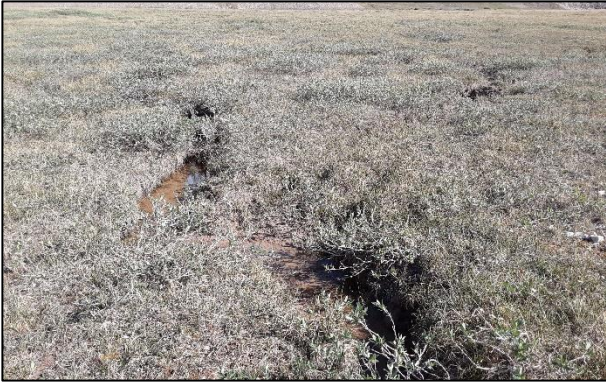
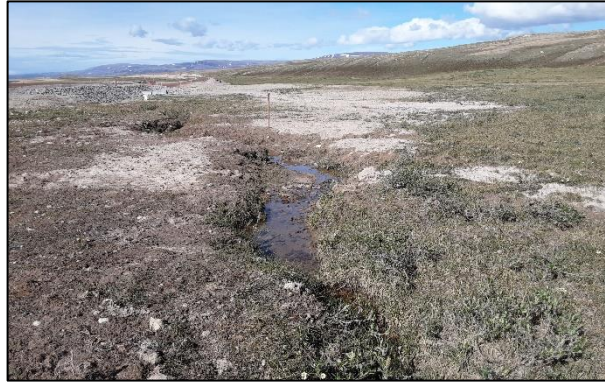
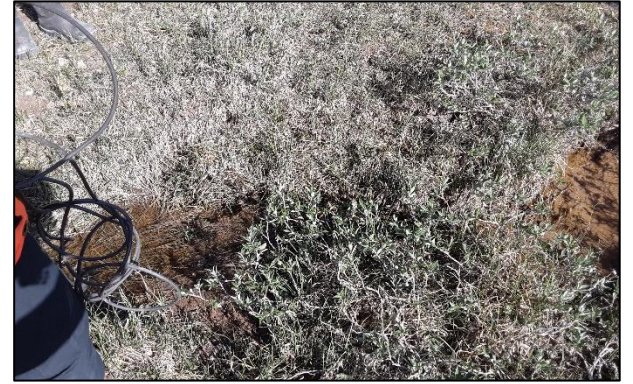
Photos 1-4. Photos taken 100 m upstream in spring 2024: (A) facing upstream; (B) facing downstream; and (C) across (left bank looking at right bank).

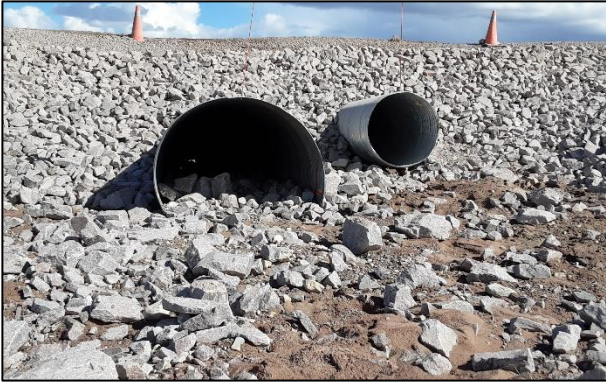
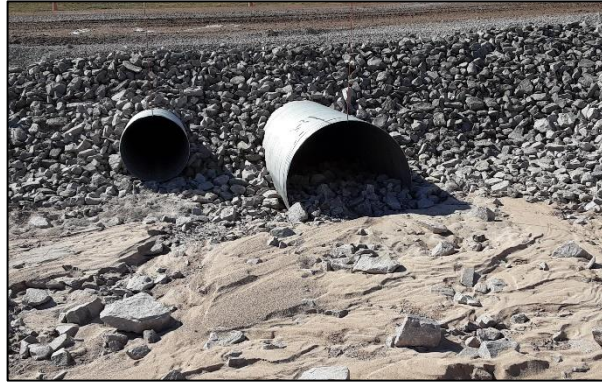
This crossing was remediated in winter 2023/2024. There is now a large, embedded fish passage culvert at the crossing, however the large aggregate material used in the apron and inside the culvert is too large for typical flows in this stream. As a result, by the site visit on 12 July, flows had become subsurface under the aprons and fish no longer had access to upstream habitat.

Photos 1-5. Photos taken of the culverts in spring 2024: (A) downstream end; and (B) upstream end.

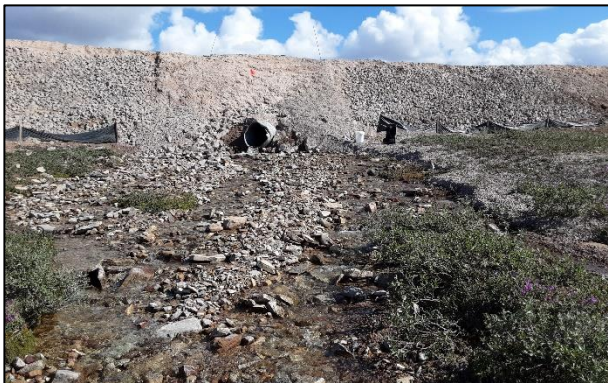
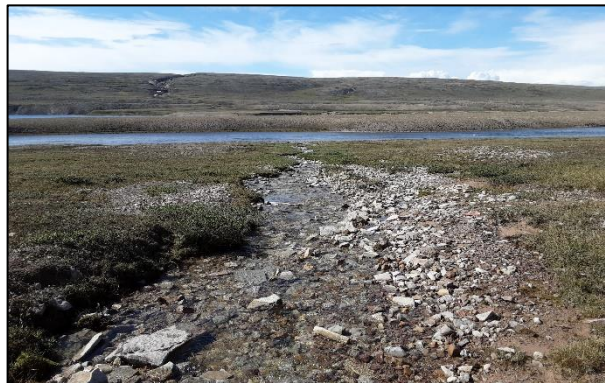
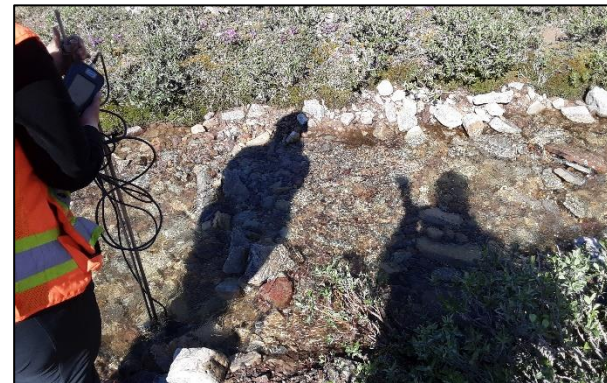
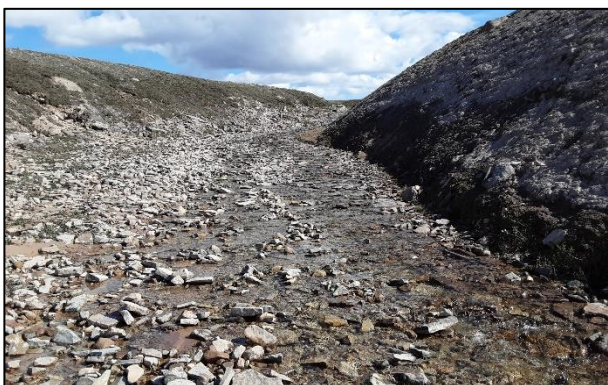
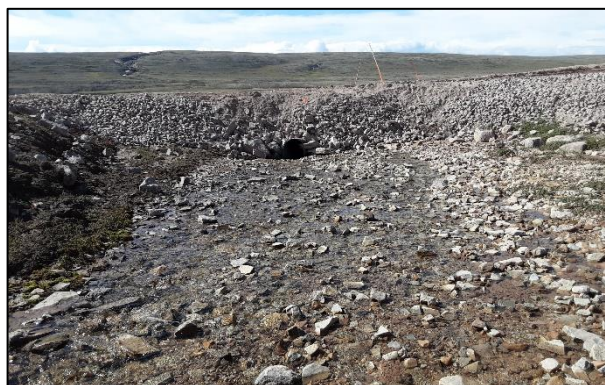
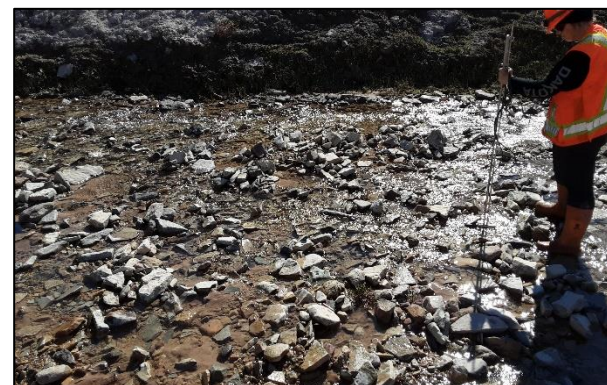
Photos 1-1. Photos taken 20 m downstream (top) and 20 m upstream (bottom) in spring 2024: (A,D) facing upstream; (B,E) facing downstream; and (C,F) across (right bank looking at left bank).

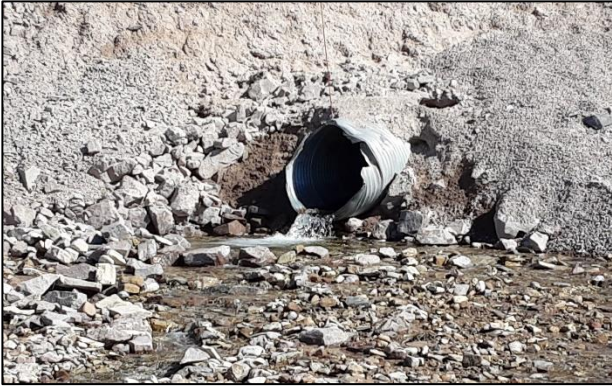
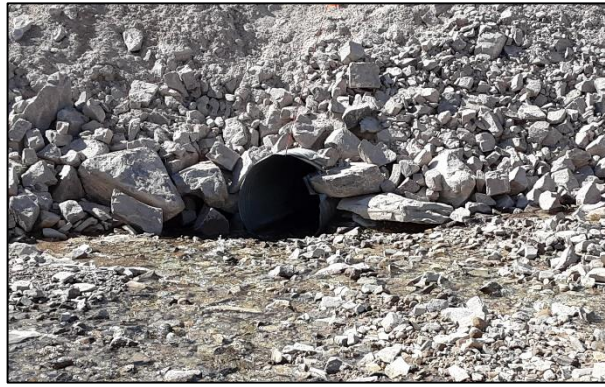
Twenty-one small (43-98 mm) juvenile Arctic Char were captured downstream of the crossing in spring 2024. A single large (200 mm) juvenile was captured upstream. The culvert is currently perched (0.33 m) and is likely preventing most, if not all, fish access to upstream areas. It is likely that the char captured upstream originated from one of the upstream lakes. Ninespine Stickleback were not captured in spring 2024 and have not been captured or observed in this stream during previous site surveys. It is unknown if the species is present in the watershed.

Photos 1-2. Photos taken of the culvert in spring 2024: (A) downstream end; and (B) upstream end.

The Tote Road crosses a small, unnamed stream at site CV-111 that flows 120 m west into Phillips Creek near its outflow from Km 32 Lake. The lake is of sufficient depth to support overwintering of both species. In addition, there are two small lakes >2.5 km upstream from the crossing, one of which has been confirmed to be of sufficient depth to support overwintering. Although a bathymetric survey of the second upstream lake has not been conducted it is also believed to be of sufficient depth to support overwintering. Juvenile char were captured along the shorelines of both upstream lakes in 2019. This crossing has been identified for remediation.

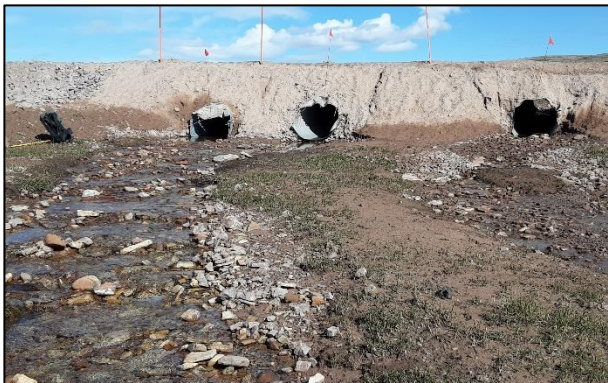
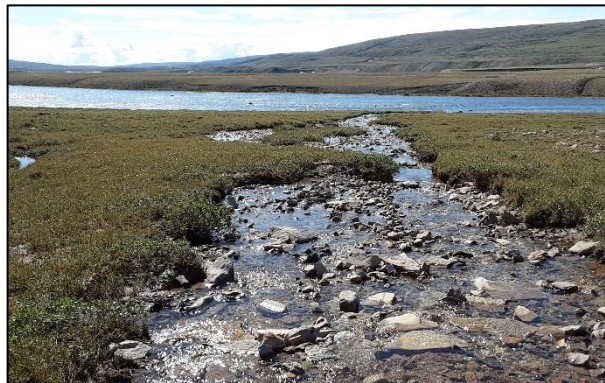
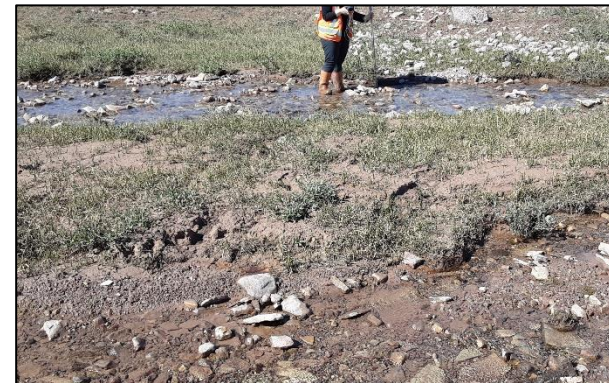
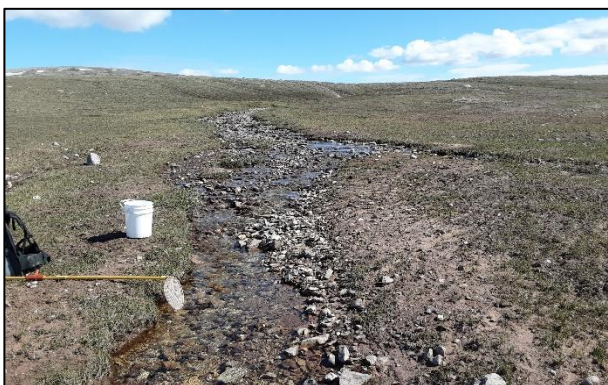
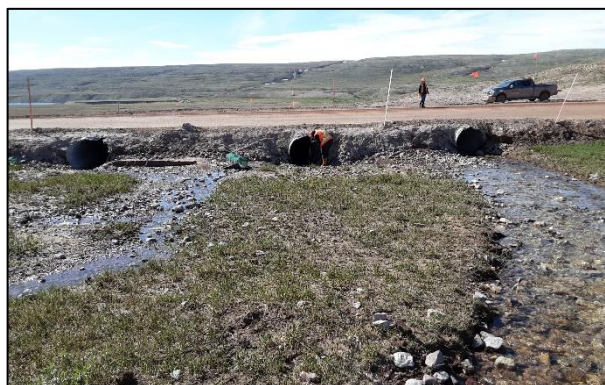
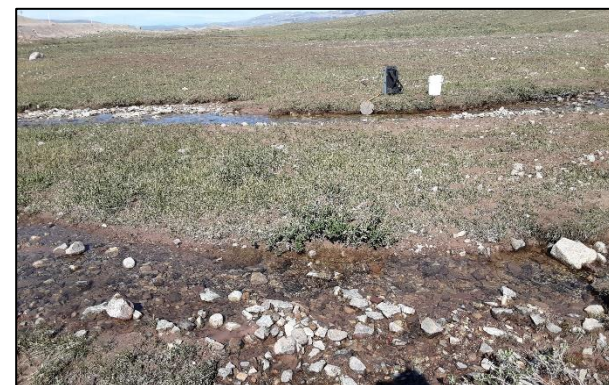
Photos 1-1. Photos taken 20 m downstream (top) and 20 m upstream (bottom) in spring 2024: (A,D) facing upstream; (B,E) facing downstream; and (C,F) across (left bank looking at right bank).

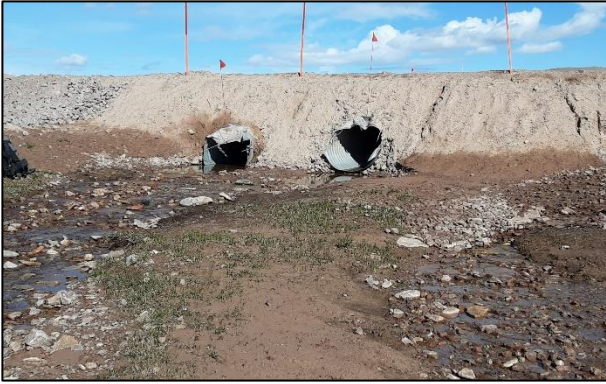
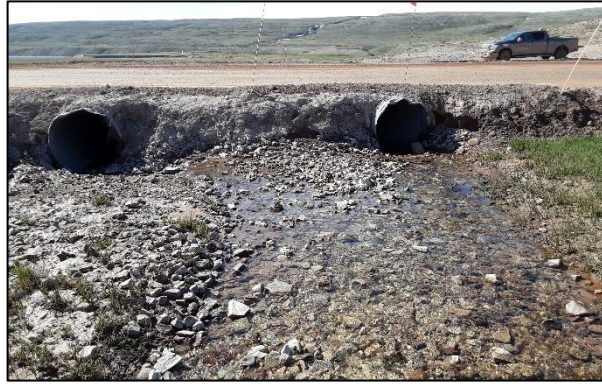
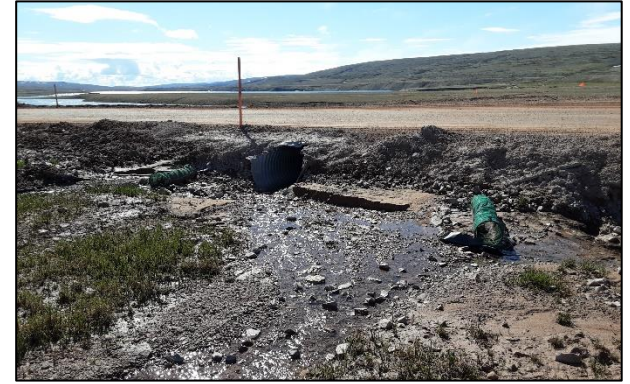
Photos 1-2. Photos taken of the culvert in spring 2024: (A) downstream end; and (B,C) upstream end.

The Tote Road crosses a small, unnamed stream at site CV-112 that flows 120 m west into Phillips Creek, approximately 600 m downstream from Km 32 Lake and 300 m upstream from a smaller, unnamed lake. Km 32 Lake is of sufficient depth to support overwintering of both species. It is unknown if the smaller lake is of sufficient depth to support overwintering. This crossing has been identified for remediation.

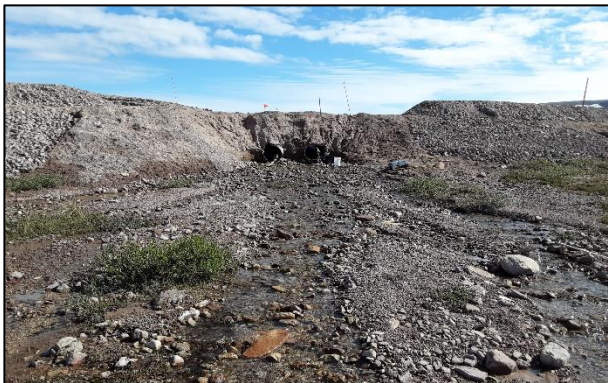
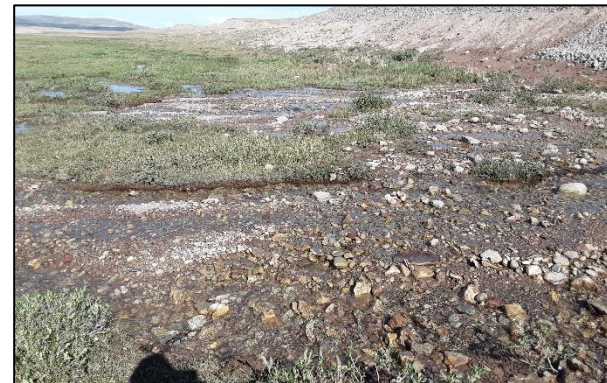
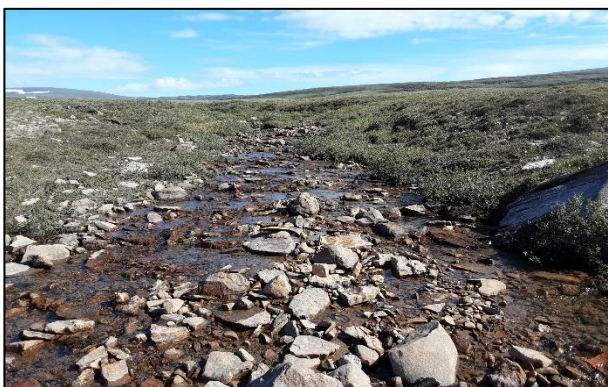
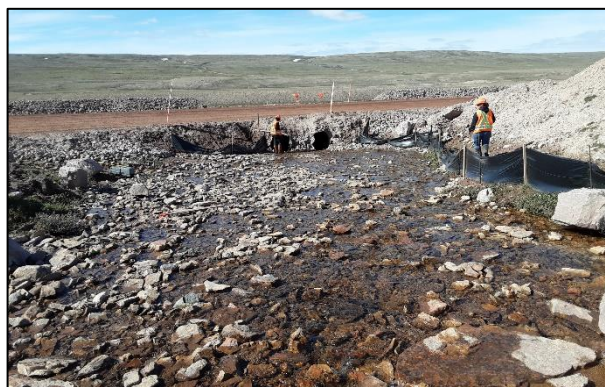
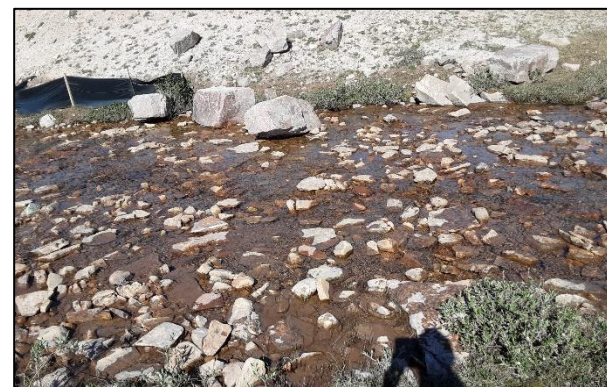
Photos 1-1. Photos taken 20 m downstream (top) and 20 m upstream (bottom) in spring 2024: (A,D) facing upstream; (B,E) facing downstream; and (C,F) across (left bank looking at right bank).

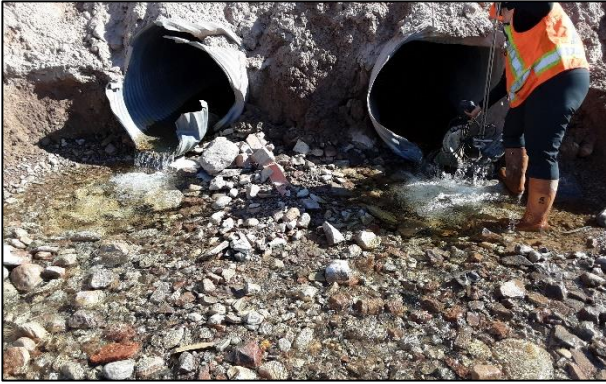
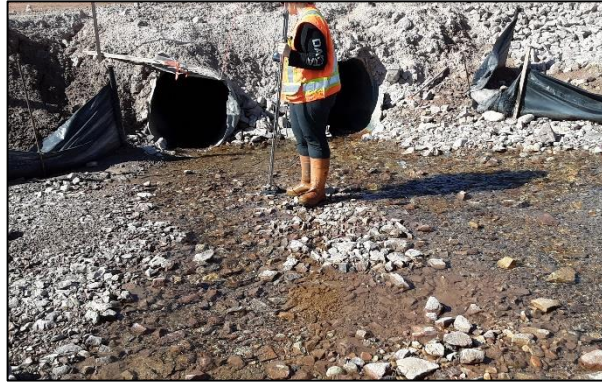
Fifteen juvenile Arctic Char were captured downstream and none were captured upstream of the crossing in spring 2024. The culverts were perched and likely prevented most, if not all, upstream access for fish. Ninespine Stickleback were not captured in spring 2024 and have not been captured or observed in this stream during previous site surveys. It is unknown if the species is present in the watershed.

Photos 1-2. Photos taken of the culverts in spring 2024: (A) downstream end; and (B) upstream end.

The Tote Road crosses a small, unnamed stream at site CV-114 that flows 70 m west into Phillips Creek, approximately halfway (2.8 km in each direction) between two of the larger lakes (Km 32 and Km 26 lakes) in the Phillips Creek system. Both lakes are of sufficient depth to support overwintering. This crossing has been identified for remediation.

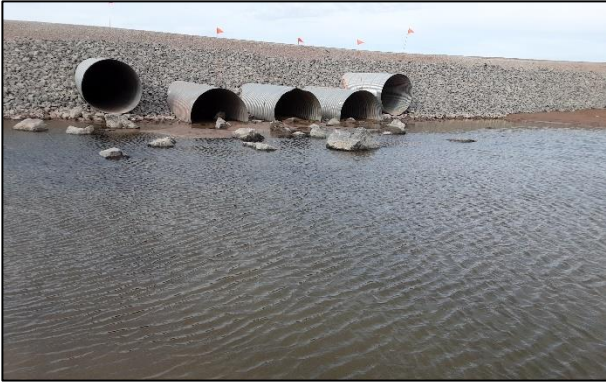
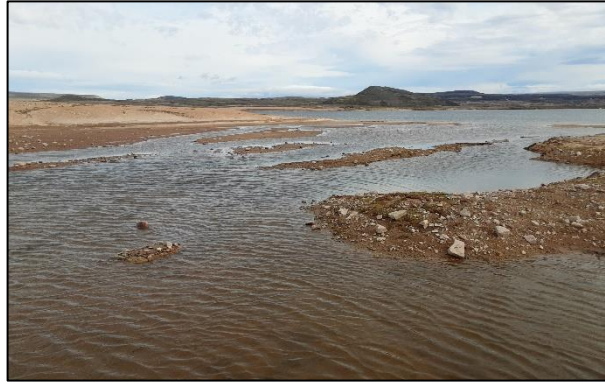
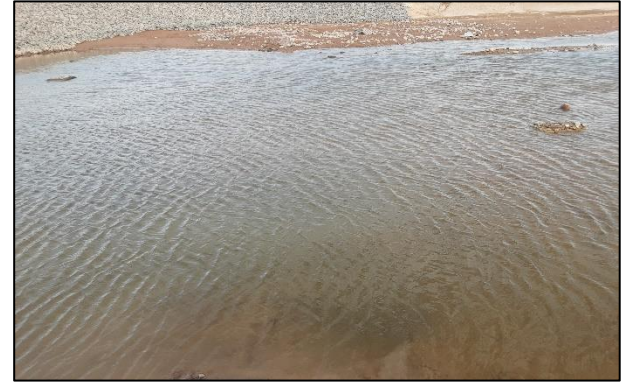
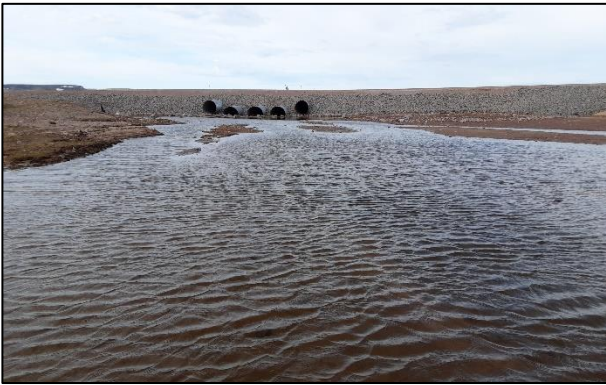
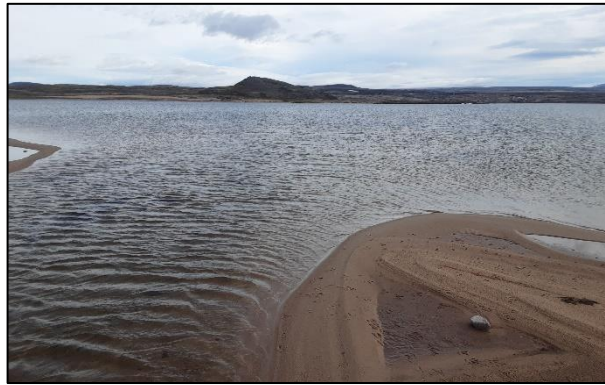
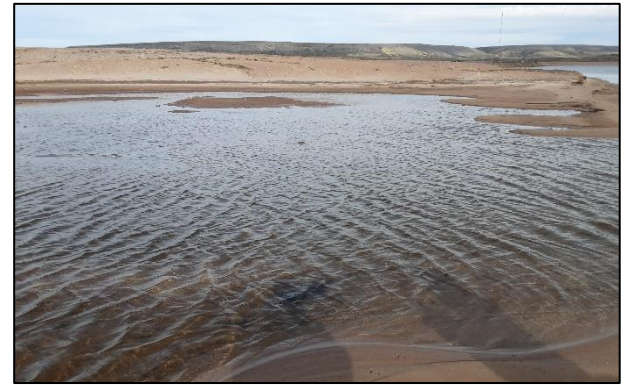
Photos 1-1. Photos taken 20 m downstream (top) and 60 m downstream (bottom) in spring 2024: (A,D) facing upstream; (B,E) facing downstream; and (C,F) across (right bank looking at left bank).
