Baffinland Iron Mines Corporation Mary River Project

Potential Offsetting Sites: 2023 Freshwater Habitat Surveys

BAFFINLAND IRON MINES CORPORATION
MARY RIVER PROJECT – STEENSBY RAILWAY

POTENTIAL OFFSETTING SITES:
2023 FRESHWATER HABITAT SURVEYS

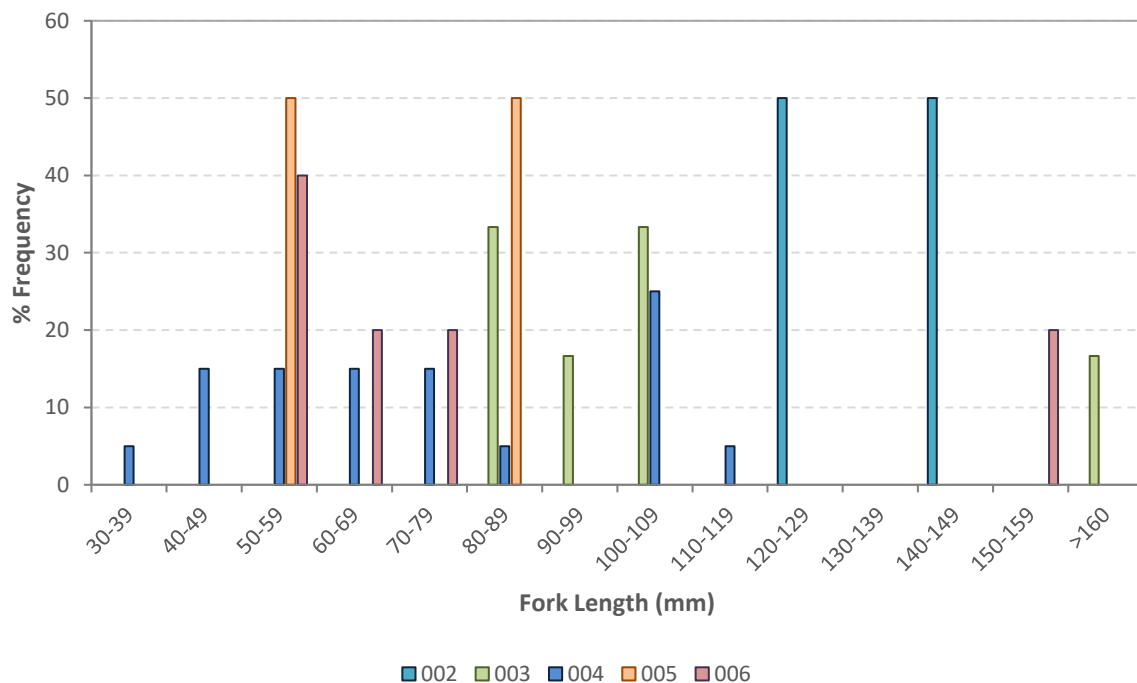
Figure 3. Length-frequency of Arctic Char (n = 38) captured via electrofishing at Sites 002 (Lake ST-93; n = 2), 003 (Lake ST-176; n = 6), 004 (Lake ST-352; n = 23), 005 (Ikpikitturjuaq Lake/10 Km Lake; n = 2), and 006 (Ikpikitturjuaq Lake/10 Km Lake; n = 5) in the Ikpi-kitturjuaq Lake/River drainage.

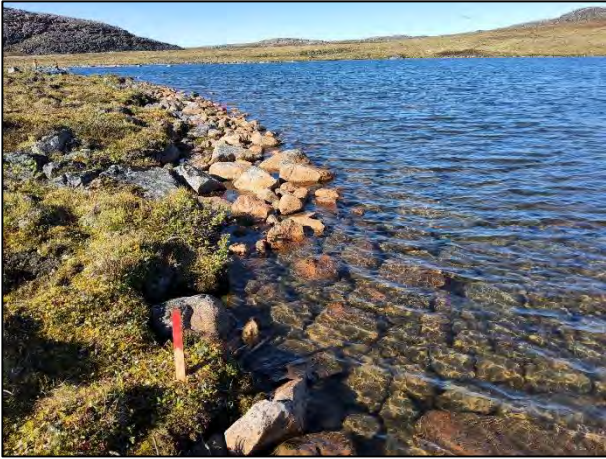
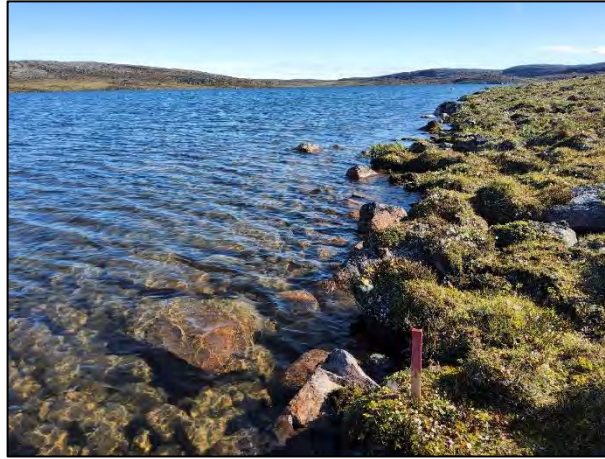
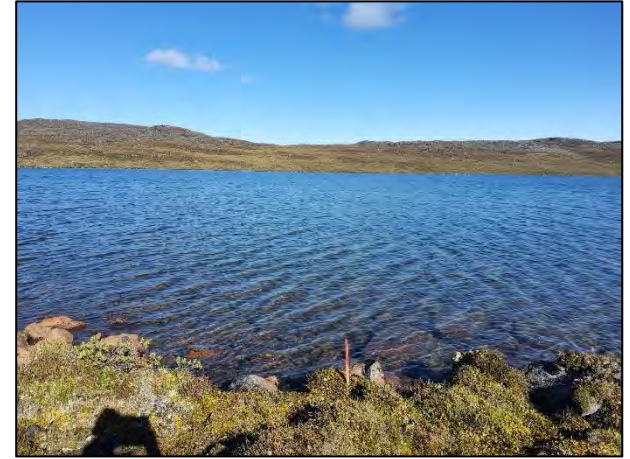
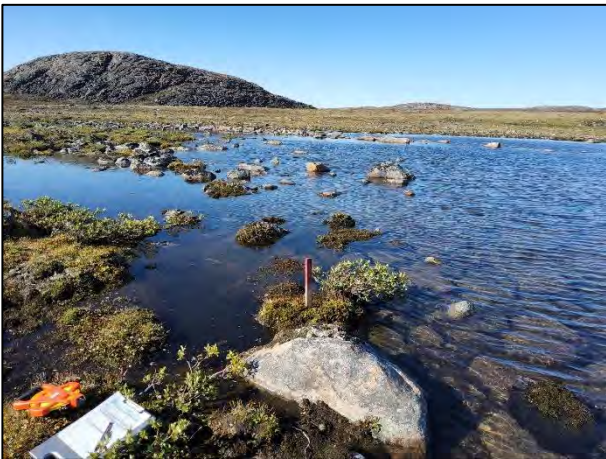
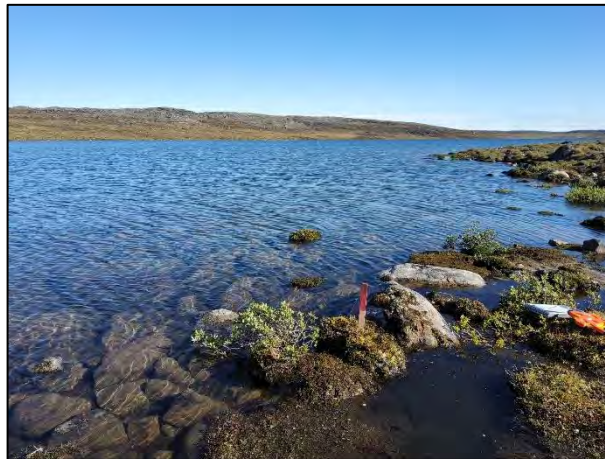
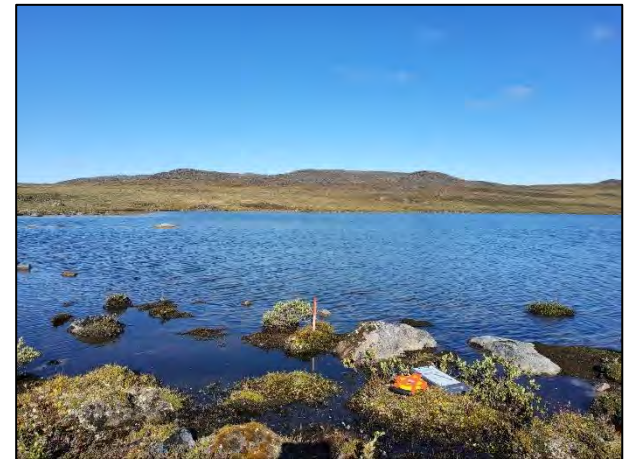
Photos 1. Photos taken at habitat transect 1 (top) and transect 3 (bottom) at Site 001: (A,D) facing west; (B,E) facing east; and (C,F) facing North.

At the time of the survey, specific conductance (mean 233.5 µS/cm) was highest among all the surveyed offsetting sites (Table 5). Aquatic habitat is comprised of a mixture of substrate types but is predominantly cobble. There was no aquatic vegetation in the area and riparian vegetation was mainly grass and willows. The area has a gentle slope with depths ≤1 m within approximately 20 m offshore.

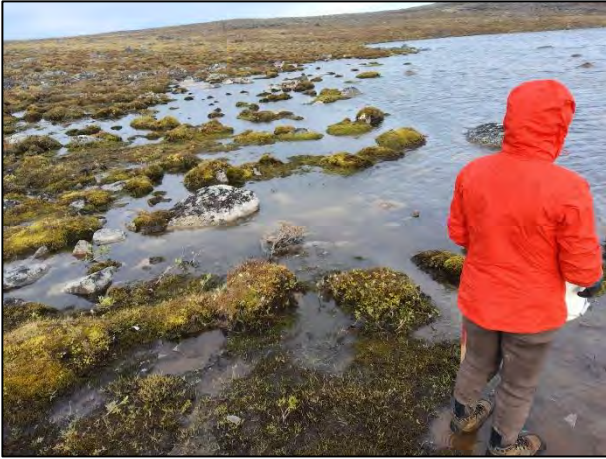
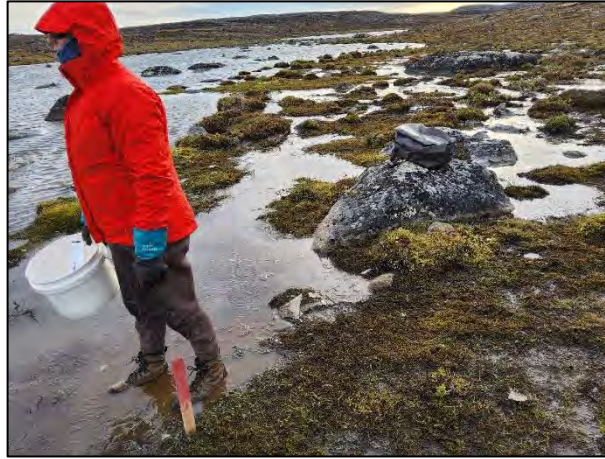
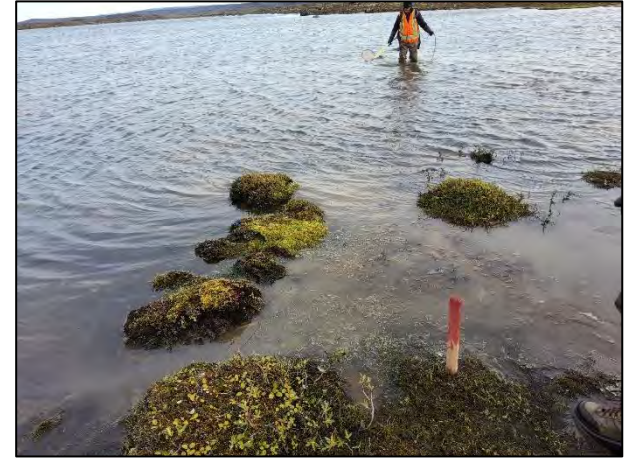
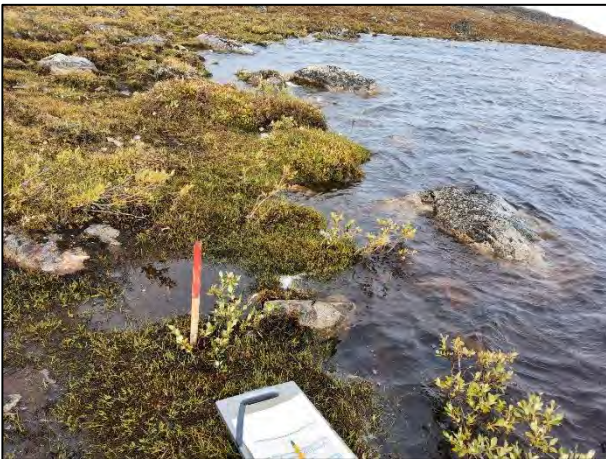
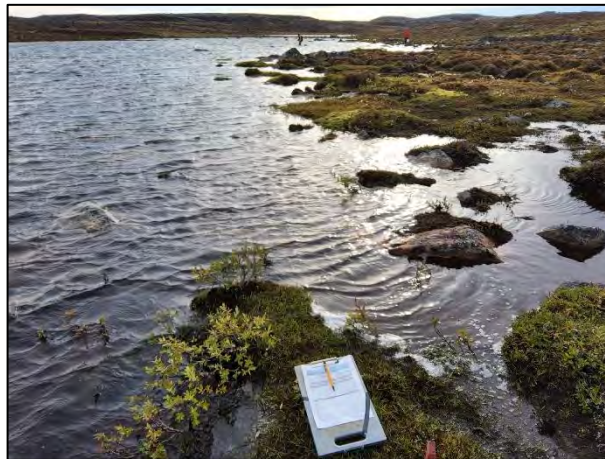
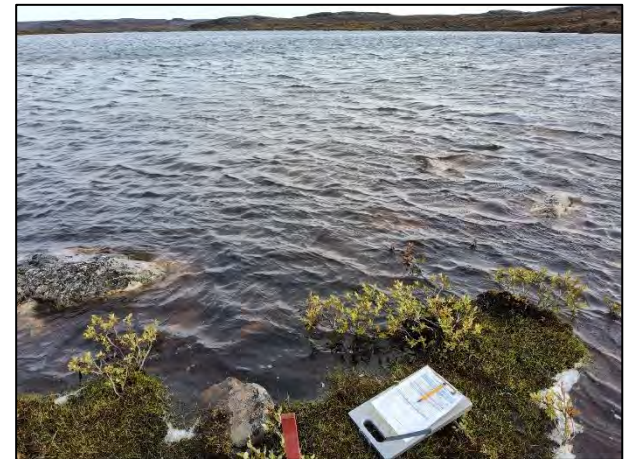
Photos 1. Photos taken at habitat transect 1 (top) and transect 3 (bottom) at Site 002: (A,D) facing northwest; (B,E) facing southeast; and (C,F) facing northeast.

Aquatic habitat at Site 002 is comprised predominantly of boulders and cobble with fines present in areas with aquatic vegetation. Aquatic vegetation was composed of macrophytes and algae. Riparian vegetation consisted mainly of grass, willows, and moss. Two juvenile char and two stickleback were captured/observed at the offsetting site during the August 2023 survey.

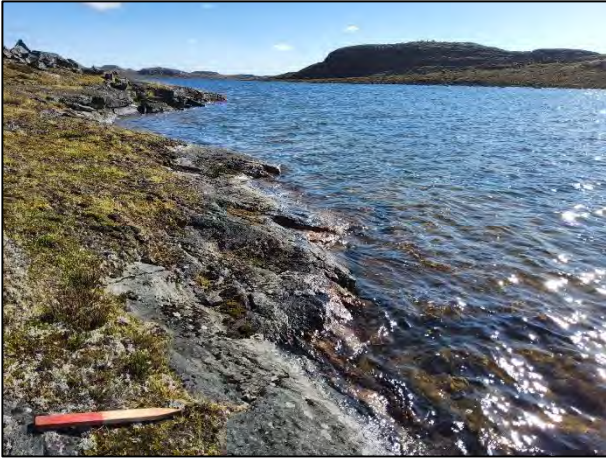
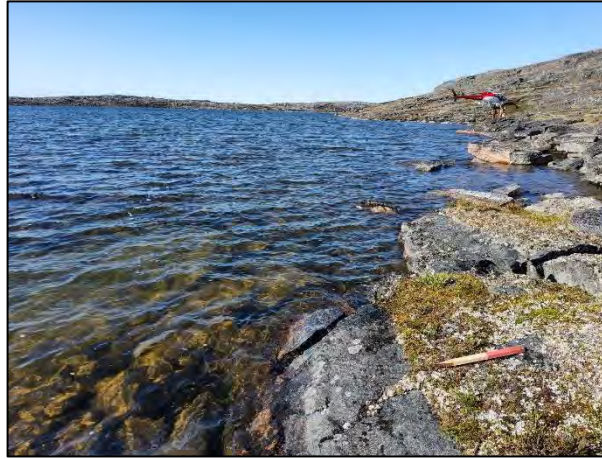
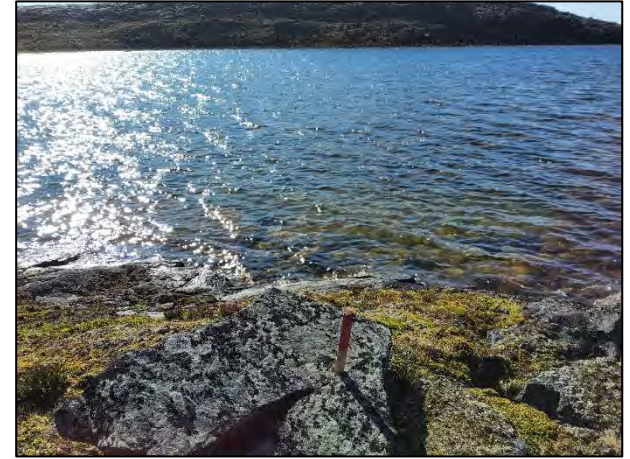
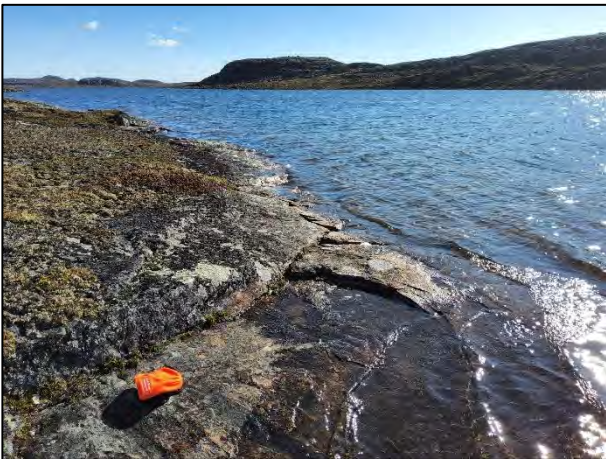
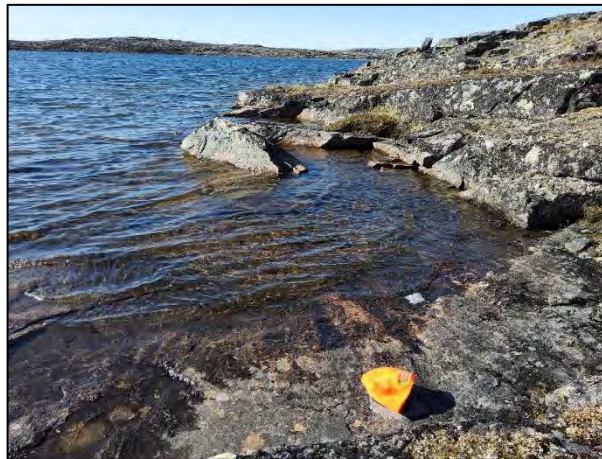
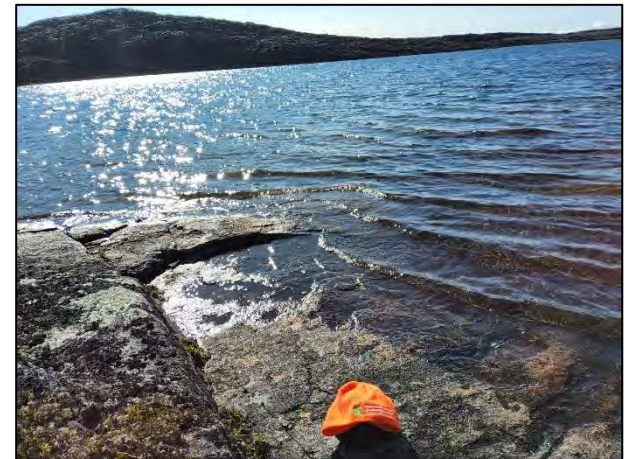
Photos 1. Photos taken at habitat transect 1 (top) and transect 3 (bottom) at Site 003: (A,D) facing east; (B,E) facing west; and (C,F) facing south.

At the time of the survey, mean specific conductance was 59.8 $\mu\text{S}/\text{cm}$ (Table 5). Aquatic habitat at the offsetting site is comprised predominantly of boulders and cobble with some aquatic vegetation in the area. Aquatic vegetation was composed of macrophytes and algae and riparian vegetation mainly of willows and moss.

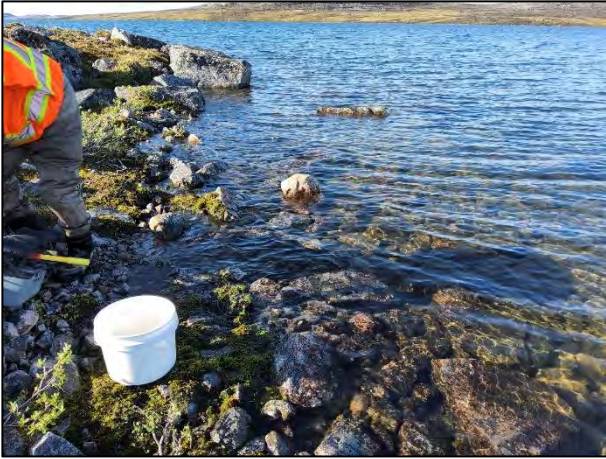
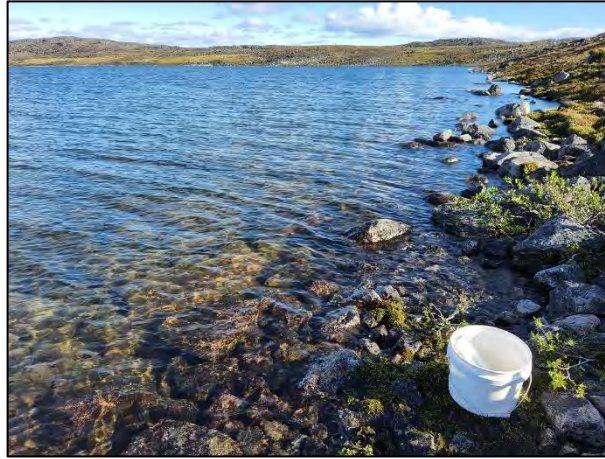
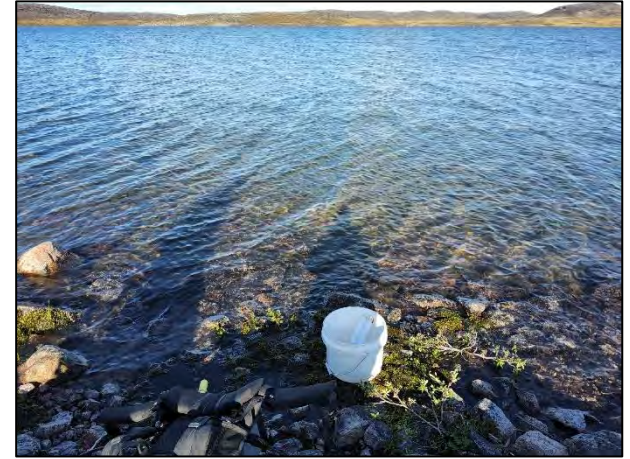
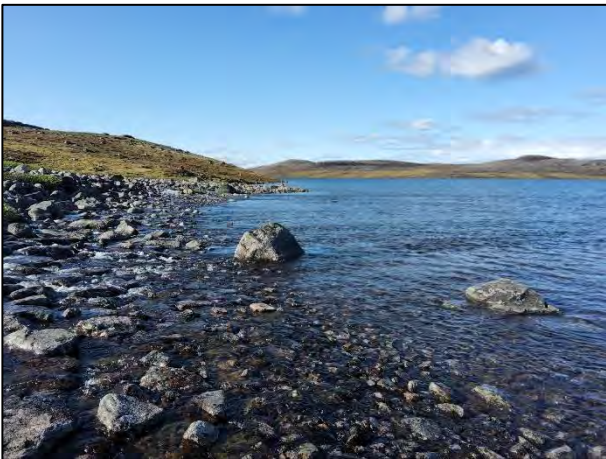
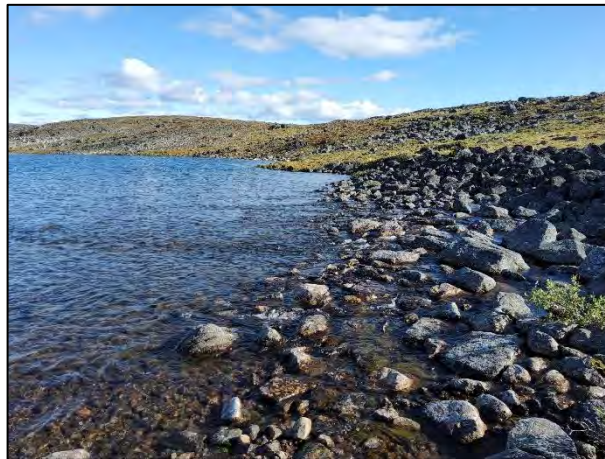
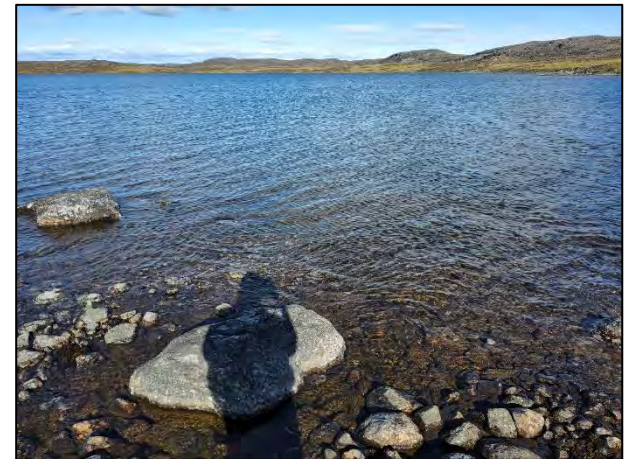
Photos 1. Photos taken at habitat transect 1 (top) and transect 3 (bottom) at Site 004: (A,D) facing northwest; (B,E) facing southeast; and (C,F) facing northeast.

At the time of the survey, specific conductance (mean 33.3 $\mu\text{S}/\text{cm}$) was among the lowest surveyed (Table 5). Aquatic habitat at the offsetting site is comprised mainly of cobble and boulder. There was no aquatic vegetation in the area and riparian vegetation was mainly grass and willows. The area has a relatively steep slope with depths ≤ 0.75 m within approximately 3-4 m offshore for much of the surveyed area.
