# POTENTIAL OFFSETTING SITE 005

**BAFFINLAND IRON MINES  
MARY RIVER PROJECT**

**North/South Consultants Inc.**  
Aquatic Environment Specialists

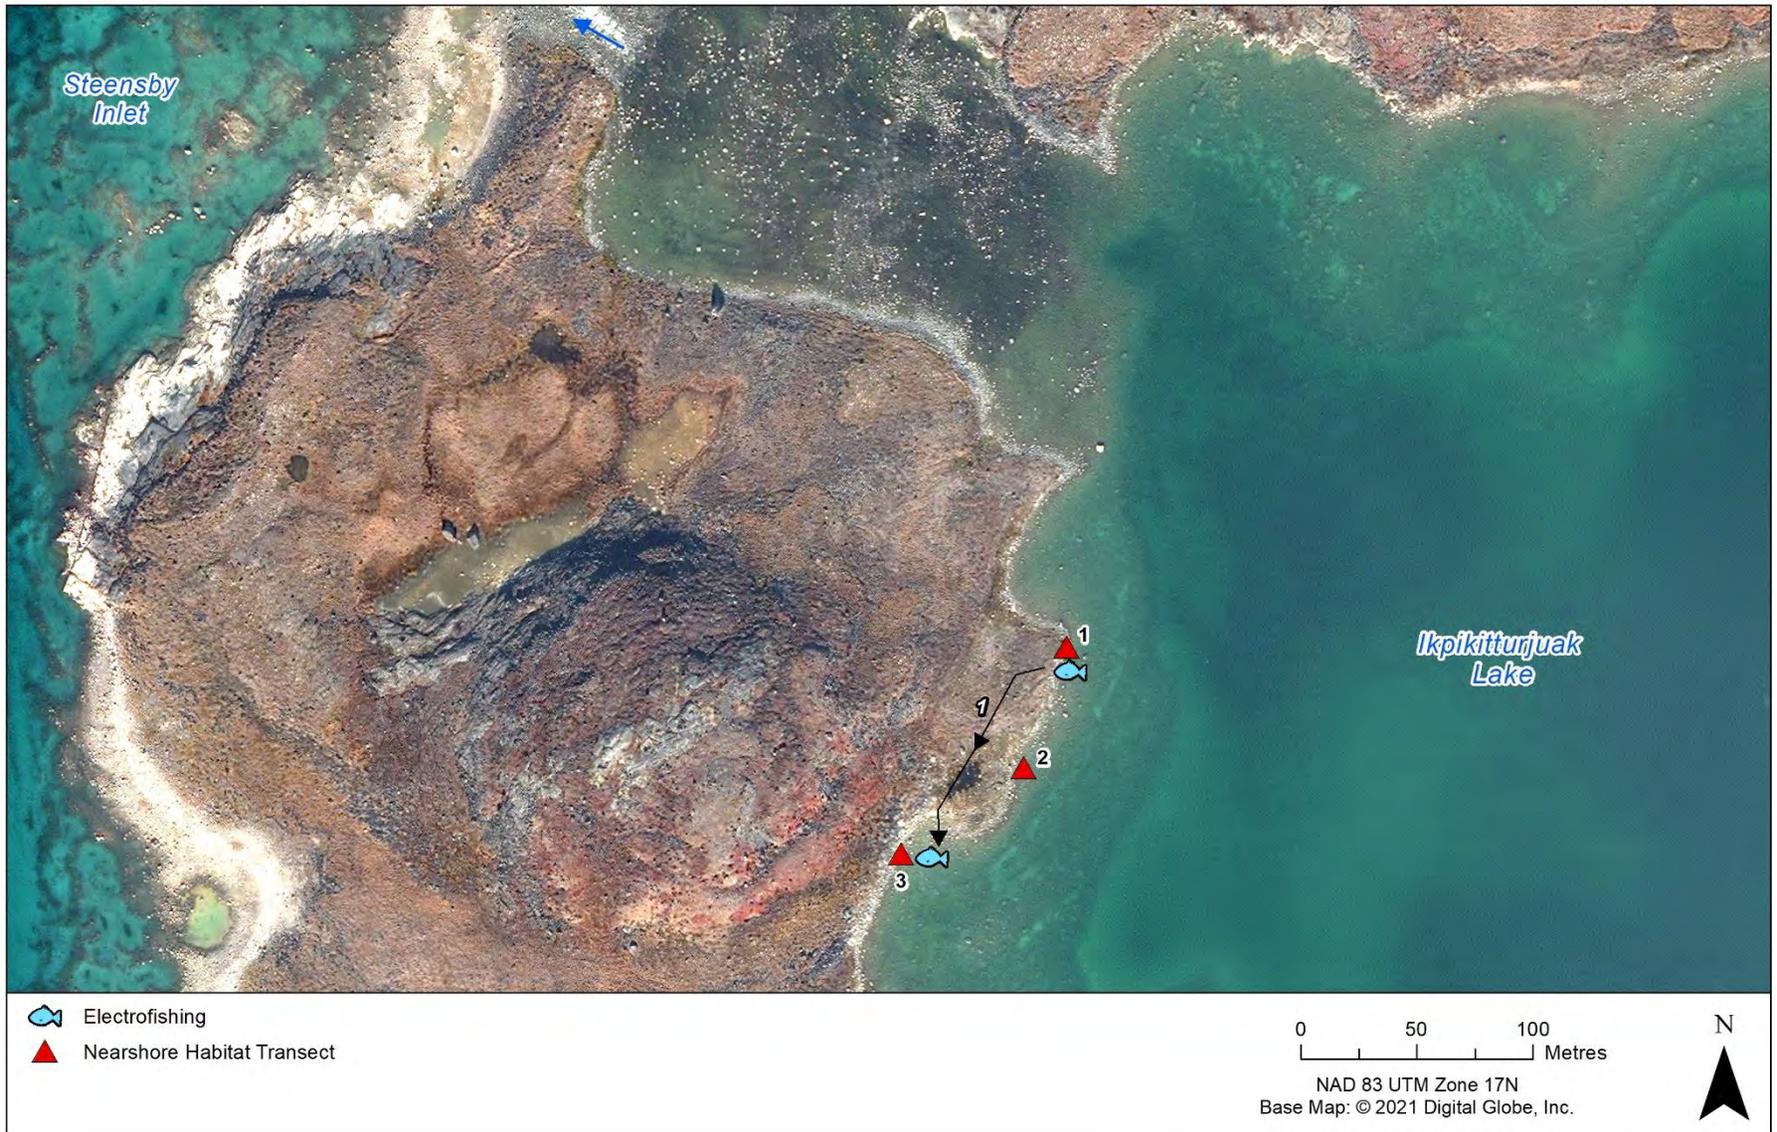
## FISHING AND HABITAT SURVEY SITES

Aquatic habitat at Site 005 is comprised mainly of cobble and boulder. There was no aquatic vegetation in the surveyed area and riparian vegetation was mainly grass, moss, lichens, and willows. The area has a moderate slope with depths  $\leq 0.75$  m within approximately 5-15 m of the shoreline for much of the surveyed area. Specific conductance was very low (30.5-31.9  $\mu\text{S}/\text{cm}$ ).

Small numbers of both species were captured in the surveyed area in August 2023. Habitat within the survey polygon is used for open-water rearing/feeding by both species. Depths ( $<0.75$  m) are insufficient for overwintering or char spawning, both of which likely occur farther offshore in this lake, though bathymetry and substrate data for the lake are lacking. Stickleback spawning is unlikely given the lack of vegetation at this site for nest building, though there is sufficient cover in the form of boulders.

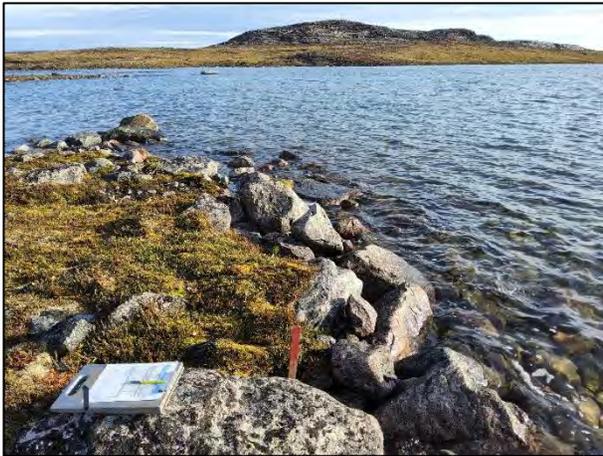
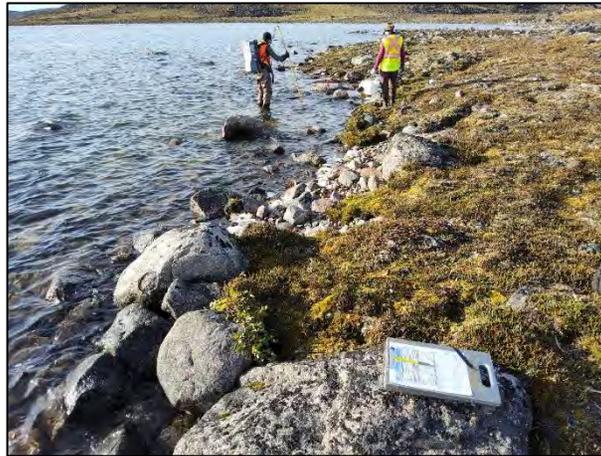
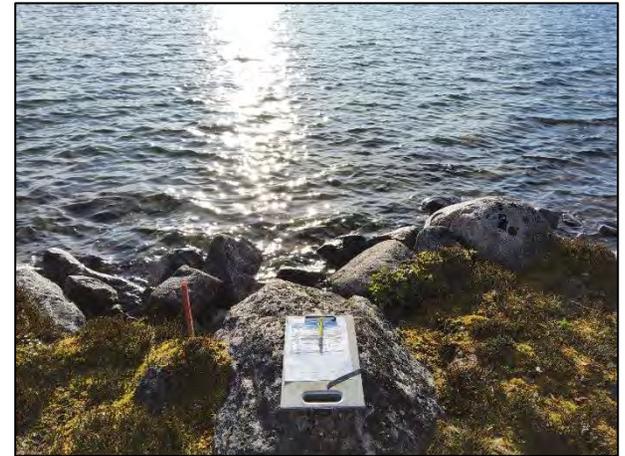
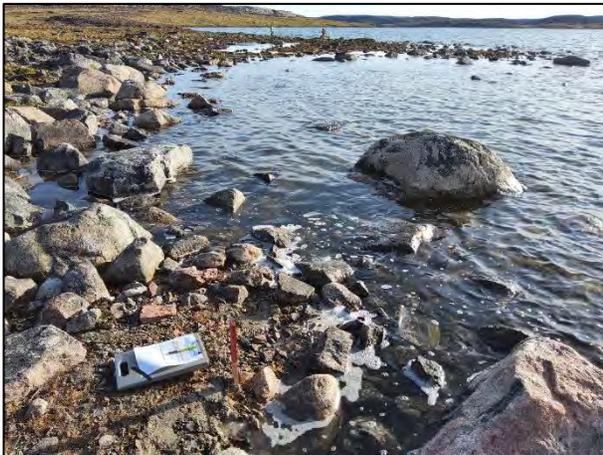
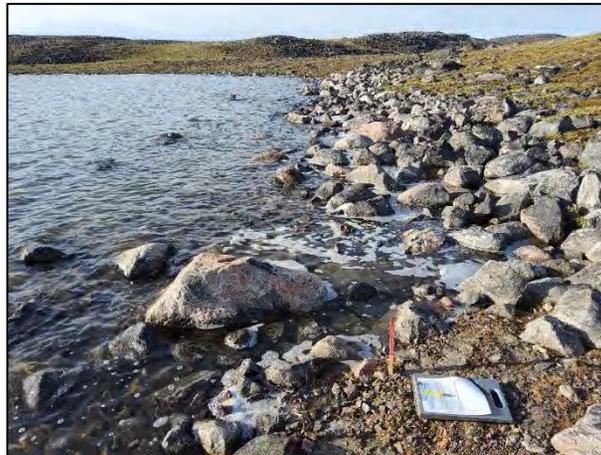
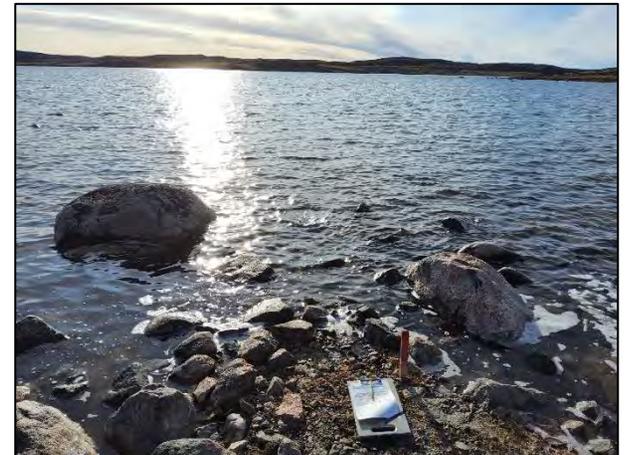
Photos 1. Photos taken at habitat transect 1 (top) and transect 3 (bottom) at Site 005: (A,D) facing north; (B,E) facing south; and (C,F) facing east.

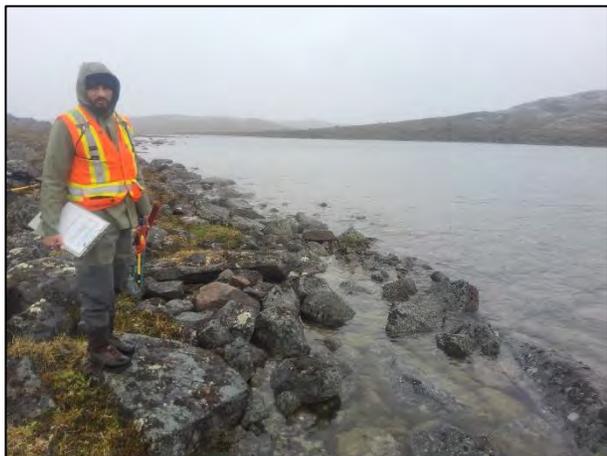
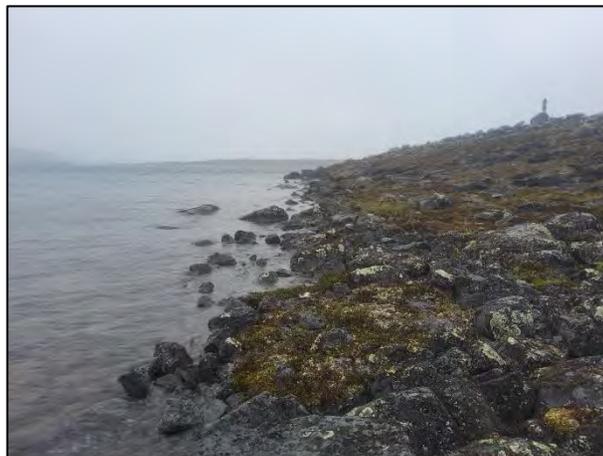
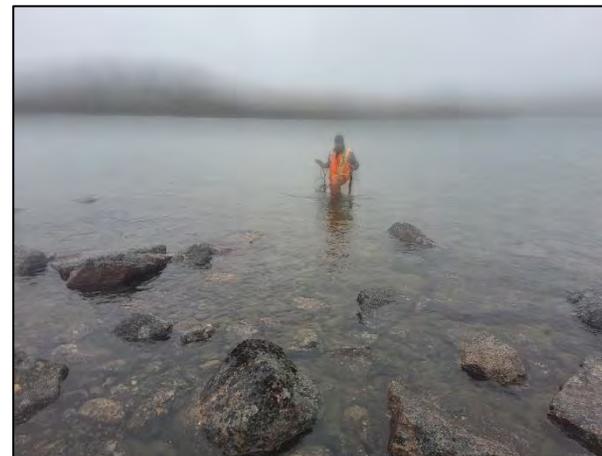
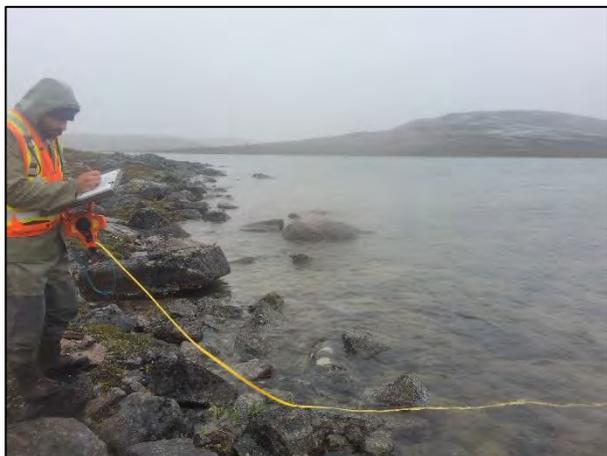
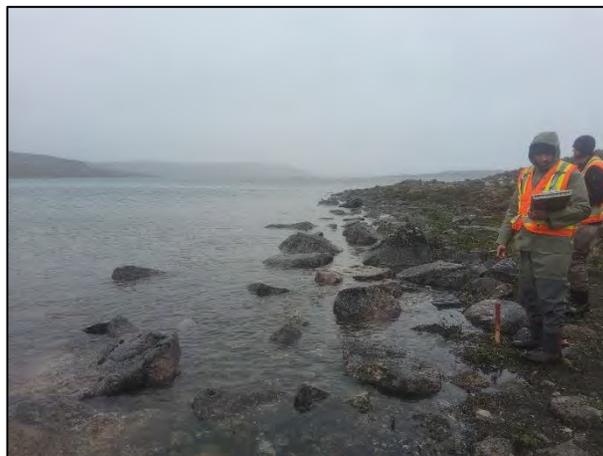
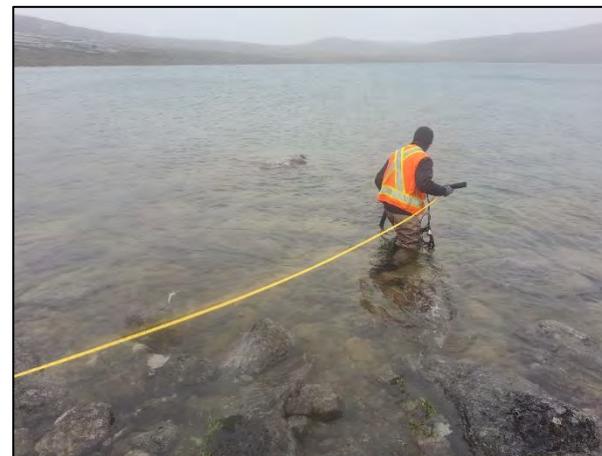
Aquatic habitat at Site 006 is comprised mainly of boulder and cobble. There was no aquatic vegetation in the surveyed area and riparian vegetation was mainly grass and willows. The area has a moderate slope with depths  $\leq 0.75$  m within approximately 5-10 m of the shoreline within the surveyed area. Specific conductance was very low (18.2-18.6  $\mu\text{S}/\text{cm}$ ).

Photos 1. Photos taken at habitat transect 1 (top) and transect 3 (bottom) at Site 006: (A,D) facing southwest; (B,E) facing northeast; and (C,F) facing northwest.

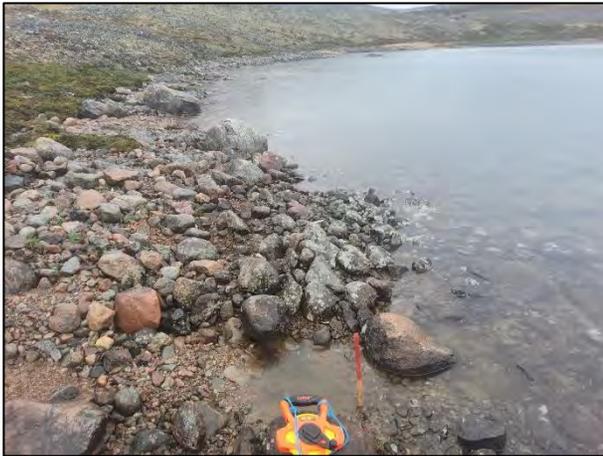
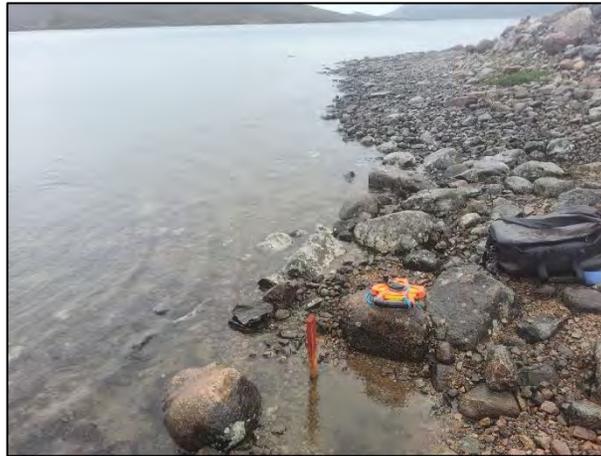
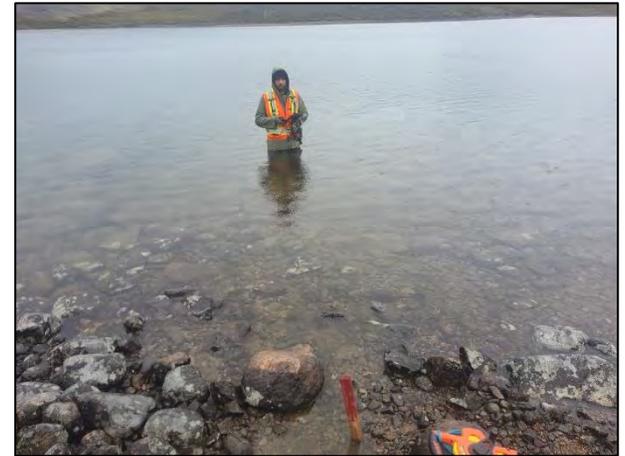
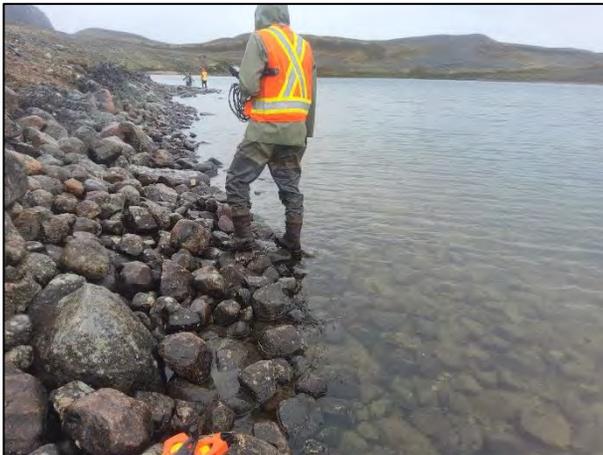
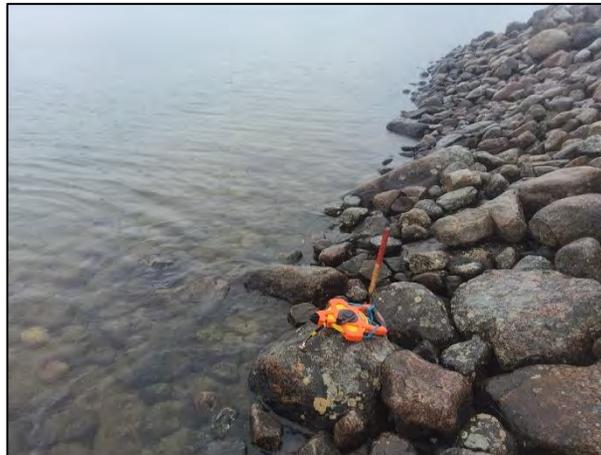
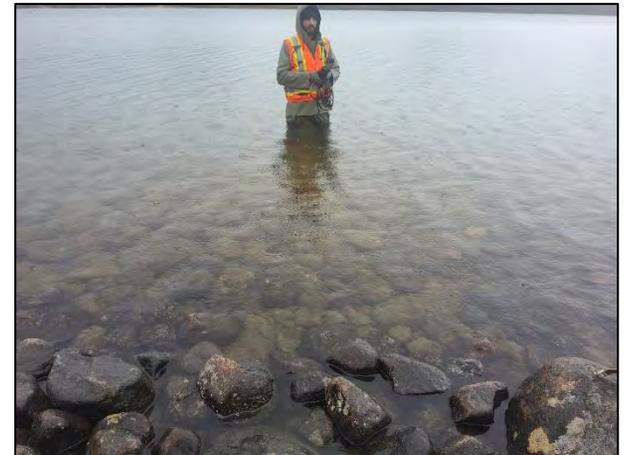
Aquatic habitat at Site 007 is comprised mainly of cobble, boulder, and gravel. There was no aquatic vegetation in the surveyed area and riparian vegetation was mainly grass and moss. The area has a moderate to steep slope with depths <0.75 m within approximately 4-12 m of the shoreline. Specific conductance was very low (13.9-15.2 µS/cm).

Photos 1. Photos taken at habitat transect 1 (top) and transect 3 (bottom) at Site 007: (A,D) facing east; (B,E) facing west; and (C,F) facing south.

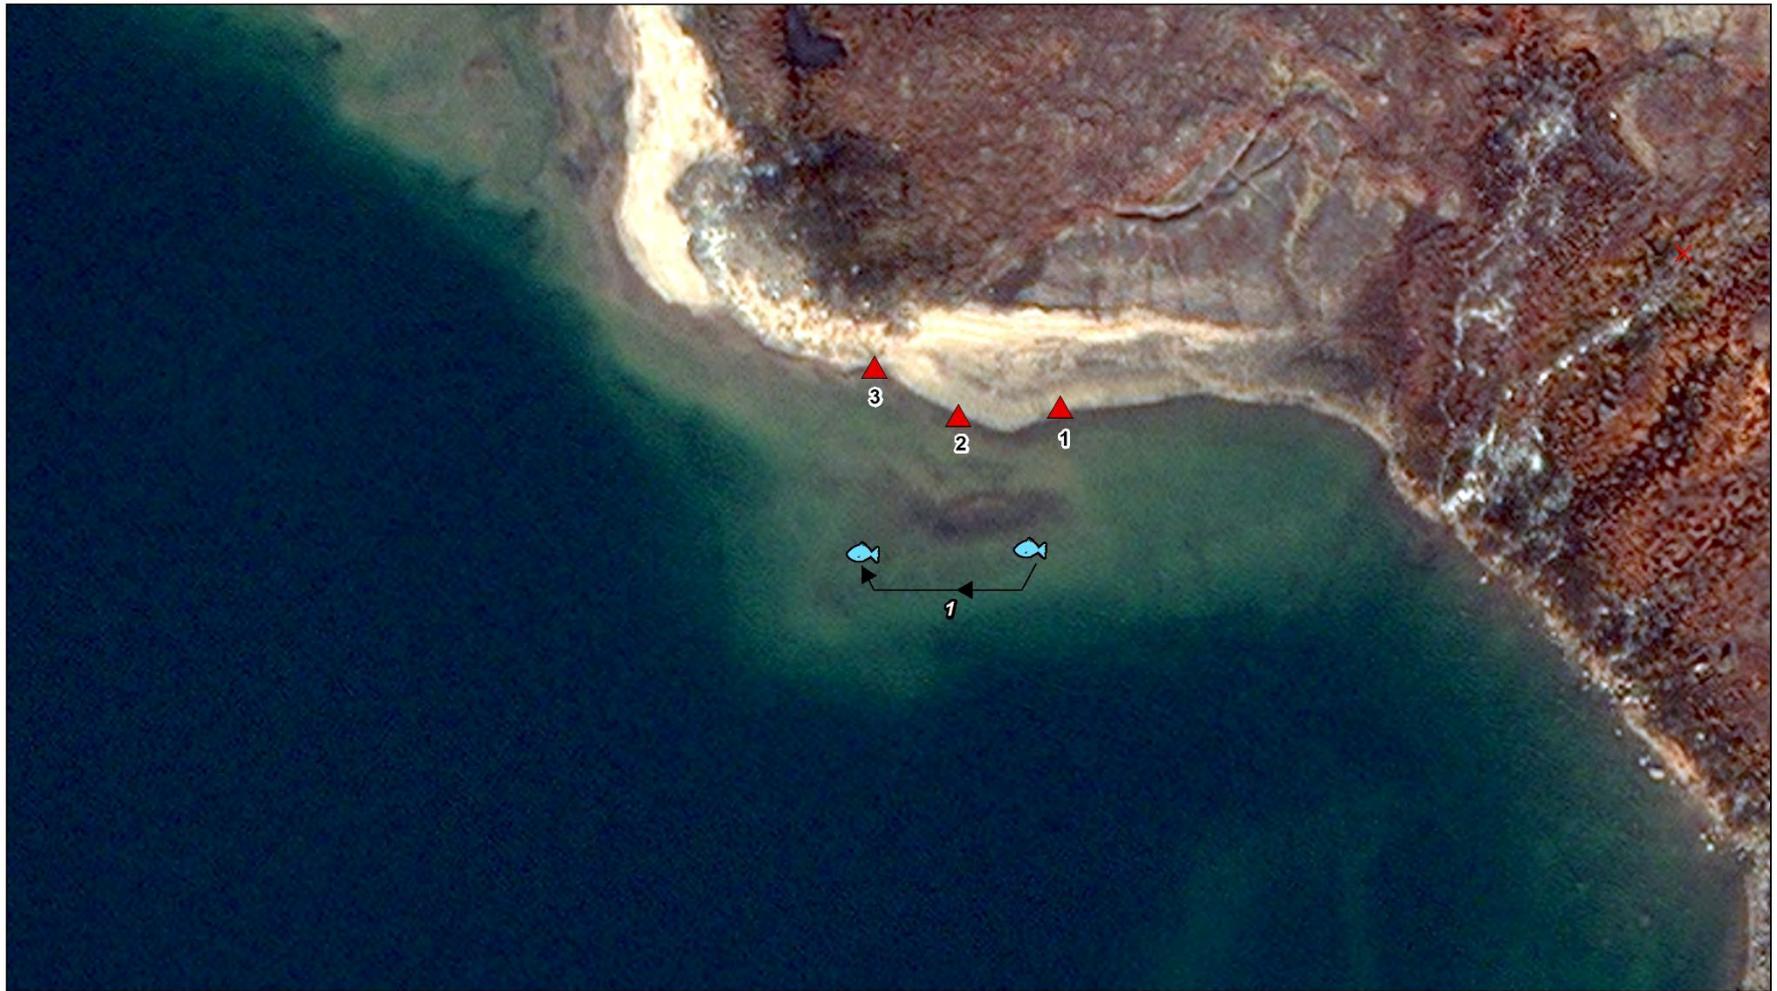
## FISHING AND HABITAT SURVEY SITES

No fish were captured or observed in the survey area in August 2023.

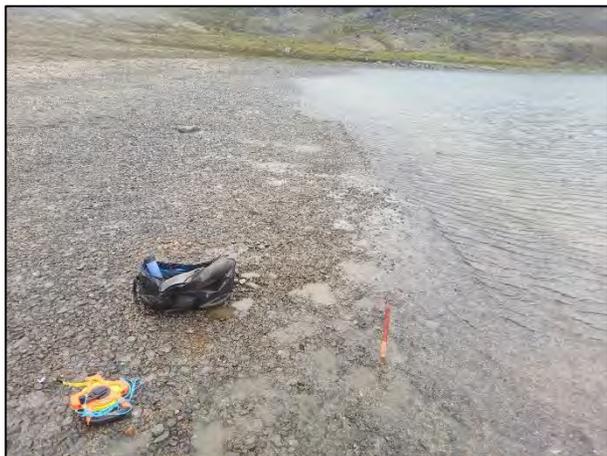
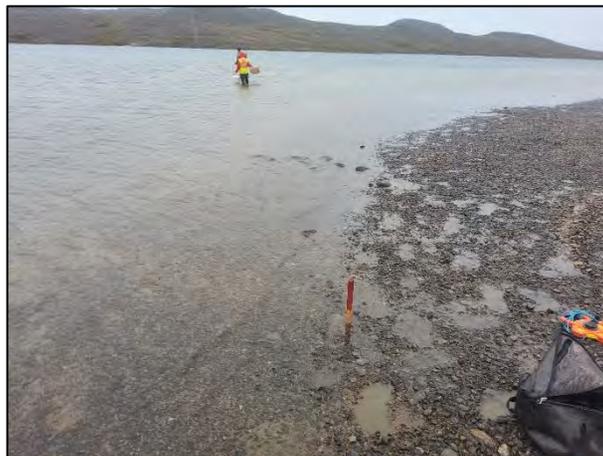
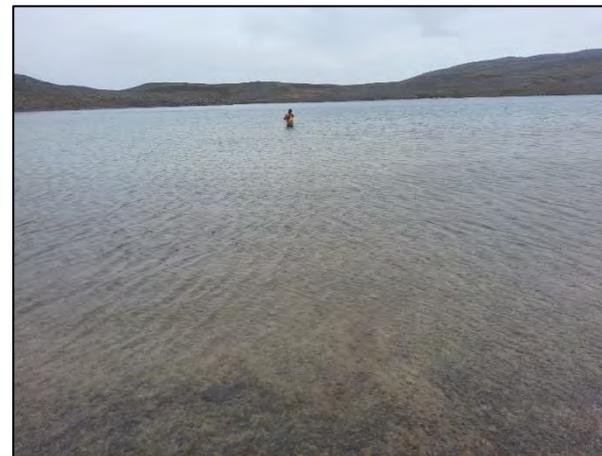
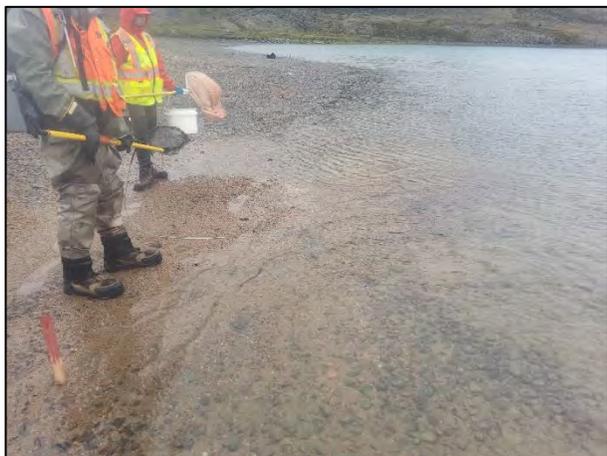
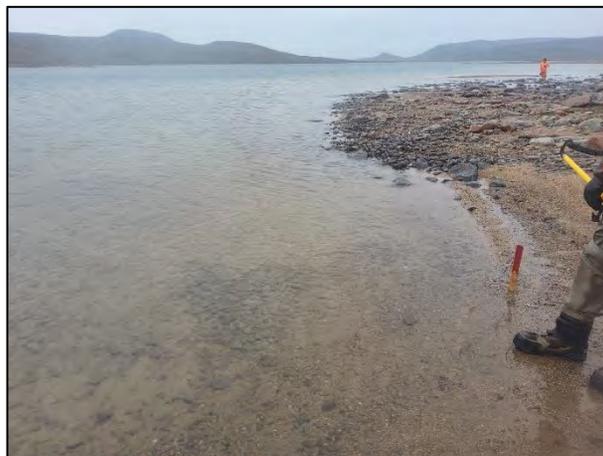
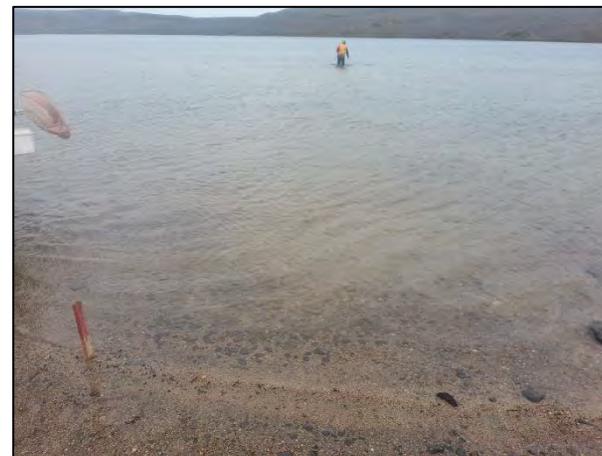
Aquatic habitat at Site 008 is comprised mainly of fines (sand) and gravel. There was no aquatic vegetation in the surveyed area and riparian vegetation was mainly lichens and moss. The area has a very low slope as a result of sediment input and deposition from the large inflow stream, with depths <0.75 m within approximately 30-60 m of the shoreline. Specific conductance was very low (13.2 µS/cm).

Photos 1. Photos taken at habitat transect 1 (top) and transect 3 (bottom) at Site 008: (A,D) facing east; (B,E) facing west; and (C,F) facing south.

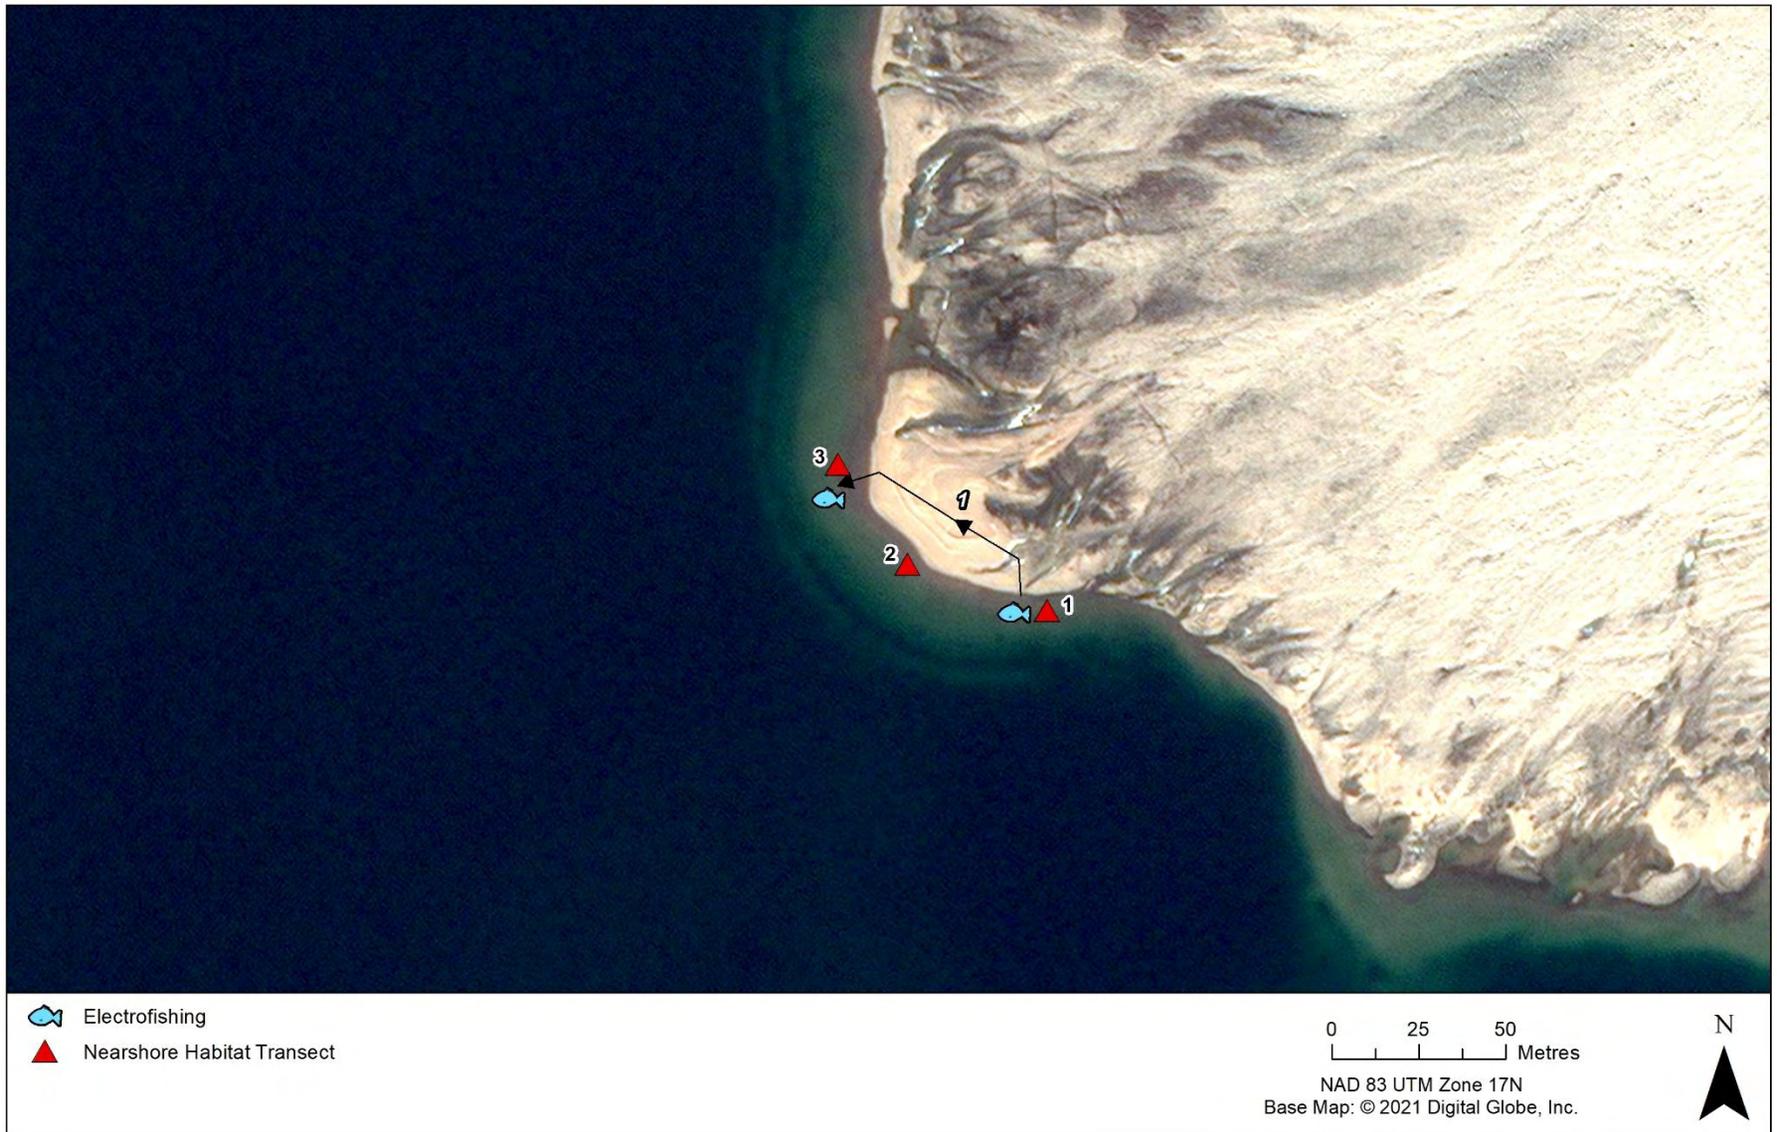
## FISHING AND HABITAT SURVEY SITES

Nineteen small juvenile Arctic Char and one stickleback were captured/observed in the surveyed area in August 2023. CPUE (2.24 fish/60 s) for char was the second highest of all the surveyed sites. The predominantly sand/gravel habitat within the offsetting polygon is generally not preferred by either species due to a lack of cover but there may be some feeding/rearing use by both species and it may possibly be a staging area for fish moving into the nearby stream. Depths (<0.75 m) are insufficient for overwintering or char spawning, both of which occur farther offshore in this lake. Bathymetry and substrate surveys indicate the lake has a maximum depth approaching 200 m and there are suitable char spawning substrates at depths >3.0 m.

Nineteen small (51-122 mm) juvenile Arctic Char and one stickleback were captured/observed at this site in August 2023.

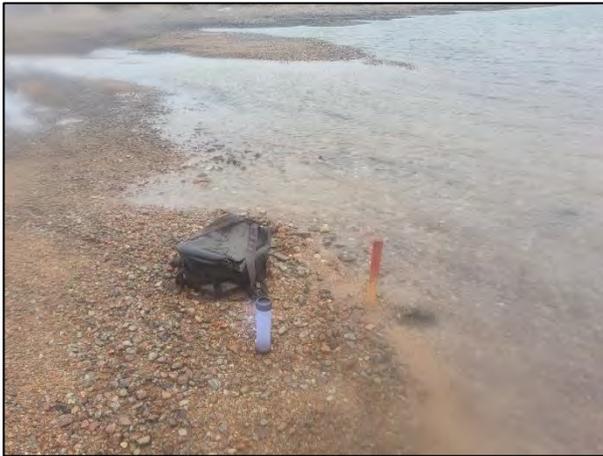
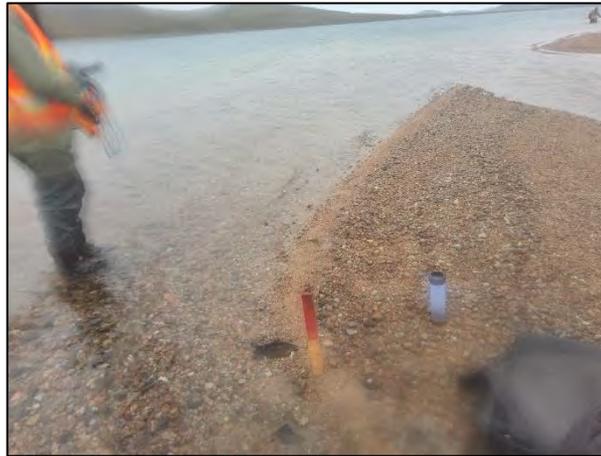
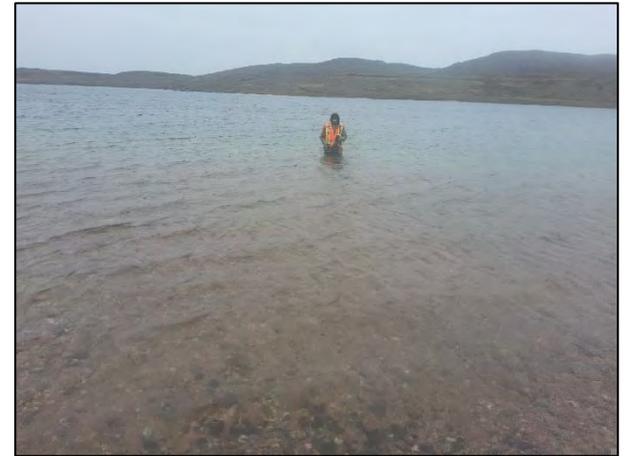
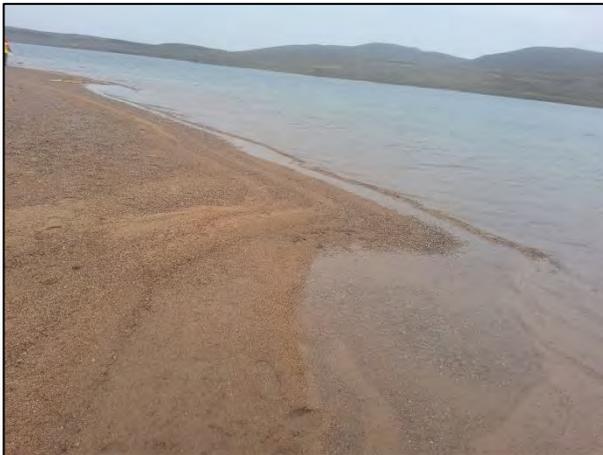
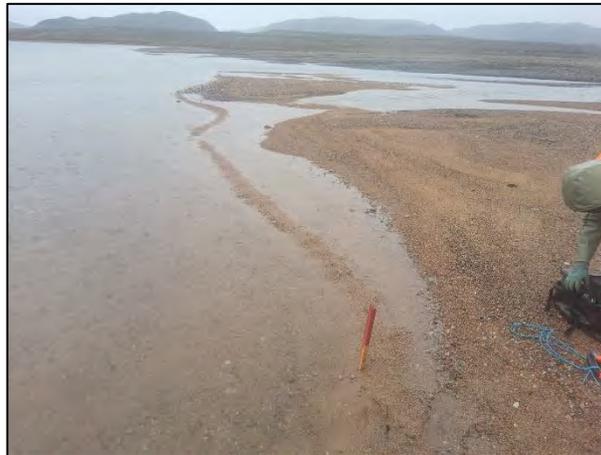
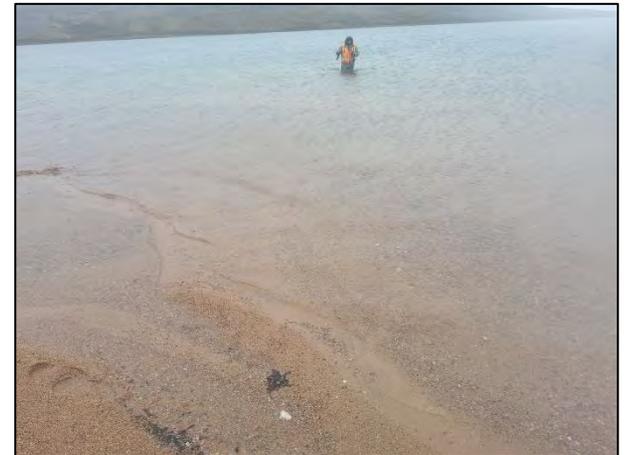
Aquatic habitat at Site 009 is comprised mainly of fines (sand) and gravel. There was no aquatic or riparian vegetation in the survey area. The area has a low slope as a result of sediment input and deposition from the large inflow stream, with depths <0.75 m within approximately 11-17 m of the shoreline. Specific conductance was very low (12.3 µS/cm).

Photos 1. Photos taken at habitat transect 1 (top) and transect 3 (bottom) at Site 009: (A,D) facing southeast; (B,E) facing northwest; and (C,F) facing south/southwest.

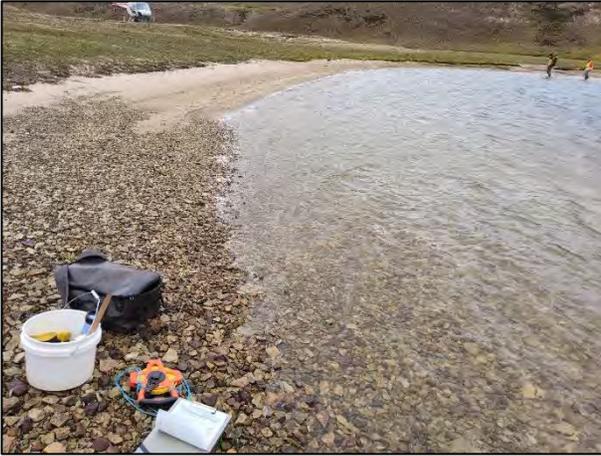
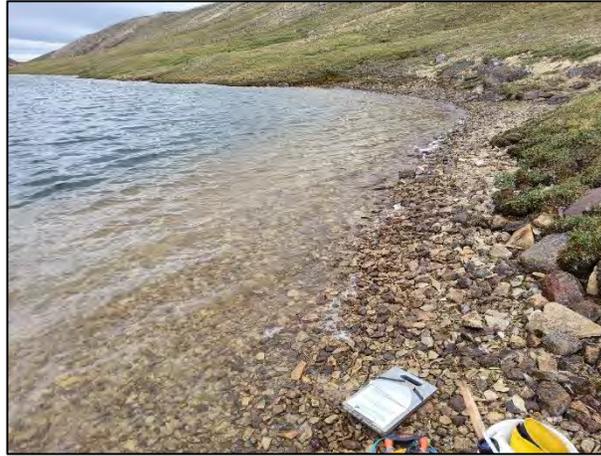
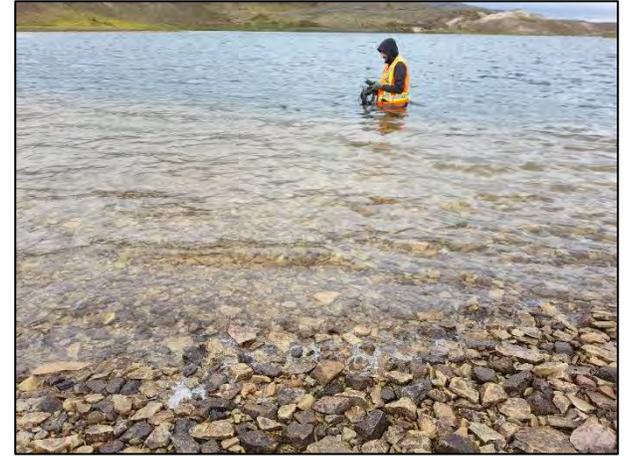
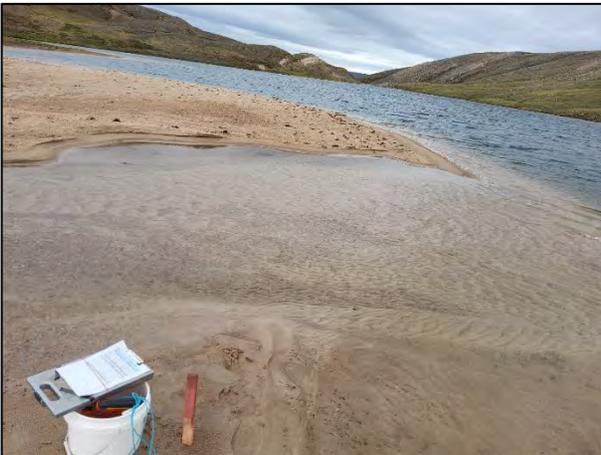
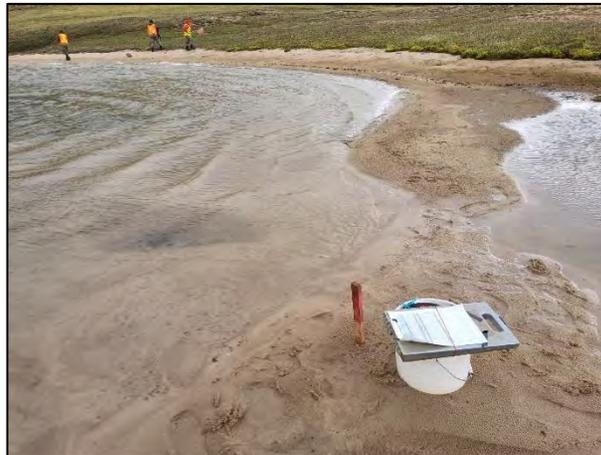
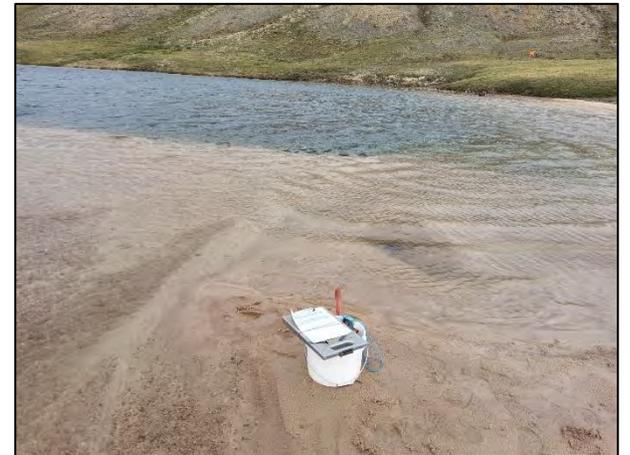
Aquatic habitat at the Site 010 is comprised mainly of gravel/fines/cobble at one end of the polygon, transitioning to almost exclusively fines at the other end. There was no aquatic vegetation in the survey area and riparian vegetation was mainly grass and moss. The area has a moderate slope, with depths <0.75 m within approximately 5-9 m of the shoreline. Specific conductance was low (83.8-85.4 µS/cm).

Photos 1. Photos taken at habitat transect 1 (top) and transect 3 (bottom) at Site 010: (A) facing north; (B, F) facing south; (C) facing east; and (E) facing southwest.

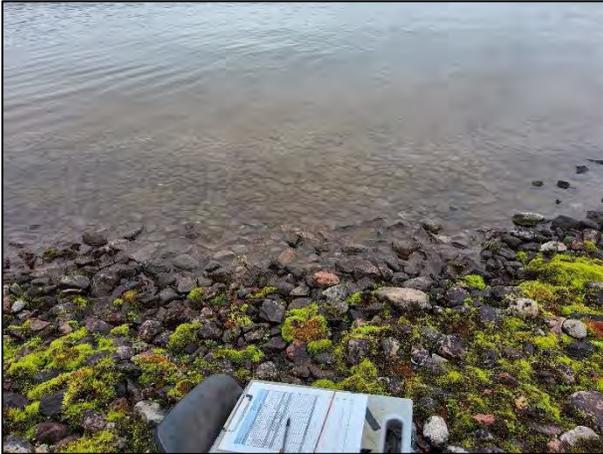
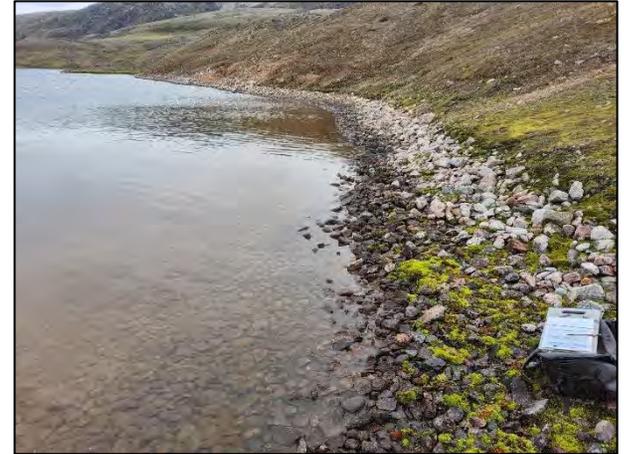
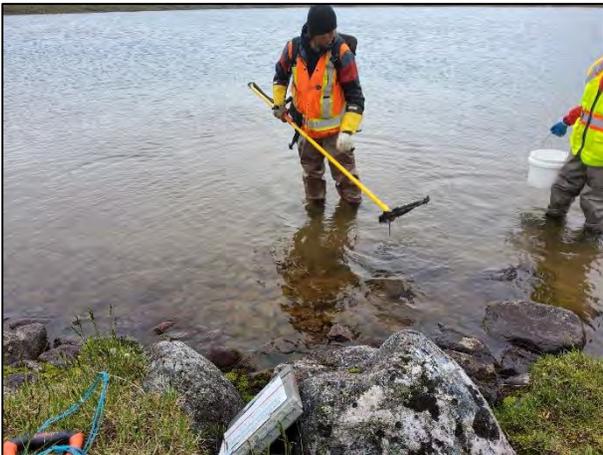
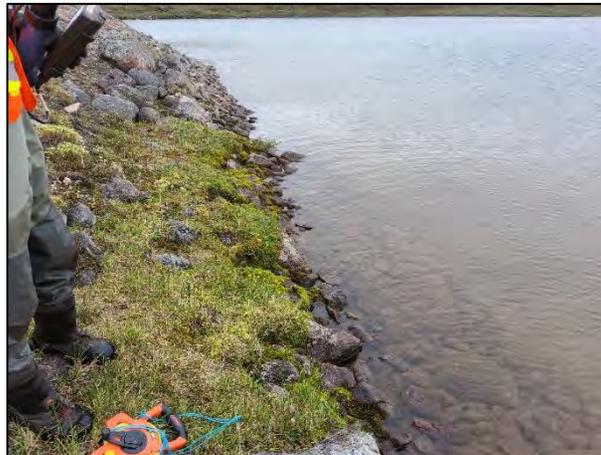
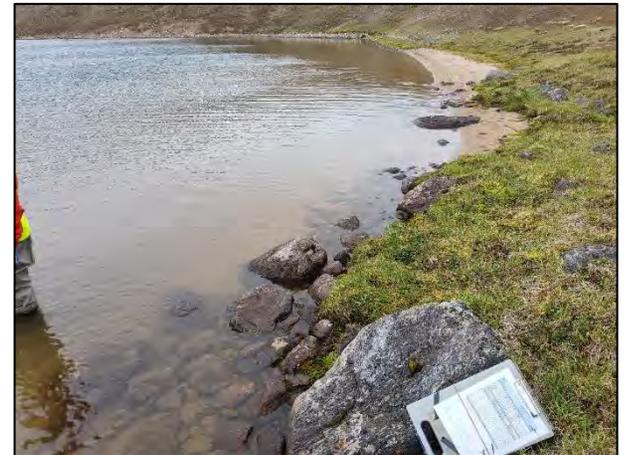
Photos 1. Photos taken at habitat transect 1 (top) and transect 3 (bottom) at Site 011: (A,D) facing west; (B,E) facing south; and (C,F) facing north.

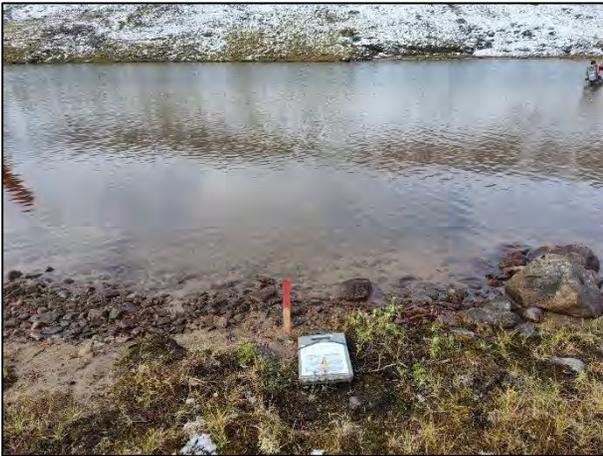
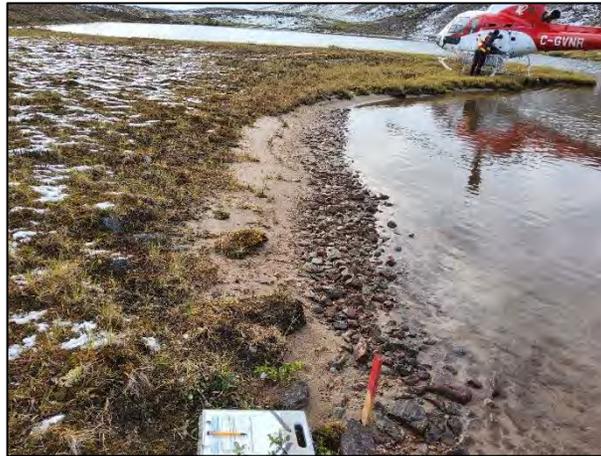
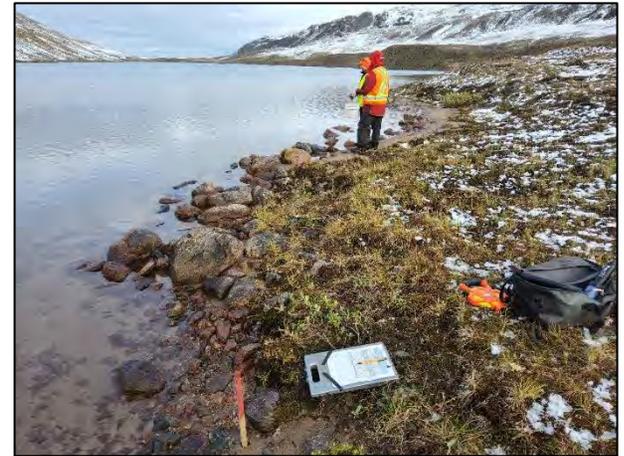
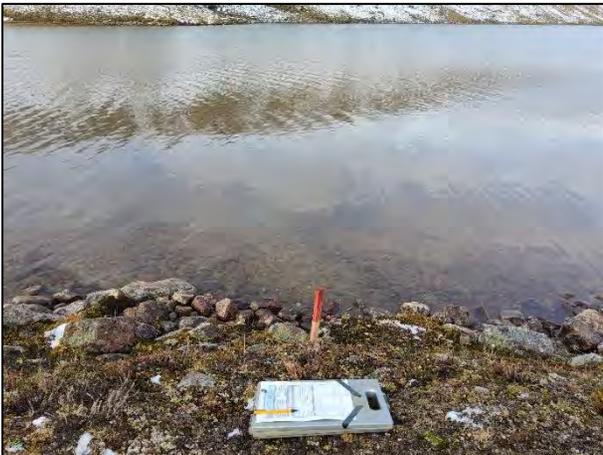
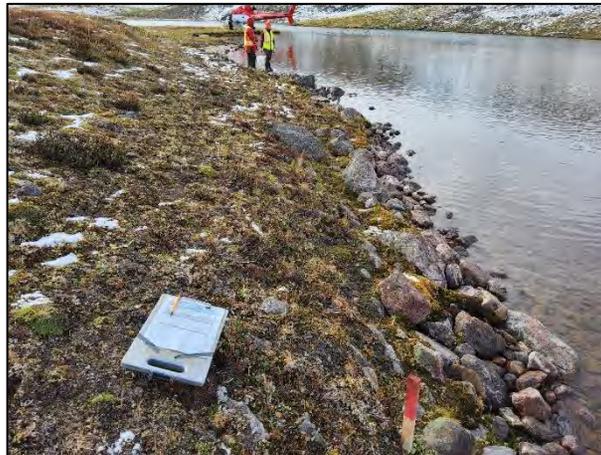
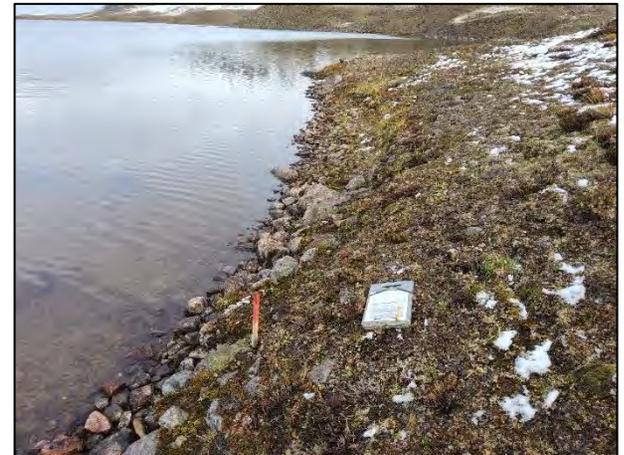
Photos 1. Photos taken at habitat transect 1 (top) and transect 3 (bottom) at Site 012: (A,D) facing west; (B,E) facing south; and (C,F) facing north.

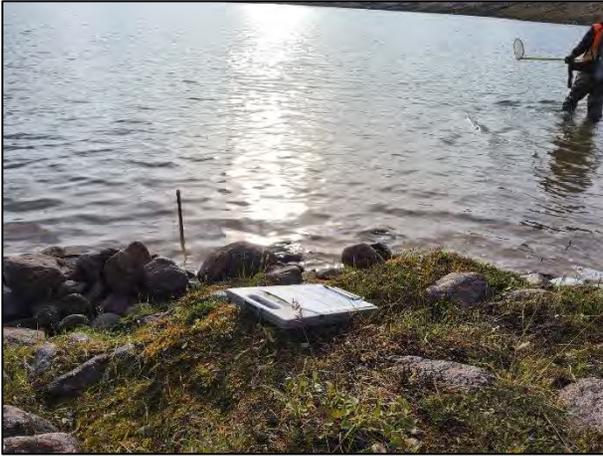
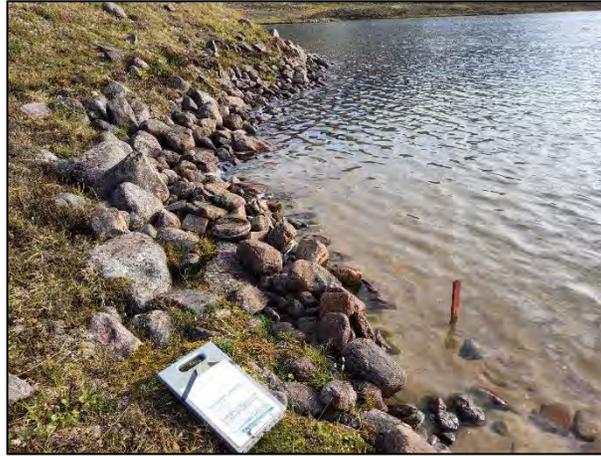
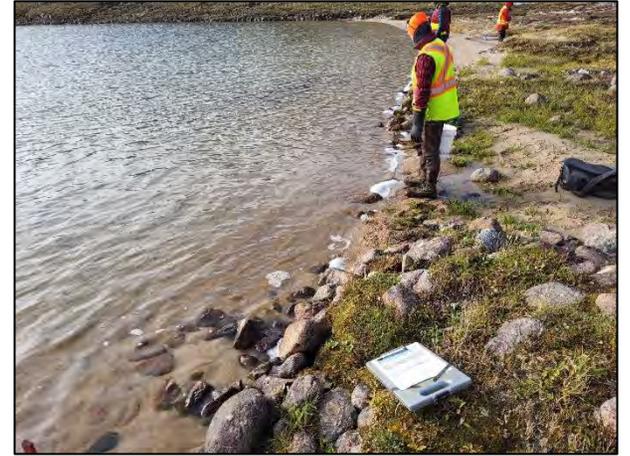
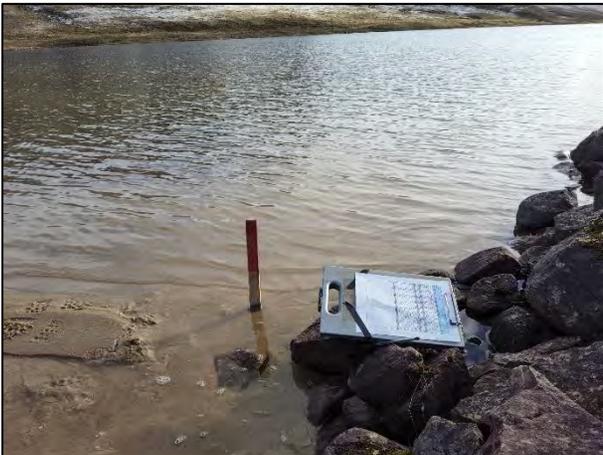
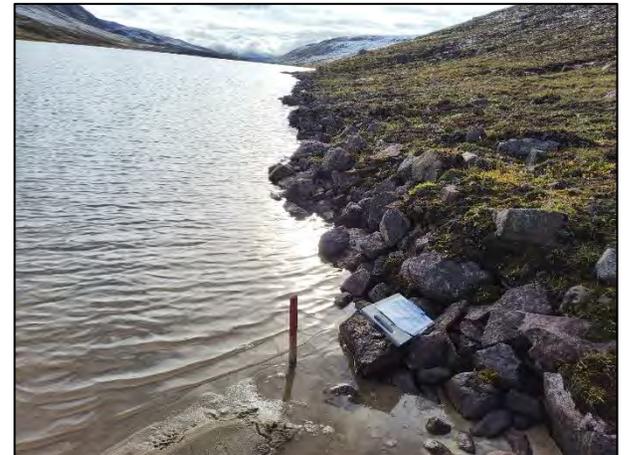
Photos 1. Photos taken at habitat transect 1 (top) and transect 3 (bottom) at Site 013: (A) facing southeast; (B) facing northeast; (C) facing southwest; (D) facing east; (E) facing northeast; (F) facing southeast.
