N2015C0014
2018 CIRNAC LAND USE ANNUAL REPORT

**FOR THE ASTON BAY PROPERTY
(ALSO KNOWN AS THE STORM PROPERTY)
NUNAVUT, CANADA**

January 2019

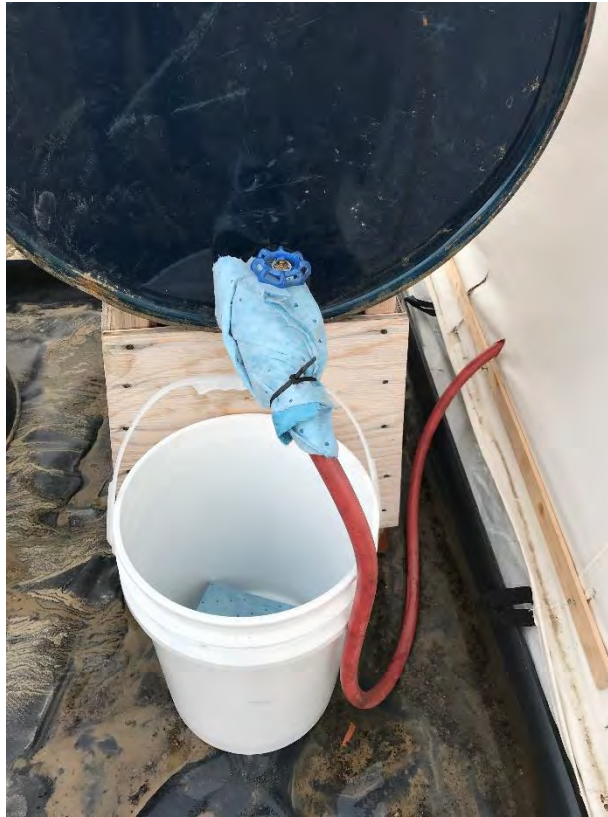
Photo 5: Tent drum in secondary containment berm. Fittings are wrapped in absorbent matting.

During the 2018 program, the existing fuel cache was used, located adjacent to Storm Camp at approximately 73° 39' 23" N latitude and 94° 26' 58" W longitude. Jet fuel and diesel/gasoline were stored in separate caches within the same general area. All fuel was stored within secondary containment berms. Mini berms were used for tent drums. Fittings for each tent drums were wrapped in absorbent matting, and buckets were hung below the drum spigot to mitigate any fuel leakage (Appendix 3, Photo 5).

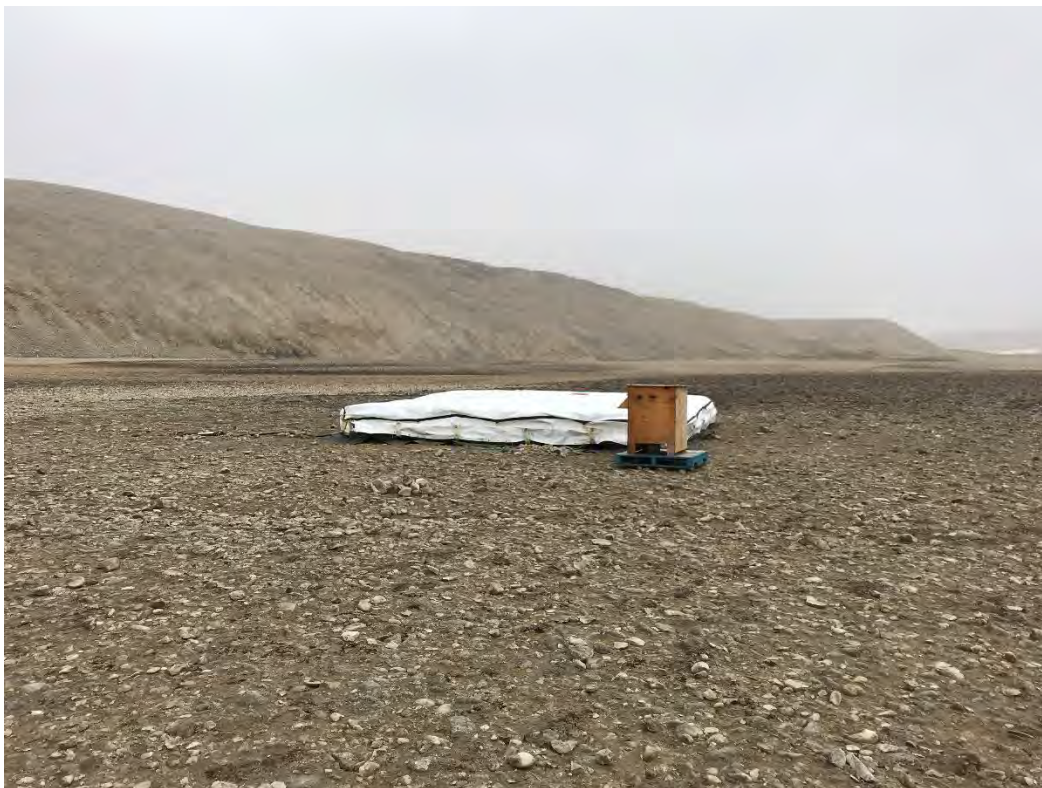
Photo 6: Storm Camp jet fuel cache after shutdown (looking east)

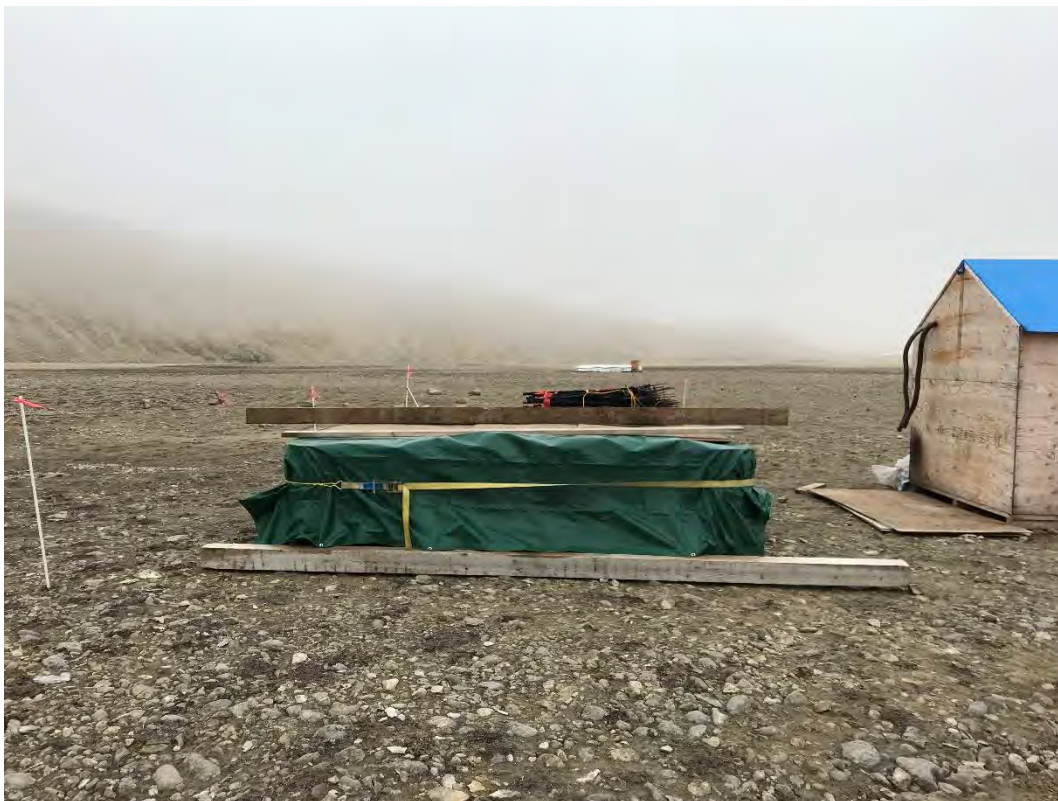
Photo 7: Storm Camp diesel/gas fuel cache after shutdown (looking east)

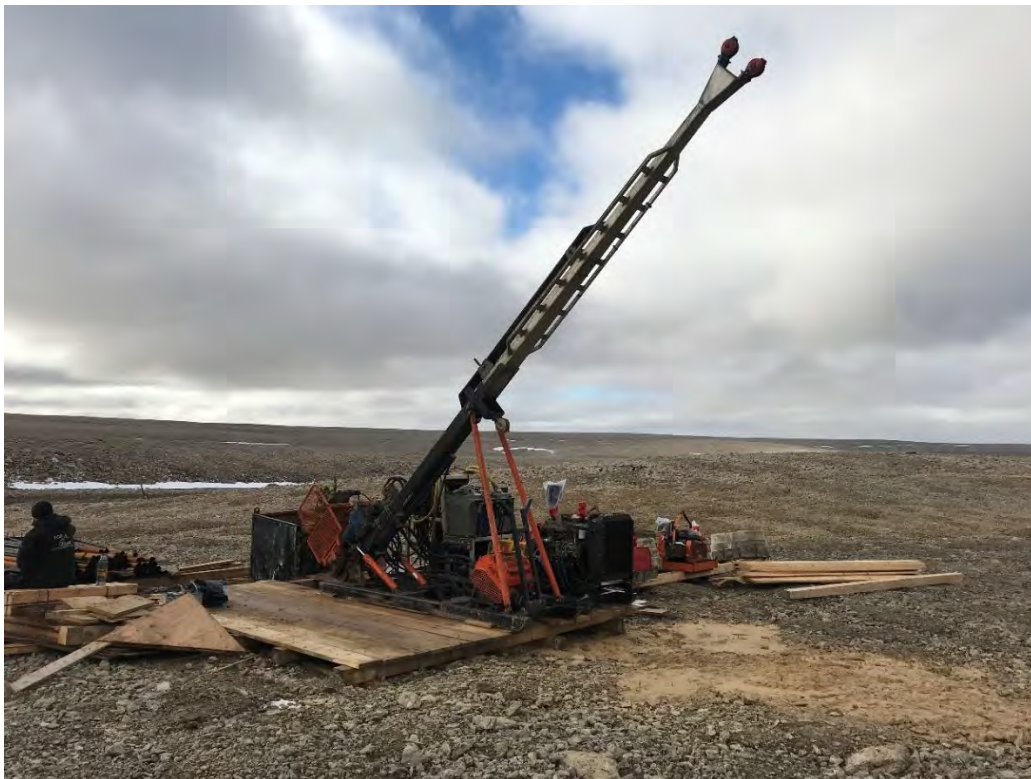
Photo 17: Drill Pad AB18-09 (drill stored on site – materials subsequently tidied up, all fuel & oil drained from equipment)

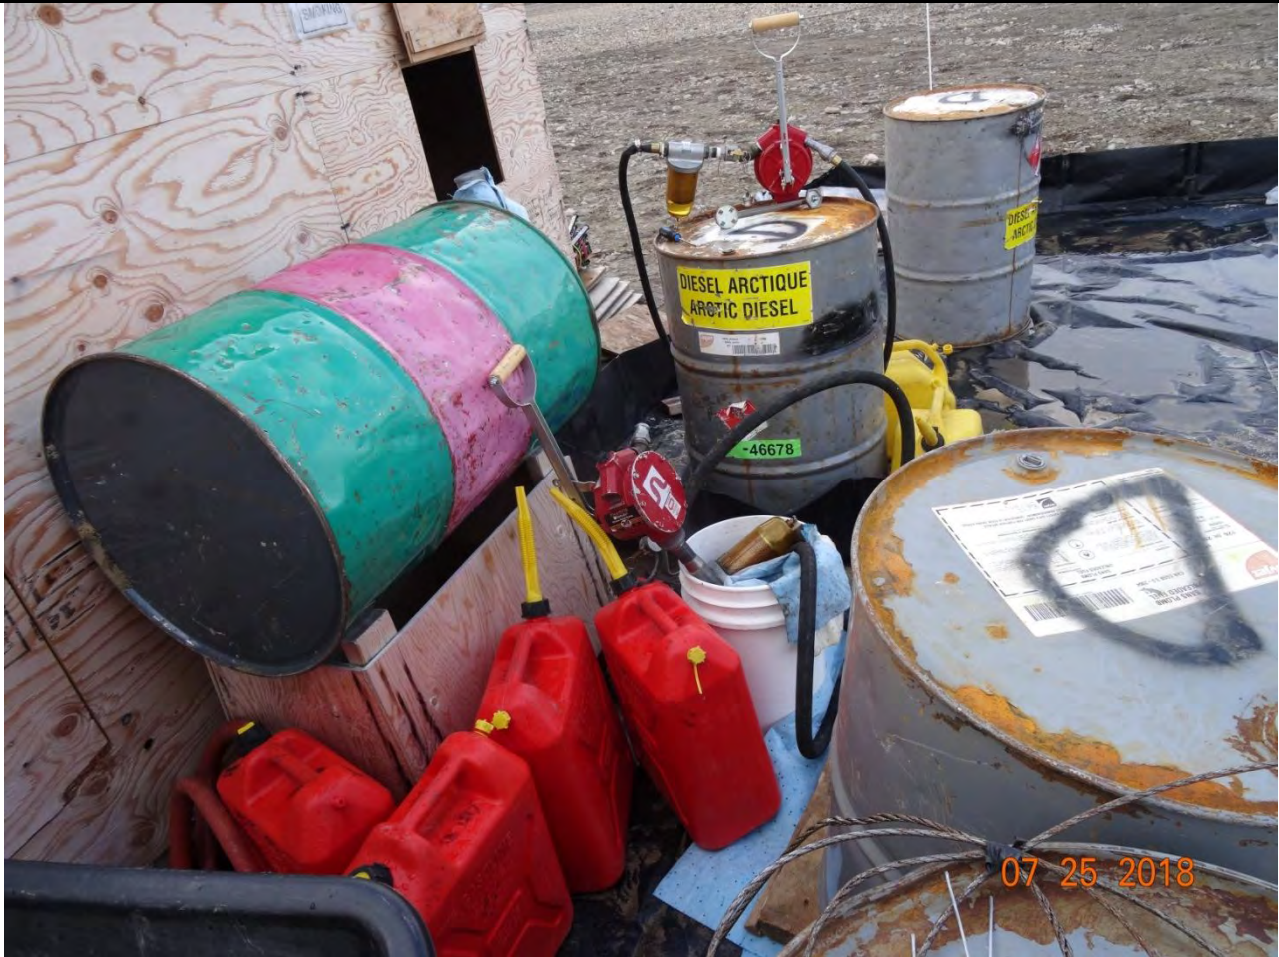
- During the inspection it was noted that three (3) small fuel containers were left open, this is in contradiction of, item 66, of the permit N2018N0004 which states; "the permittee shall seal all container outlets except the outlet currently in use." The licensee was informed of this issue at the time of the inspection and was encouraged to ensure all employees are aware of the terms and conditions of their LUP.

Figure 1: Containers not sealed

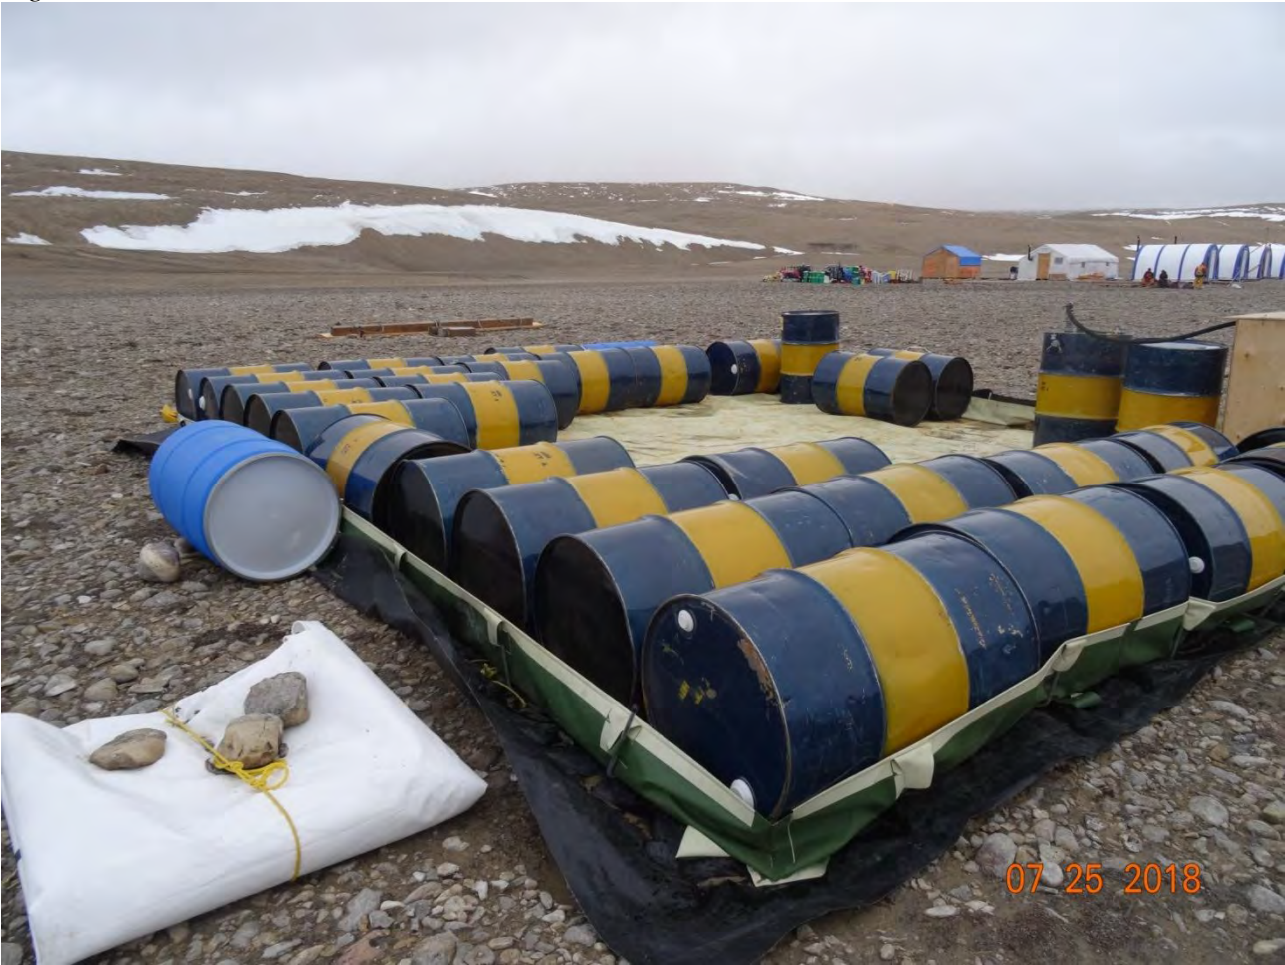
- The licensee is still in the process of remediating old drill collars from exploration that occurred in the 1970's.
- At the time of the inspection the licensee was storing fuel outside their bear fence, Item 63, of the LUP N2015C0014 states that "the permittee shall store fuel and chemicals in such a manner that it is inaccessible to wildlife.", It is recommended that the licensee consult with the Engineer of Lands at CIRNAC to determine the extent of the inaccessibility to wildlife is required.

Figure 2: Jet fuel

future programs. In addition, removal of legacy drill casings will continue. As recommended, Aston Bay will also consult the CIRNAC Engineer in regards to Item 63 of the Land Use Permit.

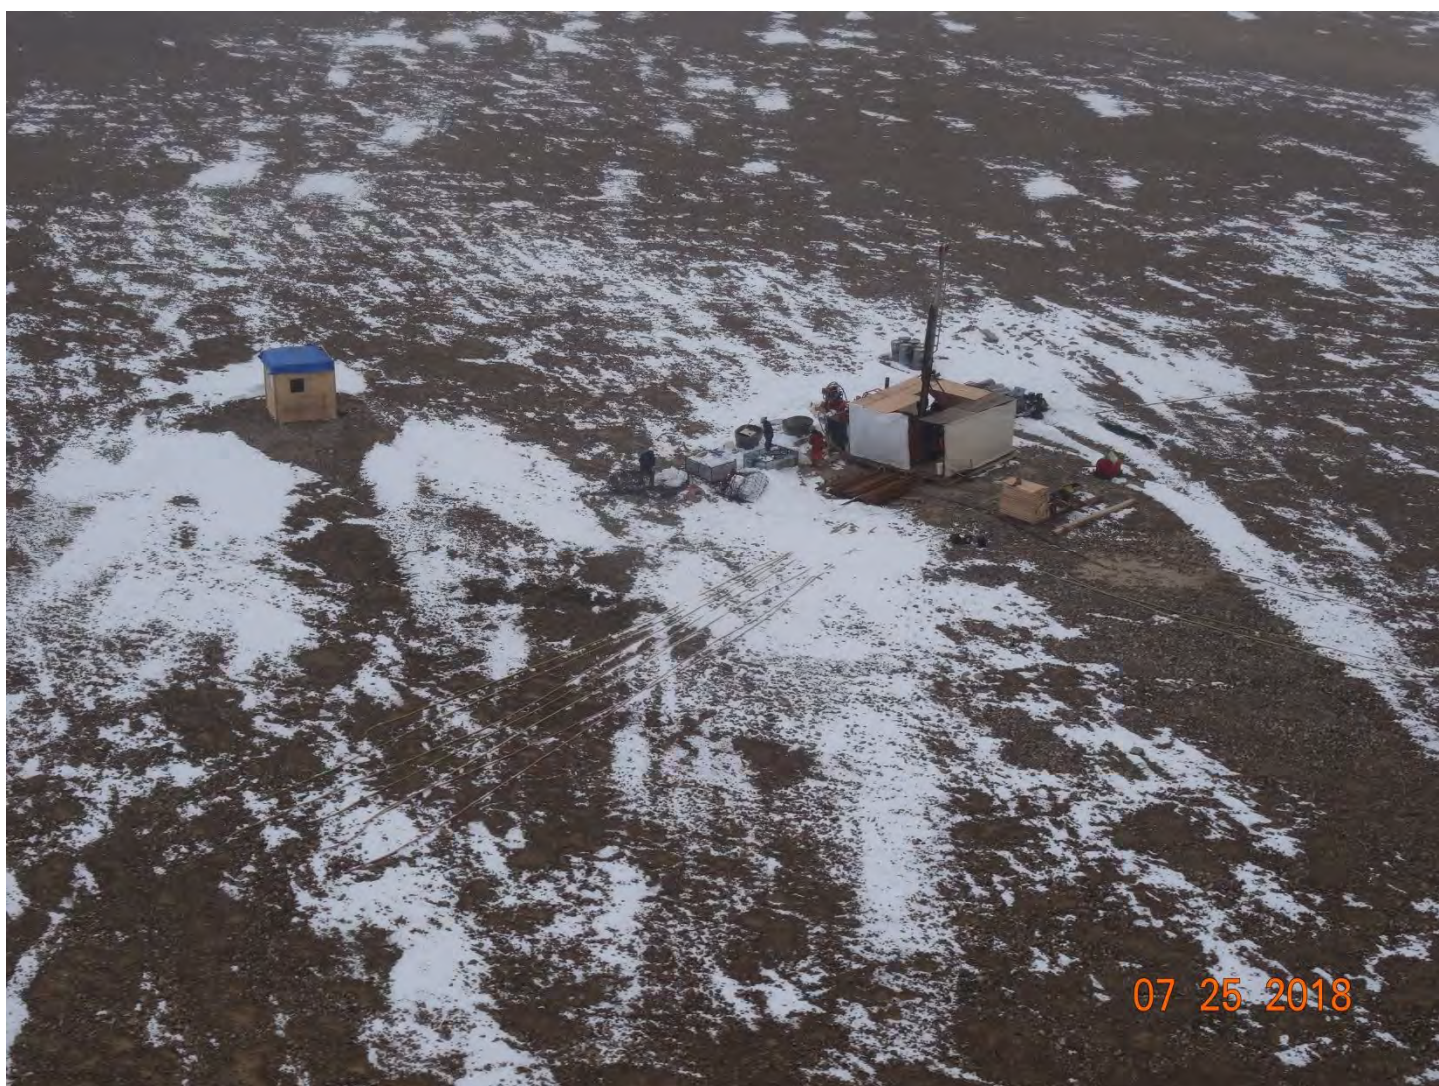
- The previous inspector and the permittee had agreed to deposit drill cuttings in porous boulder fields, I am recommending that the Licensee use sumps as required in this permit. The use of sumps will help to ensure that the drill cutting so not spread to surrounding lands.

Figure 4: drill cuttings not disposed into a sump

During the 2016 and 2018 drilling programs, cuttings were deposited into porous boulder fields and natural depressions. This practice was deemed acceptable during previous inspections. At the request of the inspector in 2018, sumps are to be constructed to contain cuttings during

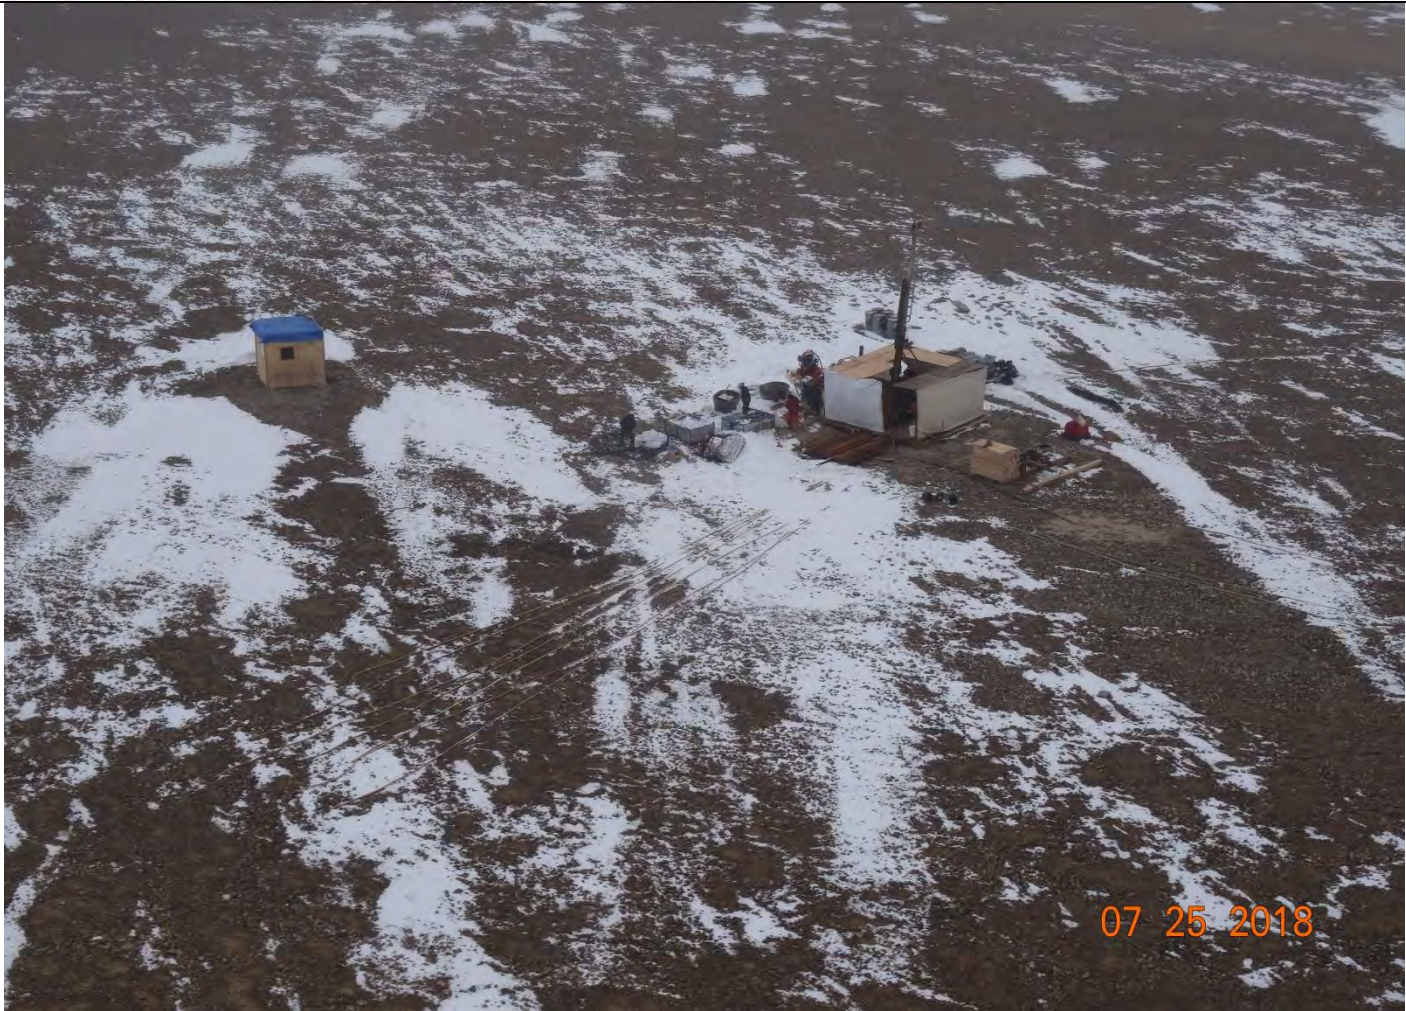
Figure 5: drill site
