**RE: Lupin Mine Winter Access  
Land Use Permit N2019F0001 – Annual Reporting**

**Lupin Mine Winter Access Project March 2020**

# **WINTER ACCESS PROJECT**

## **WATER LICENSE ANNUAL REPORT**

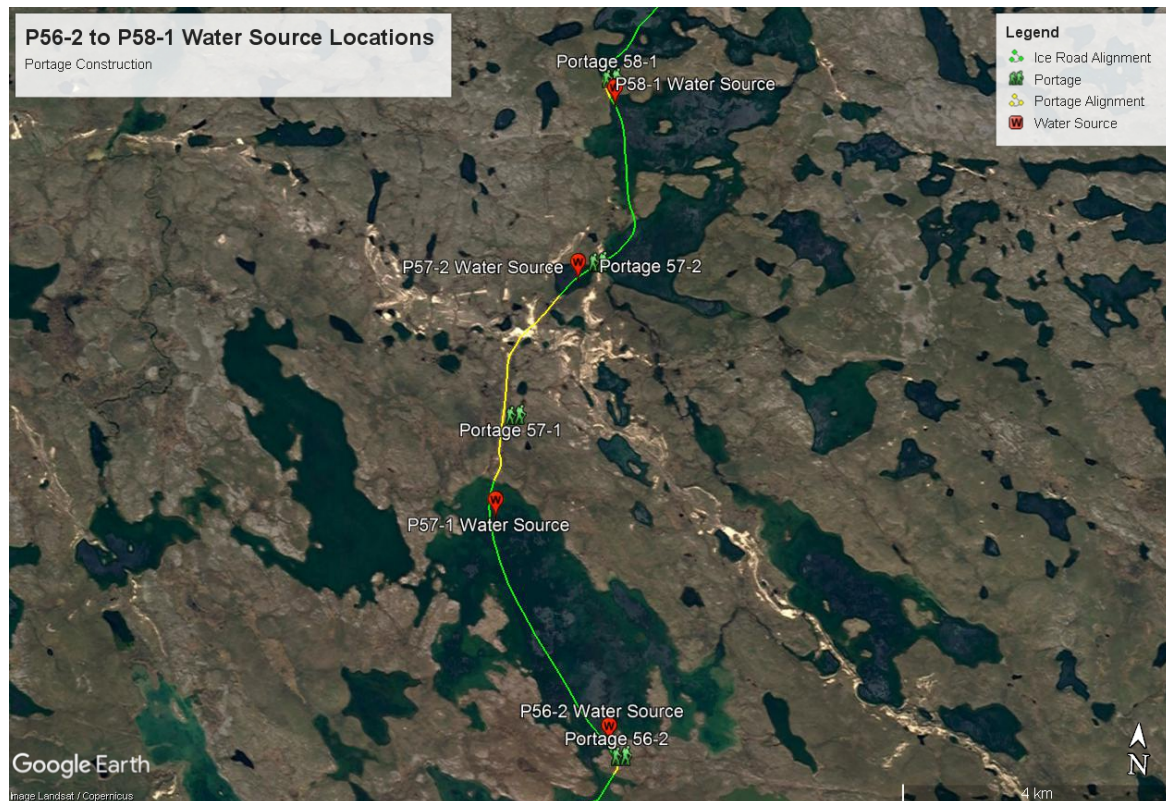
Figure 2-2 P56-2 to P58-1 Water Source Locations

Figures 2-1 to 2-5 display the locations where water was obtained for the camp operation and portage construction.

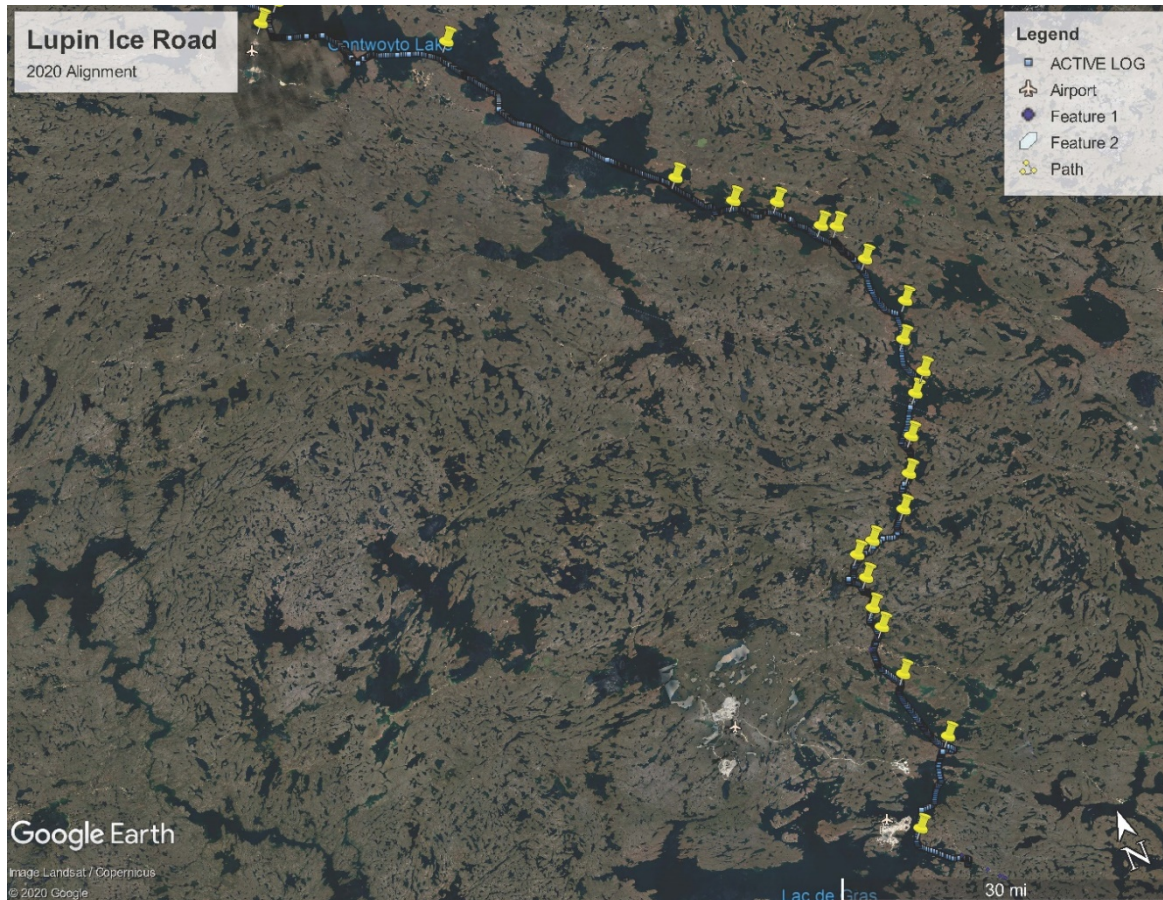
**Figure 3-1** displays the overall alignment of the Lupin ice road route from the JVWR near Diavik to the Lupin Mine site.

**Figure 3-1: Lupin Mine Ice Road 2020 Alignment**

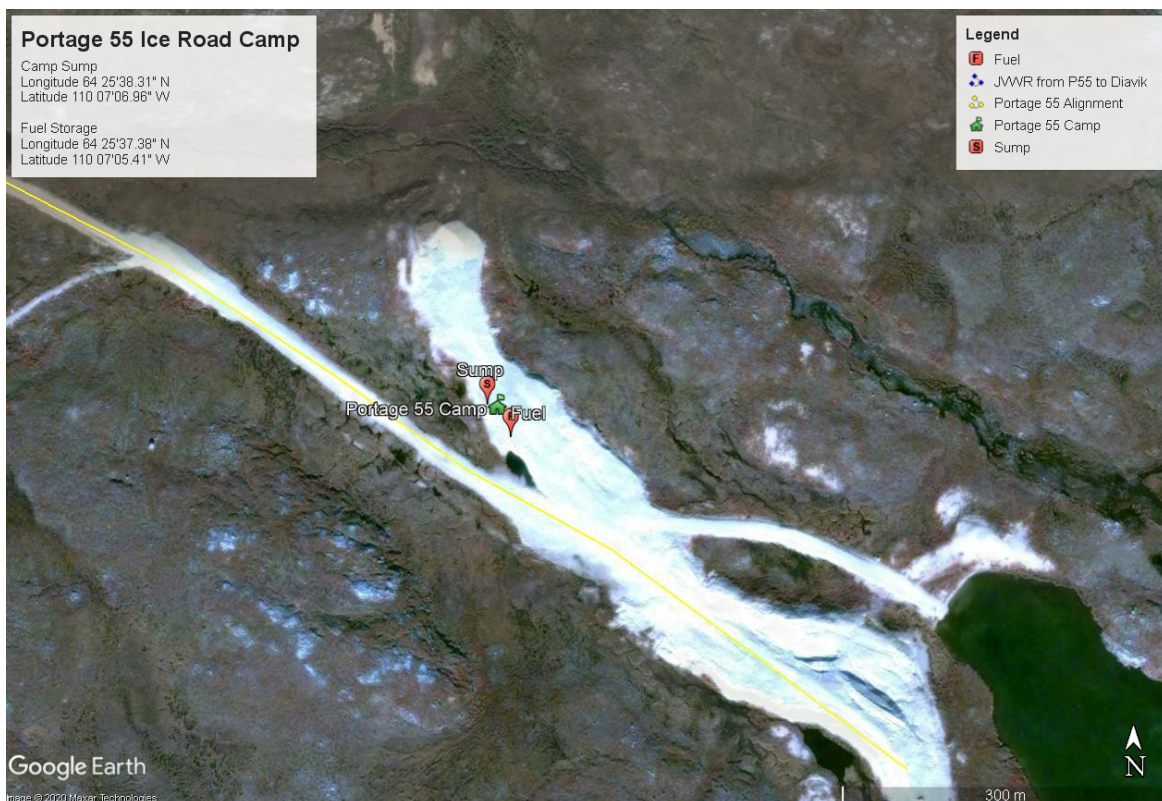
**Figures 3-2 and 3-3** display the Portage 55 (P55) temporary camp location that was used following inspector approval along with the backfilled sump and fuel storage areas.

Figure 3-3: Portage 55 Lupin Mine Ice Road Camp Sump and Fuel Locations

Nahanni maintained a temporary ice road camp at Portage 55. The camp included a sump pit for discharge of wastewater. Closure of the ice road camp included the demobilization of the 2 trailers and all support equipment and materials. All debris was collected to leave a clean site. Lime was applied within the sump before the excavated granular material was replaced to cover the excavated area.

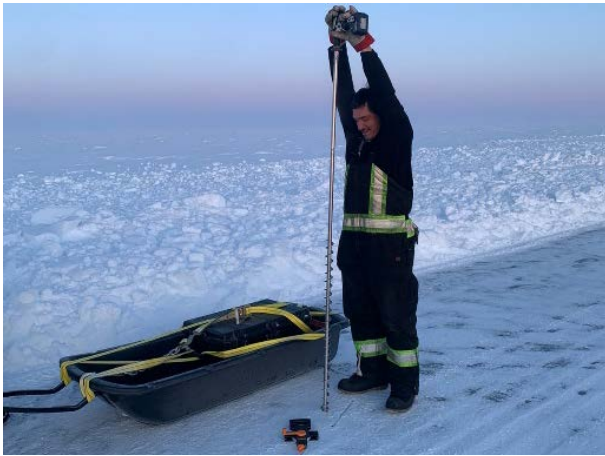
Figure 8-1: Ice Thickness Verification

Nahanni began with profiling the ice on the lakes with the use of a tracked aquatic vehicle (Haglund), pulling a profiler with GPS tracking capability. It was identified that the entire ice road route had sufficient ice for our construction fleet. Nahanni profiling continued during the ice road construction and certification phases. Ice profiling is used to identify ice thickness along the entire road. The initial ice profiling was used to identify areas along proposed route that had poor ice conditions. It is possible that currents could be encountered and an alternate spur route may require investigation to access the site. Ice information was collected and analyzed prior to pushing snow off the ice. Ice profiling and certification continued through the construction phase until the ice could be certified by a third-party engineer (Norex Engineering).

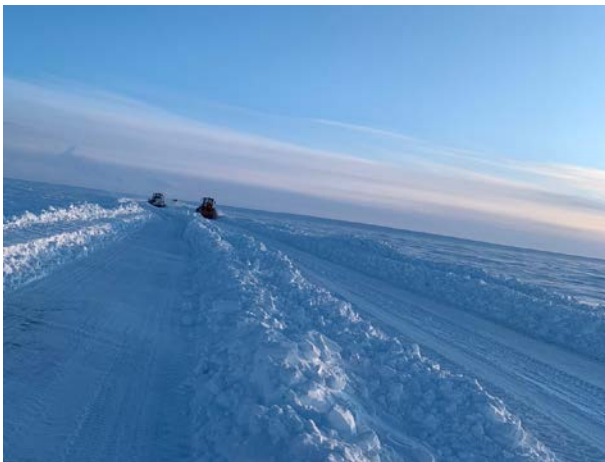
Figure 8-3: Establishing Ice Road Alignment after Profiling

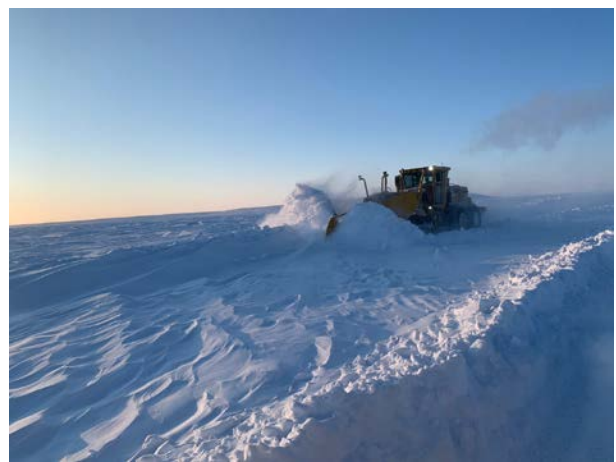
Figure 8-4: 160M Grader Plowing Ice Road Alignment

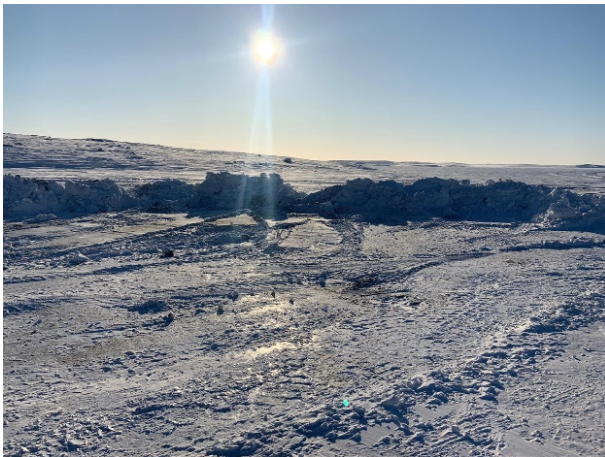
Figure 8-27: Covered 90Sump Area at P55

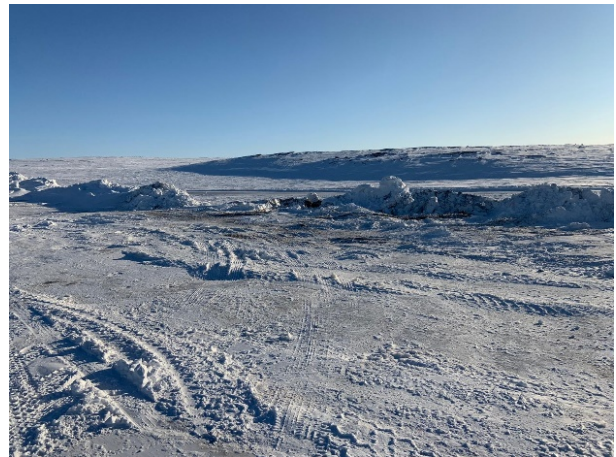
Figure 8-28: P55 Sump Closure
