Nunavut Impact Review Board

2025 Site Visit Report

Doris North and Phase 2 Hope Bay
Projects

Project Certificates 003 and 009

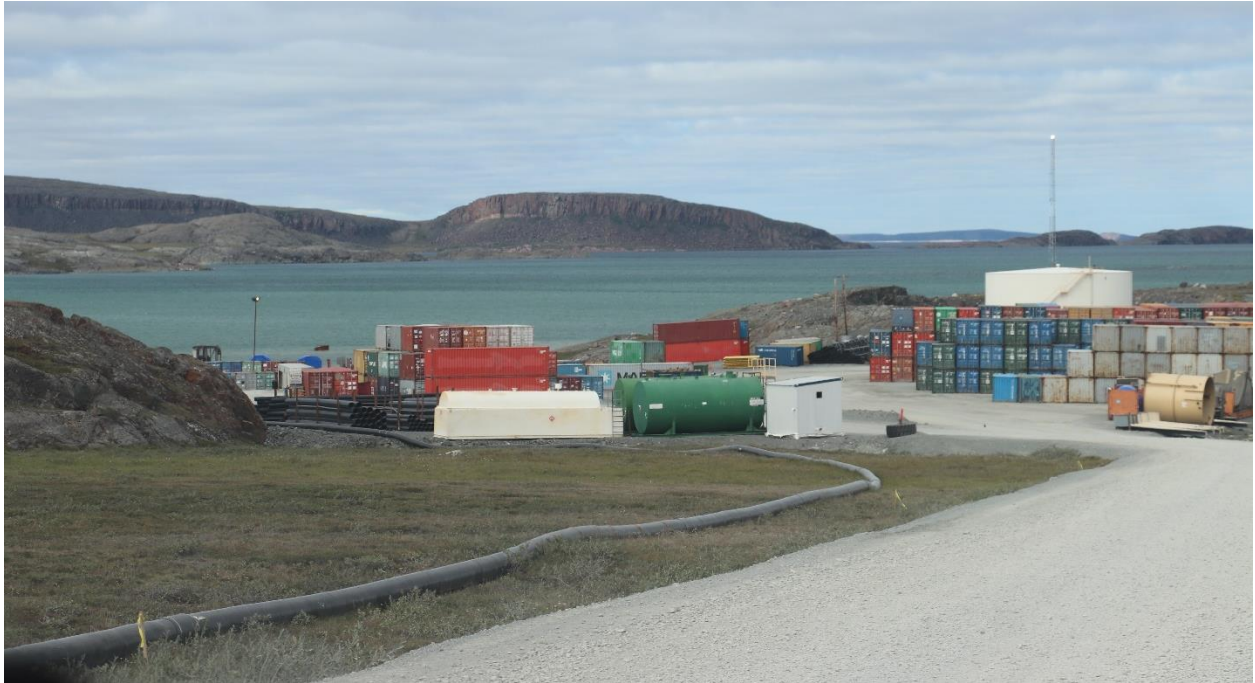
Photo 1: Roberts Bay Facilities and Laydown Area, Northwest View from the Primary Road

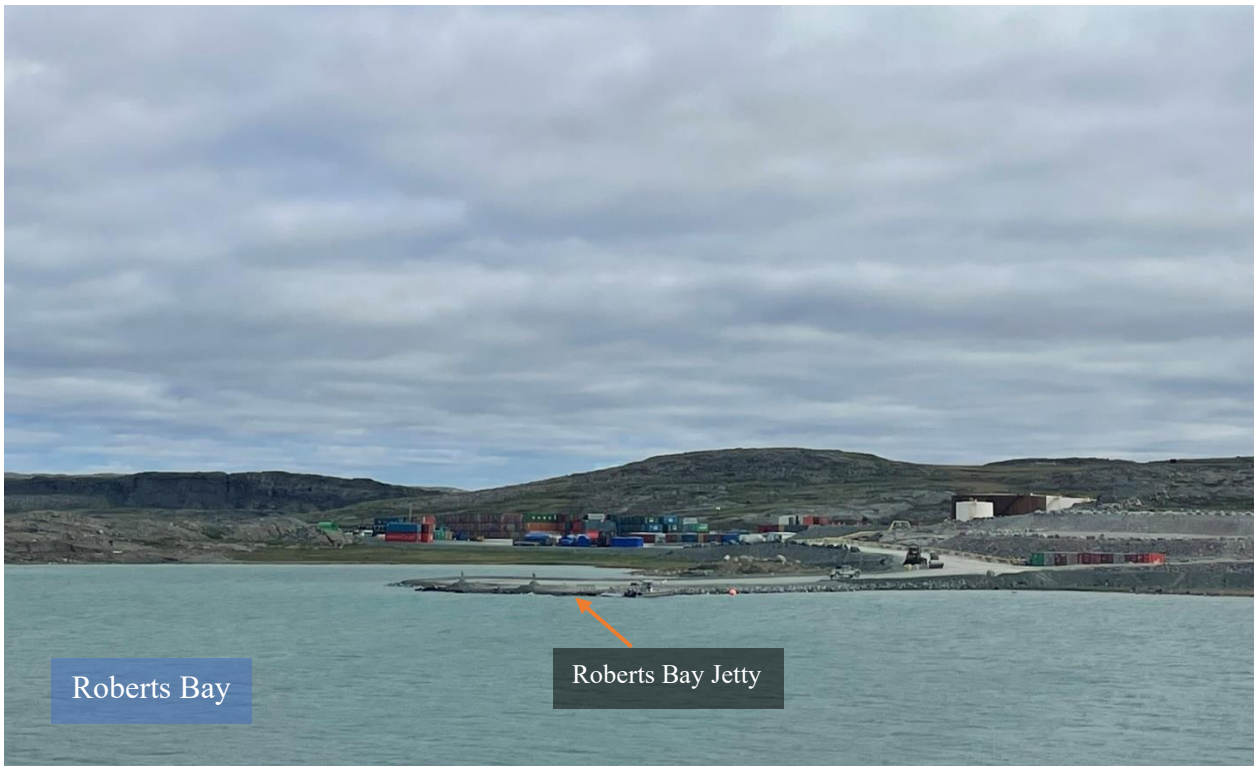
Photo 2: Roberts Bay Laydown Area, west view from the Roberts Bay Access Road

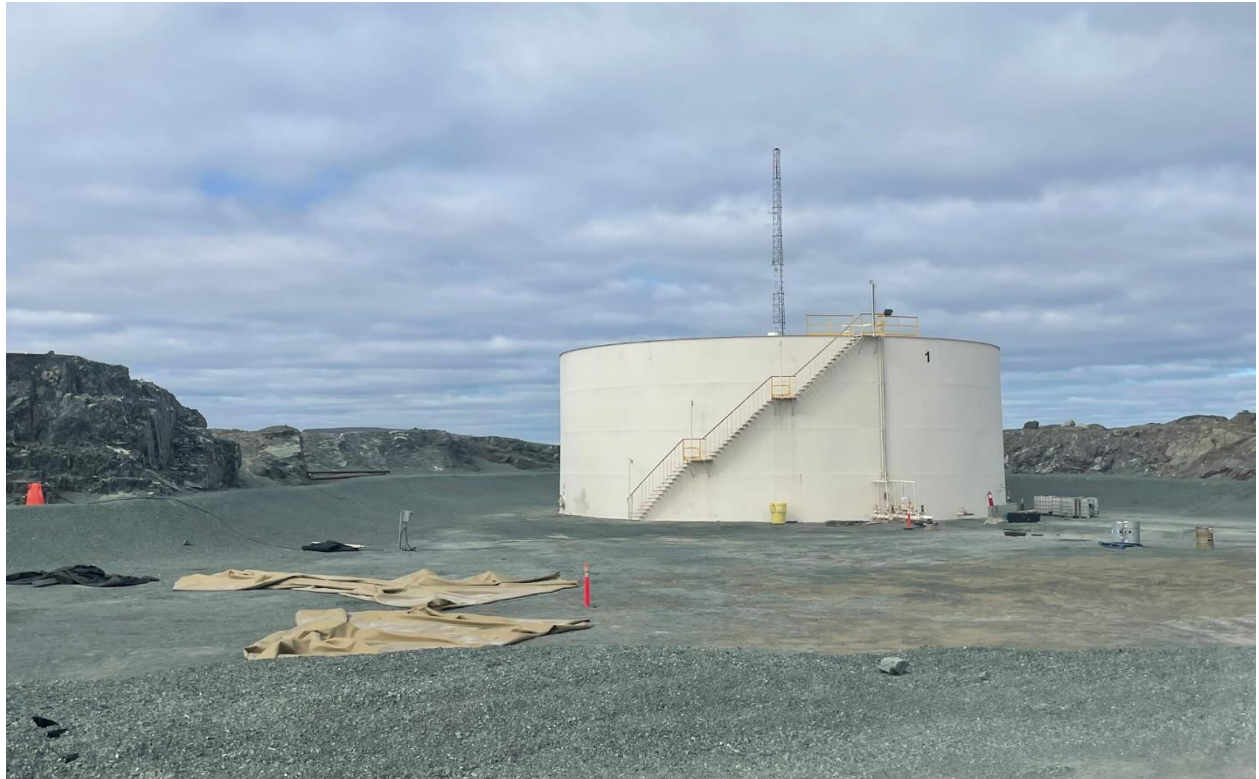
Photo 3: Tankfarm within Secondary Containment

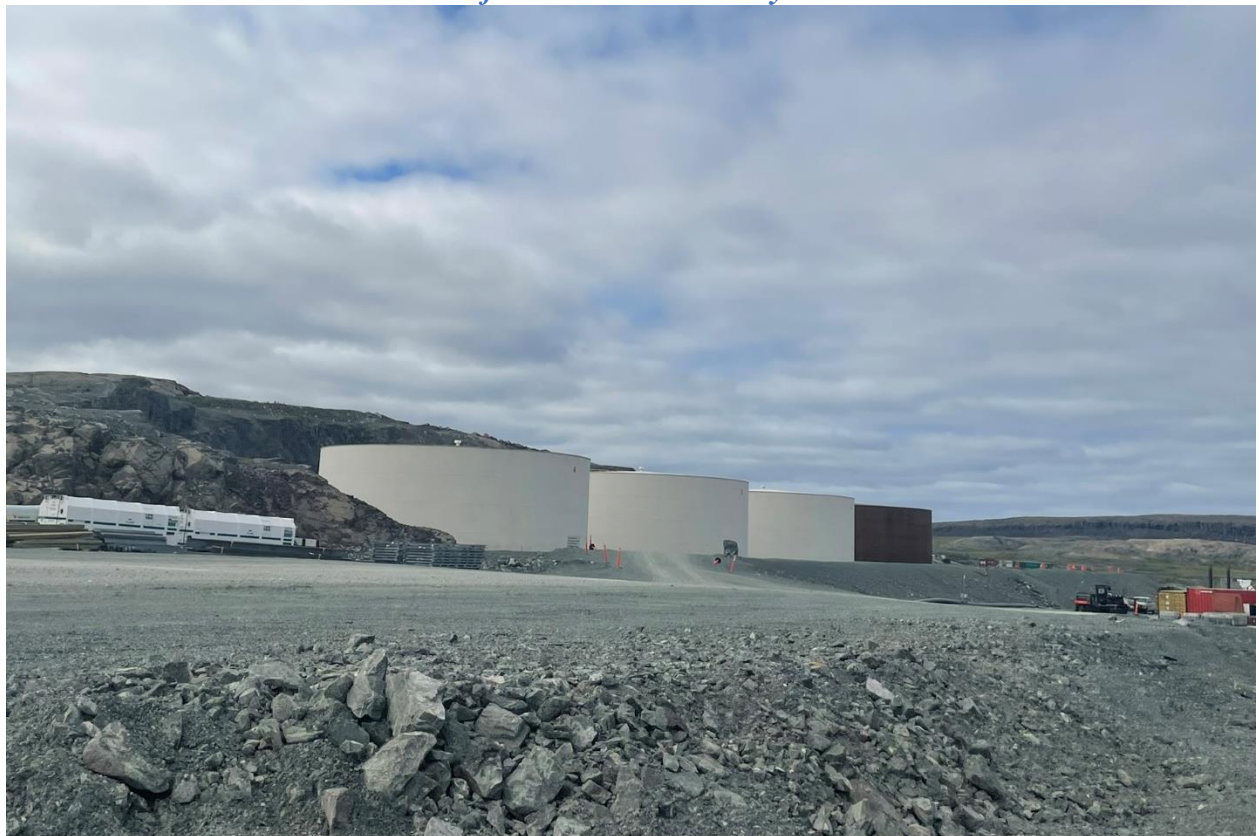
Photo 4: Tankfarm – Southwest View from Primary Road

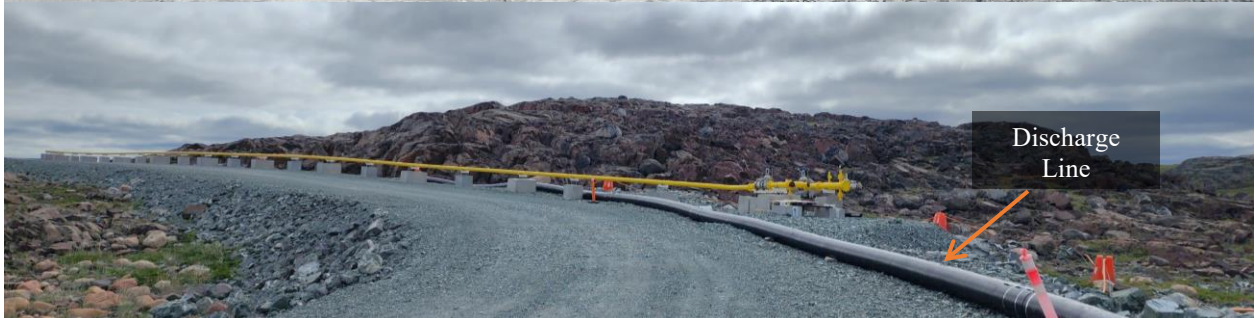
Photo 6: Fuel Line at Roberts Bay

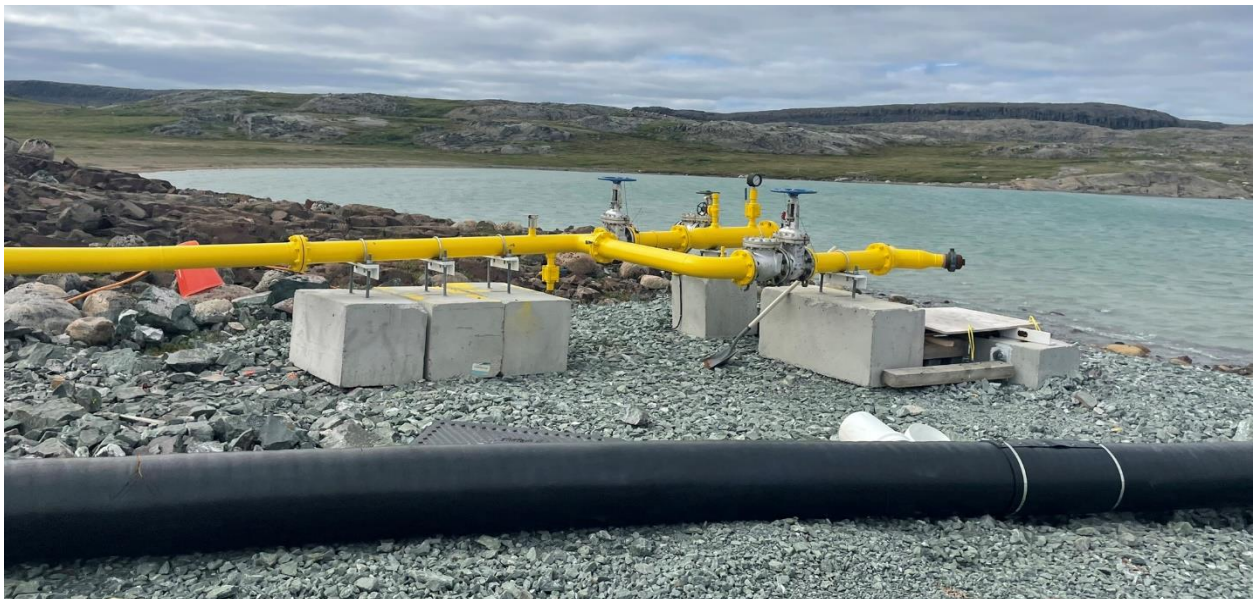
Photo 8: Fuel Line Anchor

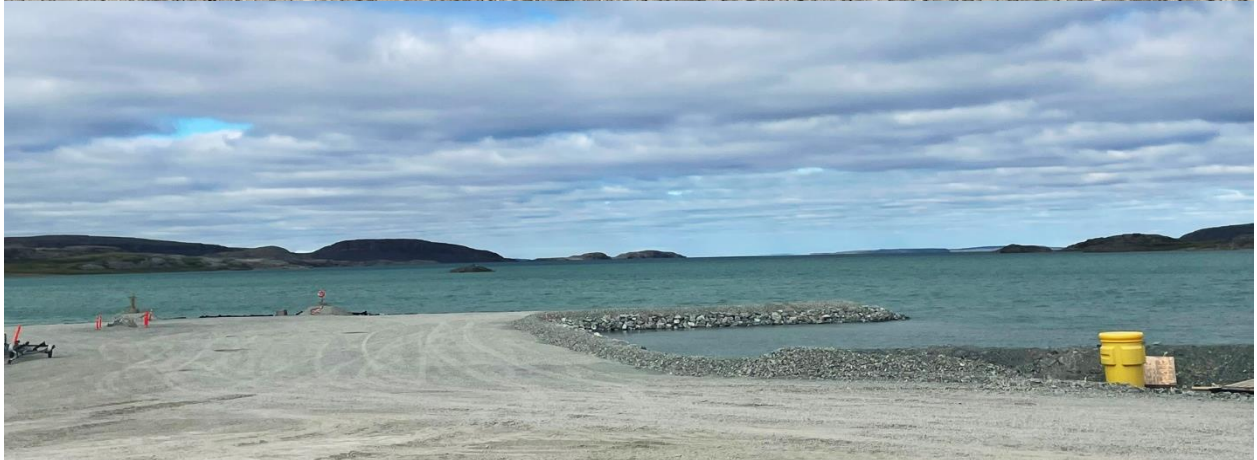
Photo 10: Roberts Bay Jetty

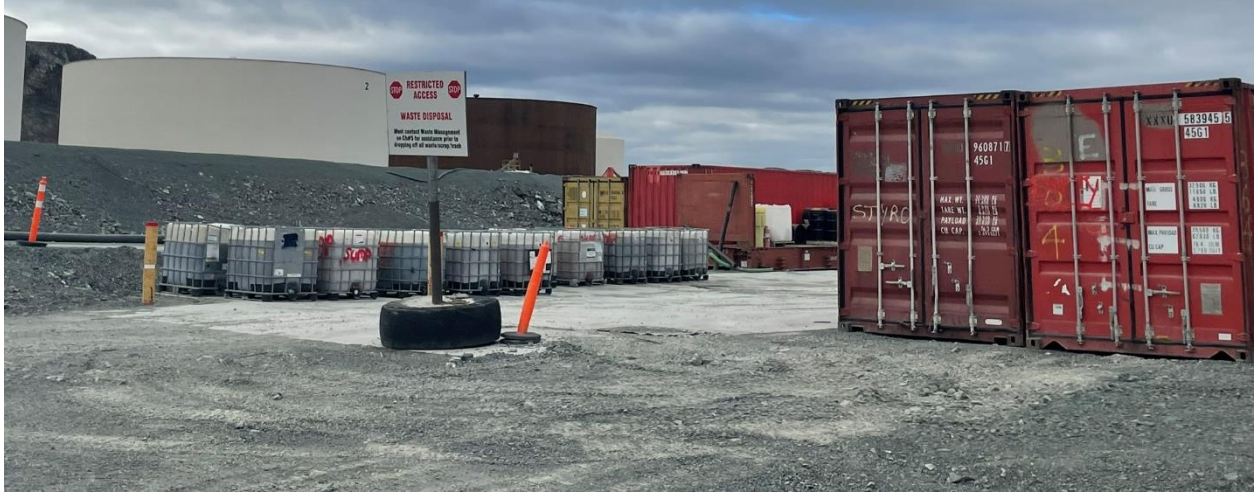
Photo 11: Waste Disposal Area

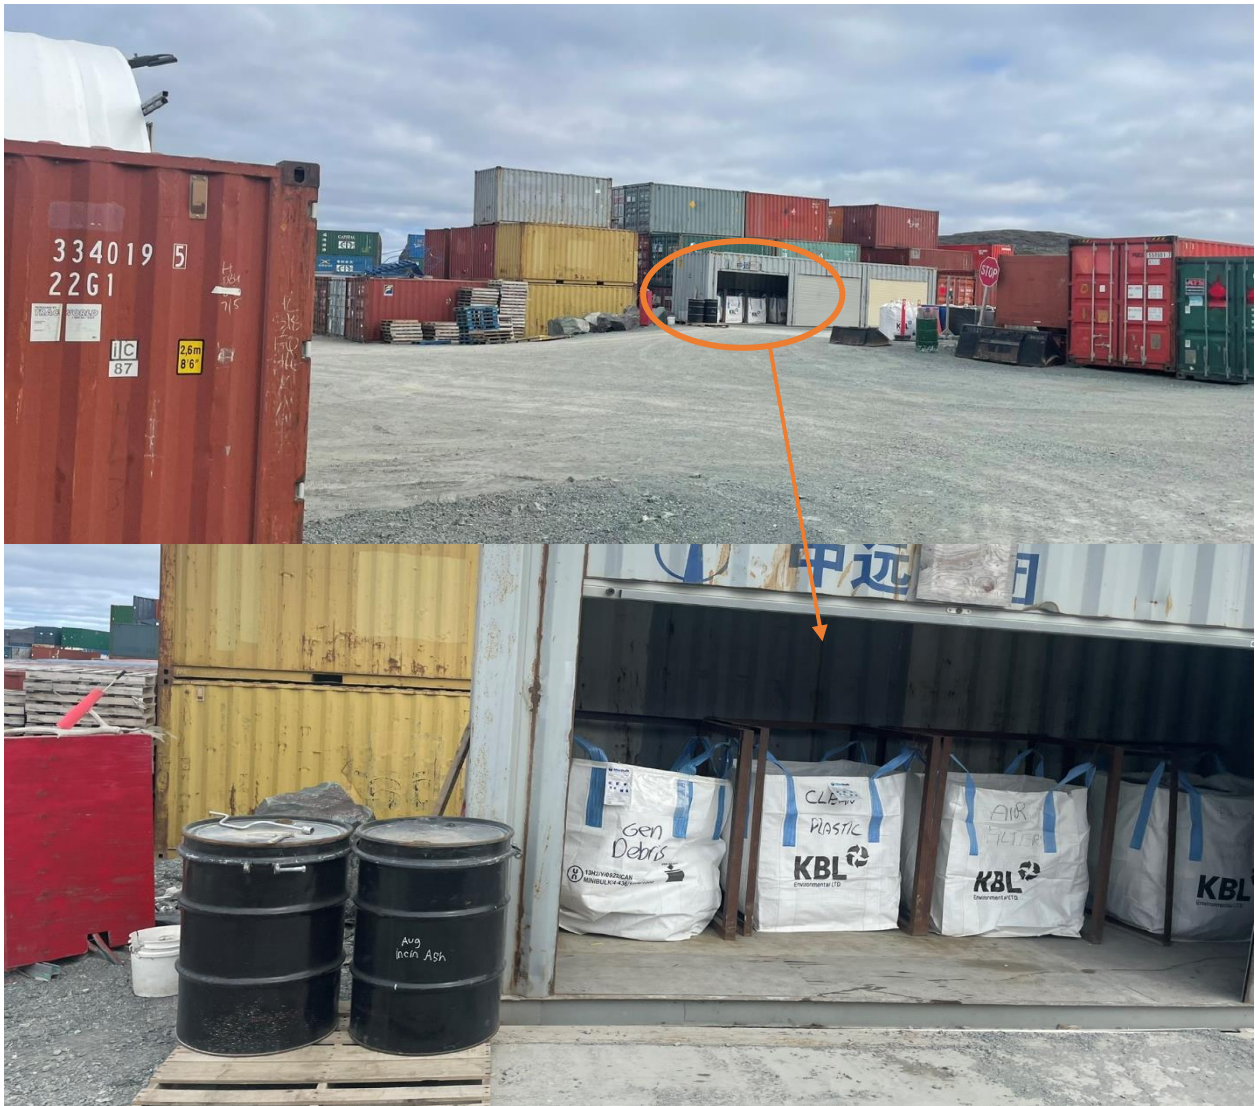
Photo 12: Non-Hazardous Waste Segregation Seacan

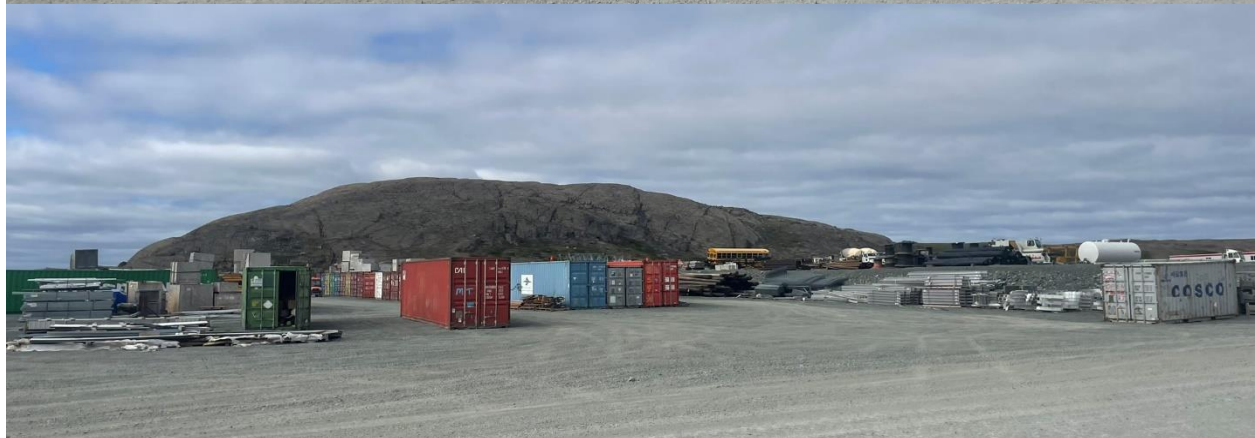
Photo 14: Laydown Area along the Primary Road

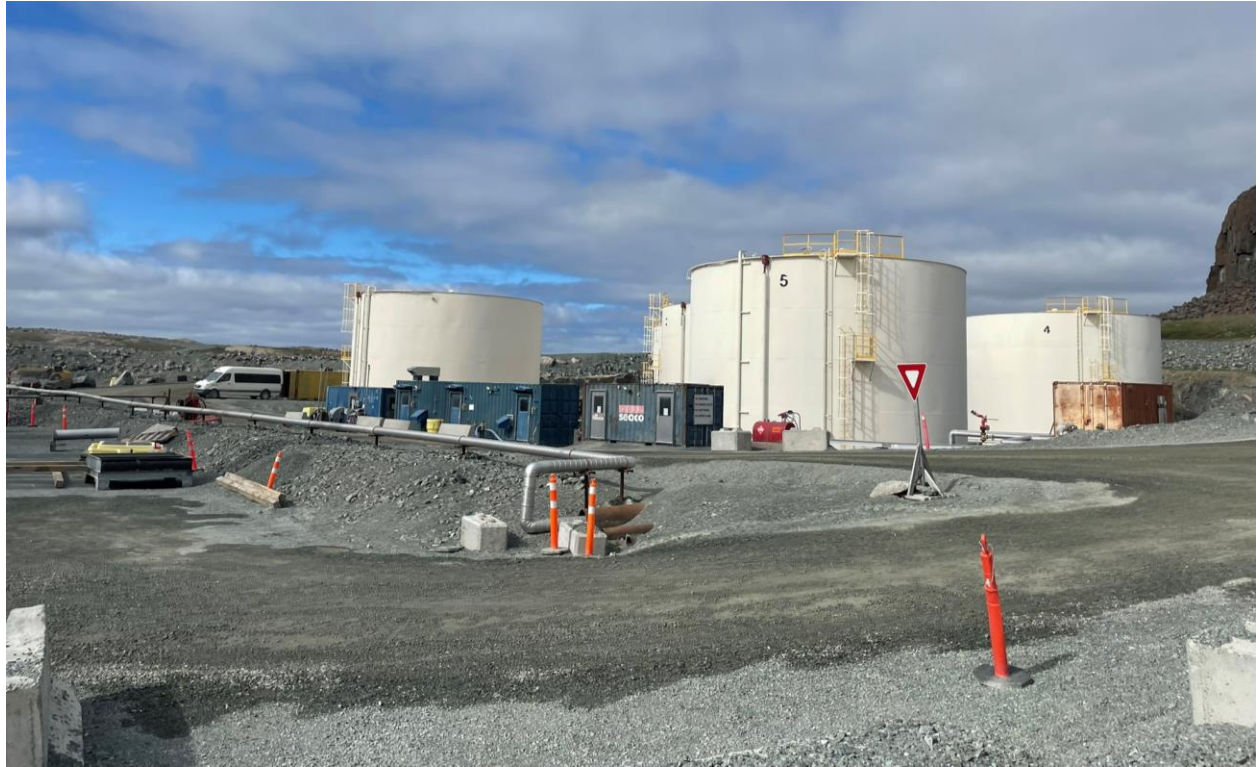
Photo 23: Tankfarm and Fuel Modules - Doris Camp

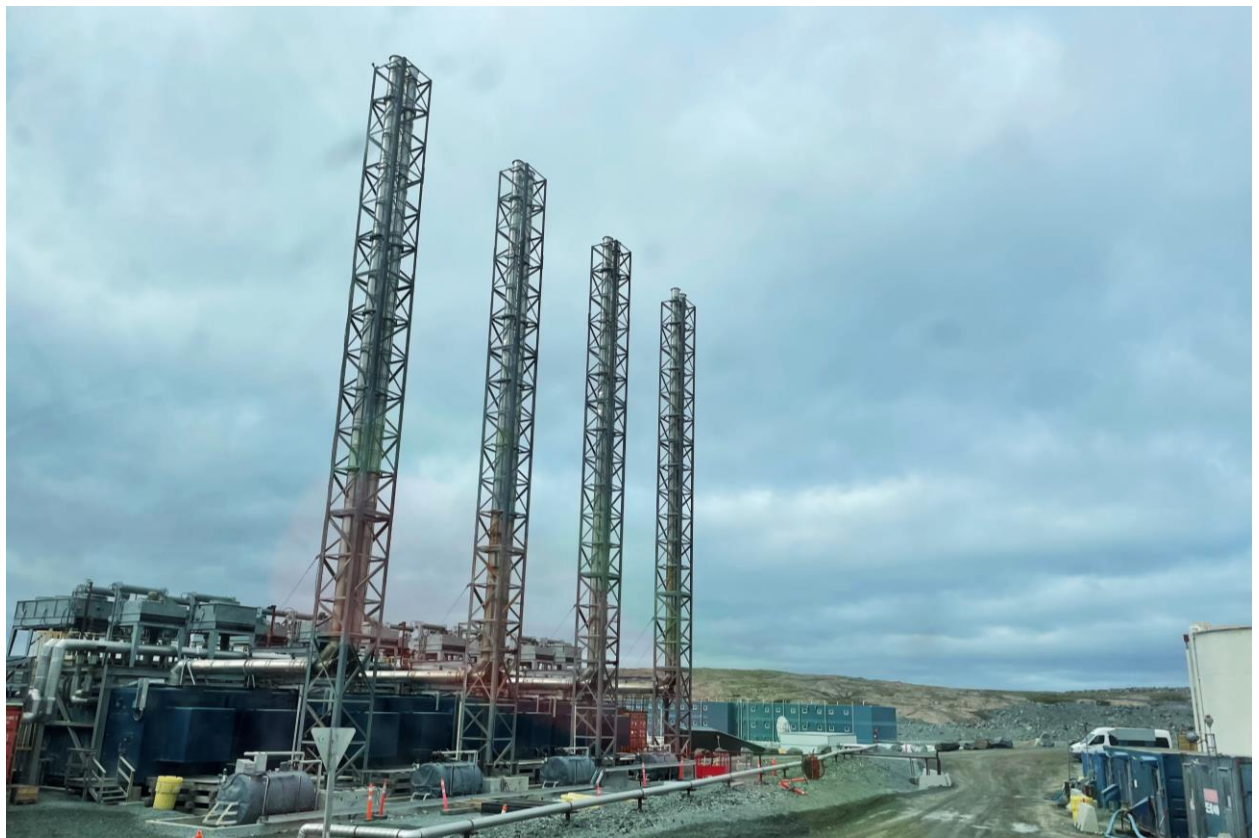
Photo 24: Power Plant – Doris Camp

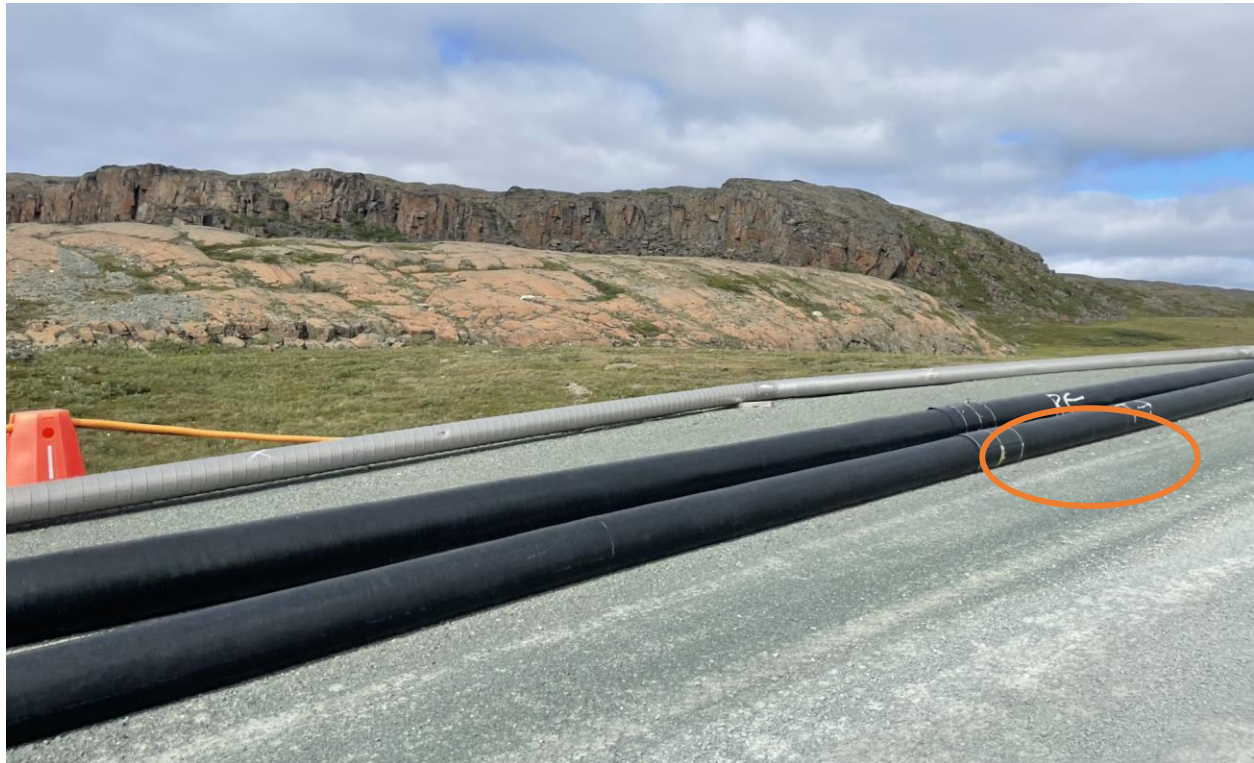
Photo 29: Waterlines labelled 'T' and 'R' run along the TIA Access Road, Transferring Treated Effluent to Roberts Bay and Effluent to the TIA Reclaim Pond

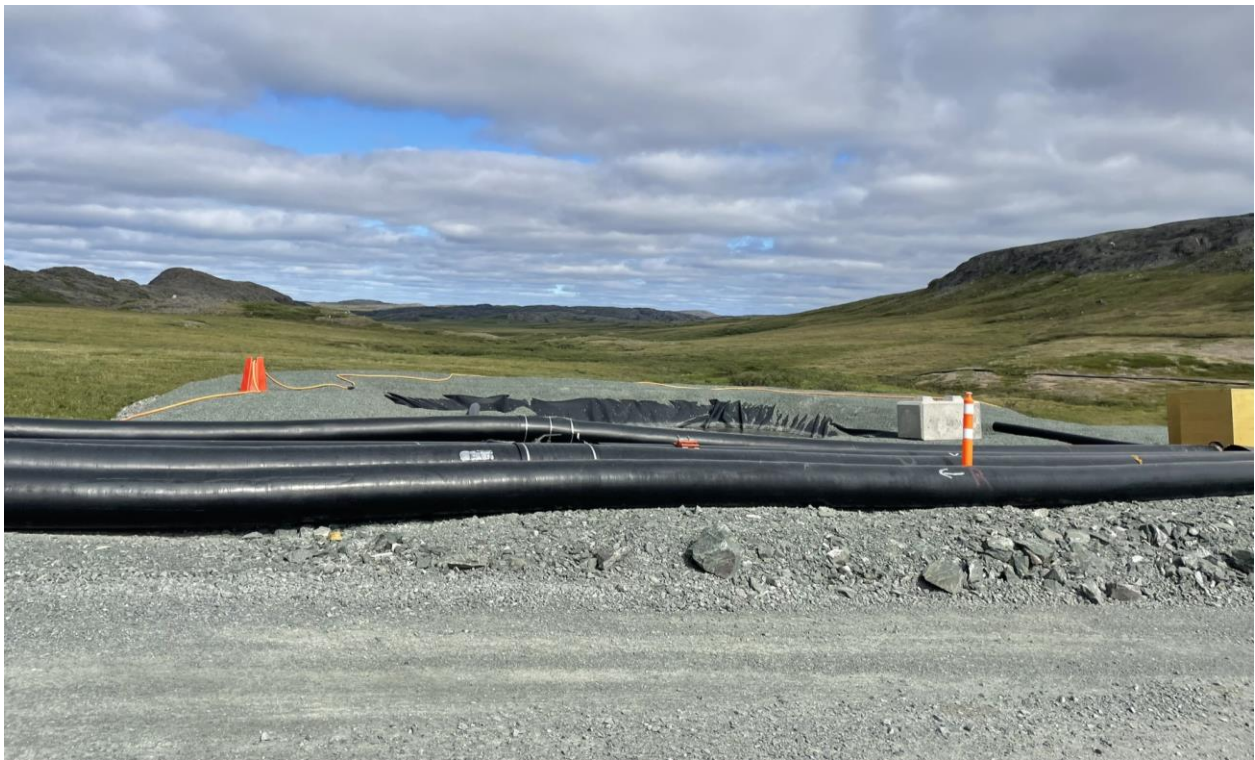
Photo 31: Catch Basin 1 - One of Two Catch Basins Located on Opposite Sides of Doris Creek Bridge for Emergency Discharge

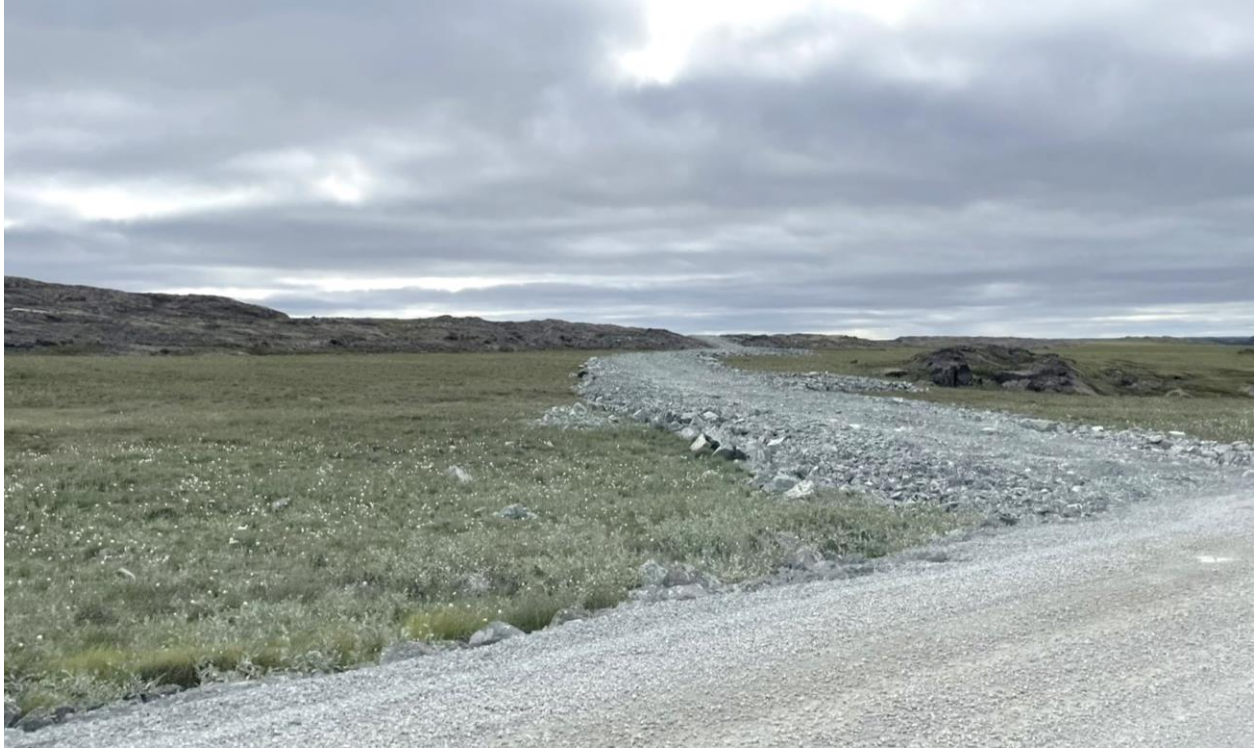
*Photo 42: Under-Construction road for Wind Turbine 2-
no equipment or materials at the site yet*

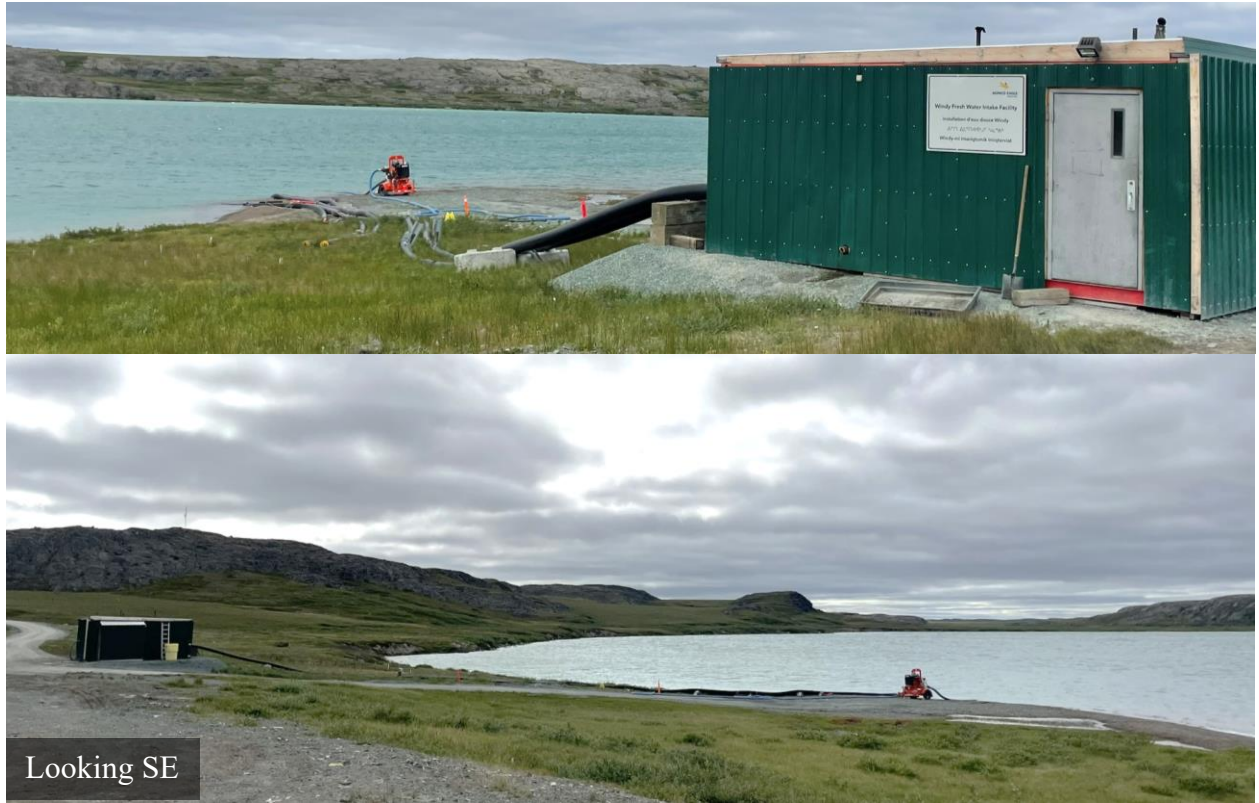
Photo 44: Windy Lake and Windy Fresh Water Intake Facility

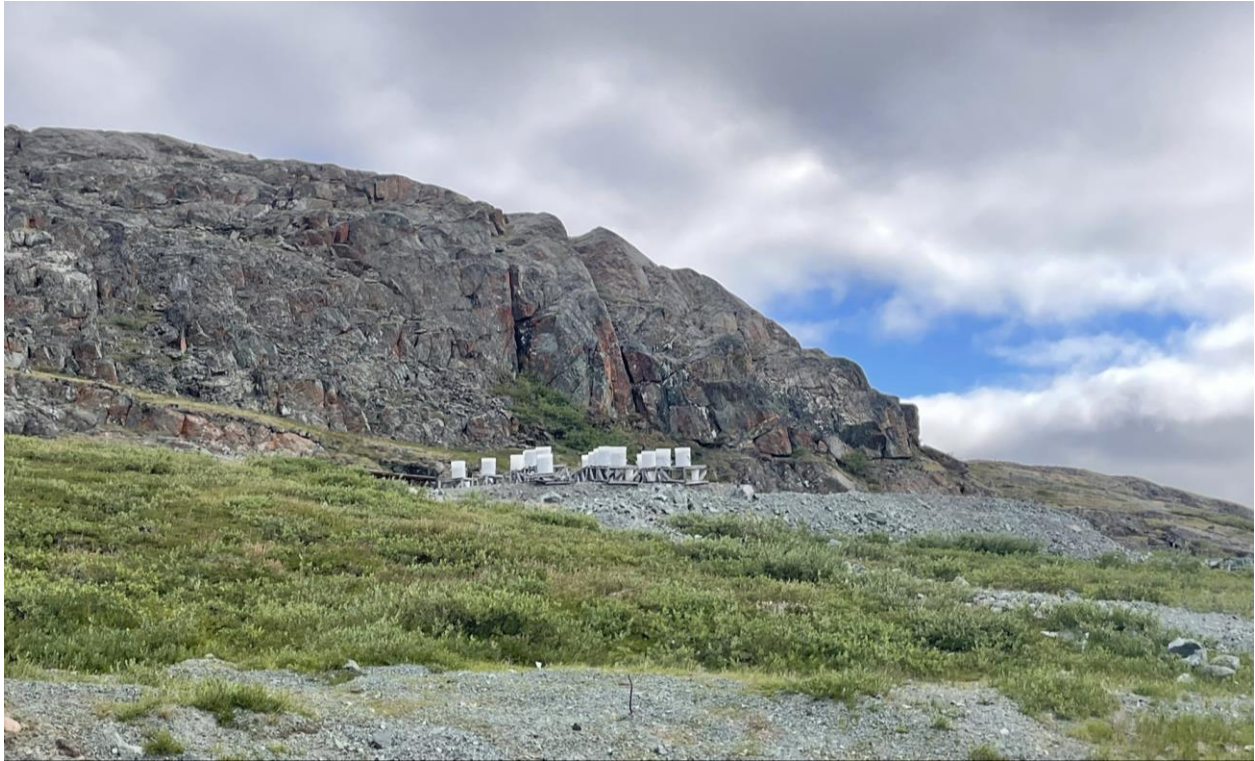
Photo 46: Acid Rock Testing Area near Windy Lake-Looking Northeast from Intake

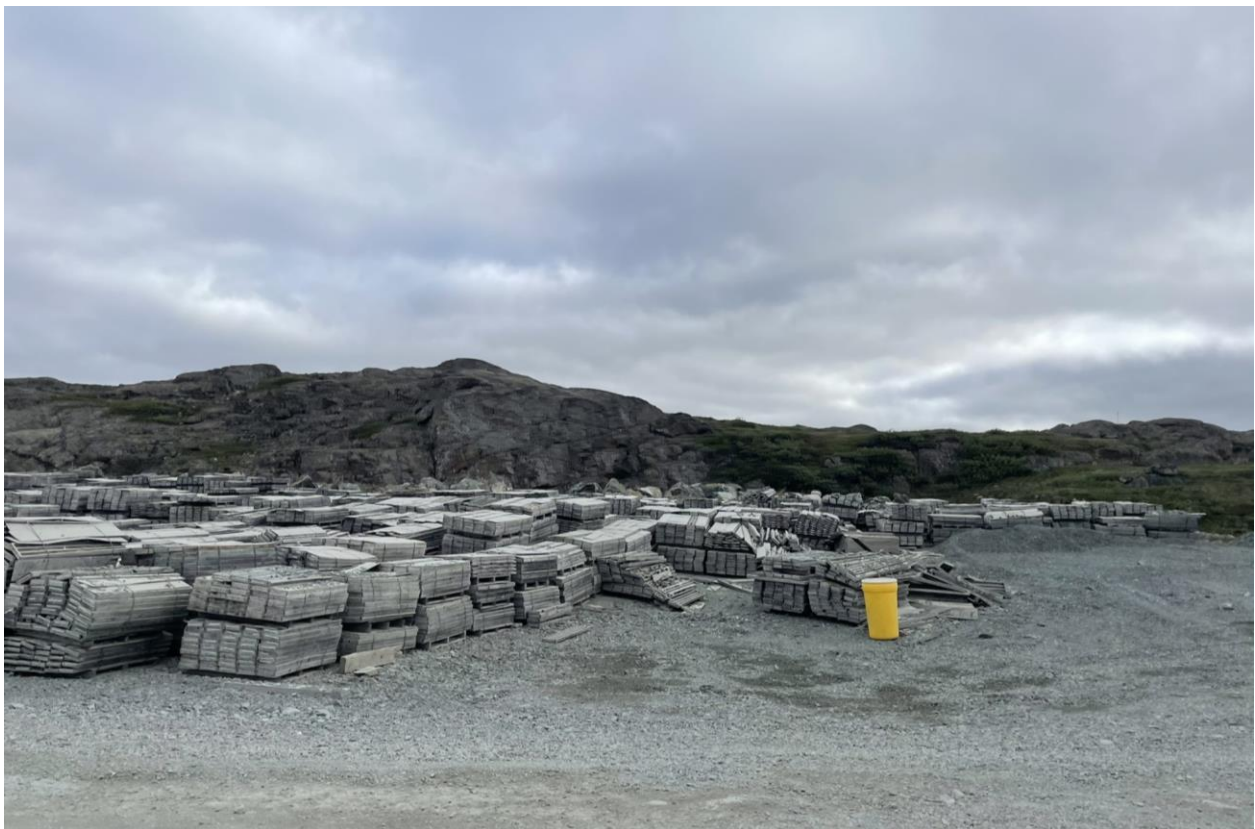
Photo 47: Core Storage Pad on Doris-Windy All-Weather Road near Quarry D

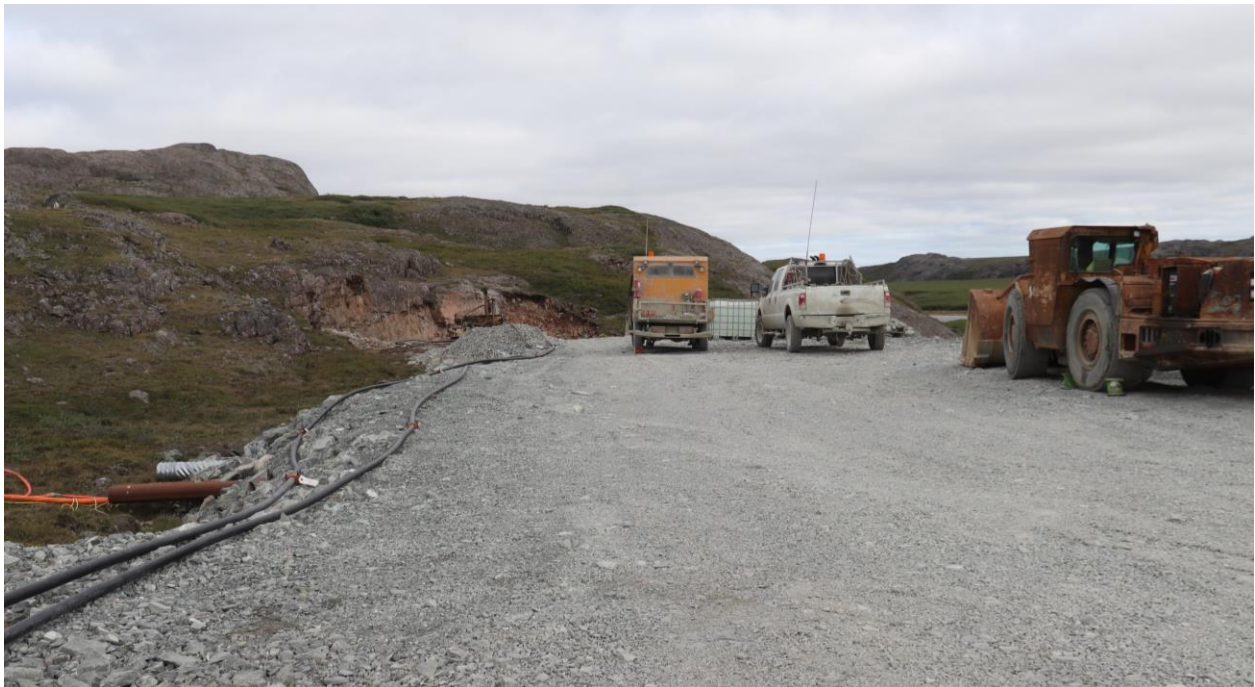
Photo 49: Construction of Ventilation Raise Collar at Naartok East

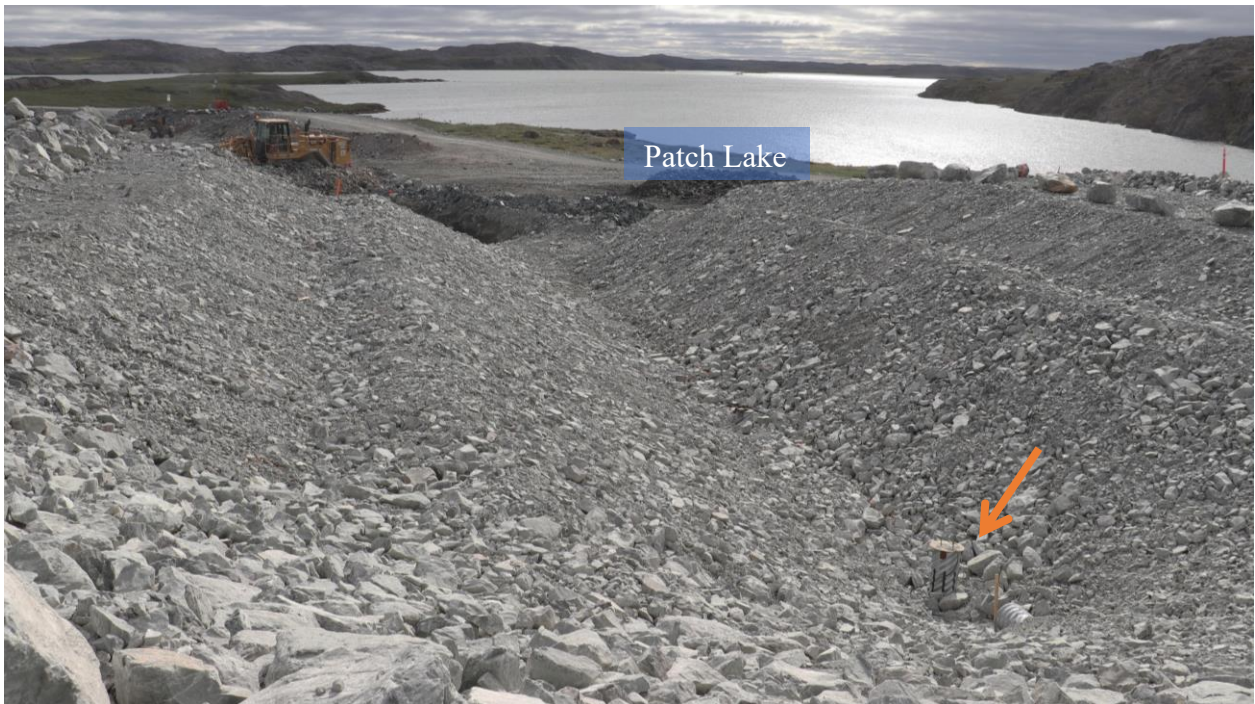
Photo 52: Crown Pillar Recovery Trench (CPRT) and Sump

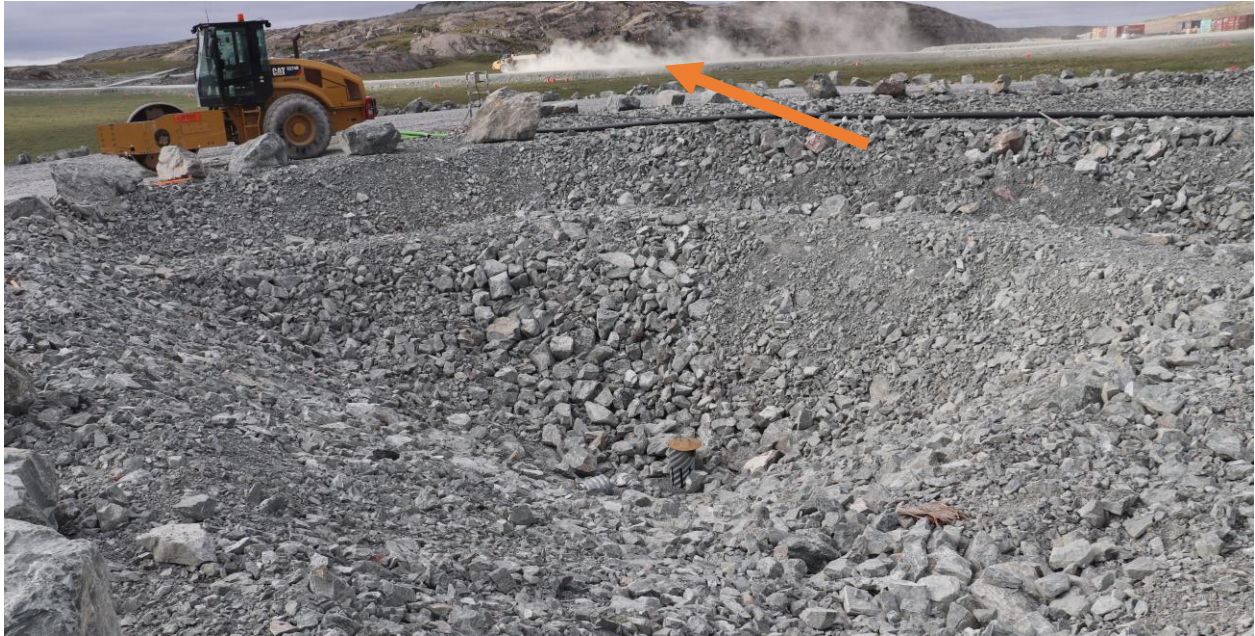
Photo 53: CPRT Sump with vehicle transit on Madrid All-Weather Road in background

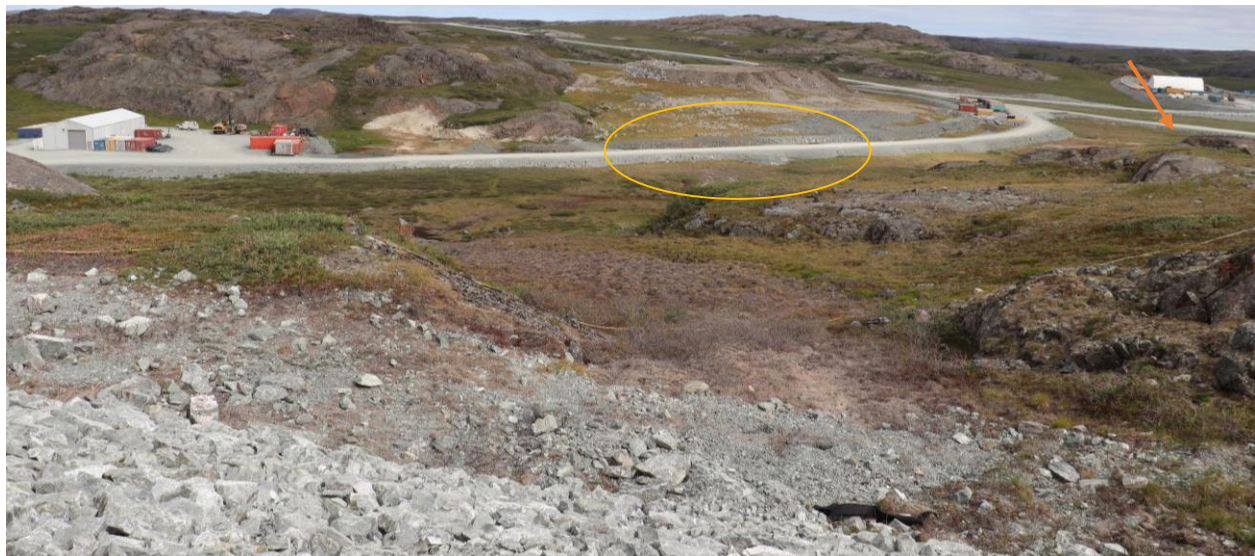
Photo 57: Looking northeast from Madrid Waste Rock Pad: Naartok East CPR Overburden Stockpile and Naartok CPR in the Distance

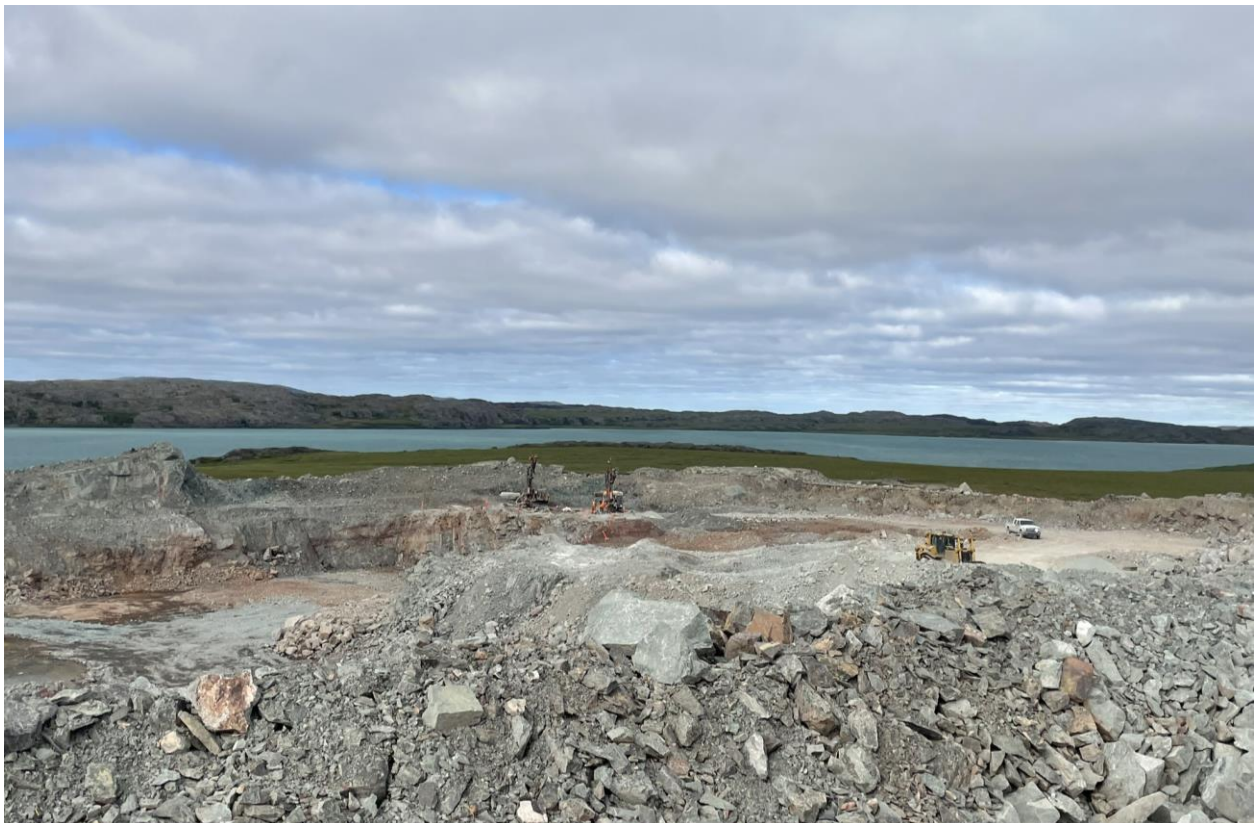
Photo 59: Construction of Saline Water Storage Pond at Quarry D
