APPENDIX F RASCAL STREAM WEST CROSSING CONSTRUCTION SUMMARY REPORT

Rascal Stream West Crossing Construction Summary Report

Back River Project (B2Gold Back River Corp.)

22567626-163-R-Rev0-8000

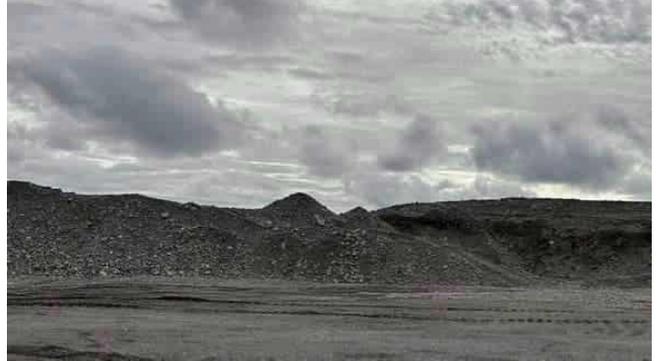
Channel substrate for the main channel culverts and secondary channel culvert was specified to be excavated native channel substrate. The excavated channel substrate was deemed unsuitable for the culvert channel substrate due to high saturation and esker material was substituted. The esker material placed was observed to be undersized gravelly cobbles with an approximate D_{50} of 75 mm and is a modification from the design specifications. WSP recommends monitoring the channel substrate for channel migration and erosion within the main channel culverts and secondary channel culvert and completing repairs as required.

Photo 2: Proposed Substitute Material for Channel Substrate 09:30.

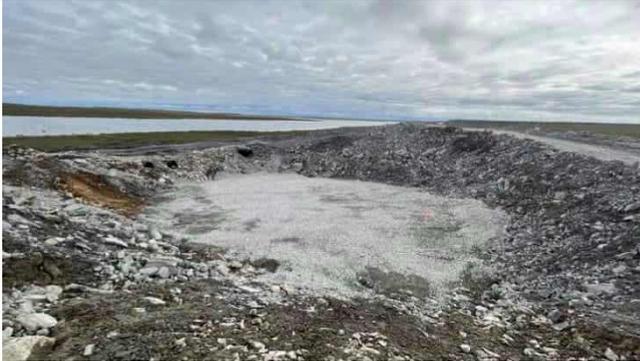
Photo 3: Prepared Segment of The Culvert Bedding at 08:40.

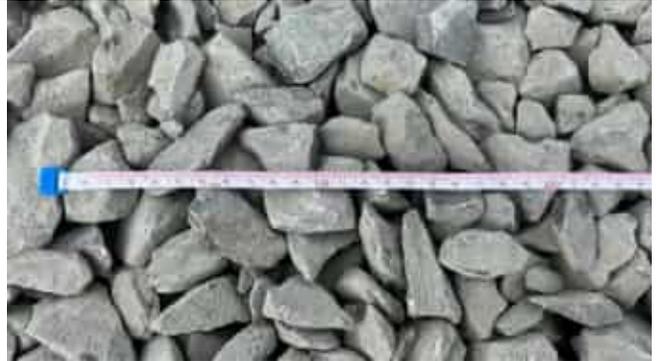
The bedding material used for the main channel culvert construction, 2-inch clear crush, is a modification from the design specifications. Based on visual observations, the material is poorly graded with no fines, and the maximum particle size exceeds 25 mm. The gradation of the 2-inch clear crush was not provided to WSP for approval. The modification from the design specifications may result in modified foundation loading from the culvert to the design from Armtec. WSP recommends notification to Armtec and monitoring for culvert deformation.

Photo 4: Measurement of The Bedding Material

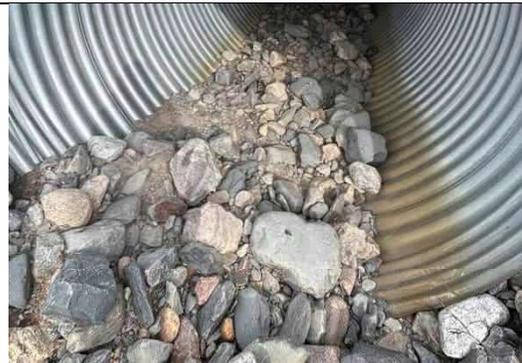
The channel embedment depth for the secondary channel culvert was specified to be 960 mm. The constructed embedment depth was observed to be approximately 310 mm on September 17, 2023 and is a modification from the design specifications. This is not anticipated to adversely affect the conveyance capacity of the secondary channel culvert. However, WSP recommends including the secondary channel culvert in future fish monitoring programs.

Photo 6: Minimal channel substrate was identified inside the secondary culvert

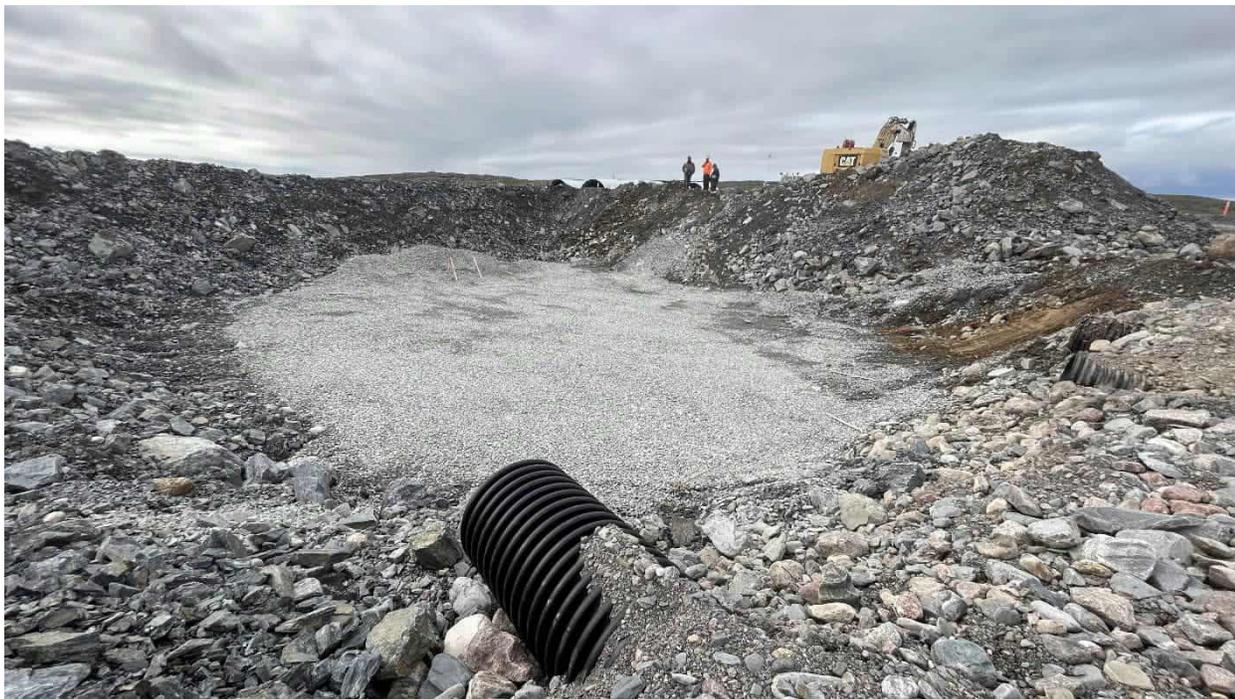
Photograph 1: Main Channel Excavation Extents and Bedding Layer Looking Upstream. Taken August 5, 2023

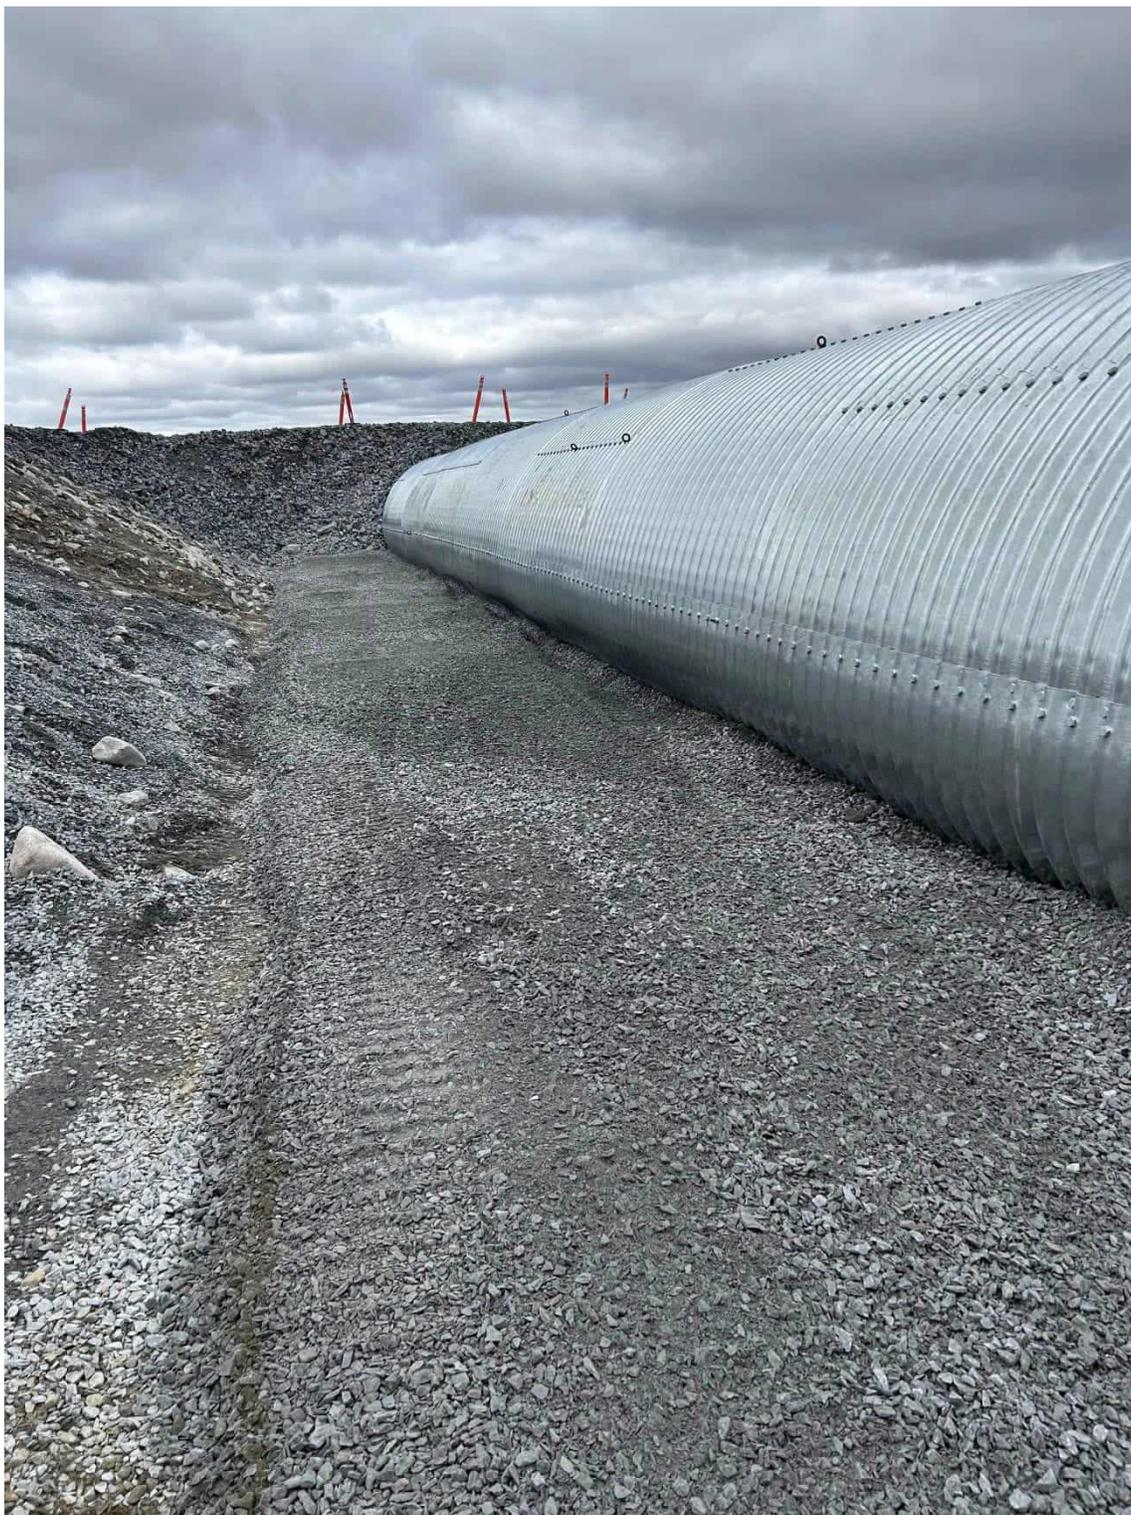
The specifications for the backfill material used for the main channel culvert construction were not provided to WSP. Based on photographs provided by B2Gold Nunavut, the material appears to be 1-inch crushed aggregate, however, based on information received from B2Gold Nunavut (Richards 2023), the material used was 2-inch clear crush, which is a modification from the design specifications. The modification from the design specification may result in unsatisfactory material compaction and load bearing. WSP recommends notification to Armtec and monitoring for culvert deformation and road subsidence.

Photograph 5: Start of Backfill Placement for Main Channel Culverts. Taken August 21, 2023 (Provided by B2Gold)

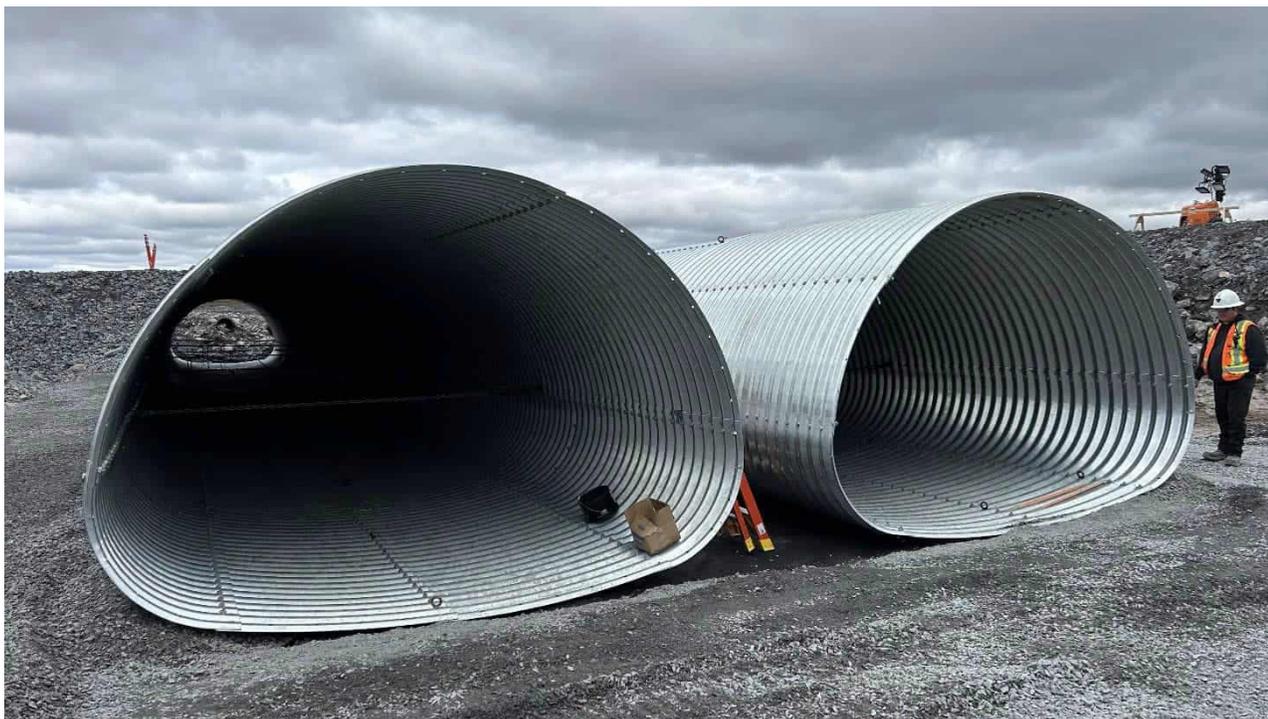
Photograph 6: Geotextile Placed Below Main Channel Cuvlerts and Backfill at Culvert Inlets. Taken August 21, 2023 (Provided by B2Gold)

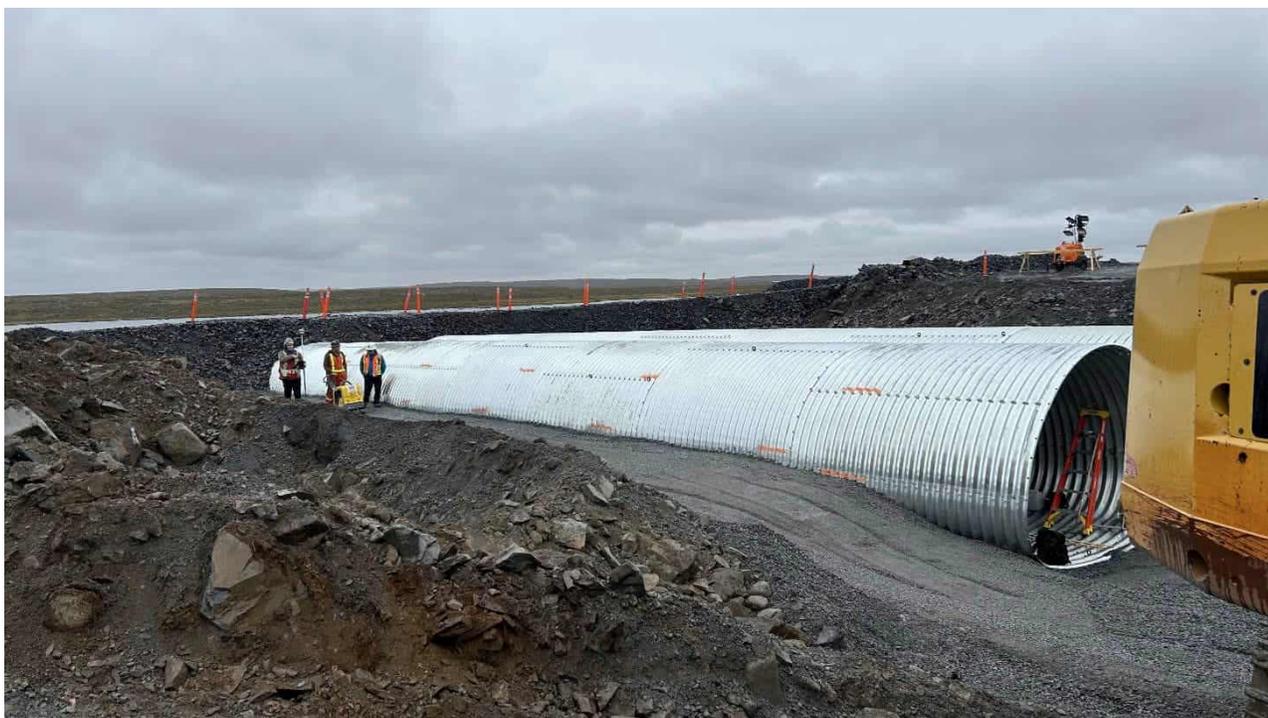
Photograph 7: Main Channel Culverts Backfill Placement and Compaction to Approximately 900 mm Above Culvert Invert. Taken August 22, 2023 (Provided by B2Gold)

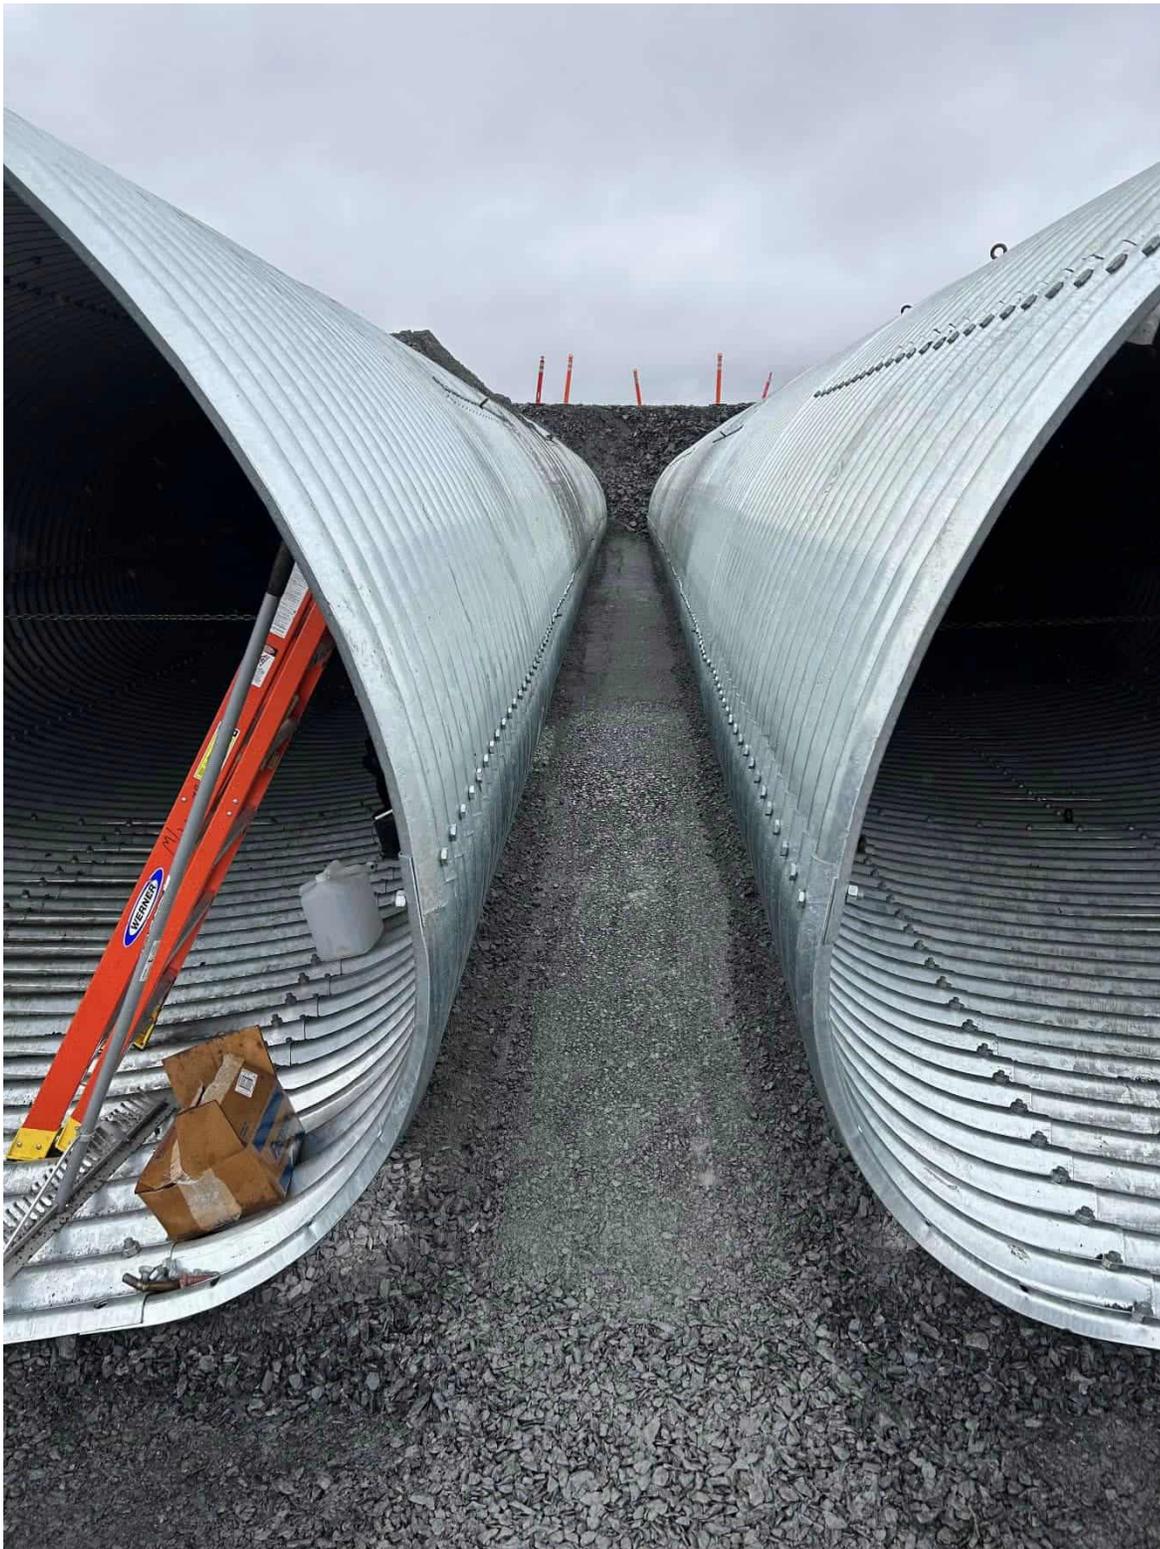
Photograph 8: Backfill Placement and Compaction Between the Main Channel Culverts. Taken August 22, 2023 (Provided by B2Gold).

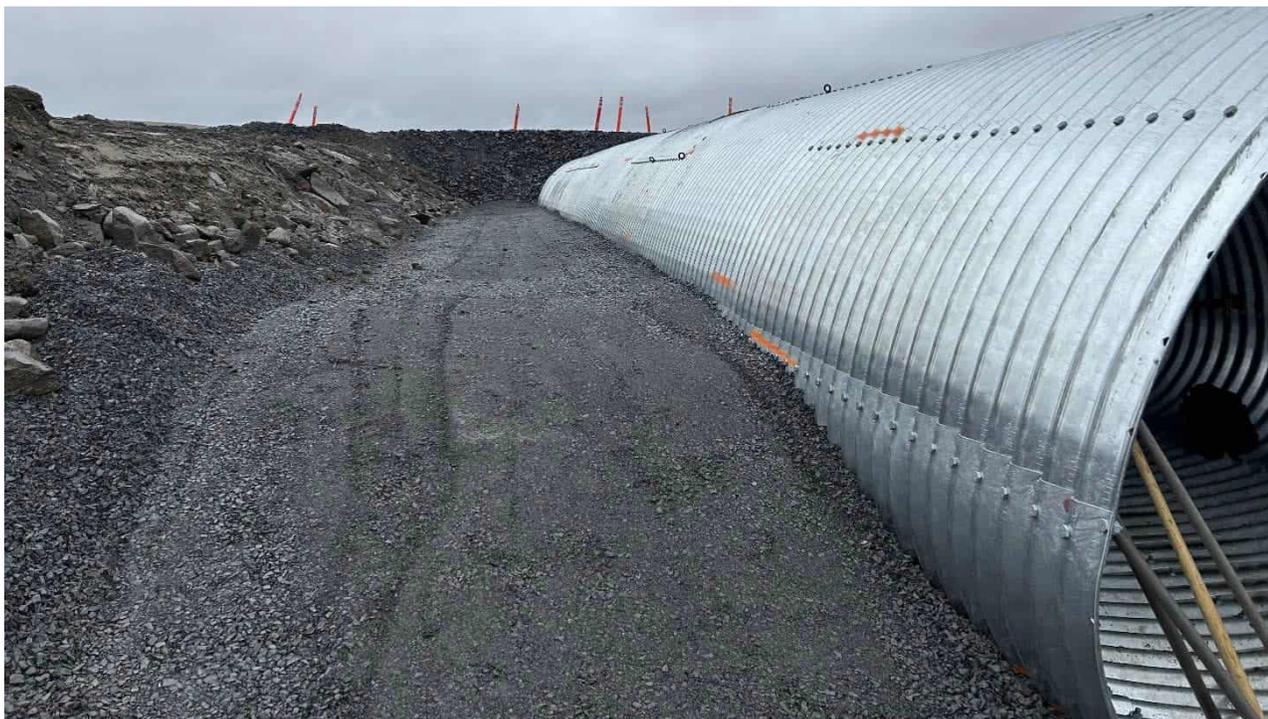
Photograph 9: Main Channel Culvert Left Barrel Backfill Placement and Compaction to Approximately 900 mm. Taken August 22, 2023 (Provided by B2Gold).

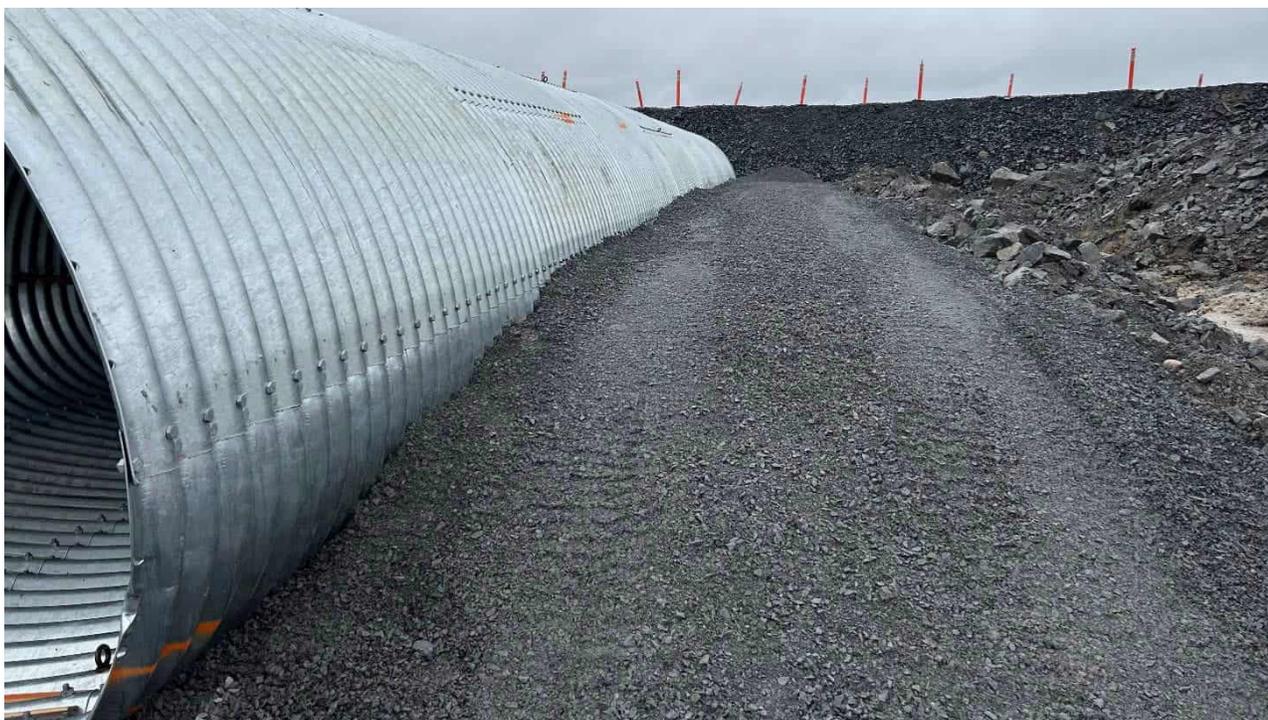
Photograph 10: Main Channel Culvert Right Barrel Backfill Placement and Compaction to Approximately 900 mm. Taken August 22, 2023 (Provided by B2Gold).

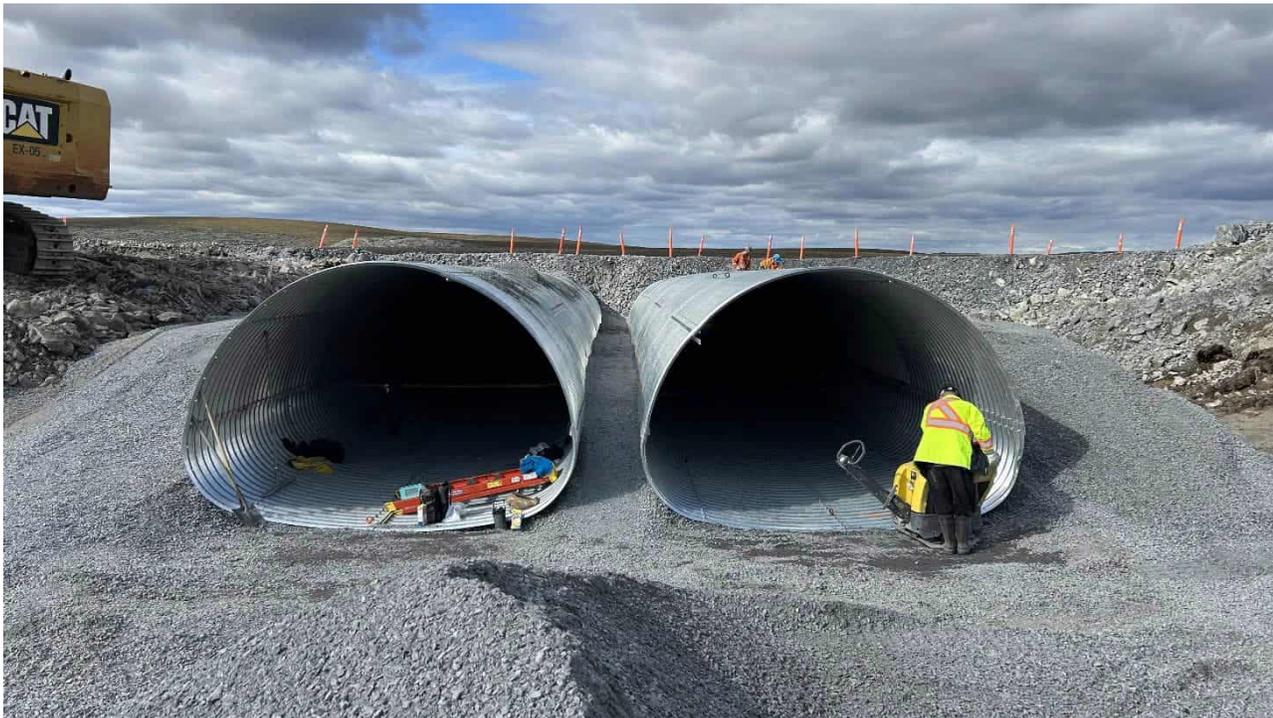
Photograph 11: Main Channel Culverts Inlets and Backfill Placement and Compaction. Taken August 23, 2023 (Provided by B2Gold).

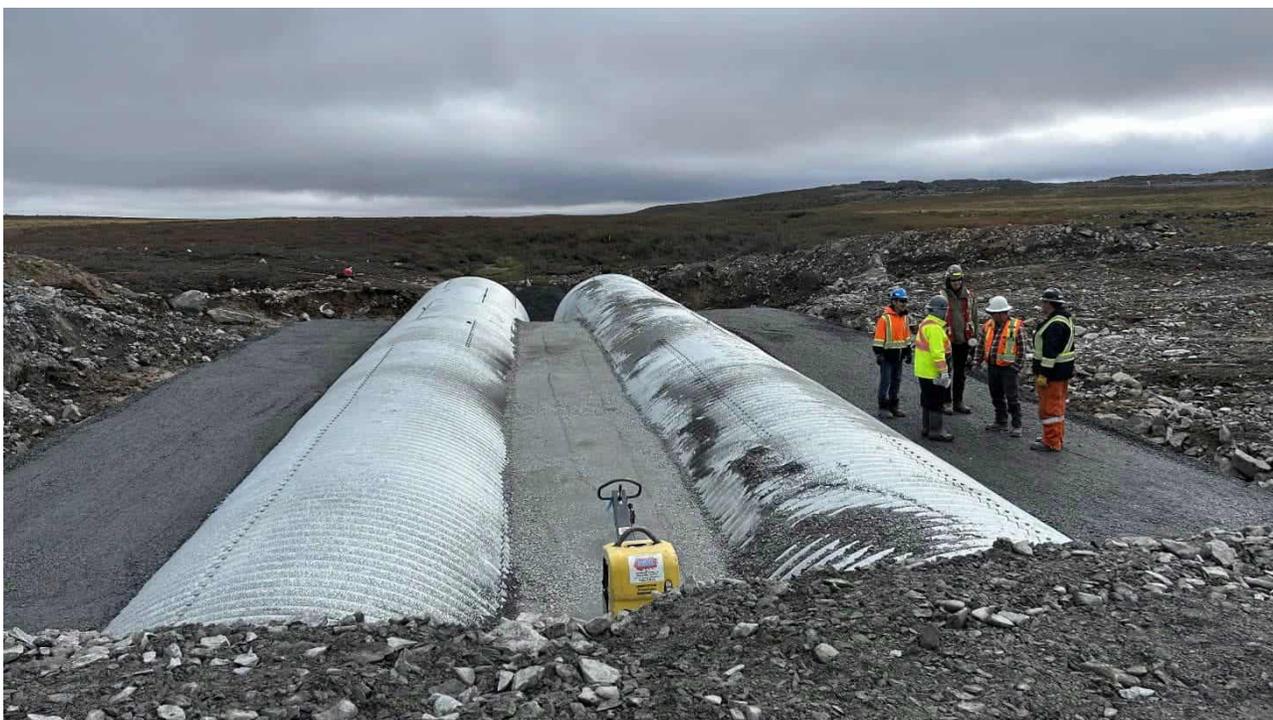
Photograph 12: Main Channel Culverts Backfill Placement and Compaction to Approximately 2400 mm Looking Upstream. Taken August 24, 2023 (Provided by B2Gold).

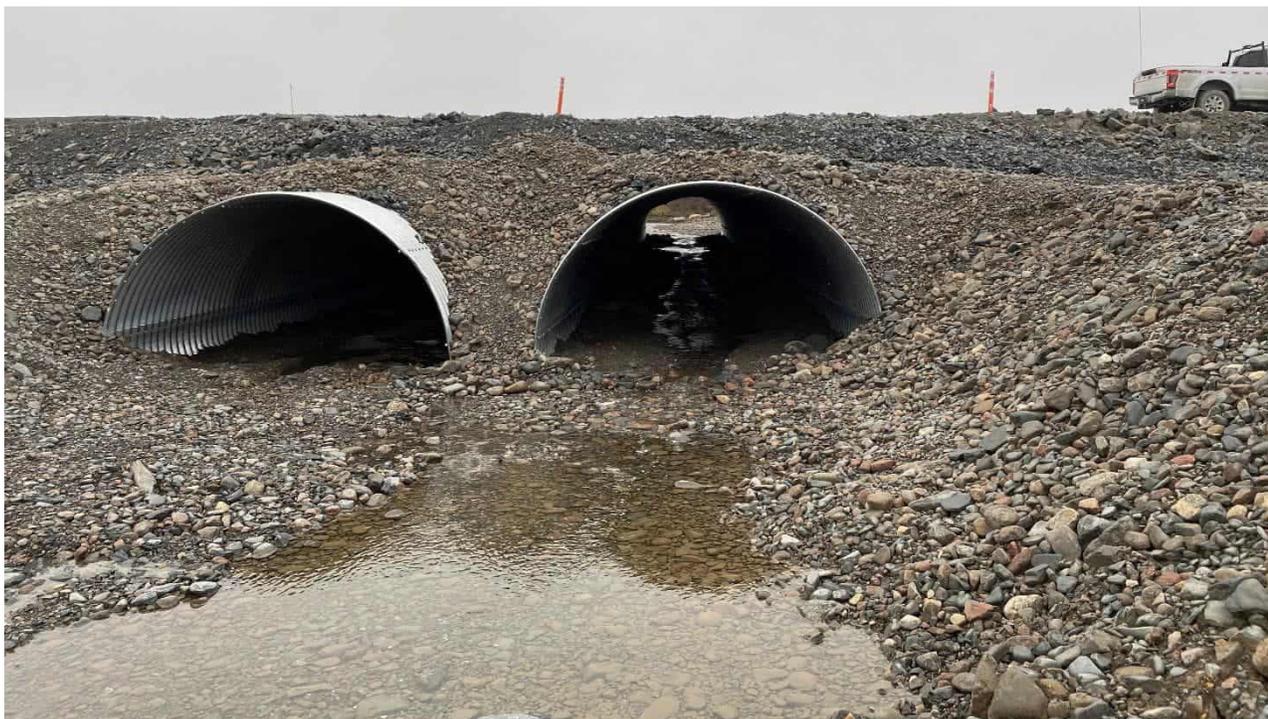
Photograph 13: Main Channel Culverts Looking Upstream from Downstream Apron, Taken September 17, 2023

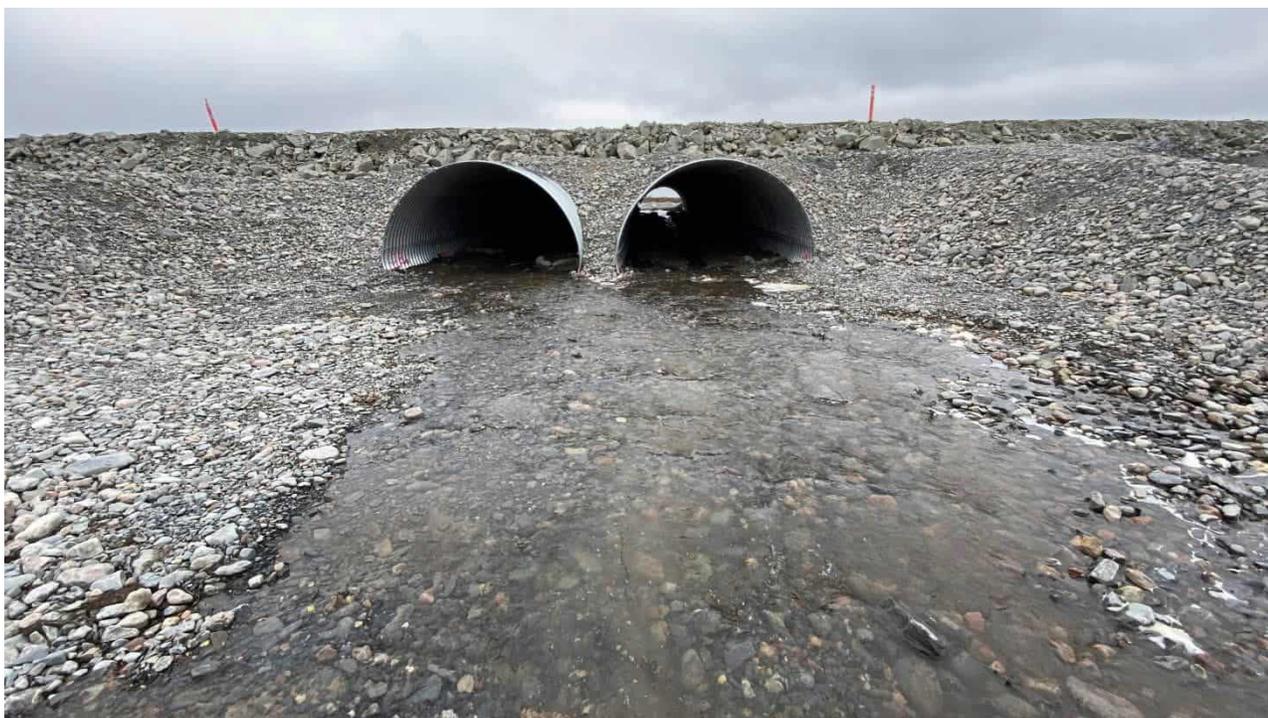
Photograph 14: Main Channel Culverts Looking Downstream from Upstream Apron, Taken September 17, 2023

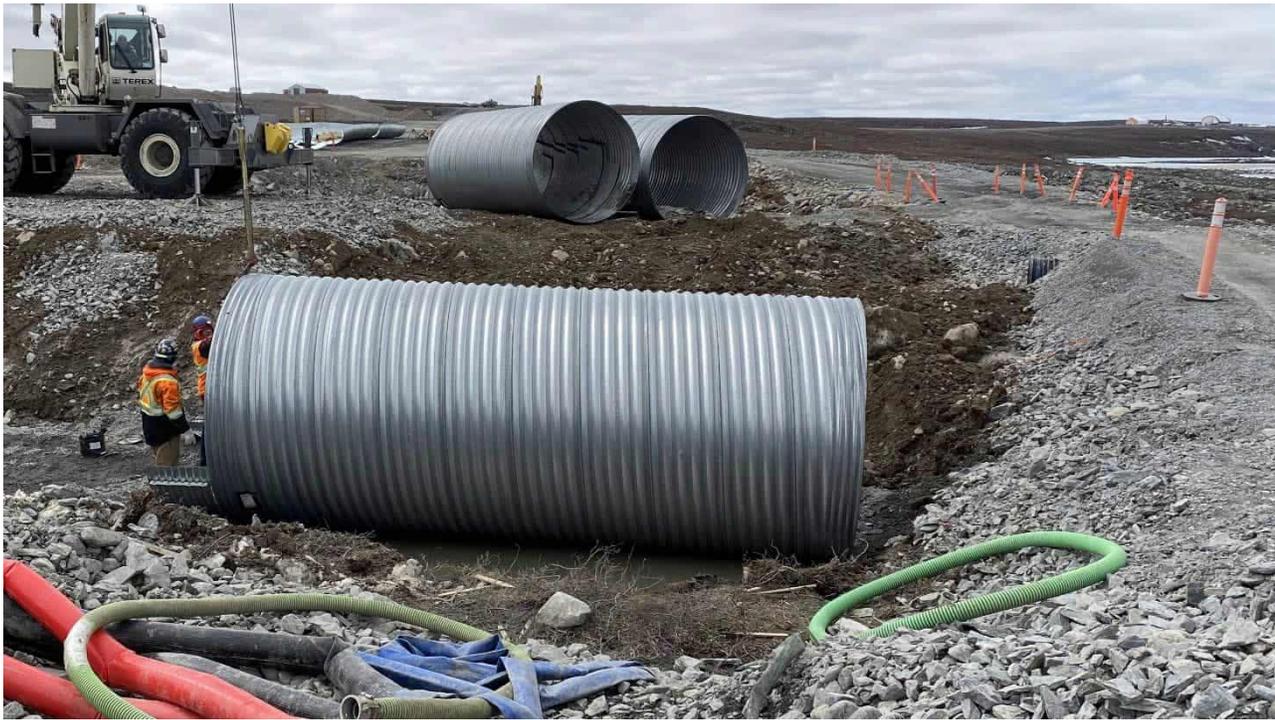
Photograph 19: Secondary Channel Culvert Outlet Placement on Bedding Material, Taken May 11, 2023

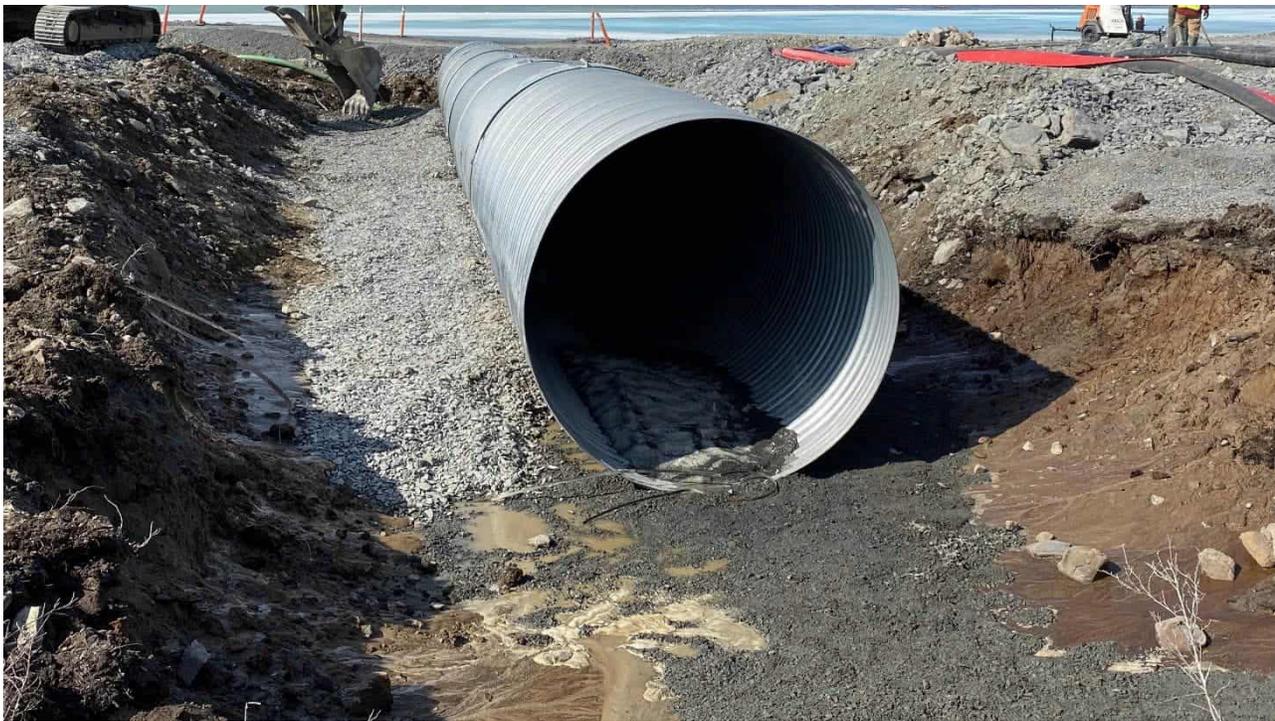
Photograph 20: Secondary Channel Culvert Inlet Placement on Bedding Material, Taken May 11, 2023

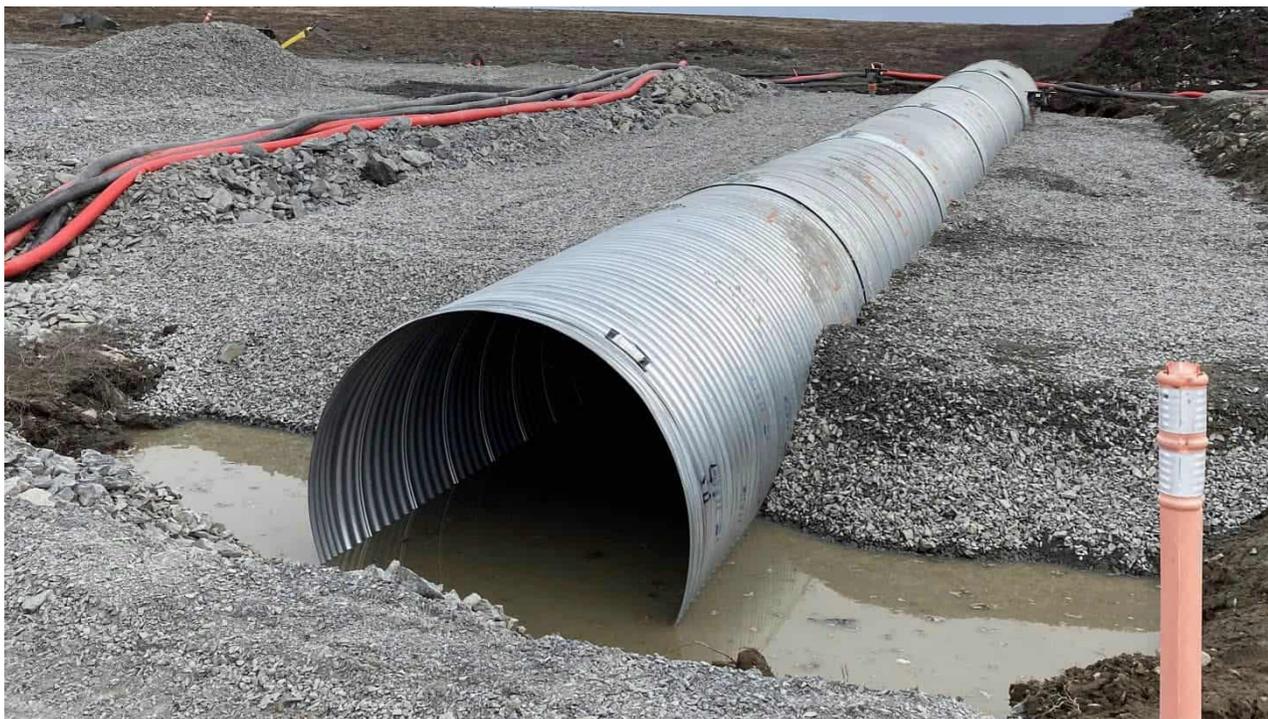
Photograph 21: Secondary Channel Culvert Backfill Placement with Approximately 900 mm on Left Downstream Wall From Outlet at Left Downstream Bank, Taken May 13, 2023

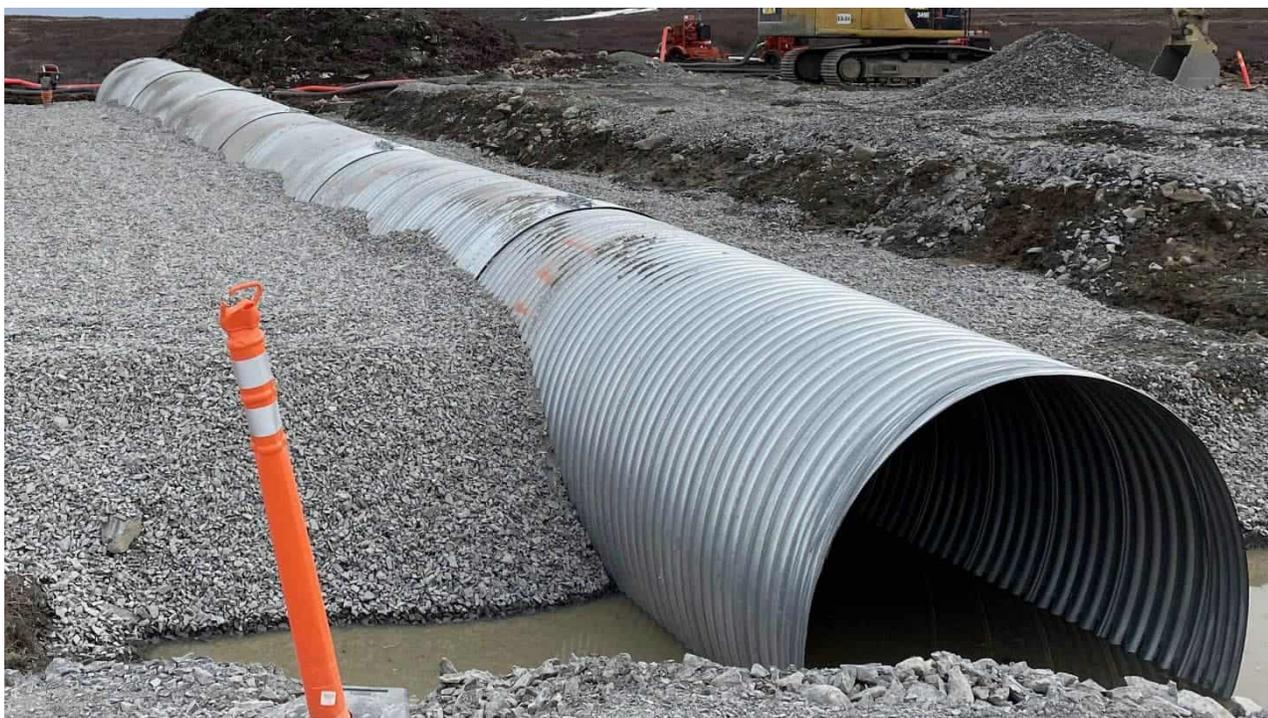
Photograph 22: Secondary Channel Culvert Backfill Placement with Approximately 1500 mm on Right Downstream Wall From Outlet at Right Downstream Bank, Taken May 13, 2023

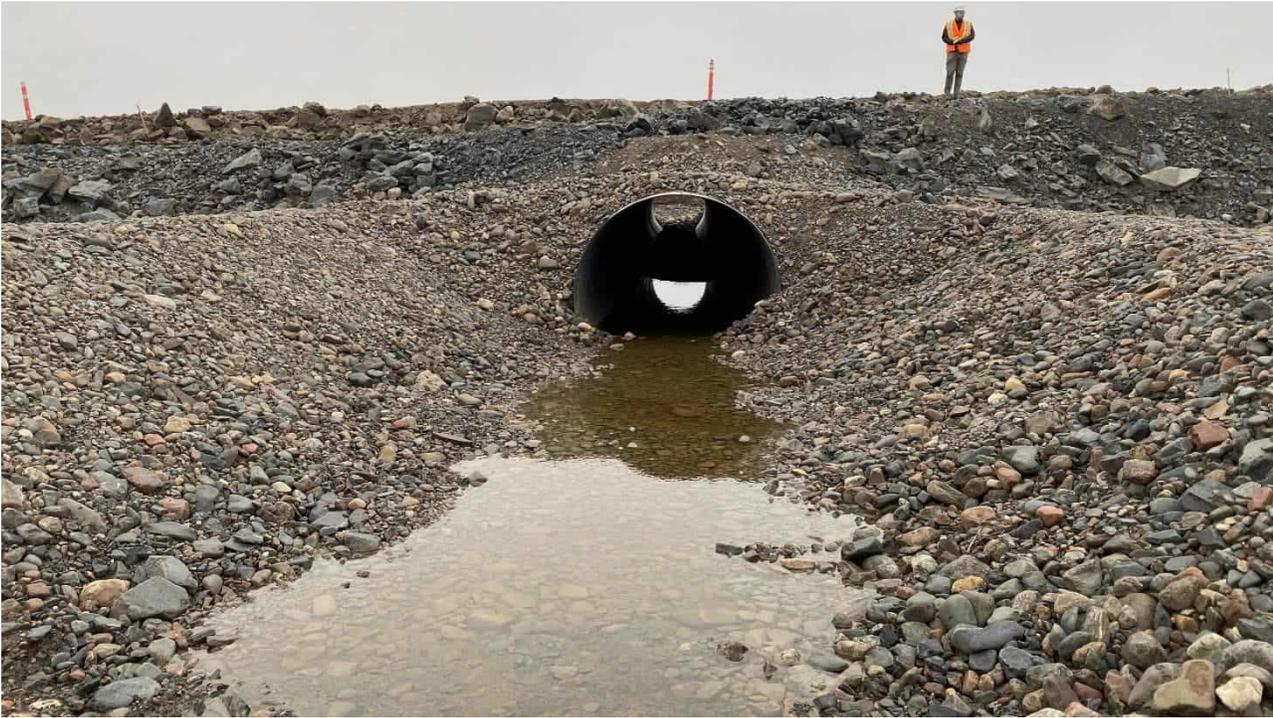
Photograph 23: Secondary Channel Culvert Looking Upstream from Downstream Apron, Taken September 17, 2023

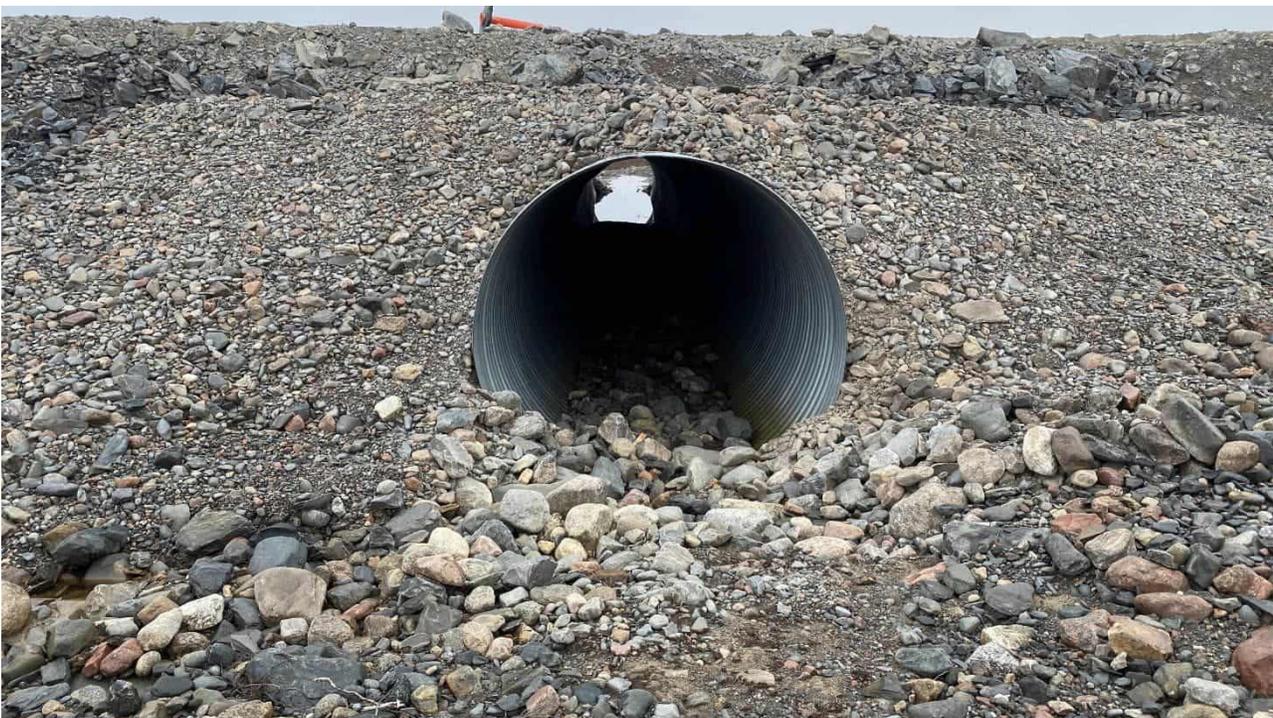
Photograph 24: Secondary Channel Culvert Looking Downstream from Upstream Apron, Taken September 17, 2023
