Nunavut Impact Review Board

2022 June Site Visit Report

The Mary River Project

Baffinland Iron Mines Corporation

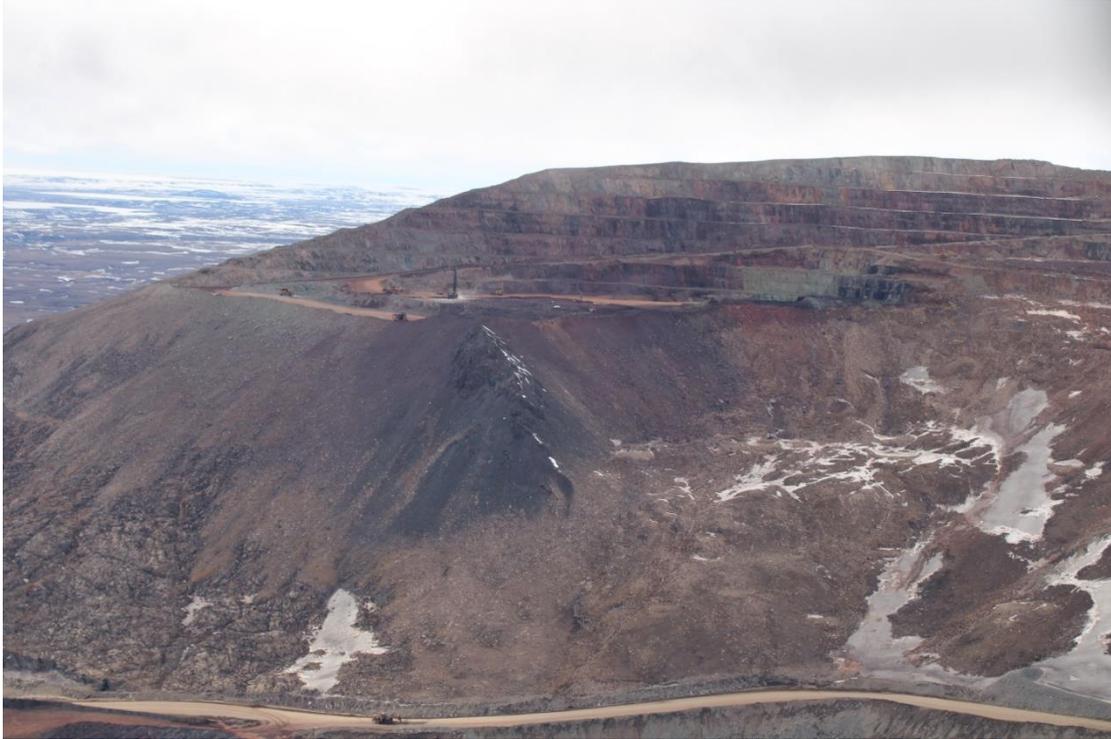
Photo 5: Aerial View of Deposit No. 1

NIRB staff visited the Deposit No.1 pit and noted that ore extraction and mining activities were ongoing. Since the last site visit in 2020, NIRB staff observed the active mining location within the pit had changed. As a result, Baffinland has moved the Mine site haul road to be closer to the active face to ensure safe access and shorter distances for haul trucks to travel.

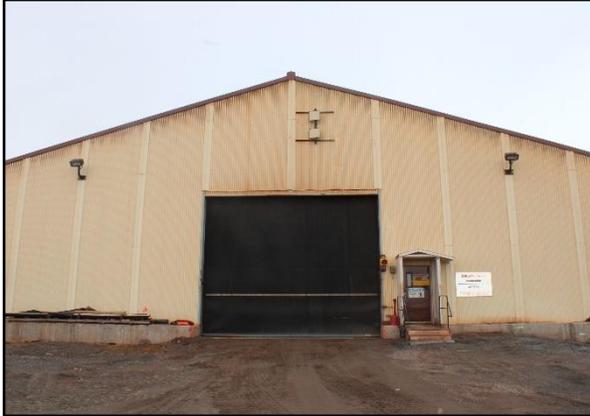
Photo 21: Incinerator Building at Mary River Mine Site.

The incinerator facility at the Mary River Mine Site (Photo 21) remains well maintained and organized for dispensing of oils and other maintenance fluids (Photo 22). Most waste materials were observed to be segregated into labelled bins (Photo 23 & 24) for incineration or for backhaul off site.

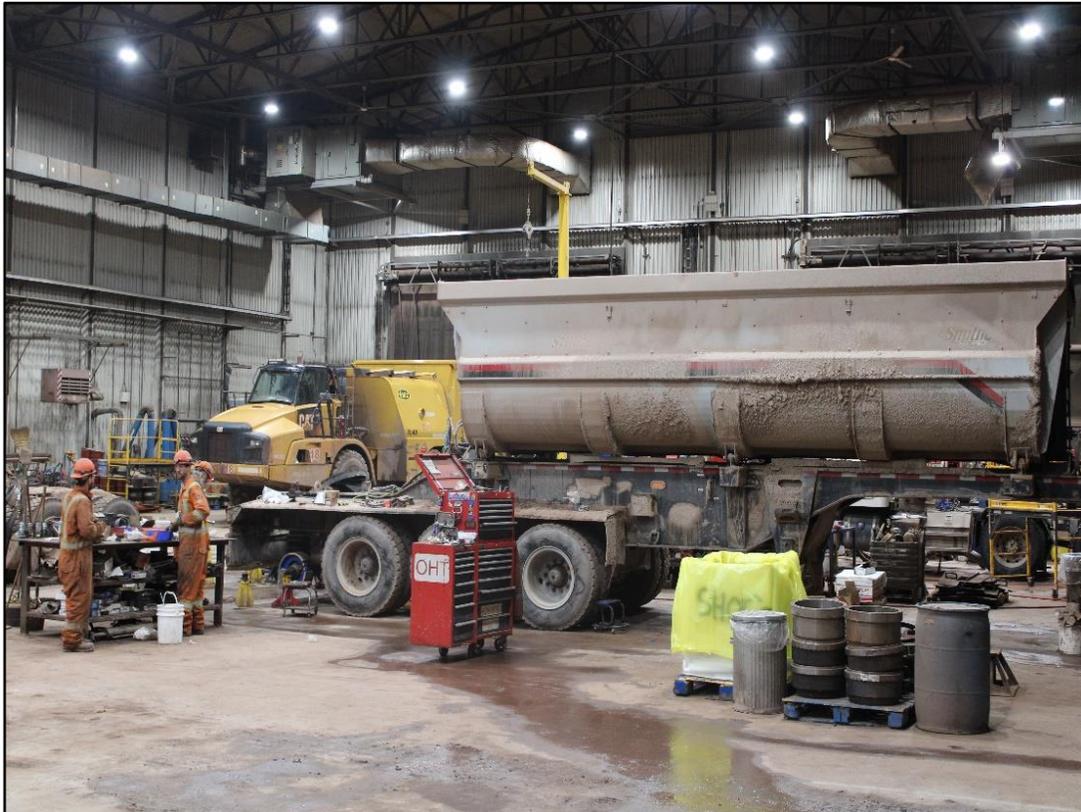
Photo 27: Inside of Maintenance Shop at Mary River Mine Site.

NIRB staff also visited various vehicle and equipment maintenance shops on site where regular maintenance is performed on everything from light vehicles to Ore Haul Trucks and Mining Vehicles (Photo 27). NIRB Staff were also able to observe the new, more energy efficient diesel generators that were installed on site to replace the previous aging generators (Photo 28) as Baffinland has been transitioning to new generators. The shops and generator buildings were clean, well-organized, and generally well maintained.

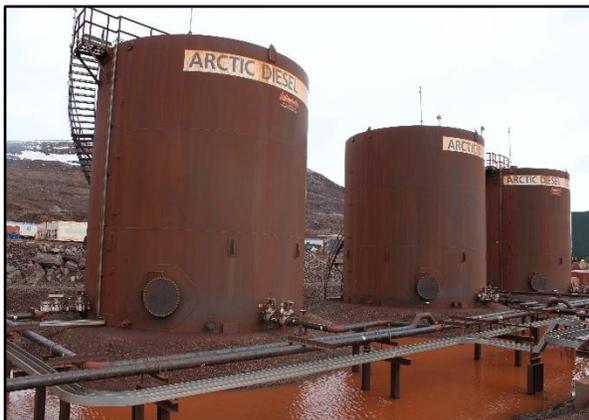
Photo 29: Mary River Mine Site Fuel Tank Farm.

While touring the site, NIRB staff observed the fuel tank farm and the secondary containment facilities in place for Baffinland staff to fuel up vehicles (Photo 29). Baffinland employees were in the process of managing the meltwater and the Tote Road was a priority for water management during the freshet. Baffinland's spill response equipment stored near the Emergency Response Team garage for quick access in case of a spill (Photo 30).

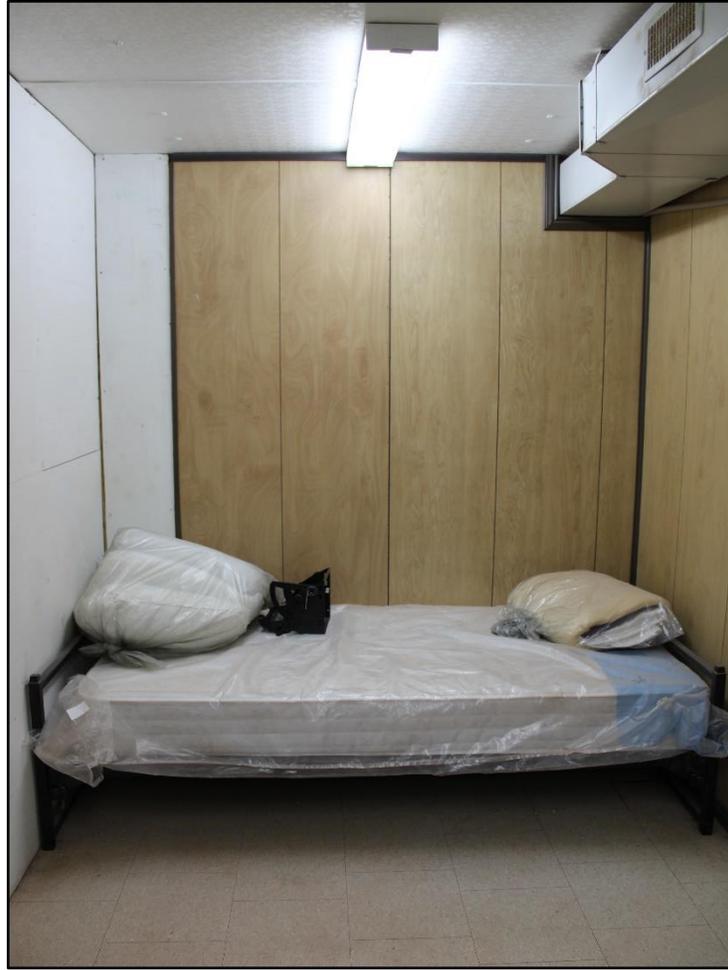
Photo 33: Inside of Emergency Shelter at KM 66.

On the return trip, NIRB staff made several stops along the road to observe the condition of emergency shelters (Photo 33), water passage through various culverts (Photos 34 & 35). At culvert CV-059, NIRB staff were able to observe a culvert that was still frozen, blocking the flow of water (Photo 36). As a result, Baffinland staff had installed a temporary diversion to allow water to continue flowing and prevent road washouts (Photo 37). NIRB staff also observed various dust fall stations which were installed at multiple heights (Photo 38 & 39) to reflect discussions from the Terrestrial Environment Working Groups on capturing a better estimate of dust accumulation on ground level.

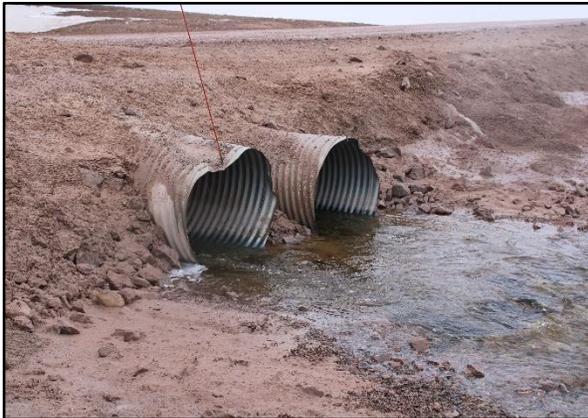
Photo 34: Culvert CV-104 Along the Tote Road.

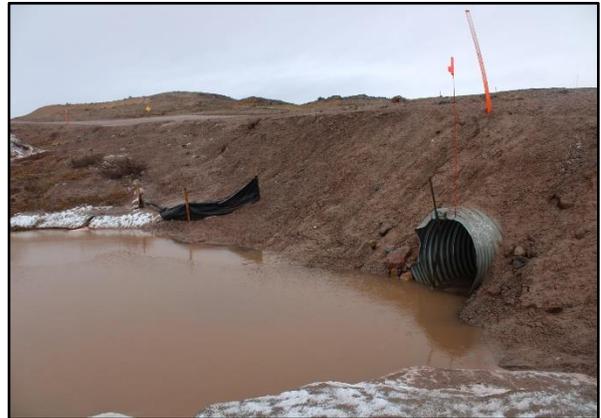
Photo 35: Culvert BG-29 Along the Tote Road.

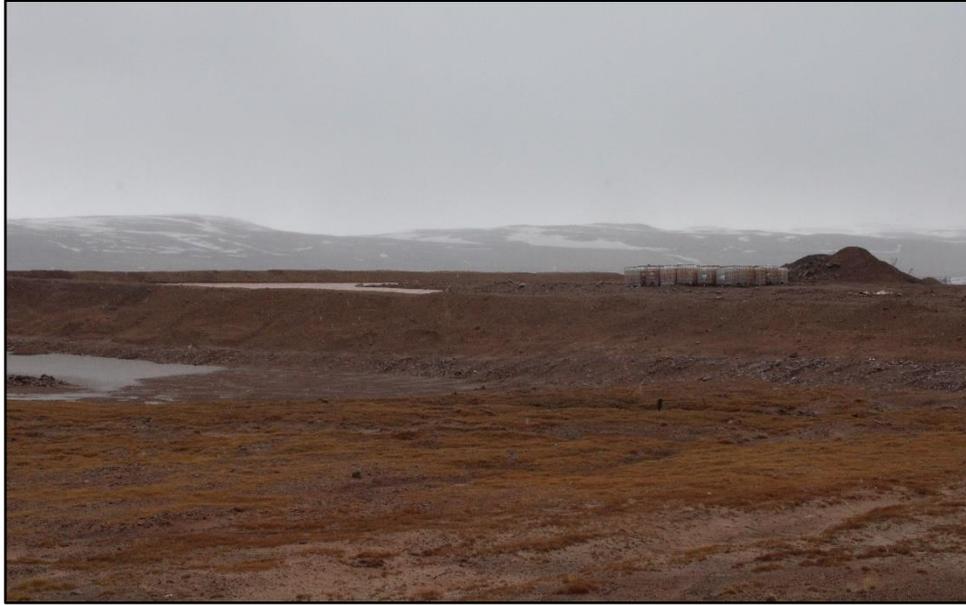
Photo 40: Landfarm at Milne Port.

NIRB staff visited the landfarm facility and with it being early in the spring Baffinland had yet to turn over the soil for 2022. NIRB staff will follow-up during the summer site visit to observe progress made to the facility in accordance with Baffinland's *Hazardous Materials and Hazardous Waste Management Plan* management plans (Photo 40).

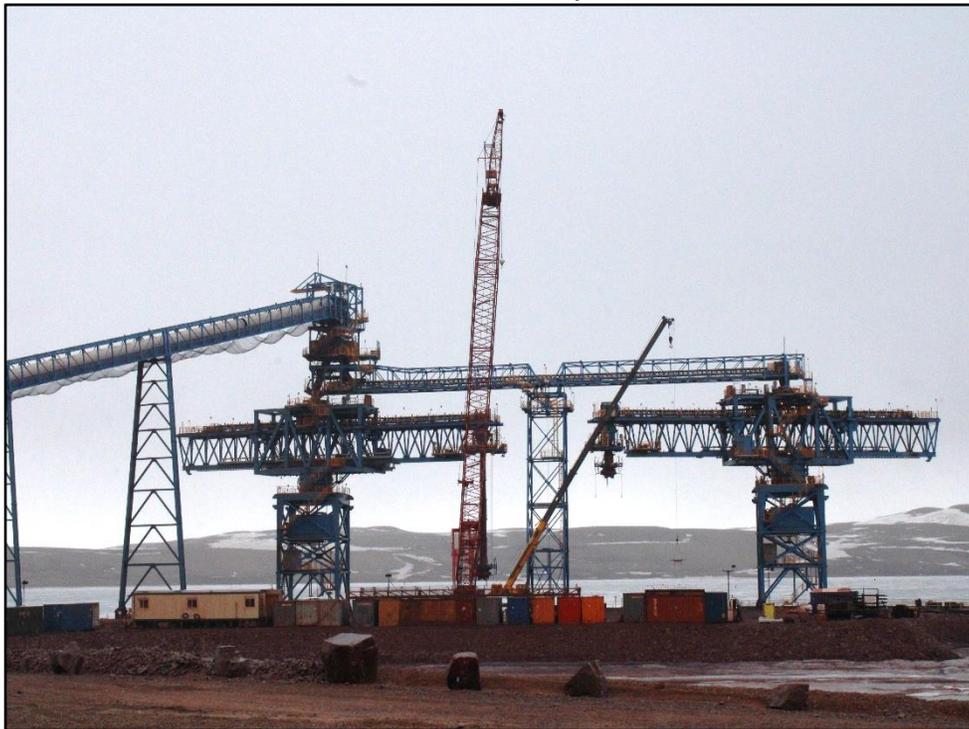
Photo 42: Ore Dock.

NIRB staff toured the Ore Stockpile (Photo 41) and the Ship Loader Facility (Photo 42). The Ore Dock and Ship Loader were not in operation at the time of the visit; however, Baffinland staff had started working on them for the upcoming shipping season. During ore stockpiling activities, there was noticeable dust produced from the transfer point between the conveyor and the stockpile (Photo 43), resulting in dust being blown into the environment.

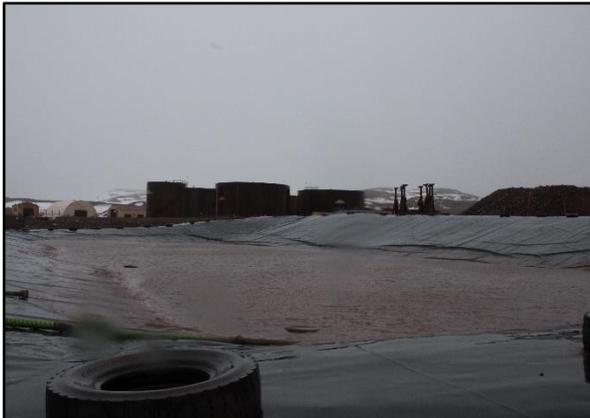
Photo 45: Sedimentation Ponds at Milne Port.

NIRB staff also observed the sedimentation ponds that are adjacent to the ore stockpile (Photo 45) where contaminated water is stored, allowed to settle before being treated and tested for release. With the weather beginning to warm-up on site and these sedimentation ponds beginning to thaw, and NIRB staff were able to observe Baffinland's Environment Team performing grab sampling to test the water from the ponds (Photo 46).

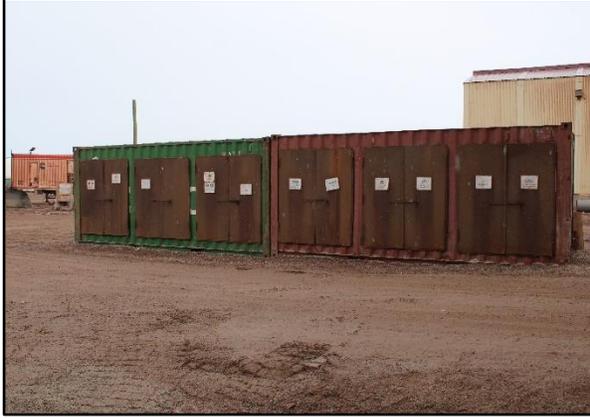
Photo 47: Waste Sorting at the Milne Port Incinerator Facility.

NIRB staff visited the Incinerator and Waste Management Facility at Milne Port and noted that the facility appeared to be following appropriate waste segregation practices (Photo 47) and to be clean and well-maintained (Photo 48).

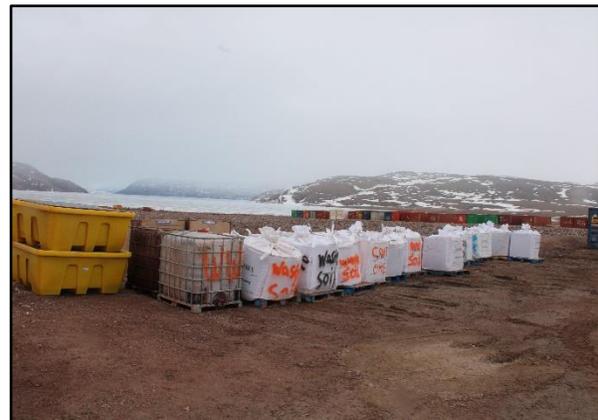
Photo 54: Milne Port Hazardous Waste Storage Area.

NIRB staff visited the Fuel Tank Farm and noted that the facility appeared to be well maintained and organized (Photo 53); however, there was water ponding in the berm and this is expected during freshet and would be removed once tested. At the same time, the NIRB staff also observed the Hazardous Waste Storage Area (Photo 54). The area is surrounded by a berm, has spill response equipment available and is fully lined in case of any spills. The area is also a fenced and gated to provide control over access to the storage of hazardous waste and to ensure that fluids are stored properly prior to back-hauling.

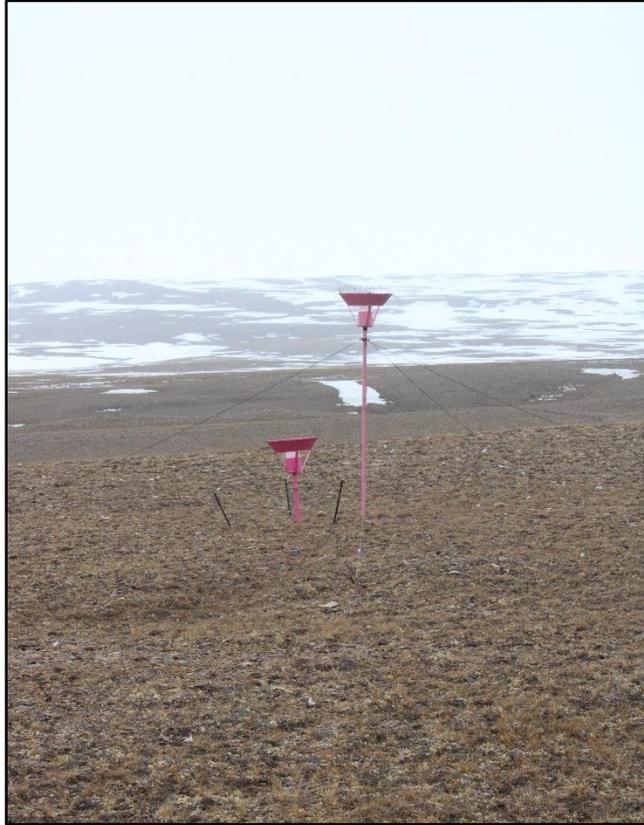
Photo 55: Dust Fall Monitoring Stations Located Along the Tote Road.

Dust management and monitoring plans were followed up on during the site visit pursuant to Terms and Conditions 10 and 58 pursuant to the NIRB's Project Certificate No. 005. During the drive along the Tote Road, NIRB staff observed several dust-fall monitoring stations (Photo 55).

Dust emissions have been an ongoing issue at the Mary River site since 2014 and continuous efforts have been made to lower the amount of dust being generated. For example, hoods, shrouds, and bellows have been added to the crusher system and various liquid products applied to the Tote Road and Ore Stockpile in an effort to contain but success has been limited, especially with regards the ore stockpile area at Milne Inlet. The amount of both road dust and ore dust was considerably lower than previous site visits; however, it was raining during the June 2022 site visit. NIRB staff anticipate that the wet conditions helped to reduce dust at the time of the visit and the NIRB will complete follow-up observations to obtain a more accurate indication of dust emissions on site in August 2022.
